ERDC/CERL TR-01-11

Structural Evaluation of Aircraft Hangar 46, Corpus Christi Army Depot

Ghassan K. Al-Chaar, Daniel J. Randolph,
Gregory E. Lamb, and Pramod J. Desai

February 2001

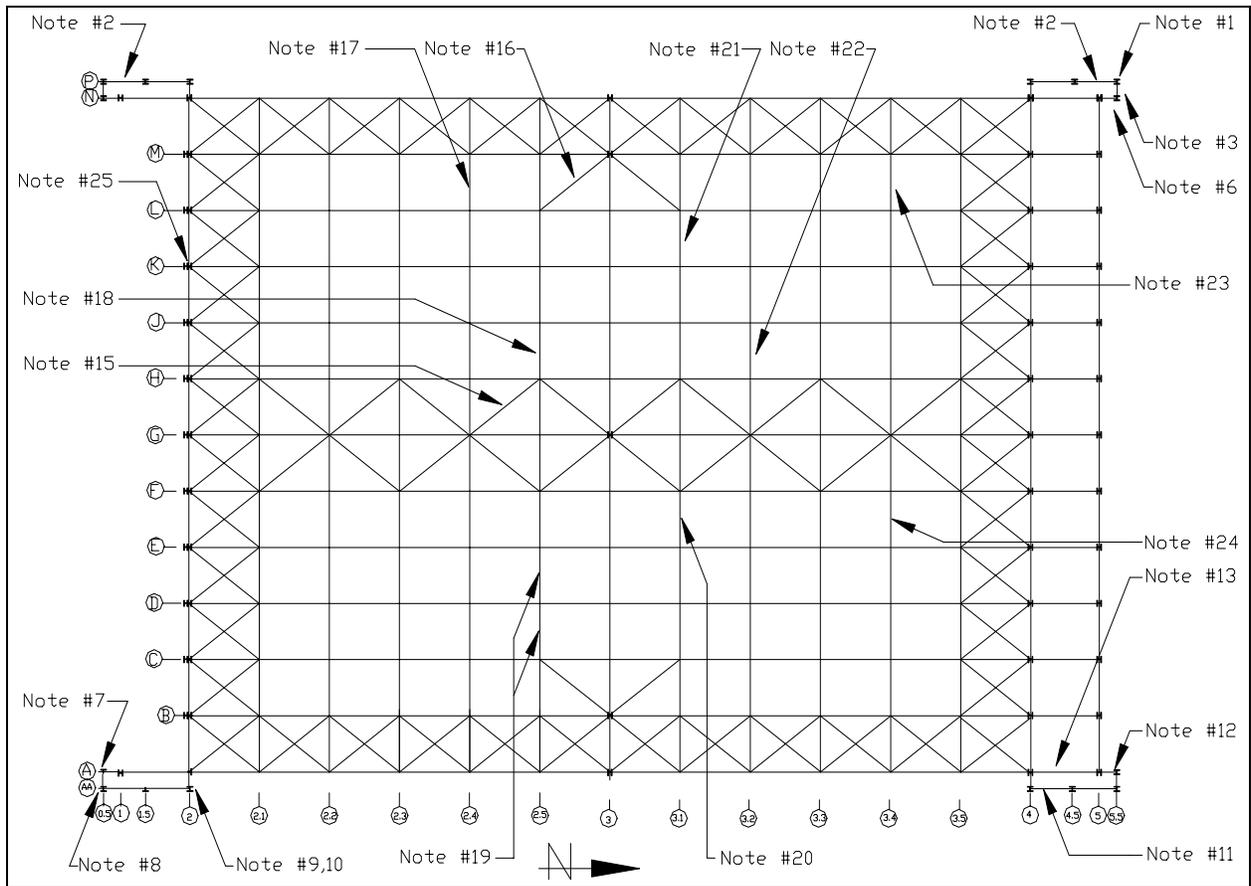
Figure 2-3. Locations of deficient structural members.

The following notes on specific deficiencies were recorded from observations made during the inspection. These notes are related to strength reduction and in many cases indicate the need for repairs. For location of members on a plan view of the hangar, see Figure 2-3. Notes in parentheses indicate member size.

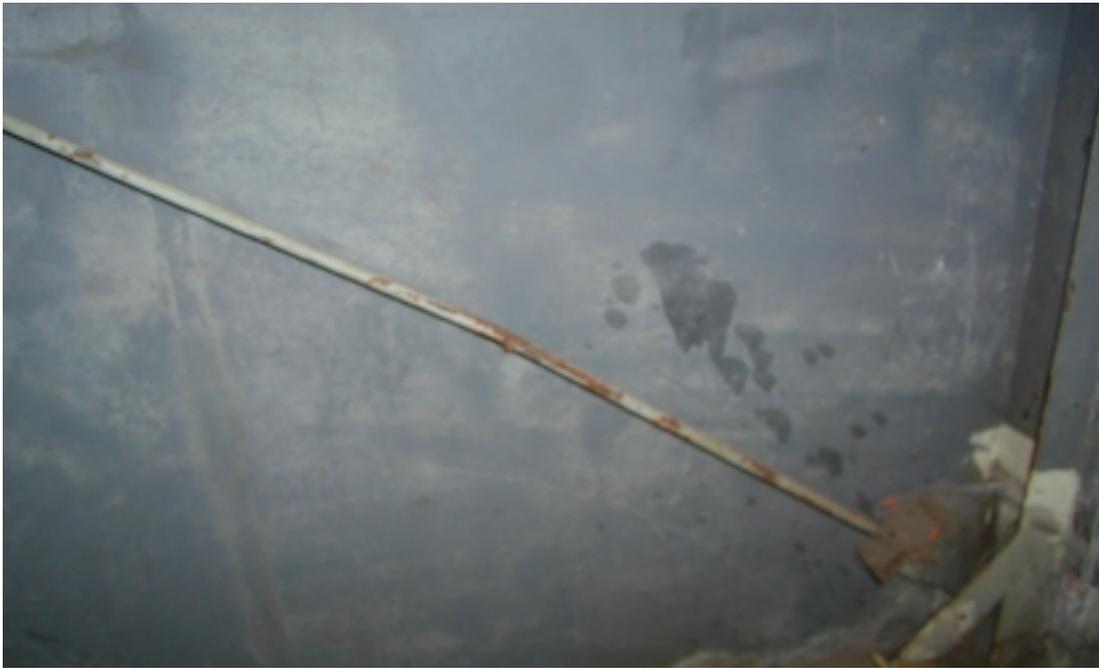
1. Tie rod (7/8 in. diameter) located at column P5.5, is bent. See Appendix A, Figure A-1.
2. Tie rods (7/8 in. diameter) located at columns P0.5, P1.5, P4.5, and P5.5 are loose.
3. Horizontal brace (10-I-21) located at second floor, between columns P5.5 and N5.5, is buckling. See Figure A-2.
4. Hangar door wheels are rusting and deteriorating. See Figure A-3.
5. Vertical members by handles on hangar doors are dented, likely resulting from opening doors with hooks and chains.
6. Concrete is spalling at column N5.5 (8-H-31). See Figure A-4.
7. Spalled concrete allowed major corrosion of column A0.5 (8-H-31), resulting in an estimated strength reduction of up to 30 percent. See Figure A-5.
8. Minor corrosion was found at the base of column AA0.5 (12-I-25).

Figure A-1. Buckled tie rod (7/8 in. diameter) near Column P5.5.

1. Replace the bent tie rod (7/8 in. diameter) attached to column P5.5 with identical or larger member that has the same connection details with same configuration of bolts and welds.

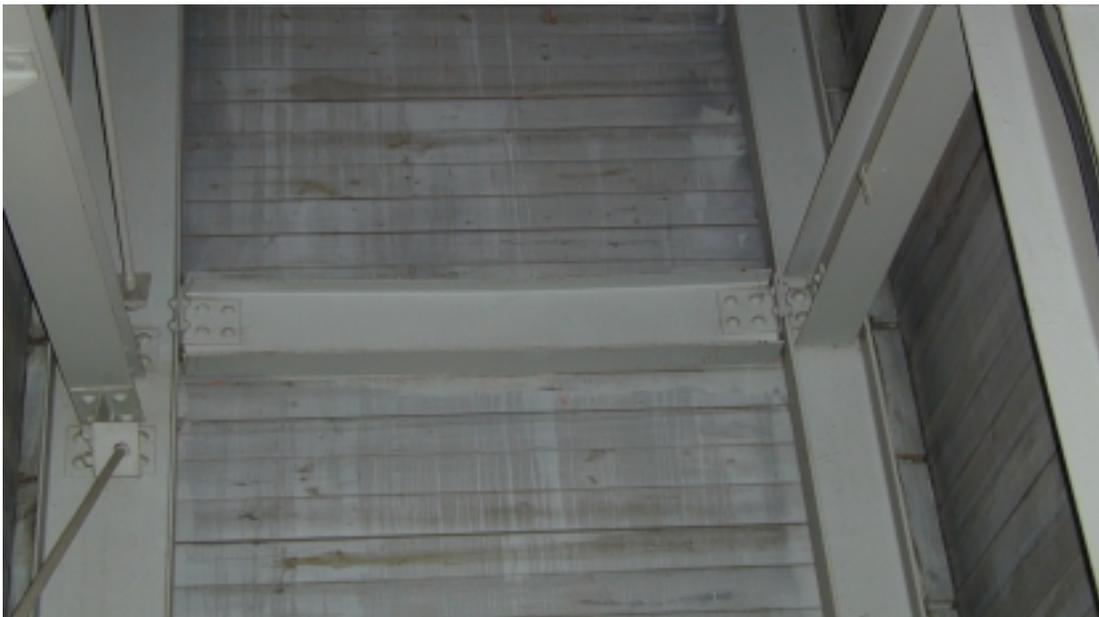
Figure A-2. Buckled horizontal brace (10-I-21), second floor between Columns P5.5 and N5.5.

2. Tighten or replace loose tie rods (7/8 in. diameter) attached to columns P0.5, P1.5, P4.5, P5.5.
3. The buckling horizontal brace (10-I-21) on the second floor, between columns P5.5, N5.5, is not designed for compression, but has been acting as a compression member. This brace is considered to be a secondary member. It would be possible to increase stiffness and strength through retrofit, but this would make connections more vulnerable to failure. Therefore, no retrofit is advised.

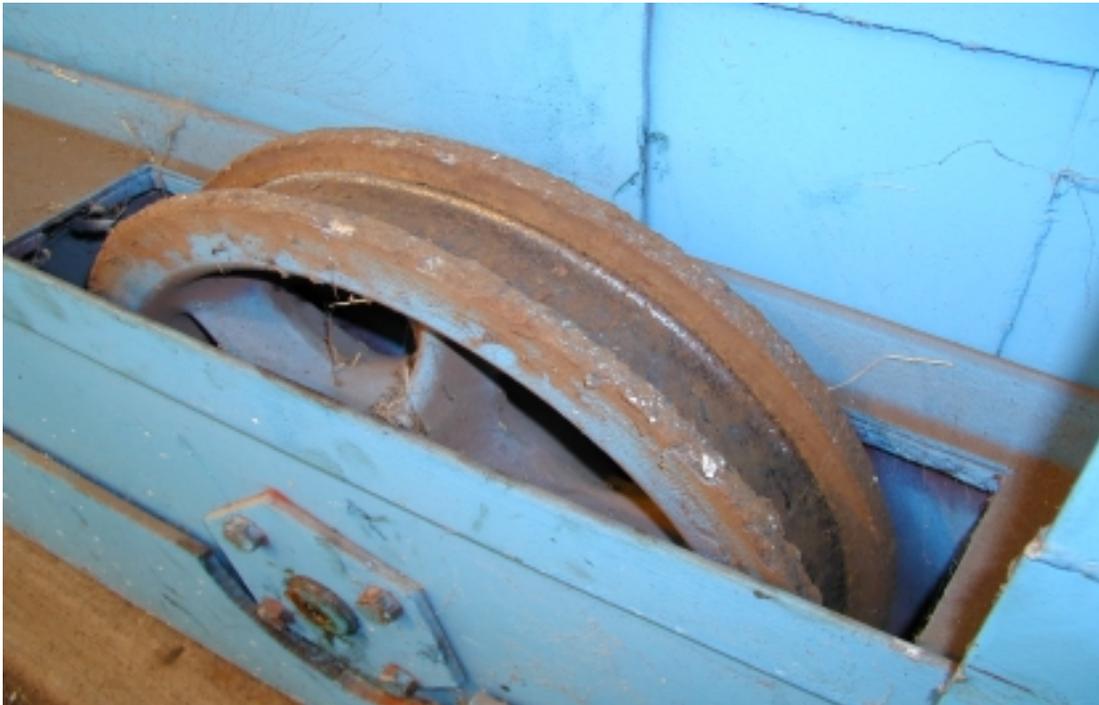
Figure A-3. A typical deteriorated hangar door wheel.

4. Deteriorated hangar door wheels should be replaced to ensure the strength of the door system under wind loading.
5. Dented vertical members near handles on hangar doors can result in loss of structural integrity of doors. Do not open doors with chains; use original design method for opening doors.

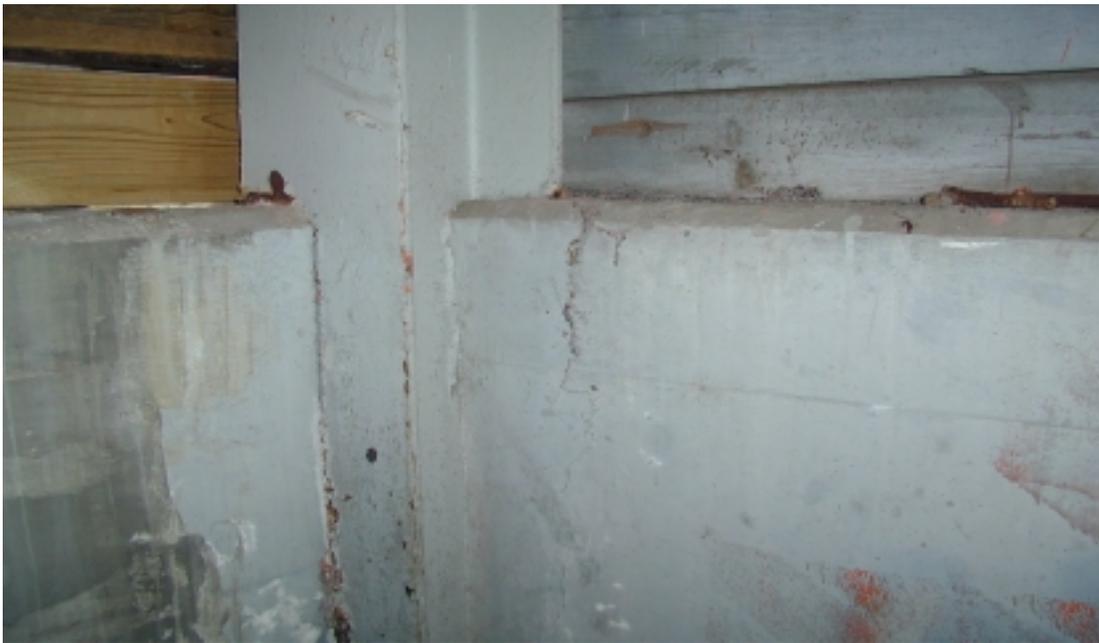
Figure A-4. Spalling concrete at the base of Column N5.5.

6. Remove spalling concrete from column N5.5 (8-H-31), sandblast rust off of the column structural steel, repair steel as shown in Figure D-4 of TR-99/27, and re-cast the concrete.

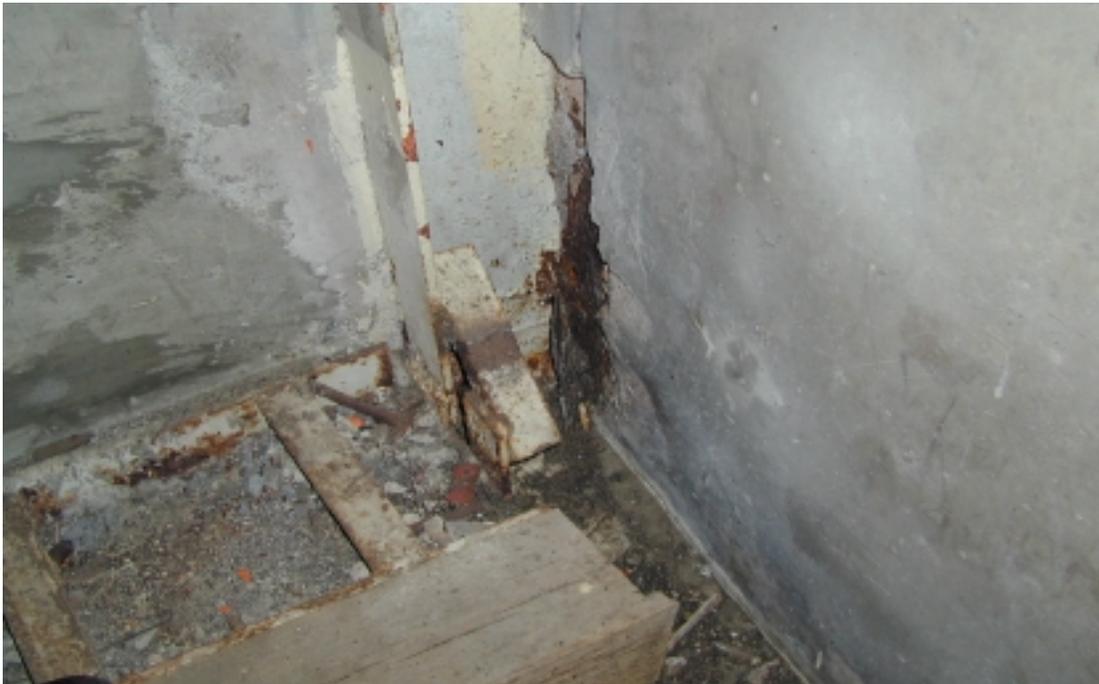
Figure A-5. Major corrosion sample retrieved from base of Column AO.5 (8-H-31).

7. Remove spalling concrete from column A0.5 (8-H-31), sandblast rust off of the column structural steel, repair steel as shown in Figure D-5 of TR-99/27, and re-cast the concrete.

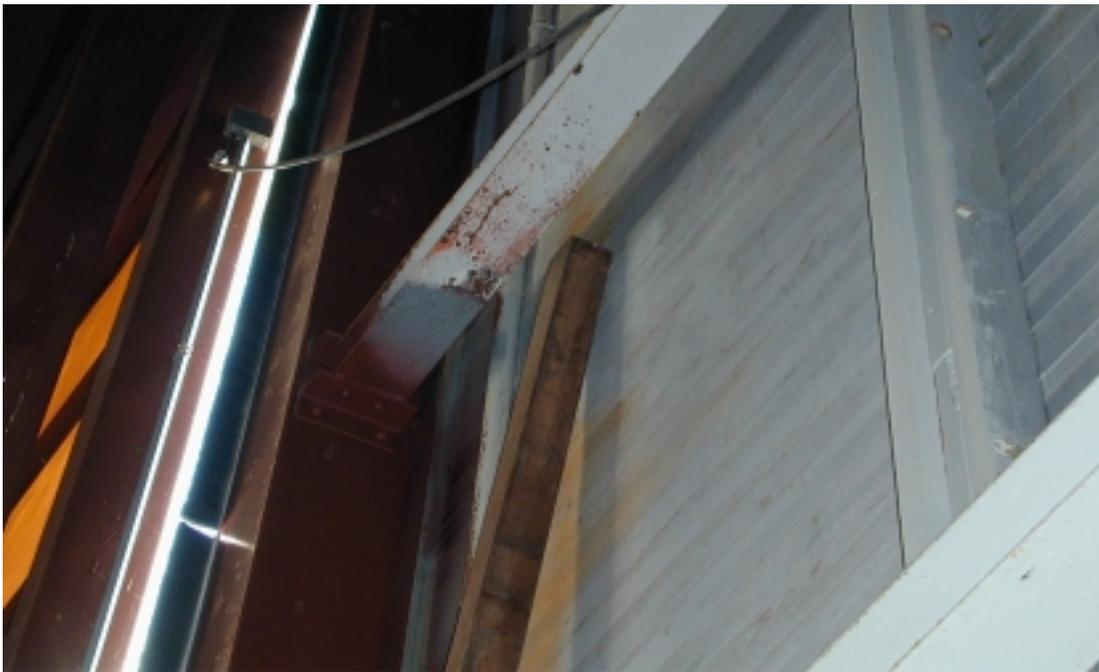
9. Unsupported wood column (4x4 post) near column AA2 is a safety hazard. See Figure A-6.
10. A makeshift wood column (4x4 post) near column AA2 provides inadequate support of second floor beam between columns AA2 and AA1.5. See Figure A-7.
11. A beam is under torsional stress at the second floor between columns AA4 and AA4.5 (6-H-15.5).
12. Major corrosion of the web and flange at the base of column A5 (18-I-47) has resulted in an estimated 30 percent strength reduction. See Figure A-8.
13. Minor corrosion of the web and flange at the base of column A5.5 (8-H-31) has resulted in an estimated 10 percent strength reduction. See Figure A-9.

Figure A-6. Loose timber near Column AA2.

8. If the base and anchorage of column AA0.5 (12-I-25) are sufficient, repair as shown in Figure D-4 of TR-99/27; if not, repair as shown in Figure D-5 of TR-99/27.
9. Remove unsupported wood column (4x4 post) at column AA2.
10. Remove makeshift wood column (4x4 post) near column AA2 or securely brace the column to the beams.
11. Retrofitting beam 6-H-15.5 on the second floor, to stiffen and strengthen it between columns AA4 and AA4.5, would make connections vulnerable to failure. Therefore, no retrofit is advised.
12. Repair column A5 (18-I-47) as shown in Figure D-5 of TR-99/27.
13. Repair column A5.5 (8-H-31) as shown in Figure D-5 of TR-99/27.

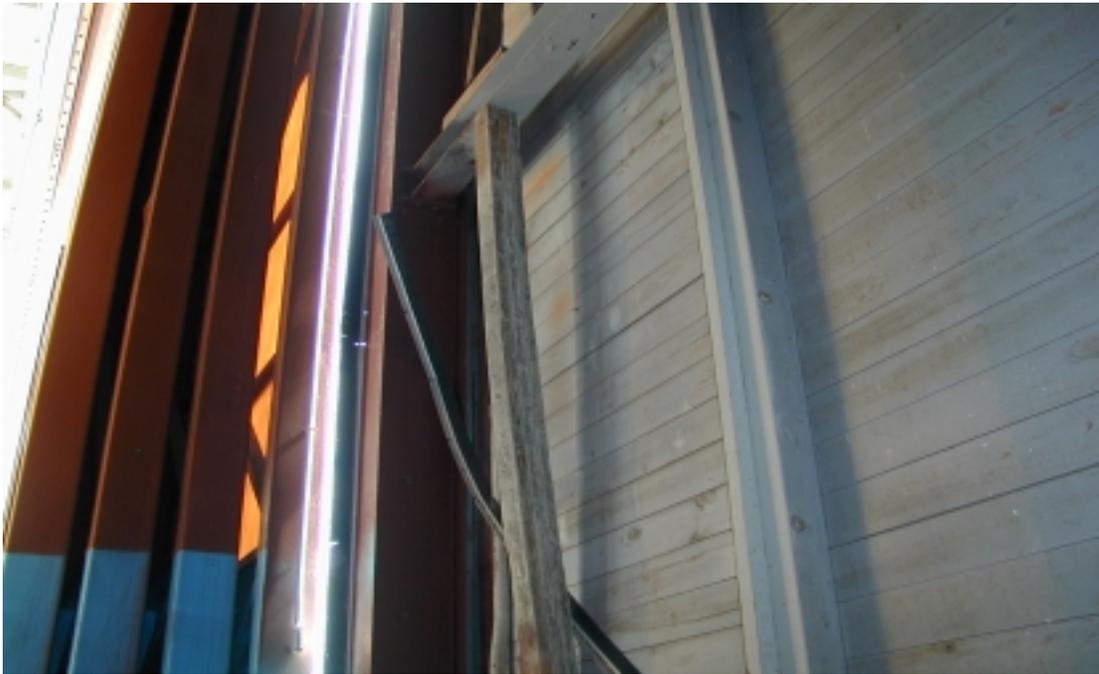
Figure A-7. Makeshift support near Column AA2.

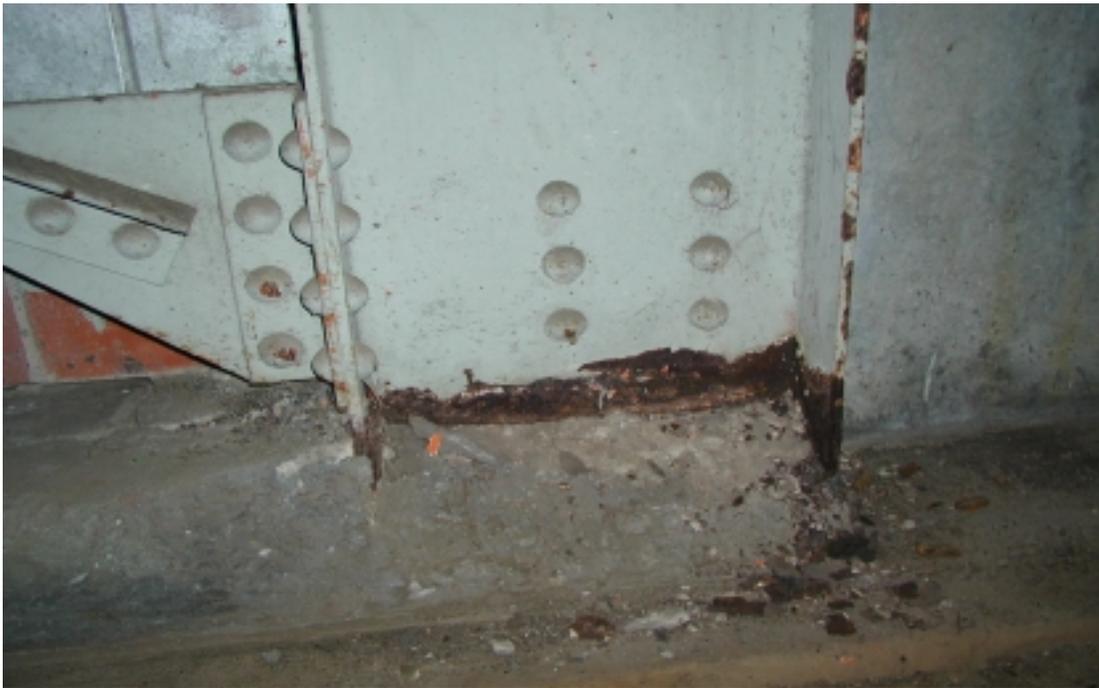
Figure A-8. Major corrosion at base of Column A5 (18-I-47).

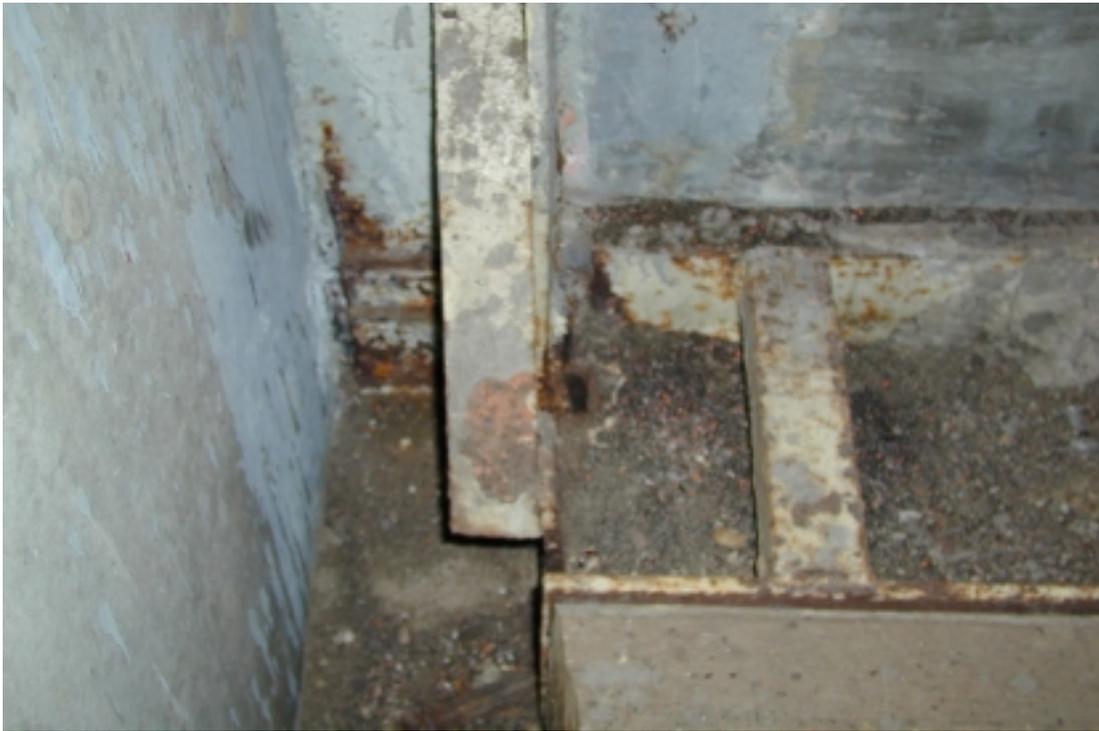
Figure A-9. Minor corrosion at the base of Column A5.5 (8-H-31).

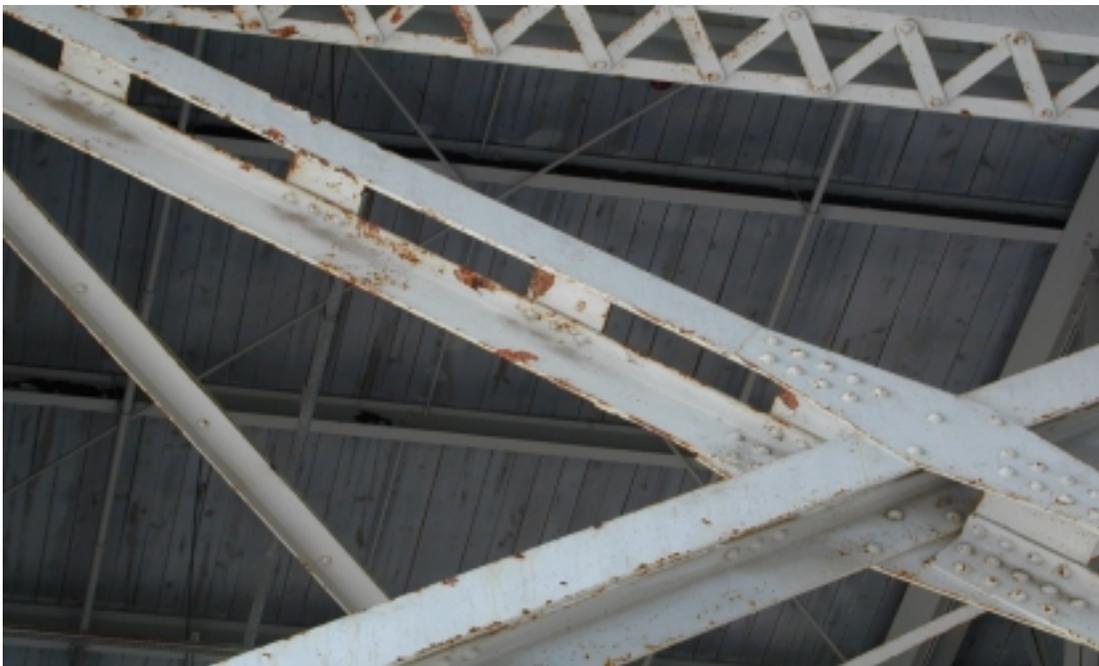
14. Entire hangar is losing paint. See Figure A-10.
15. Minor buckling of diagonal braces (single angle, $3\frac{1}{2} \times 2\frac{1}{2} \times \frac{1}{4}$) has occurred at the following locations:

Figure A-10. Typical example of elements needing fresh paint.

14. Any unpainted steel needs to be painted; use as listed in Figure D-1 of TR-99/27.
15. No retrofits are necessary for buckling bracing members listed in notes 15 and 16 of Chapter 2; these angles are intended for tension only.
16. No retrofit is necessary for column K2 (18-I-85), but further welding damage and gouging of the sort identified here should be avoided.

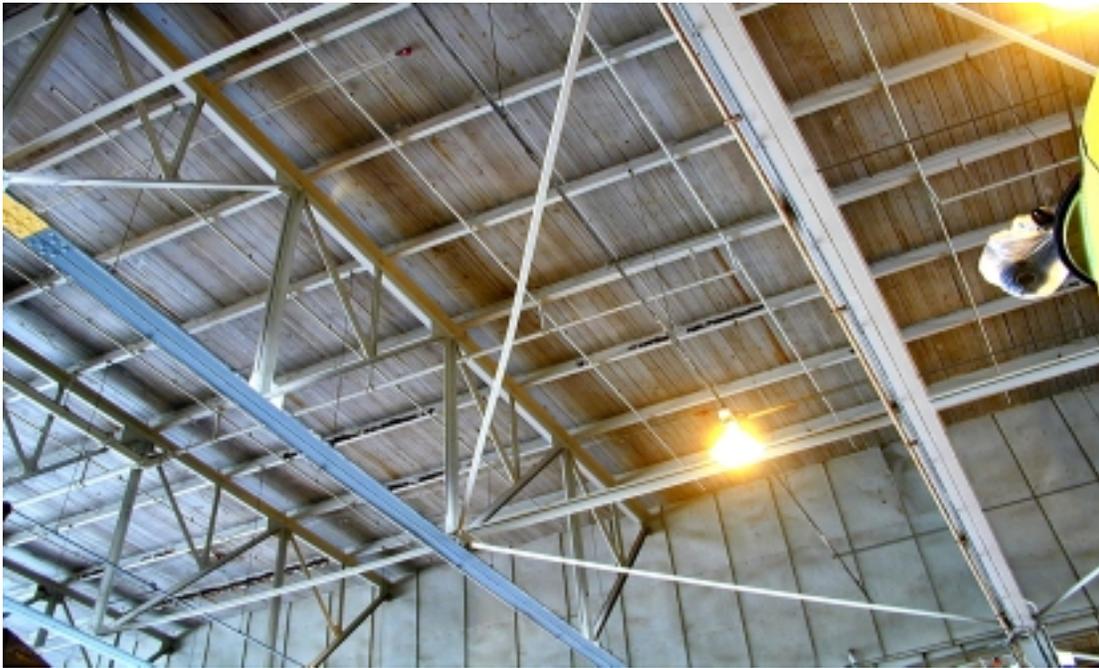
- between columns G2.4 and H2.5; see Figure A-11
 - between columns L2.5 and M3; see Figure A-12.
16. Buckling of bottom braces (single angle, $3\frac{1}{2} \times 2\frac{1}{2} \times \frac{1}{4}$) has occurred at the following locations:

Figure A-11. Buckled diagonal between Columns G2.4 and H2.5.

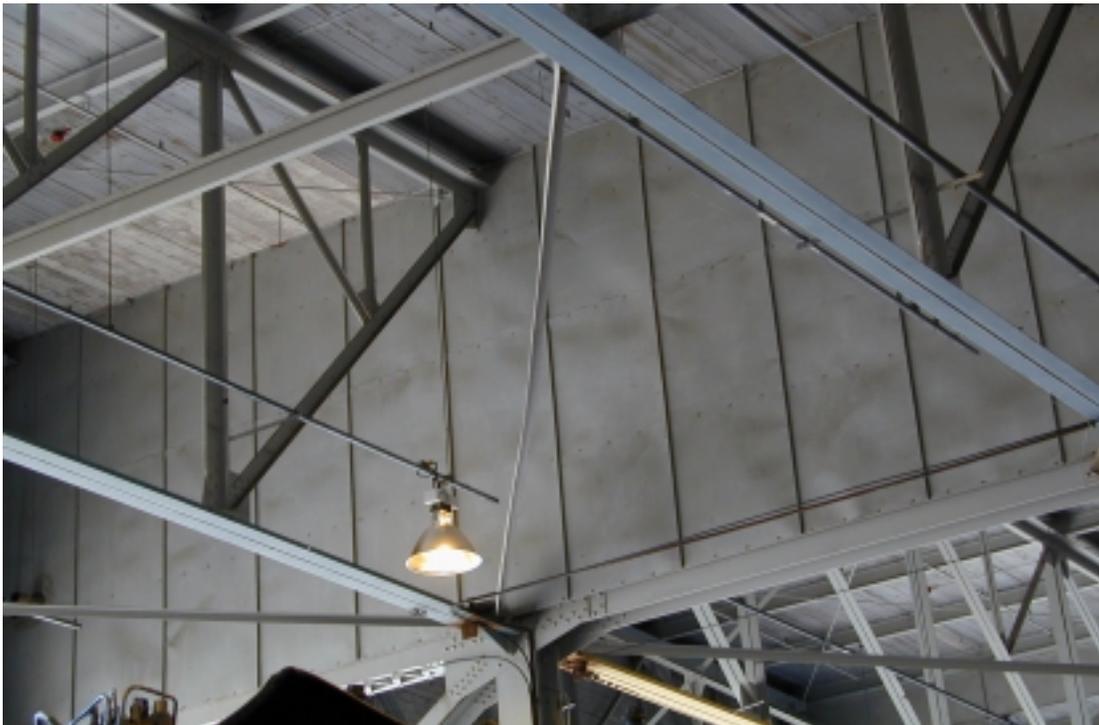
Figure A-12. Buckled diagonal between Columns L2.5 and M3.

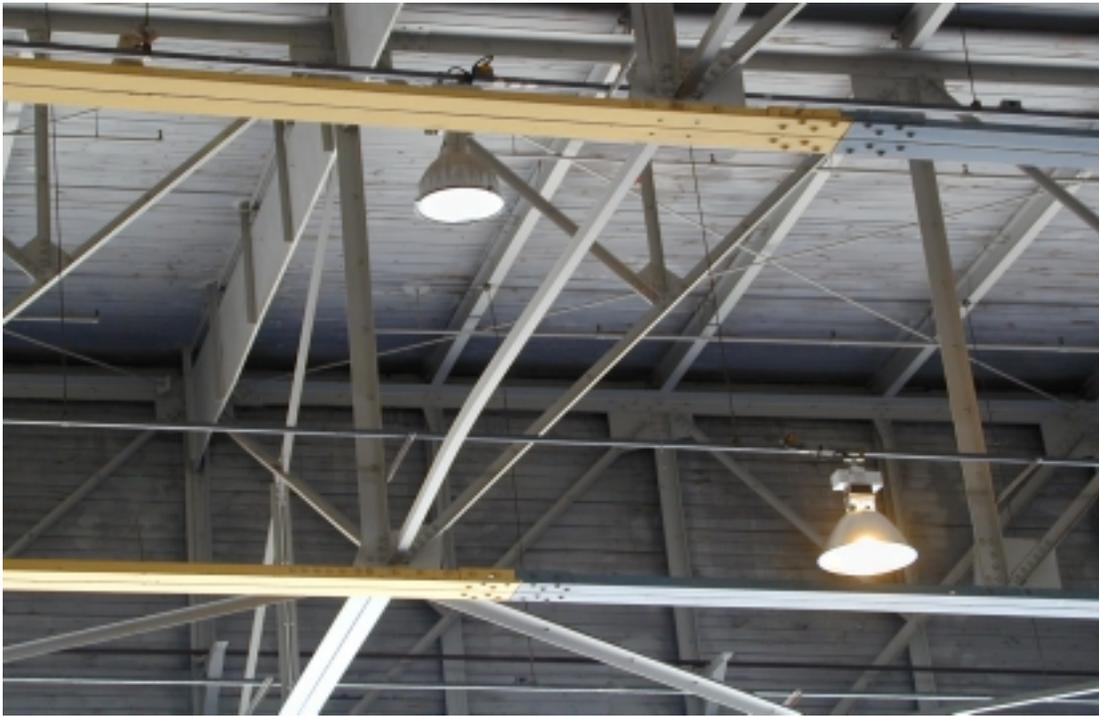
- between columns L2.4 and M2.4; see Figure A-13
 - between columns H2.5 and J2.5; see Figure A-14
 - between columns C2.5 and E2.5; see Figure A-15
 - between columns E3.1 and F3.1; see Figure A-16

Figure A-13. Buckled bottom chord between Columns L2.4 and M2.4.

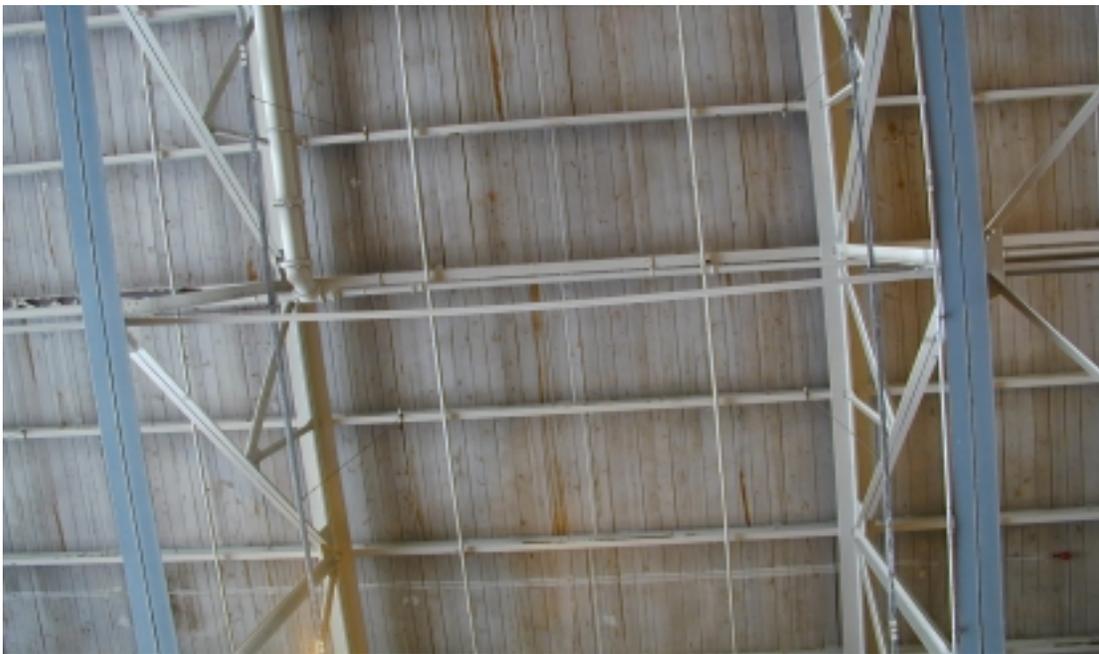
Figure A-14. Buckled bottom chord between Columns H2.5 and J2.5.

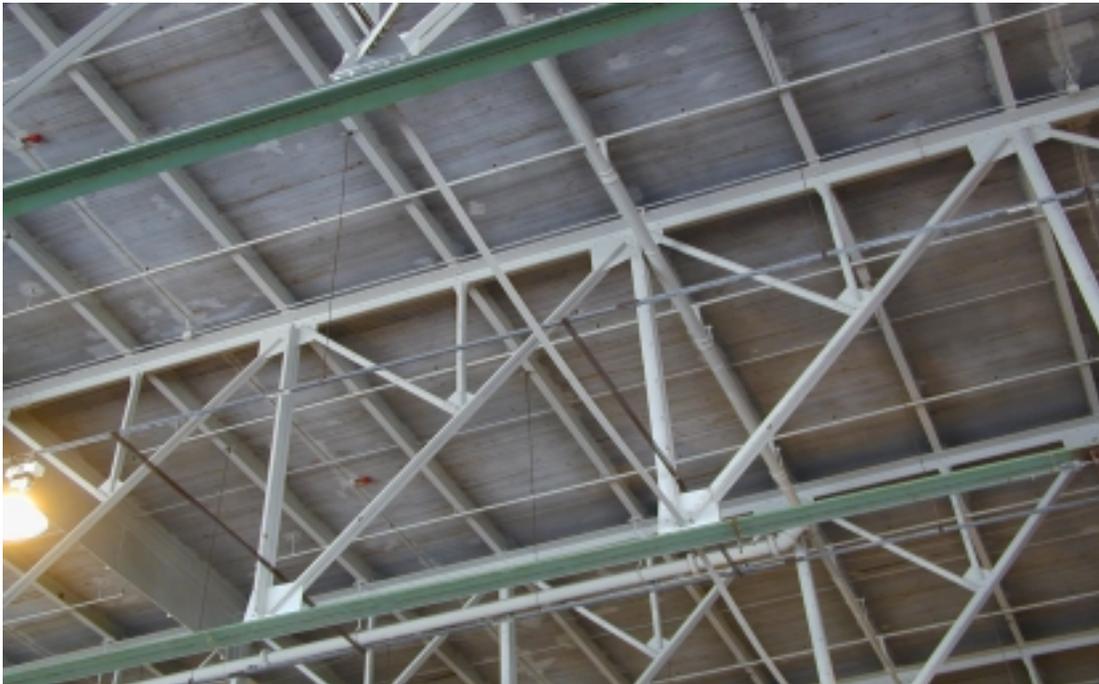
Figure A-15. Buckled bottom chord between Columns C2.5 and E2.5.

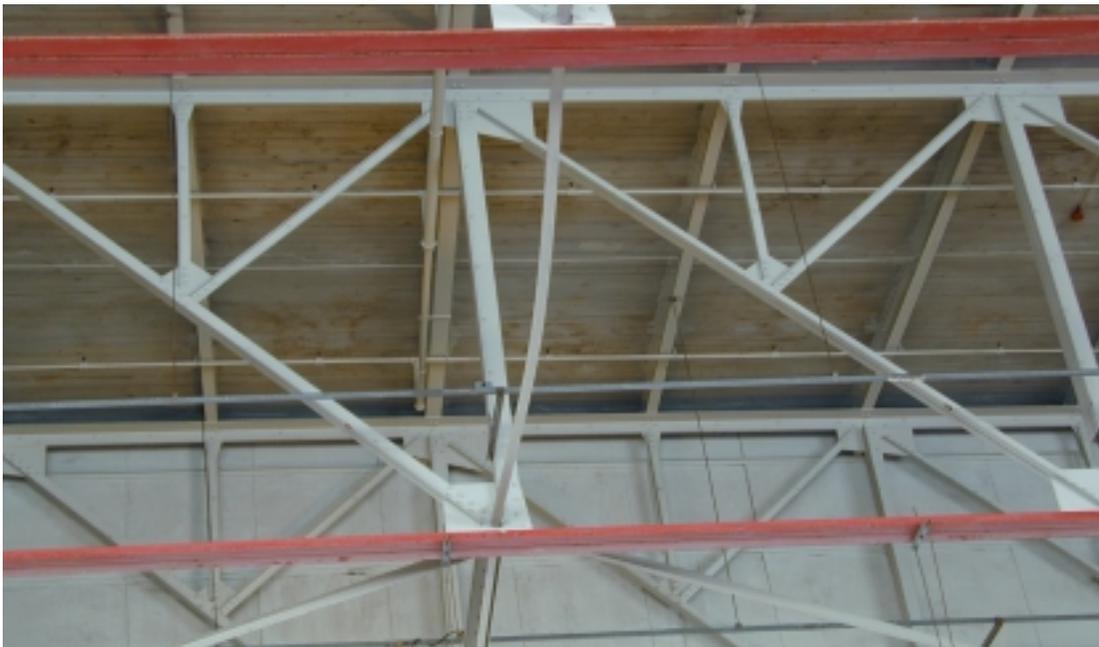
Figure A-16. Buckled bottom chord between Columns E3.1 and F3.1.

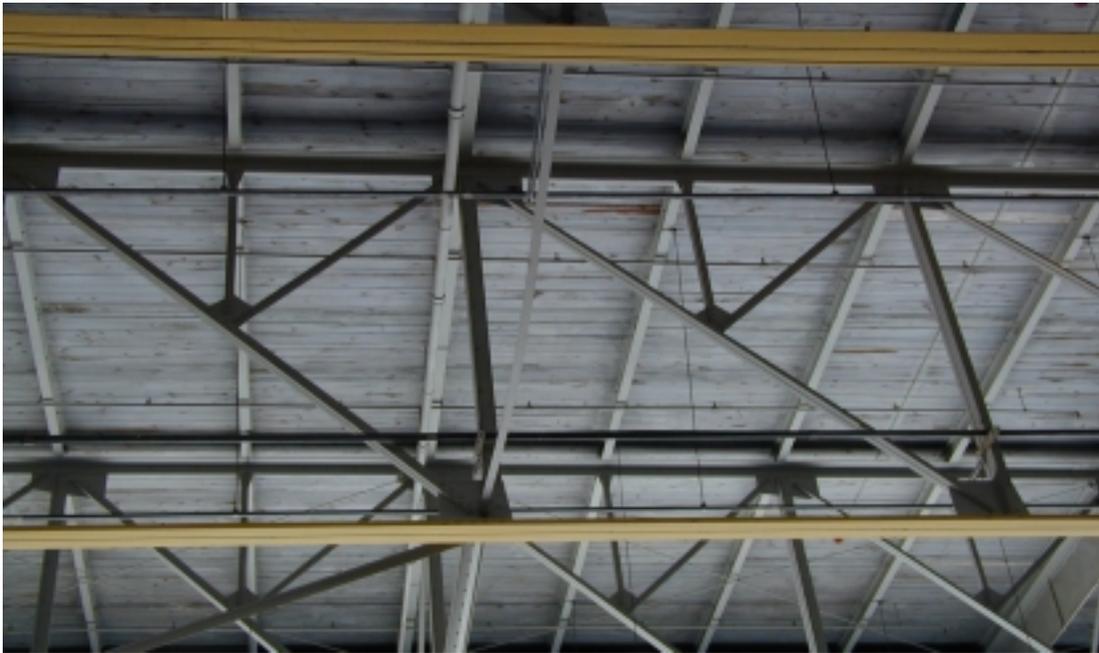
- between columns K3.1 and L3.1; see Figure A-17
 - between columns H3.2 and J3.2; see Figure A-18
 - between columns L3.4 and M3.4; see Figure A-19
 - between columns E3.4 and F3.4; see Figure A-20.

Figure A-17. Buckled bottom chord between Columns K3.1 and L3.1.

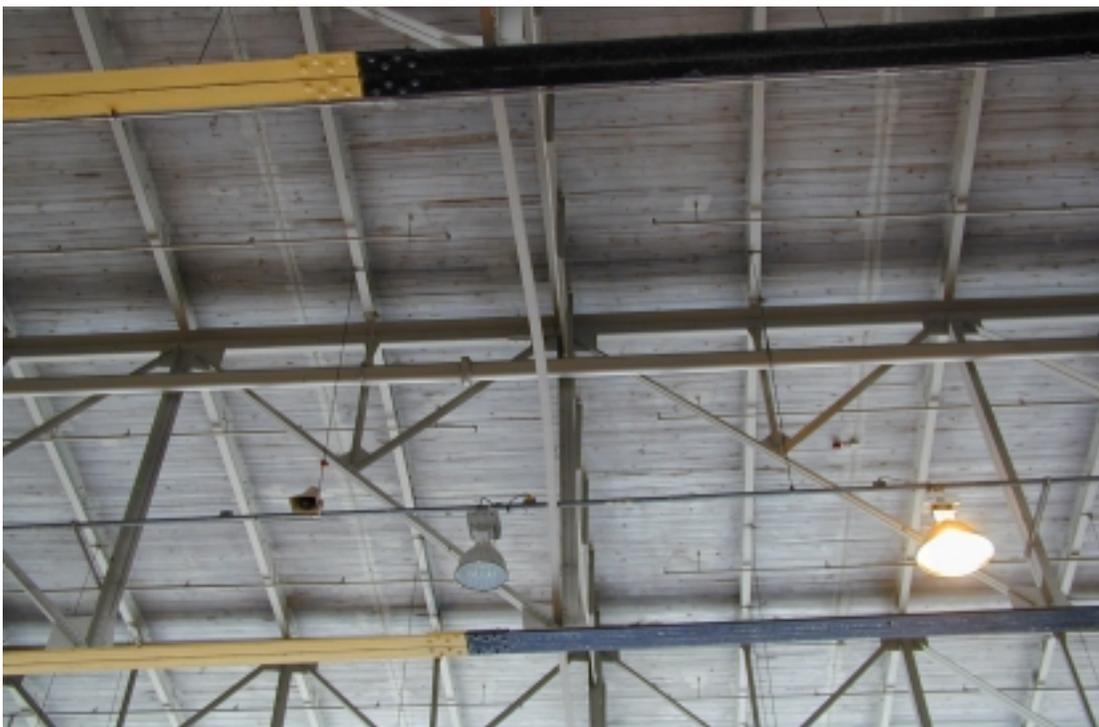
Figure A-18. Buckled bottom chord between Columns H3.2 and J3.2.

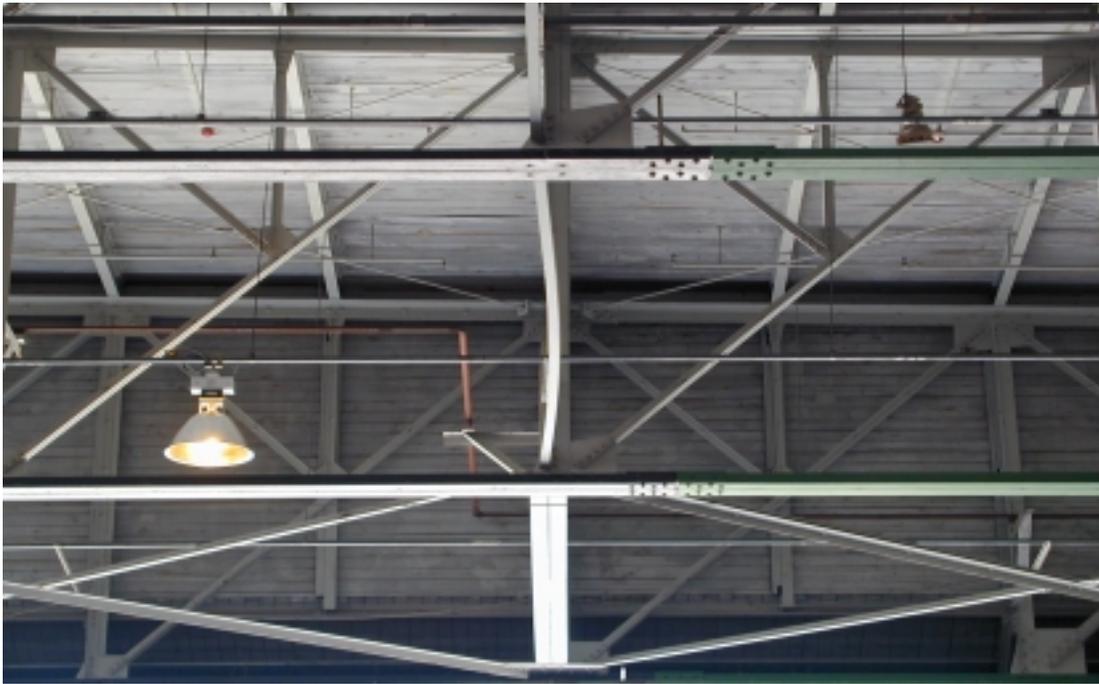
Figure A-19. Buckled bottom chord between Columns L3.4 and M3.4.

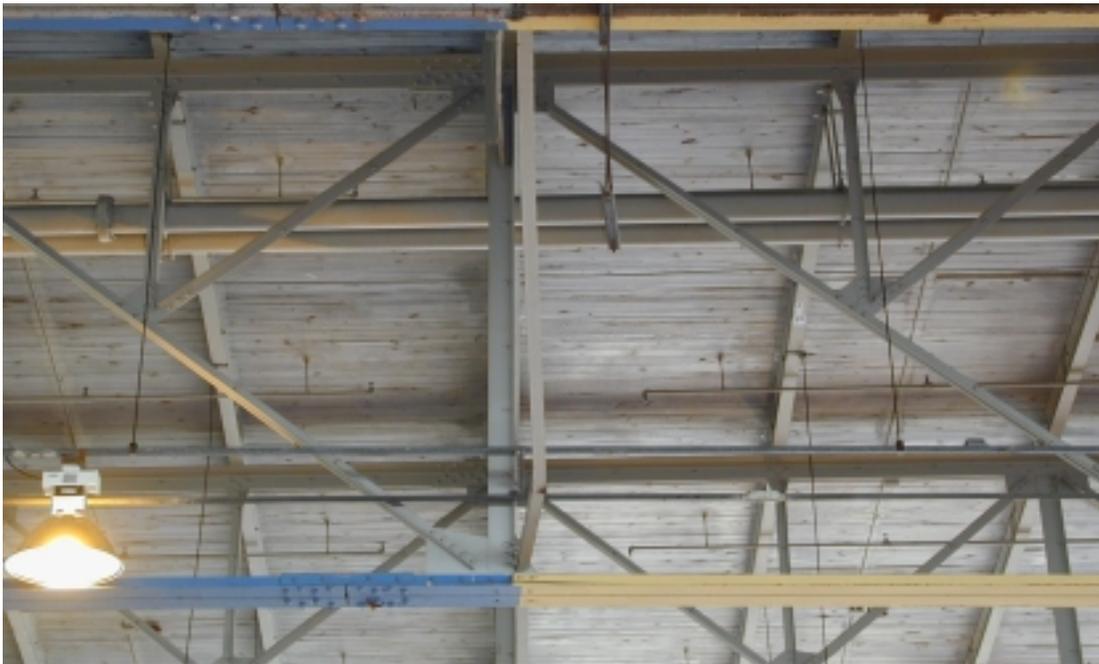
Figure A-20. Buckled bottom chord between Columns E3.4 and F3.4.

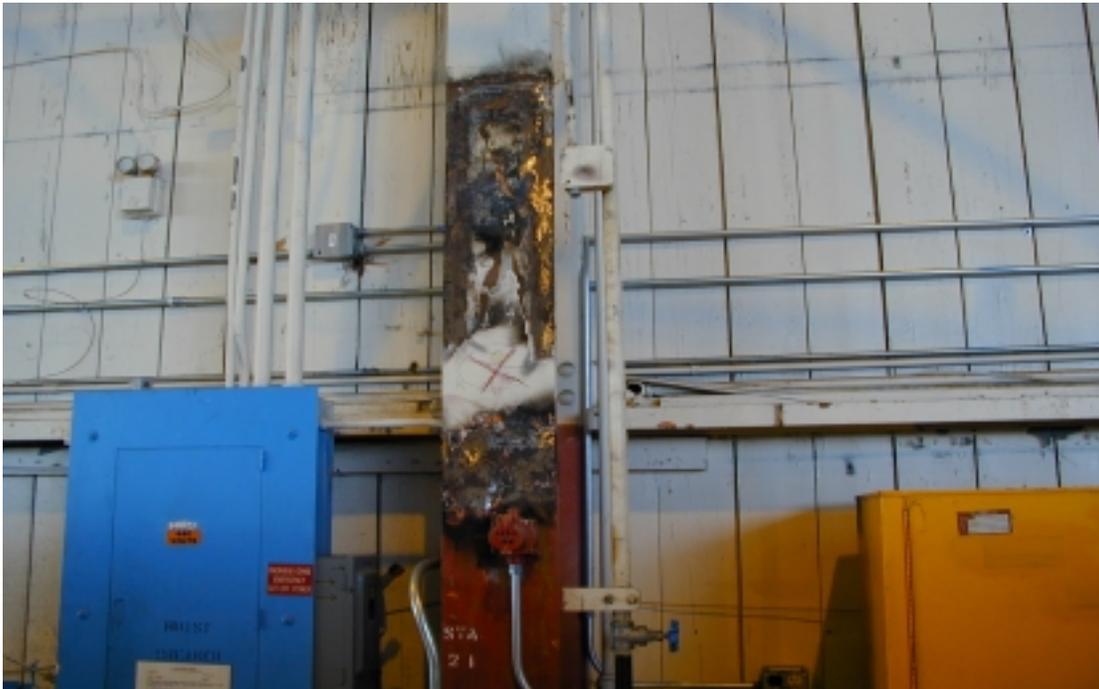
17. A column located at K2 (18-I-85) has been damaged from welding and gouging, resulting in an estimated 5 percent strength reduction. See Figure A-21.

Figure A-21. Damage to Column K2 (18-I-85).
