**US Army Corps
of Engineers**

USACERL Technical Report 96/77
July 1996

Investigation of Preapproved Underground Heat Distribution Systems

by
Charles P. Marsh, Nicholas M. Demetroulis, and James V. Carnahan

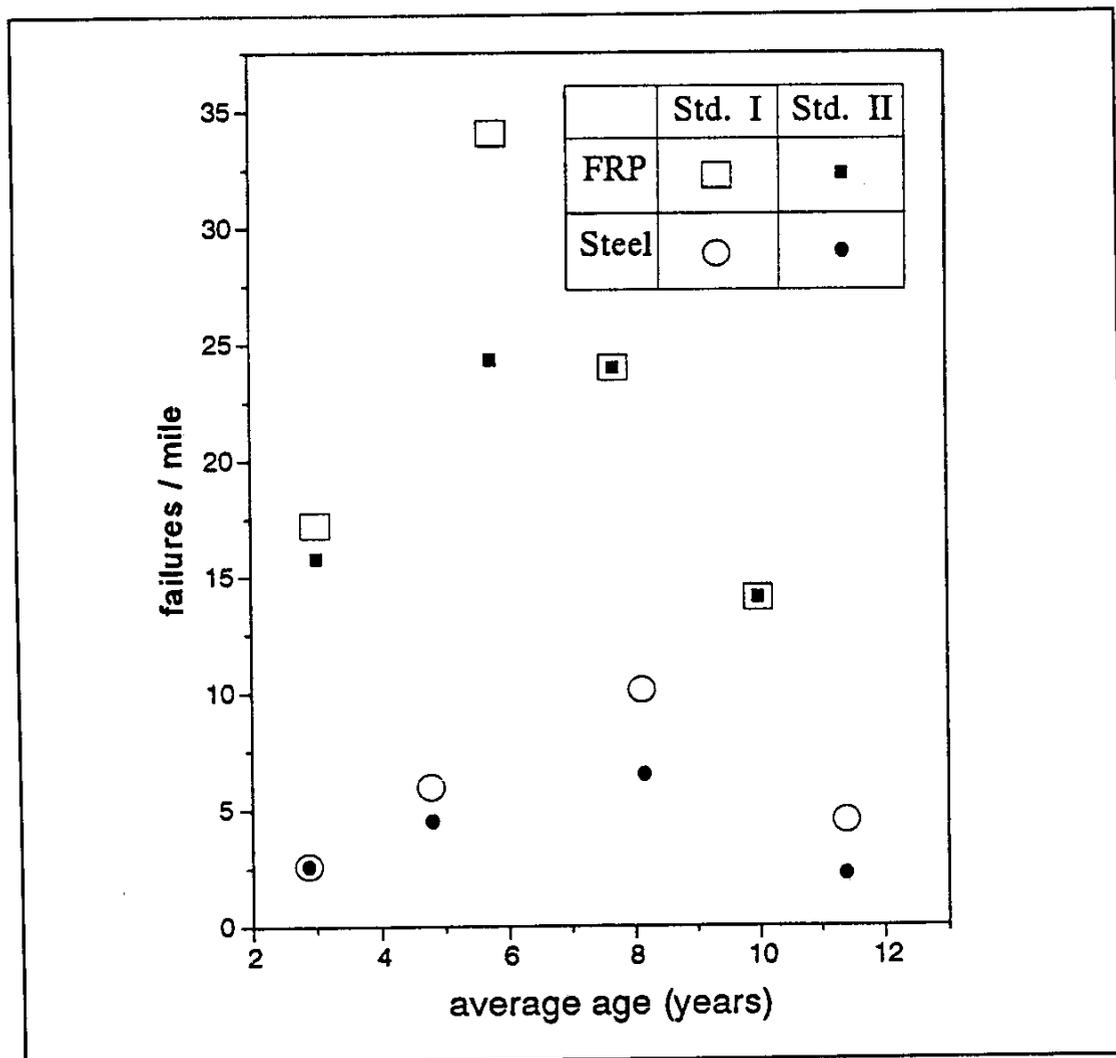
Figure B1. Failure rates versus length-weighted average age for four sequential time periods.

The Pearson correlation coefficient between failure rate and age was found to be quite small ($R^2 \leq 0.1$). A generalized linear model was fit to the data, attempting to explain variation in failure rates with material type (represented by an indicator variable) and

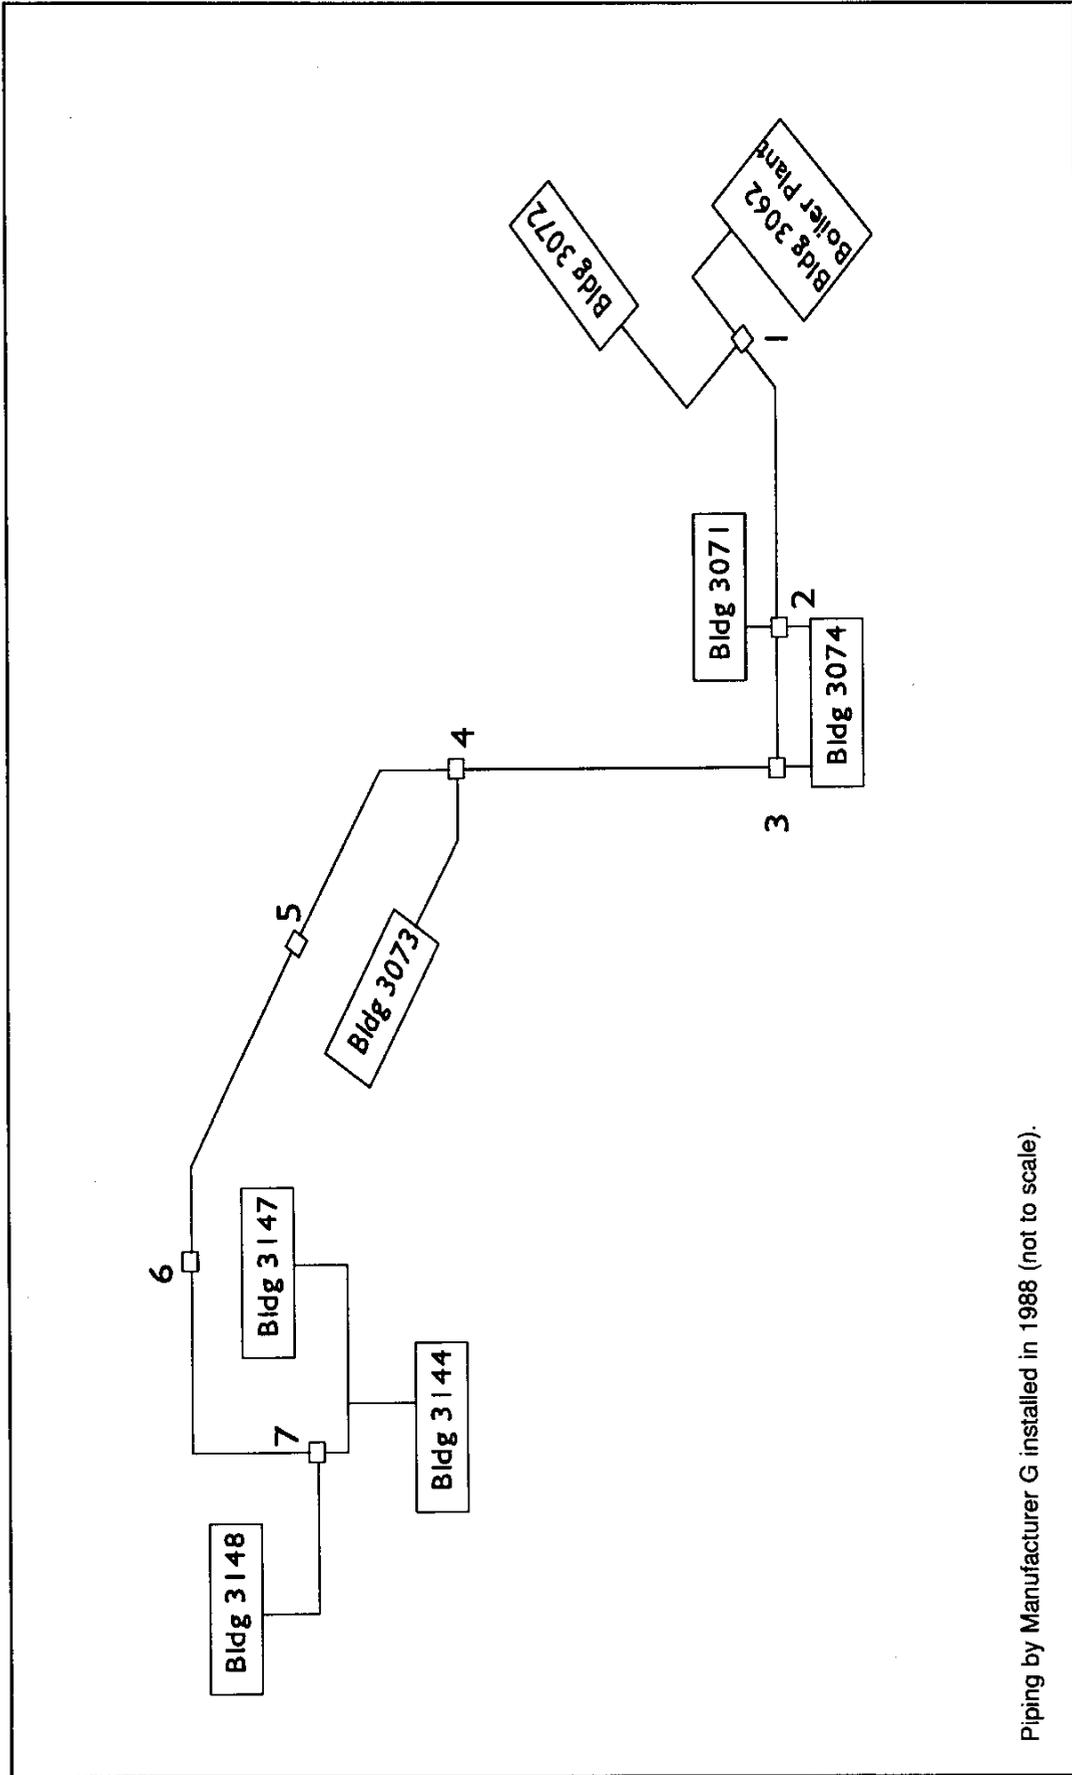
Figure C2. Schematic drawing of System 2 at Aberdeen Proving Grounds, MD.

This system consists of piping from Manufacturer G and has an FRP conduit (Figure C2). The project was "Replace Underground Steam and Condensate Piping From Boiler Plant (Bldg. 3062) to Bldgs. 3071, 3072, 3073, 3074, 3144, 3147 & 3148" (Drawing No. A38972) and was dated 1988.

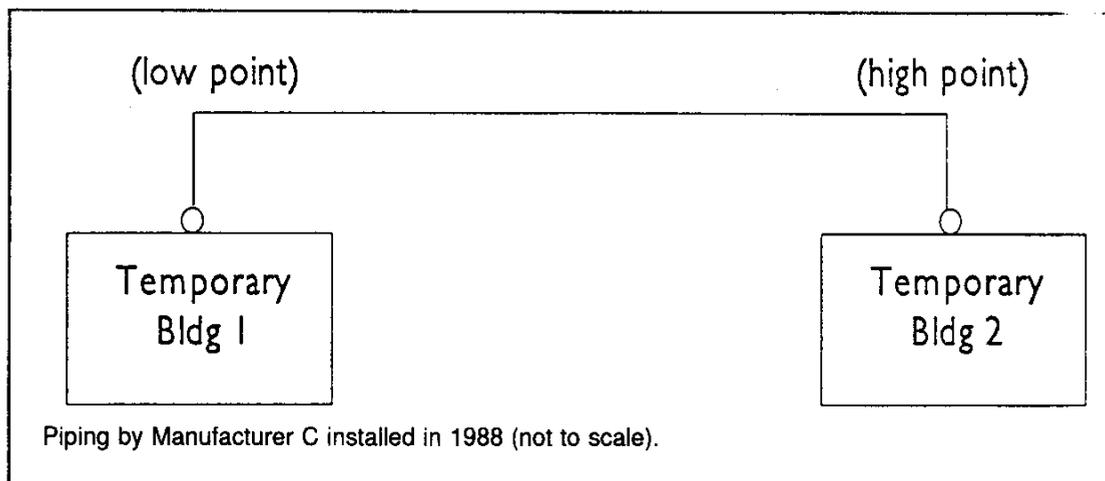
Figure D2. Schematic diagram of System 4 at Wright-Patterson AFB, OH.

This system consists of piping from Manufacturer C and has a steel conduit (Figure D2). It was installed in 1990 under contract No. F33601-89-CW027. The project consists of steam and condensate lines contained in a single conduit. It ties into an

overhead system, feeds two temporary buildings along "L" street and extends approximately 600 ft. On the lower half of the system, the route of the conduit and expansion loops were clearly defined by dried grass over the buried conduit.

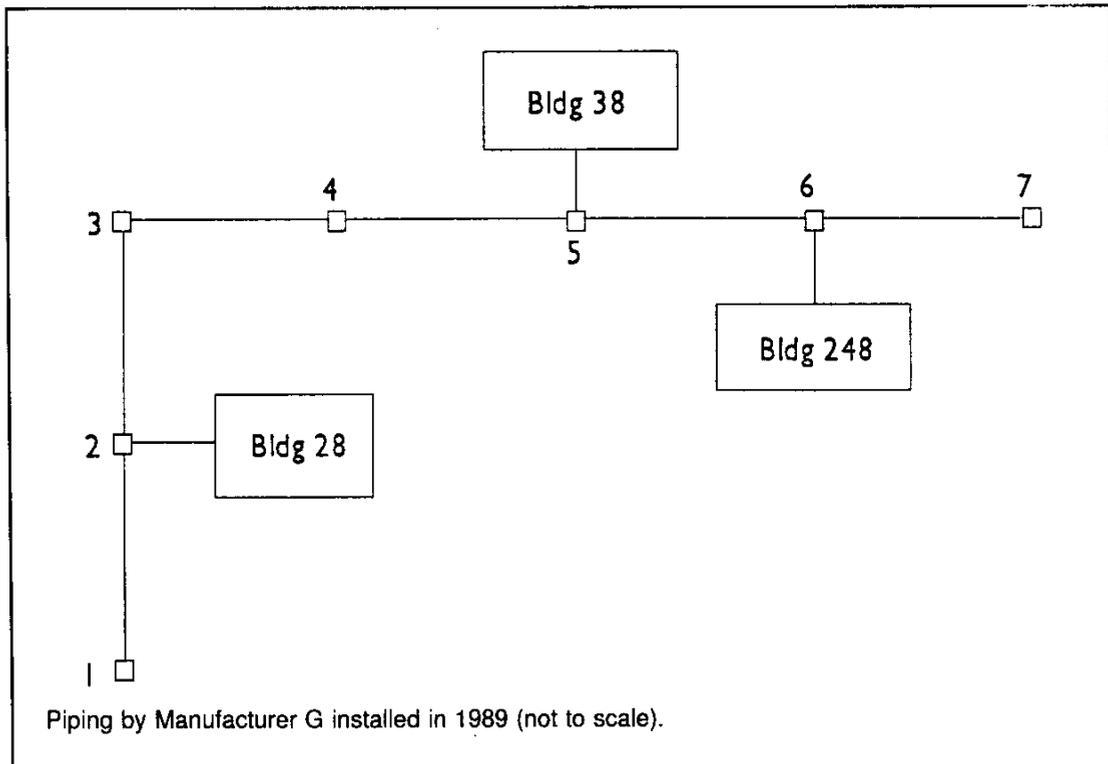
Figure D3. Schematic diagram of System 5 at Wright-Patterson AFB, OH.

This system consists of piping from Manufacturer G and has an FRP conduit (Figure D3). Drawing WP-43-7 for the project was dated May 1989. The contract involved replacing condensate lines using new vinyl ester resin conduits and steam lines

encased in conduits of the old polyester resin. The "L"-shaped system runs parallel to Buildings 28 and 38. It then makes a right angle to run along the end of Building 28. Manholes 6 and 7 were in a construction zone and were inaccessible.

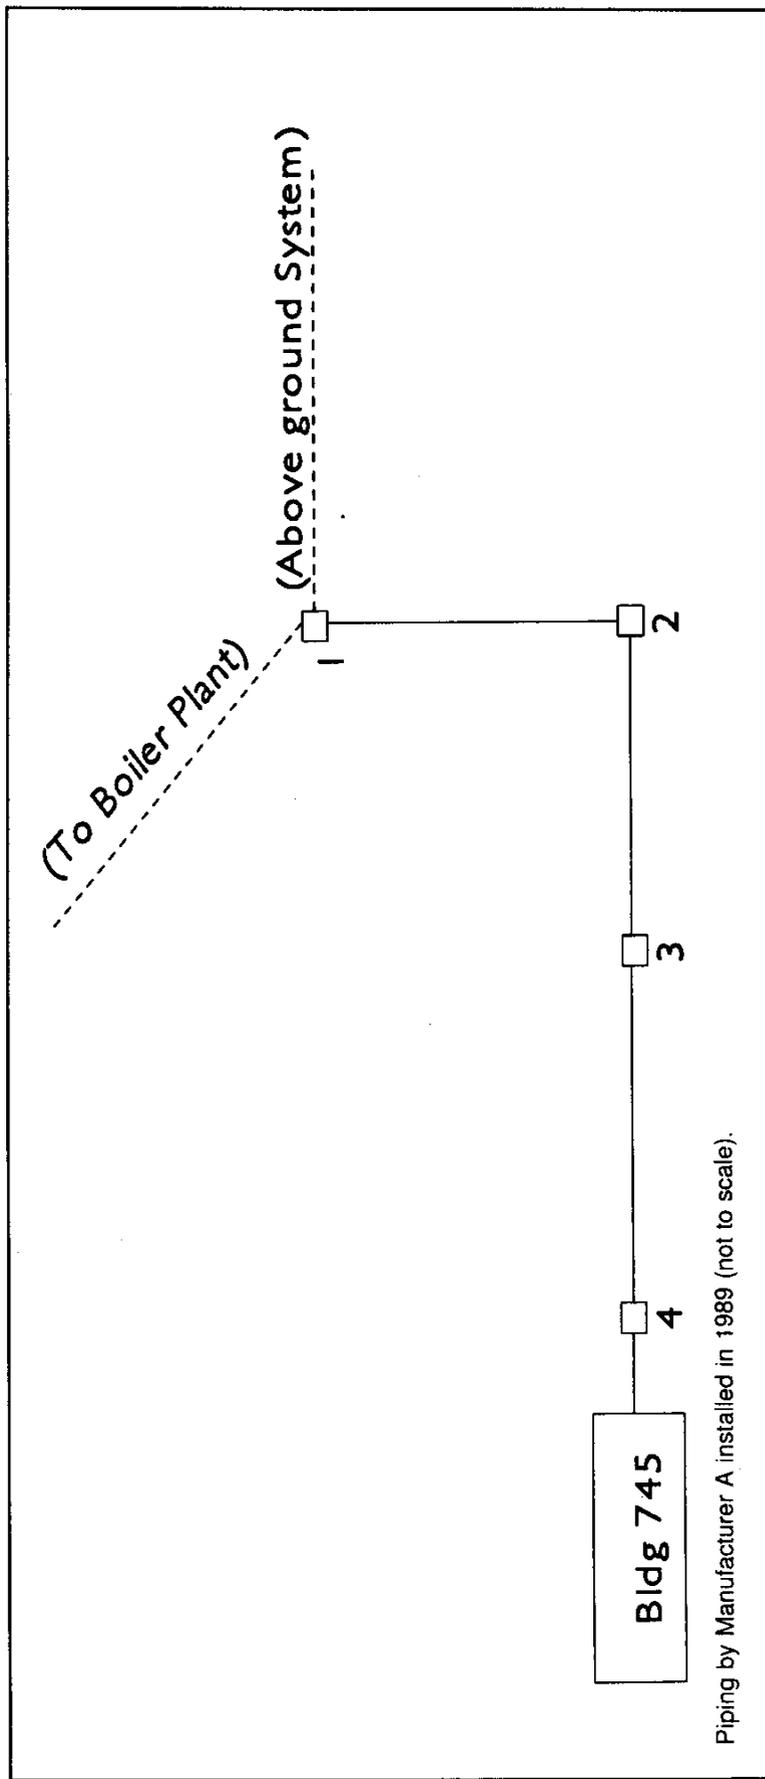
Figure D5. Schematic diagram of System 7 at Wright-Patterson AFB, OH.

8. Detailed Inspection of System #7—This system consists of piping from Manufacturer A and has a steel conduit (Figure D5). The 1989 project was designated WP 54-8, FAC. 07199, and PCF1939. The piping was at the base of a long sloping hill.

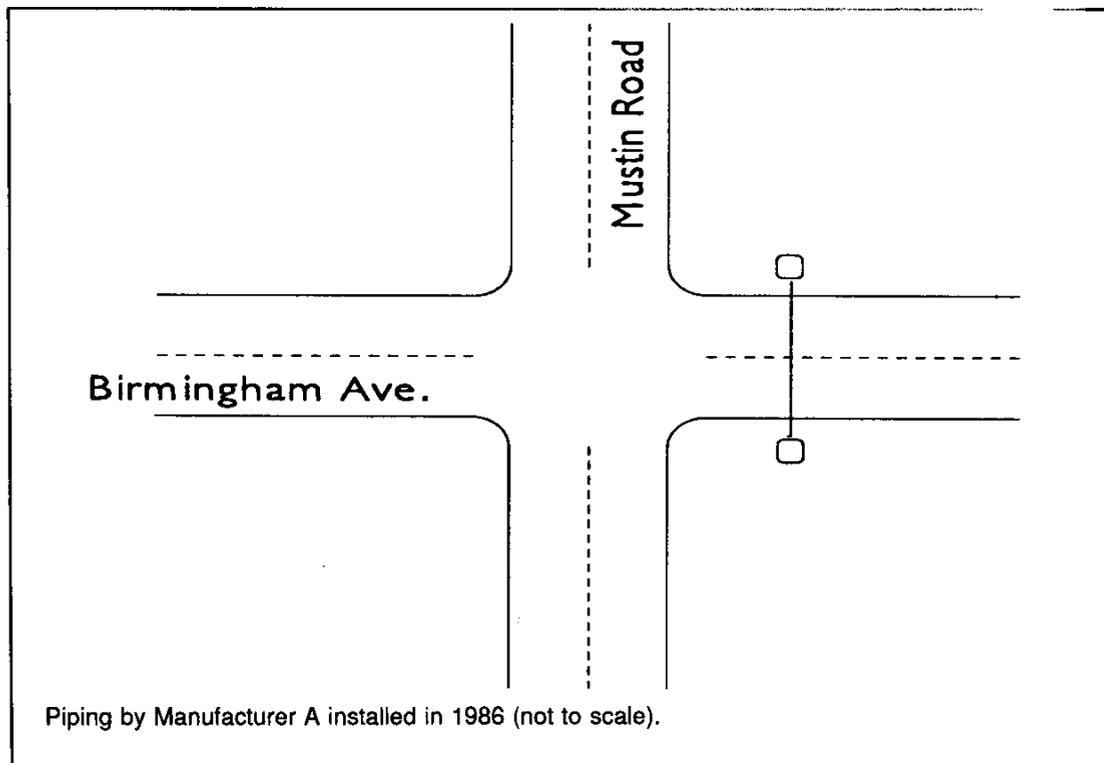
Figure I2. Schematic diagram of System 15 at Jacksonville NAS, FL.

This system consists of a single road crossing with piping from Manufacturer A and has a steel conduit (Figure I2). Installed in 1986, the project is under Birmingham Avenue near the intersection with Mustin Street. Risers on both sides of the street are fitted with loose water shed caps that precluded pressure testing.

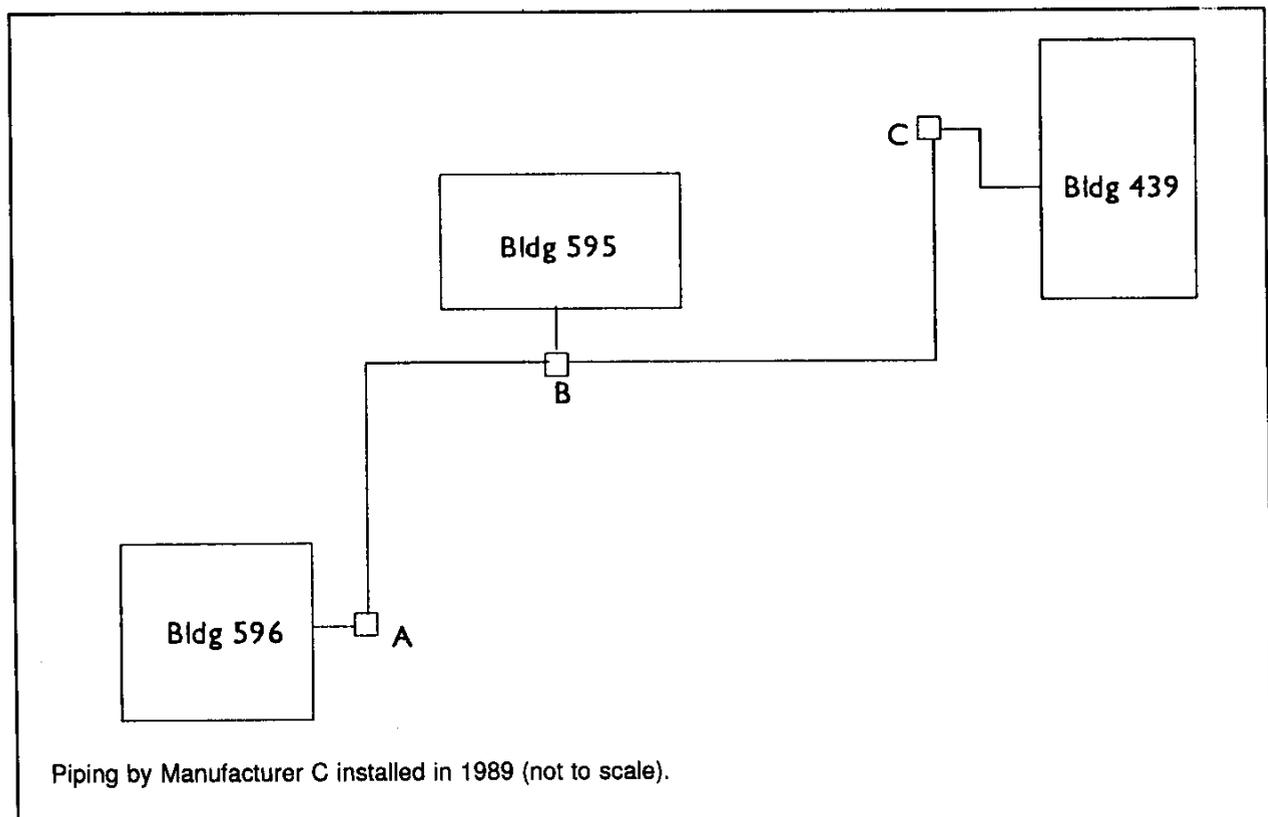
Figure M1. Schematic diagram of System 24 at Grissom AFB, IN.

This system consists of piping from Manufacturer C and has a steel conduit (Figure M1). It was installed in 1989.

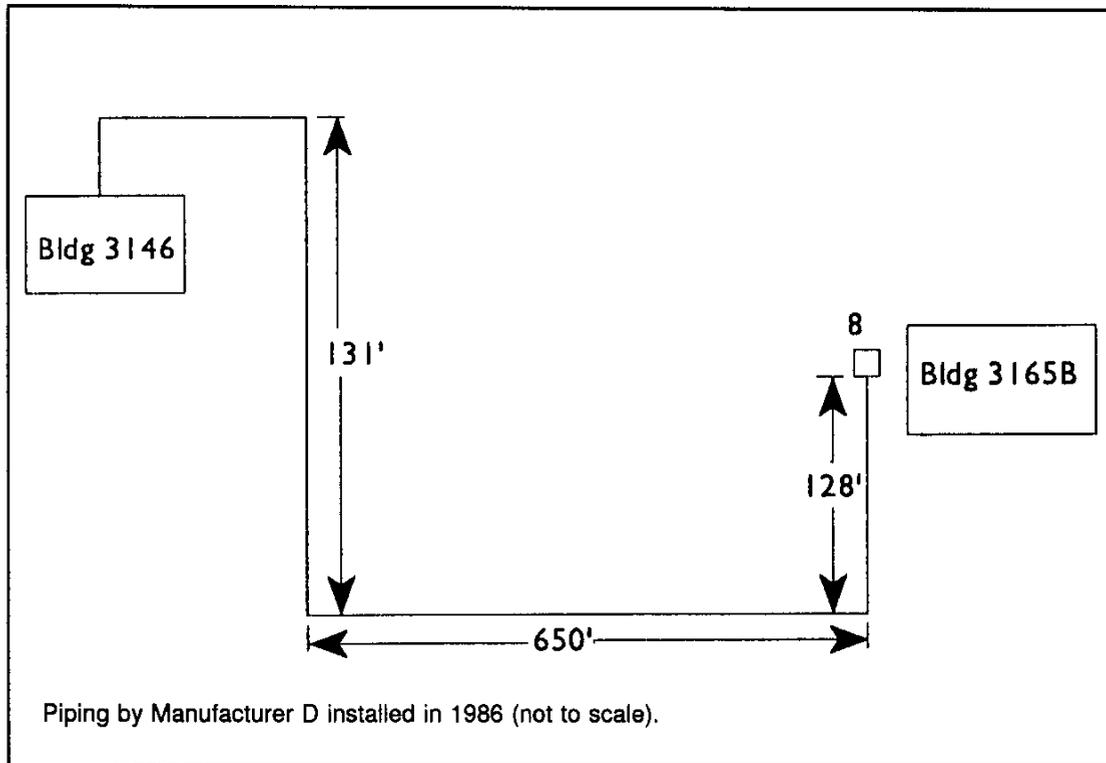
Figure O2. Schematic diagram of System 30 at Fort Lewis, WA.

This system consists of piping from Manufacturer D and has a steel conduit (Figure O2). It was installed in 1986. This section of conduit extended from Manhole 8 (just west of Bldg. 3165B) to the Special Forces Group Complex building. The length of this run was 1120 ft. Manhole 8 was concrete with top at grade containing a 30-in.-diameter access opening. The manhole had no vent piping. The conduit enters the manhole through the wall sleeve with caulking between the sleeve and the casing. Both the drain and vent openings at the end plate assembly were plugged. The

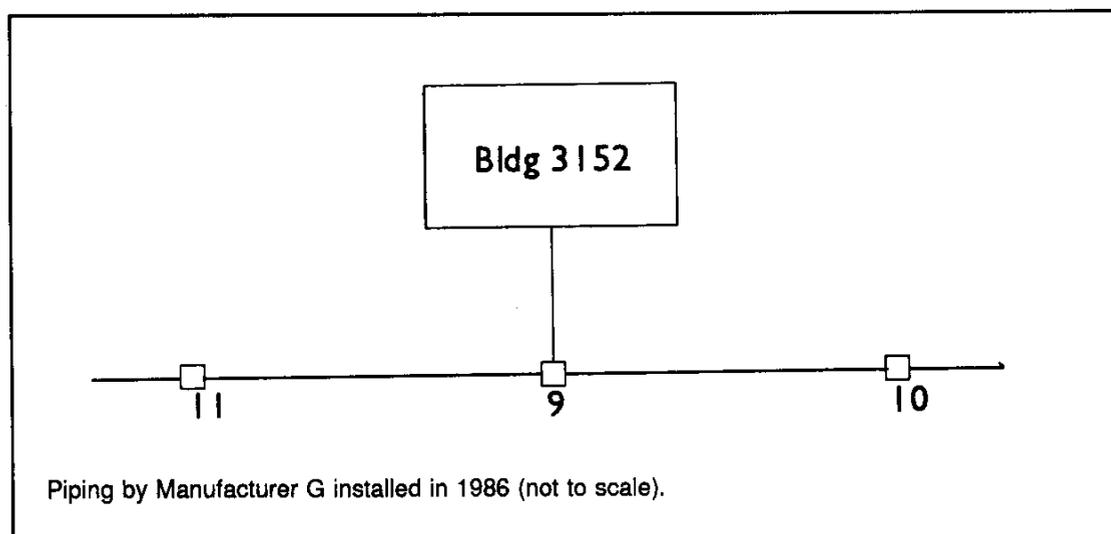
Figure O3. Schematic diagram of System 31 at Fort Lewis, WA.

Base personnel indicated that a major pipe leak was found in this system. The estimated cost for locating and repairing the leak was \$16,814 and the actual documented cost was \$14,234. However, it should be noted that the repair did not involve an "in-kind" replacement of the damaged system. Repair was accomplished by cutting out the failed section of conduit and installing a new carrier pipe covered with cellular glass insulation with a mastic coating. Cellular glass is not considered satisfactory for heat distribution system applications because of its brittleness, lack of shear strength, and its tendency to disintegrate under shock and vibration loads.
