Condition Assessment of Building 6237, Old Hospital Complex, Fort Carson, CO

by Thomas R. Napier and Sheila A. McCarthy

August 2000

ERDC/CERL TR-00-24
August 2000

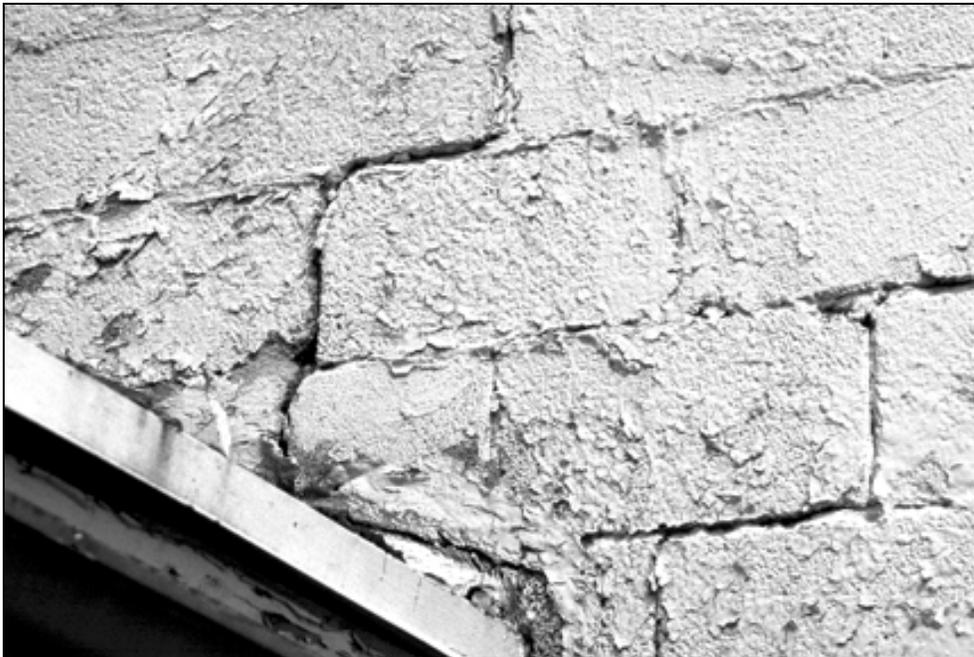
There were two locations in the west exterior wall where cracking was serious: one at the south center entry door (Point A and Figure 3-5), and one adjacent to the ninth* window from the north (Point B and Figure 3-6). However, no cracking or settling was observed in the exterior foundation wall at these locations.

Figure 3-5. Detail of cracking.

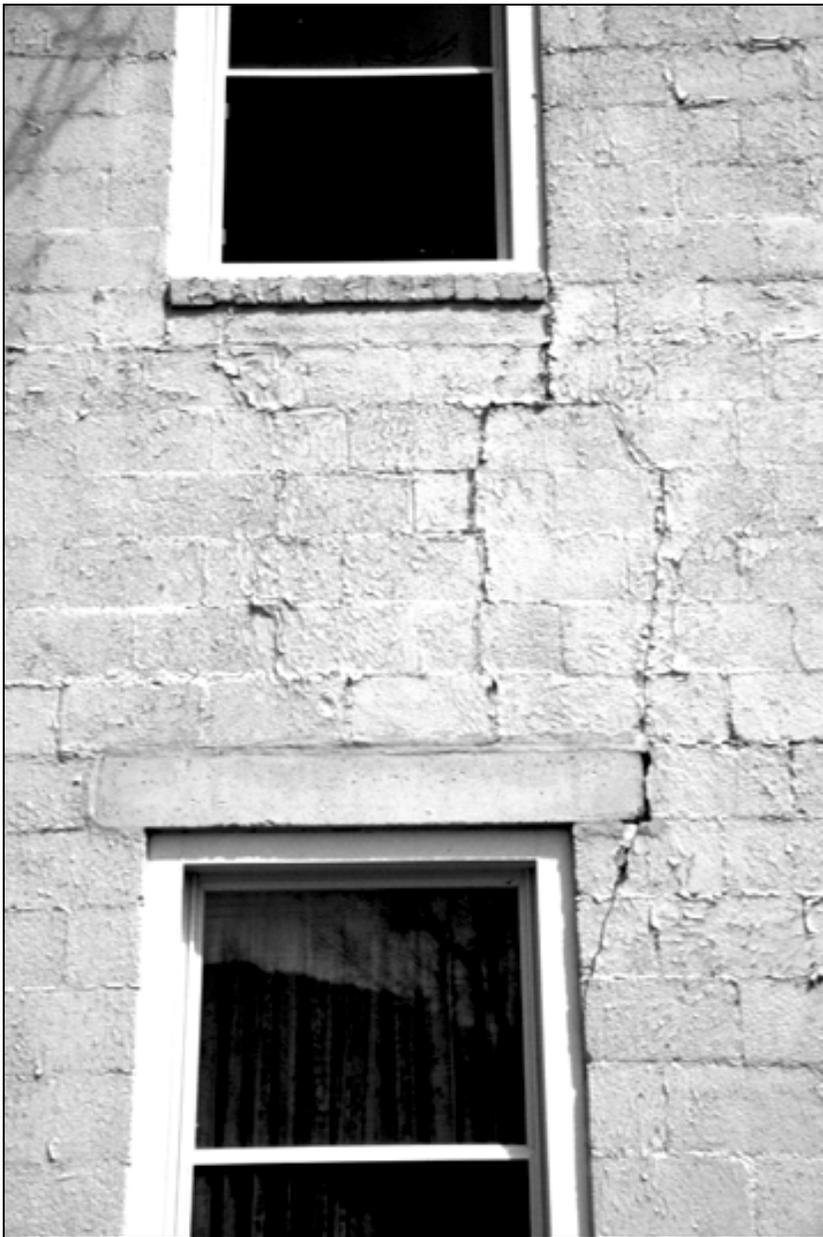
Figure 3-6. Detail of cracking adjacent to ninth window from north.

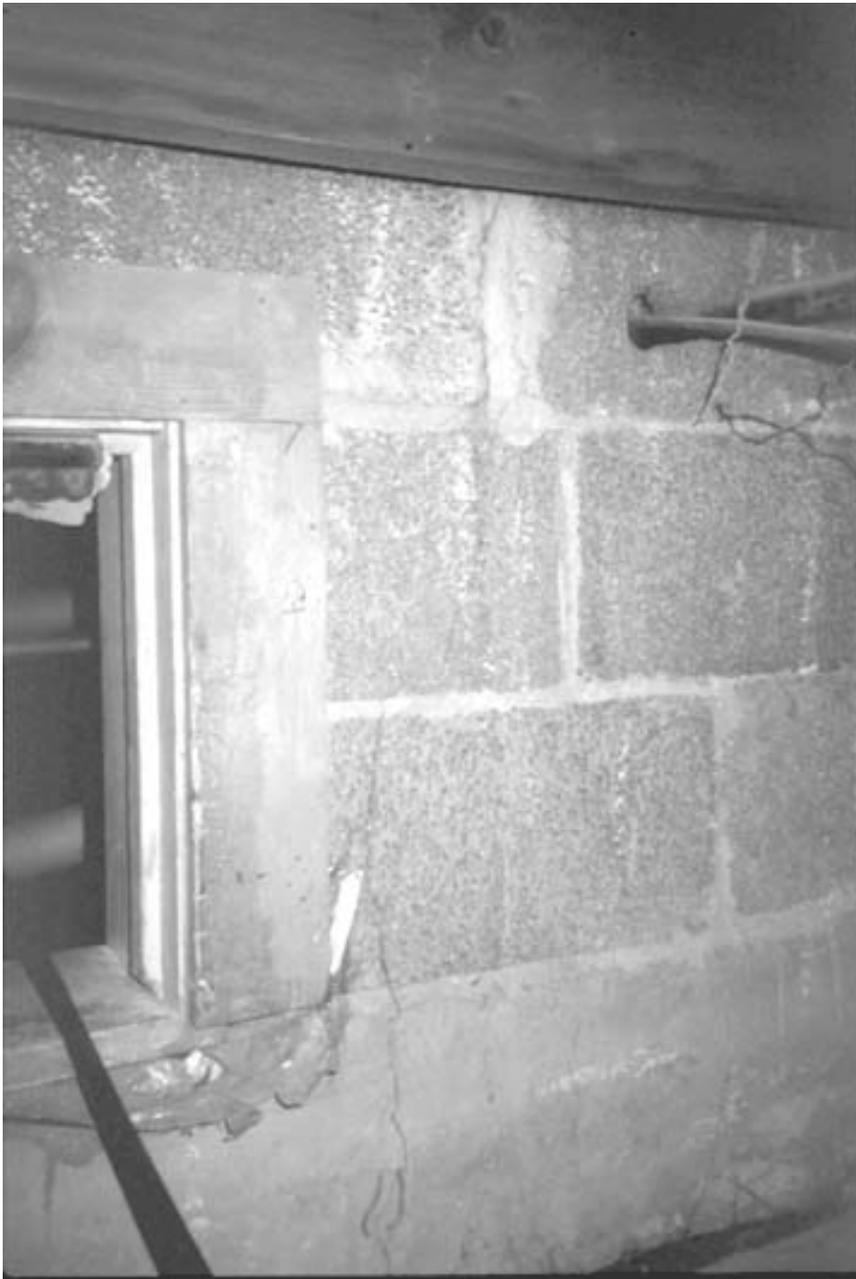
No cracking or deformations were observed in the interior foundation walls, with one exception. One crack was observed in the base of the firewall between the south stairwell and the south ward bay, immediately to the east of the access panel, but not at the pilaster (Point D). This crack did continue into the foundation wall. However, it was approximately 1/16 in. at its widest, and no differential movement was observed on either side of this crack (Figure 3-7).

Figure 3-7. Crack adjacent to access panel.

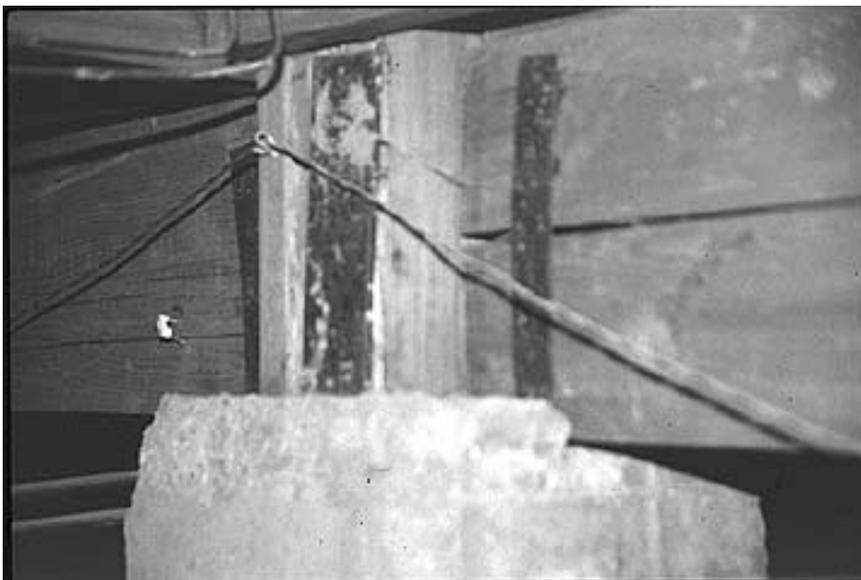
places. Beams were found to be virtually dead level where tested at several random locations. Some minor splitting was observed at the ends of many beams where they were nailed to the straps embedded in the piers (Figure 3-8). However, no other signs of distress, deflection, or delamination were observed. At the center cores, cementitious material was packed under beams (i.e., “grouted”) at the pier tops, presumably to affect more uniform bearing. Perhaps this was done by the crews installing the gunite cover in the crawl space floors. Bearing joists directly on the irregular surface of a pocket chopped in cinder block is not an accepted practice, by contemporary standards. However, no adverse effects in the floor structure were observed relative to this detail.

Figure 3-8. Beam/strap detail in crawl space.

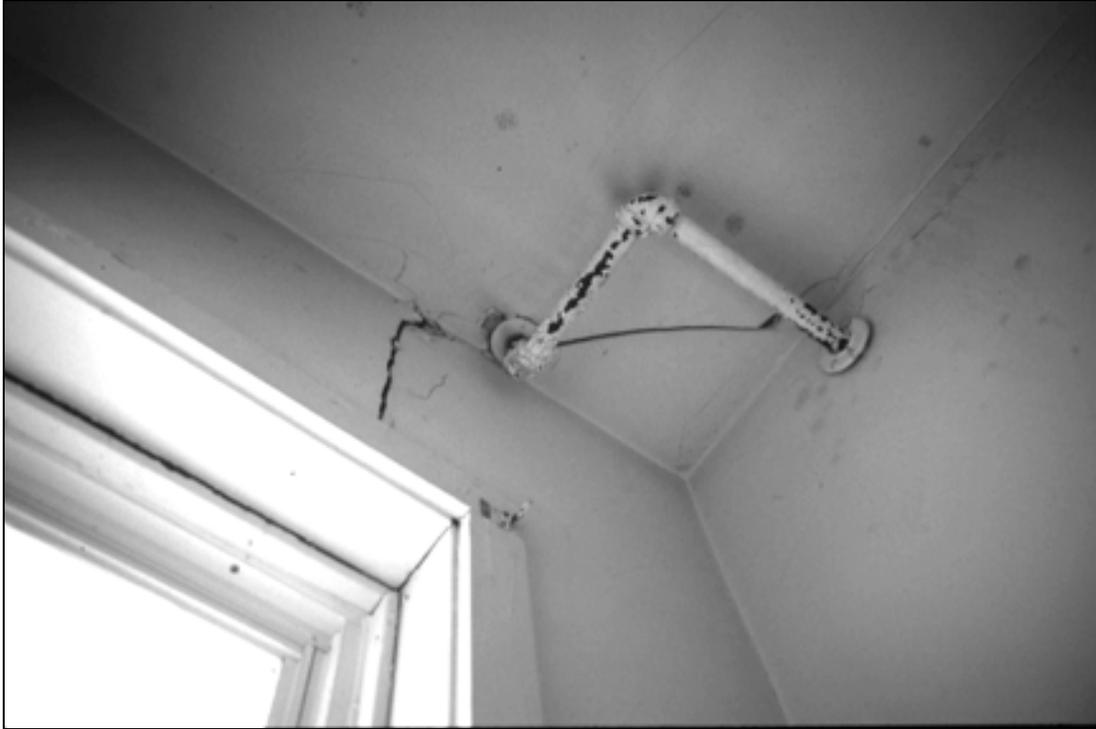
Very little cracking was observed in first floor ceilings, except in the added bathroom at the east side of the former south ward (Point I and Figure 3-10). A severe crack occurs in the east wall and ceiling adjacent to a window. However, no extraordinary deflection or slope is detected in the second floor above. The condition at this window is discussed under Load-Bearing Exterior Walls (p 42).

Figure 3-10. Cracking in southwest bathroom above the window, first floor.

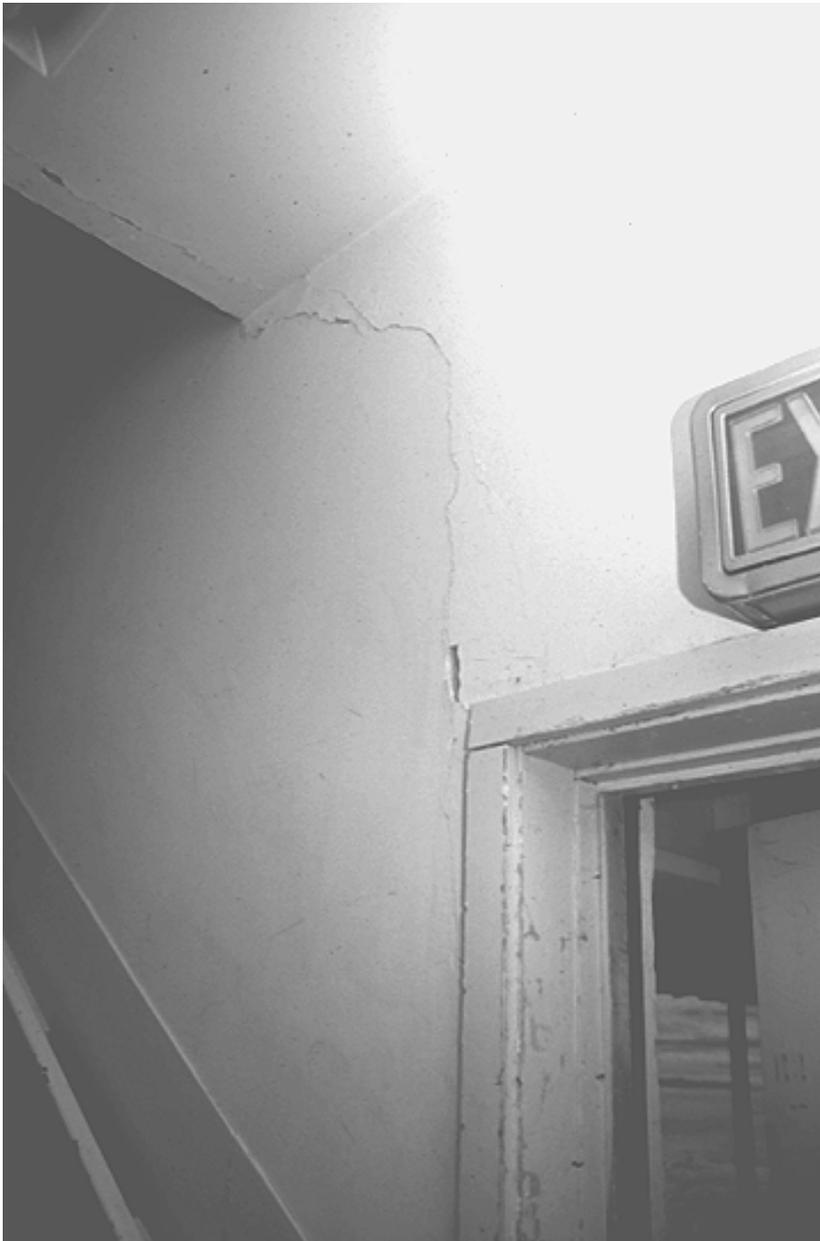
Figure 3-11. Cracking in wall of center stairs.

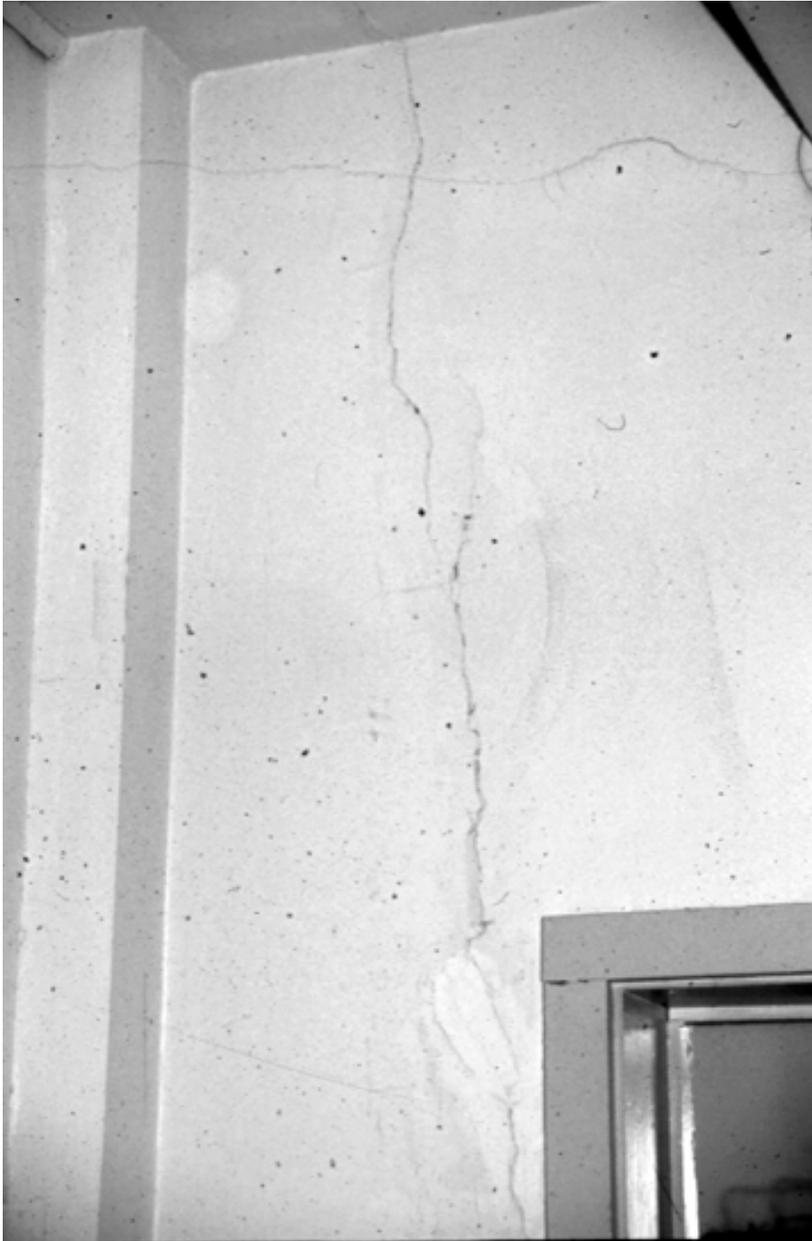
Figure 3-12. Vertical crack in firewall, first floor north ward.

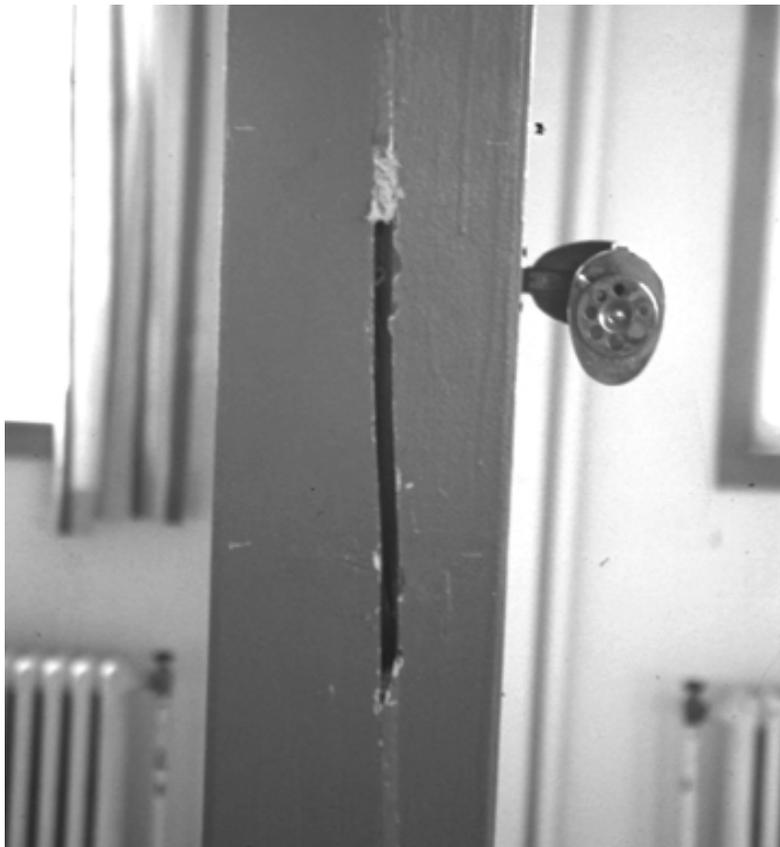
Figure 3-16. Vertical split in column.

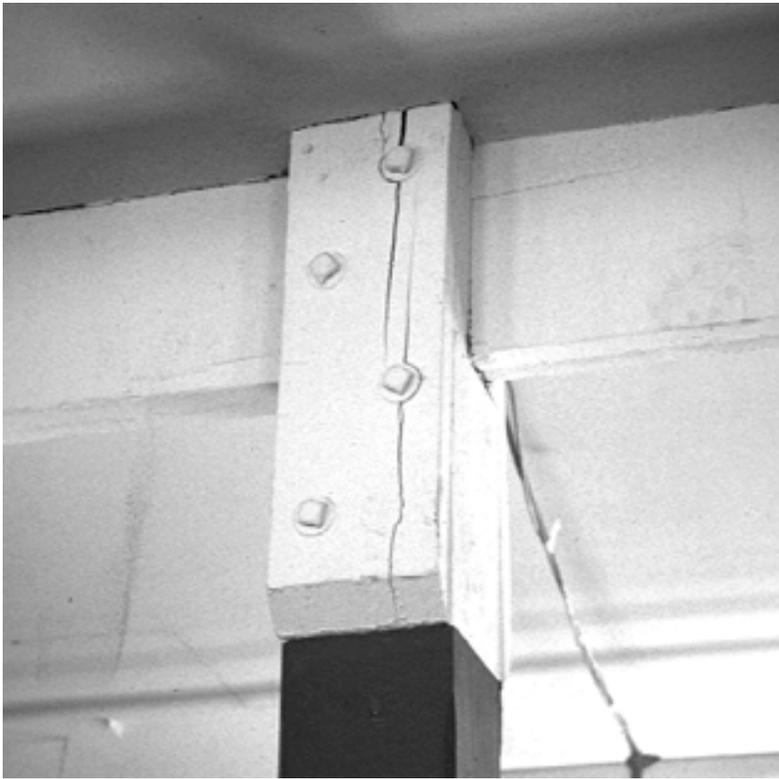
Vertical splitting had occurred at the “beam pockets” at the tops of the columns at the bolts (Figure 3-17). These pieces do not carry vertical loads, and no lateral dislocation of the beams was observed. Paint was evident within these splits, suggesting that they had been stable for quite some time.

Figure 3-17. Splitting at beam pocket.

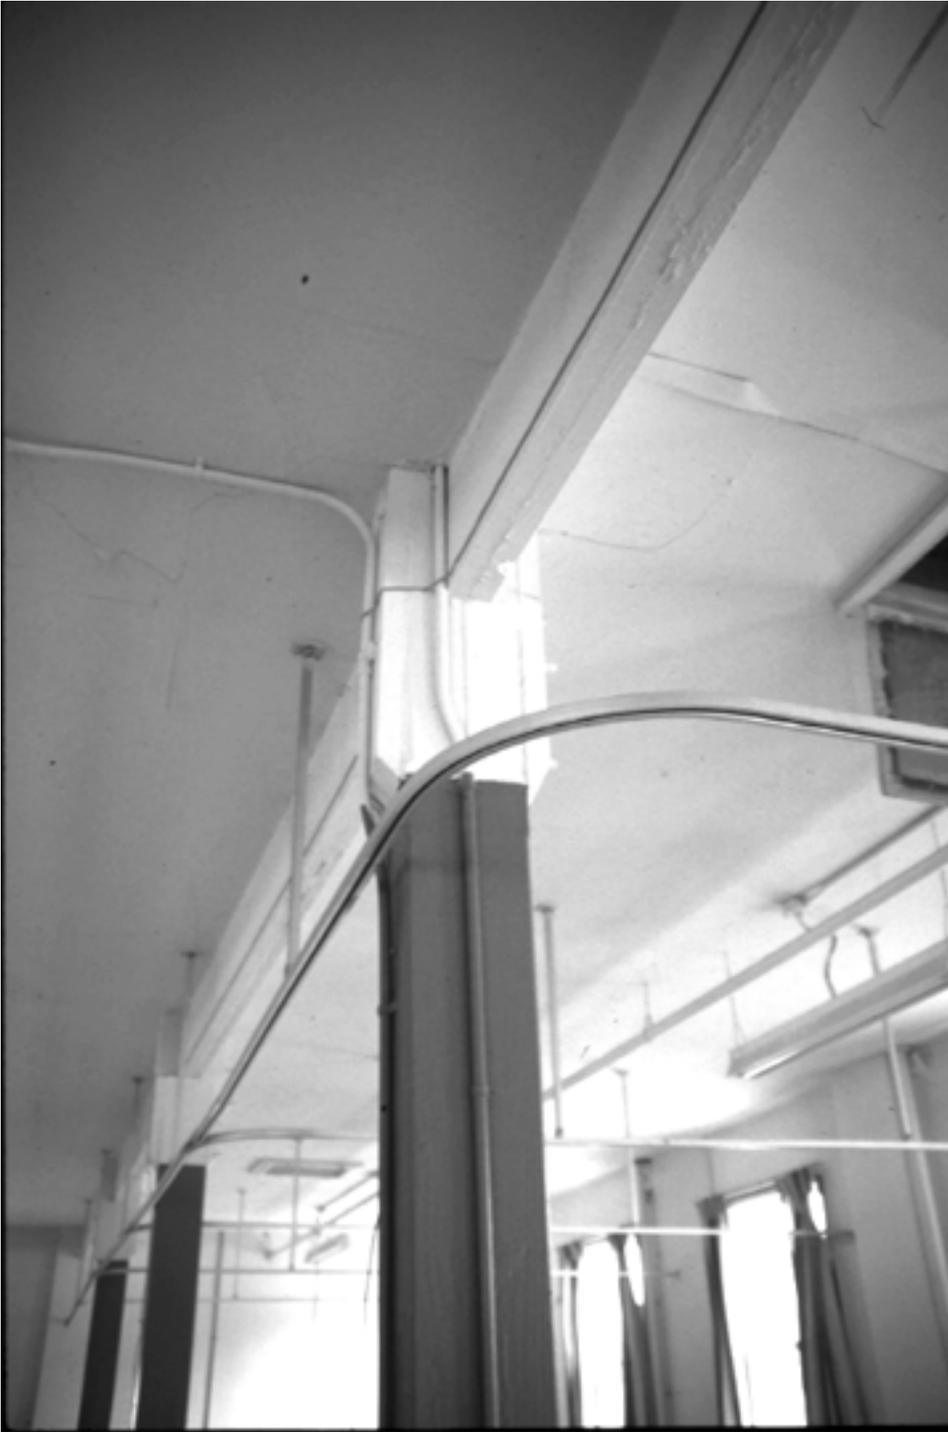
In the south open ward, the third column from the south on the west side was clearly twisted, although it was still plumb (Point M and Figure 3-18). There appeared to be no other deformations because of the twist. Again, this may be more a lumber curing problem than evidence of structural movement.

Figure 3-18. Twisted column in open ward.

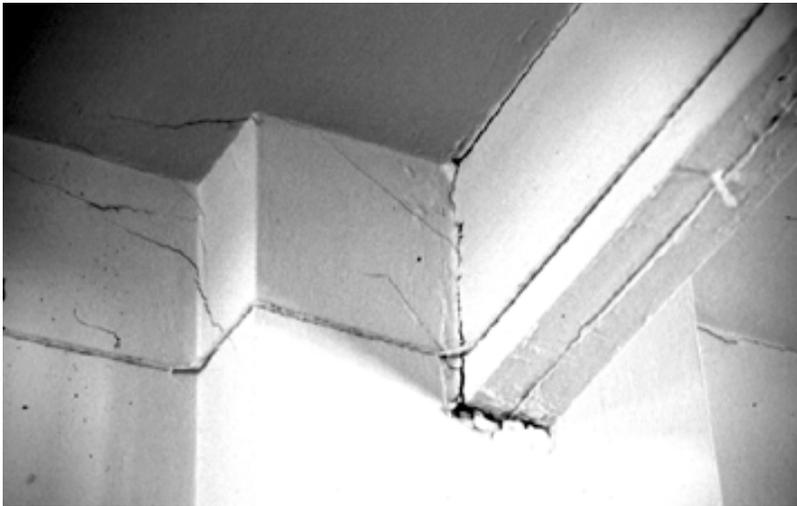
Figure 3-19. Cracking at beam/pilaster connection.

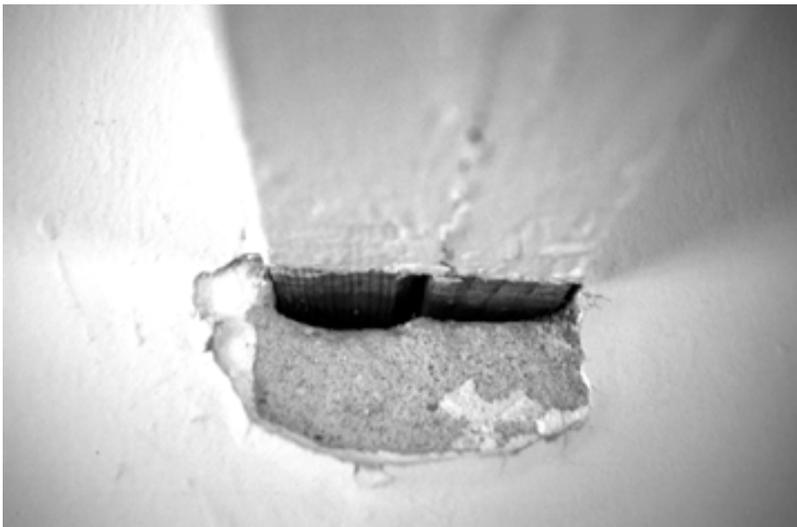
Figure 3-20. Gap below beam.

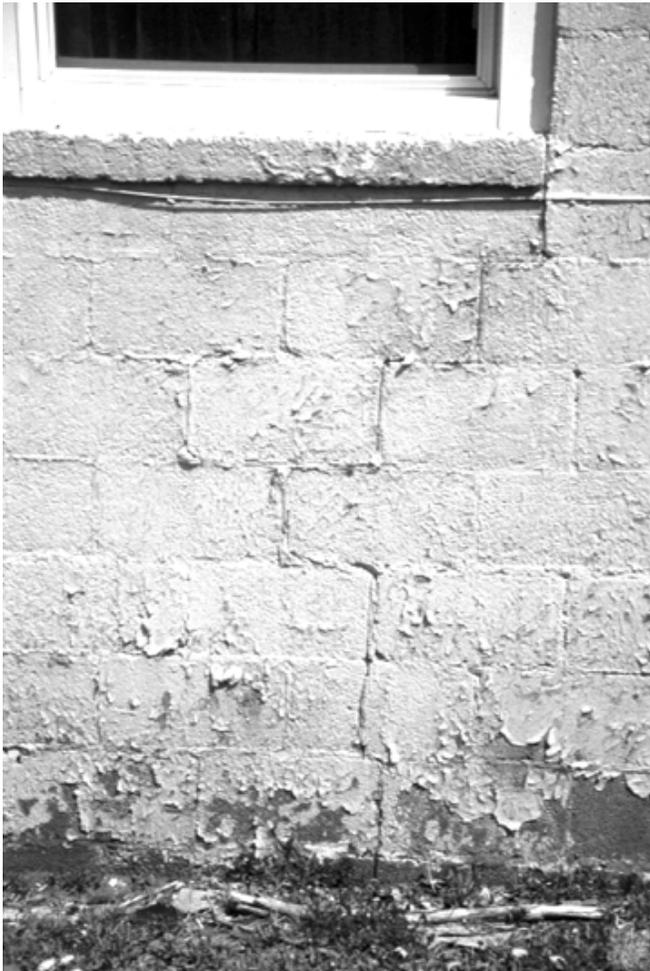
Cracking was observed throughout the exterior cinder block walls. Cracks typically radiated from the corners of window openings, and followed the stair-step pattern of the mortar joints (Figure 3-21). Occasionally cracks would split blocks vertically. Cracks were generally minor, 1/8 in. or less, although larger gaps occurred where mortar was deteriorated or absent (Figure 3-22). Exterior walls showed no evidence of vertical displacement. Framed assemblies carried by exterior walls were found to be level. Windows could be opened and closed without binding. No signs of bowing in either a vertical or horizontal direction were observed at any exterior wall; they were straight and plumb.

Figure 3-21. Stair-step cracking.

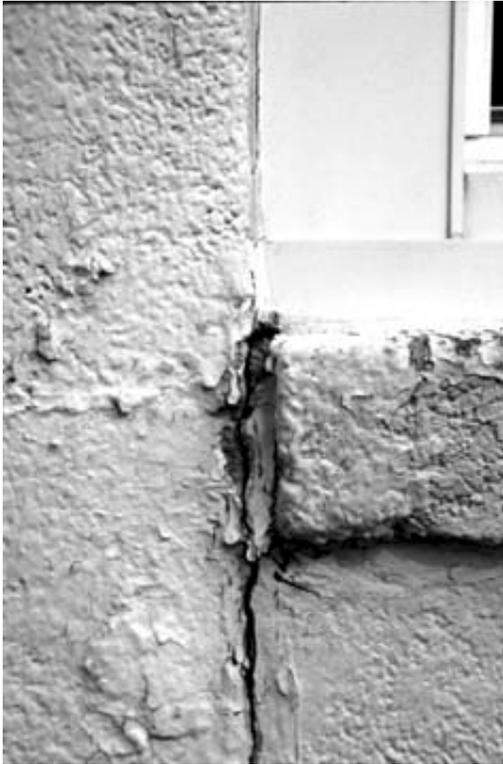
Figure 3-22. Mortar gaps at window sills.

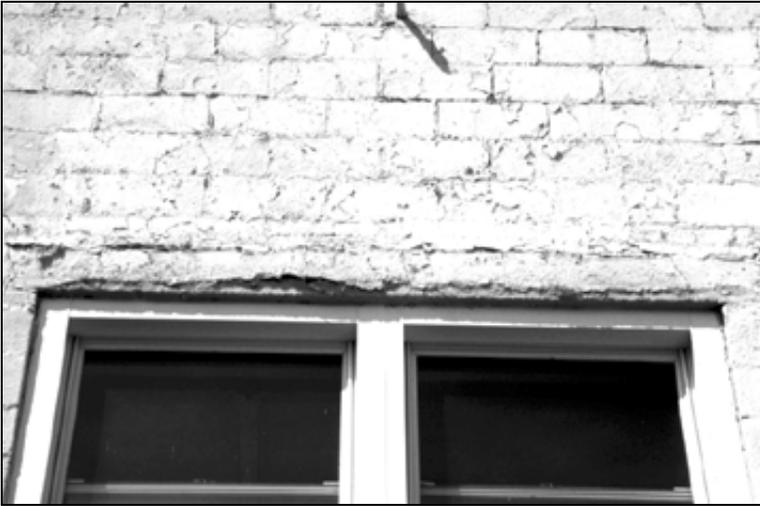
Serious distress was observed at some lintels. Lintels on the end walls (north and south walls) apparently had been parged several times, and were bulging noticeably (Point Q and Figure 3-23). On the west wall, first floor lintels had been replaced with concrete lintels, presumably reinforced (Figure 3-24). The second floor lintels appeared to be intact and exhibited no cracking. On the east wall, all the cinder block lintels remained, and most first floor lintels were seriously cracked (Figure 3-25). The most severely cracked was in the east wall, at the southernmost window of the former open ward (Point R and Figure 3-26). Deformation of almost an inch was seen in the interior trim at that window's head. Severe cracking has occurred in the interior wall and ceiling immediately adjacent to that window. Ceiling cracking was also observed adjacent to the center window in the south endwall. The lintel over that opening had apparently been cracked, and had been parged over. Water penetration through this lintel may have contributed to the ceiling cracking.

Figure 3-23. Parged and bulging lintel.

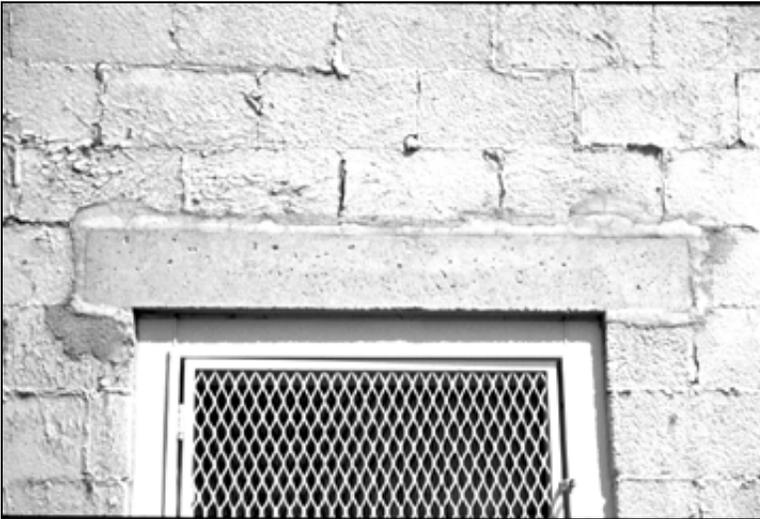
Figure 3-24. Concrete lintel replacement.

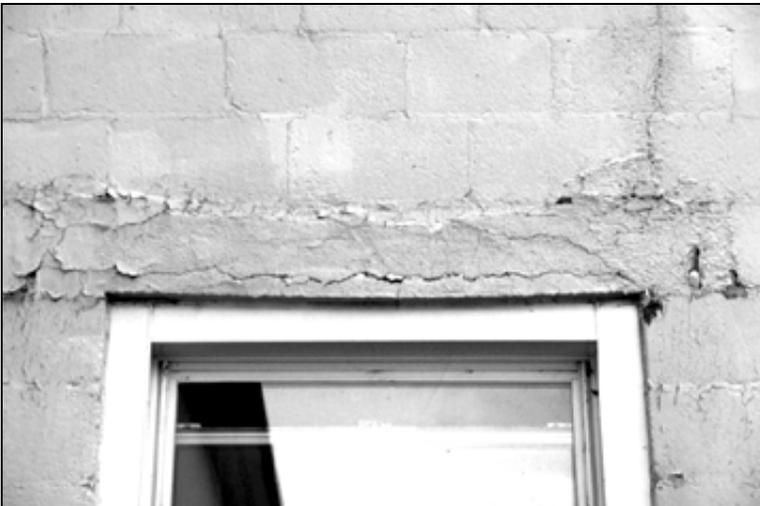
Figure 3-25. First floor lintel.

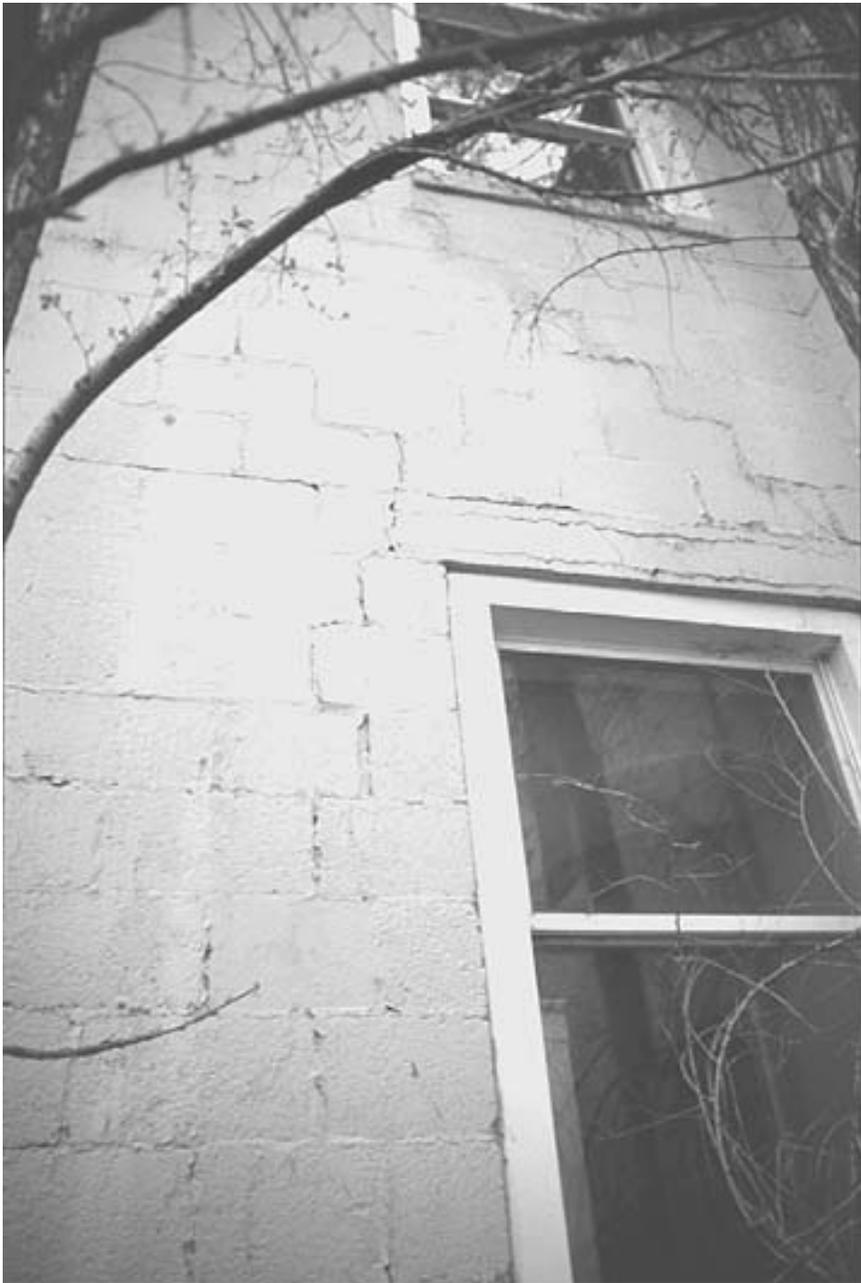
Figure 3-26. Most severe cracking at southeast window.

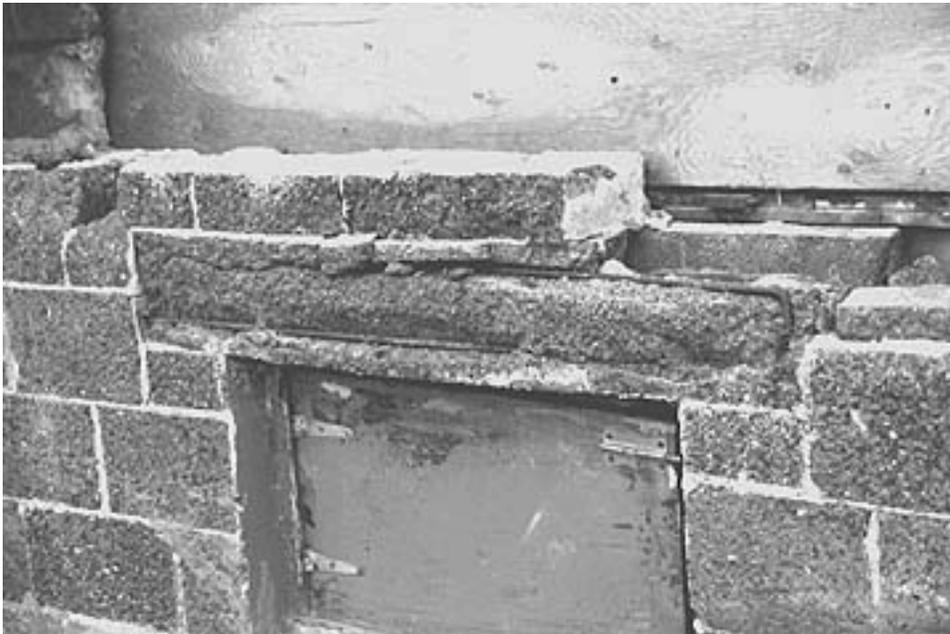
Cracked lintels were observed in Buildings 6240 and 6241, where the exterior paint and interior finishes were removed. It was clear that the reinforcing had become rusted, flaked, and spalled the cinder block cover, exposing the reinforcing (Figure 3-27). It is not apparent whether the cracks were originally caused by loading forces, or whether water penetration caused corrosion of the reinforcing, and weakened the lintels.

Figure 3-27. Exposed reinforcing in lintel (adjacent building).

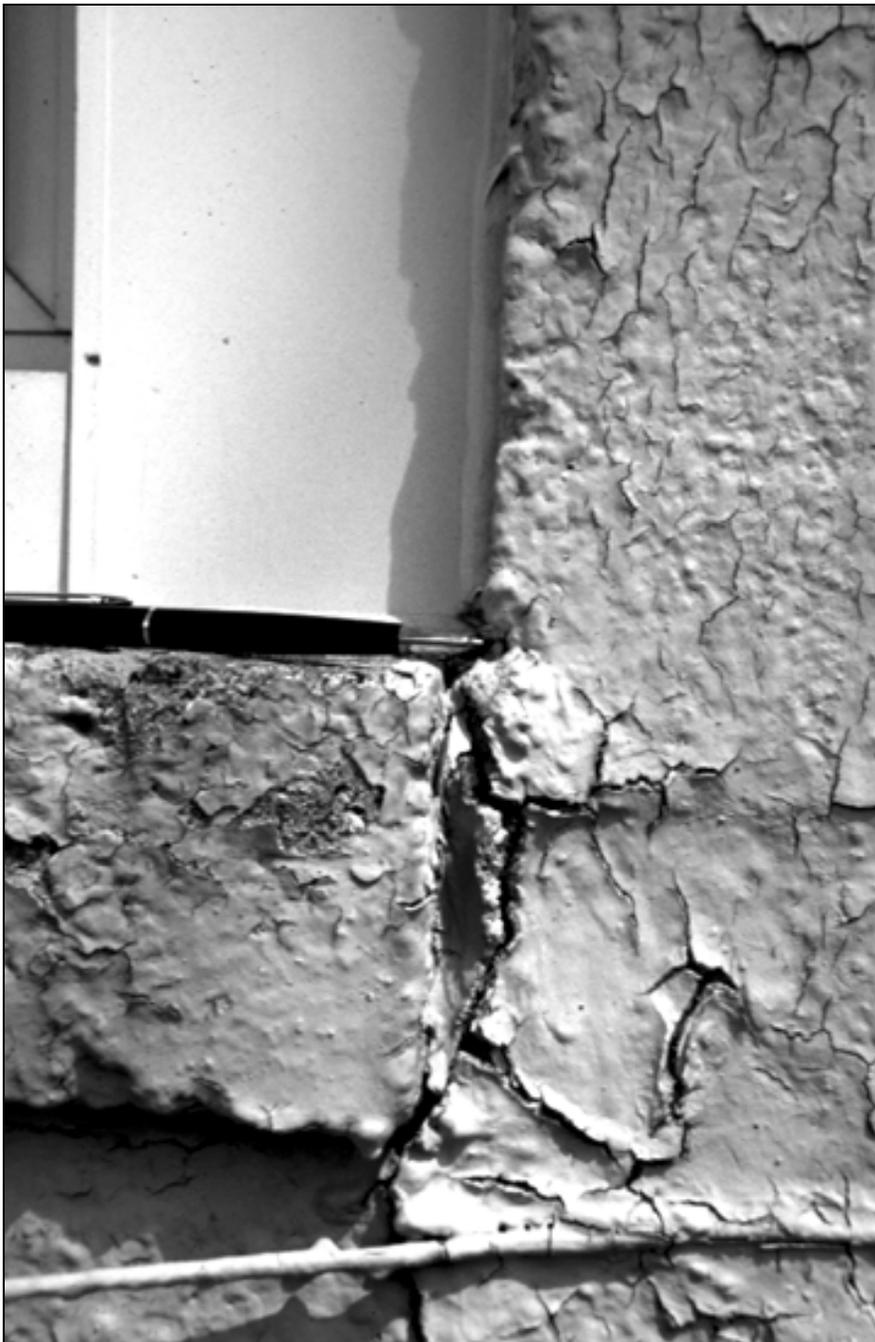
Figure 3-28. Shrunken mortar.

Regardless of the cause, it is evident that extensive repointing and painting is necessary to restore weather resistance integrity. Whether the entire wall surface must be repointed, or whether there may be areas where mortar is intact can be evaluated when the old paint is removed. There is approximately 18,000 SF of exterior masonry surface. If the structure is stable, recurrence of cracking is not imminent. Consideration must be given to mortar, sealant, and paint materials and their compatibility with the type of block used for these buildings. Consideration must also be given to providing some measure of stress relief in the exterior walls to accommodate thermal movement and minor structural movements.

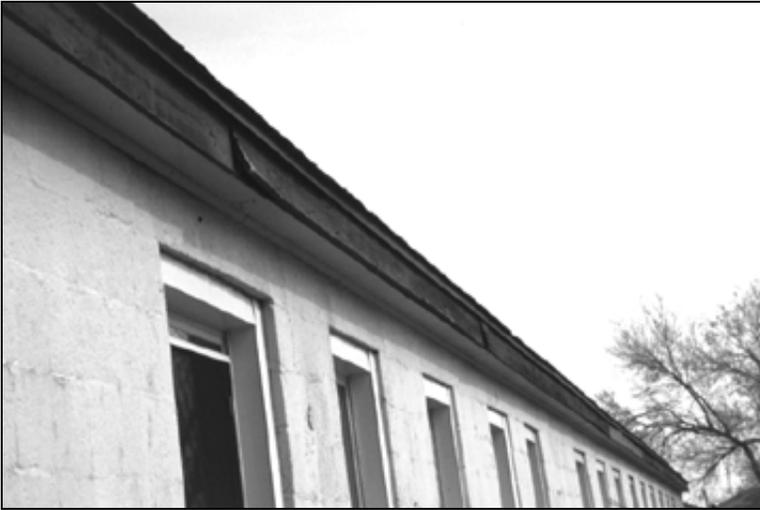
The eave trim appears to be generally intact throughout the main portion of the building. The paint is generally intact. Warping and shrinkage are evident. Warping generally has only opened up gaps in the eave trim (evidenced by daylight visible from the attic spaces), although one fascia board on the west side is severely warped (Point T and Figure 3-30). It is apparent this is caused by the lumber drying out, as opposed to structural movement.

Figure 3-30. Warped fascia board.

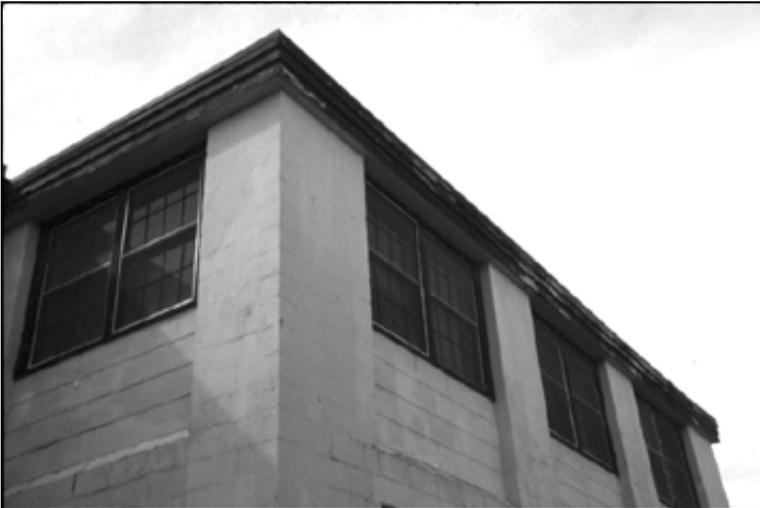
The eave trim at the porches appears to be in much worse condition (Point U and Figure 3-31). Peeling and discoloration of the paint are evident from the ground. As the roofs over the porches are nominally flat, roof leakage is more likely to occur. As the roof structure has been enclosed by ceilings, venting is less likely to occur. If renovated, upgrading roof drainage details at the porches will be critical. Keeping the roof and floor structures open at the porches is recommended, at least from the perspective of managing moisture.

Figure 3-31. Deteriorating trim.

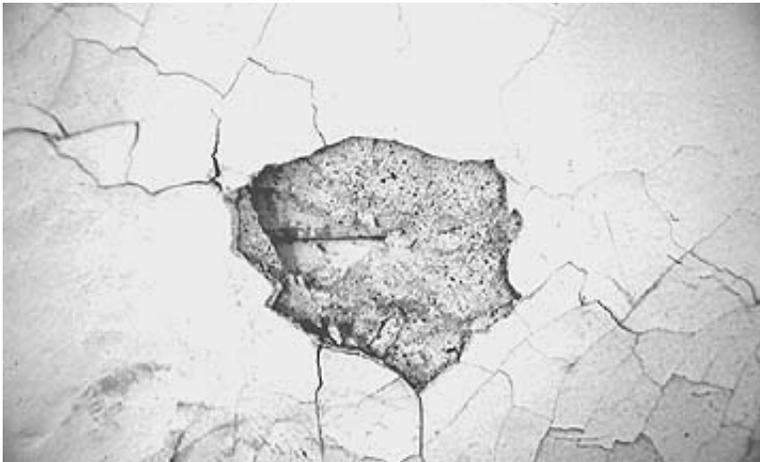
The plaster wall finish in the core areas, both within the rooms and in the hallways, appears to be in overall sound condition. However, there are numerous cracks and defects, most of which appear to be cosmetic. Damage from attached items and penetrations has also occurred throughout these areas. Damage appears behind radiators, where constant heating has spalled the finish coat away from the sheet lath (Figure 3-32). This damage occurs at almost every radiator, and there is at least one radiator in each room. In some places, plywood or Masonite boards have been nailed to the wall behind the radiator.

Figure 3-32. Spalled plaster behind radiators.
