DEMONSTRATION AND VALIDATION OF THERMAL SPRAY VITRIFICATION OF LEAD-CONTAINING PAINT ON STEEL STRUCTURES

CERL TR 99/61

July 1999

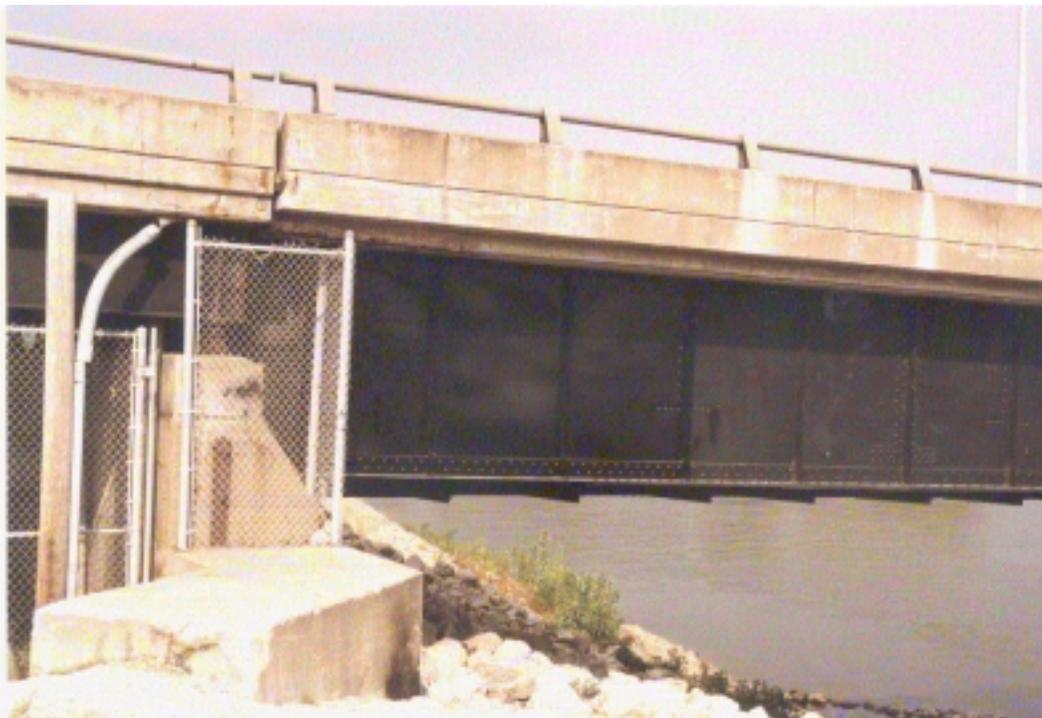
Figure B- 7. The Viaduct Bridge at the Rock Island Arsenal after the TSV demonstration.

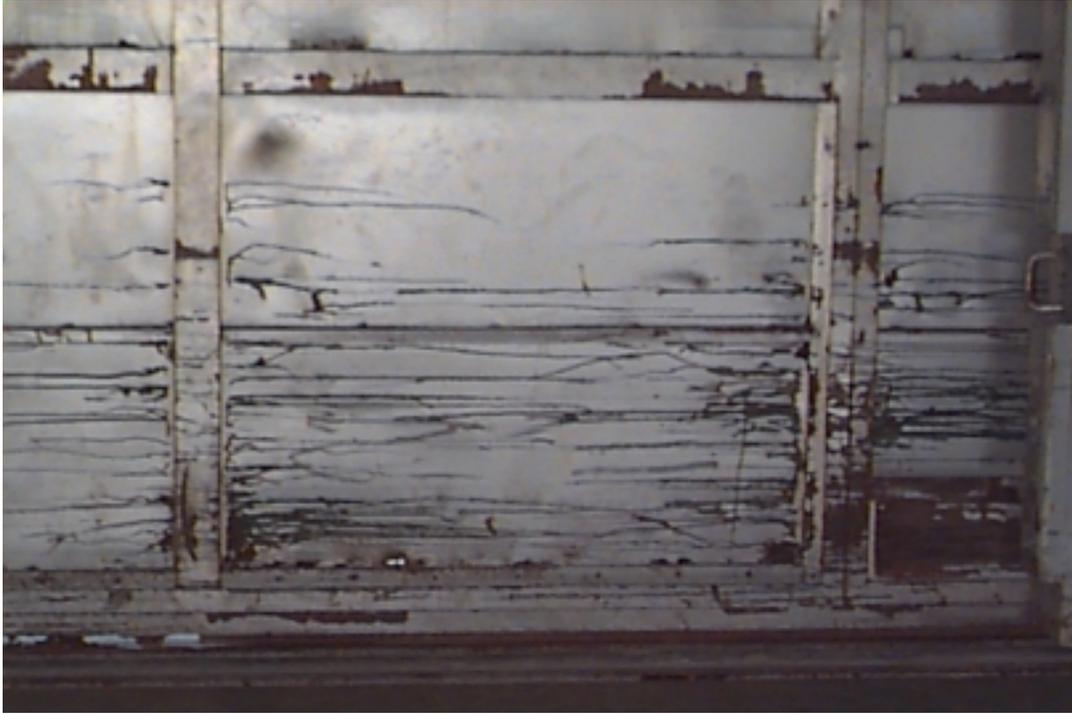
During the initial application of TSV, it was noted by the operator that the vertical web of the beam was warping. The application of TSV was immediately stopped and the degree of warping was measured and found to range up to 3/8 inch. A structural engineer from the Corps of Engineers Rock Island District inspected the beam and concluded that the warping did not adversely impact the structural integrity of the beam or of the bridge. The warping was due to excess heat applied to the vertical web of the beam during preheating of the substrate. The steel temperature on the back of a vertical web of the bridge was measured with a thermal couple during application of the TSV to the front side of the vertical web and is shown in Figure C-3 and C-4. The maximum temperature recorded for the two locations was 273 °C (523 °F) and 322 °C (611 °F). The issue of temperature control is only an issue with thin cross section substrates that are less than 0.200 inches thick. The vertical webs are relatively thin, less than 1/2 inch thick, and are fastened into place by rivets at the vertical supports between panels. When the web was heated with the preheat torch, the resulting thermal expansion of the web, which is constrained by the fasteners, could not be relieved except by warping. The TSV procedure was modified to eliminate the use of a separate torch to preheat the substrate. The thermal spray torch was used in a more controlled manner to preheat the substrate and the amount of warping was minimized. The temperature for these substrates can also be controlled by the use of forced air or wet forced air from the onsite compressors. There is limited cost associated with this control method. For each 100 sq ft, the time to set up a forced air cooling system is less than 15 minutes. At \$24/hr, the cost is \$6.00 per 100 sq ft or \$0.06 per sq ft. This is included in the revised labor cost for application of TSV, Section 6.1

Figure B- 13. Close-up of interior of hangar door showing dents and warpage of skin plate before TSV application.

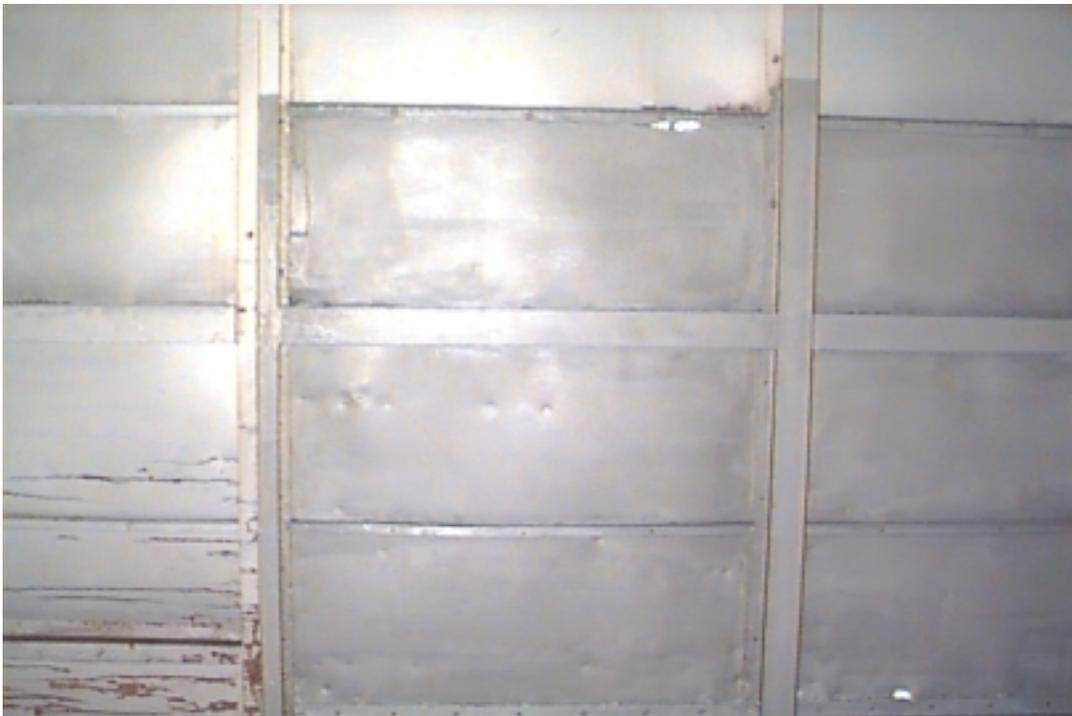
Figure B- 14. Photograph of hangar door interior after TSV and repainting showing no additional warpage.

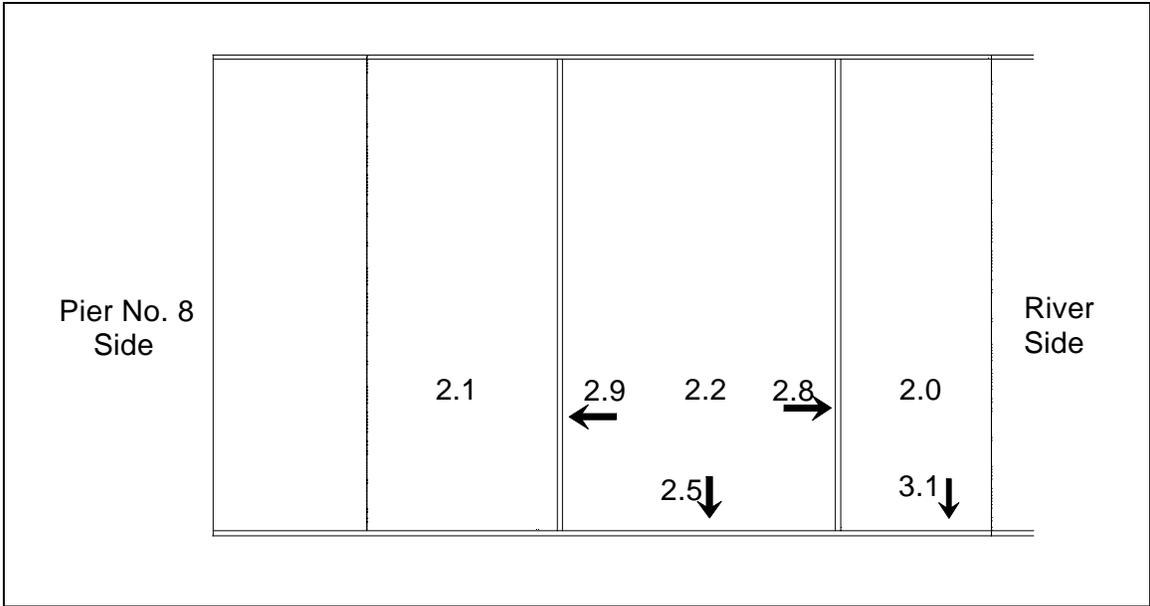
TSV met the principal performance criteria of providing surface preparation for repainting. Following application of TSV, the surface was inspected by personnel from the Paint Technology Center at U.S. Army Construction Engineering Research Laboratory and was found to meet the requirements of the Steel Structures Painting Council (SSPC) SP1 and SP3 required in the contract specification and was suitable for repainting with a surface tolerant coating system. The surface profile was measured using ASTM D 4417 and found to range from 2.0 to 3.0 mils, Figures C-5 and C-6.

Figure C- 5. Surface profile after TSV application (mils), east side.

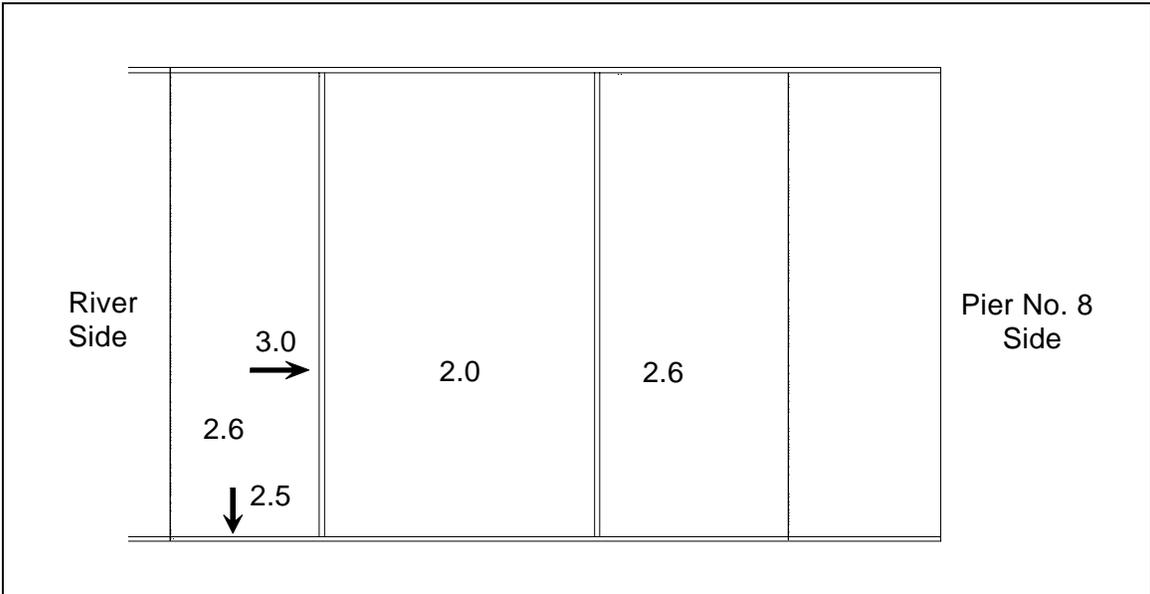
Figure C- 6. Surface profile after TSV application (mils), west side.

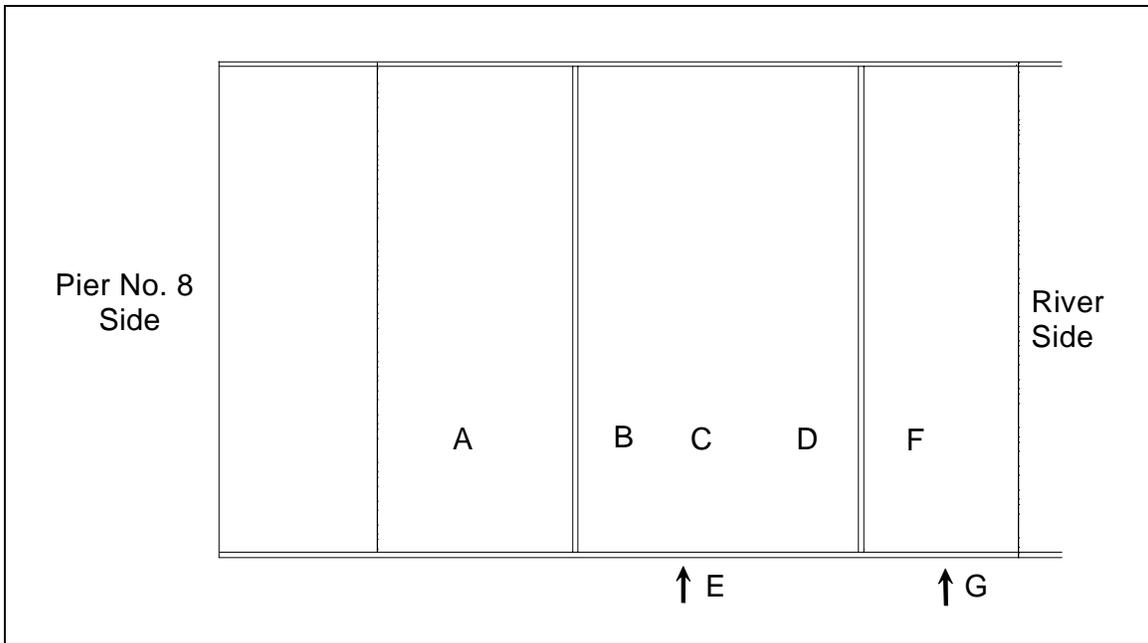
The first paint coat was a Sherwin Williams industrial coating SSPC 25 red primer. The top coat was a Sherwin Williams VOC complying industrial enamel No. 2.16. This is a medium oil, alkyd, all purpose enamel designed for new construction and maintenance work and provides performance comparable to products formulated to Federal Specification TT-E-489. Temperature and relative humidity were measured prior to painting. The temperature of the substrate was more than 5°F higher than the dew point and the relative humidity was below 80% before painting commenced. The contract specification required a spread rate of 500 sq ft per gallon. One gallon of the primer and one and half gallons of paint were used to apply the one coat of the primer and two top coats over the 180 sq ft area of the demonstration. The measured thickness of the dried primer ranged from 1.7 to 3.4 mils and was on average 3.0 mils, Figure C-7, Table C-3, Figure C-8, and Table C-4. The measured thickness of the completed coating system primer plus top coats ranged from 5.4 to 8.4 mils and was on average 6.9 mils, Figures C-9 and C-10, and Tables C-5 and C-6.

Figure C-9. Location of thickness measurement (primer plus topcoat) after TSV application, east side.

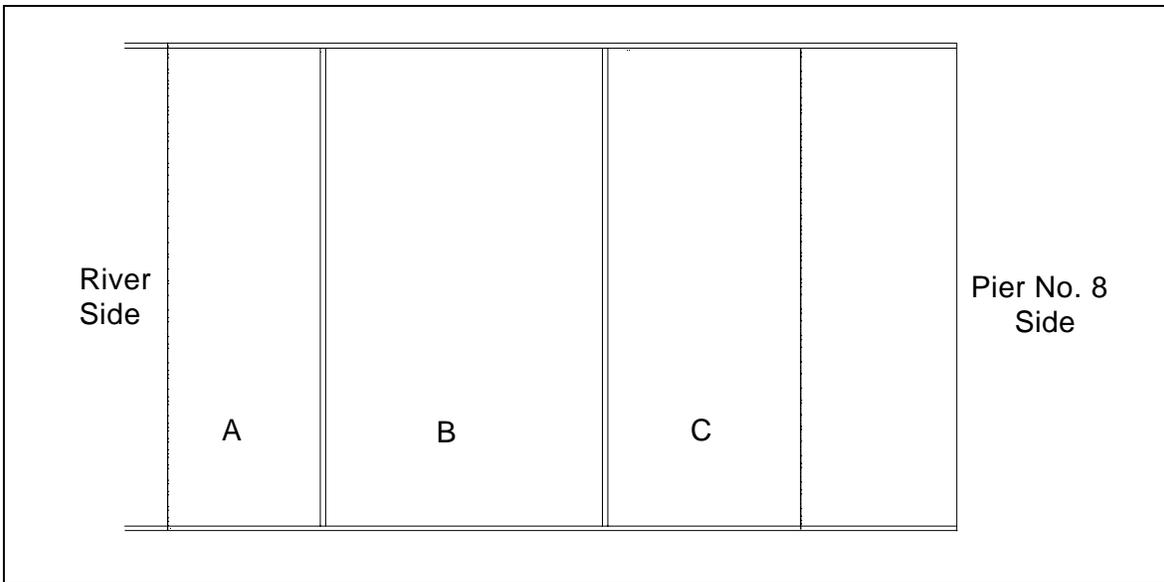
Figure C- 10. Location of thickness measurements (primer plus topcoat) after TSV application, west side.

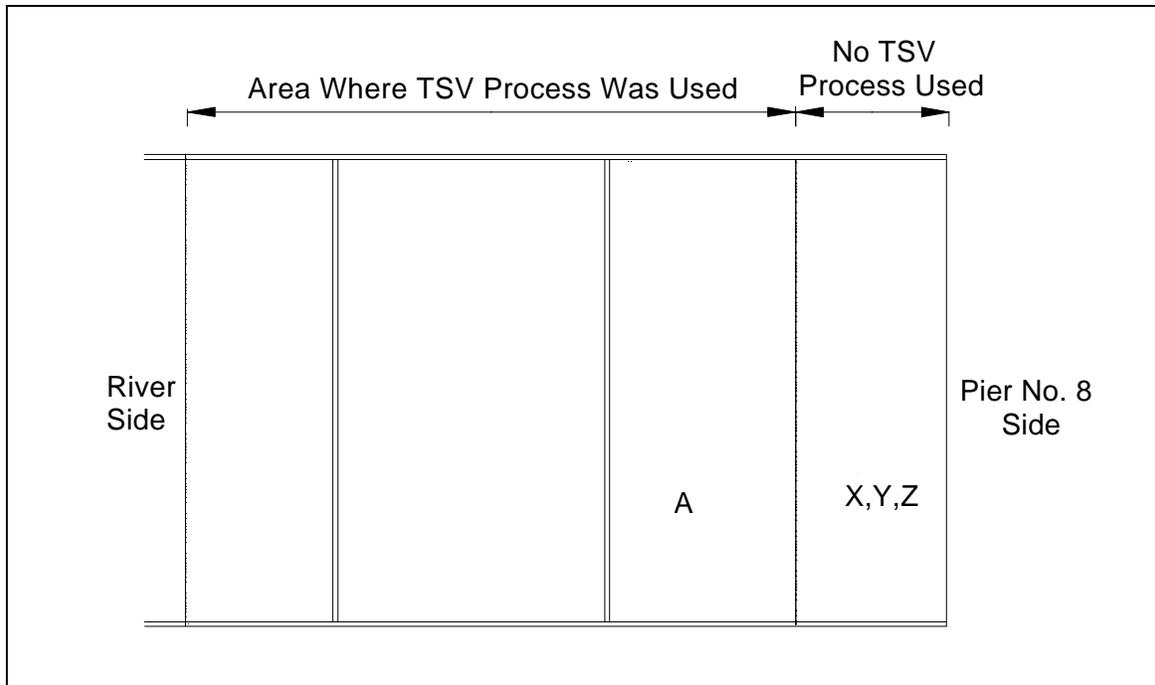
X-ray fluorescence analysis found the lead concentration in areas adjacent to the demonstration with intact original coating ranged from 4.7 to 5.8 mg/cm², Figure C-11 and Table C-7. In areas on which the thermal spray vitrification was demonstrated, the measured lead concentration was found to range from 1.0 to 2.1 mg/cm², Figures C-12 and Figure C-8. As with most other paint-removal processes, such as chemical removal, some residual lead was present on the surface. The aim of this demonstration was to reduce the concentration of lead on the surface to less than 1.0 mg/cm². The retention of lead on the steel surface is a function of the experience of the applicator, the original amount of lead present, and the number of applications of TSV utilized. During the demonstration, two applications of TSV were used. One or two additional applications of the process would be expected to further reduce the residual concentration of lead on the substrate to below 1.0 mg/cm². Experience with the technology also reduces the amount of lead remaining on the surface. The workers in this test had less than 2 days of experience by the end of the test. With a week of on-job experience, the amount of residual lead should also be reduced as the applicators become more proficient. The lead retention does not appear, with the data in hand, to be a function of the lead paint type or age. During any future paint removal from the

Figure C- 11. Location of lead-concentration measurements using x-ray fluorescence spectroscopy with and without TSV application, west side.
