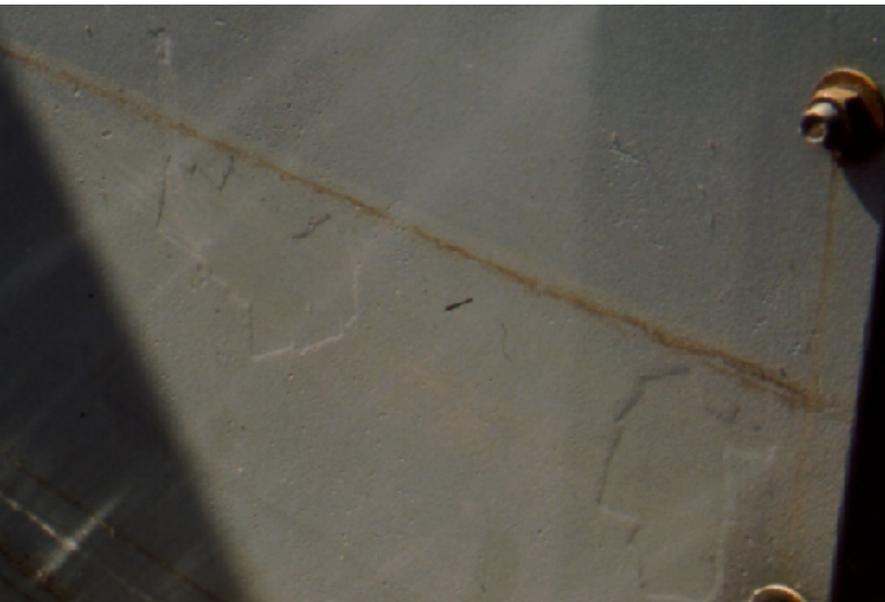
1998 – Coating on Gate #6 was first evaluated after 1 year of service. Apparently the applicator had difficulty applying the coating and produced many areas of bubbles. In some areas the entire coating was removed perhaps with a putty knife while in other areas the tops of the bubbles were scraped off. Additional coating was applied to provide the required thickness in the repaired areas. Some of the bubbling was not repaired. Overall, no coating failures were noted and the bubbles did not appear to present any imminent concern.
