Greenup Dam Tainter Gate

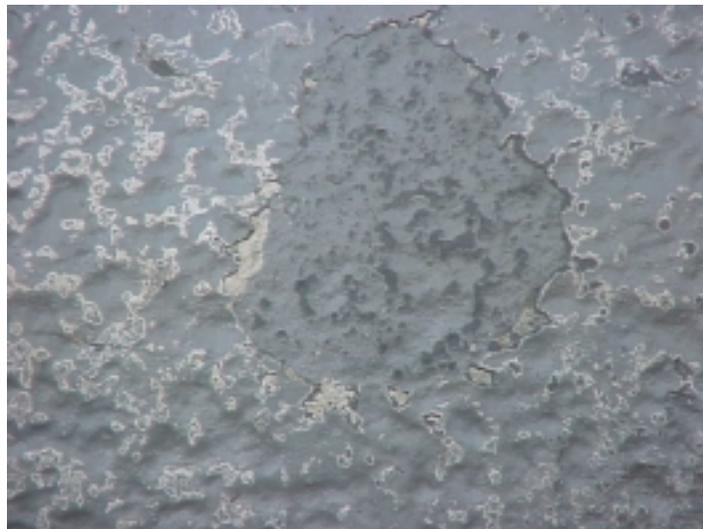
White and gray sealer is being eroded. Solid gray spot has no coating but is being galvanically protected by the metallizing.

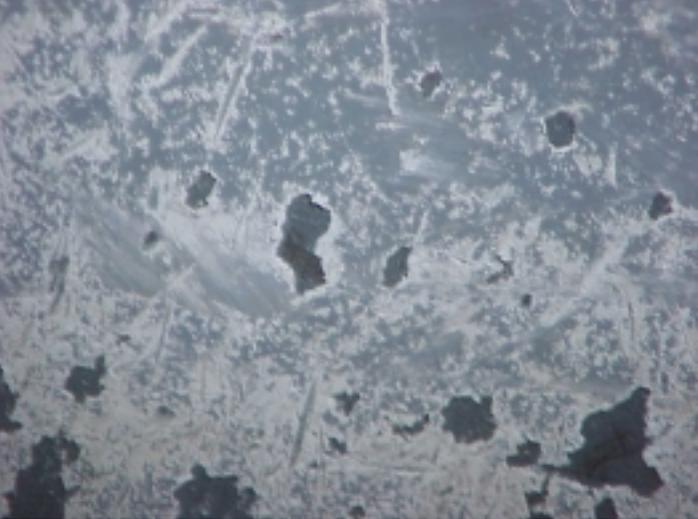
Pattern indicates damage by abrasion

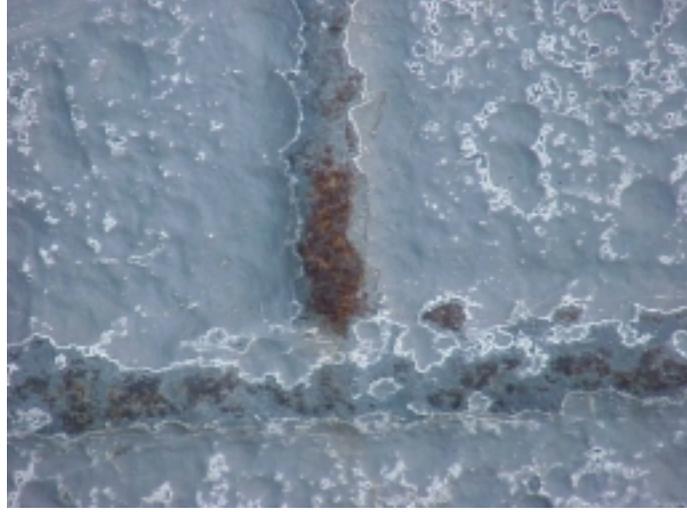
Erosion on weld lines

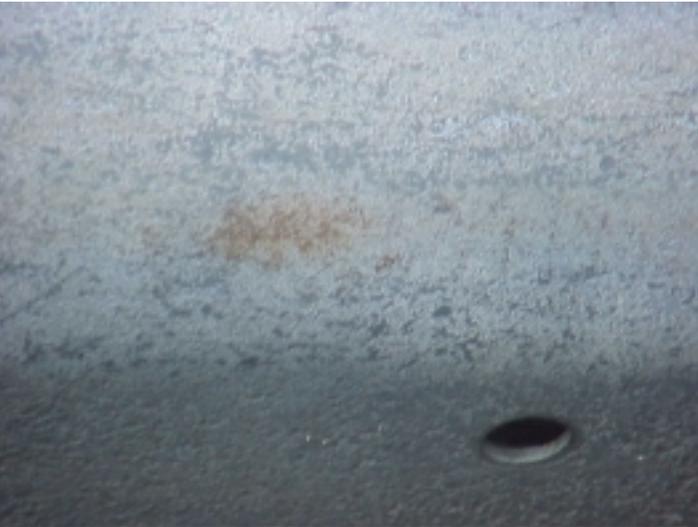
Beginning of failure on nose

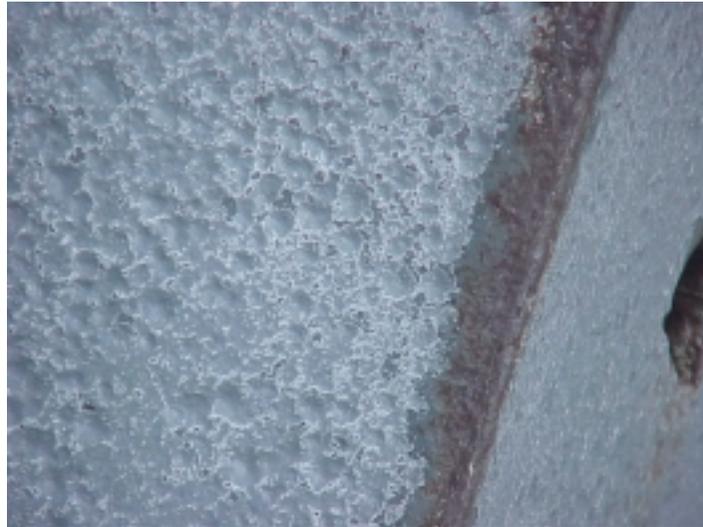
Failure on edge

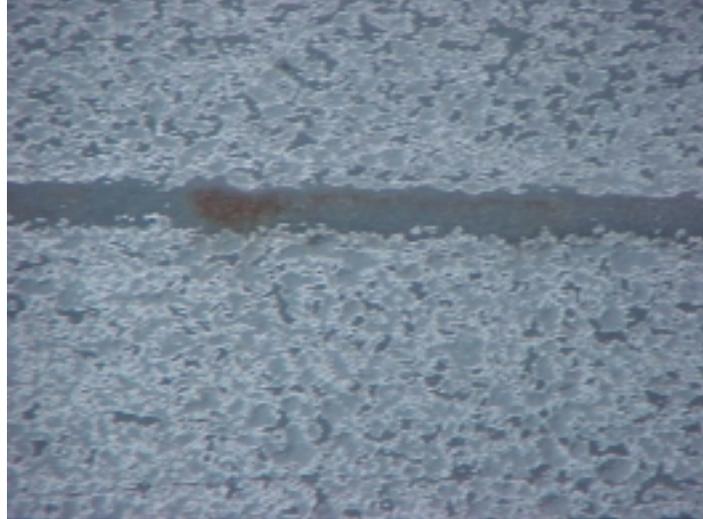
Erosion on downstream weld line above nose.

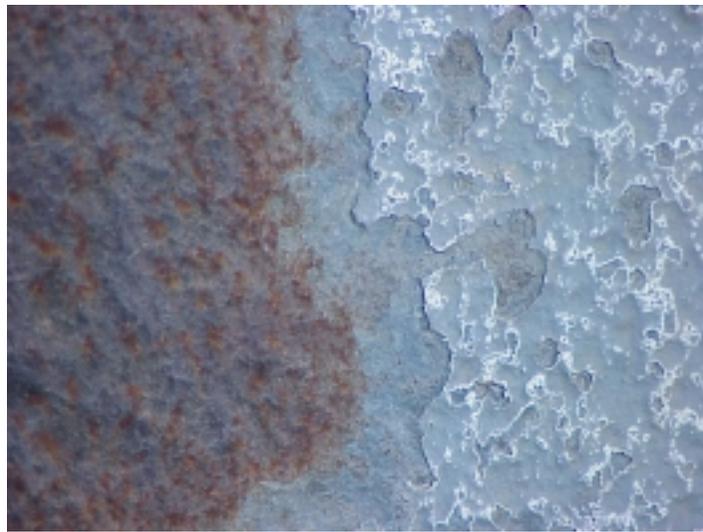
Close-up of failure on downstream nose area.

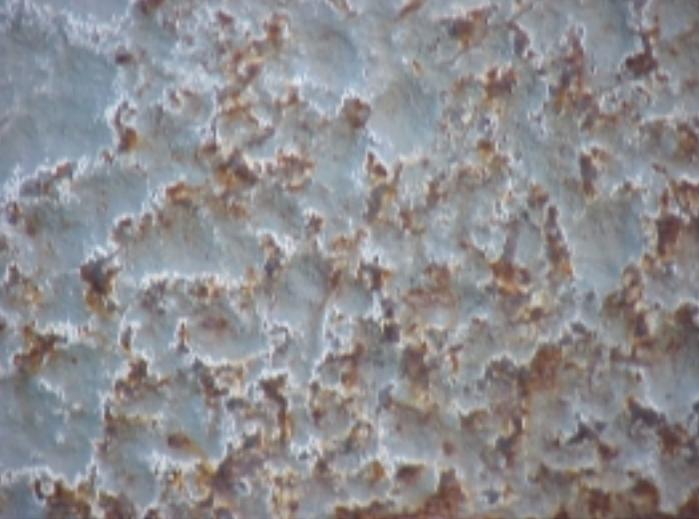
Failure often begins as the coating is worn off the protrusions of a rough surface

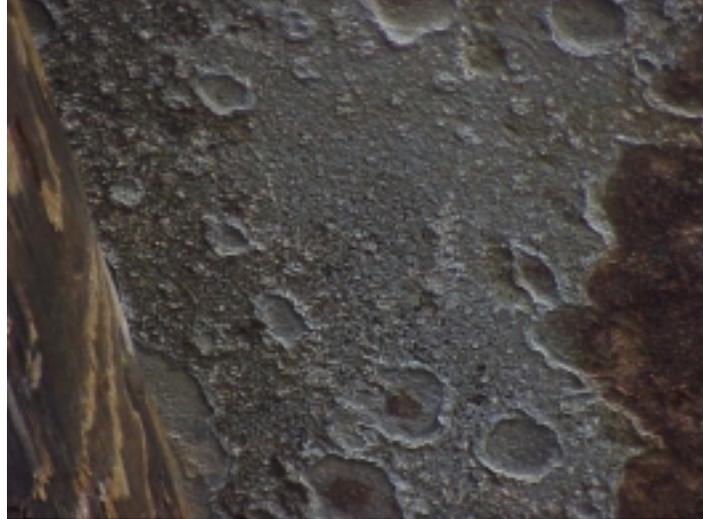
On a smooth surface failure begins at a spot; the metallizing sacrifices to protect the spot until the diameter reaches ~2.5cm (~1 inch). As the spot becomes larger, rust begins in the center.

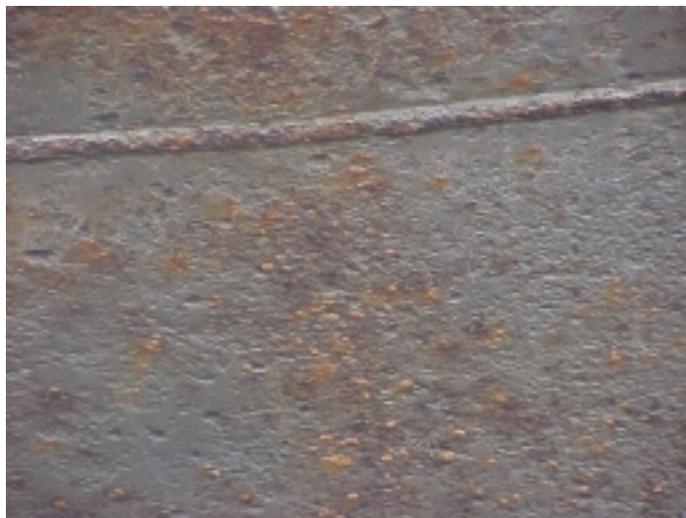
Upstream failure on lower portion of gate

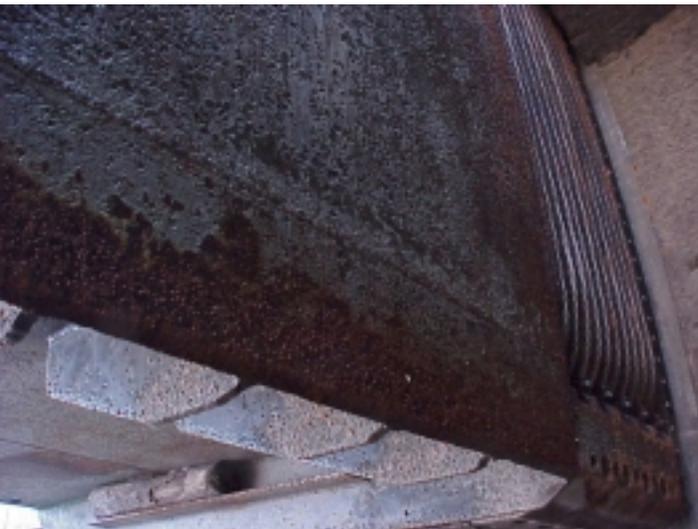
The lower section of the upstream side is high strength steel and subject to very high velocity flow.

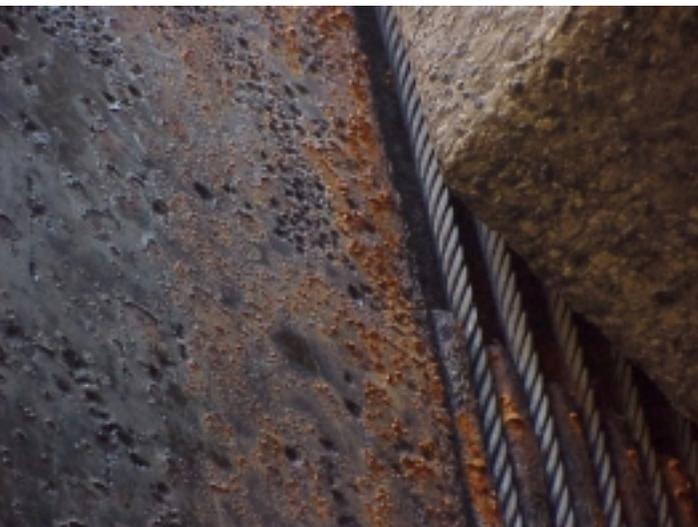
Lifting cables of stainless steel accelerate corrosion

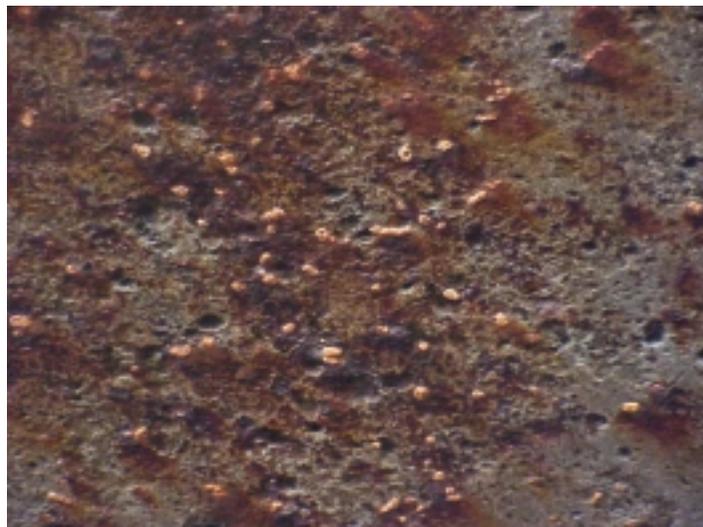
Corrosion on high strength steel may begin on pre-existing pits that were poorly coated

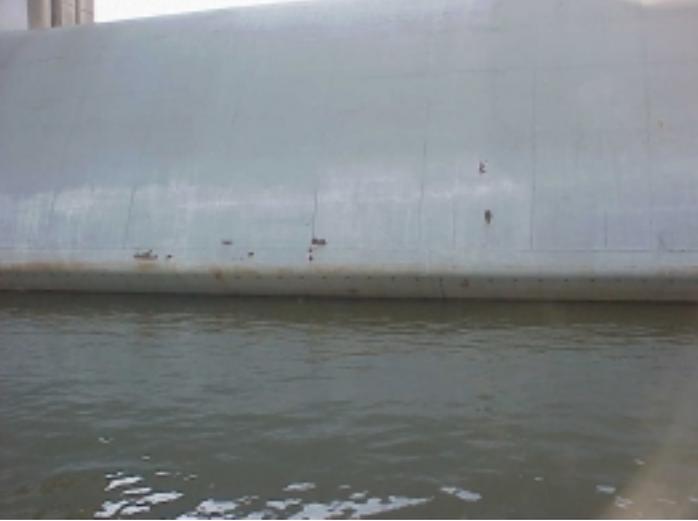
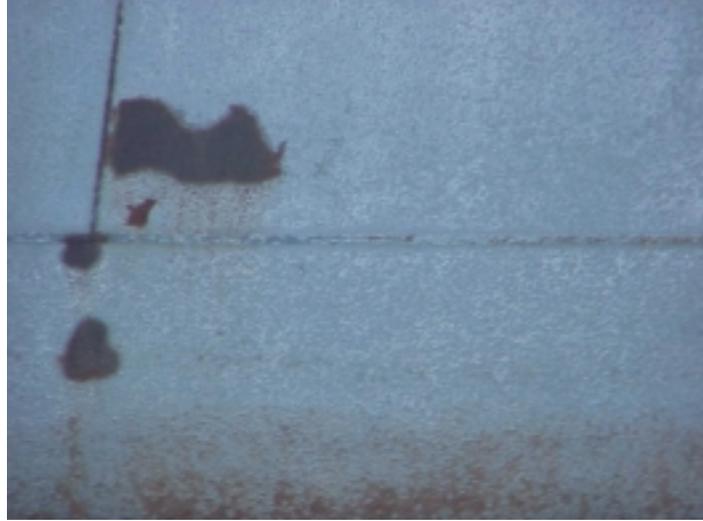
Cause of random spotty failures is unknown

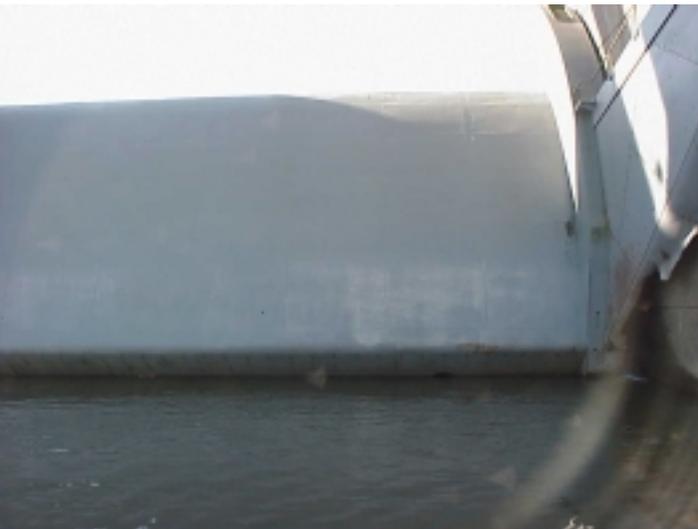
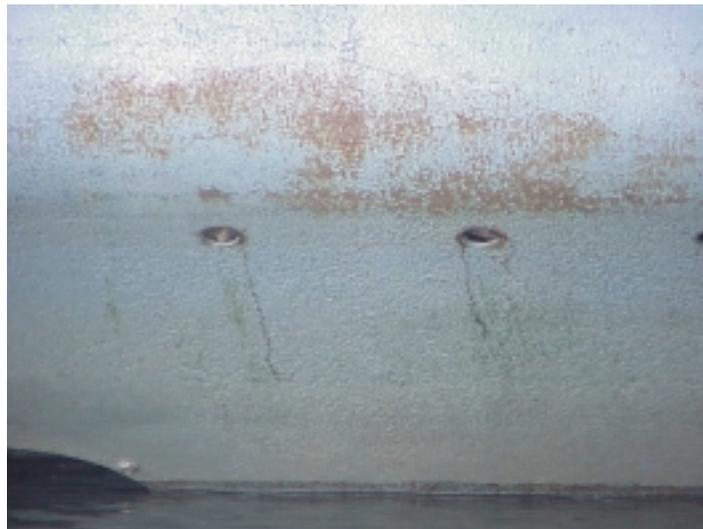
Nose area of the downstream side receives high abrasion

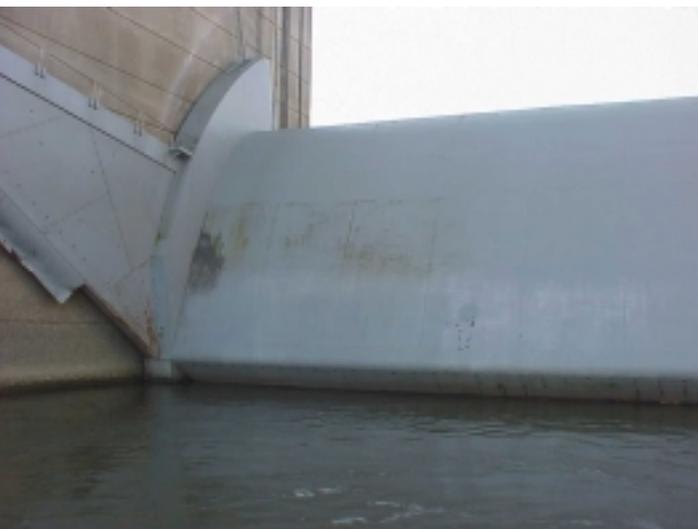
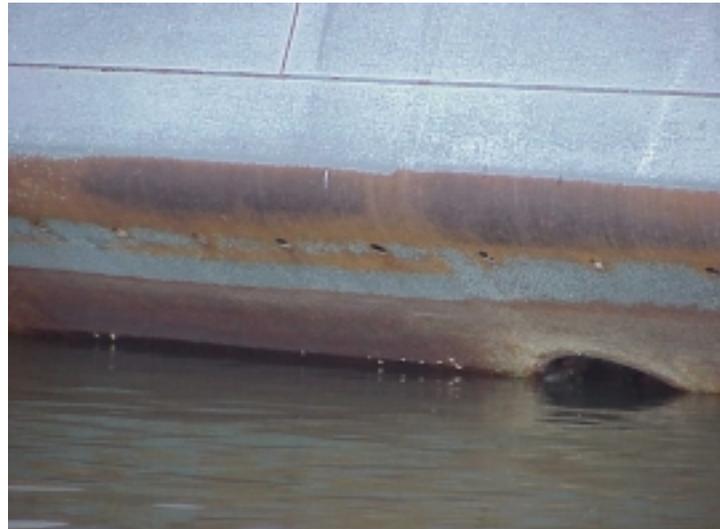
Last gate is poorest condition because area is used to pass drift

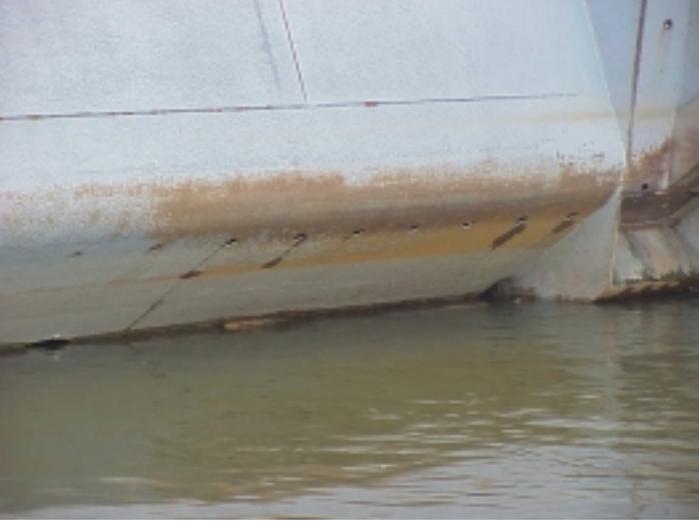
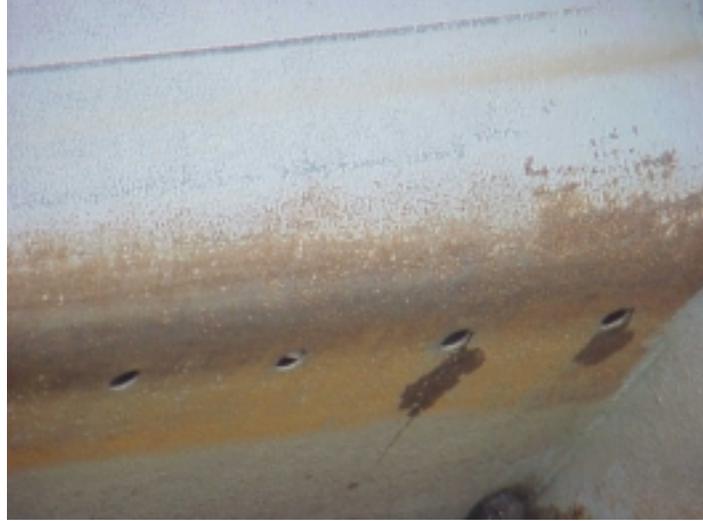
Damage of coating on nose area on second worst gate caused by passage of drift in adjacent bay.
