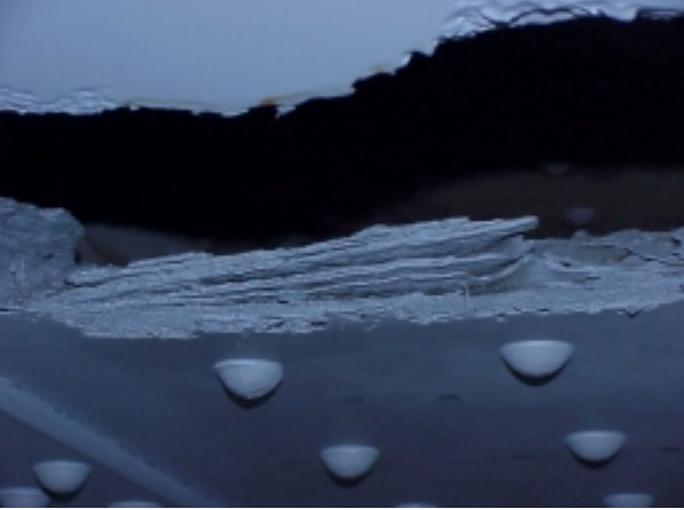
No provision in contract to grind sharp edges or remove laminar corrosion. Most of these surface problems were above the waterline.

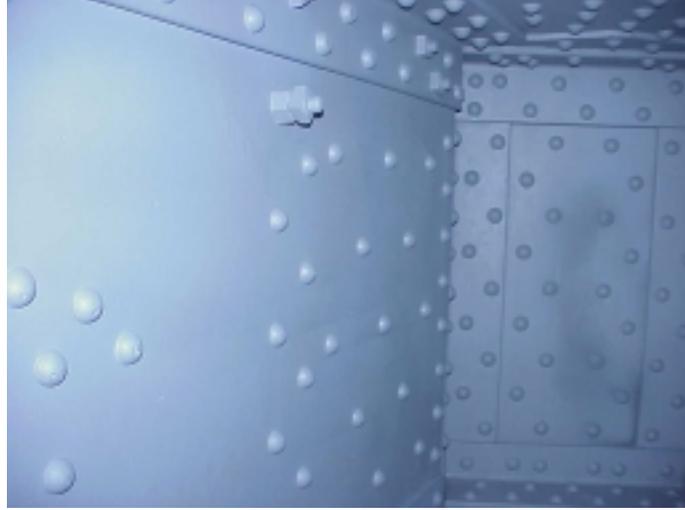
2001 Top compartment on end of gate. After the second coat bare areas were common on the shaded side of rivets and plates.

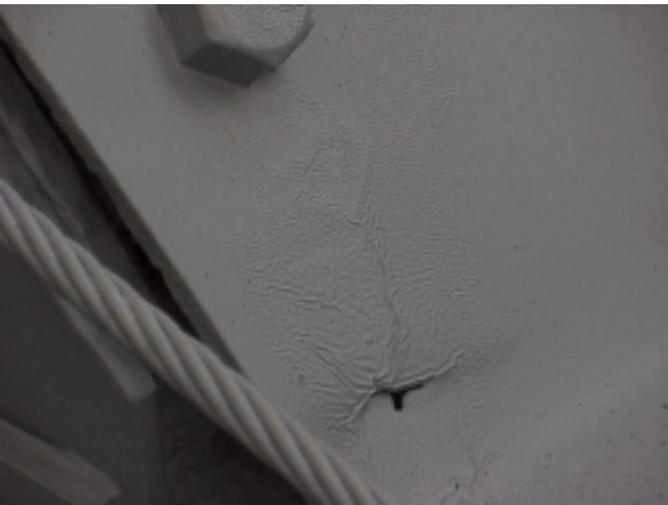
2001 Runs indicate poor spray gun handling.

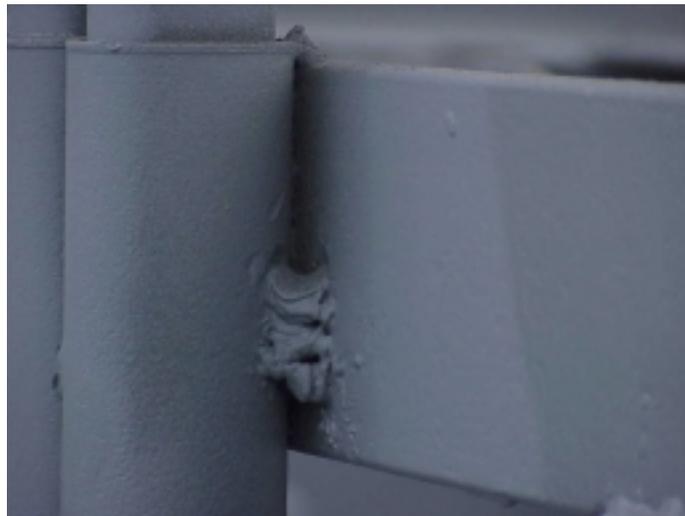
2001 Area in crevice is bare. Color difference indicates the mid-coat and topcoat have been applied.

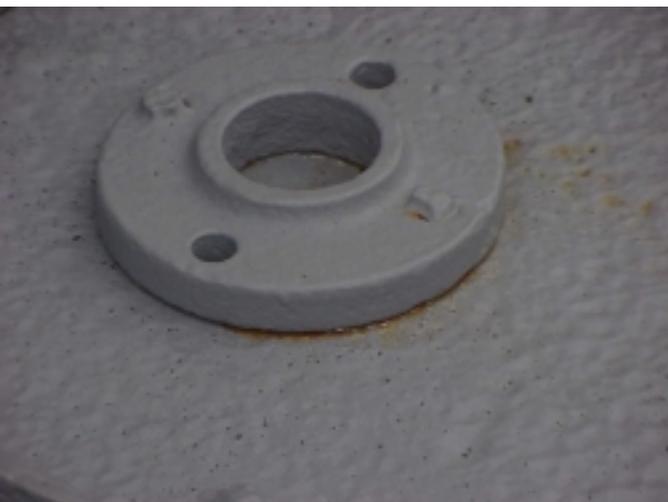
2001 Rain after the mid-coat resulted in rust around attachments.

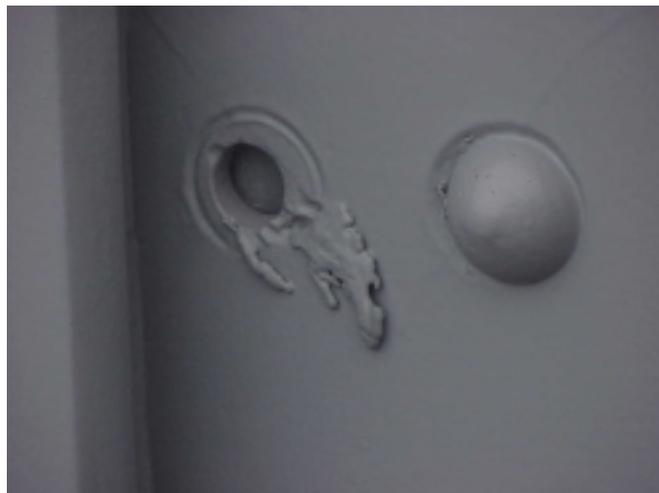
2001 Contract did not require the grinding of surface irregularities.
