Mississippi River Lock and Dam #9. Polymorphic was applied only to the upstream side of gate #11.

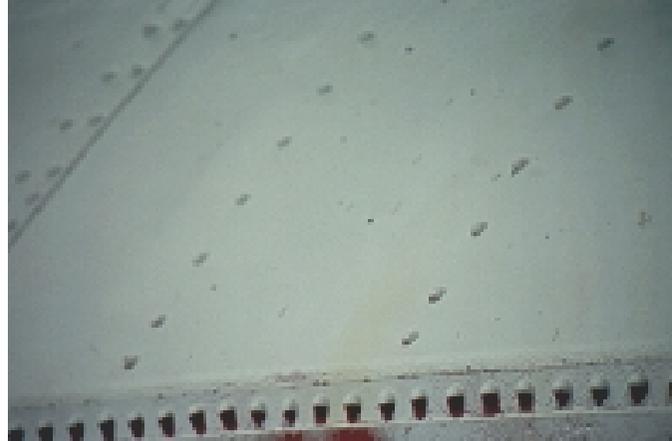
1993 – Polymorphic on lower edge of upstream side of tainter gate #11. No corrosion was visible on entire test area.

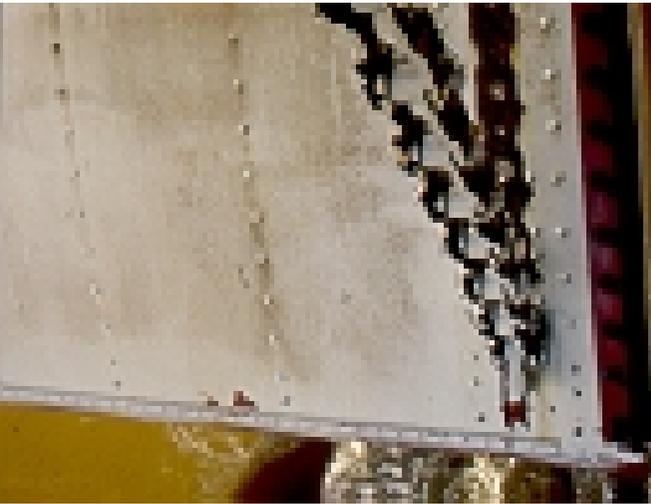
1993 – first corrosion on lower edge of gate.

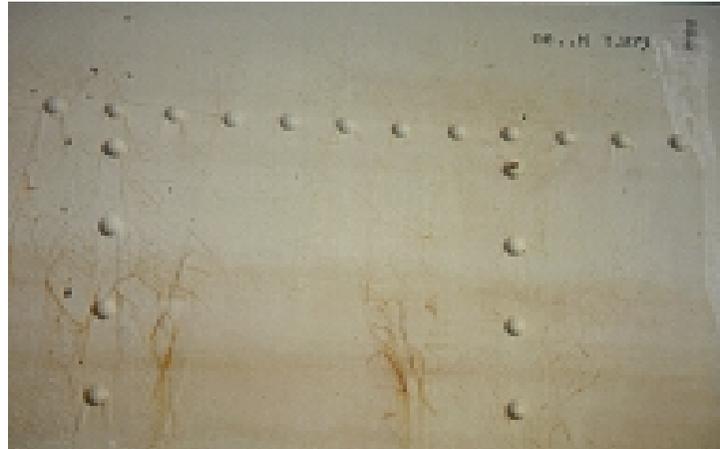
1997 – First observed cracking in atmospheric areas.

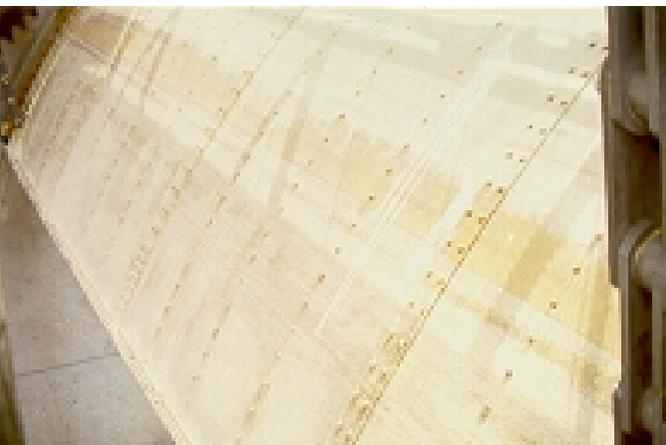
1999 – Few rivets showing rust; minor rust on lower edge of gate. Tan color is river scum.

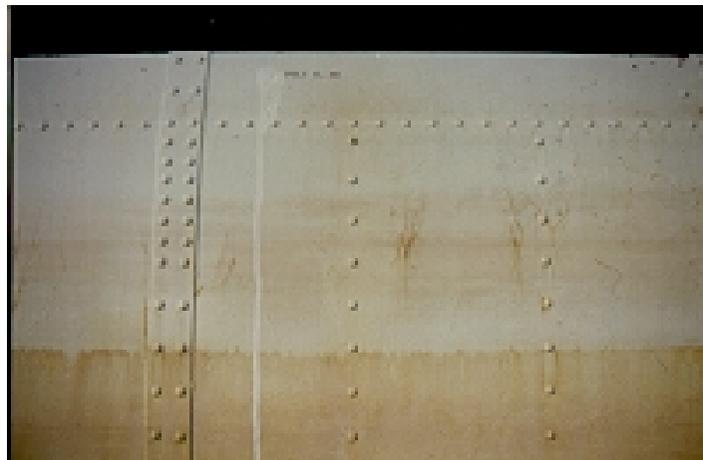
1999 – Cracking in atmospheric areas in several locations is showing minor rust.

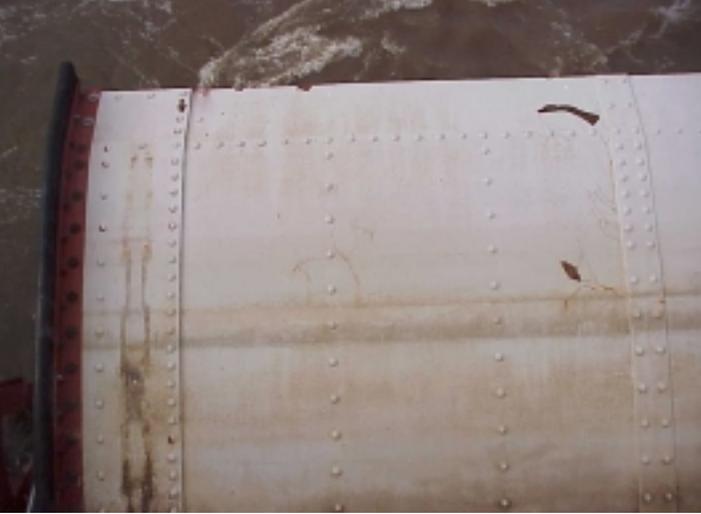
2001 – Cracking in atmospheric area.

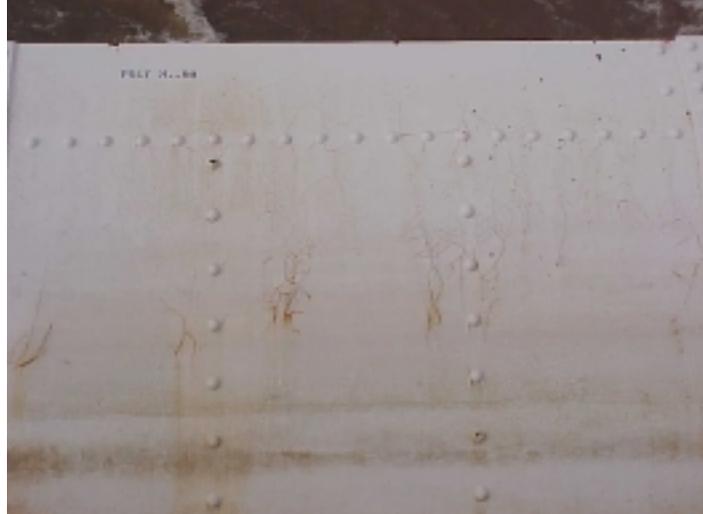
2001 – Cracking in atmospheric area.

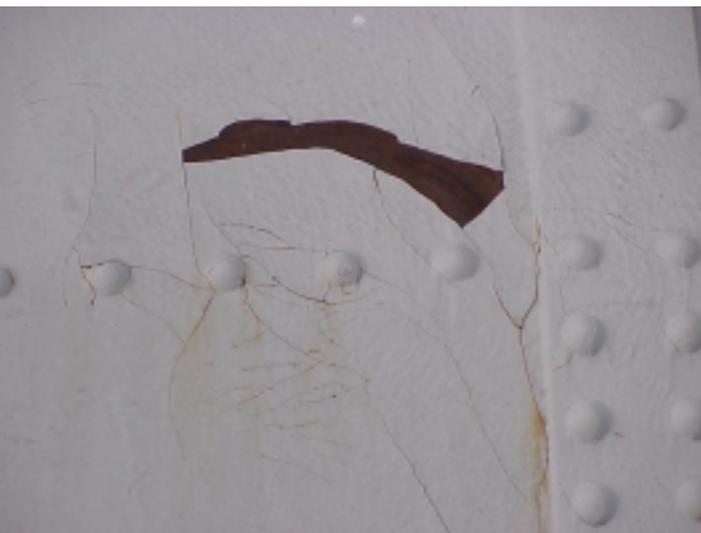
2001 – Cracking in atmospheric area.

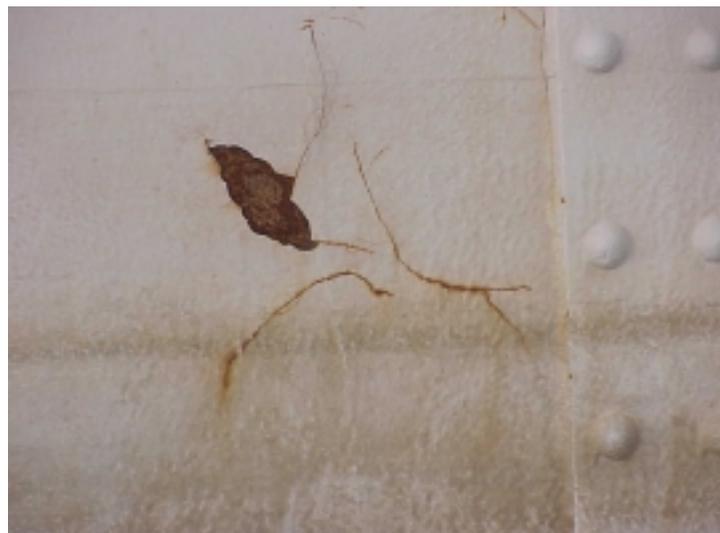
2001 – Cracking in atmospheric area.

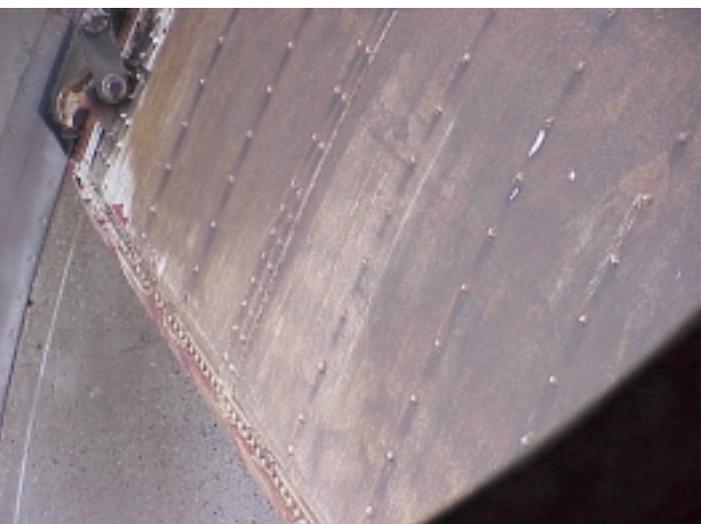
2001 – Underwater area. (Dark color is river scum.)

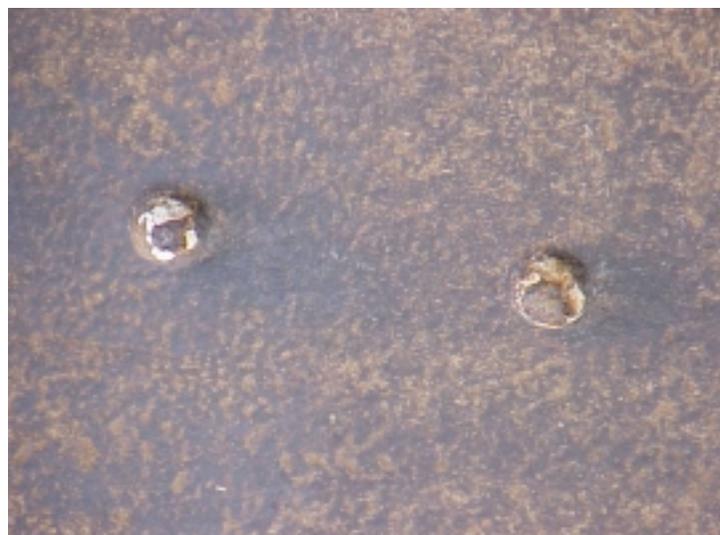
2001 – Most rivets are 10 – 50% bare in underwater area.
