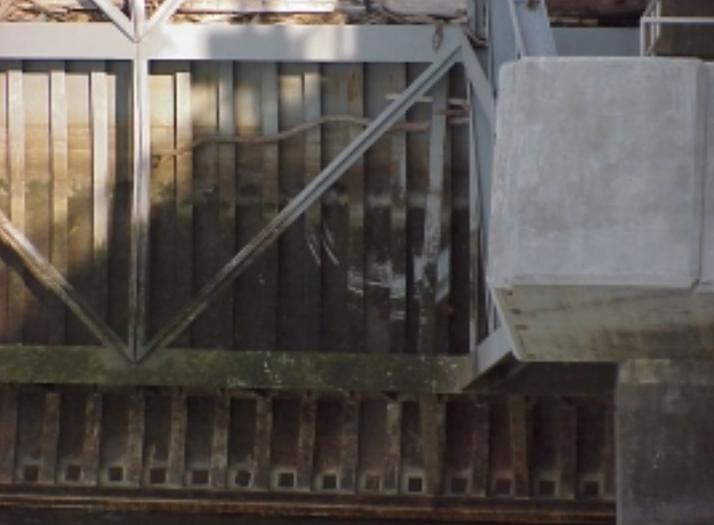
Gate #1, CeRamKote test area at 15 months.
Dark area is mostly river scum.

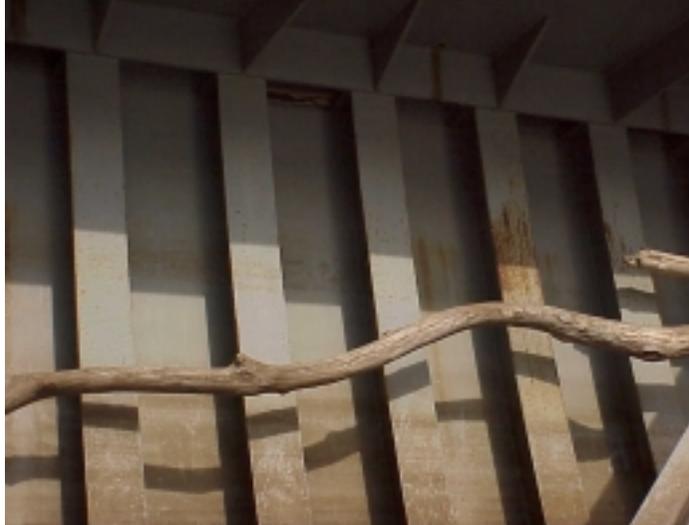
Corrosion in waterline area.

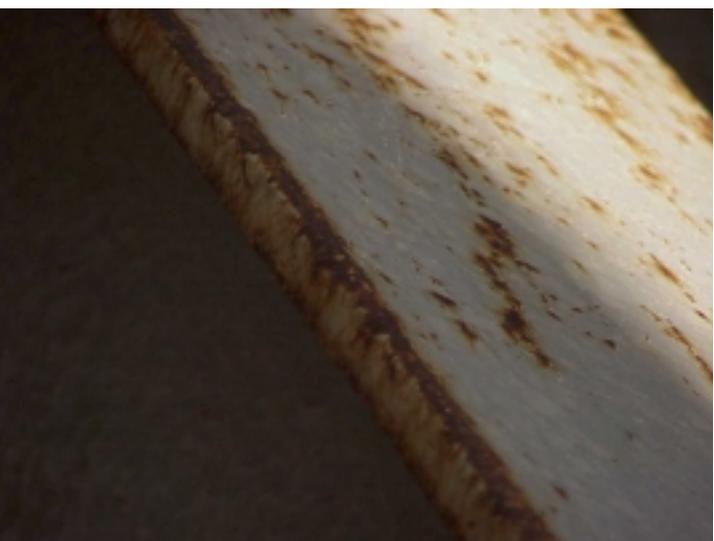
Typical corrosion at waterline. No application defects were noted in this area. Damage is due to debris.

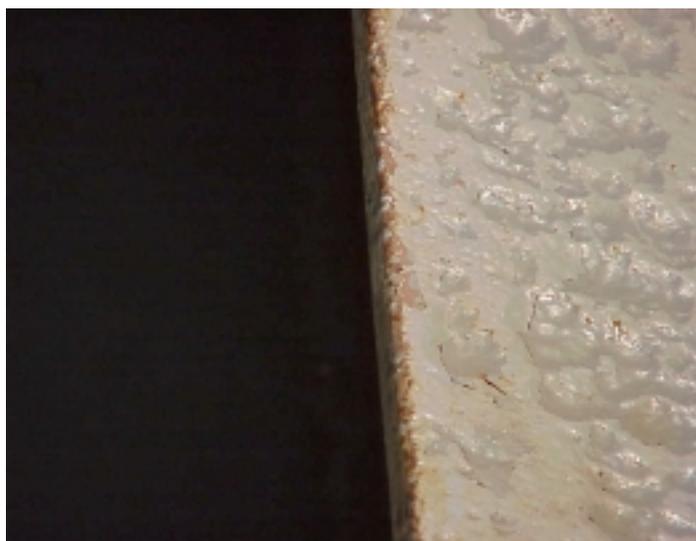
Typical corrosion observed on most ribs below the waterline area. Roughness is pitted steel.

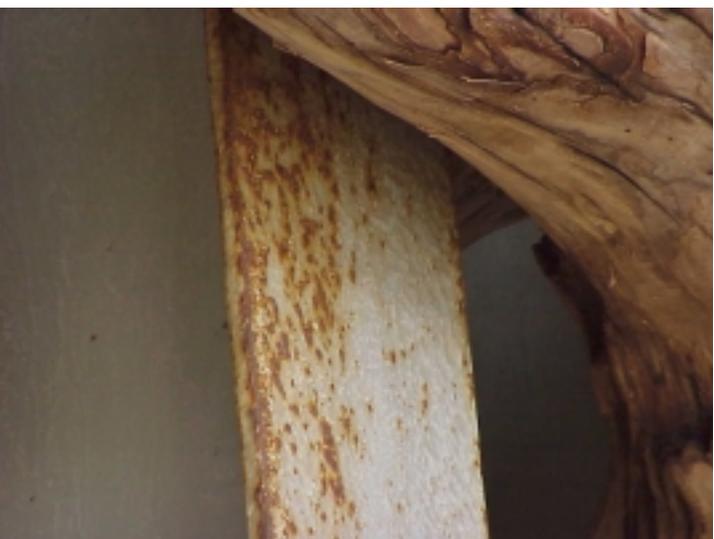
Most severe of corrosion. No application defects were noted in this area. Damage is due to debris

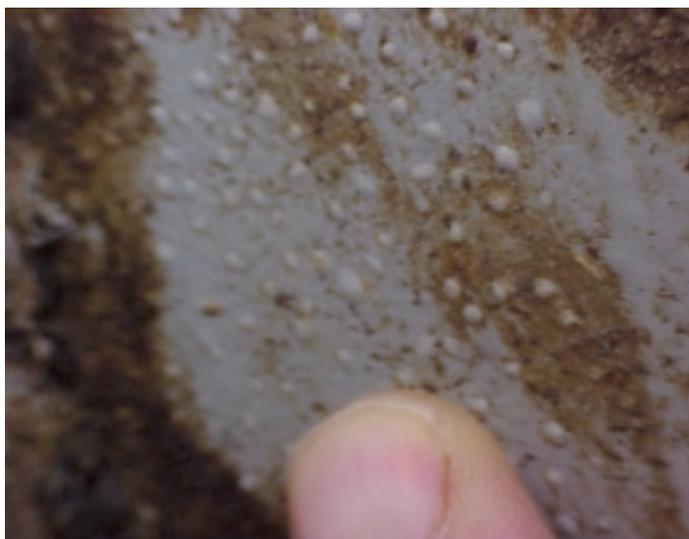
Blistering was noted in several small areas. Thickness appeared normal. Cause is undefined.
