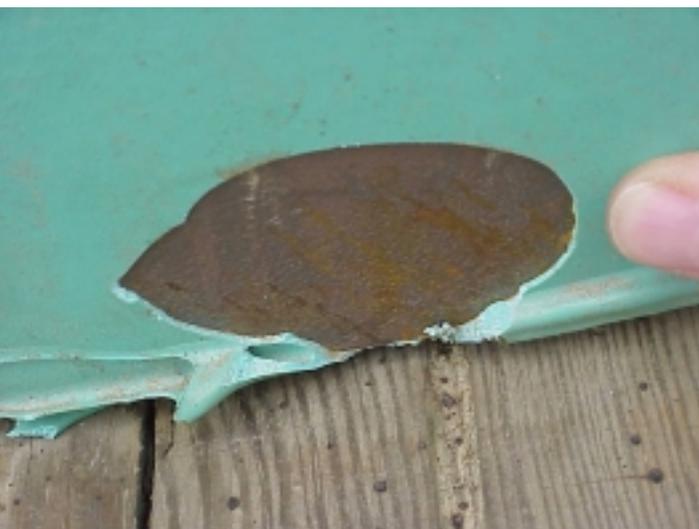
2001 Fusion bond chipped from edge

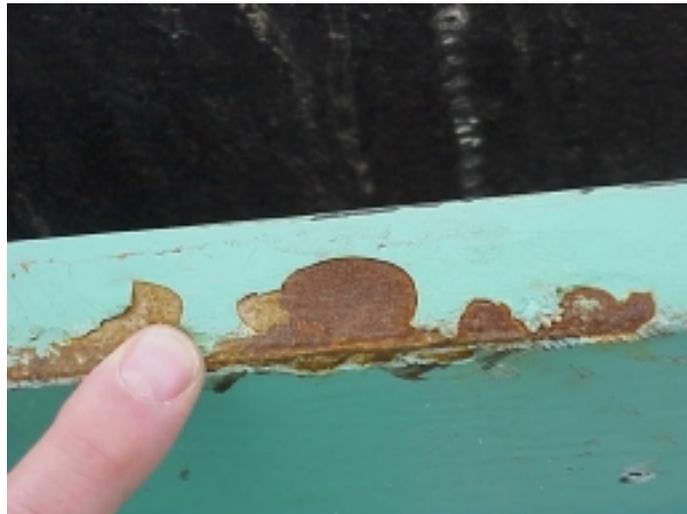
2001 Fusion bond chipped from edge

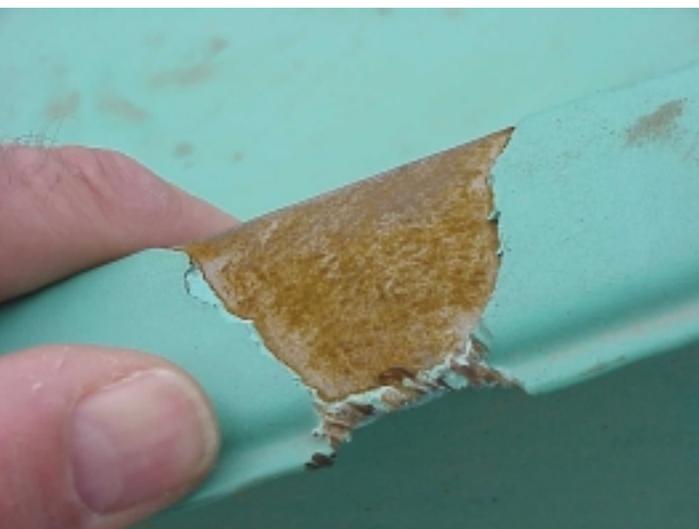
2001 Fusion bond chipped from edge

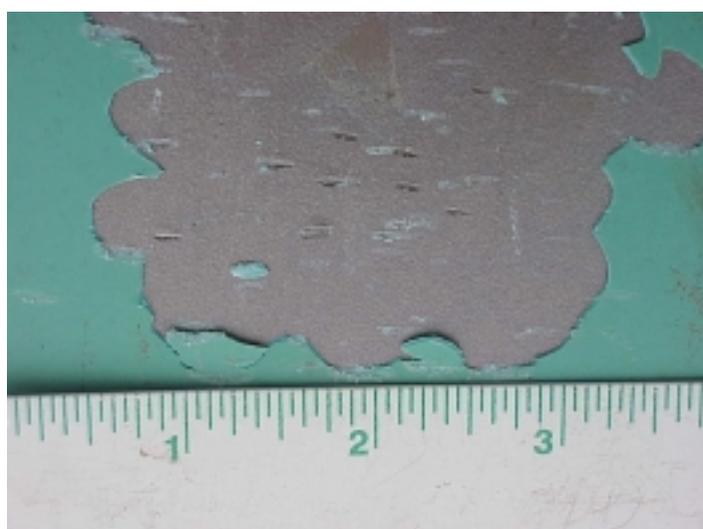
2001 Fusion bond chipped with hammer.

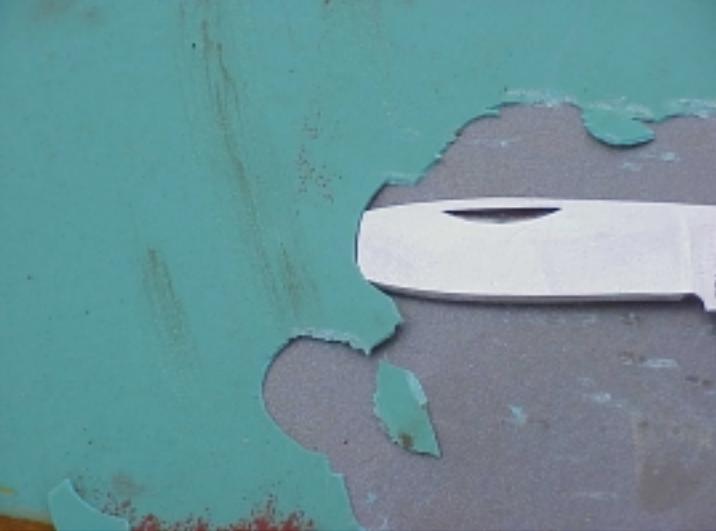
2001 Fusion bond poorly adhered

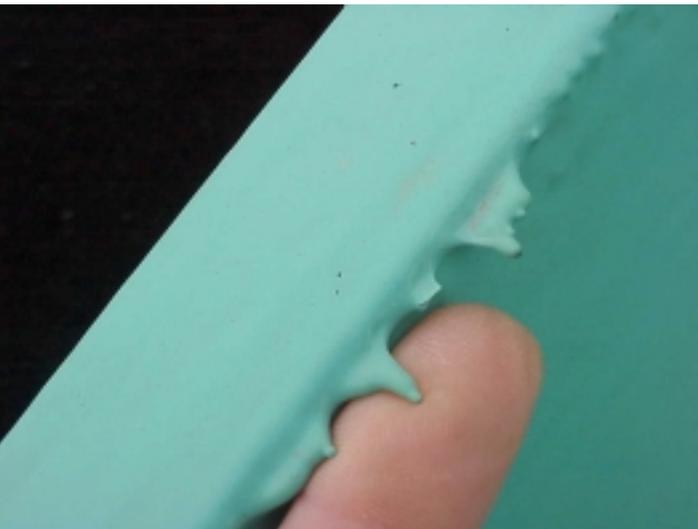
2001 Fusion bond drips on edges.
