2003 Installed piles consist of 3 coated with fusion bond epoxy (Green), 3 coated with coal tar epoxy (Black), and 4 uncoated piles.

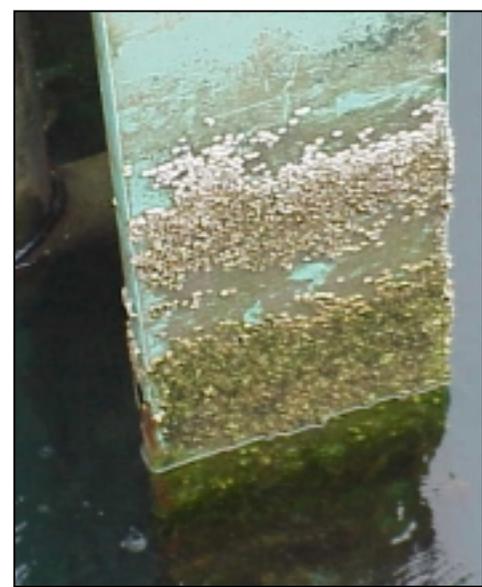
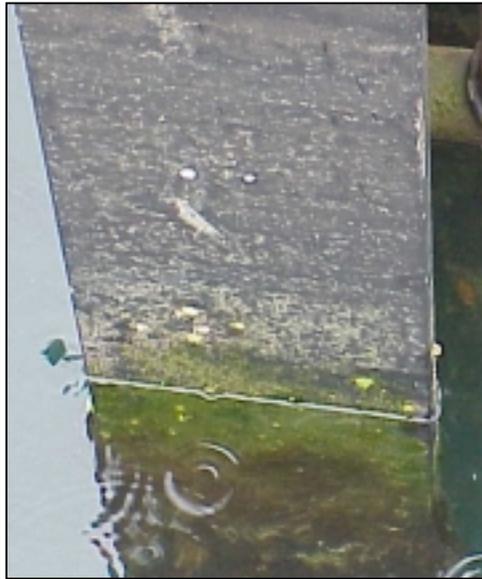
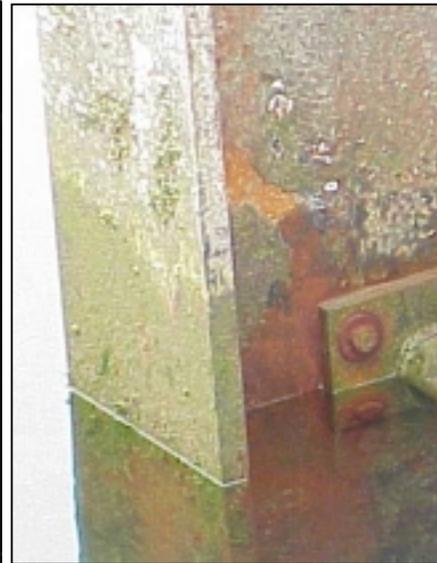
2003 Fusion bond piles have more marine growth than either coal tar epoxy coated or uncoated piles.

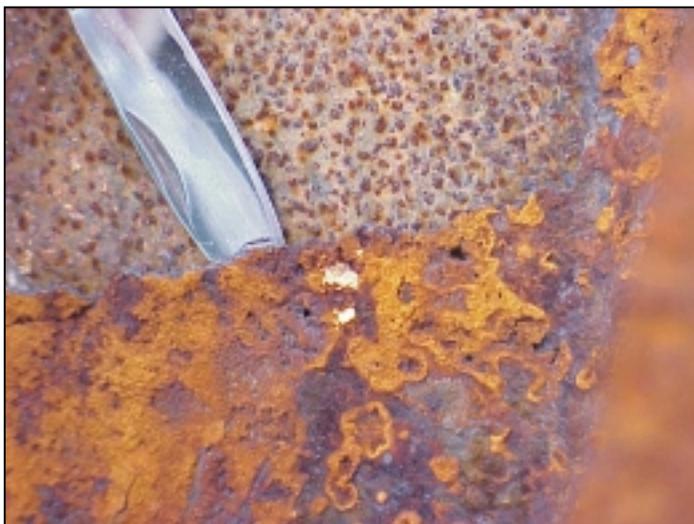
2003 Approximately a 1mm (1/16 inch) layer of mill scale and rust is delaminating from the surface of the uncoated piles.

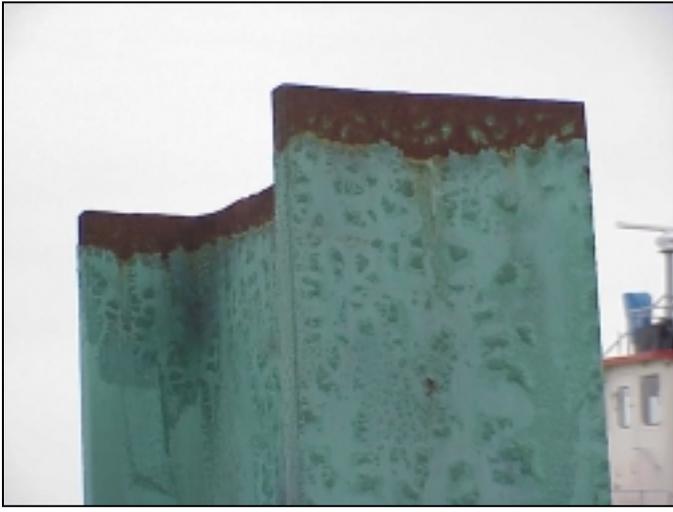
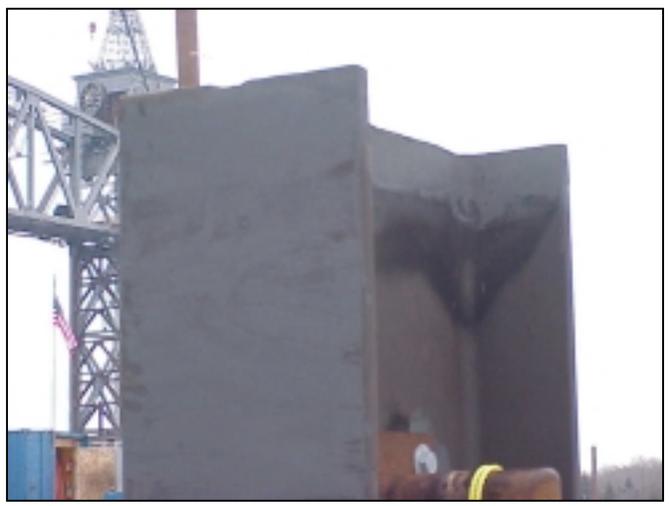
2003 Coal tar epoxy repair on top of all piles is in excellent condition. Fusion bond epoxy repair on some piles is crawling indicating improper mixing or cure.

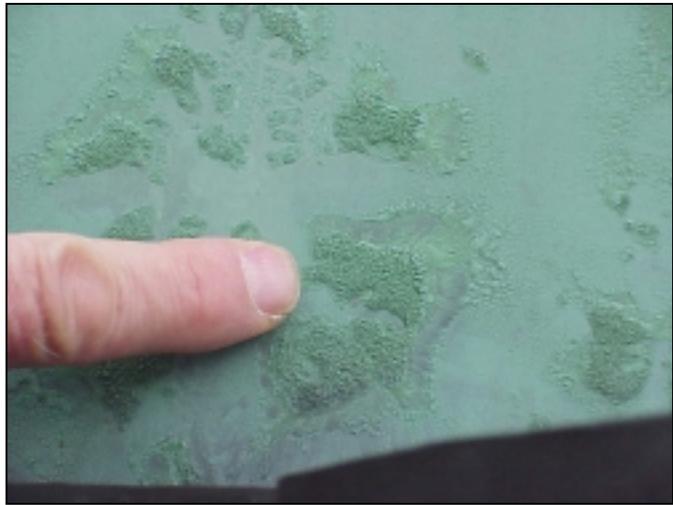
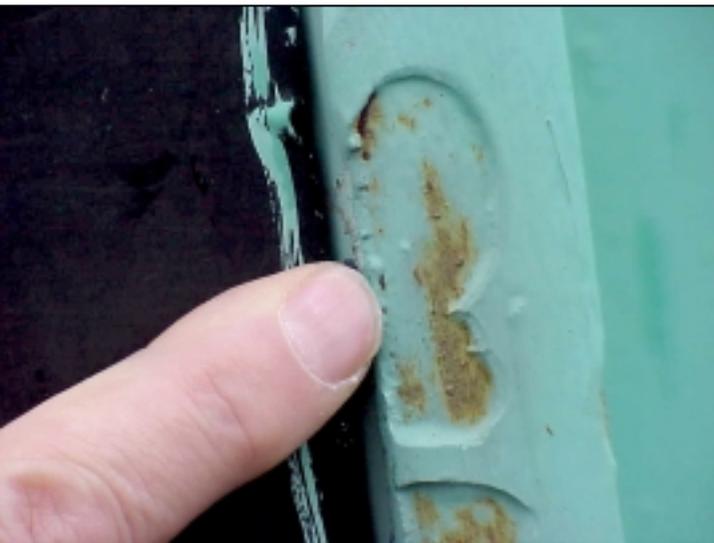
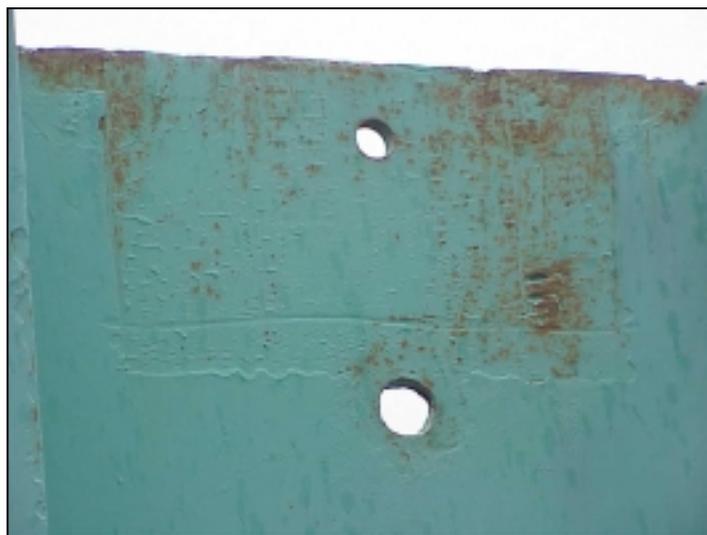
2003 Fusion bond repair on some piles appears properly cured but is not stopping corrosion. Thickness measurements were not taken.

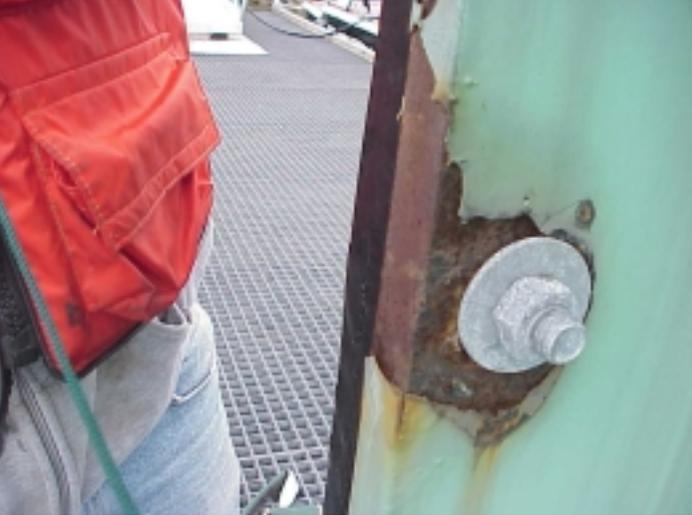
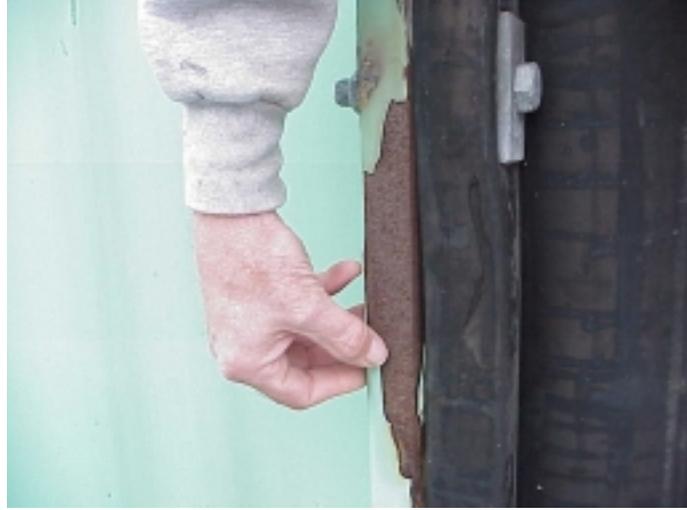
2003 Fusion bond epoxy was shattered by bolts used to attach rubber bumpers. Loss of adhesion extends well beyond bolt. This type of failure is not noted on the piles coated with coal tar epoxy.

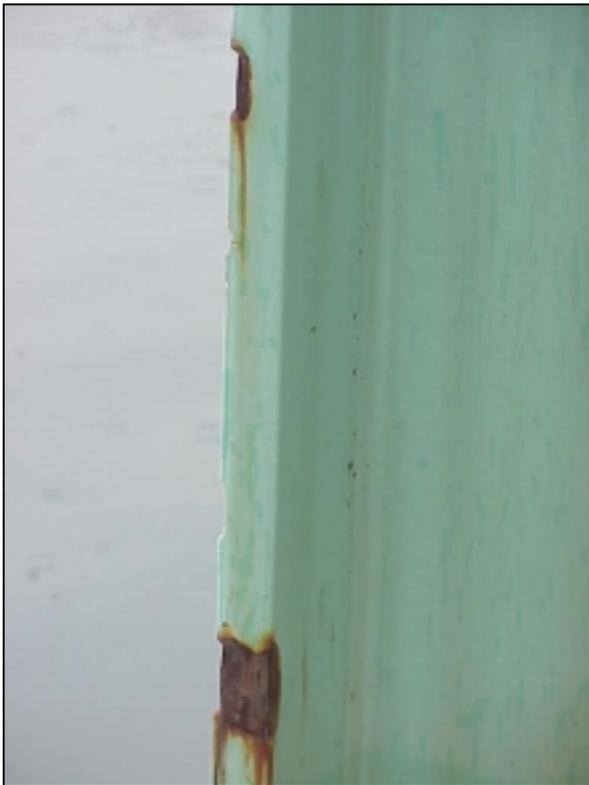
2003 Some metal loss is taking place where the fusion bond epoxy was damaged.
