Gate #1 Vinyl Paint System 1 Year Performance

Lock #12 Miter Gate #1. Vinyl paint system

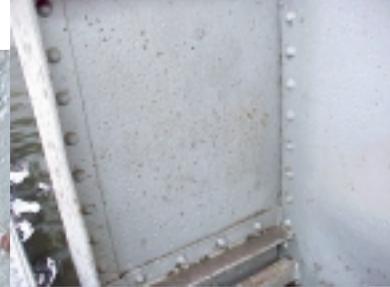
Application of vinyl with airless spray resulted in pinholes that are rusting in some areas

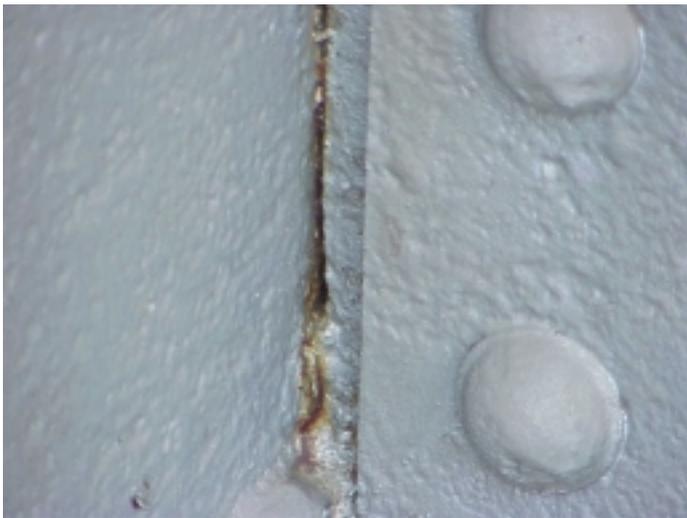
Early failures in joints may be due to moisture forced into joint during surface preparation.

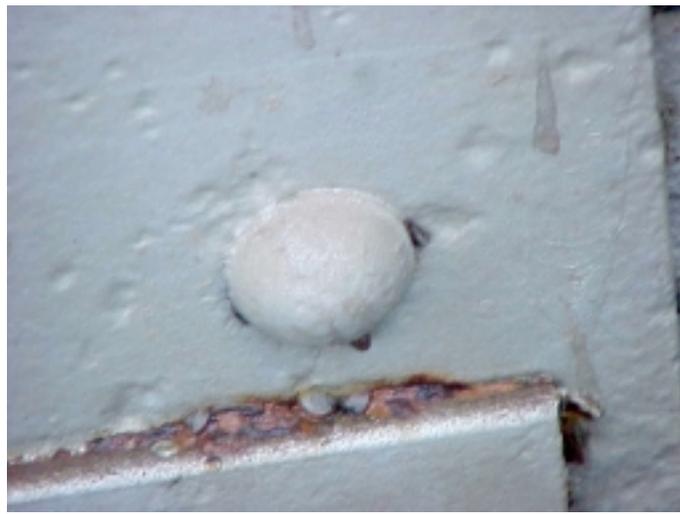
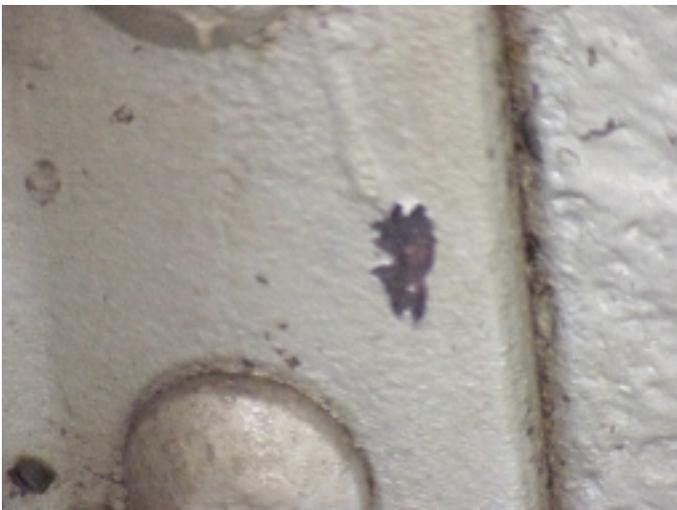
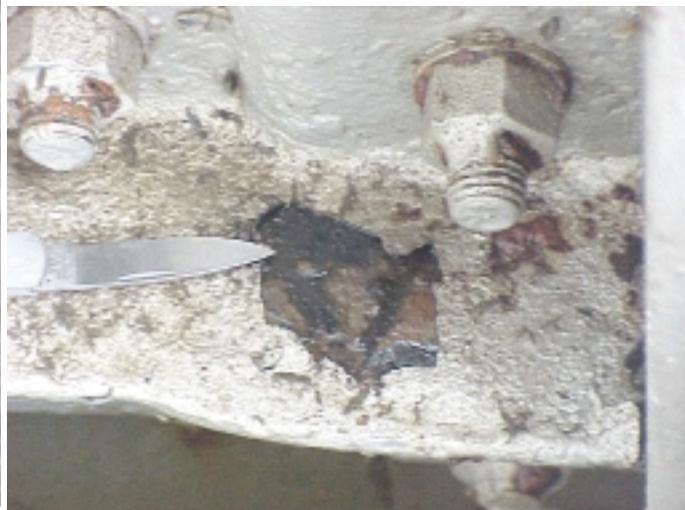
No blistering was noted but adhesion in areas of surface preparation WP-4 was very poor allowing coating to be removed with knife with ease.

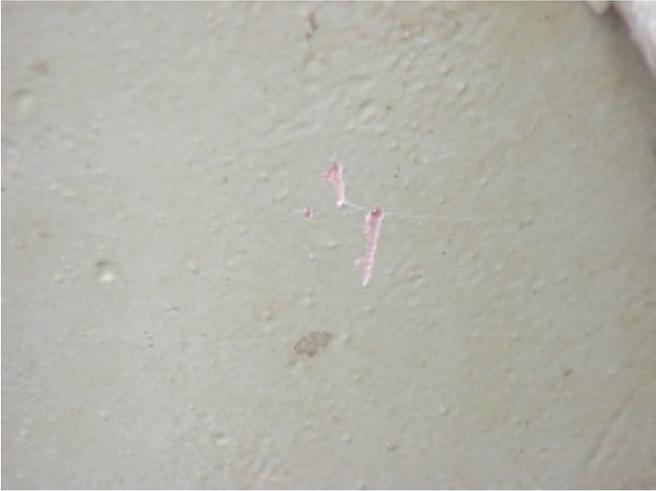
No blistering was noted on upper portions of the gate and adhesion was excellent.

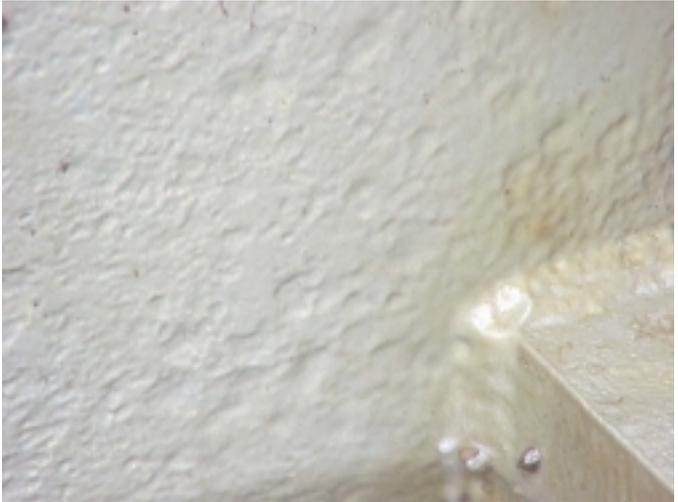
Blistering (ASTM # 6F) was noted on lower areas that are submerged much of the time.

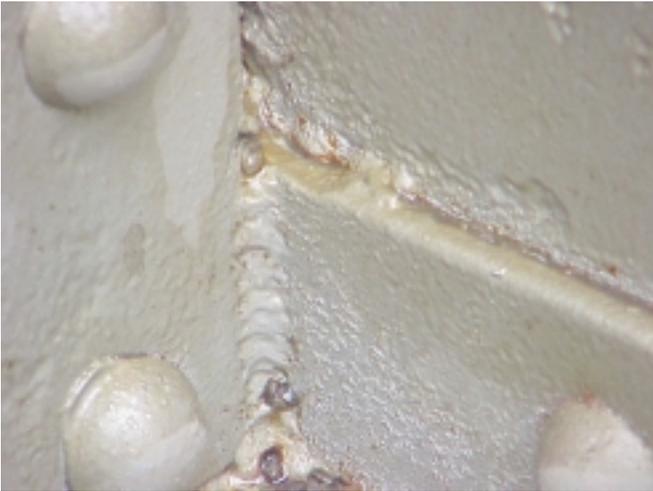
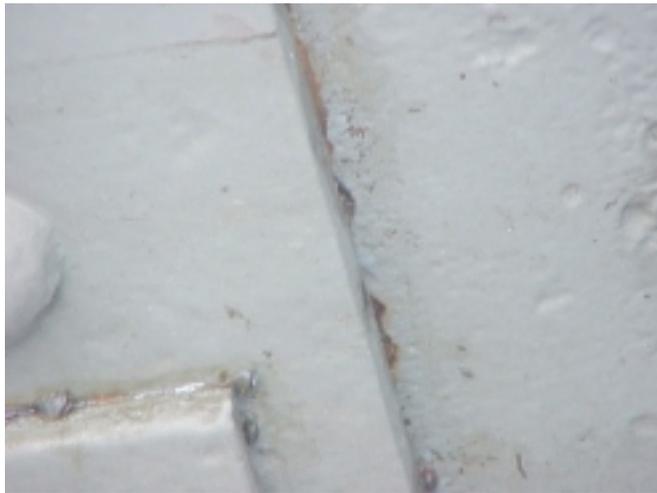
Early failures in joints may be due to moisture forced into joint during surface preparation.
