ERDC/CERL TR-03-5

Overcoating of Lead-Based Paint on Steel Structures

Cost and Performance Report

March 2003

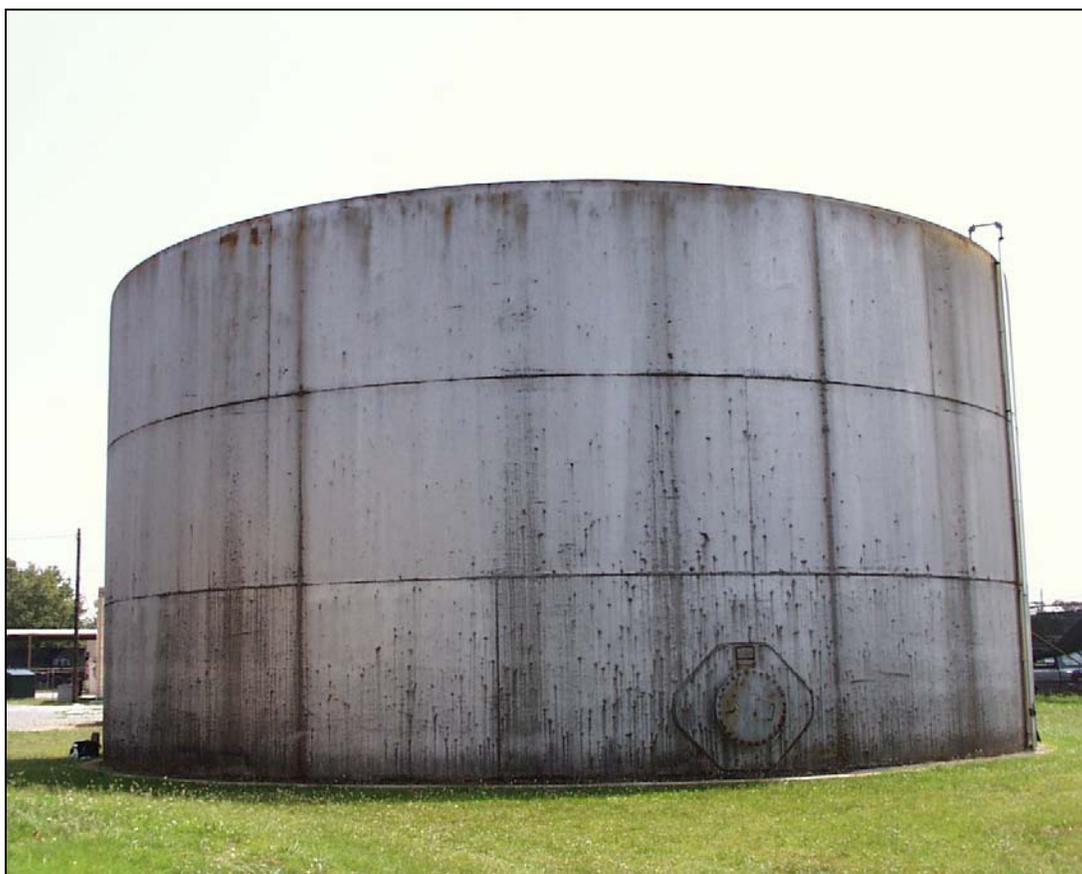
A visual inspection and physical tests were performed on the existing aged coating. Dry film thicknesses (DFTs) were measured at eight locations. The average thickness ranged from 2.0 to 4.1 mils. The overall average thickness is approximately 3.0 mils. Three adhesion measurements were taken, two with a south solar orientation and one with a north solar orientation. Crosscut adhesion values (ASTM D 3359 Method A) were 3A and 5A (south facing) and 3A (north facing), indicating slightly degraded intercoat adhesion.

Rusting ranged from 3 to 5 percent of the tank surface. Corrosion was primarily general spot corrosion with associated staining. The north side and lower portions of the tank were somewhat more degraded than the upper portions and south side. However, the rust distribution was fairly uniform overall.

Based on the generally low DFT and overall appearance, the tank has probably never been maintained or recoated.

Figure 1. Fort Campbell water tank prior to cleaning and overcoating.

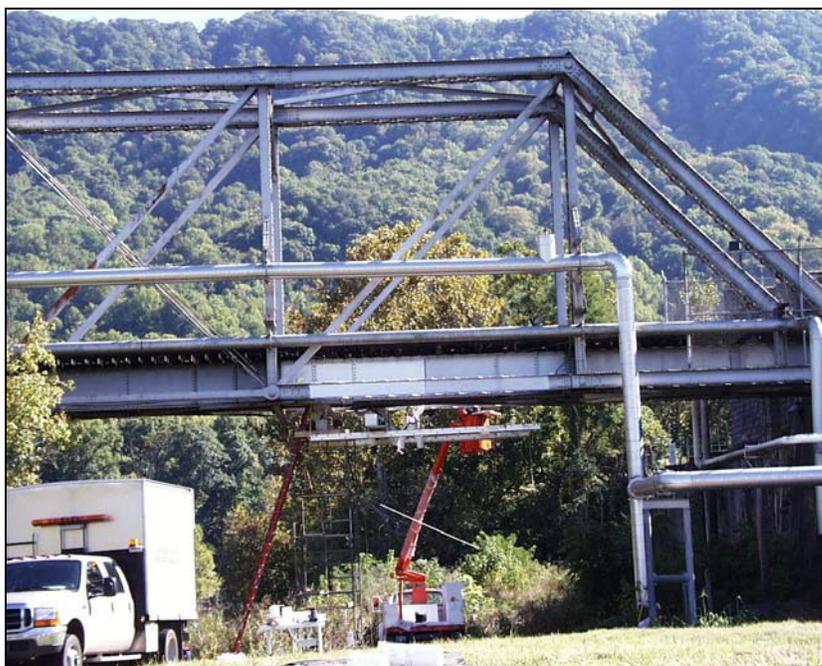
A visual inspection and physical tests were performed on the aged coating. The bridge appears to have been touched up and repainted on numerous occasions. It is doubtful that the bridge has been abrasive blasted and painted in at least the last 30 years and possibly not since it was erected at HAAP in 1943. The paint system is comprised of an orange primer and aluminum topcoat, which are probably TT-P-86, Type I, red lead in linseed oil and TT-P-38, aluminum phenolic finish coat. Most of the touchup painting was done with an aluminum finish coat. Paint film thicknesses are generally 8 to 15 mils on flat vertical surfaces and 20 to 25 mils on upward facing horizontal surfaces. The amount of visible rust is less than 1 percent of the total test area. Most of the rust was on the tops of flanges. Some rusted areas on the flanges were previously coated over and were lifting and curled. Adhesion tests were performed in accordance with ASTM D 3359 Method A X-cut tape test. Adhesion ranged from 4A to 5A. In some cases, a thin layer of aluminum pigment was lifted with the tape. This nonadherent material is the equivalent of chalk in a standard pigmented coating. A good deal of dirt had also accumulated on many of the bridge components.

Figure 2. Railroad bridge at HAAP, TN, with overcoated test areas.

Both overcoat systems were performing well after 6 months of service. The winter months were relatively harsh with numerous freeze-thaw cycles. Intercoat adhesion between the overcoat systems and the original paint system was excellent. The adhesion of the original coating to the substrate was unaffected by either overcoat system. Coating adhesion to the substrate was slightly less for surfaces with a south solar orientation. This is typical of alkyd-type paint systems as they tend to embrittle and lose adhesion with prolonged exposure to ultraviolet radiation. The risk that a catastrophic delamination failure will occur in the future is very small. Both systems are devoid of any sign of early corrosion.

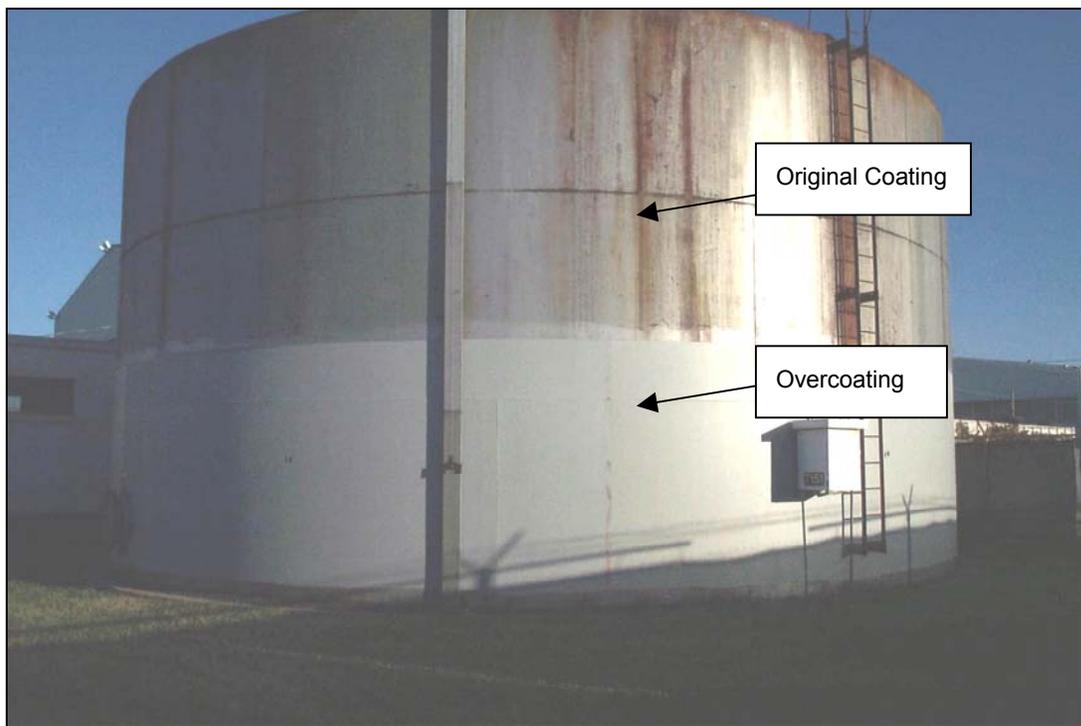
Figure 3. Deluge tank at Fort Campbell Army Airfield. (Original coating with lead-based paint primer visible at top is deteriorated and steel underneath is rusted. The tank was overcoated with test patches of moisture cure polyurethane in October 2000.)

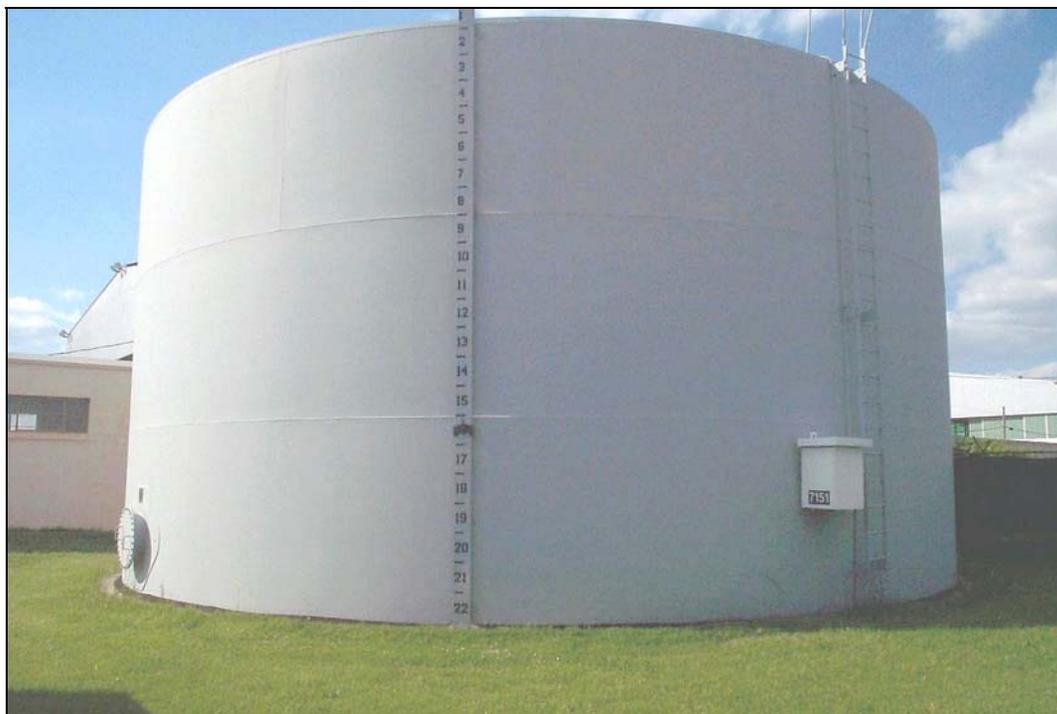
Figure 4. Deluge tank at Fort Campbell Army Airfield after overcoating completed in August 2001.

After evaluation of the two coating systems, the coating system composed of Sherwin-Williams Corothane I Mastic primer, Corothane I Ironox A intermediate, and Corothane I Ironox A topcoat was chosen for completion of the tank coating job, as shown in Figure 4. The projected life of the overcoat repair on this tank is 15 to 25 years. This projection is based on the pre-overcoat condition of the original paint system, the durability of the overcoat materials, and the severity of the exposure environment. It should also be noted that the water tank can probably be overcoated two more times provided its condition is not allowed to deteriorate past that which is suitable for overcoating.
