USA-CERL TECHNICAL REPORT M-87/13, VOL. II

Roofing Maintenance Management System

# Membrane and Flashing Condition Indexes for Built-Up Roofs

## Volume II: Inspection and Distress Manual

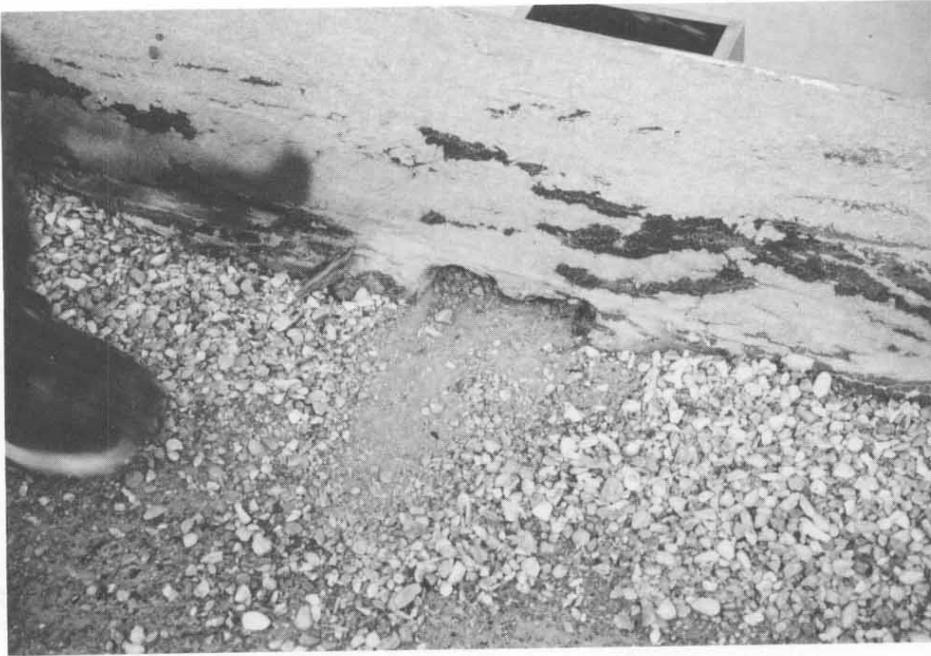
**Figure 11. Scupper opening is too small and easily clogged. Report in the "Remarks" section on the back of the Roof Inspection Worksheet.**

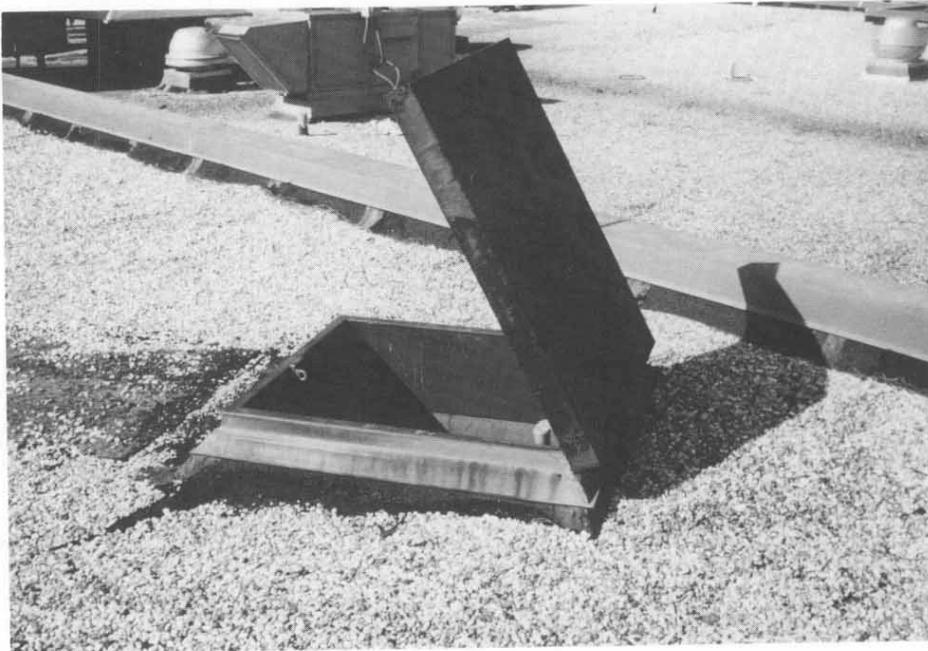
**Figure 12. Metal curb around scuttle is corroded and needs paint. Report in the "Remarks" section.**

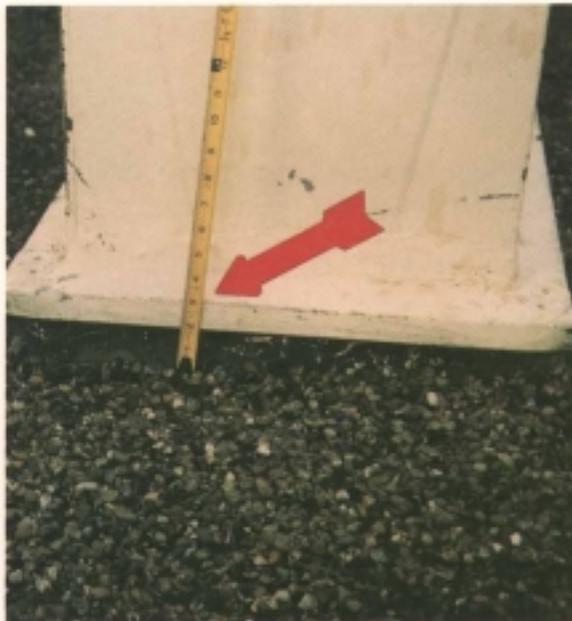
BF1 Base Flashing  
 <Low Severity>  
 Curb is not high enough--  
 6 in. minimum

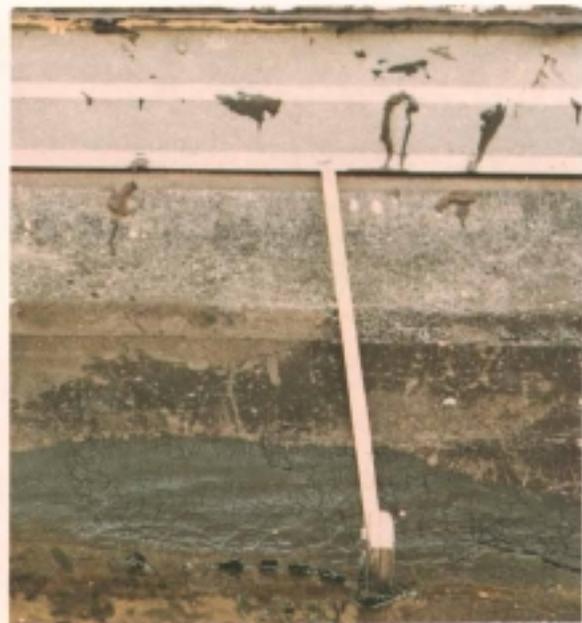
BF2 Base Flashing  
 <Low Severity>  
 Surface looks poor but there are  
 no areas that are worn through

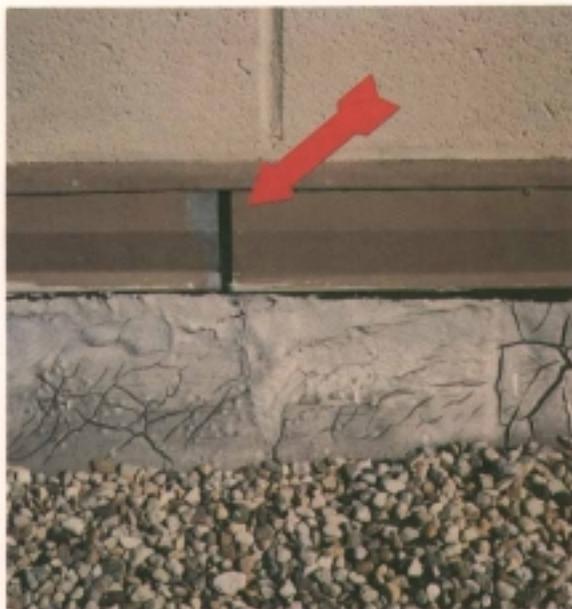
BF3 Base Flashing  
 <Low Severity>  
 Poor appearance of coating but coating  
 is not worn through. Also, counter-  
 flashing is displaced <High Severity>

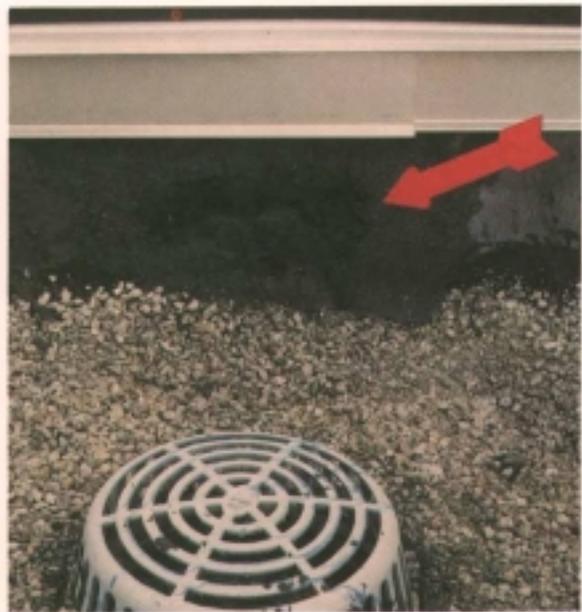
BF4 Base Flashing  
 <Low Severity>  
 Mineral surfacing is worn but  
 surface is still intact

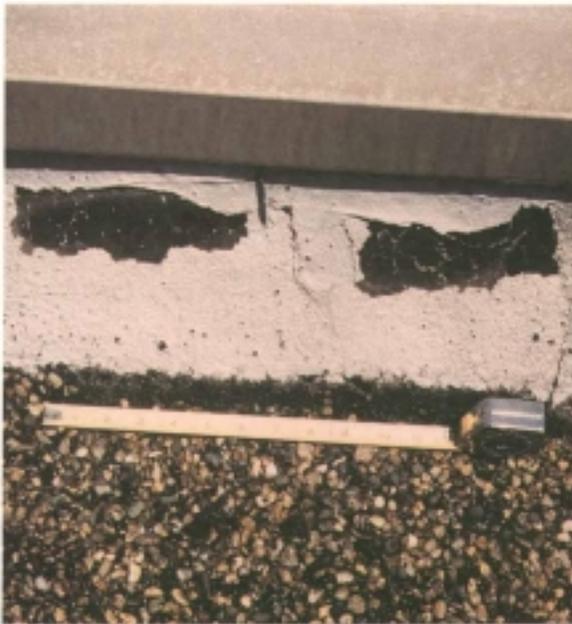
**BF5** Base Flashing  
<Medium Severity>  
Surfacing is worn but hole is not all the way through the flashing

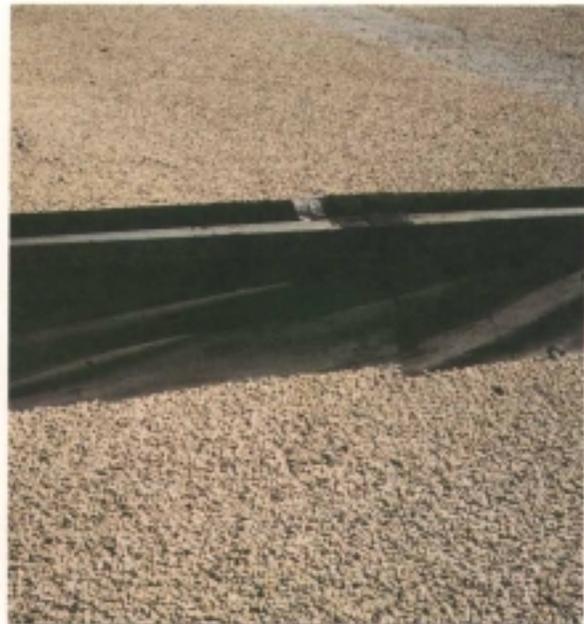
**BF6** Base Flashing  
<Medium Severity>  
Base flashing is pulled and not firmly bonded to the curb

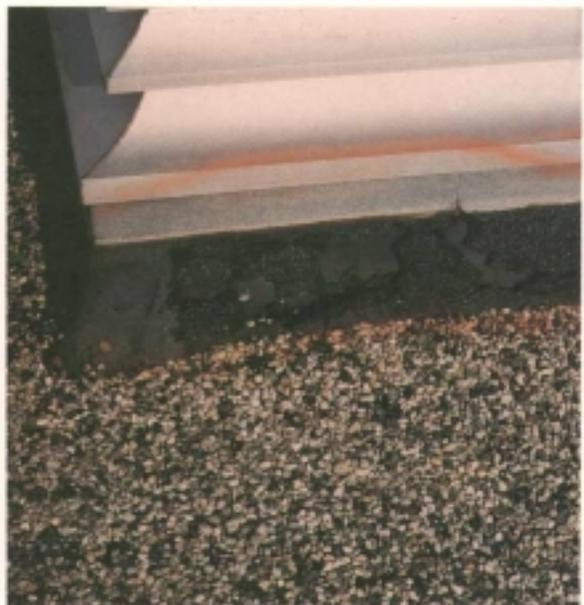
**BF8** Base Flashing  
<High Severity>  
Deteriorated flashing material; there are holes through all piles of the flashing

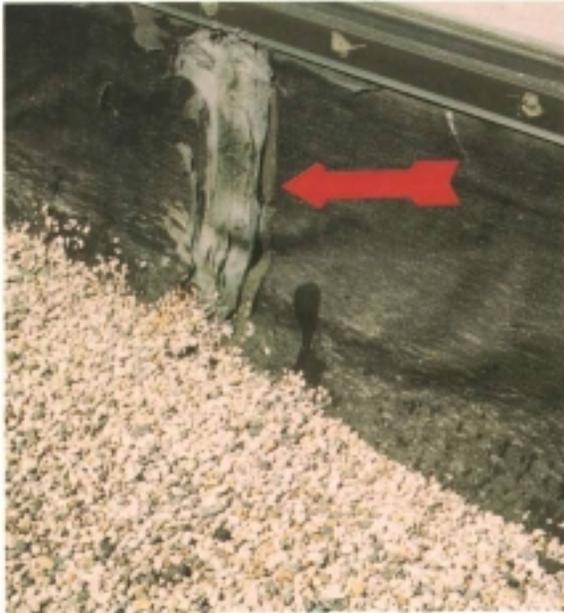
BF9 Base Flashing  
<High Severity>  
There is an open seam and the material has sagged

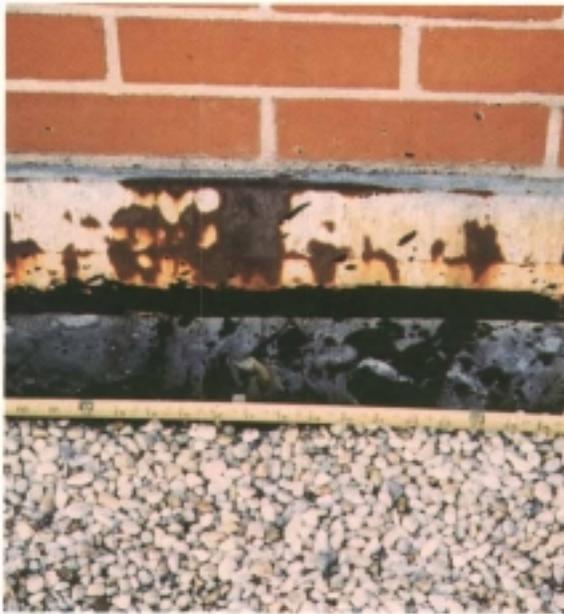
**MC1 Metal Cap Flashing**  
 <Low Severity>  
 The metal has begun to corrode but no holes are evident

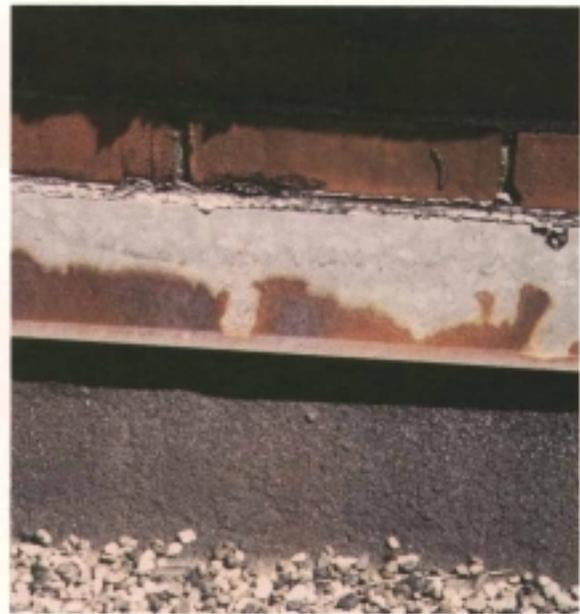
**MC2 Metal Cap Flashing**  
 <Low Severity>  
 The metal is bent but still functions; there is some corrosion

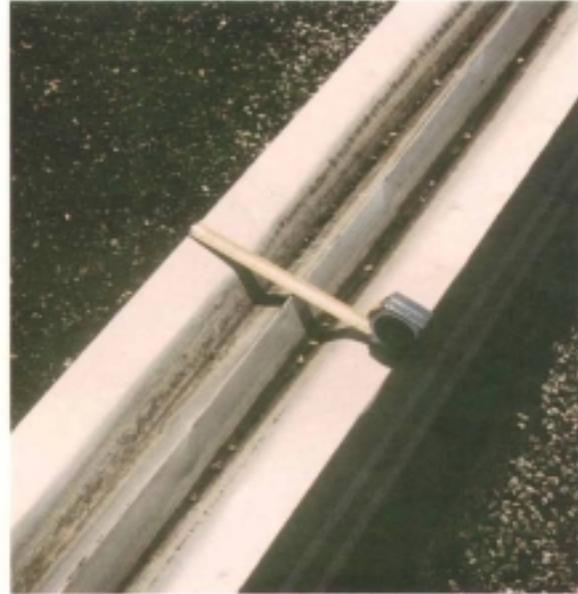
MC6 Metal Cap Flashing  
 <Low Severity>  
 Water can accumulate on top of the cap

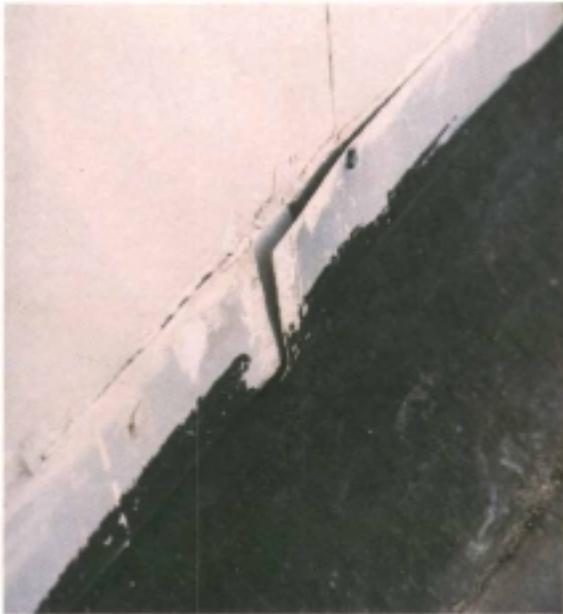
**MC9 Metal Cap Flashing**  
<Medium Severity>  
The top of the counterflashing is loose

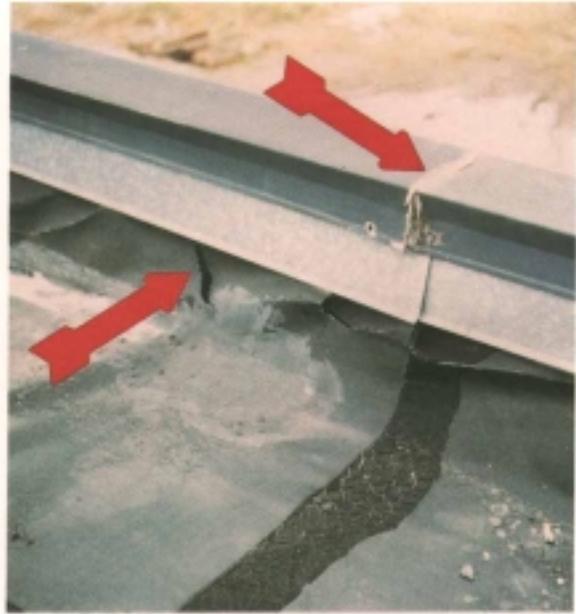
**MC10 Metal Cap Flashing**  
<Medium Severity>  
Joint in cap has failed; caulking has not corrected the problem.  
Also, Base Flashing has holes  
<High Severity>

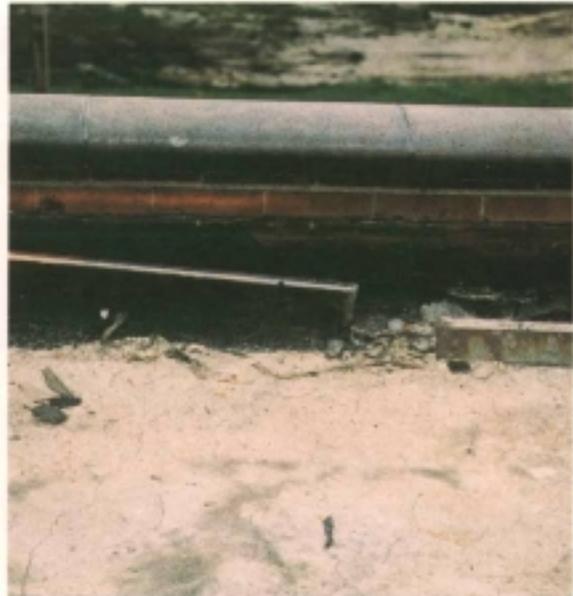
**MC12 Metal Cap Flashing**  
<High Severity>  
The metal counterflashing has fallen off of the wall

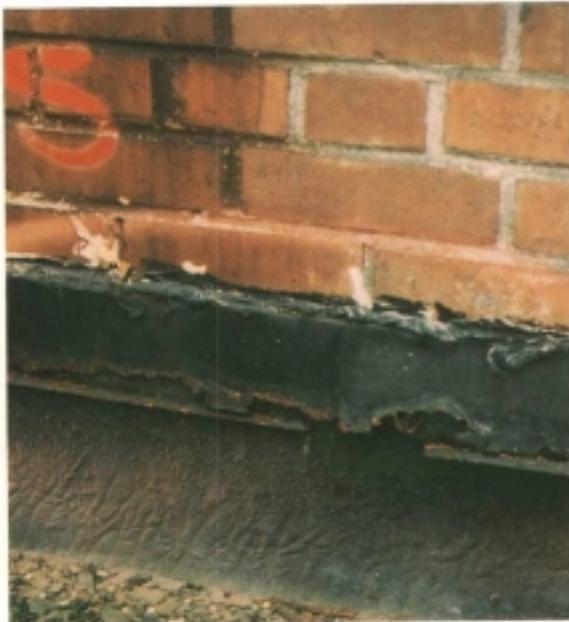
MC13 Metal Cap Flashing  
 <High Severity>  
 The metal has corroded so that there are holes in the metal

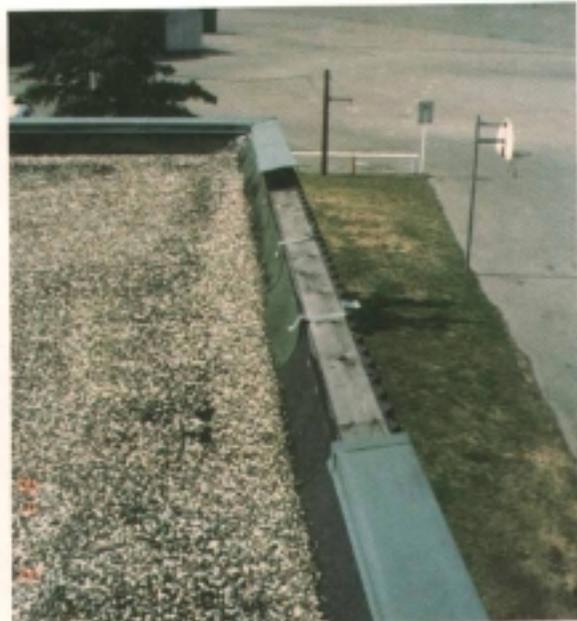
MC14 Metal Cap Flashing  
 <High Severity>  
 Joint covers are missing

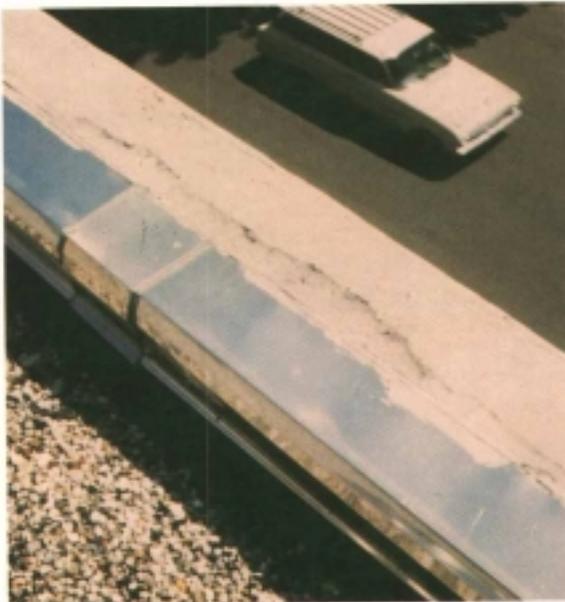
MC15 Metal Cap Flashing  
 <No Severity level--report in remarks>  
 The reglet has been cut into the top of the parapet wall; the caulking has failed

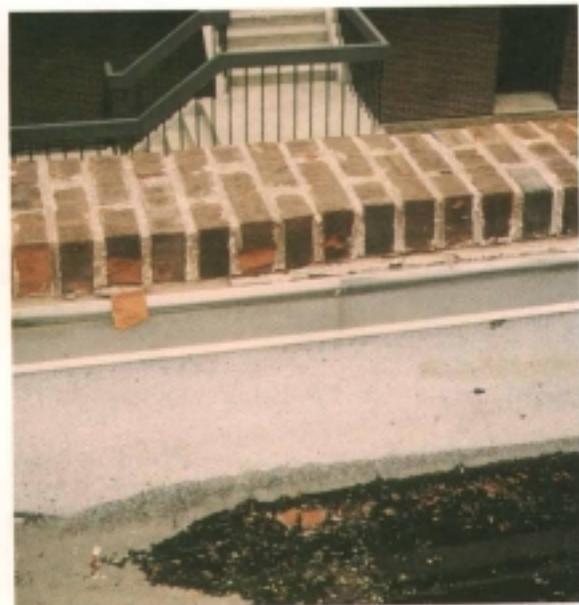
MC16 Metal Cap Flashing  
 <No Severity level--report in remarks> There is no cap flashing; water has penetrated the masonry and deterioration has occurred due to freeze-thaw action

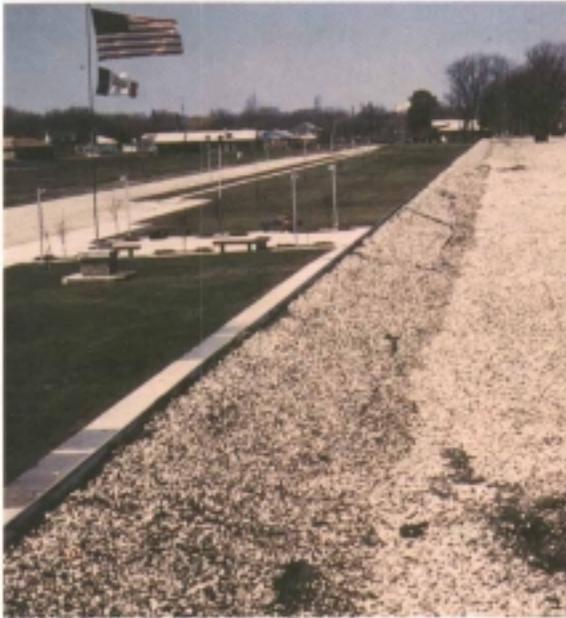
EM1 Embedded Edge Metal  
 <Low Severity>  
 Tapered edge metal is raised but strip-in still presents a potential hazard

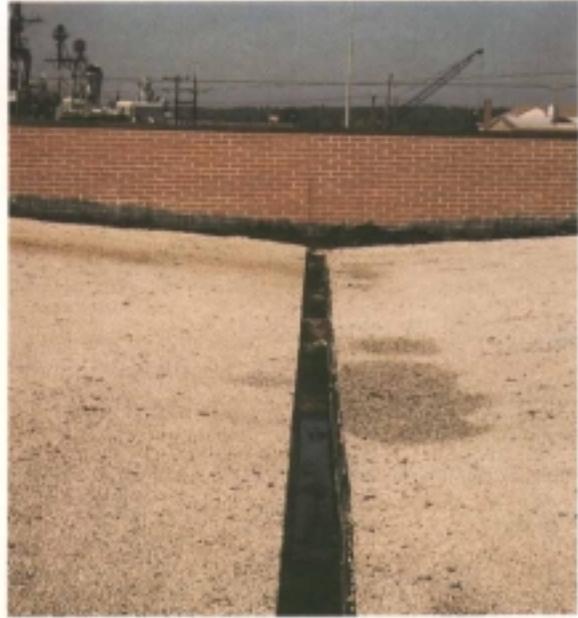
EM2 Embedded Edge Metal  
 <Medium Severity>  
 There are interior gutters

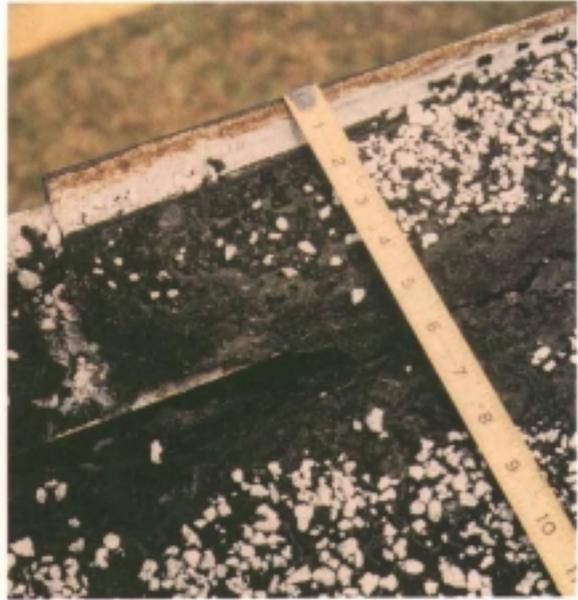
EM4 Embedded Edge Metal  
 <High Severity>  
 The metal is loose or lifted

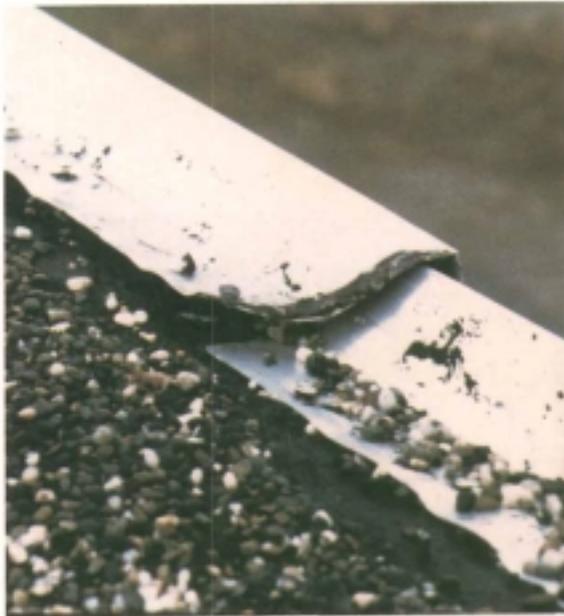
EM5 Embedded Edge Metal  
<Medium Severity>  
Stripping felts are missing

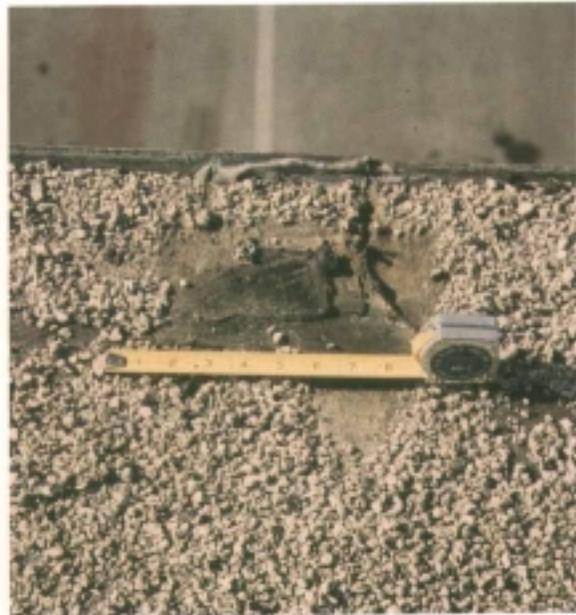
EM6 Embedded Edge Metal  
<High Severity>  
The stripping is torn or broken

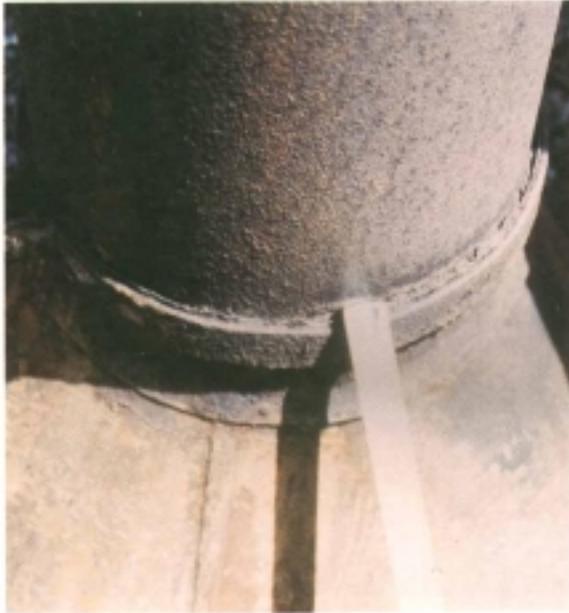
**FP5** Flashed Penetration  
<Medium Severity>  
The seal at the umbrella is broken

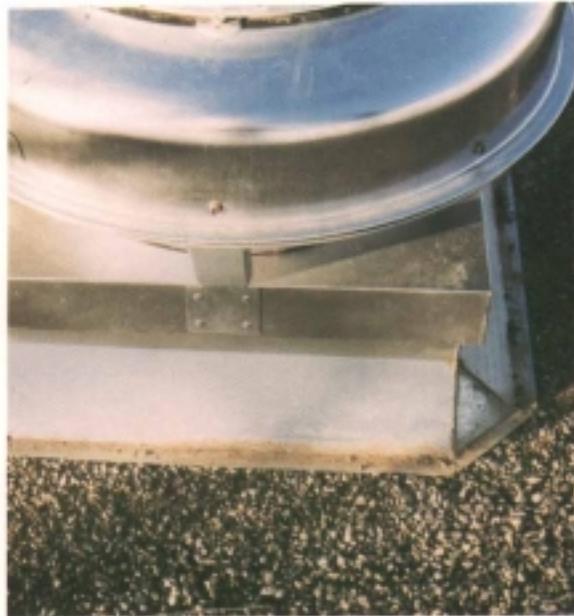
**FP6** Flashed Penetration  
<Medium Severity>  
The flashing curb has not been stripped-in

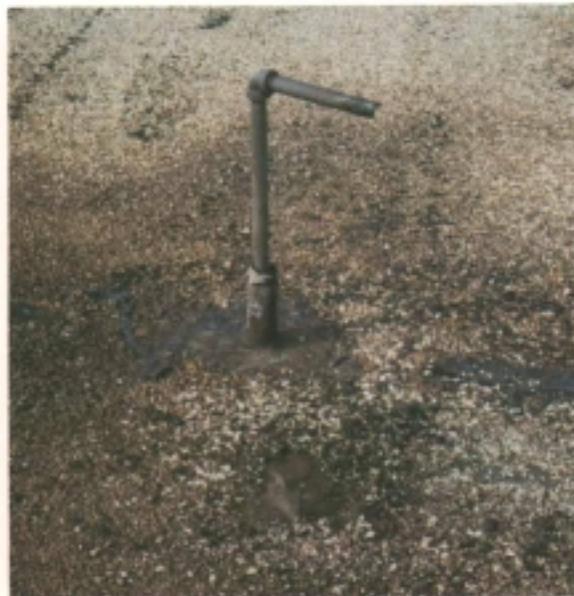
**FP8** Flashed Penetration  
<Medium Severity>  
The flashing umbrella is missing

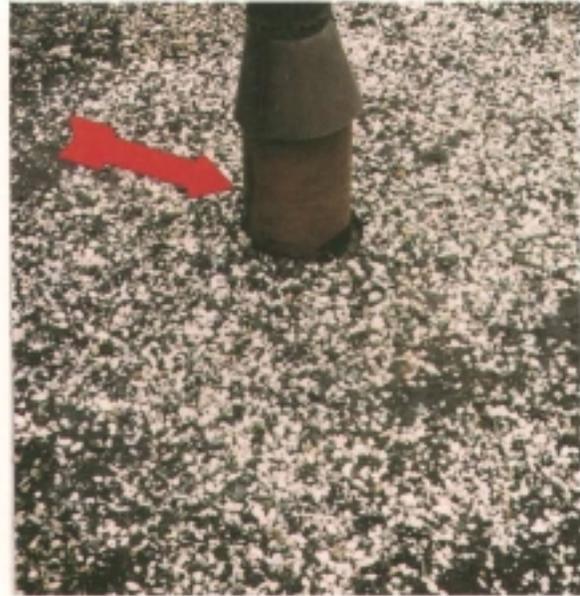
FP10 Flashed Penetration  
<High Severity>  
The joint in the metal sleeve has failed

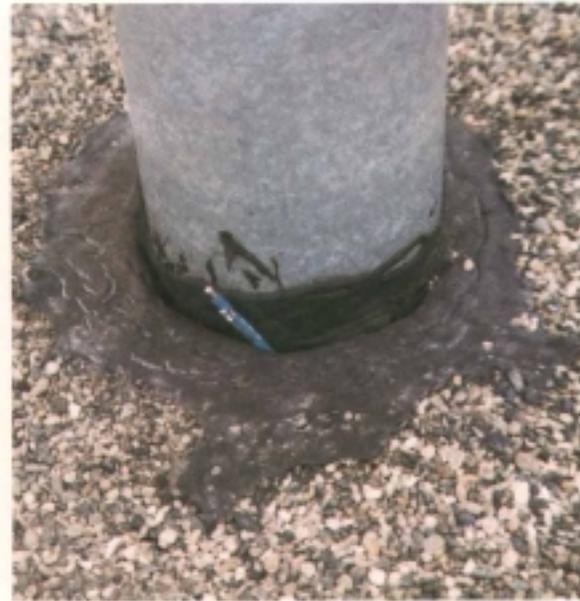
FP12 Flashed Penetration  
<High Severity>  
The metal flashing has been left out

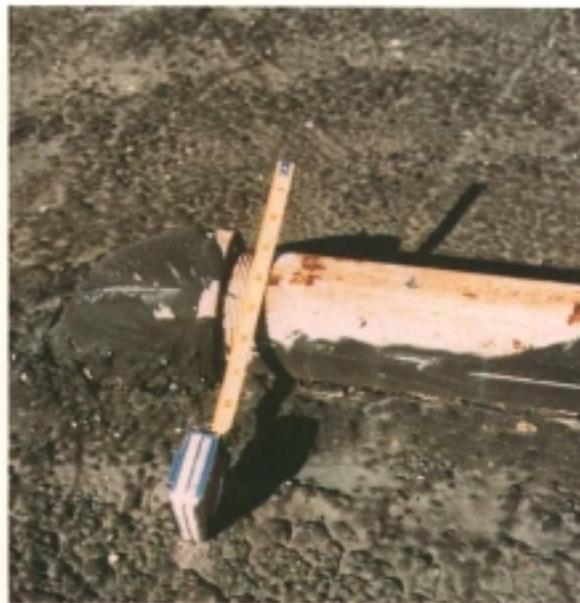
FP15 Flashed Penetration  
<High Severity>  
The sleeve around the penetration is  
missing; the conduit is lying on the  
roof without supports

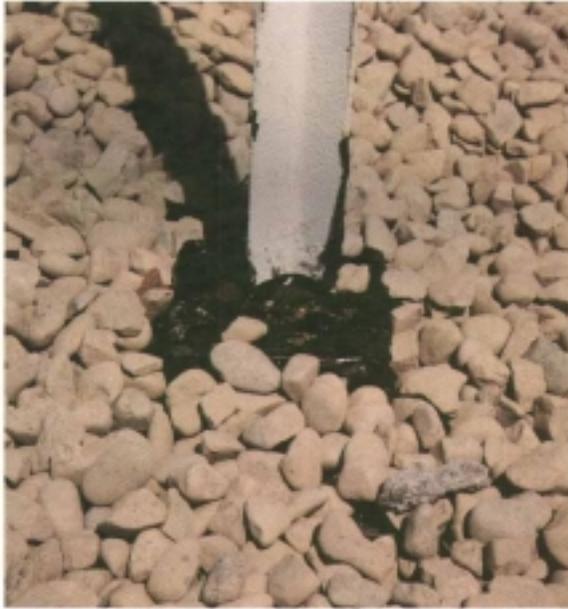
PP1 Pitch Pans  
<Low Severity>  
Pitch pan installed and maintained correctly but presents a hazard

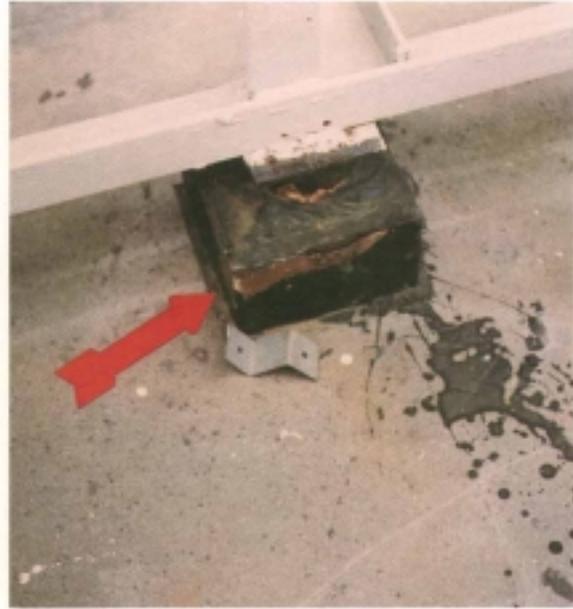
PP2 Pitch Pans  
<High Severity>  
Metal shows light corrosion

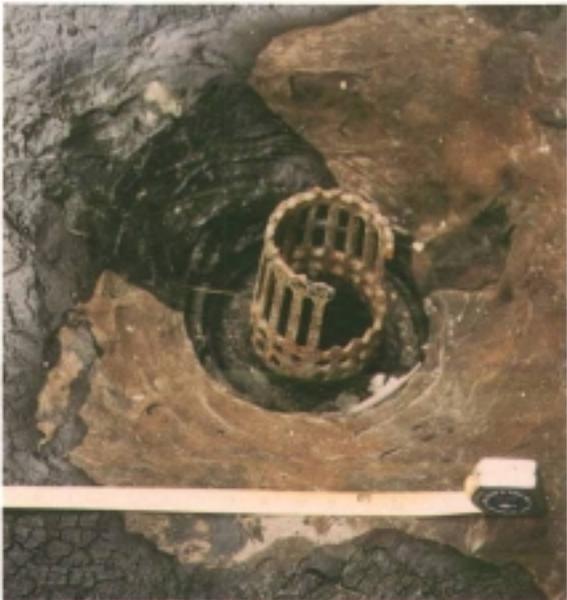
DR3 Drains and Scuppers  
 <Medium Severity>  
 The strainer is broken

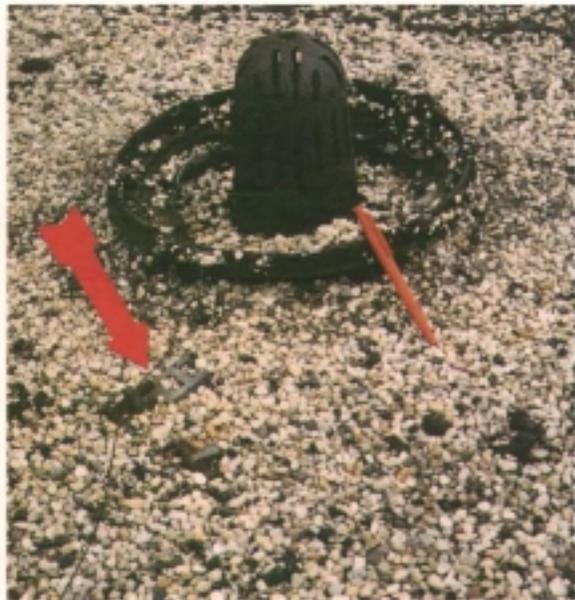
DR4 Drains and Scuppers  
 <High Severity>  
 The clamping ring is loose. Bolts are lying next to the ring

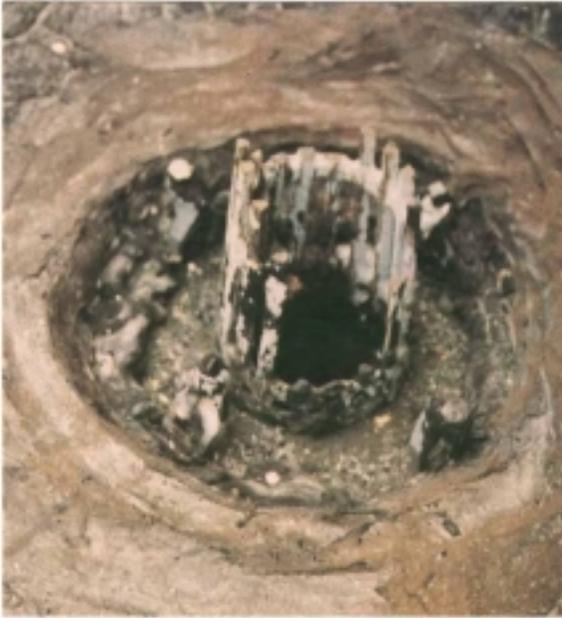
DR5 Drains and Scuppers  
<High Severity>  
The clamping ring is missing; also, the strainer is broken and the drain is clogged with bitumen

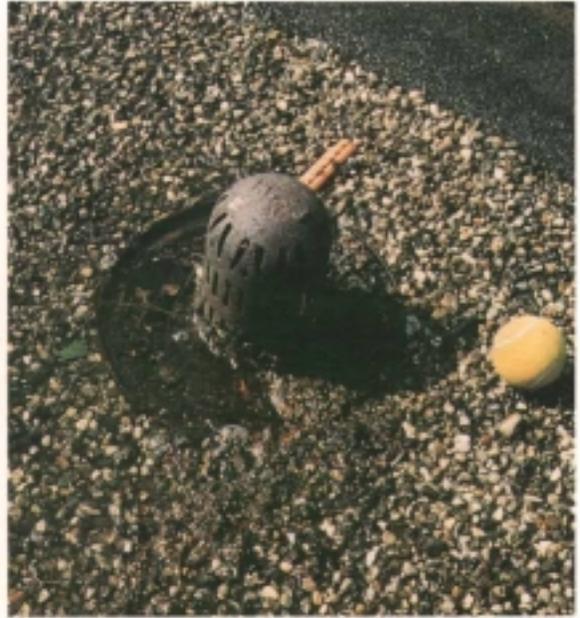
DR6 Drains and Scuppers  
<High Severity>  
The drain is clogged

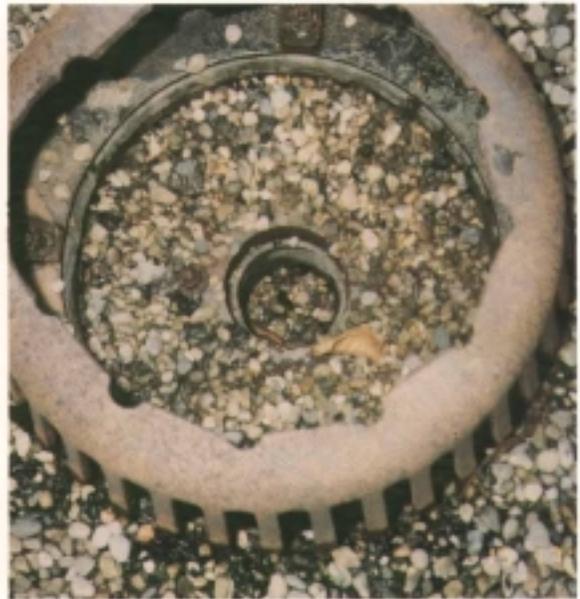
DR8 Drains and Scuppers  
<High Severity>  
The drain is clogged

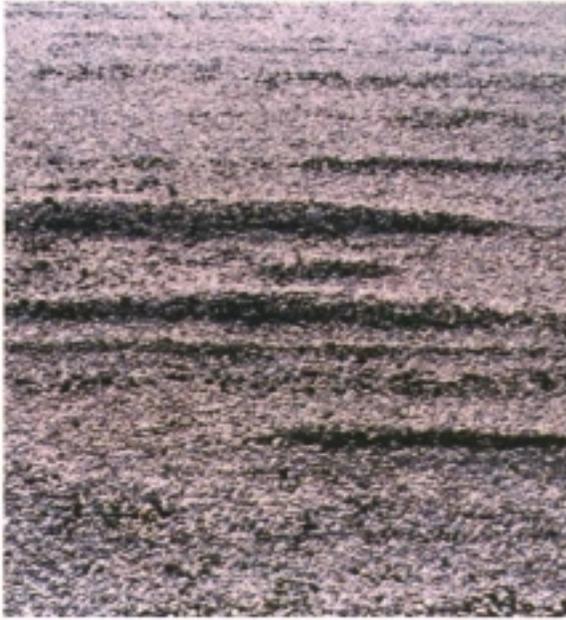
BL1 Blisters  
<Low Severity>  
Low severity blisters.  
The surface is still in place

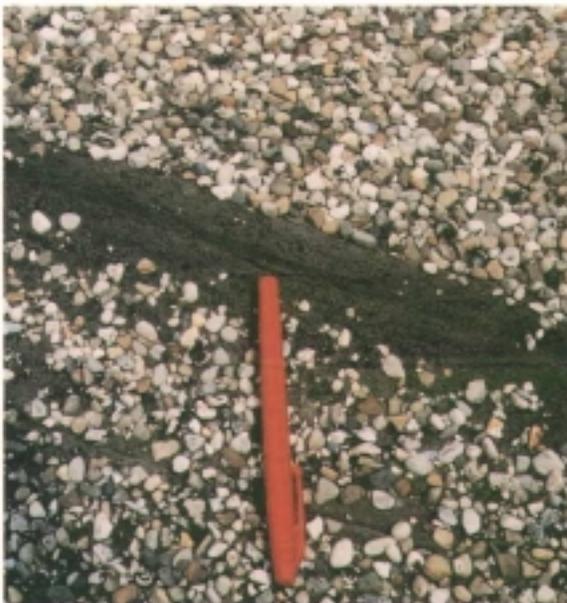
BL7 Blisters  
<Medium Severity>  
Blister is bare and felts are starting to show wear

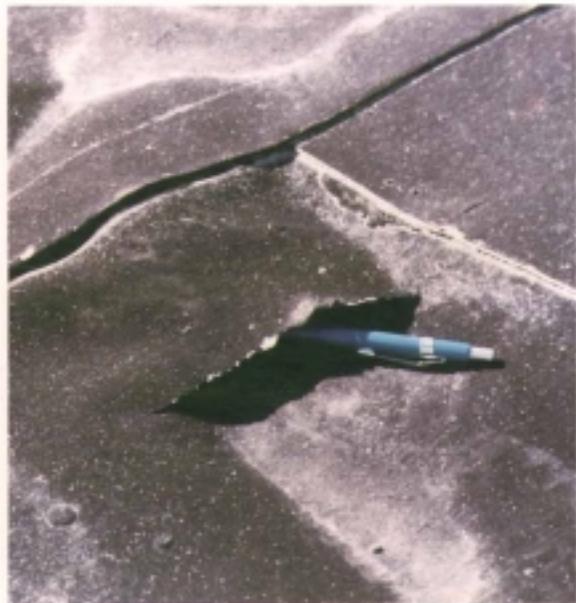
BL8 Blisters  
<High Severity>  
Blister has broken

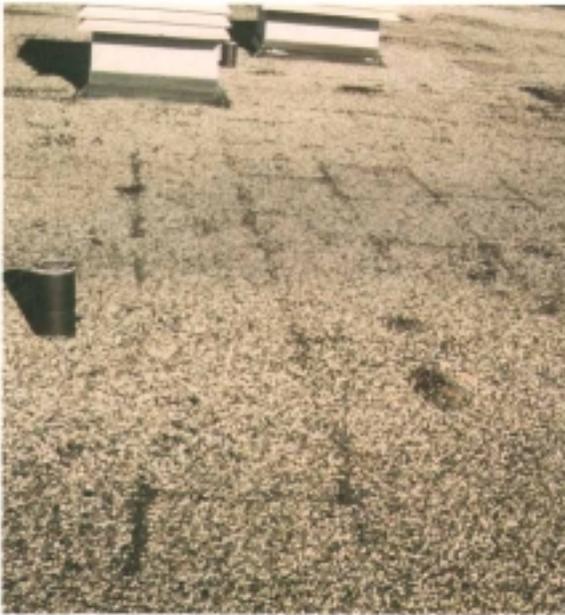
RG1 Ridges  
 <Low Severity>  
 Beginnings of ridges evident in surface; some picture framing evident

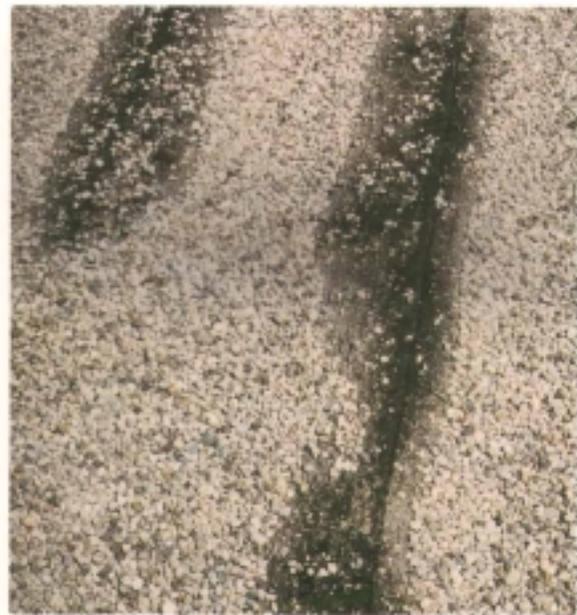
RG2 Ridges  
 <Medium Severity>  
 Closeup of medium severity ridging condition

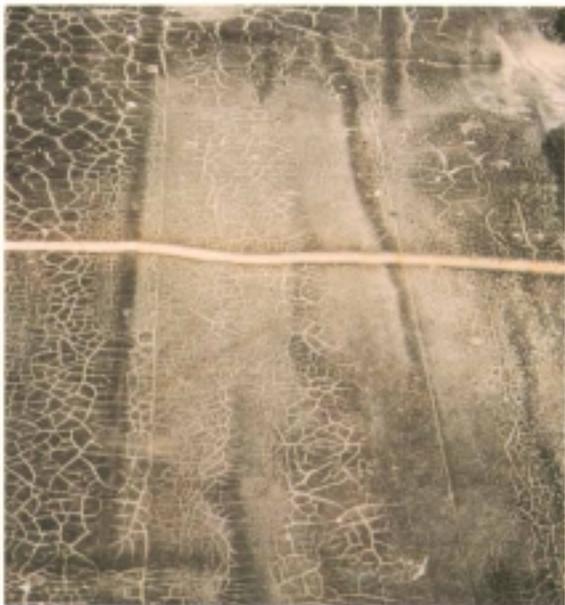
RG3 Ridges  
 <Low Severity>  
 Ridges in a smooth surface membrane

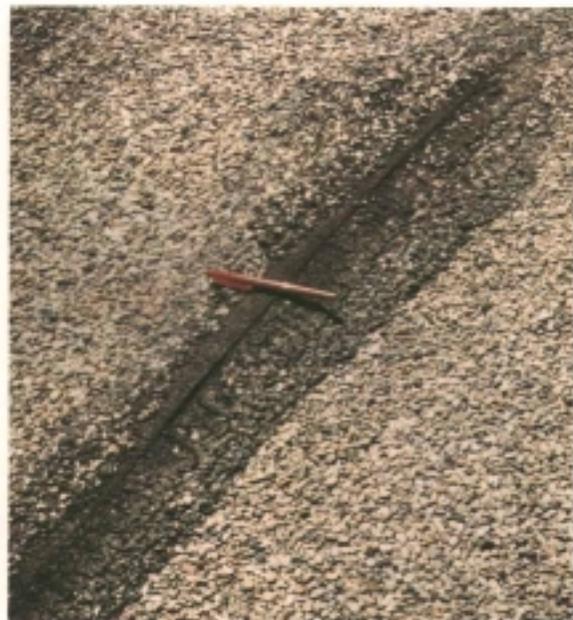
RG6 Ridges  
 <High Severity>  
 Felts are distorted; felt lap is opening up; first felt shows deterioration

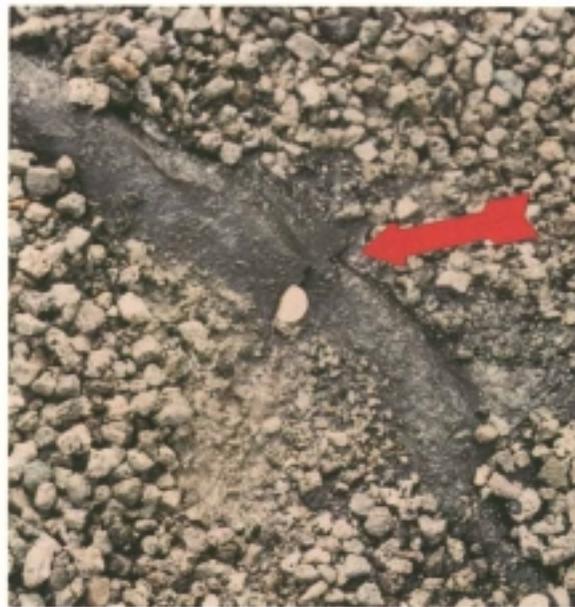
RG7 Ridges  
 <High Severity>  
 Ridge has collapsed; felt is broken or torn

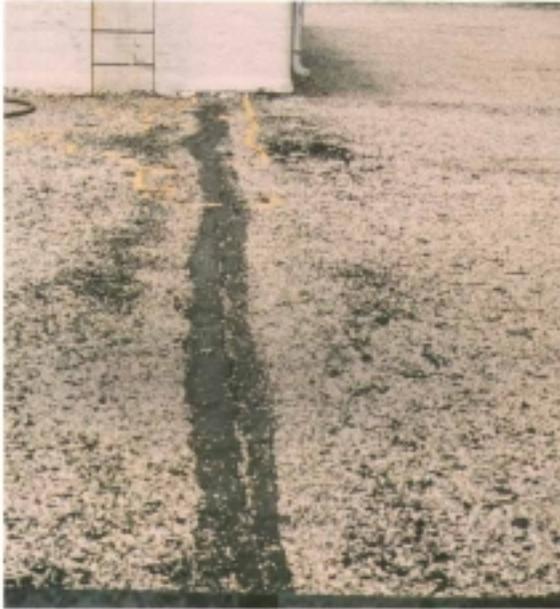
SP1 Splits  
 <High Severity>  
 Long split over structural member;  
 yellow markings indicate water  
 penetration determined by infrared  
 (IR) scanning

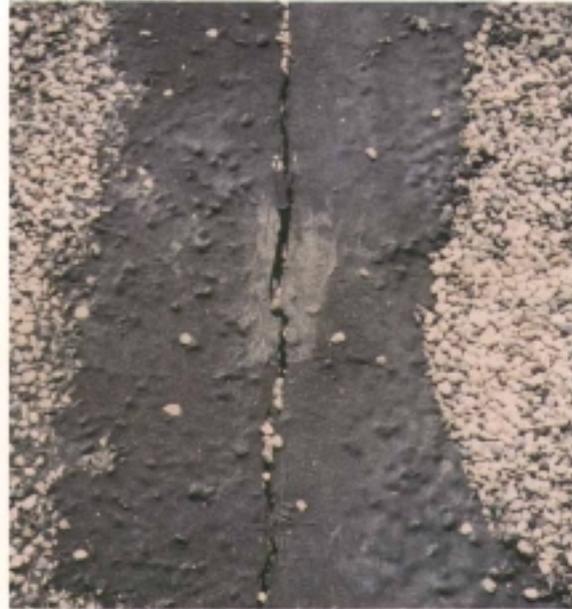
SP2 Splits  
 <High Severity>  
 Closeup of split in gravel surface;  
 repair attempt made using mastic  
 without reinforcing fabric

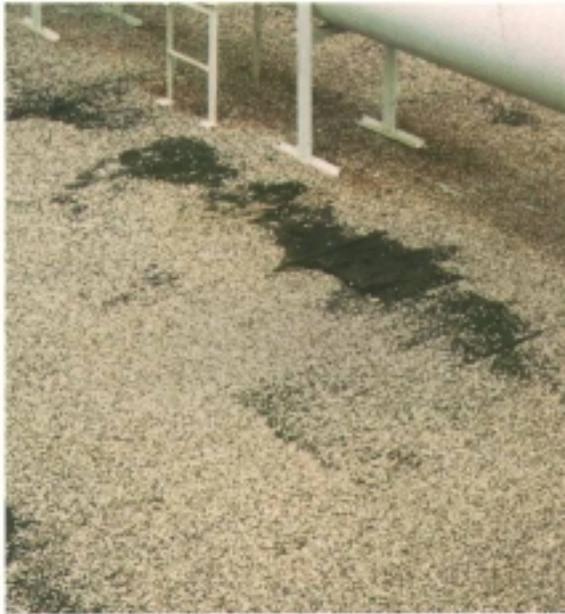
SR1 Surface Deterioration  
 <Low Severity>  
 Gravel is loose and easily displaced  
 by wind; imbedment of gravel is minimal  
 <Medium Severity>  
 Bare areas

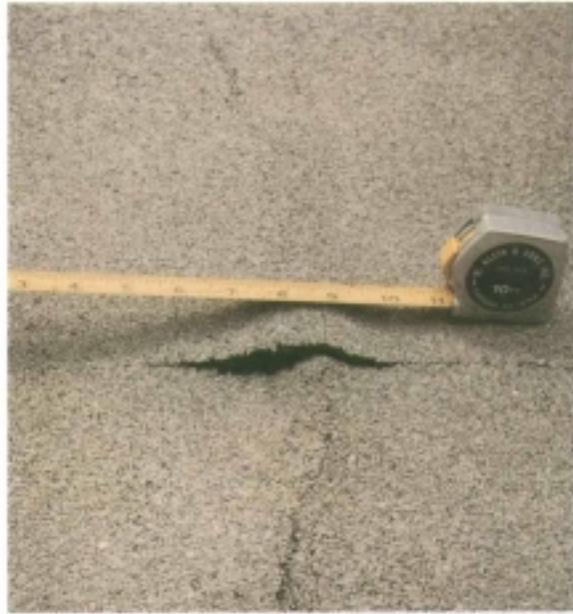
SR2 Surface Deterioration  
 <Low Severity>  
 There are open edge laps or  
 fishmouths

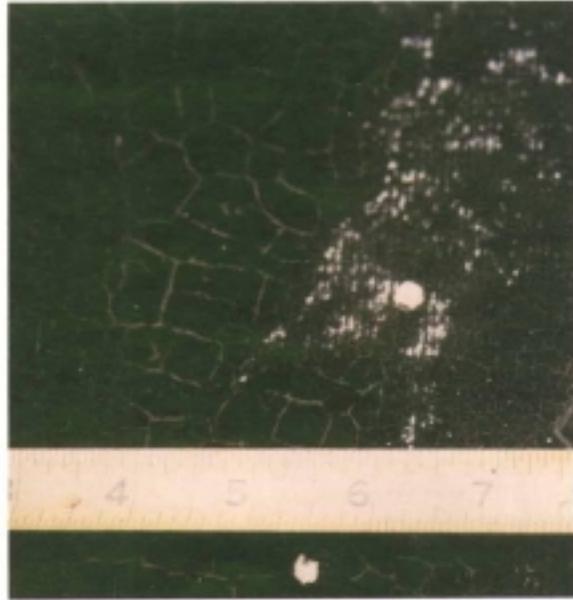
SR4 Surface Deterioration  
 <Low Severity>  
 Hairline alligator cracking of the  
 surface is evident

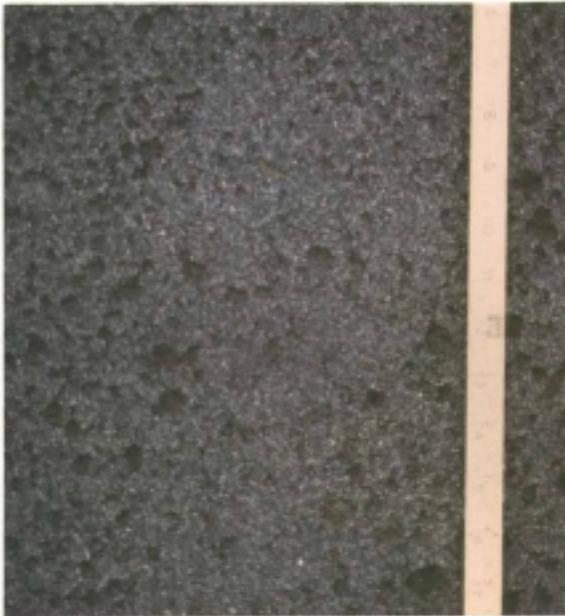
SR5 Surface Deterioration  
<Medium Severity>  
Granule surface on cap sheet is eroded

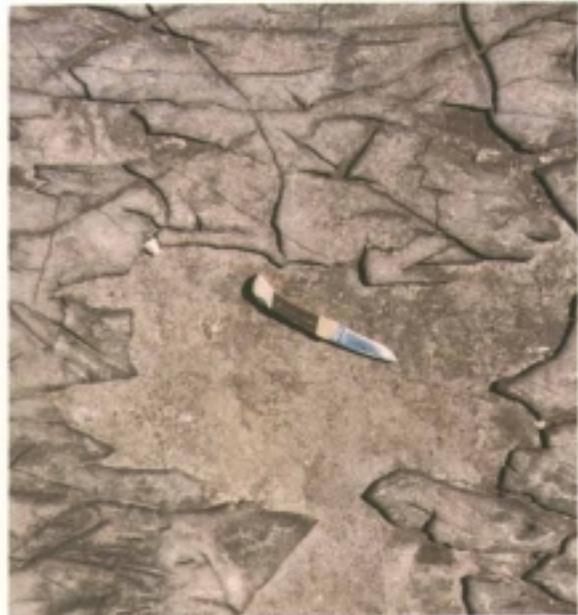
SR6 Surface Deterioration  
<Medium Severity>  
Loss of surface coating on  
smooth surface roof

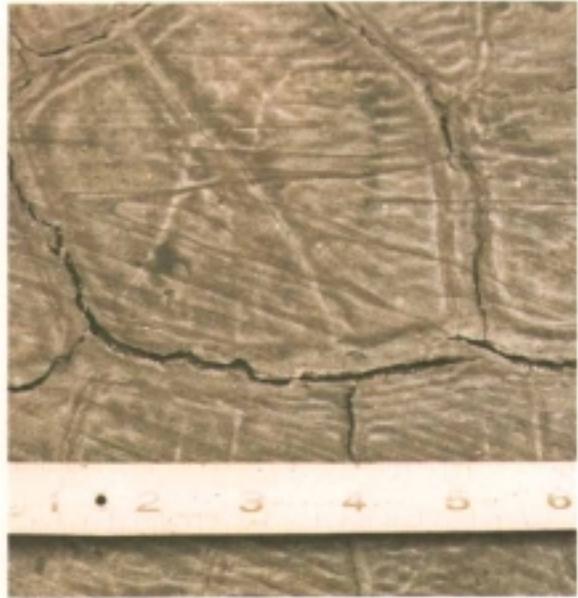
SR8 Surface Deterioration  
<Medium Severity>  
Alligator cracking of the surface  
extends down to the felt

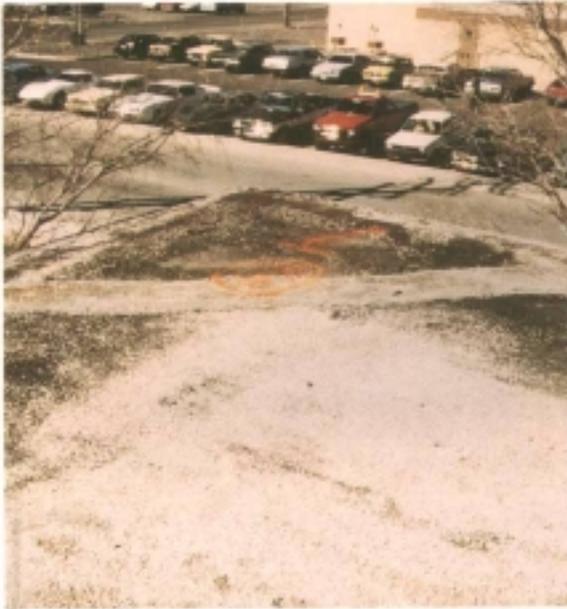
SR9 Surface Deterioration  
 <Medium Severity>  
 Gravel surfacing shows erosion from wind coming over corner of building

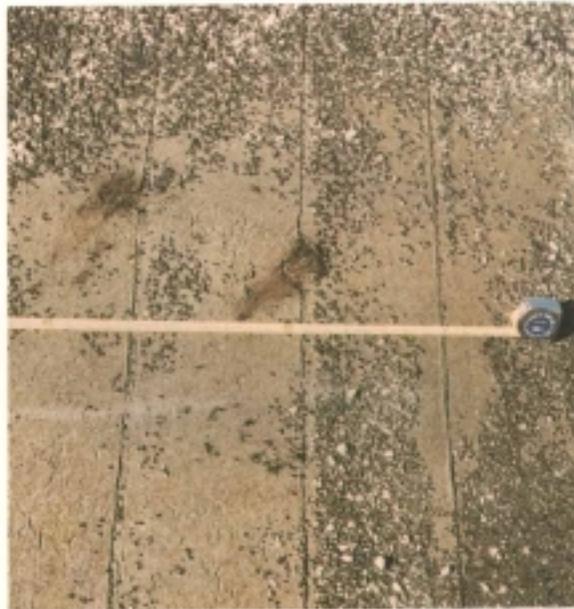
SR10 Surface Deterioration  
 <High Severity>  
 Gravel surfacing is gone and felts are starting to show wear

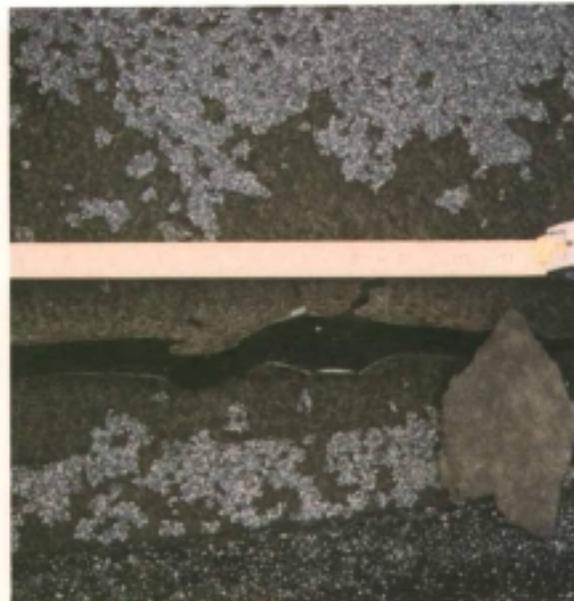
SR12 Surface Deterioration  
 <High Severity>  
 Cap sheet is completely worn and felt is torn or broken

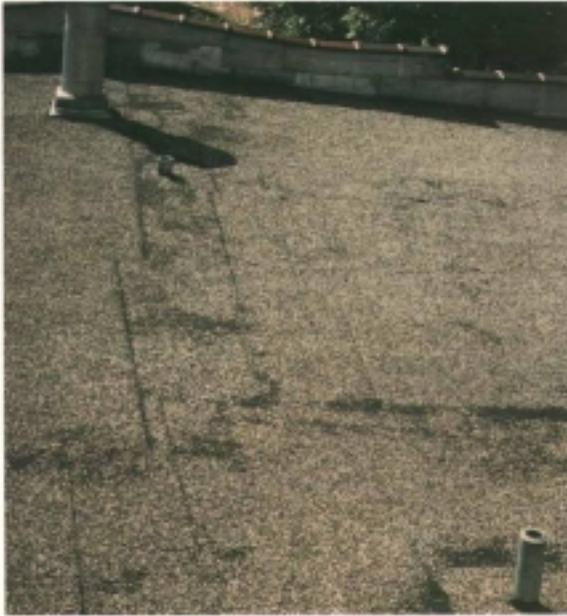
SL1 Slippage  
<Low Severity>  
Slippage lines can be seen in the  
roof surface

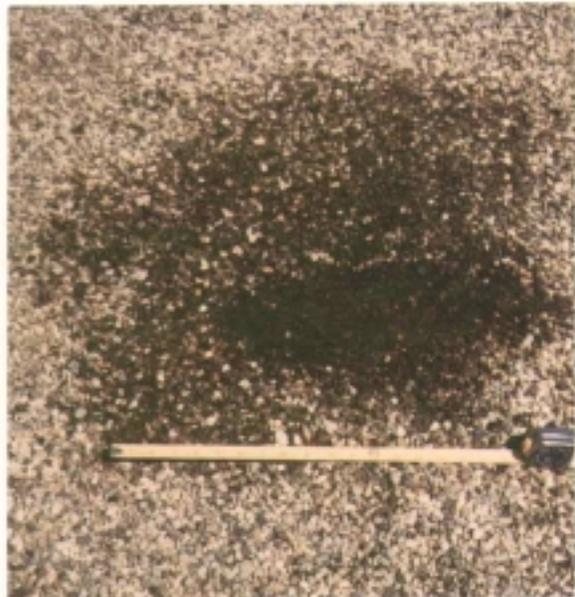
DV8 Debris and Vegetation  
<High Severity>  
Degradation of membrane due to  
oil or solvent drippage

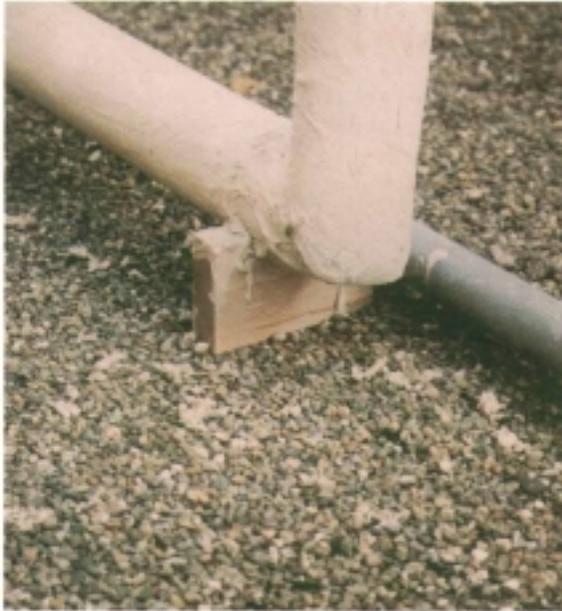
EQ1 Improper Equipment Supports  
<Low Severity>  
Pipe supported by wood block
