USA-CERL TECHNICAL REPORT M-87/13, VOL. II

Roofing Maintenance Management System

# Membrane and Flashing Condition Indexes for Built-Up Roofs

## Volume II: Inspection and Distress Manual

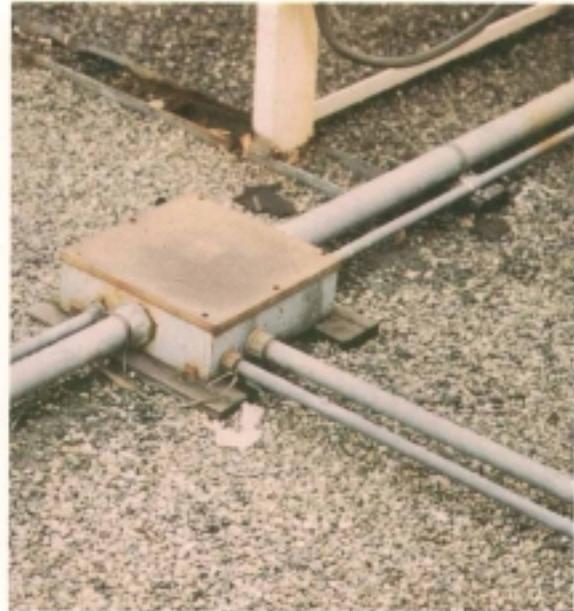
EQ2 Improper Equipment Supports  
<Low Severity>  
Conduit supported by wood blocks

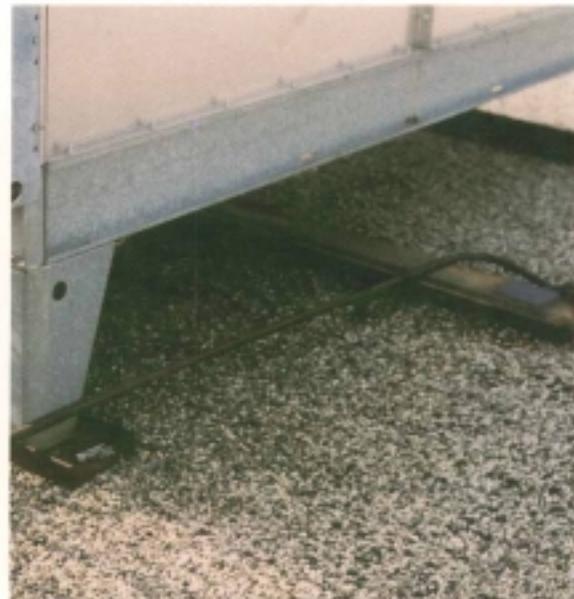
EQ4 Improper Equipment Supports  
<Low Severity>  
Large air-conditioning unit  
supported on unflashed steel

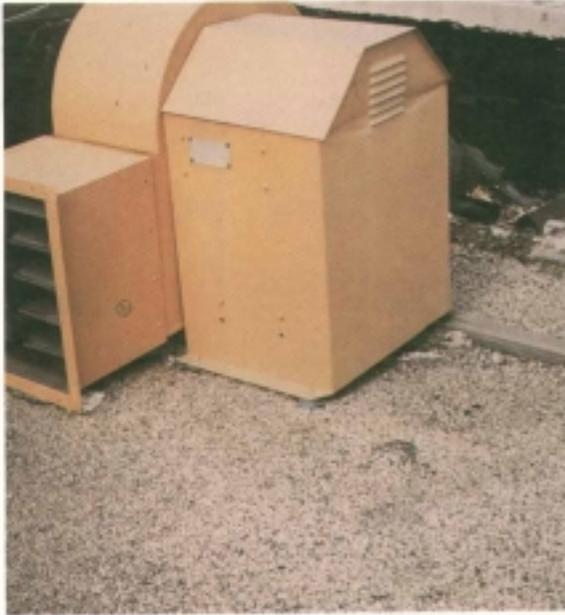
**EQ5** Improper Equipment Supports  
<Medium Severity>  
Air handling equipment installed directly on the roof surface

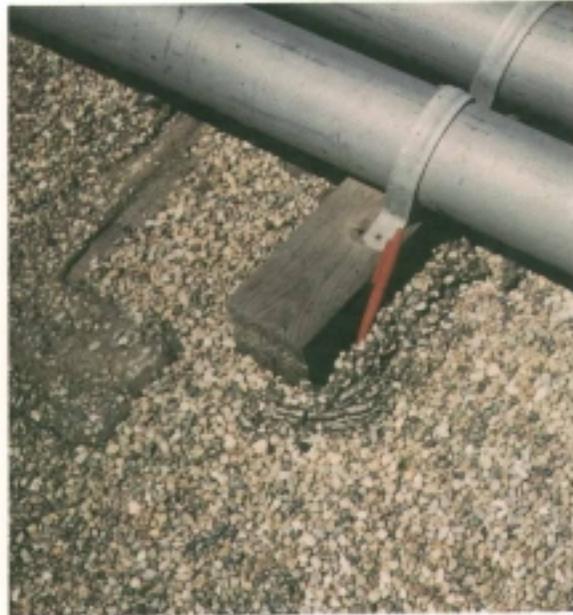
**EQ6** Improper Equipment Supports  
<High Severity>  
Blocks supporting piping have moved, tearing the roof membrane

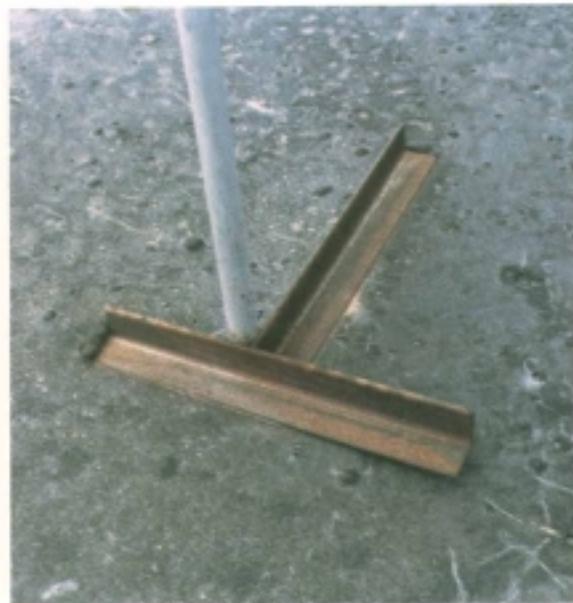
**EQ8** Improper Equipment Supports  
<High Severity>  
Equipment support has damaged membrane

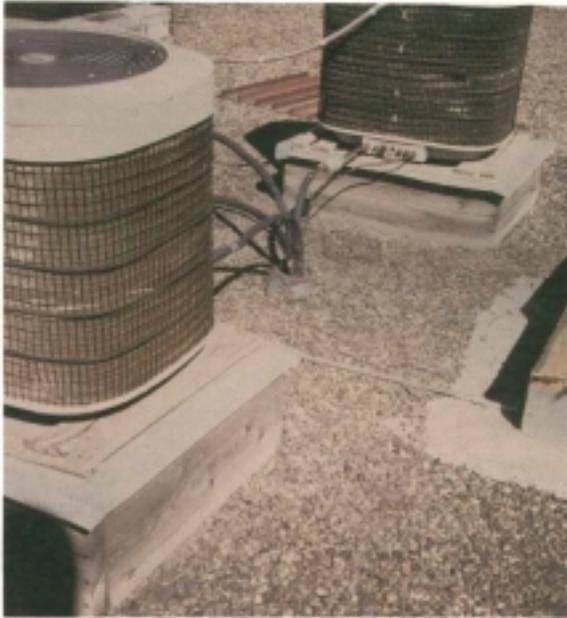
EQ9 Improper Equipment Supports  
<High Severity>  
Improper A/C support and pipe penetration

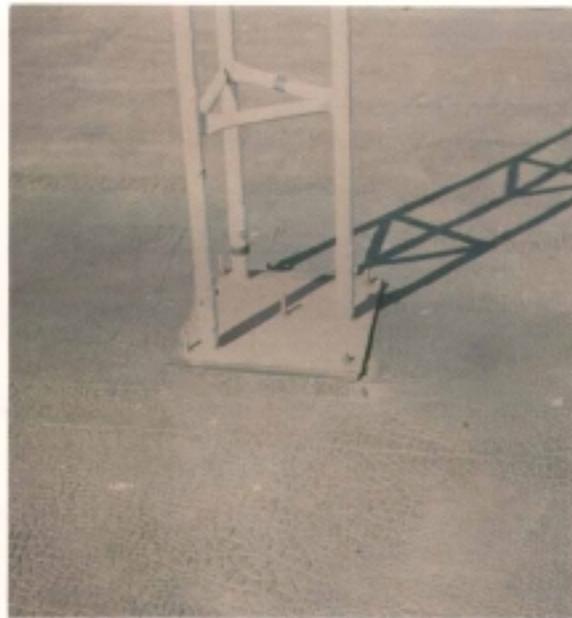
EQ10 Improper Equipment Supports  
<High Severity>  
Base for antenna has not been placed on a flashed curb.  
Bolts penetrate membrane

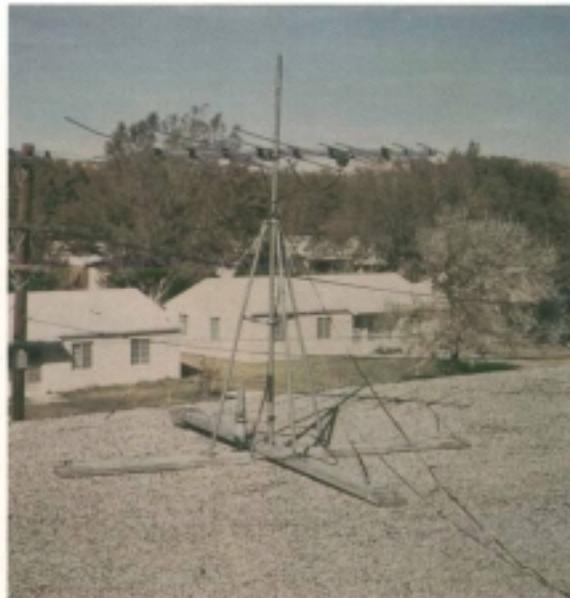
EQ11 Improper Equipment Supports  
<High Severity>  
Antenna base is nailed to roof

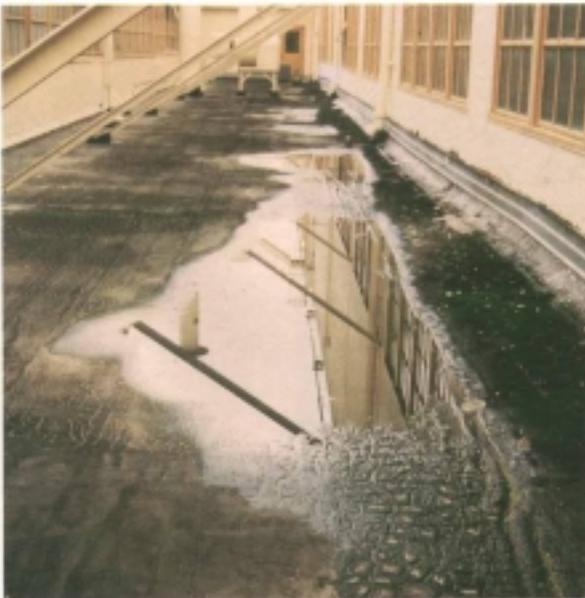
PD1 Ponding  
<Low Severity>  
Ponding is occurring between drains
