CERL Technical Report 99/72  
August 1999

# **Piezoelectric Patch Sensors for Structural Integrity Monitoring of Composite-Upgraded Masonry and Concrete Structures**

This report includes details on the development of the impedance-based technique and documents a demonstration of the technology on a composite-upgraded pier at Norfolk, VA.

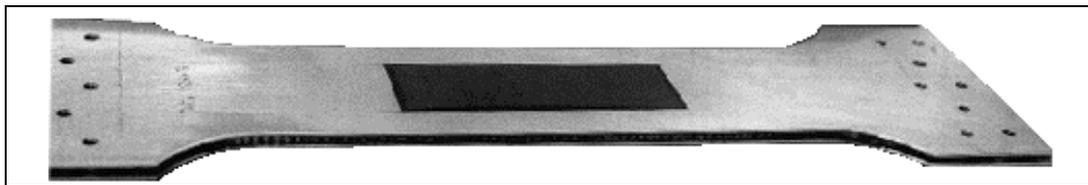
Figure 7. Cracked aluminum dog-bone specimen repaired with graphite/epoxy composite patch.

The next experiment in this phase of the project was to test the impedance-based technique on a cracked aluminum substrate repaired with a high-strength composite repair patch (Figure 7) to determine whether the PE sensors could identify debonding and distinguish it from other defects.

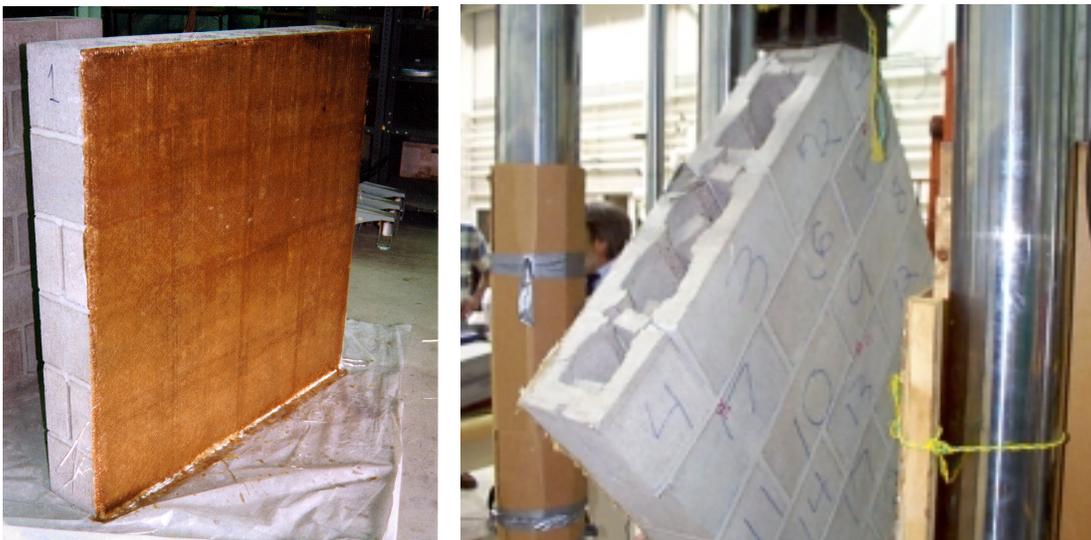
Figure 18. Wall 1 before loading (left) and after failure (right).

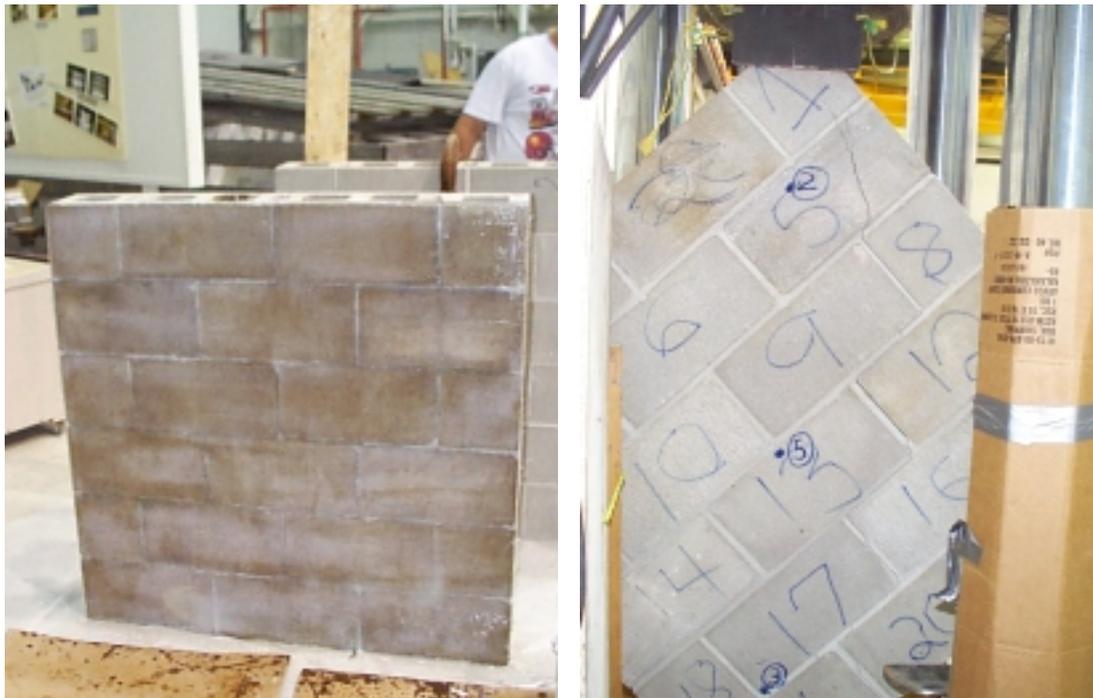
Figure 22. Wall 3 before loading (left) and after failure (right).

Wall 3 was upgraded with composite reinforcement called the TYFO™ S Fibrwrap System, manufactured by Fyfe Co., LLC (E-glass / epoxy / *in situ* [woven, 2 layers]). The wall was loaded in stages to 49,000 lb, at which point failure occurred (Figure 22). The Correlation Metric was used to interpret and summarize the data from PE sensors 1 – 5.

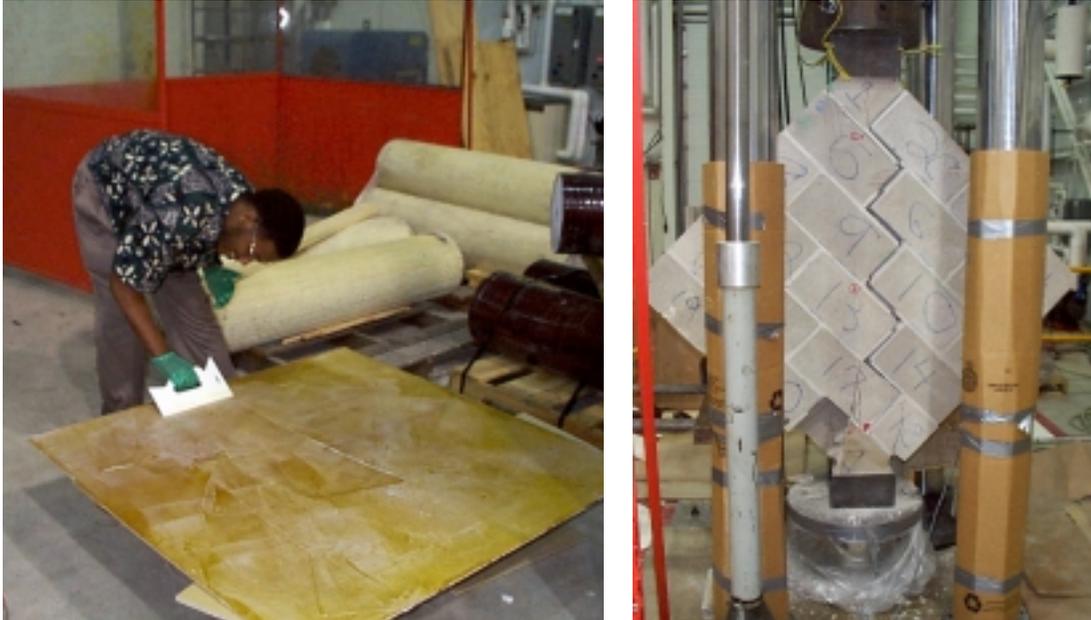
Figure 24. Preparing composite plate for Wall 4 (left) and failed wall (right).

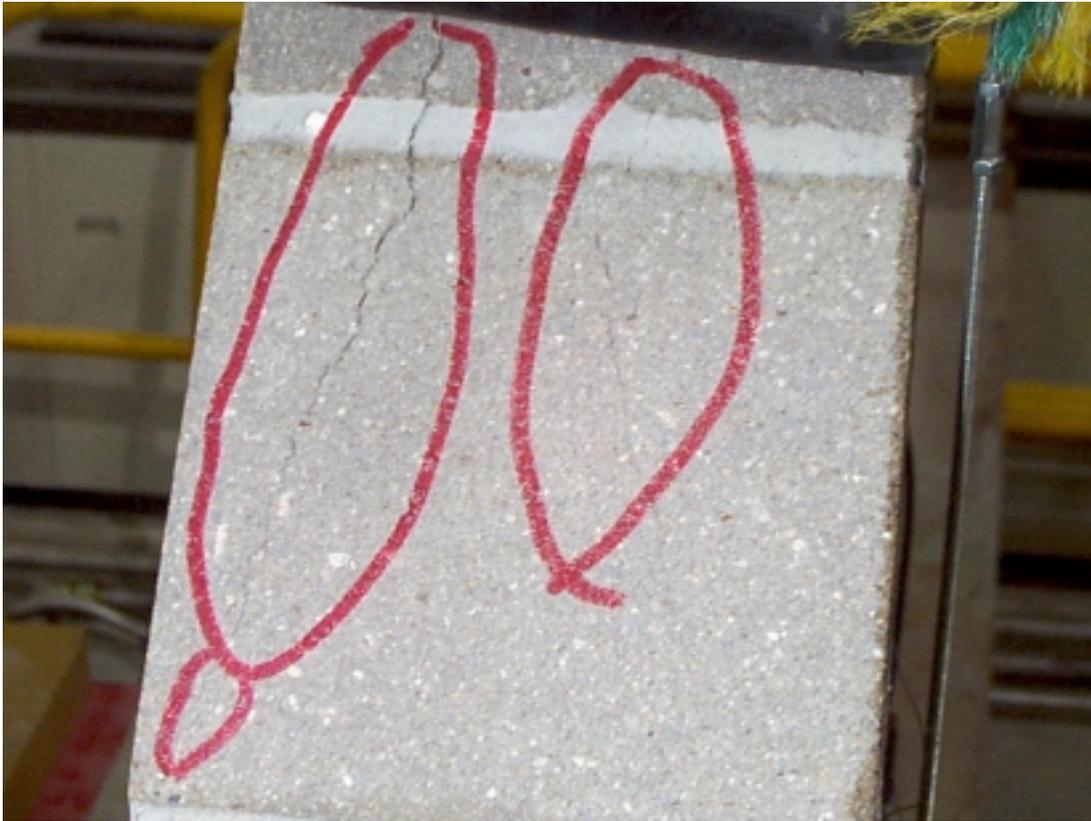
Figure 28. A side view of the top of Wall 2 showing the cracks that appeared at 30,000 lb load.

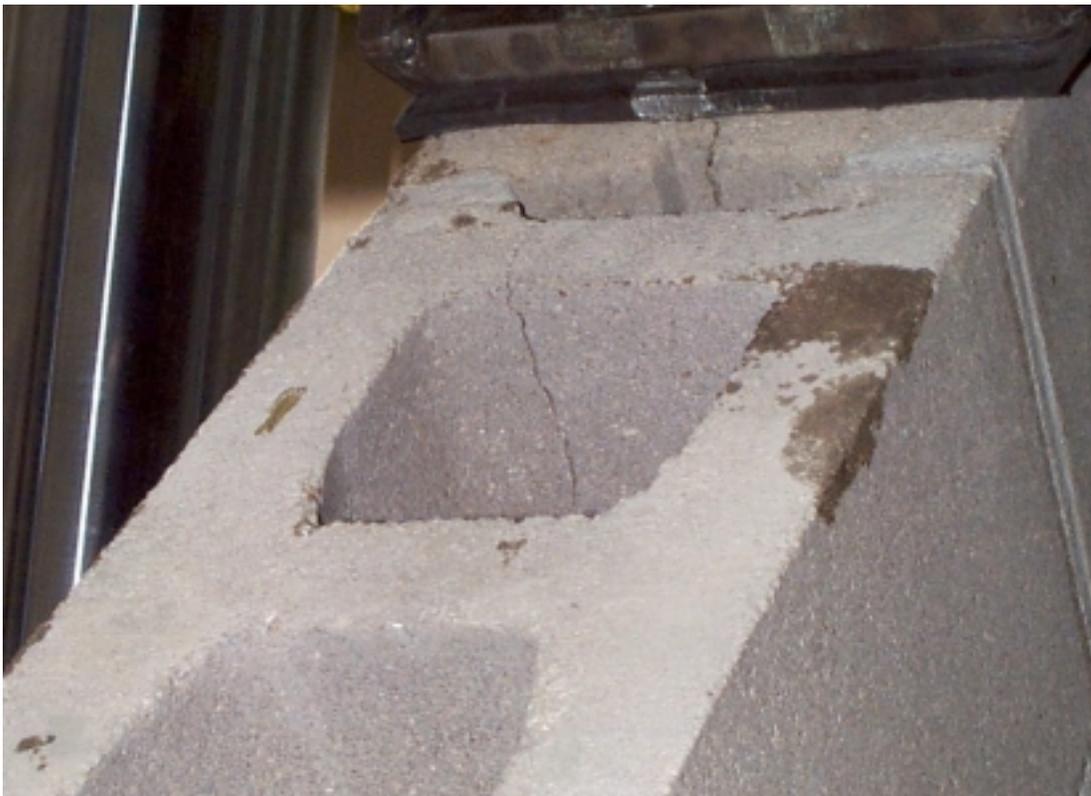
Figure 29. Oblique view of concrete block from Wall 6 showing internal cracks that appeared at 30,000 lb load.

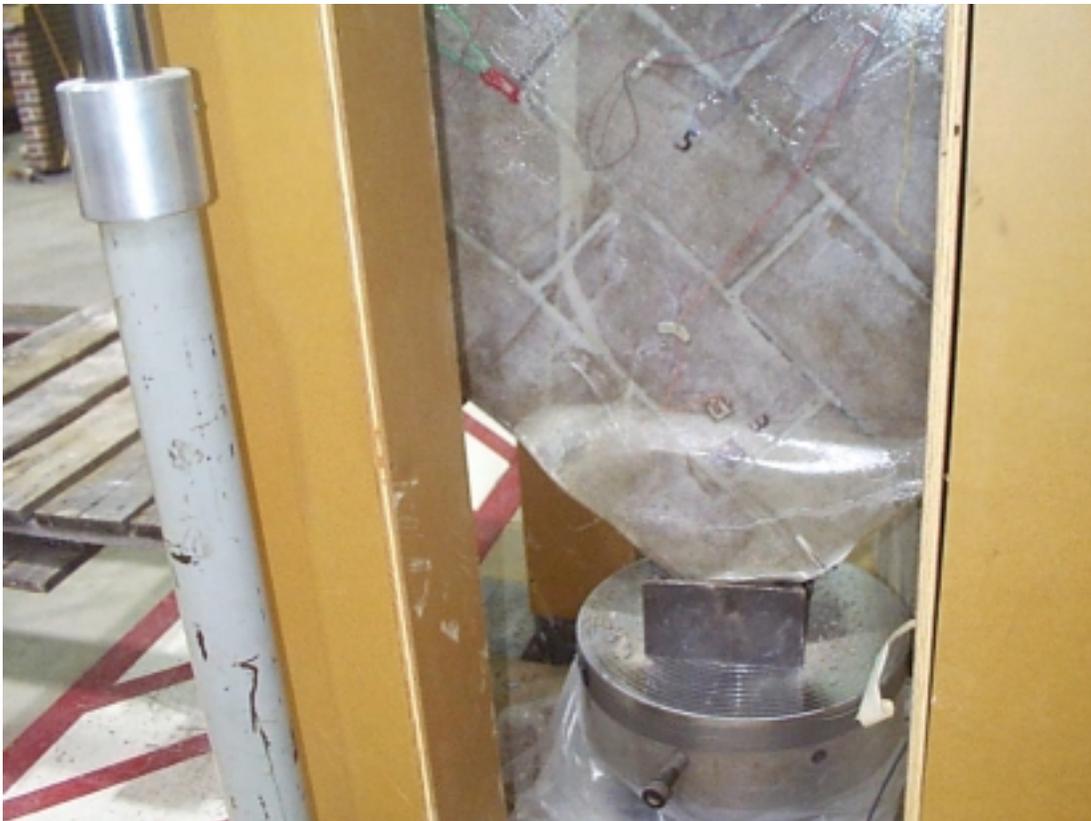
**Figure 30. Wall 6 after failure. Note the large section of composite layer that has debonded near the bottom load shoe. The top to bottom failure in the wall can be seen as a lighter gray zigzag on the left of the picture.**

The wall broke at 46,000 lb but continued to hold the load. A stairstep crack appeared in the wall (see inset diagram in Figure 27). The break occurred while measuring PE sensor 4, so the data for PE sensors 4 and 5 are missing from the chart. The wall continued to hold the load until it failed at 56,000 lb. When the wall broke, the damage metrics for all PE sensors jumped. The composite material held the wall together, however, enabling the wall to continue holding the load. When the wall finally failed completely, the composite layer sheared off the bottom blocks and the lower blocks collapsed (see Figure 30).

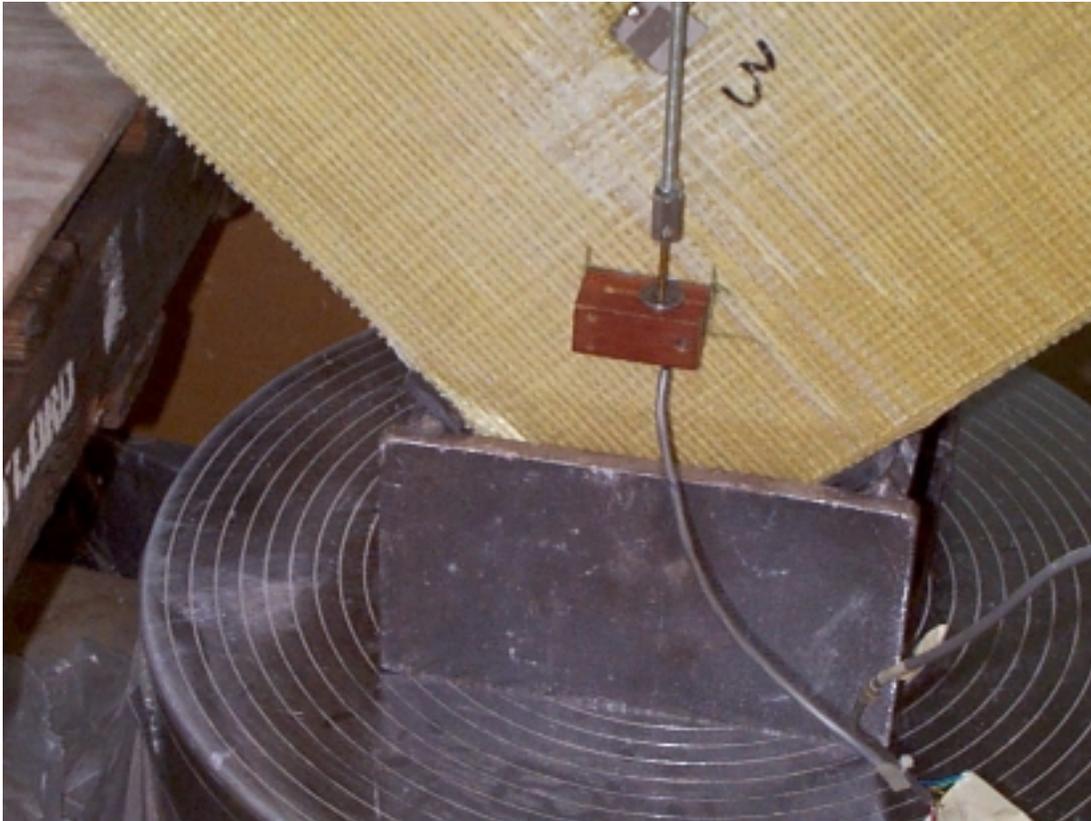
**Figure 33.** A view of the bottom shoe at 54,000 lb. The concrete masonry block had given way and a small portion of the composite was crushed. The crushed portion is visible at the left edge of the shoe. PE sensor 3, visible at the top of the picture, only recorded a slight increase in damage metric.

There was no further cracking from 36,000 to 51,000 lb. At 54,000 lb, we again heard a noise. Upon inspection, the bottom block had crushed slightly (see Figure 33). That damage was not reflected in the damage metric for PE sensor 3. That PE sensor only showed normal growth with load. On the other hand, PE sensor 5, in the center of the wall, damage metric increased dramatically. The value is off the graph in Figure 31 and had a value of 0.27 — 10 times the largest value of any other PE sensor. Finally, at 56,000 lb, the wall failed with a large stair step pattern along the mortar lines. In addition, several blocks along that line were shattered.

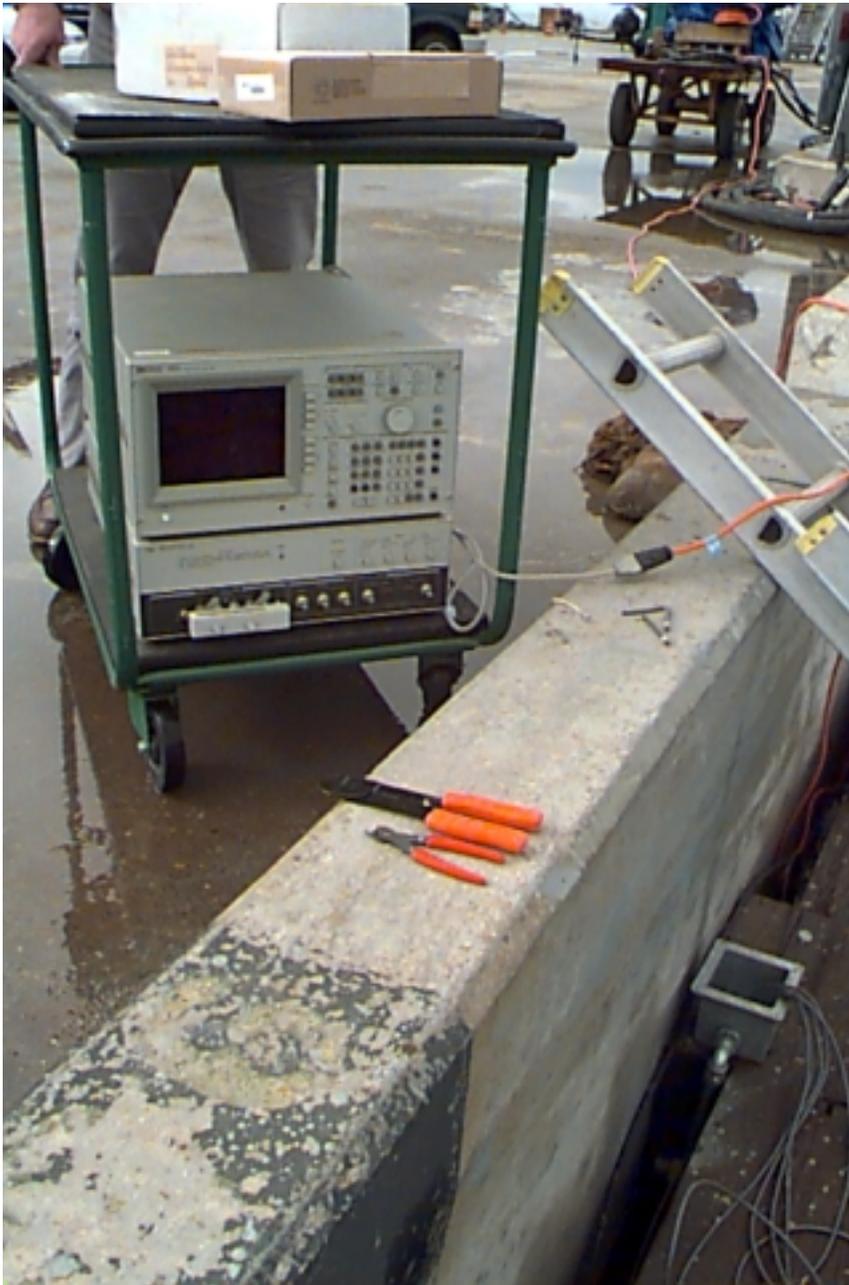
Figure 38. Impedance analyzer setup showing junction box at lower right.
