Pearl River Lock Chamber.
Poly Armor test areas on
Sheet pile walls

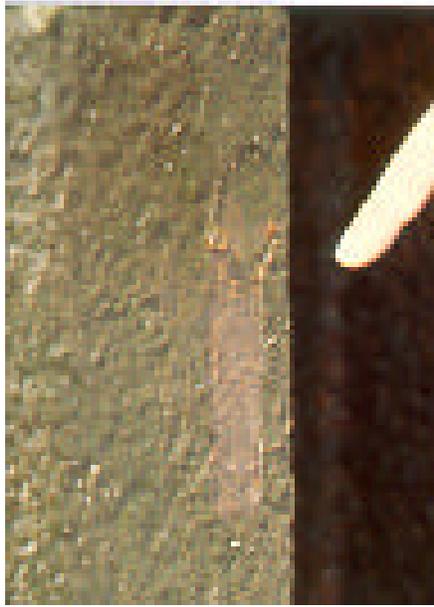
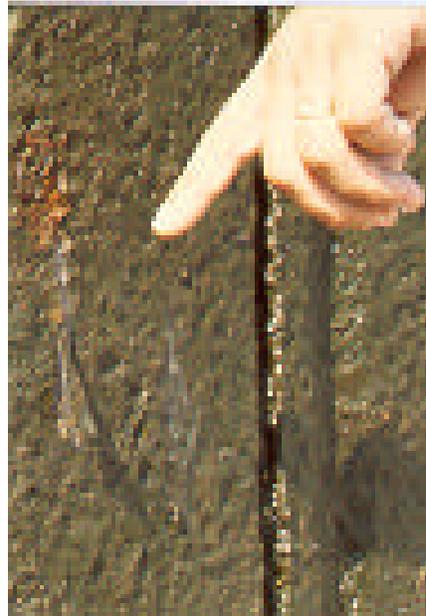
Topcoat could be easily stripped
from primer in test areas with
White Metal Grade surface
preparation.

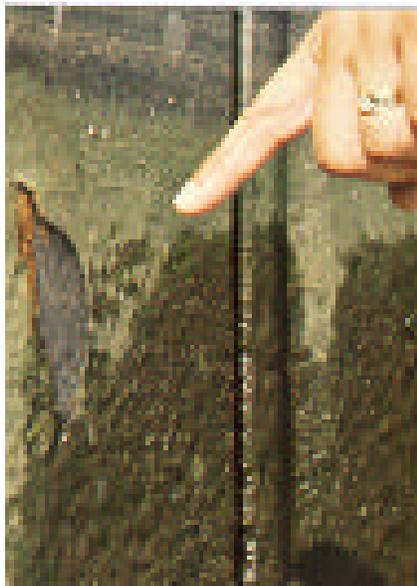
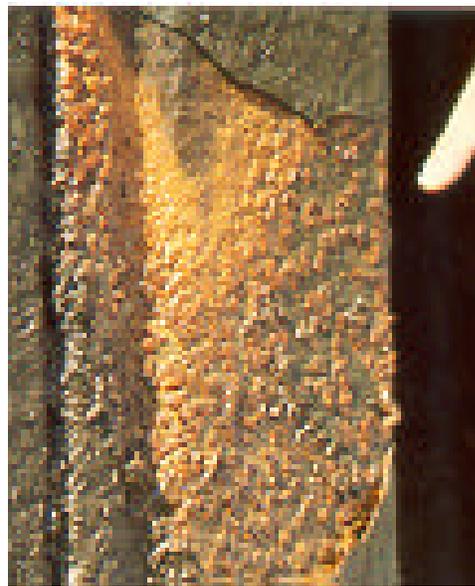
Coating had very poor adhesion
to test areas with Commercial
Grade surface preparation. On
some areas the coating was gone
after only 4 months.
