# Underground Storage Tank Location and Mapping of Former Landfills by Electromagnetic Surveys for the Delaware National Guard

Paul H. Nielsen

August 2001

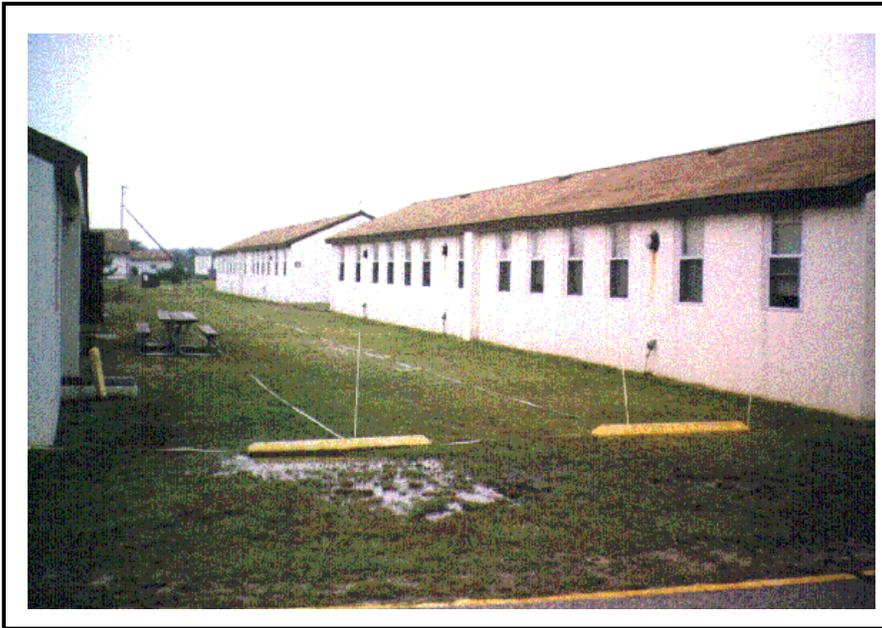
**Figure 1. Tape measure placement for electromagnetic survey of area between rows of barracks, Bethany Beach, Delaware National Guard Training Base.**

If a 5-ft grid is used, reasonably accurate positioning can be accomplished by placing tape measures 10 ft apart and by walking along the tape, taking a data point every 5 ft for one line of data points, then by walking in the middle between two tapes and reading the numbers on one of the two tapes for the intermediate data points. This is easy to accomplish for open, nonvegetated areas. Heavy vegetation makes it more difficult to set up the survey area and to accurately position the instrument for readings. **Figure 1** shows a survey location set up between rows of barracks at Bethany Beach National Guard Training Base. The GEM-300 has a feature that allows it to take data at timed intervals. Thus a survey conducted at a walking pace can rapidly cover a relatively large area. (The operator does not need to stop at fixed locations to take data with the GEM-1.) The analysis software assumes a constant pace to locate the data points, so this technique is best suited for surveying nonobstructed areas.

These surveys were conducted as shown in Figure 1, by laying a short tape measure at both the south end and north end of each search area with the ends coincident with the building corners or the end of the survey area. Two long tape measures were then placed lengthwise at the 10- and 20-ft points on the short tapes. Data was taken on a 5-ft grid using the long tapes starting at with the first line at 5 ft from the building and completing the fifth line of data at 25 ft (5 ft from the neighboring building). Data was not taken at zero or 30 ft (at the building wall surface) because high readings caused by metal objects (bunk beds, refrigerators, and air-conditioners) inside or near the buildings would tend to mask any information from subsurface objects. Some building effects are still visible at 5 ft from the buildings.

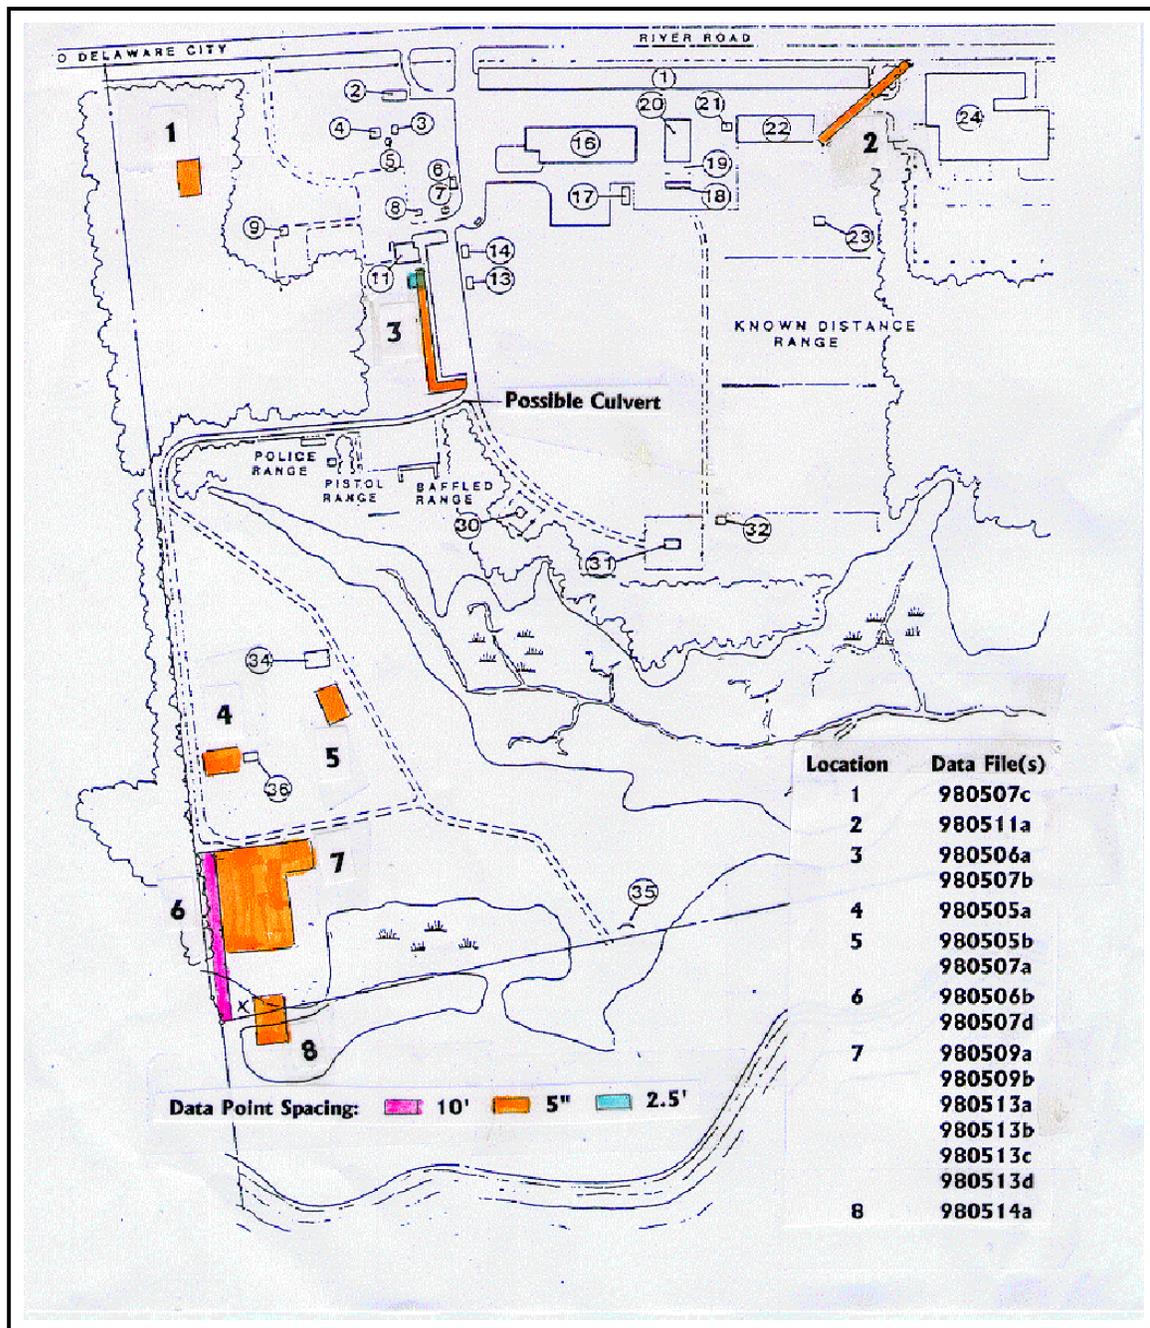
**Figure 2** shows a map of part of the facility that identifies the areas surveyed in this part of the study. Note that, in this illustration, orientations are not exact and sizes were not scaled. The areas are:

1. An historic latrine with the building no longer present. This survey was conducted to identify possible underground storage tanks in the immediate area of the facility.

Figure 2. Locations of electromagnetic surveys conducted at the New Castle, Delaware Rifle Range, Delaware National Guard.

2. A diagonal path approximating a proposed sewer line exiting the base. This survey was conducted to identify possible conflicting metallic underground structures or to document their absence.
3. An area near a former building. One underground fuel storage tank had been removed from this area.
4. The open area by ammunition storage building #36 for possible buried barrels.
5. The open area by the ammunition igloo #34 for possible buried barrels.

6. (also 7 and 8) These are all parts of one area (identified as the tower area) to be searched for buried metallic structures. The goal was to survey the whole area, but portions were too densely covered with vegetation to allow traversing of the area. Significant quantities of surface metal items were also present in some areas.

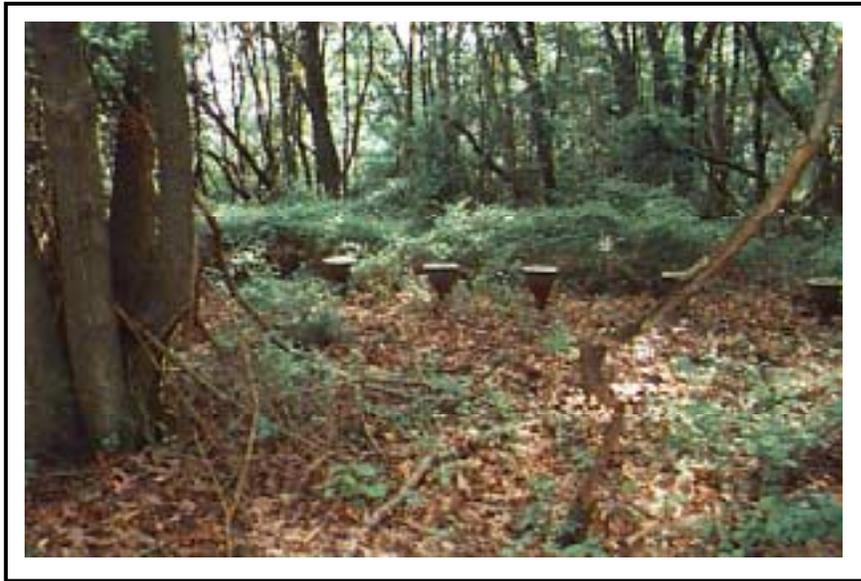
Location 1 on Figure 2 is a former latrine site probably dating from WWI. It is located in an area of forest with considerable underbrush in the immediate area (Figure 3). The building is gone except for the concrete floor and 12 stool fixtures. Nine, approximately 6-in. diameter metallic cylindrical and 1-in. pipe structures (4-5 ft total length) and a rusted out sheet metal structure (probably the urinal) were in the immediate area. These were placed near the stools during the surveys. A 50 X 75-ft area surrounding and including the floor was surveyed on 7 May 1998, to locate possible underground storage tank and/or septic tank fixtures related to the latrine structure. The results of this survey are given in Figure 4 (3200 Hz, in-phase data). The line of the stools is centered on the horizontal 30-ft line. The other target (between 40-50 horizontal and vertical is located where the urinal sheet metal had been found and may indicate an additional near surface, relatively small metal object in that area. No obvious tank-shaped structures were found in the survey area

**Figure 3. Location 1, former latrine site, New Castle Delaware National Guard Rifle Range.**

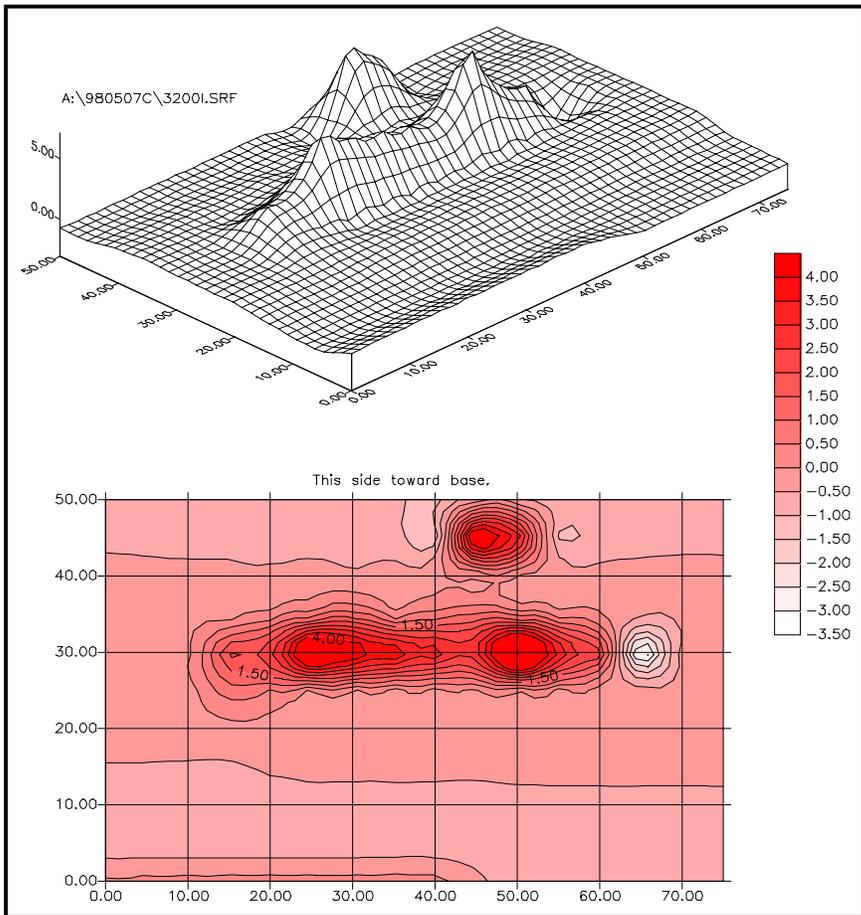
**Figure 4. Electromagnetic survey results, Location 1, former latrine building site, 3200 Hz, in-phase data.**

1. *Location 1, Historic Latrine.* No obvious tank-shaped structures were found in the survey area.
2. *Location 2, Proposed Sewer Line.* No subsurface objects or structures were identified.

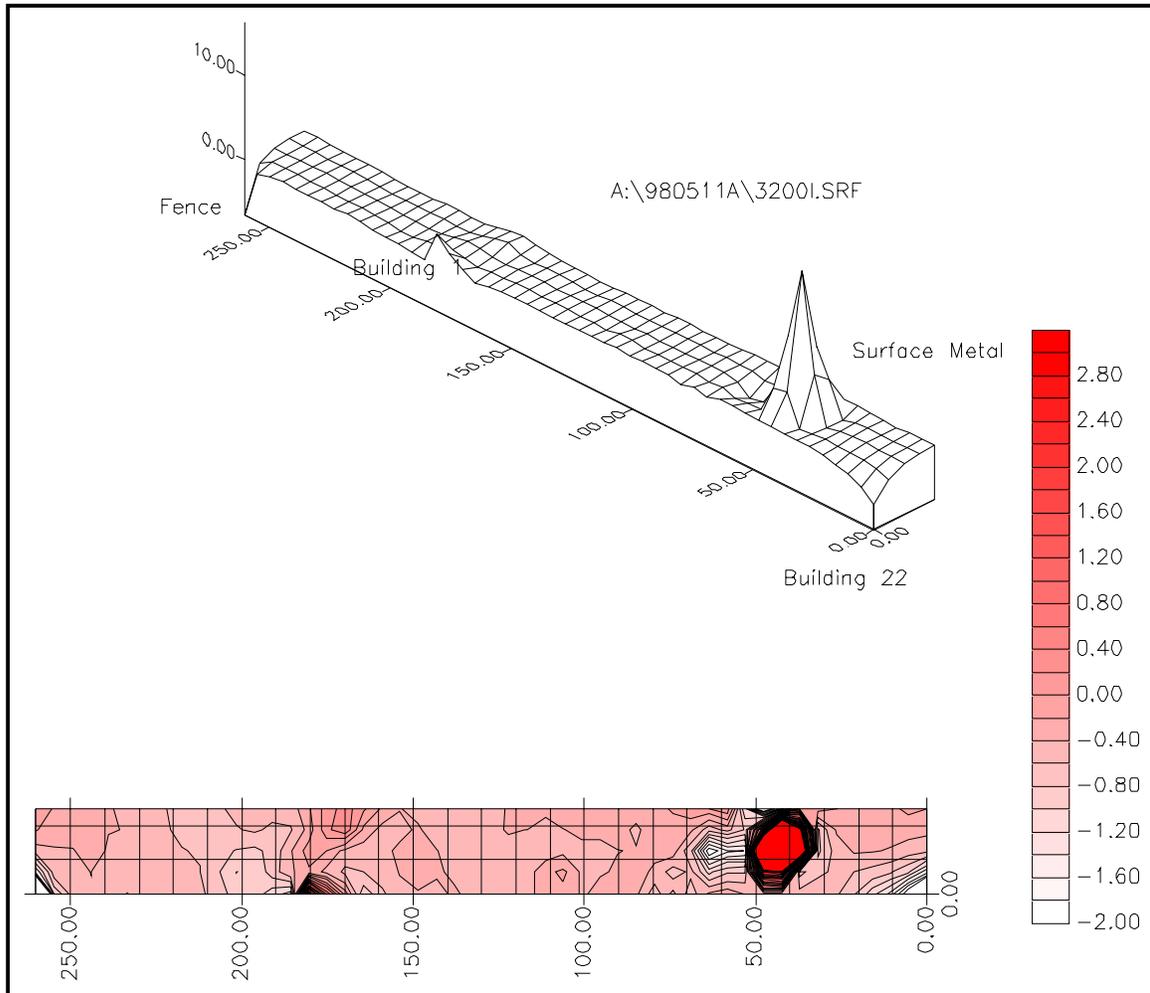
Location 2 is an area identified for future installation of a sewer line. It was surveyed 11 May 1998. The survey was conducted within 10 ft of Buildings 1 and 22 and the perimeter fence. The plot of the survey data (Figure 5) shows the effects of each of these. Some surface metal objects were in the area surveyed. These consisted of a small portion of metallic landing mat material and a broken box of small metal plates scattered near the portion of landing mat. No subsurface objects or structures were identified.

**Figure 5. Electromagnetic Survey Results, Location 2, Proposed Sewer Line, 3200 Hz, in-phase data.**

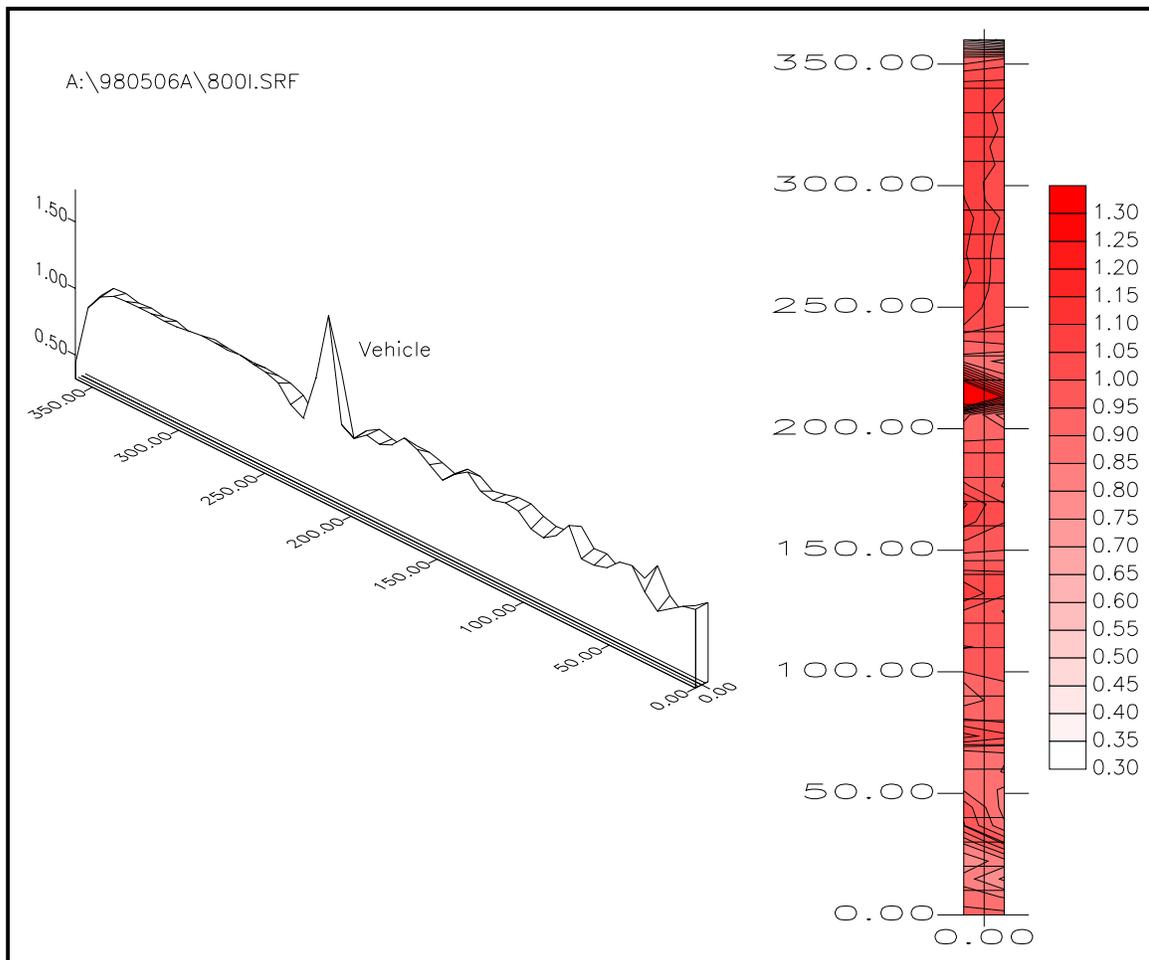
Location 3 is next to the slab for a former building adjacent to Building 11 currently used as a parking lot for military vehicles. The survey consisted of a 15-ft wide L-shaped area 360 ft long along the side of the slab, and a 15 X 35-ft area along the end. The search area was located 10 ft from the slab.

**Figure 6** shows partial results of this survey. A buried object was found near the manhole cover close to Building 11 and a more detailed survey (with 2.5-ft data point spacing) was conducted there (see **Figure 7**). Note that the axis dimensions are a factor of 10 more than the actual distances due to fact that the macro used for the automated spreadsheet calculations will not accept decimal numbers. The results of this more detailed survey indicated that the underground structure extended to a point near the manhole. It was concluded that the underground object was probably the septic tank for Building 11 (**Figure 8**). The high reading at about 225 ft in Figure 6 coincided with a vehicle parked near the edge of the slab. An apparent covered culvert was found where the road turns to go past the target ranges. This location is identified in Figure 2.

Figure 6. Electromagnetic survey location 3, 3200 Hz, in phase measurement.

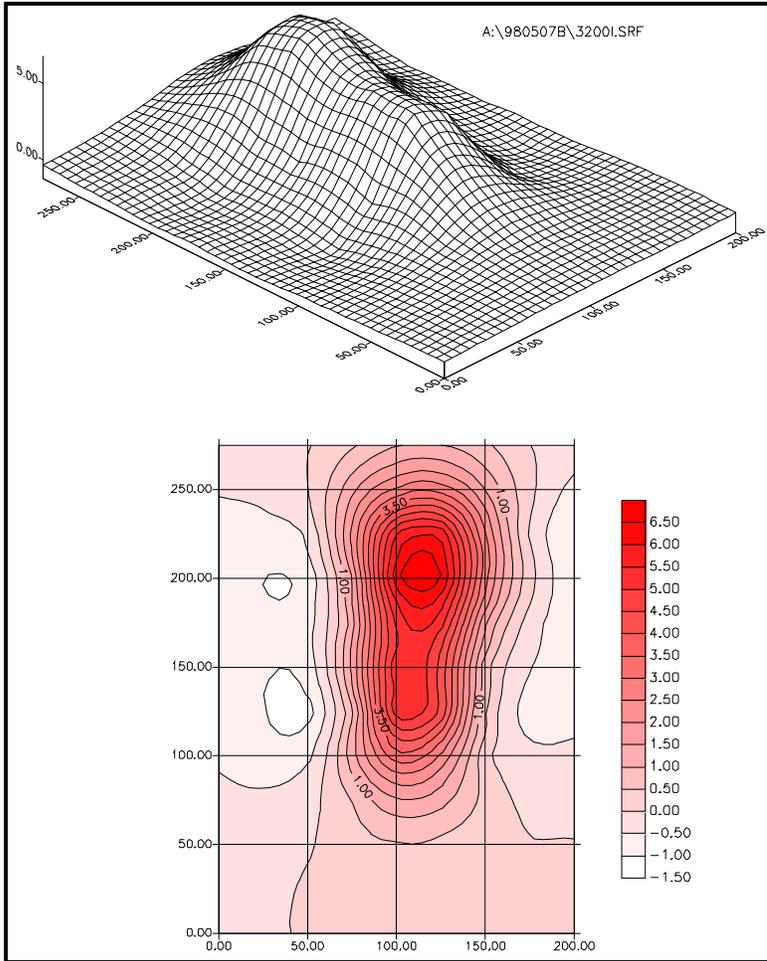
Figure 7. Suspected underground tank near building 11 (2.5-ft data point spacing).

3. *Location 3, Near Slab Used for Vehicle Parking.* A buried object was found near the manhole cover close to Building 11, probably the septic tank for this Building. An apparent covered culvert was found where the road turns to go past the target ranges.

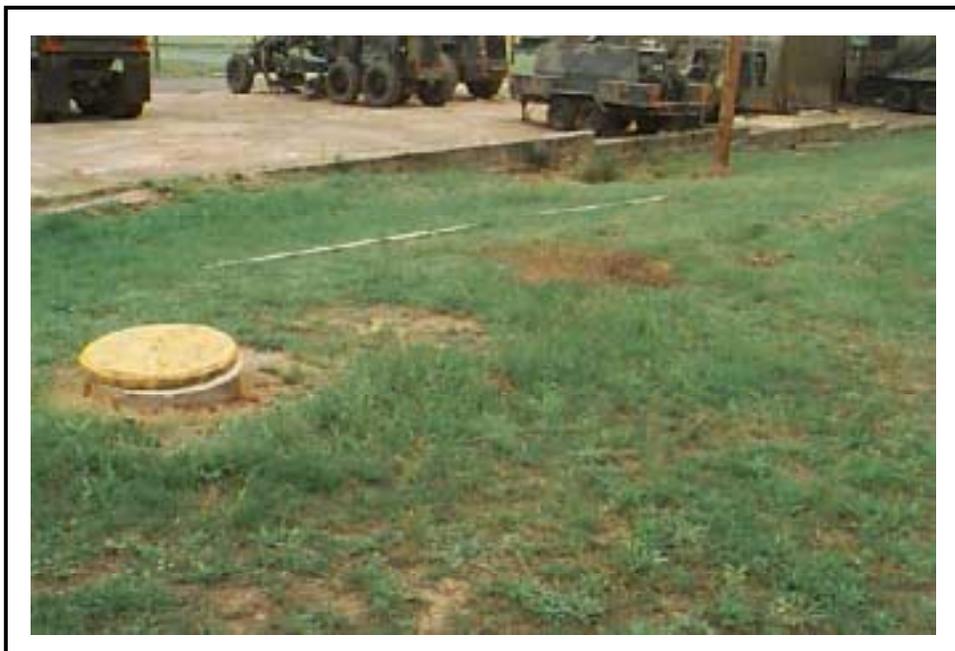
Figure 8. Apparent location of septic tank location for Building 11.

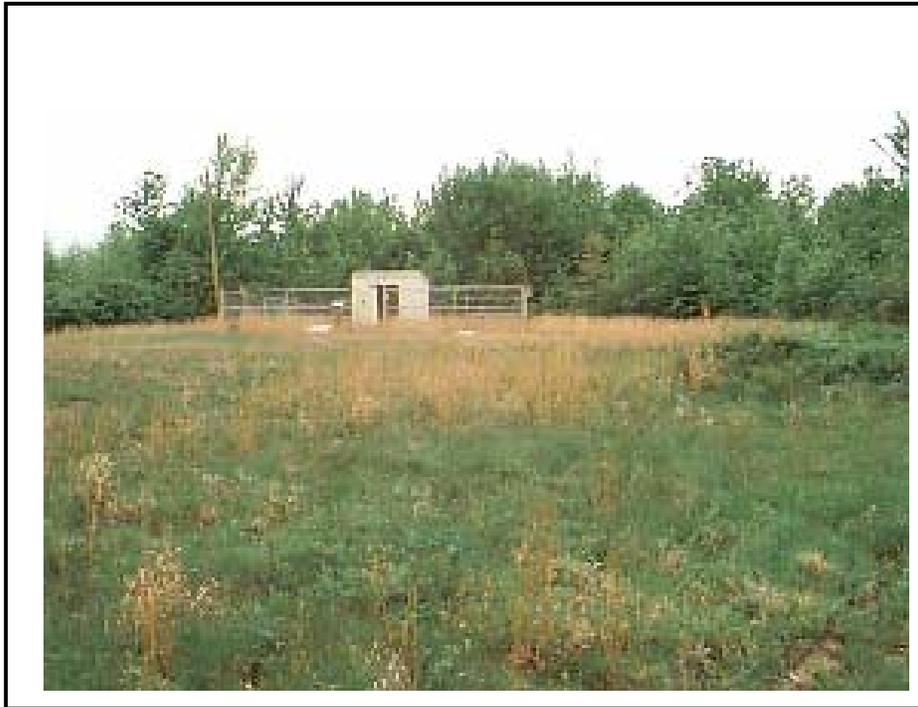
Location 4 is the generally open area between the fence surrounding the ammo storage building #36 and the perimeter road (Figure 9). A 150 X 70-ft area was surveyed as sketched in Figure 10. No significant targets were discovered in this area. Figure 11 shows the results of this survey. The low level data value at the corner (0, 90) is due to instrument startup drift. The linear structure indicated by the data at (20, 0-120) is probably due to a small instrument instability. The variations in the data magnitudes here are relatively small when compared to other readings and do not indicate subsurface structures in this area. The drift effects could be filtered out with specialized data processing techniques if the surveys were being conducted for locating very small objects. The GPS reading at the corner labeled "Start" was 39 degrees 37.80 minutes north latitude and 75 degrees 36.52 west longitude.

Figure 9. Location 4 survey area, New Castle Rifle Range, Delaware.

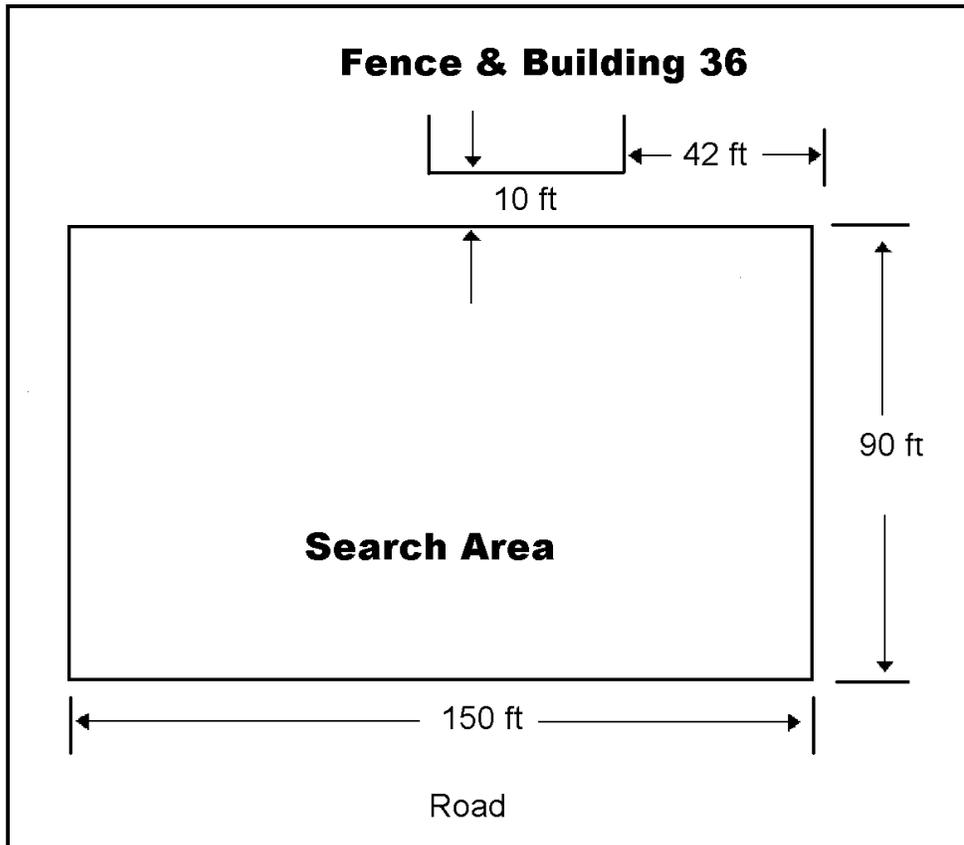
Figure 10. Orientation of location 4 search area.

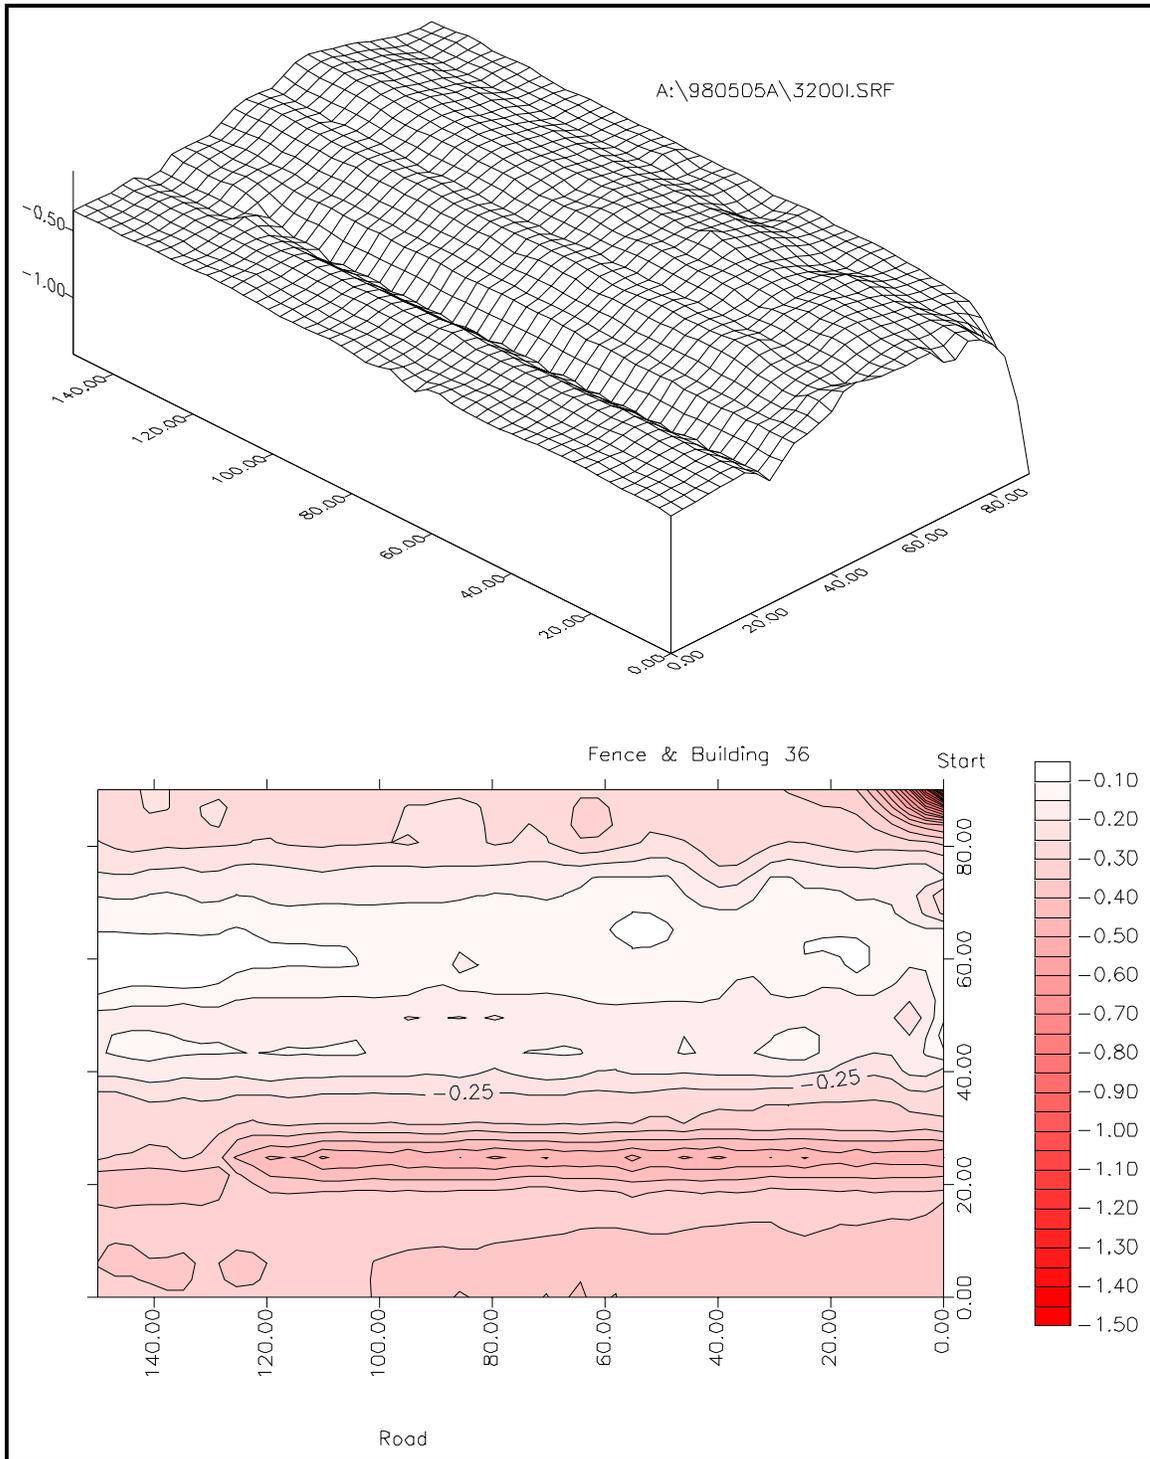
Figure 11. Electromagnetic survey results, 3200 Hz, in-phase, near Building 36, Location 4.

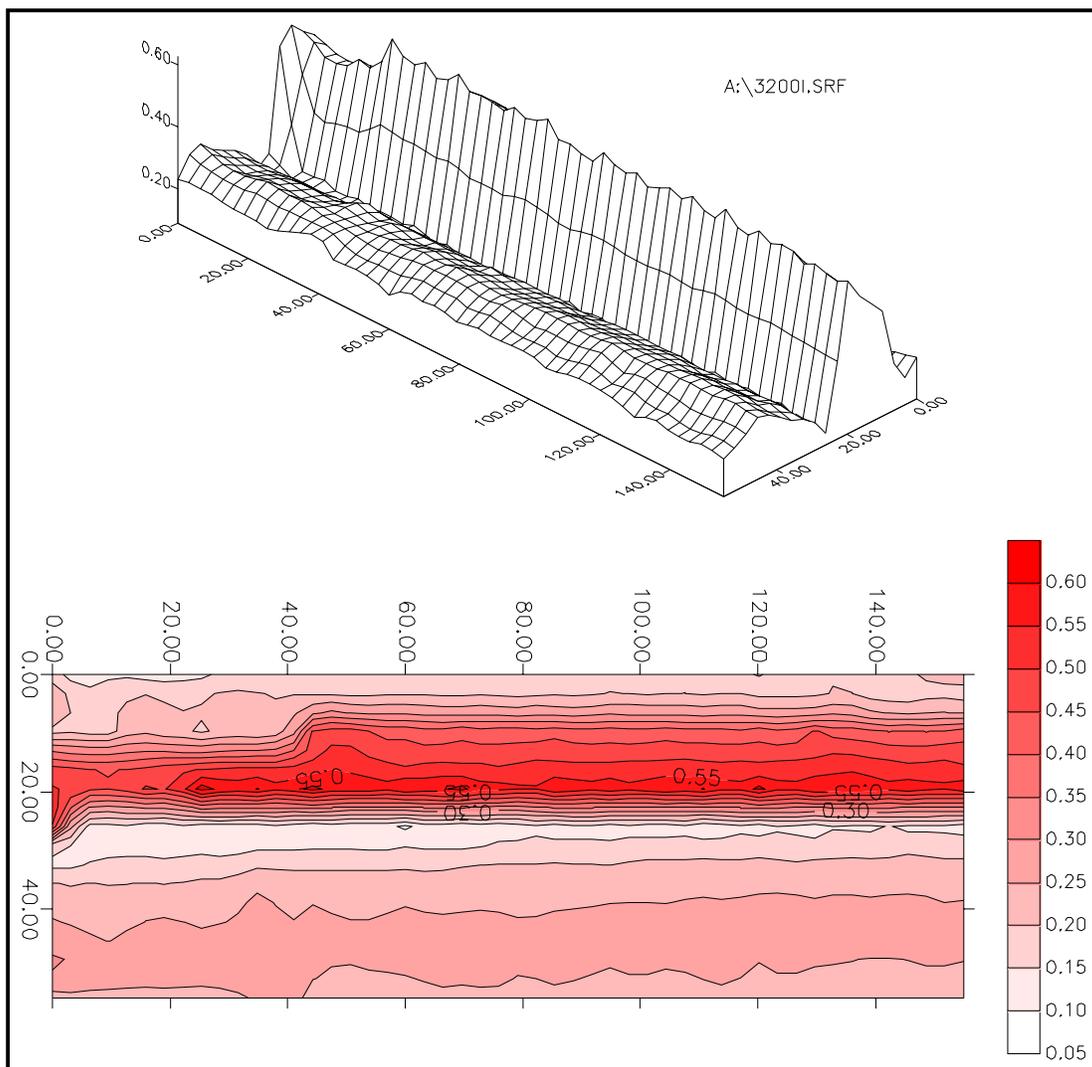
**Figure 12.** Electromagnetic survey results from location 5, 3200 Hz, in-phase data.

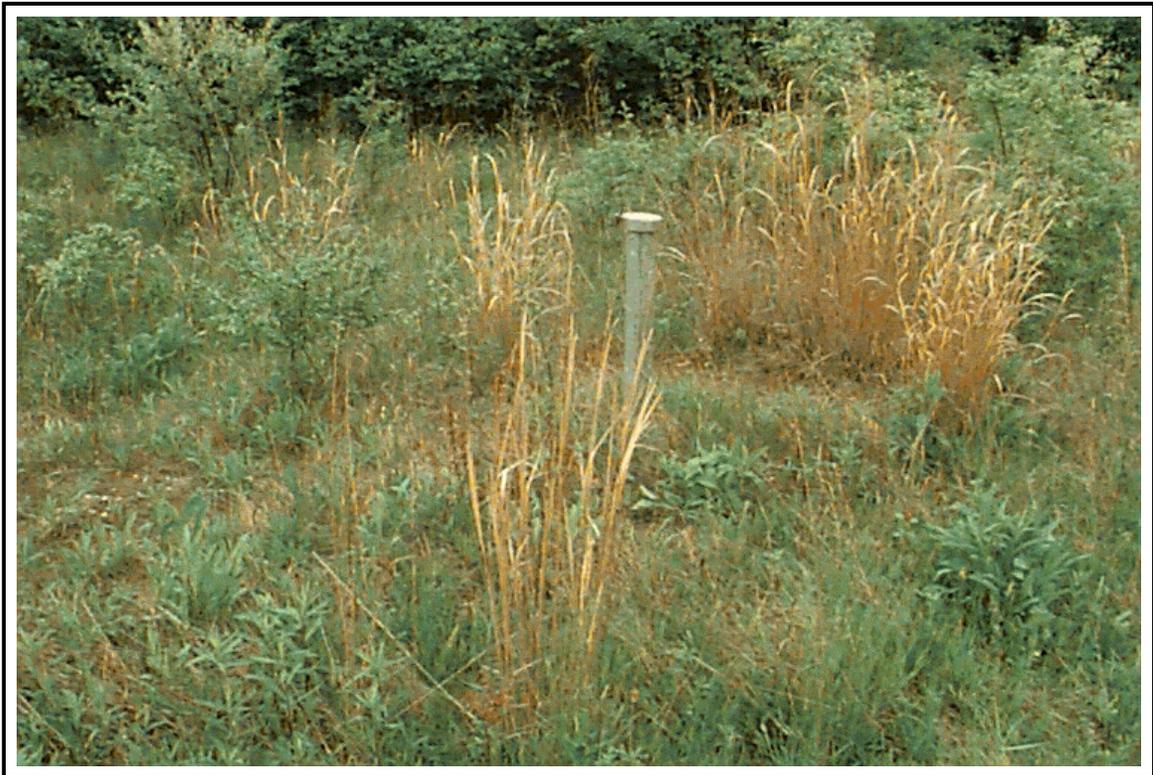
The results of the surveys conducted in this area are plotted as Locations 6, 7a, 7b, and 8. **Figure 13** shows a photograph of the test well located along the road side of survey Location 6 and **Figure 14** shows a photograph of the watch tower area from the adjacent road.

Figure 13. Test well on road end of survey location 6, New Castle Rifle Range, Delaware.

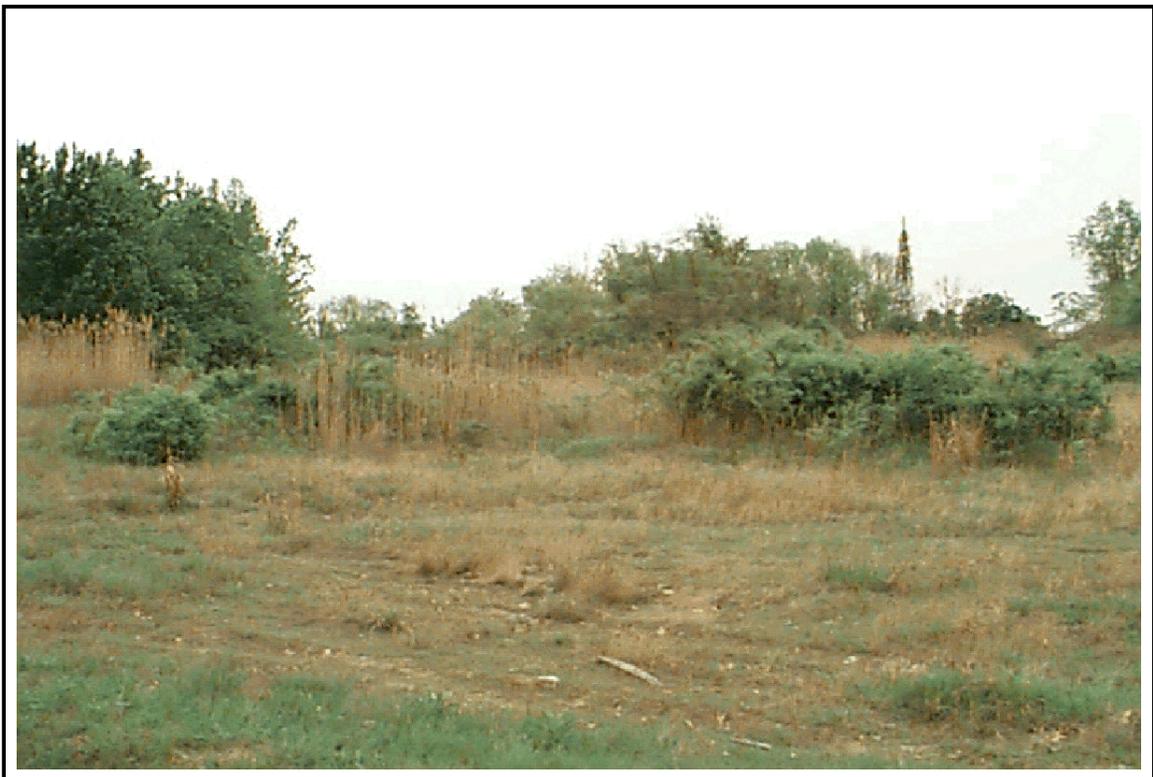
Figure 14. Watch Tower area, New Castle Rifle Range, Delaware.

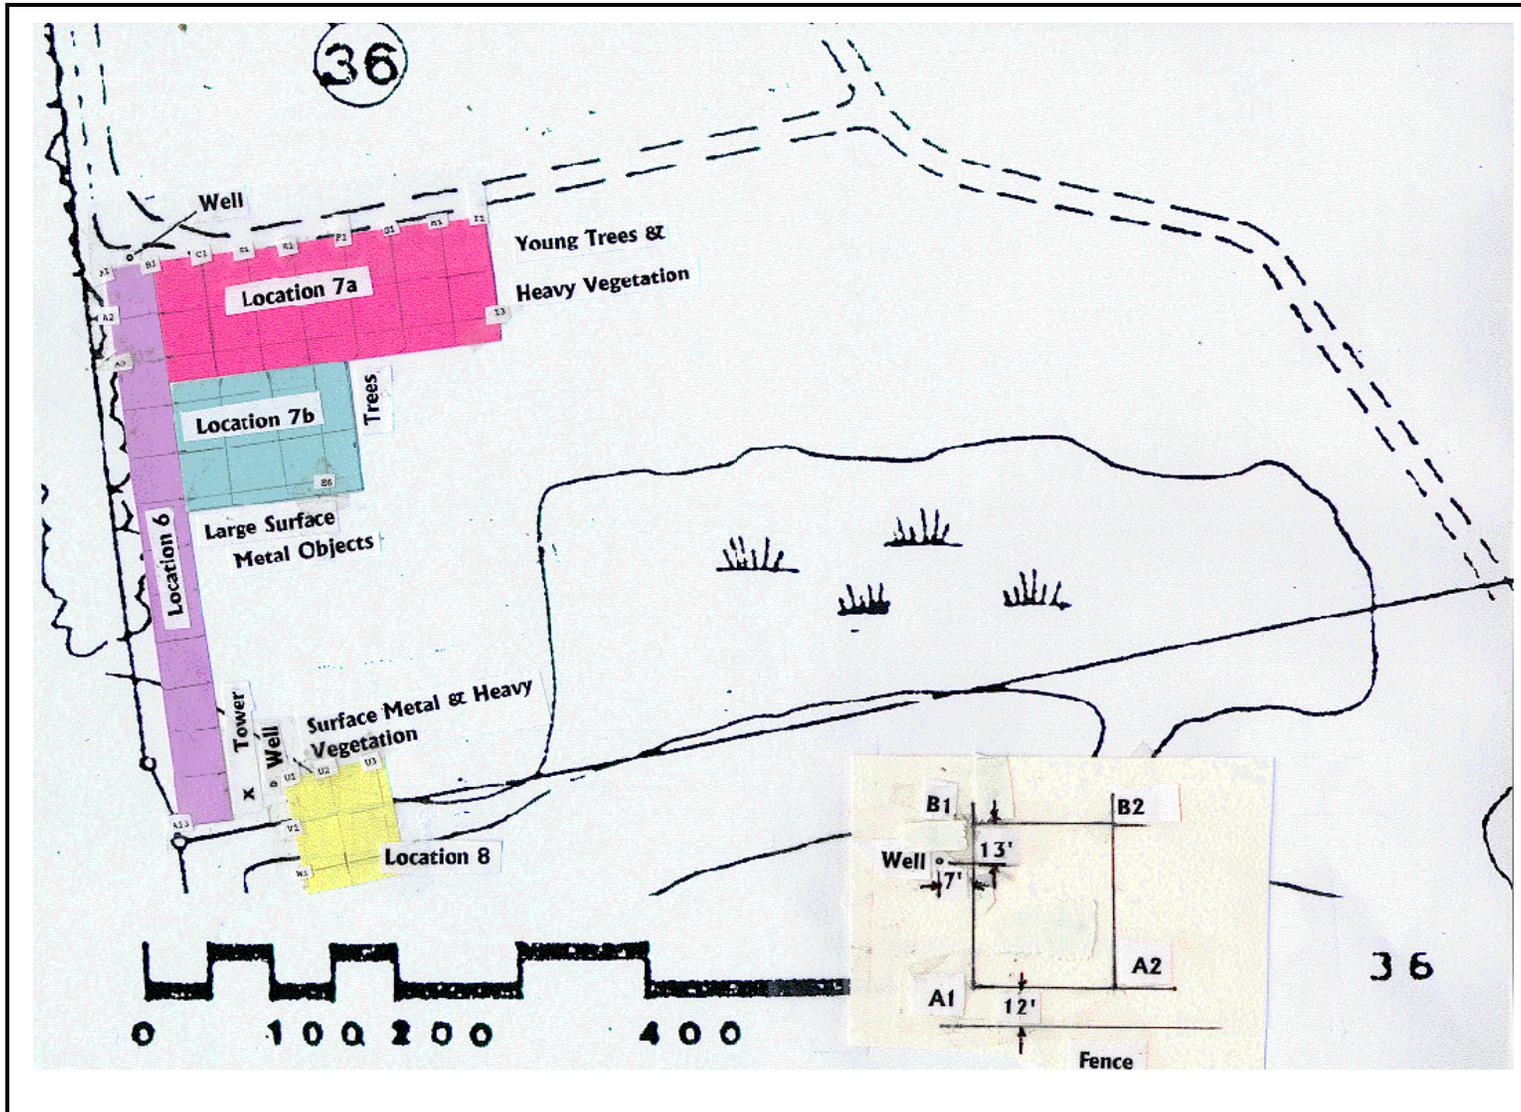
Initial plans were to collect data from the total area bounded by the installation borders and the road. Since this is a relatively large area and the objects to be located are relatively large, the survey for the area was begun by laying measuring tapes every 10 ft from the road on the base side of the area to the creek by the watchtower. The first tape was placed 12 ft from the border fence. Data points were taken every 10 ft. It was determined that this technique was impractical for surveying the total area due to the amount of vegetation and the amount of surface metal found. The area labeled Location 6 was surveyed in this way. To ensure location of objects as small as a 55-gal drum, the remainder of the accessible area was surveyed on a 5-ft grid. The area to be searched was laid out in 40-ft squares with wooden stakes placed at the corners. The stakes were labeled starting with A1 near where the road turns away from the facility border fence to A13 next to the creek near the watchtower and from A1 – I1 along the road. The data plots are presented to facilitate conversion to this grid. Location 8 was near the watchtower and not directly adjacent to any of the other search areas. The grid for Location 8 was labeled from U1 – W1 to U3 – W3. These areas are shown in greater detail in [Figure 15](#).

Figure 15. Detail of Watchtower survey area.

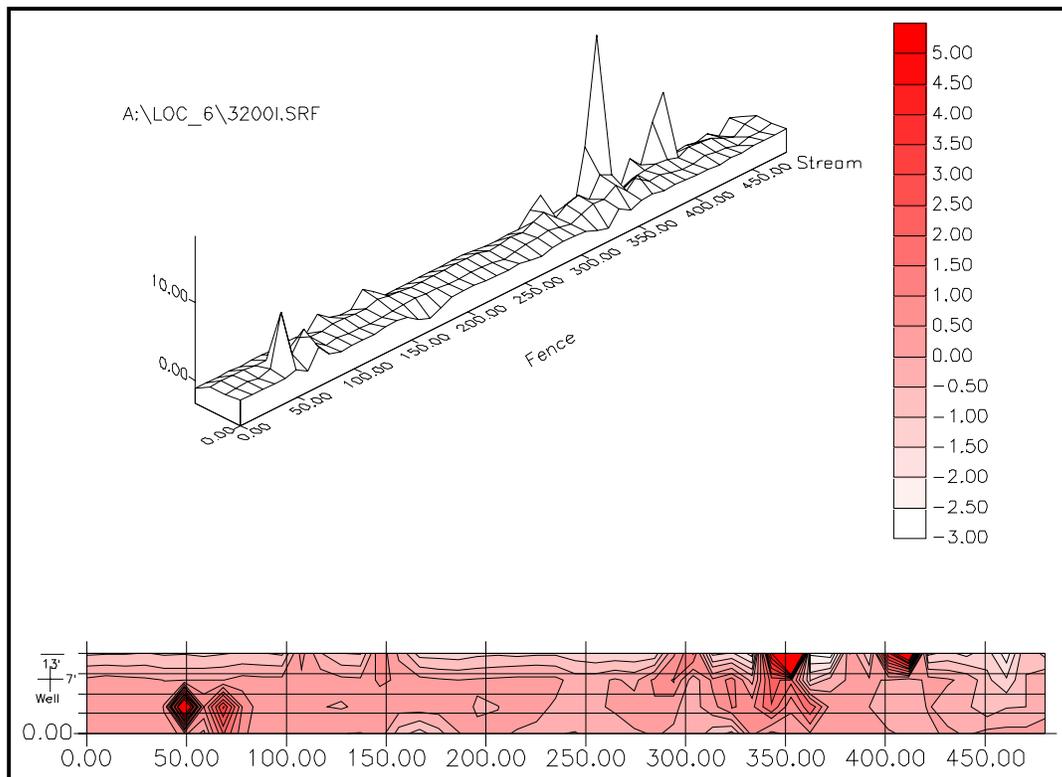
Location 6 is a part of the watch tower area as shown in Figures 2 and 15. This data was taken on 10-ft centers with the tape measures placed 10 ft apart and aligned parallel to (approximately 12–13 ft distant from) the facility border fence. Due to the dense brush and forest conditions, it was not possible to continue conducting the survey in this way. In addition, 10-ft point spacing may result in missing small metal objects located in the center of the 10 ft squares delineated by the data points. Thus, 5-ft data point spacing was used for the remainder of the surveys in this area. Possible subsurface metallic objects at the 50-ft marker in location 6 ([Figure 16](#)) and between 300–400 ft markers in location 6 strongly indicate typical landfill conditions. The high peak reading at about 350 ft coincided with a surface location of metallic landing mat material. Significant other surface metal was present in this area. [Figure 16](#) shows the results of the survey of Location 6.

Figure 16. Electromagnetic survey results of location 6, 3200 in-phase data.

6. *Locations 6, 7, and 8, Watchtower Area.* In Location 6, possible subsurface metallic objects exist at the 50-ft marker in location 6 (cf. Figure 16). The area between the 300- and 400-ft markers in location 6 strongly indicates typical landfill conditions. The high peak reading at about 350 ft coincides with a surface location of metallic landing mat material. Significant other surface metal was present in this area

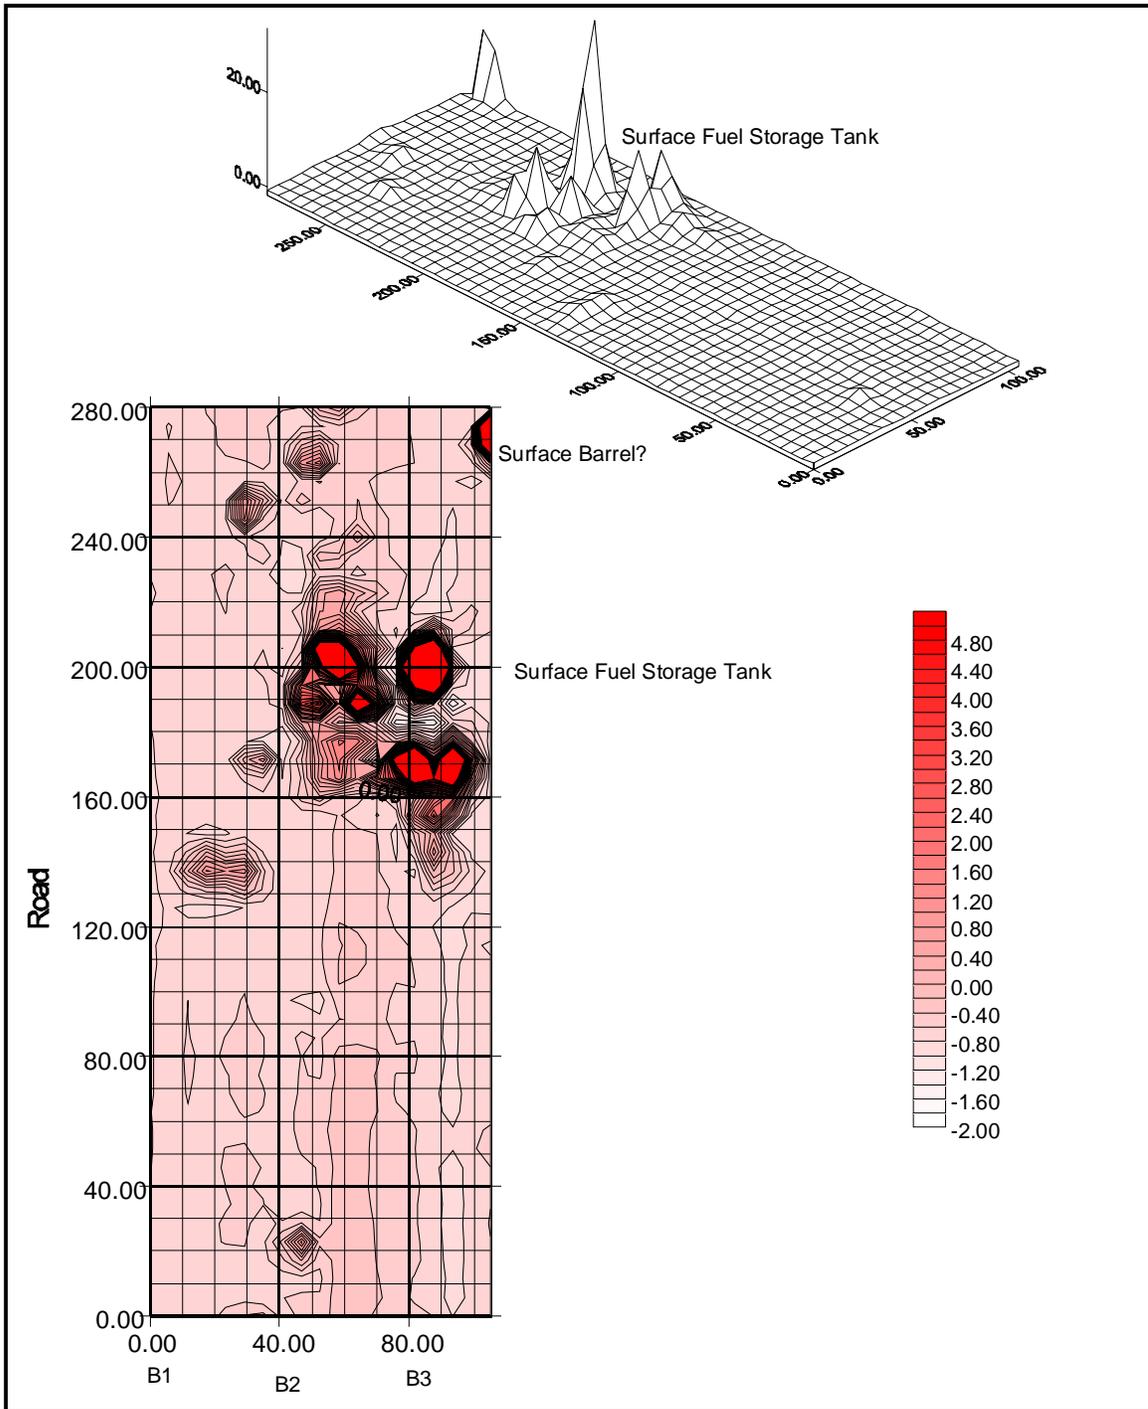
Location 7a is the area from B1, I1 to 25 ft past B3, I3 in the watch tower area as shown on Figures 2 and 15. The results of this survey are shown in [Figure 17](#). Two empty barrels and an empty aboveground fuel storage tank were on the surface in or near this area. The tank was located near the G3 stake. The area near the tank appears to have a considerable amount of buried metal and may have been used as a landfill. It is recommended that the surface metal in this area be removed and the area be considered for resurveying. The item appearing at (40, 25) is a surface snow shovel. The open area from B1, E1 to B3, E3 seems to be relatively clean.

Figure 17. Electromagnetic survey results of location 7a, Watchtower area, New Castle Rifle Range, New Castle, DE, 3200 Hz, in-phase data.

Location 7a appears to have a considerable amount of buried metal and may have been used as a landfill. It is recommended that the surface metal in this area be removed and the area be considered for resurvey.

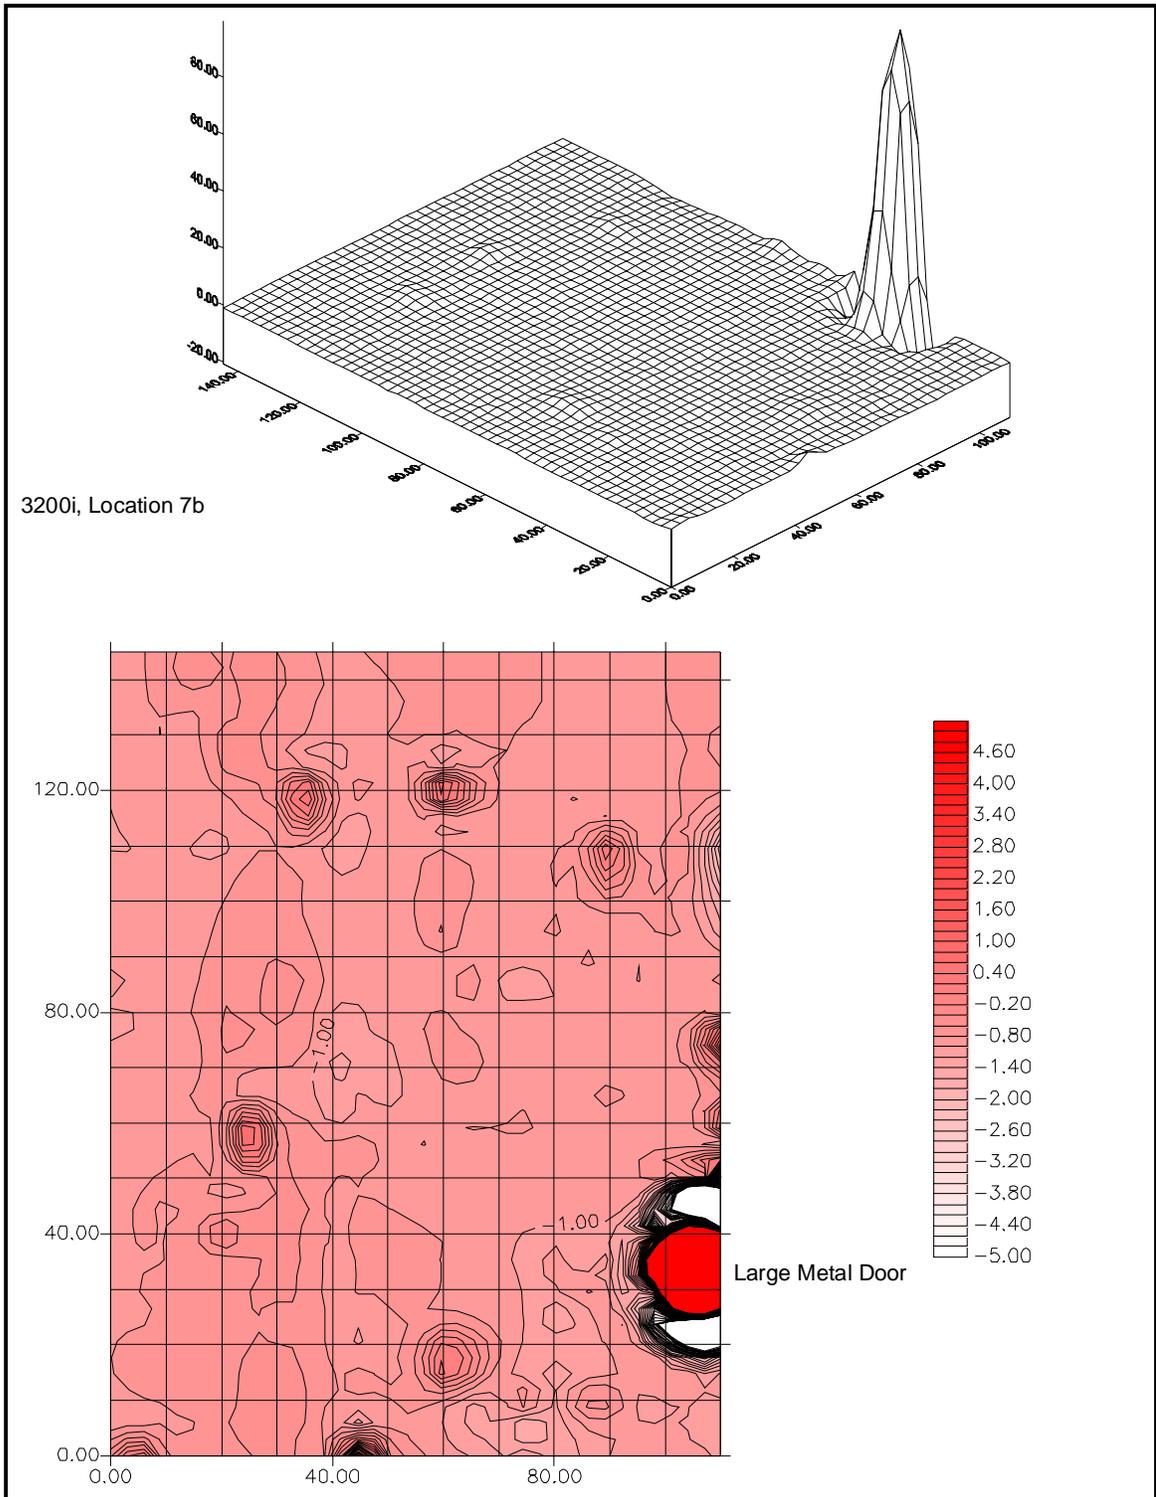
Location 7b is immediately adjacent to Location 7a, but the data rows are 145 ft in length rather than 280 ft as in Location 7a. The heavy stand of trees and brush made data gathering beyond 145 ft impossible. This area was relatively clean with the exception of a large metal door on the surface located at about (100, 30-40). The survey was not continued further in this direction because of other similar large surface metal structures and because of the dense brush beyond the surface metal. This area did not appear to have been used as landfill. The item at 45,0 did not appear on the adjacent Location 6 plot and is probably a small shallow buried metal item. The 3200 Hz, in-phase data are shown in [Figure 18](#). Some of the surface metal in this area is shown in [Figure 19](#).

Figure 18. Location 7b, Watchtower Area, 3200 Hz, in-phase data.
