# Underground Storage Tank Location and Mapping of Former Landfills by Electromagnetic Surveys for the Delaware National Guard

Paul H. Nielsen

August 2001

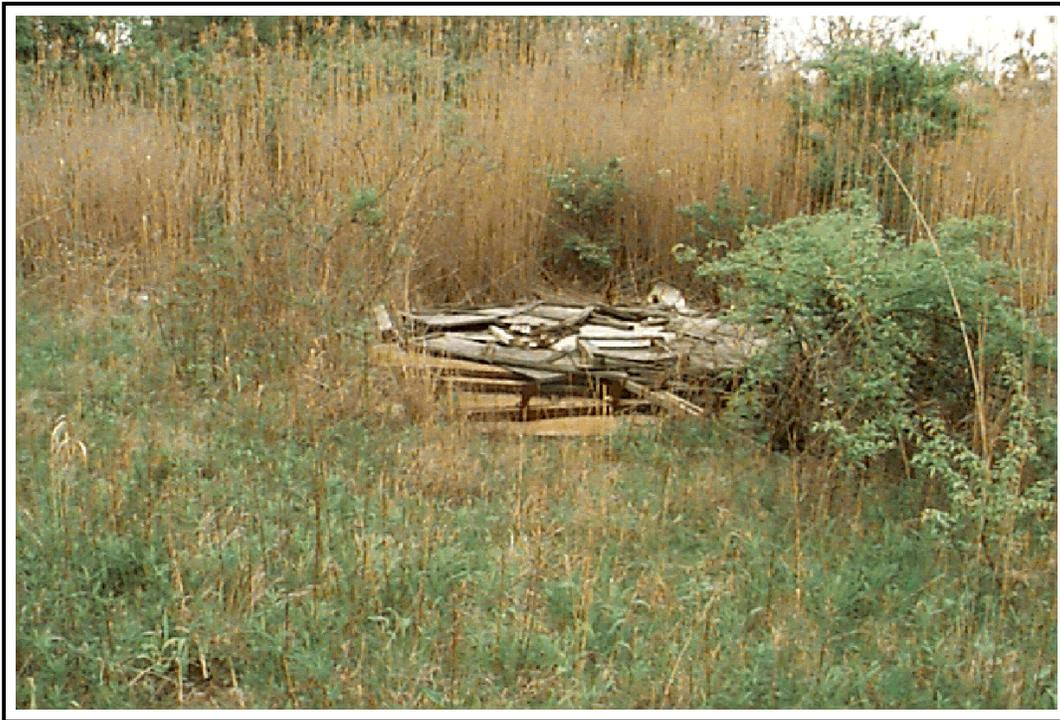
Figure 19. Surface metal present on survey location 7, New Castle Rifle Range, DE.

Location 7a appears to have a considerable amount of buried metal and may have been used as a landfill. It is recommended that the surface metal in this area be removed and the area be considered for resurvey.

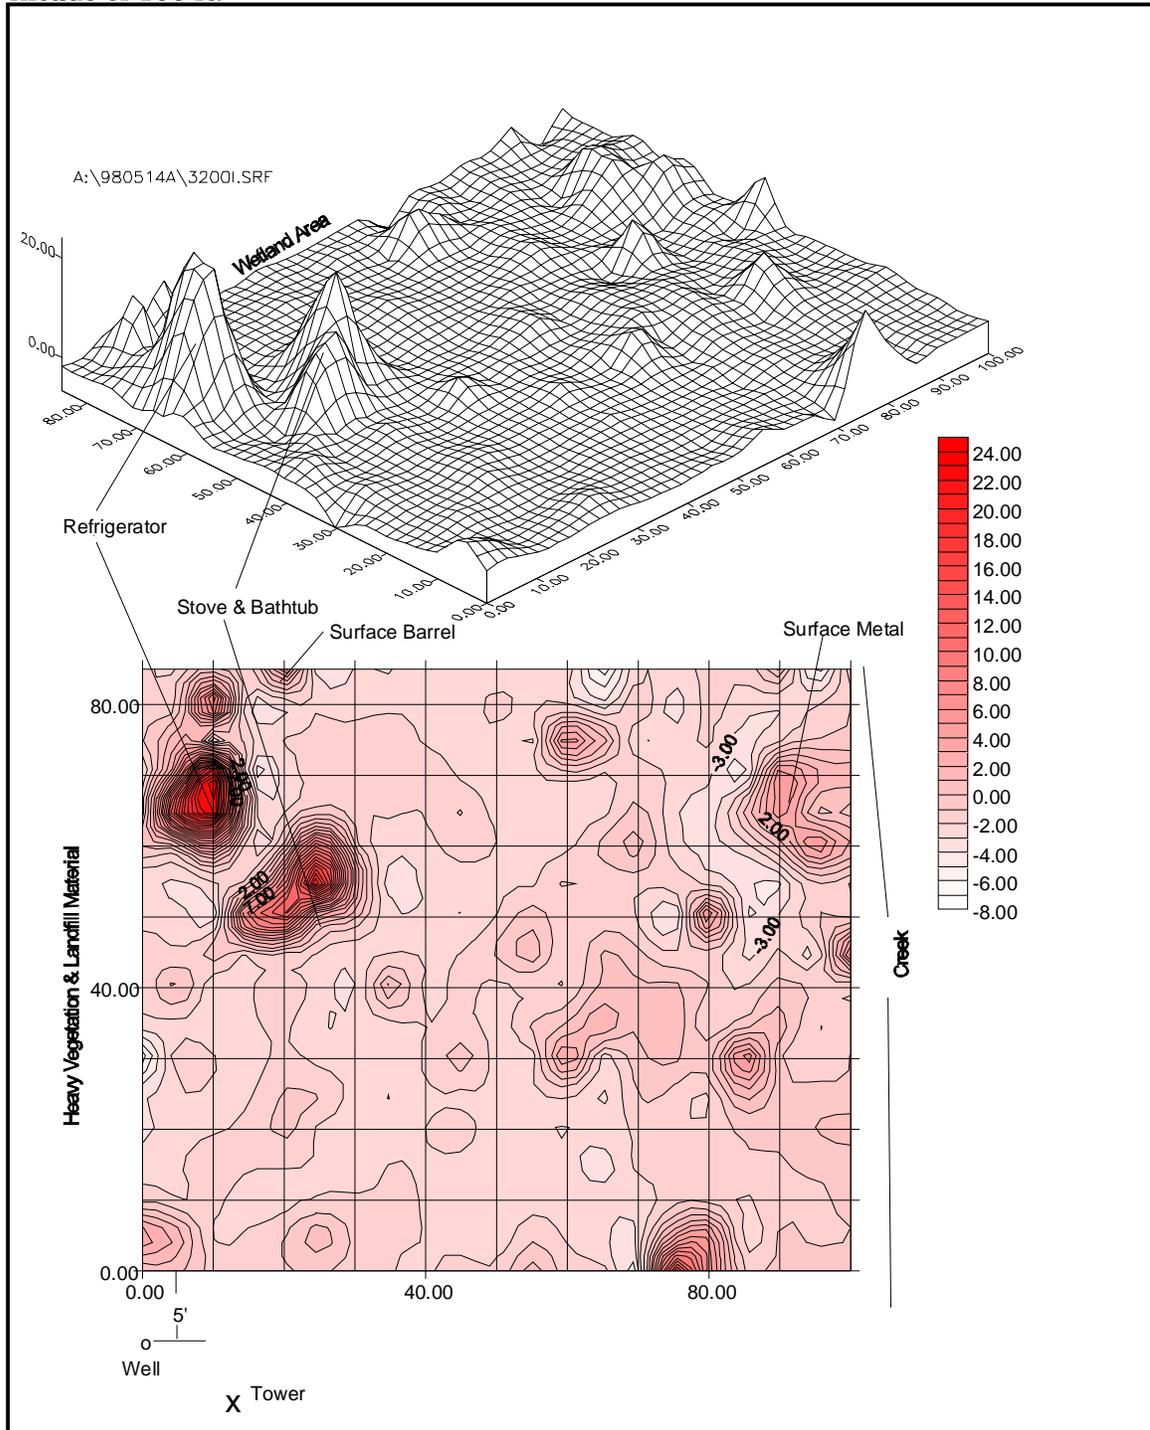
Location 8 is situated to the upstream river side of the watchtower near the tower. Figures 2 and 15 show its approximate location and orientation. It is more or less bounded by a heavily vegetated area with considerable surface metal and other landfill type materials on one end, the creek on the other end, and the creek and wetlands on one side. [Figure 20](#) shows the results of this survey. Several large metallic items (labeled in Figure 20) were found on the surface in this area ([Figure 21](#)). The remainder of the plot indicates possible random relatively small metal items such as would exist in a landfill area.

Figure 20. Electromagnetic survey results, 3200 Hz, in-phase data, location 8, Watchtower area.

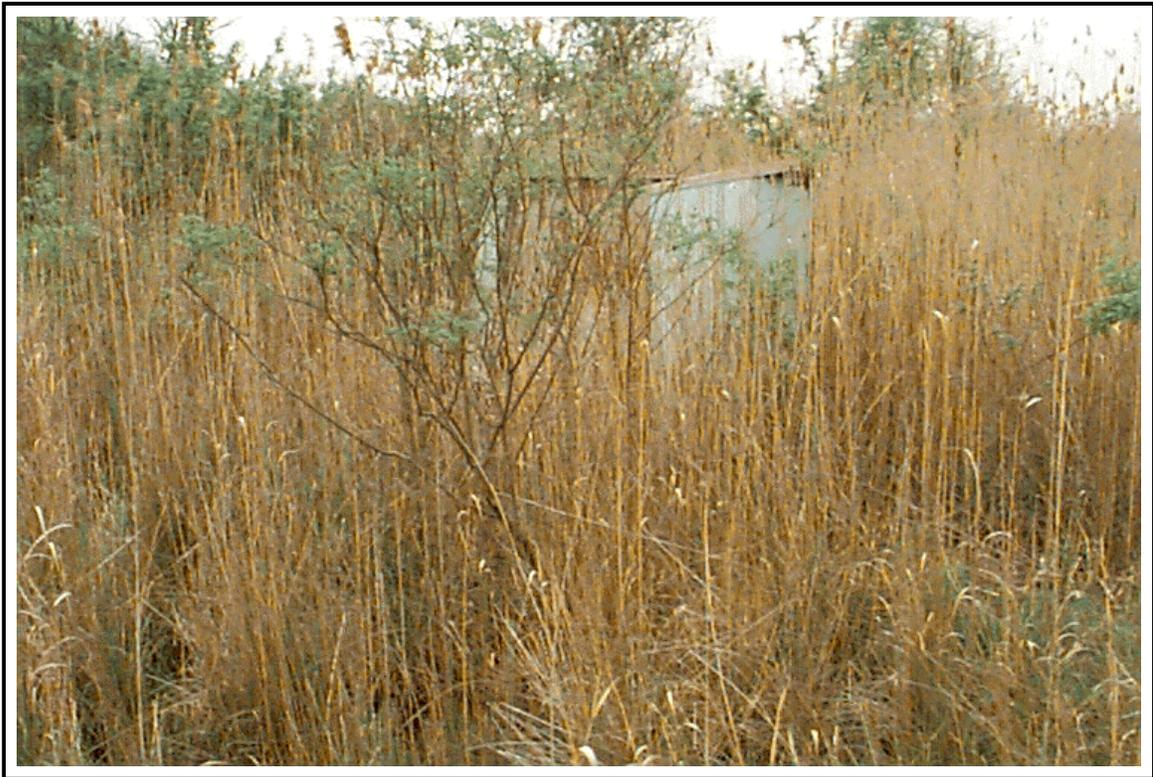
**Figure 21. Surface metal item and dense vegetation in the watch tower area, New Castle Rifle Range, DE.**

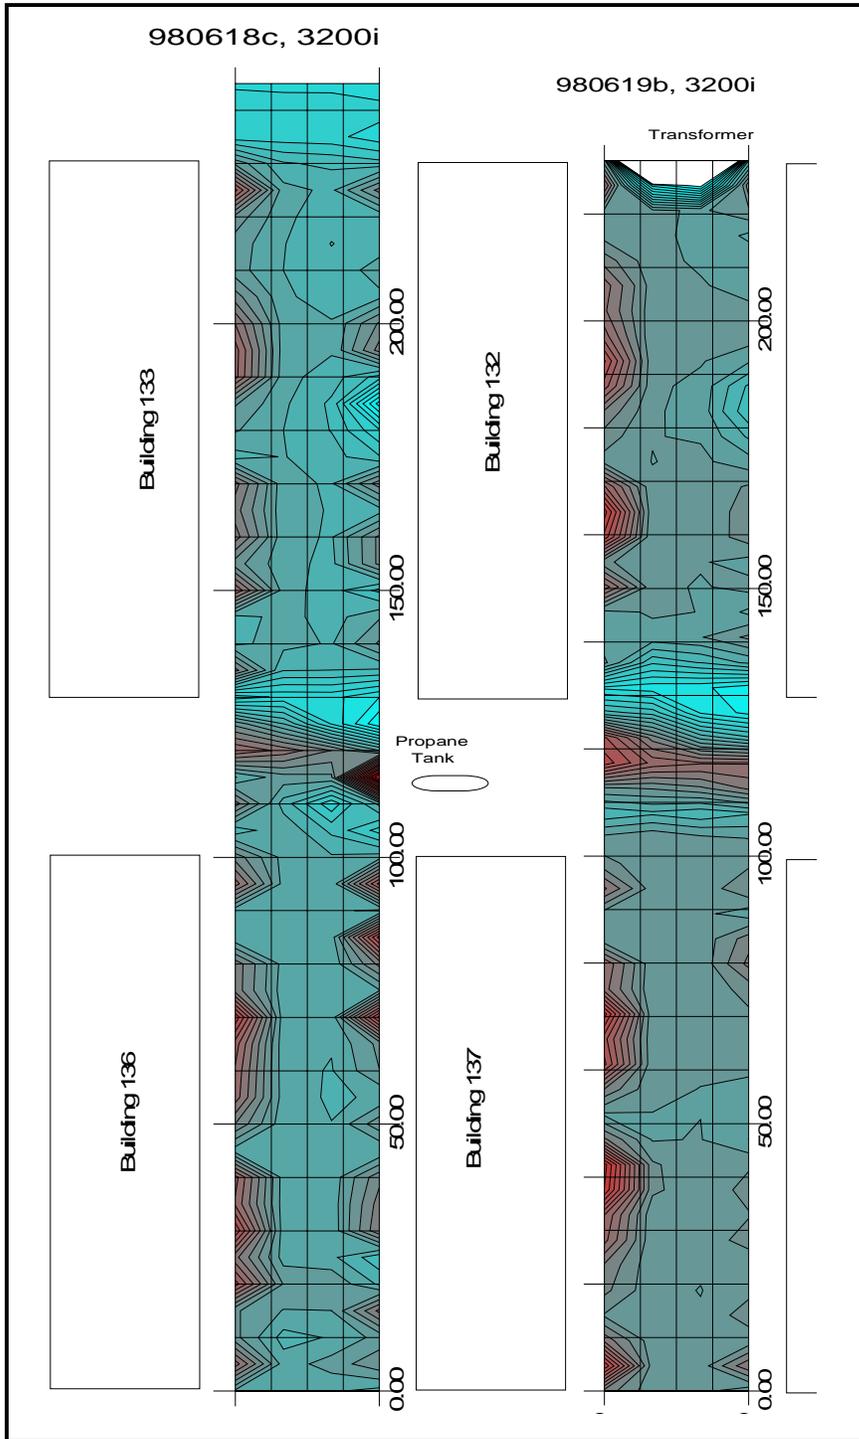
The west block (or Block 1) consists of data files 980618c between Buildings 136-137 and 133-132, and 980619b between Buildings 137-138 and 132-131. **Figure 24** shows the 3200 in-phase data for these surveys in contour plots. The primary items of interest that can be identified in this data include the effects of metallic objects in the buildings along the edges of the plots. High readings caused by the presence of the propane tank area are also visible.

Figure 24. Electromagnetic survey data, Bethany Beach, DE, National Guard Training Site, Barracks area, Block 1.

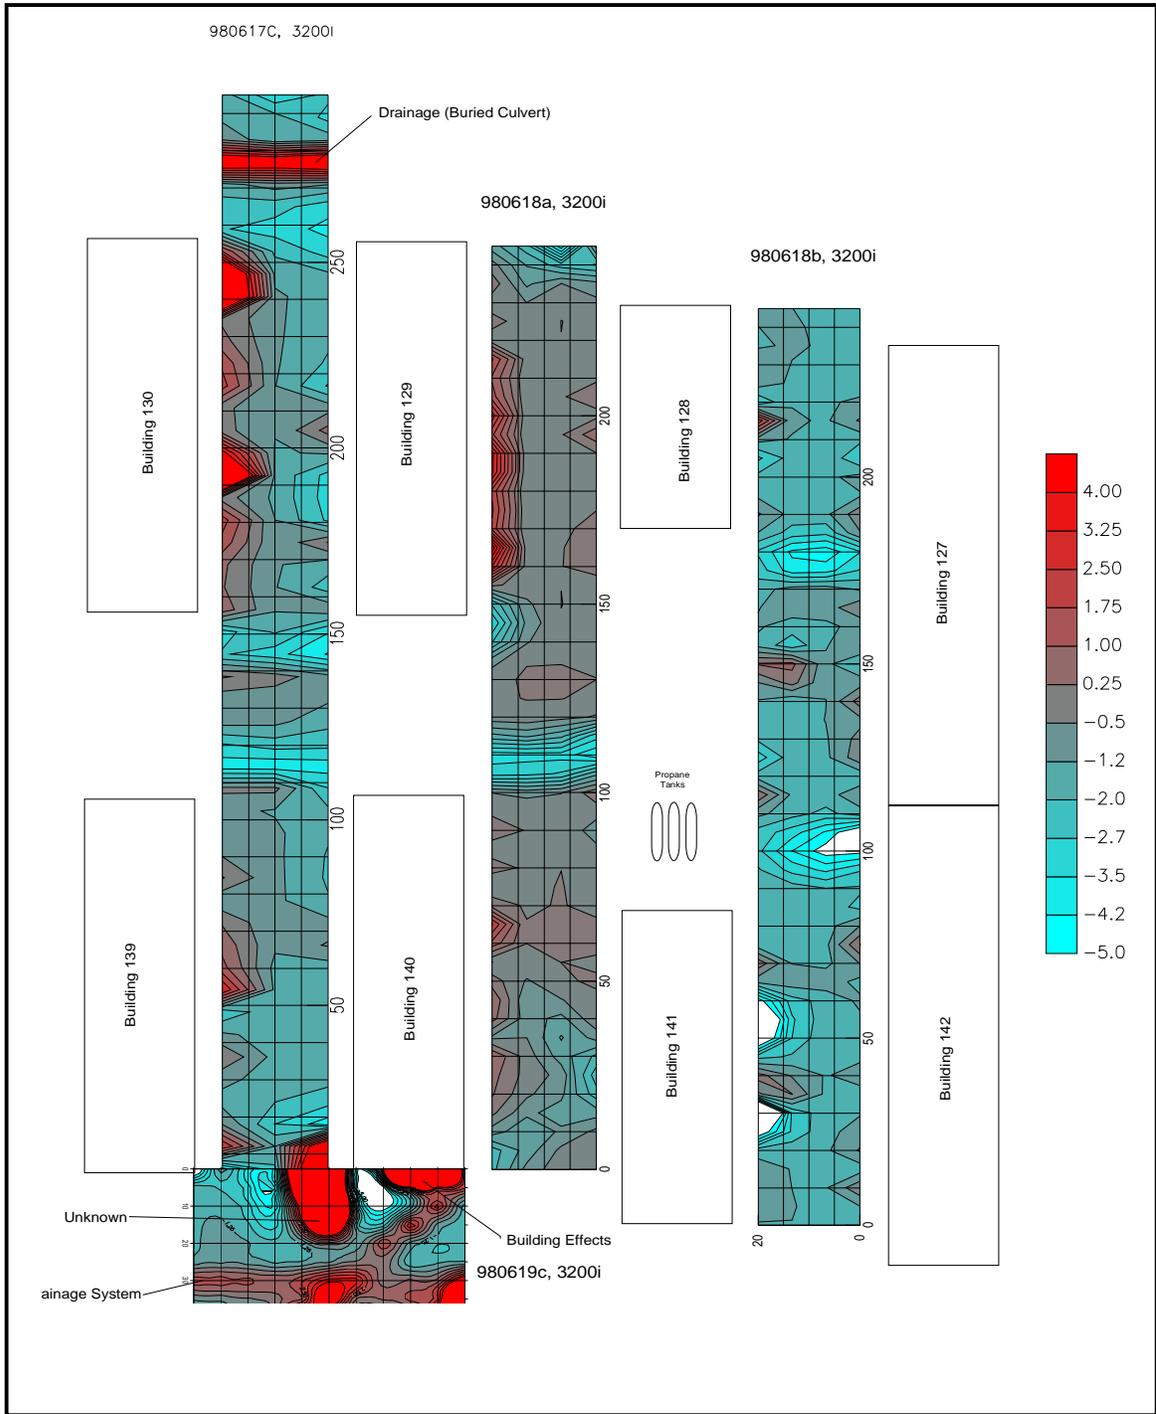
An additional data set, 980619c (40 X 50 ft), was taken adjacent to the south end of 980617c to further define the size and shape of this object. Additional features that appear in this data include the manhole cover in the southeast corner, the diagonal electrical service (there is a matching pavement patch install diagonally across the paved street coincident with this) and an east-west feature under the south side of the road, which appears to be attached to the manhole and may be part of the drainage system. This data set was taken right up to Building 140; there appears to be some kind of relatively large metallic object (refrigerator or bed) in the southeast corner of this building. The unknown object first identified in 980617c does not appear to be attached to any of the other objects in this set of data (that is to say, it does not appear to be part of the drainage system). Two cast iron pipe studs extend up out of the foundation at the 100-ft point by Building 142. This is indicated as low readings at this point. The data does not indicate that the pipes are attached to any large metallic underground systems that extend into the surveyed area.

Figure 25. Electromagnetic survey data, Bethany Beach, Delaware National Guard Training Site, barracks area, Block 2.

An additional data set, 980619c, included a manhole cover in the southeast corner, the diagonal electrical service, and an east-west feature under the south side of the road, which appears to be attached to the manhole and may be part of the drainage system. The unknown object first identified in 980617c does not appear to be part of the drainage system. Two cast iron pipe studs extend up out of the foundation at the 100-ft point near Building 142. The data does not indicate that the pipes are attached to any large metallic underground systems that extend into the surveyed area.

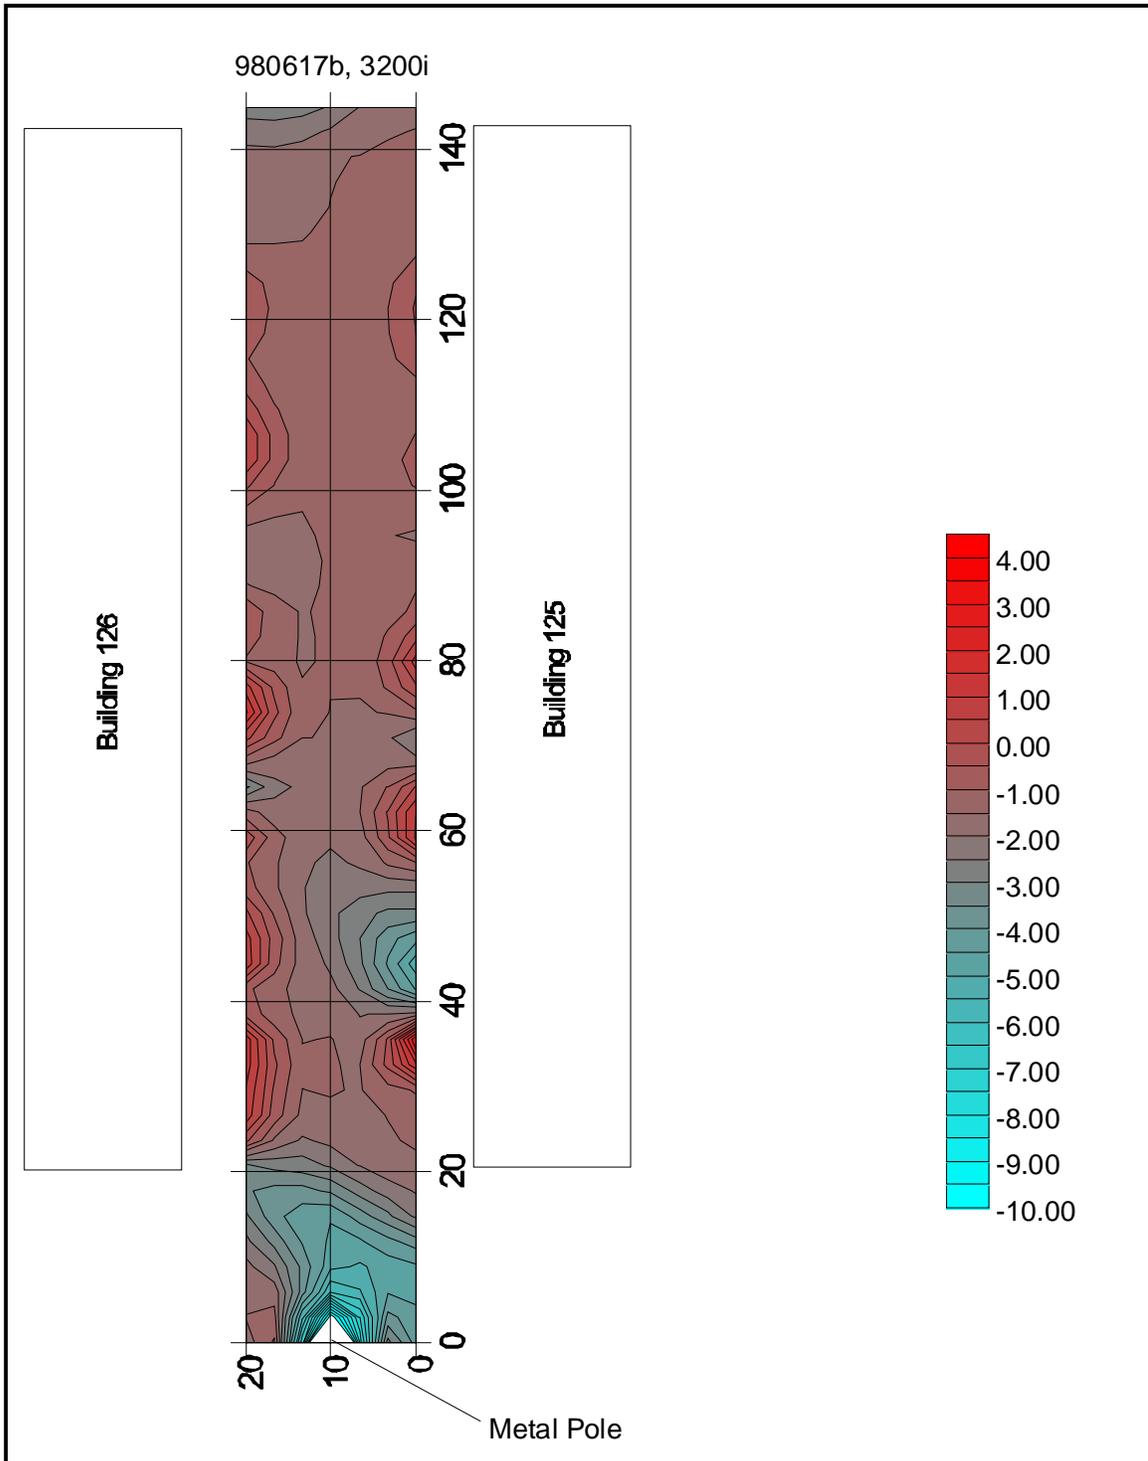
**Figure 26** shows the 3200 Hz, in-phase data for 980617b taken between buildings 126-125. This plot shows some minor building effects and the effects of a metal pole in the center of the south edge of the data.

Figure 26. Electromagnetic survey data, Bethany Beach, Delaware National Guard Training Site, 980617b, 3200 Hz, in-phase data, block 3.

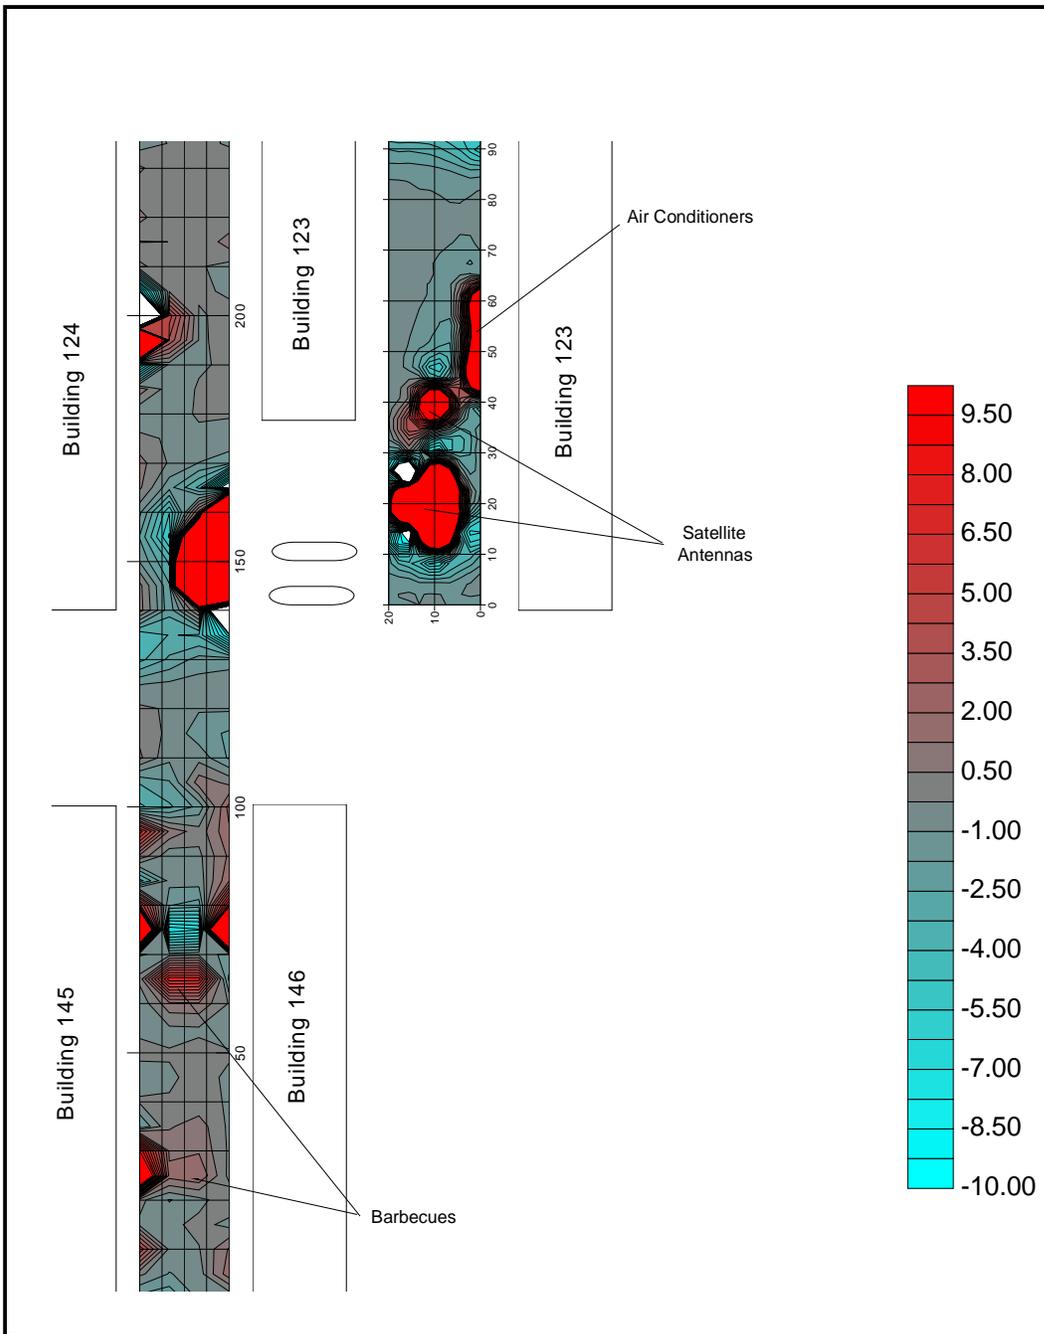
**Figure 27** shows the 3200 Hz, in-phase data for the files 980619a between buildings 145-146 and 124-123, and 980618d between buildings 123-124. All the outstanding objects appearing on these plots are surface features including building effects, barbecues, propane tanks, air conditioners, and satellite antennas. No subsurface objects can be identified from this data.

Figure 27. Electromagnetic survey data, Bethany Beach, Delaware National Guard Training Site, 3200 Hz, in-phase data, block 4.

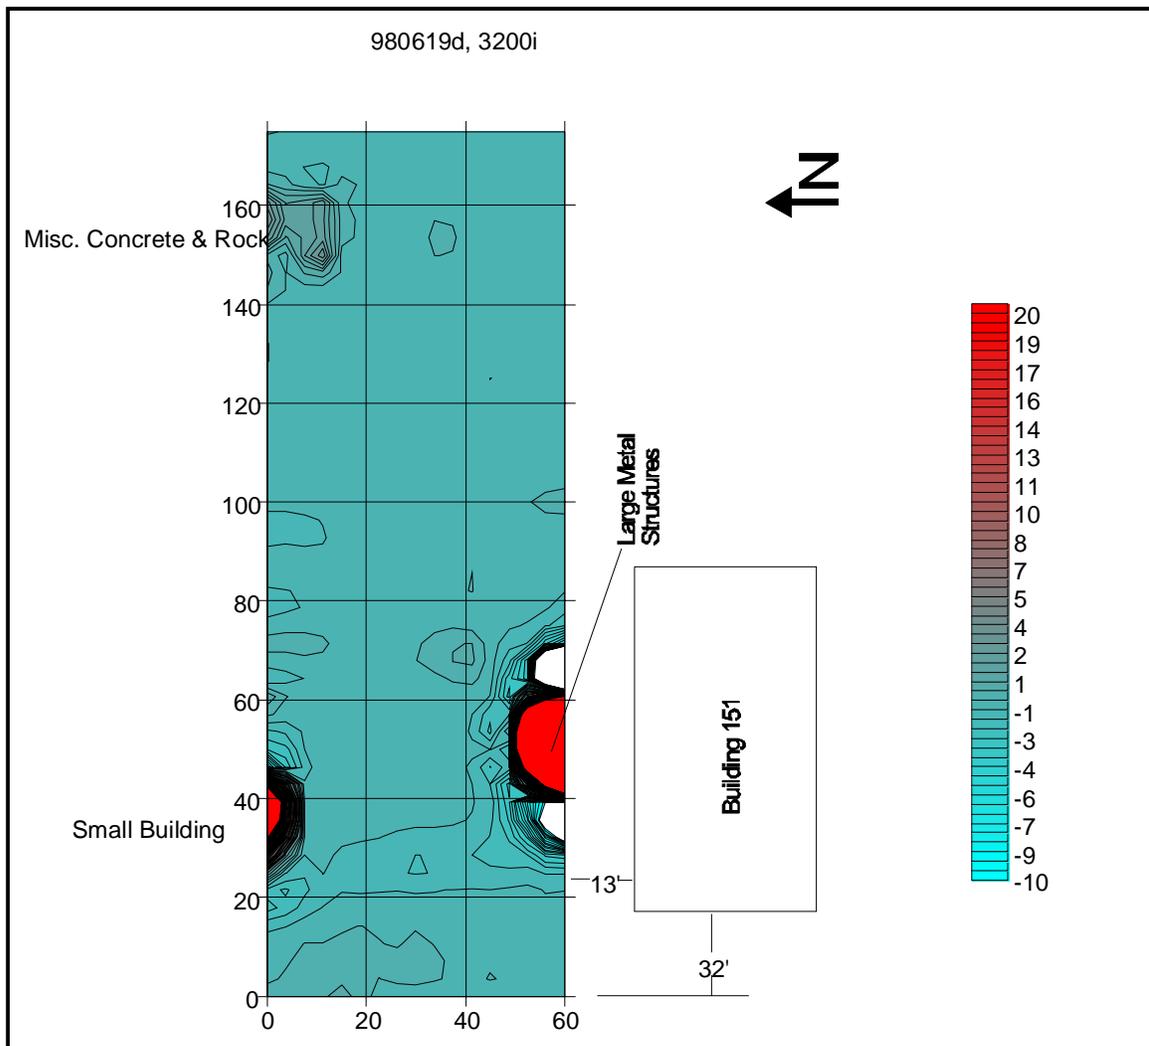
Figure 28. Electromagnetic survey data, Bethany Beach National Guard Training Site, paved area north of Building 151, 3200 Hz, in-phase data.

A survey of the paved area north of Building 151 conducted as a follow-up on the removal of an underground fuel storage tank in that area showed no evidence of any additional buried storage tanks or other significant metal under the paved area. No subsurface objects were observed.

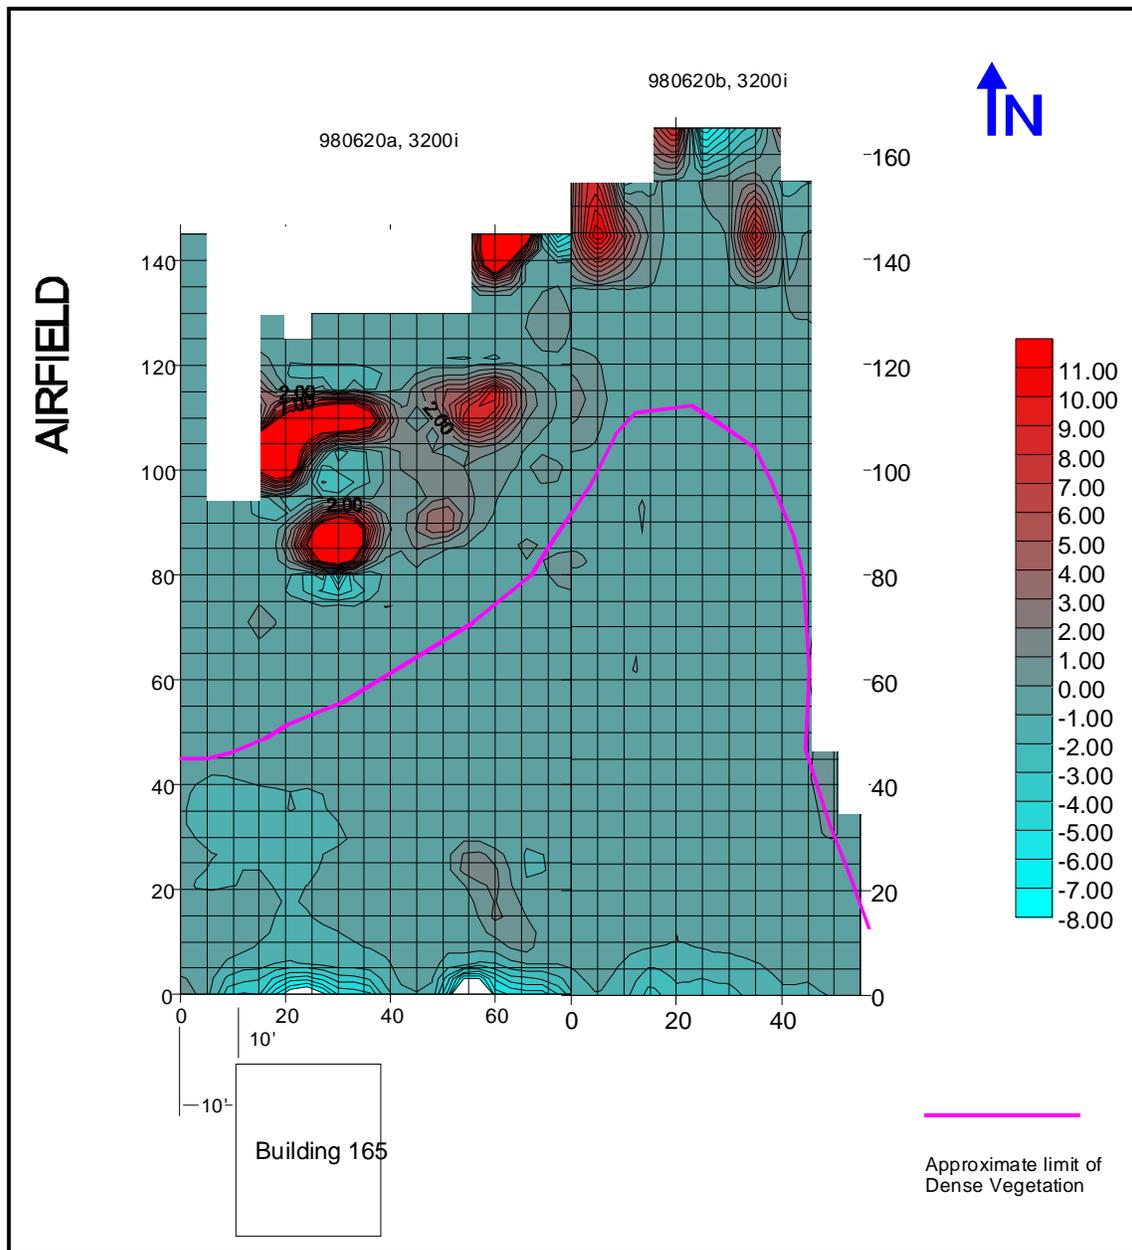
**Figure 29** gives the results of the electromagnetic surveys conducted north of Building 165 on the cleared area and into the heavily vegetated area. This survey was conducted by placing tape measures on the ground with a 5-ft spacing. The tapes were carried into the vegetation a distance determined by the density of vegetation and the density of the poison ivy. Thus the lines of data are not of equal length and data point location is not as accurate as that typically expected in open areas. Some of the objects that appear on this plot are associated with broken concrete with metal reinforcement (generally heavy wire type) that was visible on the surface. Other objects were not associated with any surface articles. The spacing and configuration of the findings in this area are typical of landfills. No significant objects were found in the open (grassy) area covered in this search.

**Figure 29. Electromagnetic survey data, Bethany Beach National Guard Training Site, area north of Building 165, 3200 Hz, in-phase data.**

The major problems related to surveying this area are setting up an accurate search grid, accurate positioning of the sensor for collecting data, and transporting the sensor through the area. It is recommended that any further (or follow-up) surveys in this area be conducted in the winter after the leaves of the poison ivy and any other deciduous plants have fallen.

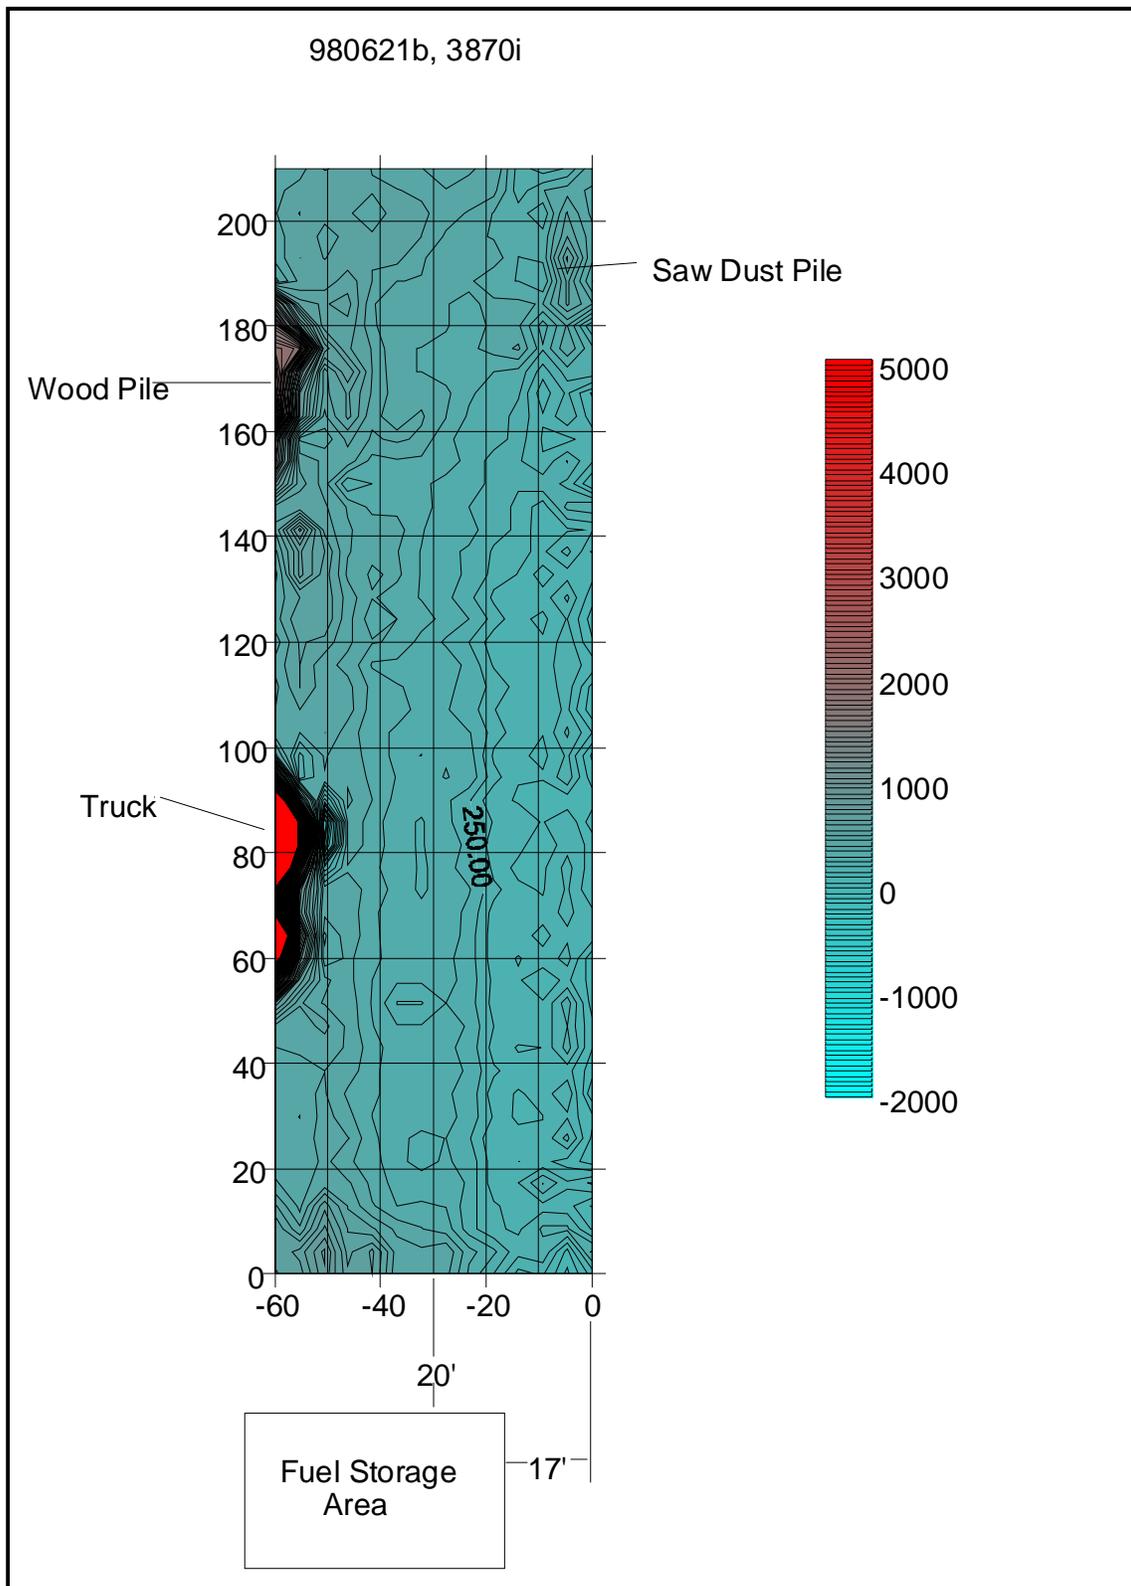
The Pennsylvania Air National Guard was using the landing strip for training during the period the surveys were being conducted and not all of the area to the east of the runway was available to be surveyed. However a strip 50 ft wide and 235 ft long south of the fuel storage area and a strip 60 ft wide and 210 ft long north of the fuel storage area were free of vehicles. These areas were surveyed with the GEM-300. **Figure 30** gives the results of the north survey at 3870 Hz, in phase.

The objects of interest in this plot are effects from the National Guard trucks parked near the search area and high readings associated with the waste wood pile near the north end of the search area. No subsurface objects were observed.

Figure 30. Electromagnetic survey data, Bethany Beach, Delaware National Guard Training Site, area near air field, 3870 Hz, in-phase data.

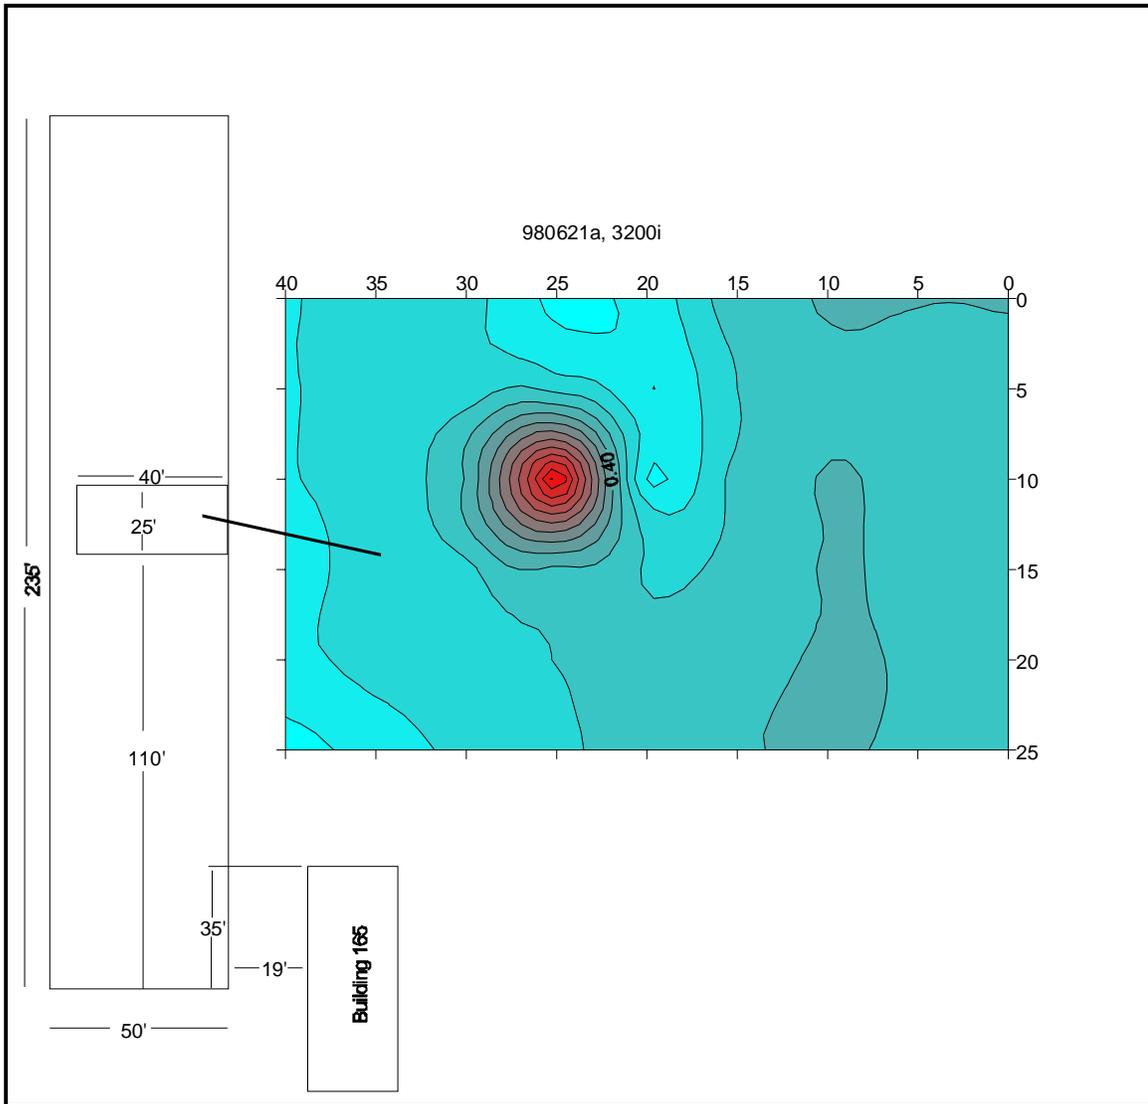
Figure 31. Electromagnetic survey data, Bethany Beach, Delaware National Guard Training Site, area near air field, 3200 Hz, in-phase data.
