USACERL Technical Report 99/26  
February 1999

# Case Study: Structural Evaluation of Heavy Wood Trusses at Corpus Christi Army Depot, Texas

by Ghassan K. Al-Chaar, Dexter S. Yoon, and Pramod Desai

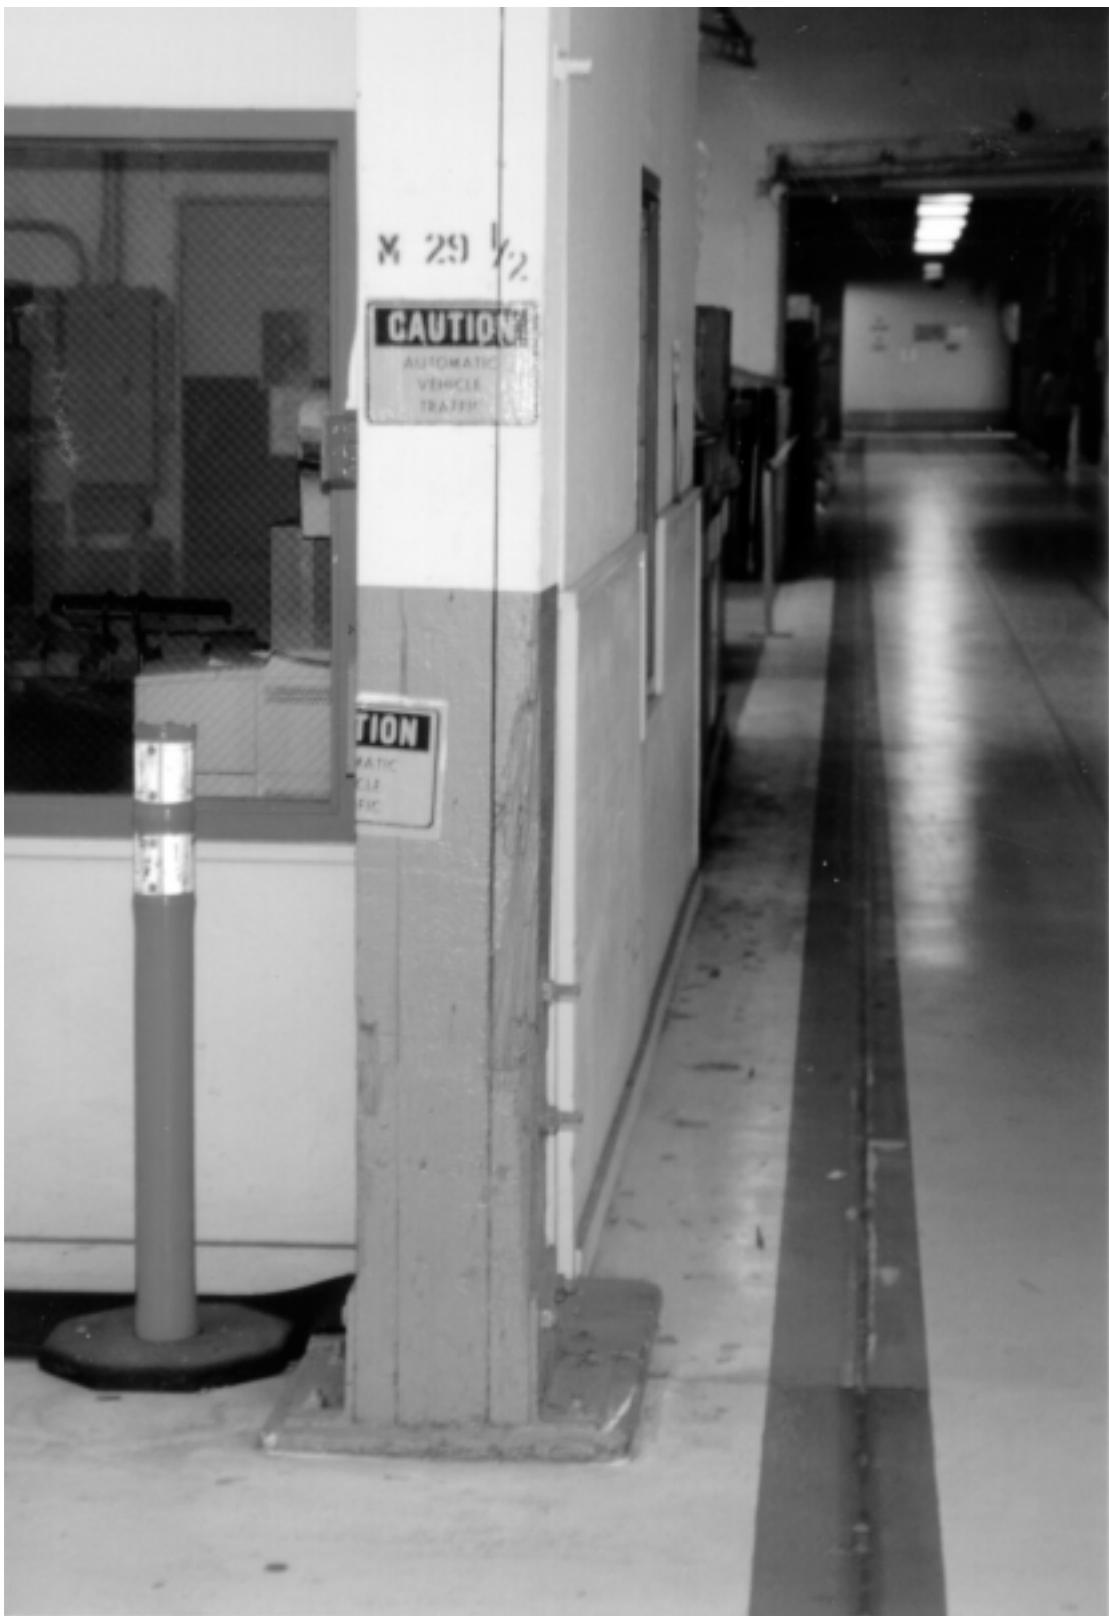
2. Over time, some of the 32 columns along column line M have been hit by passing sharp objects and gouged. These columns are located in heavy traffic areas and must be protected. A typical column damaged by passing objects is shown in Photo 1. See Chapter 6 for recommended protection scheme.

Photo 1. Column 29.5, Line M, damage by passing objects.

Item 2: Protection for columns along column line M is recommended, as presented in Figure I1 (Appendix I).

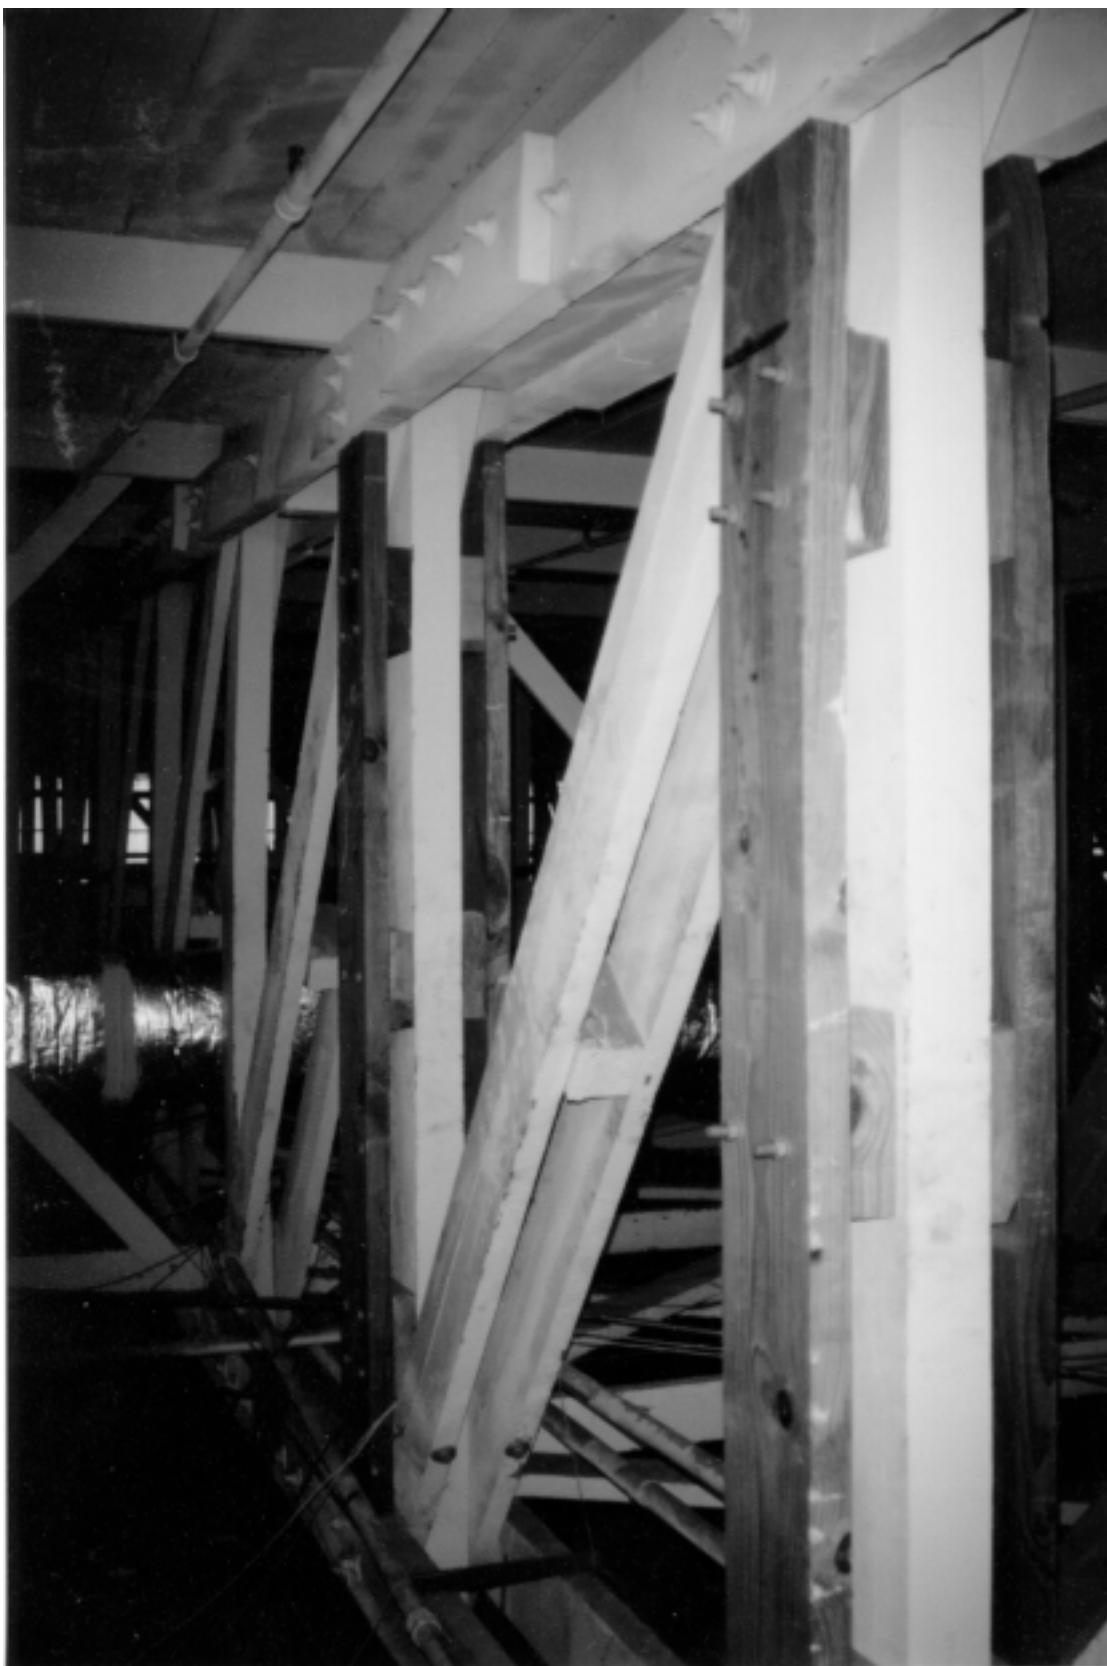
1. A total of 72 chords were repaired for longitudinal splits along their neutral axes. It was found that another 141 members, nearly 9% of the total, have damage similar to those repaired. The seriousness of these splits was determined based on the factors of safety for these defective members, as calculated in the detailed analysis. These members are considered to have minor damage for a factor of safety less than 0.75. However, the presence of splits implies a reduction of the member's strength. Photos 3 and 4 show typical repairs, and Photo 5 shows a typical large split in a column in Area A.

Photo 3. Typical type of existing repair in Area A.

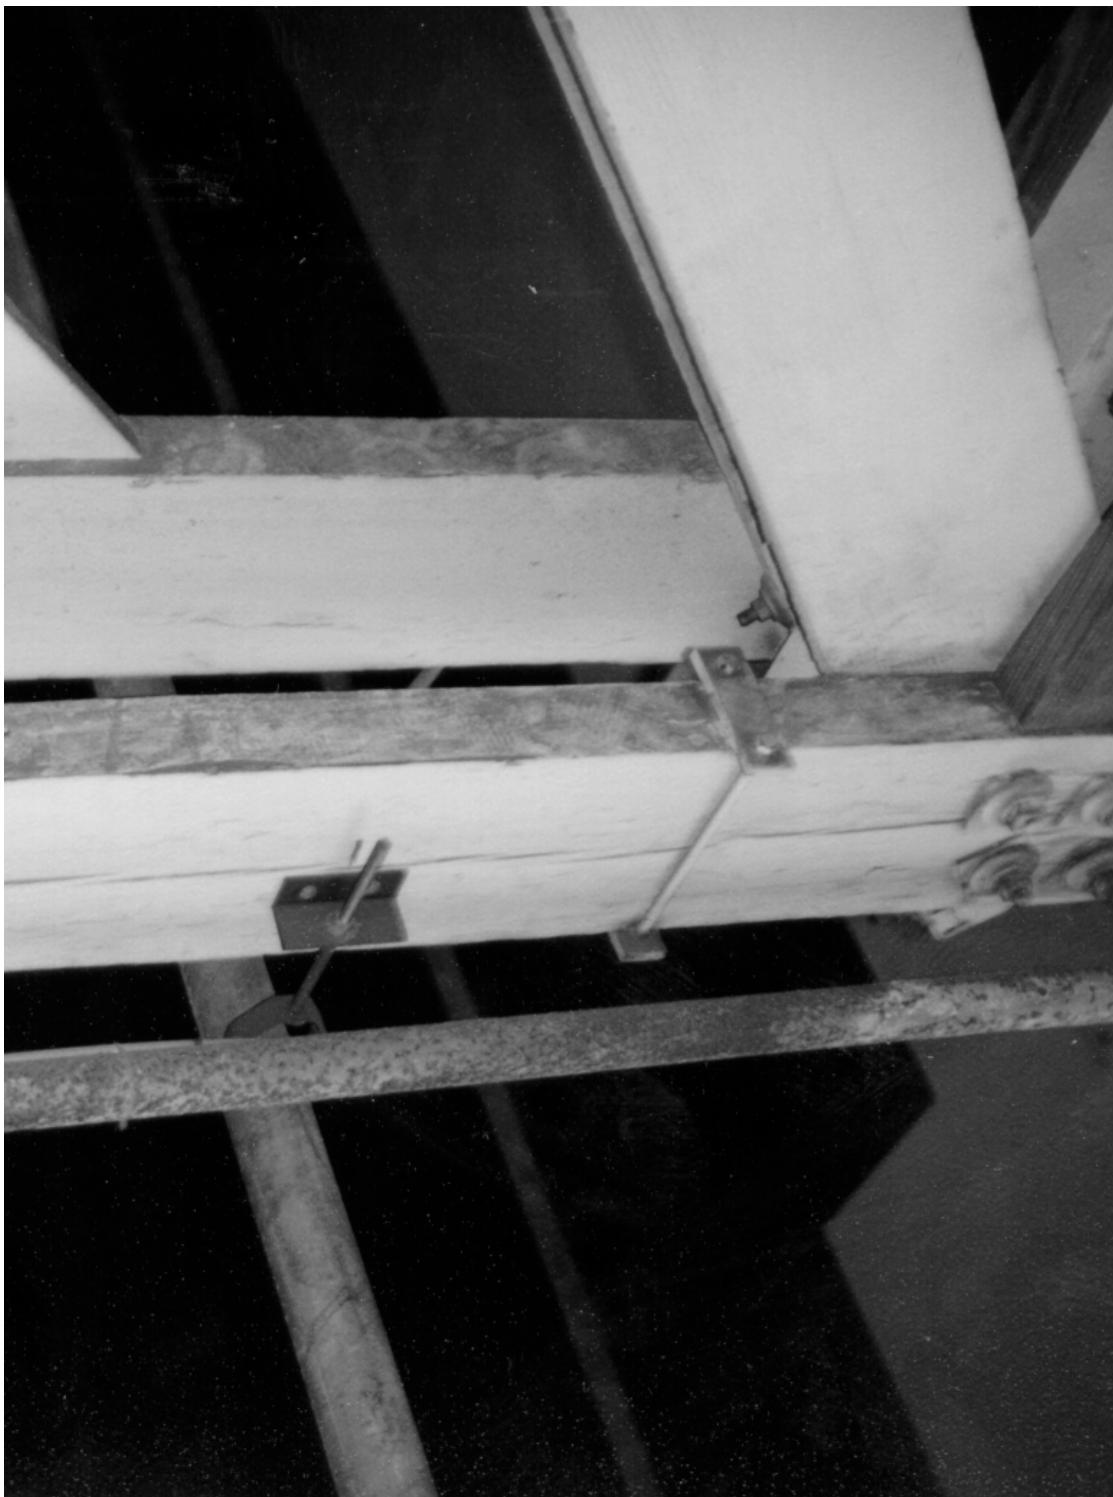
**Photo 4. Typical existing repair in Area A.**

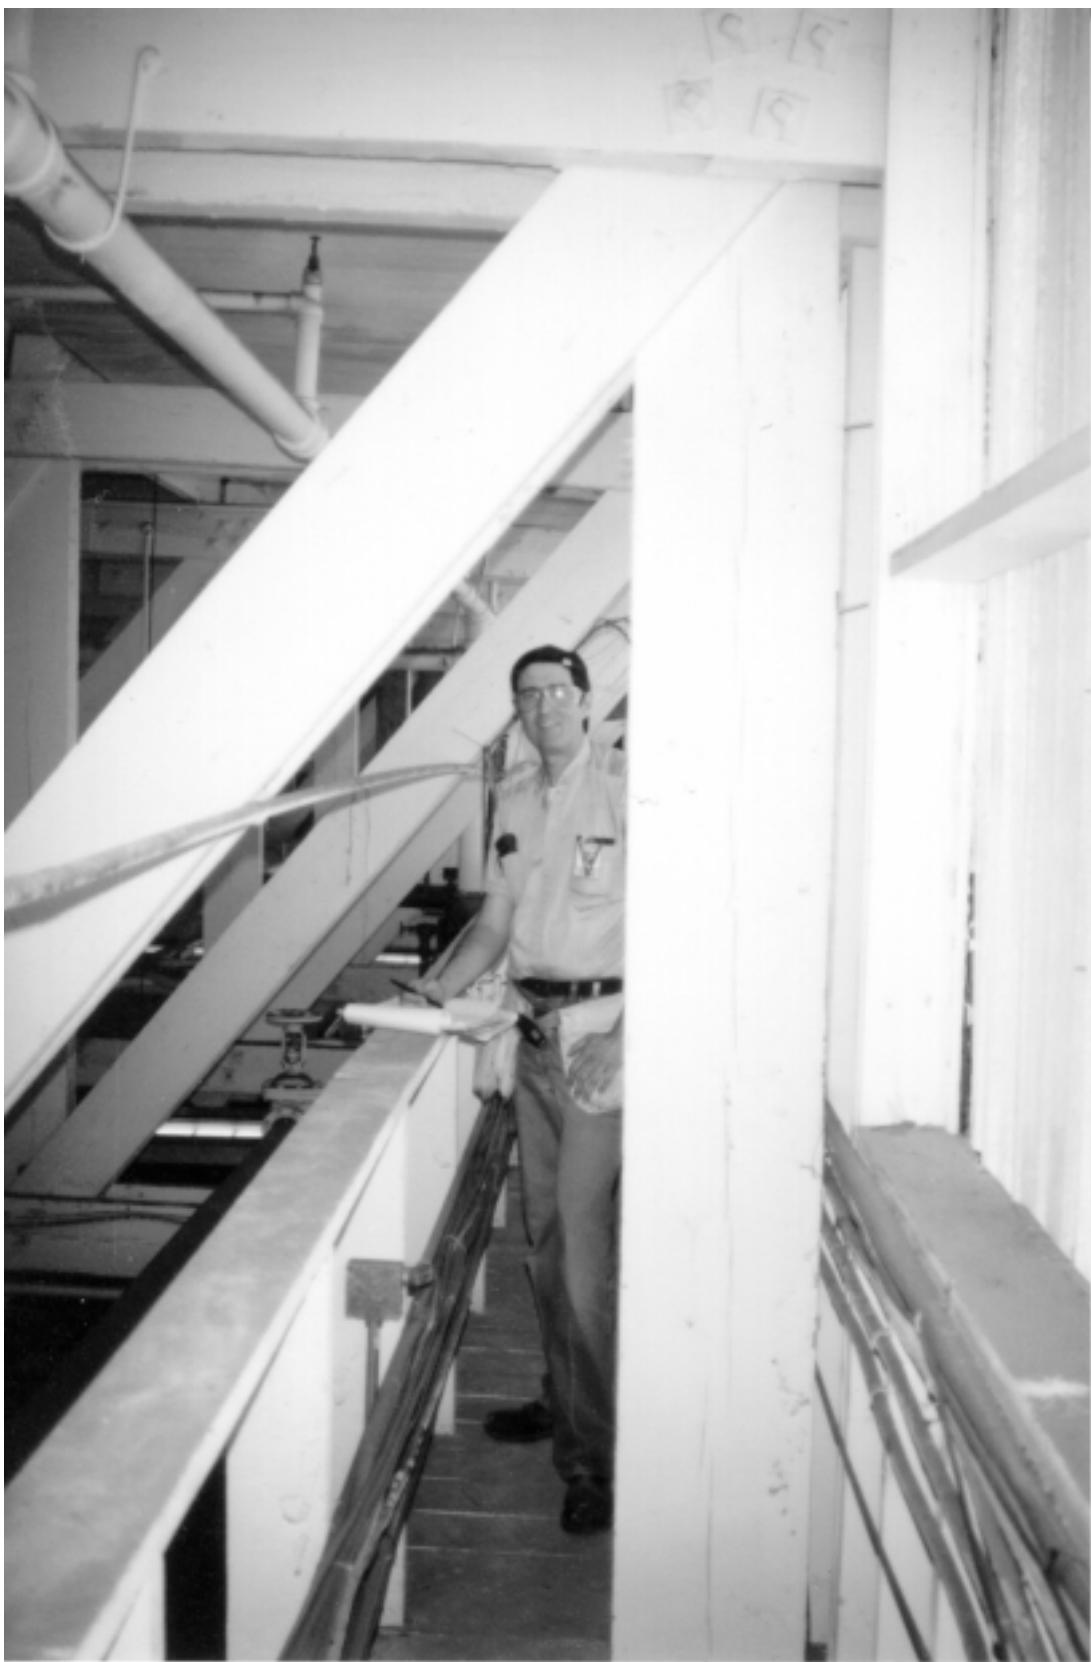
**Photo 5. Typical large split in a column in Area A.**

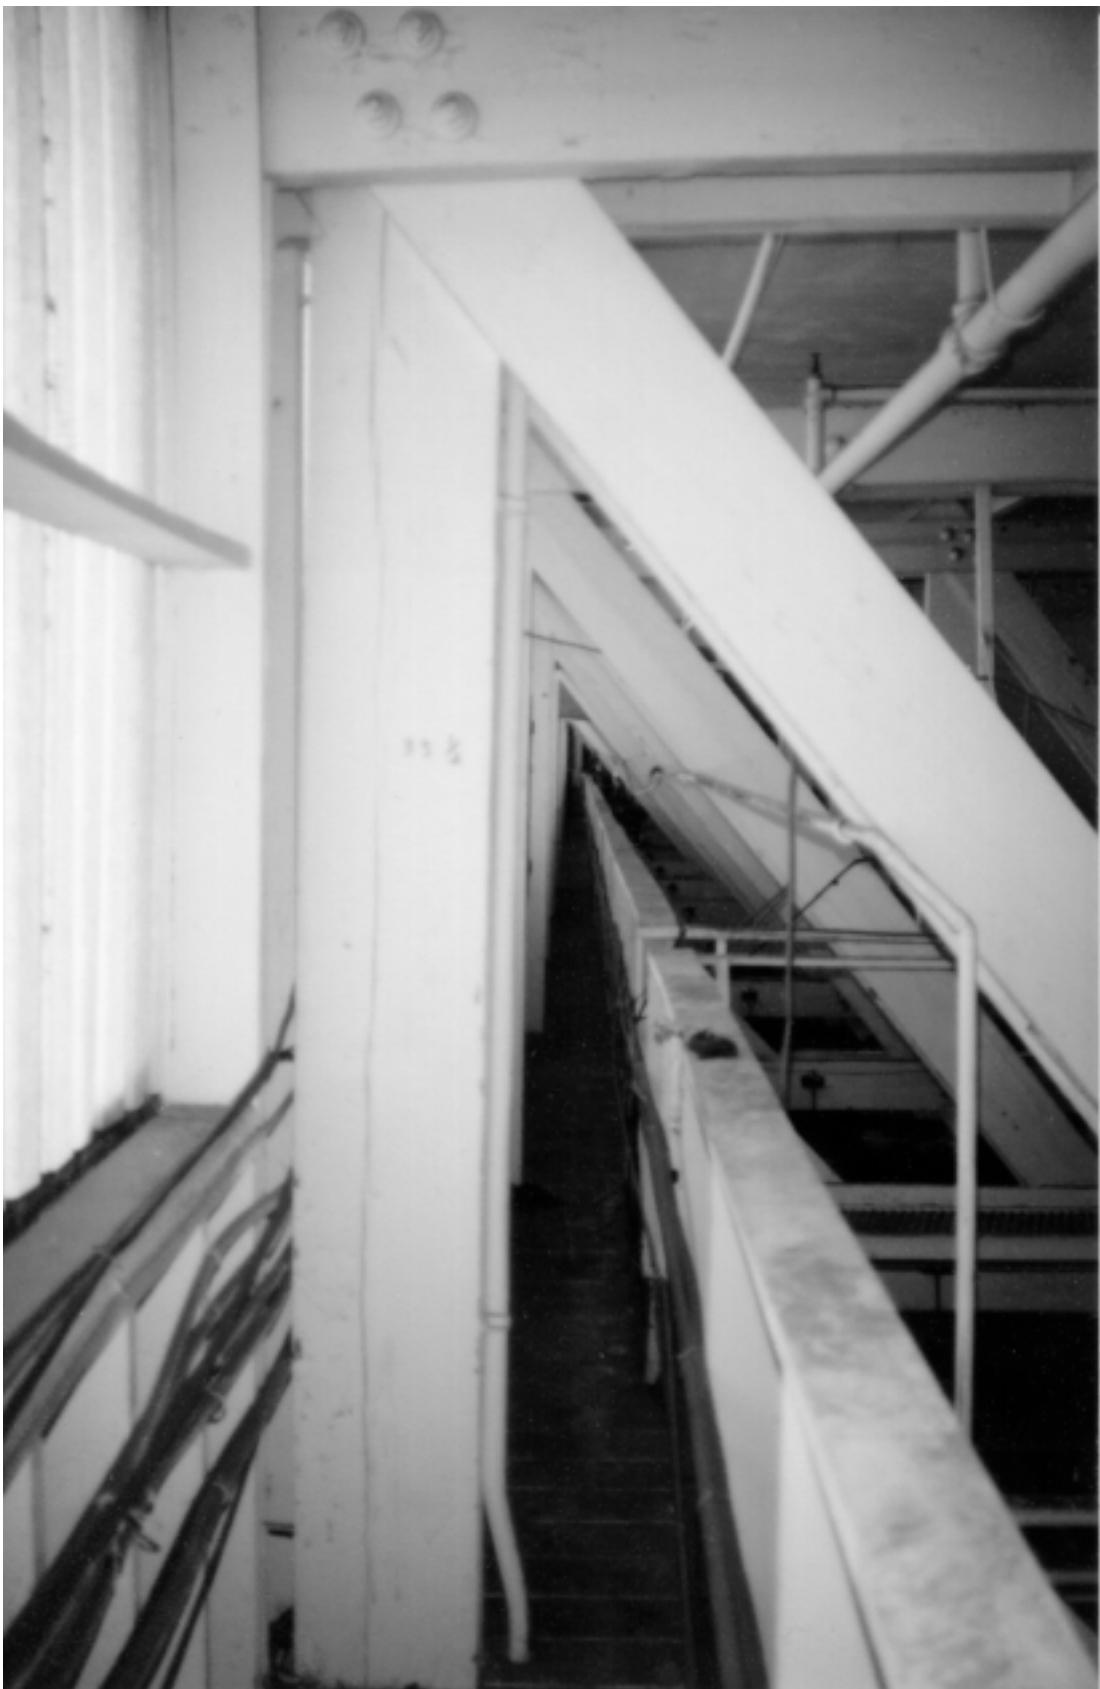
Photo 6. Typical small split in a column in Area A.

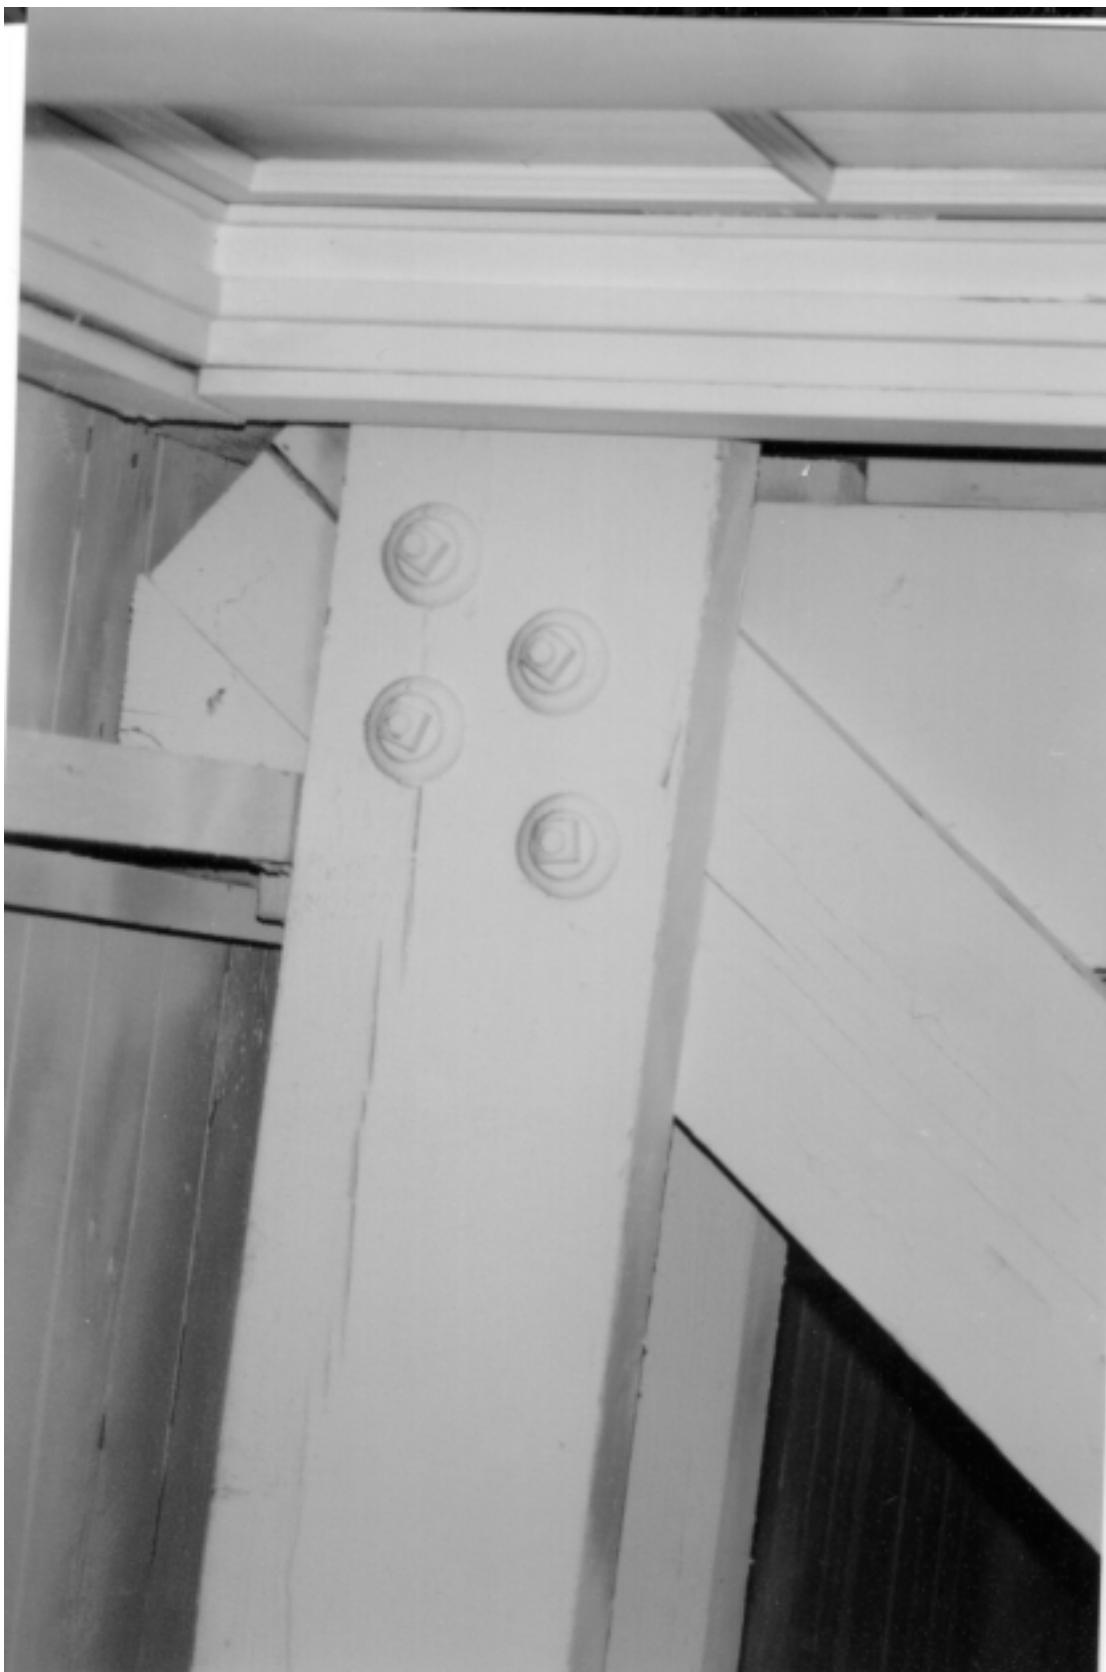
3. A total of 135 end splits were counted, but access to 74 of the 135 may require removing exterior wood siding. See Photo 7 for a typical end split in a diagonal member in Area A. Recommended repairs are specified in Chapter 6.

Photo 7. End split in a diagonal member in Building A.

Item 3: The recommended repairs are presented in Figures I4, I5, I6, I7, I8, and I9.

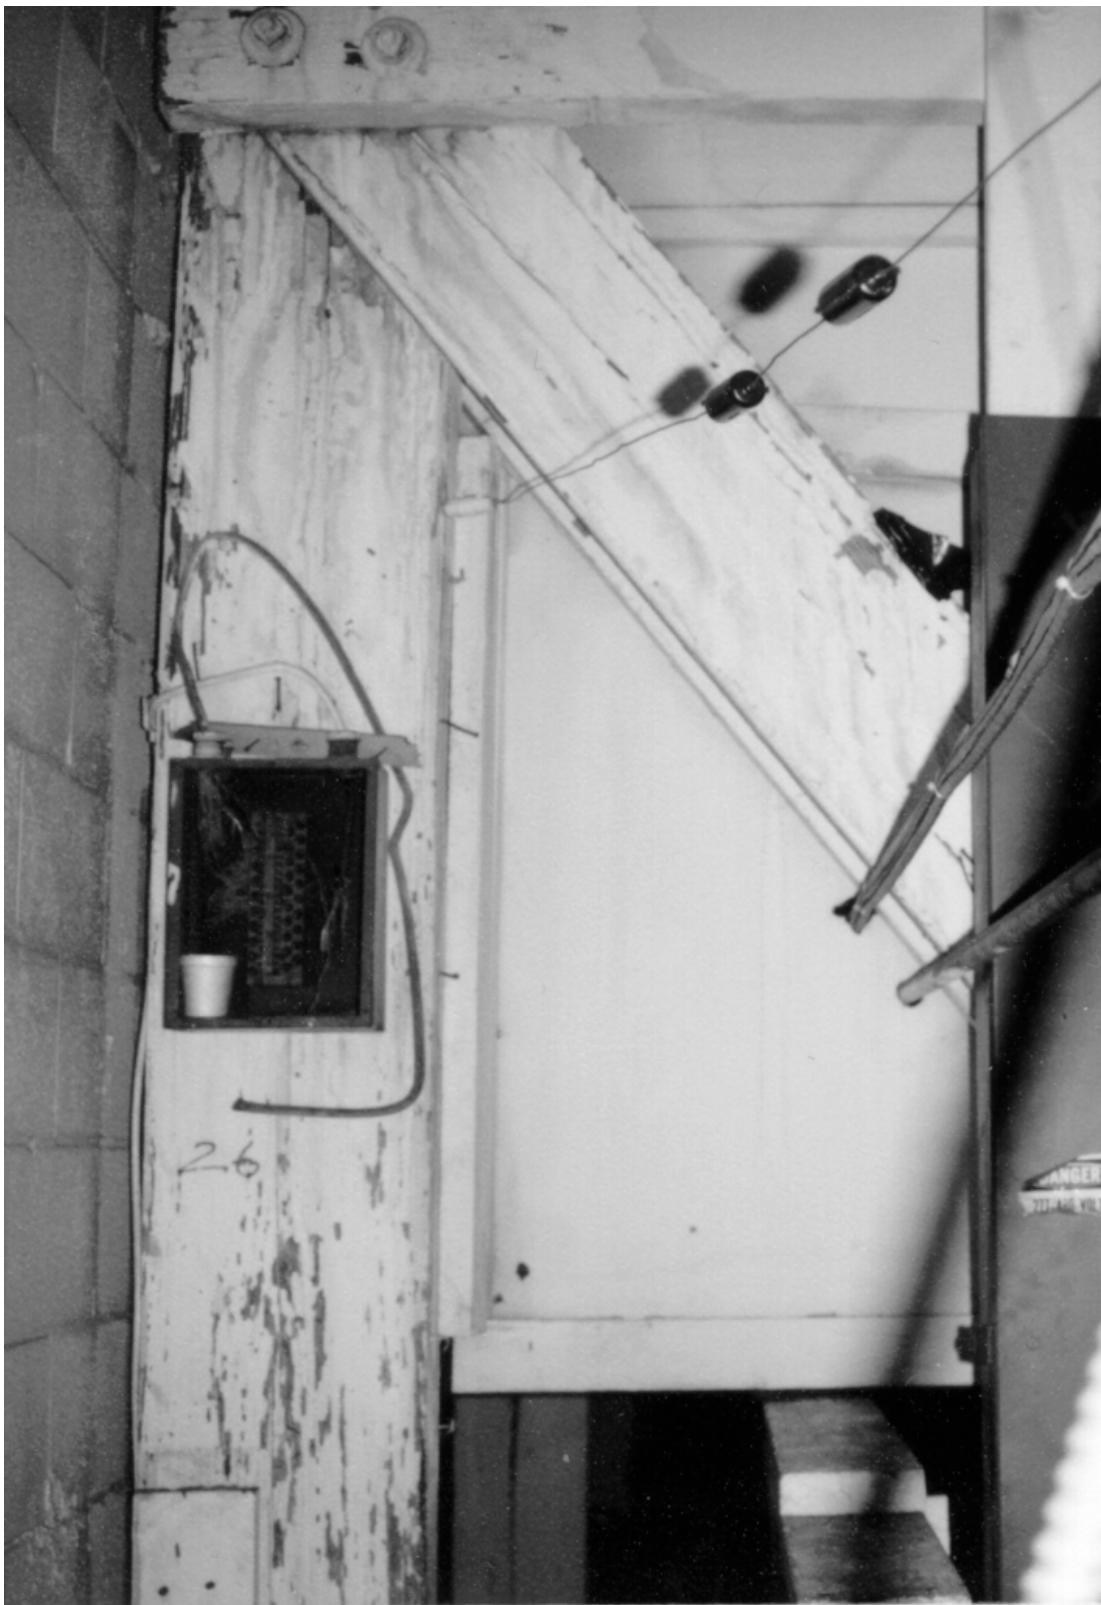
4. A total of 13 splice splits were counted—4 on tension members and 9 on compression members. Repair is recommended in Chapter 6.
5. Decay was observed on 37 members. Repair is recommended based on the degree of decay and degree of stress in each member as determined by analysis. See Photo 8 for a typical decay of a member in Area A.

Photo 8. Decay due to leakage in Area A.

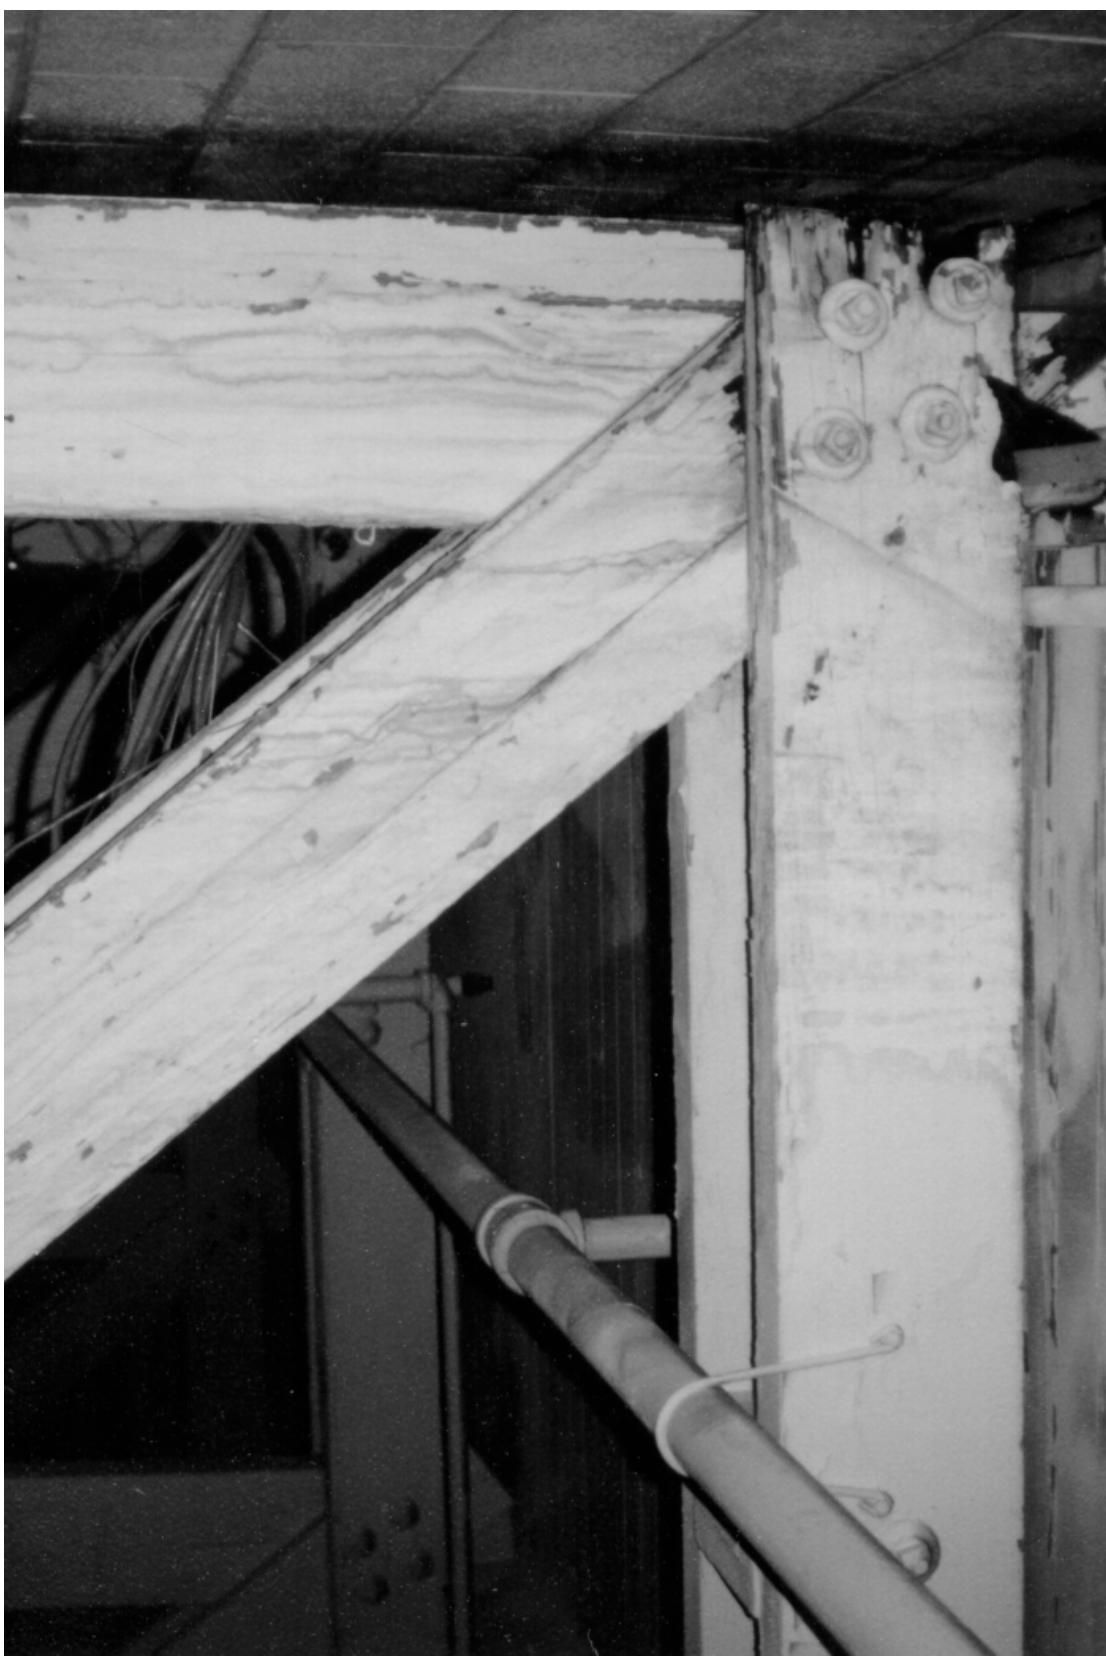
6. Decay was found in joint B, Truss 24.5. See Photo 9. The bolts are loose, and repairs are recommended in Chapter 6.
7. Eight diagonal members were found to be fractured, as shown in Photos 10 through 17. These members are: BZ and QM in Truss 27, CY in Truss 29.5, BZ and CY in Truss 34, DX in Truss 36, QM in Truss 36.5, and PN in Truss 38. See Chapter 6 for repair recommendations.

Photo 9. Major damage due to decay in a joint in Area A.

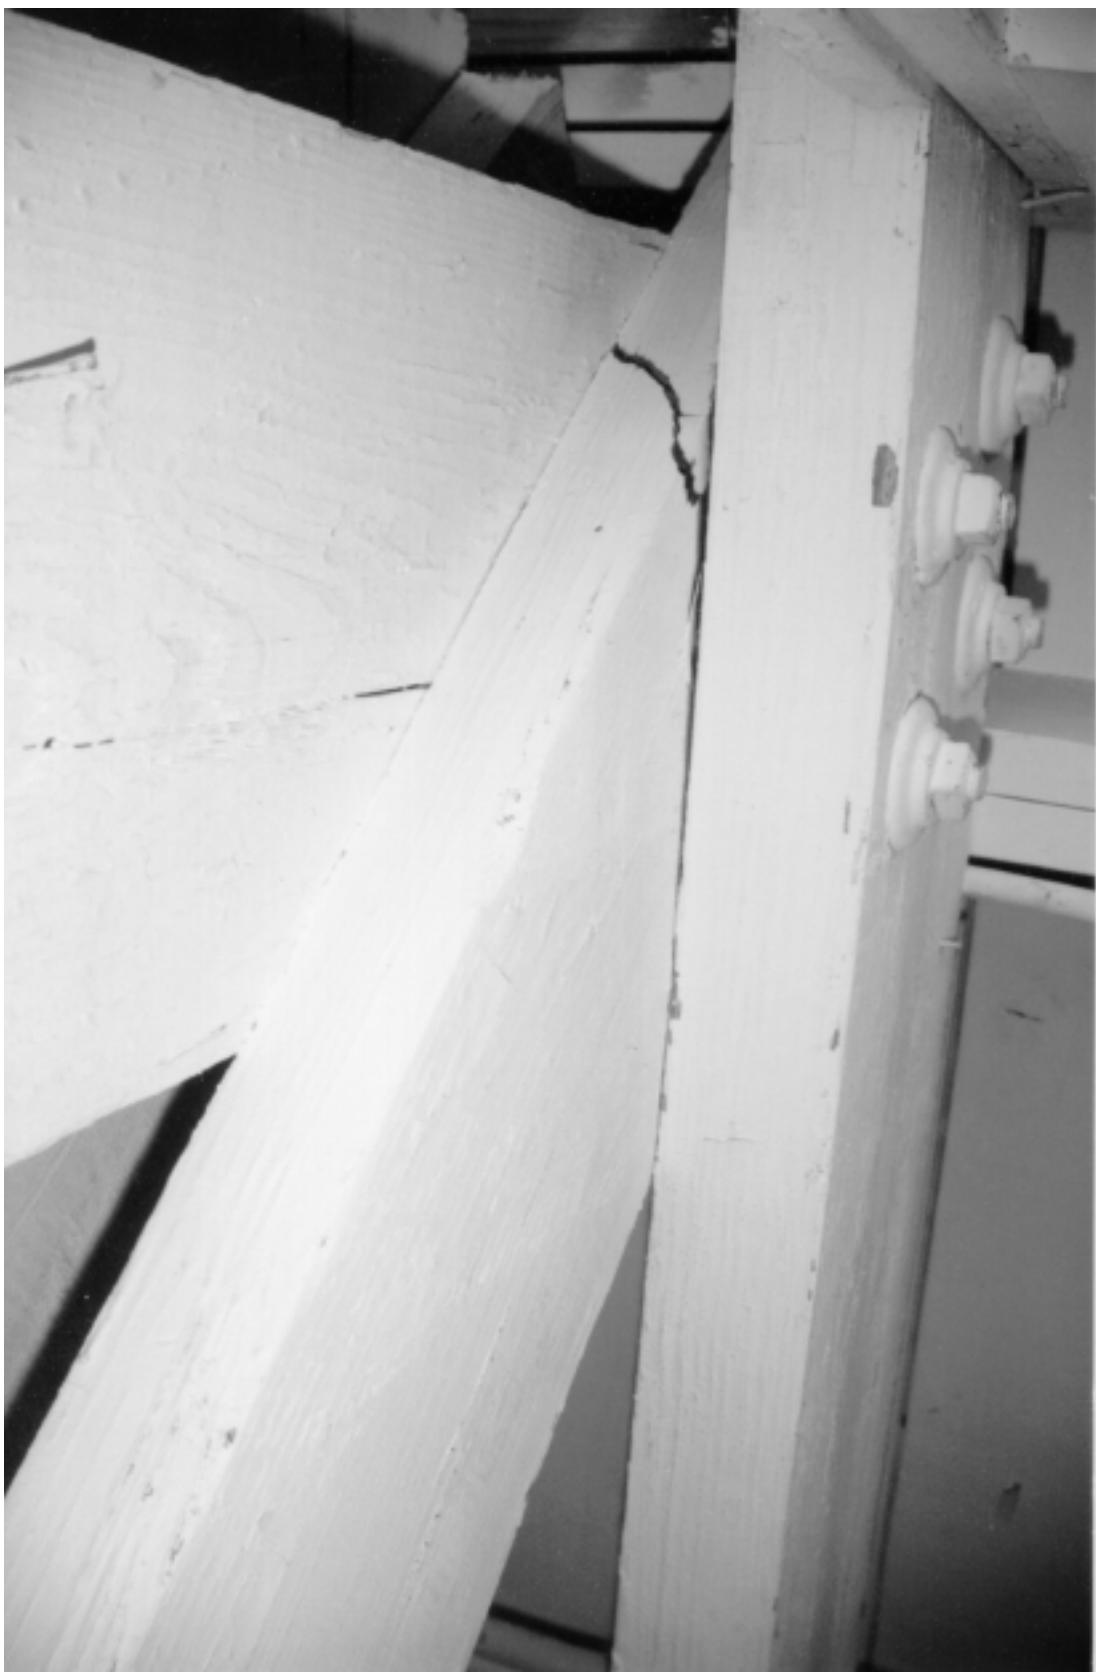
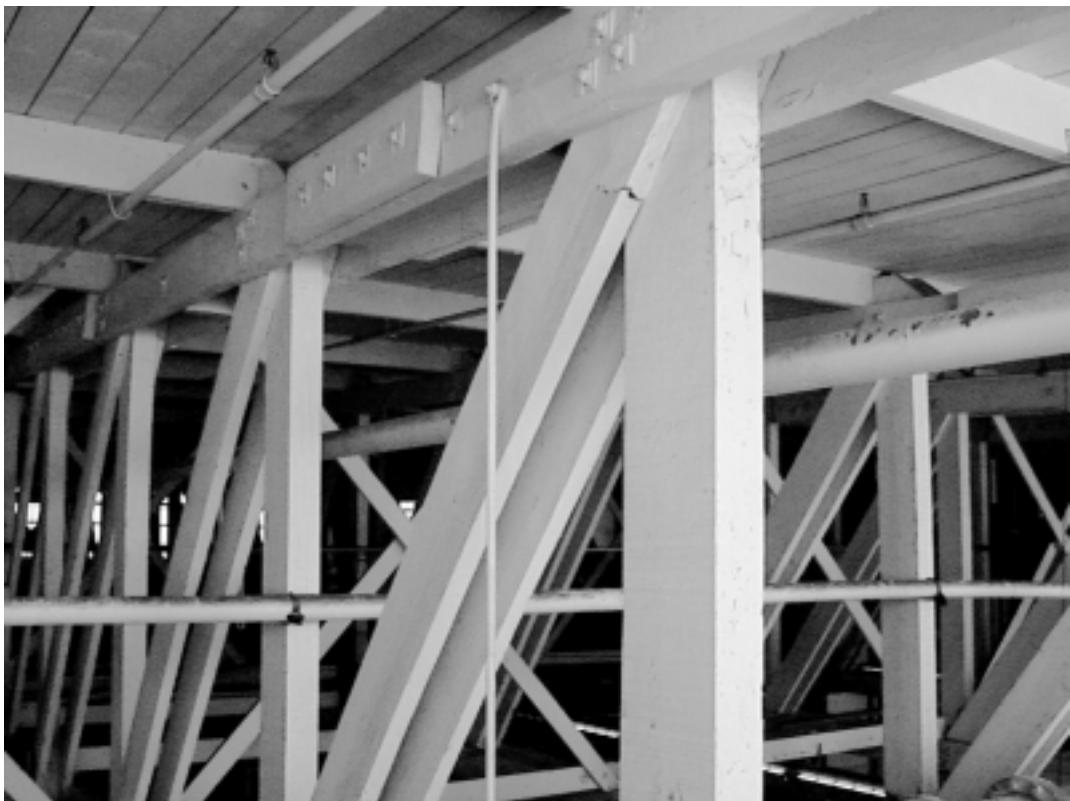
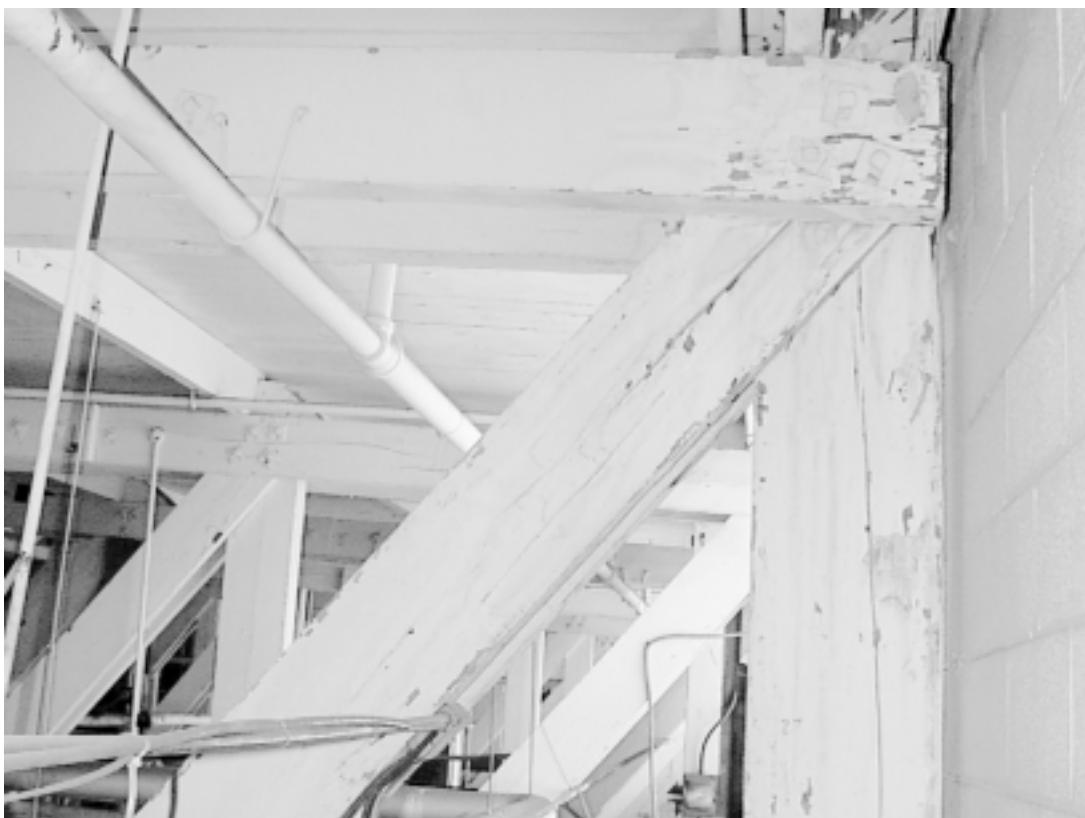
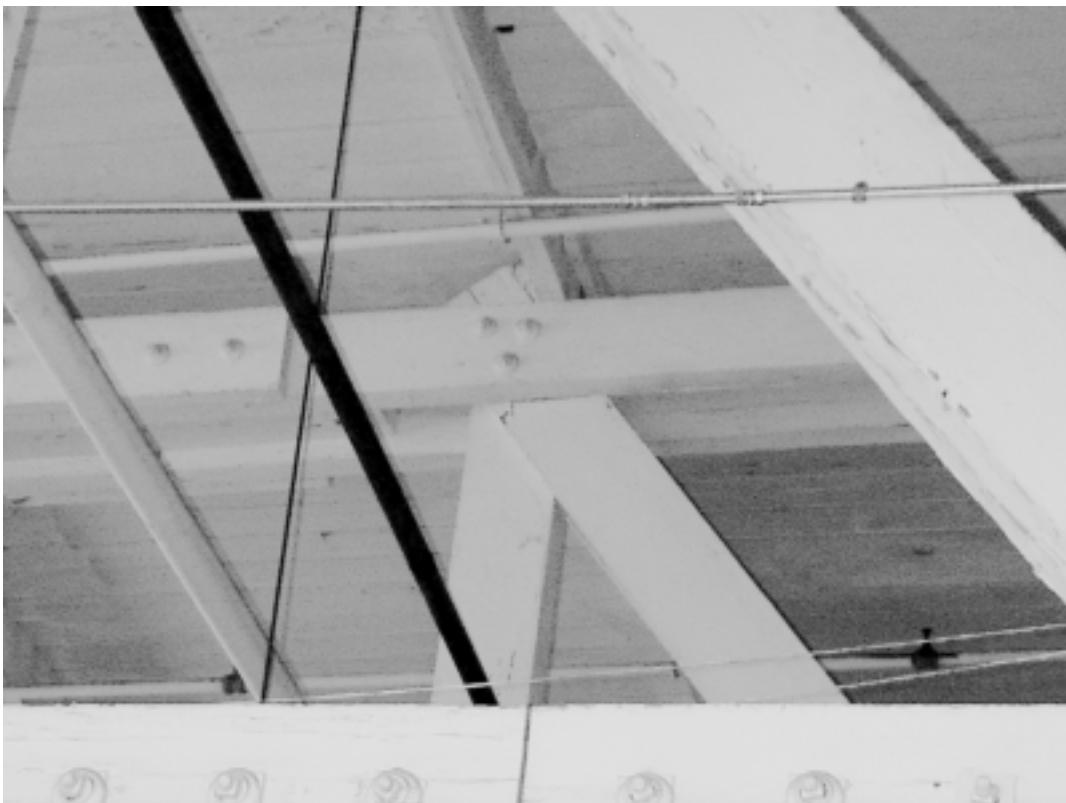
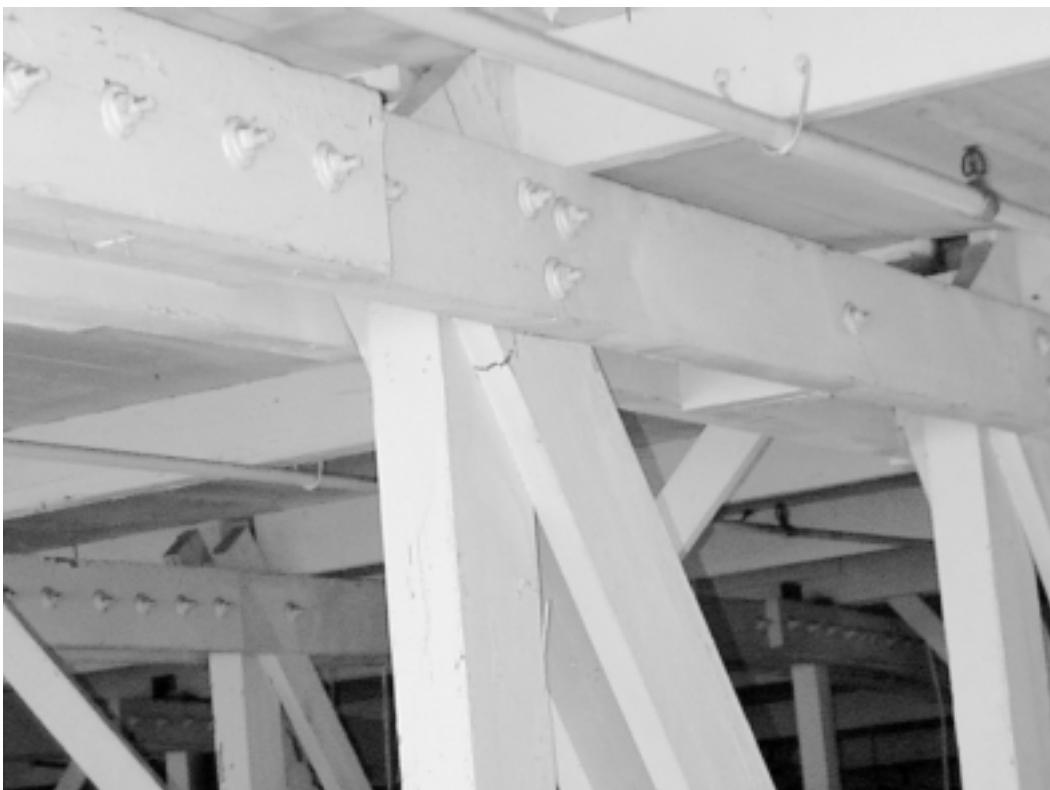
**Photo 10. Fracture in diagonal member BZ of Truss 34, Building A.**

Photo 11. Tension failure in diagonal member PN of Truss 38, Area A.

**Photo 12.** Fractured diagonal member CY of Truss 29.5, Area A.

**Photo 13.** Fractured diagonal member BZ of Truss 27, Area A.

Photo 14. Fractured member QM of Truss 27, Area A.

Photo 15. Fractured CY diagonal member in Truss 34, Area A.

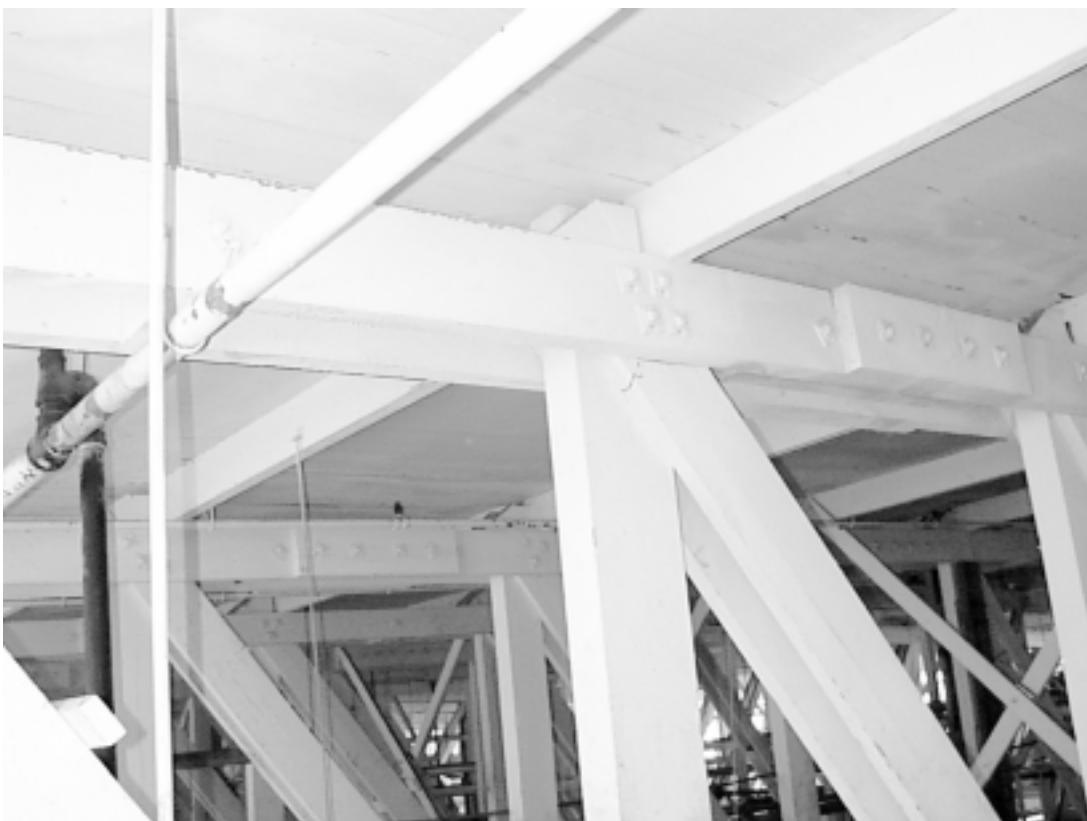
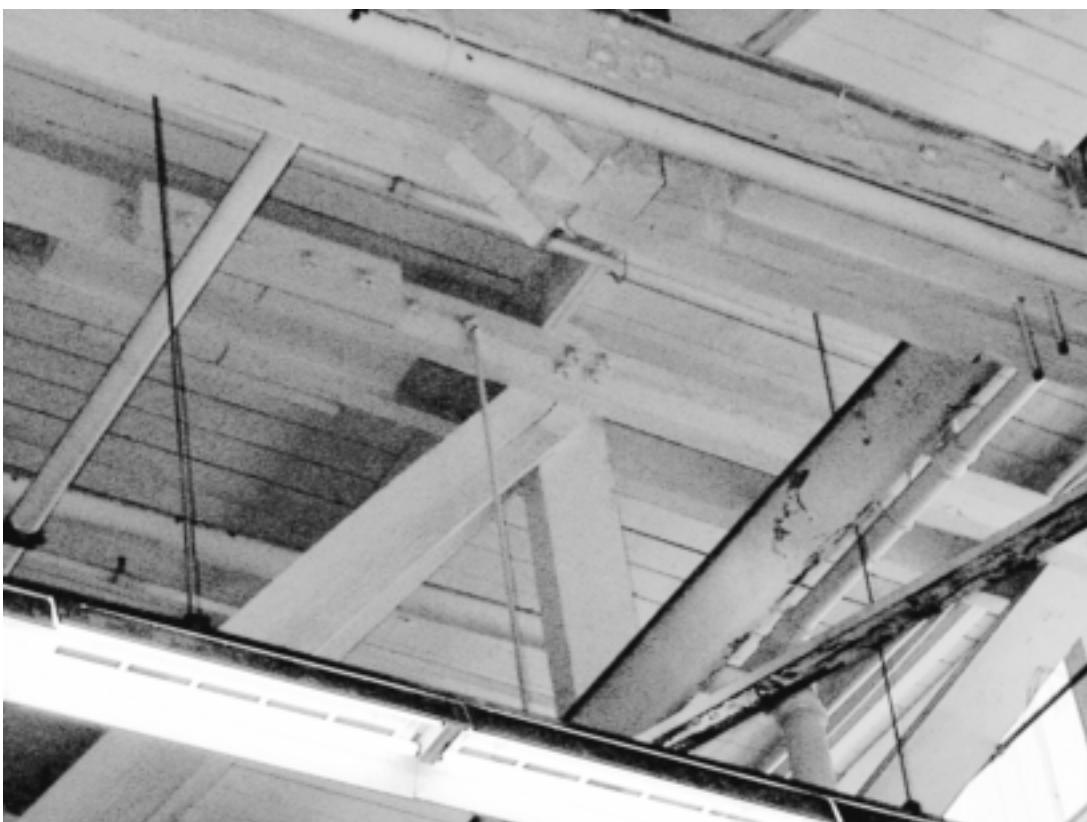
Photo 16. Fractured diagonal member DX of Truss 36, Area A.

Photo 17. Fractured diagonal member QM of Truss 36.5, Area A.

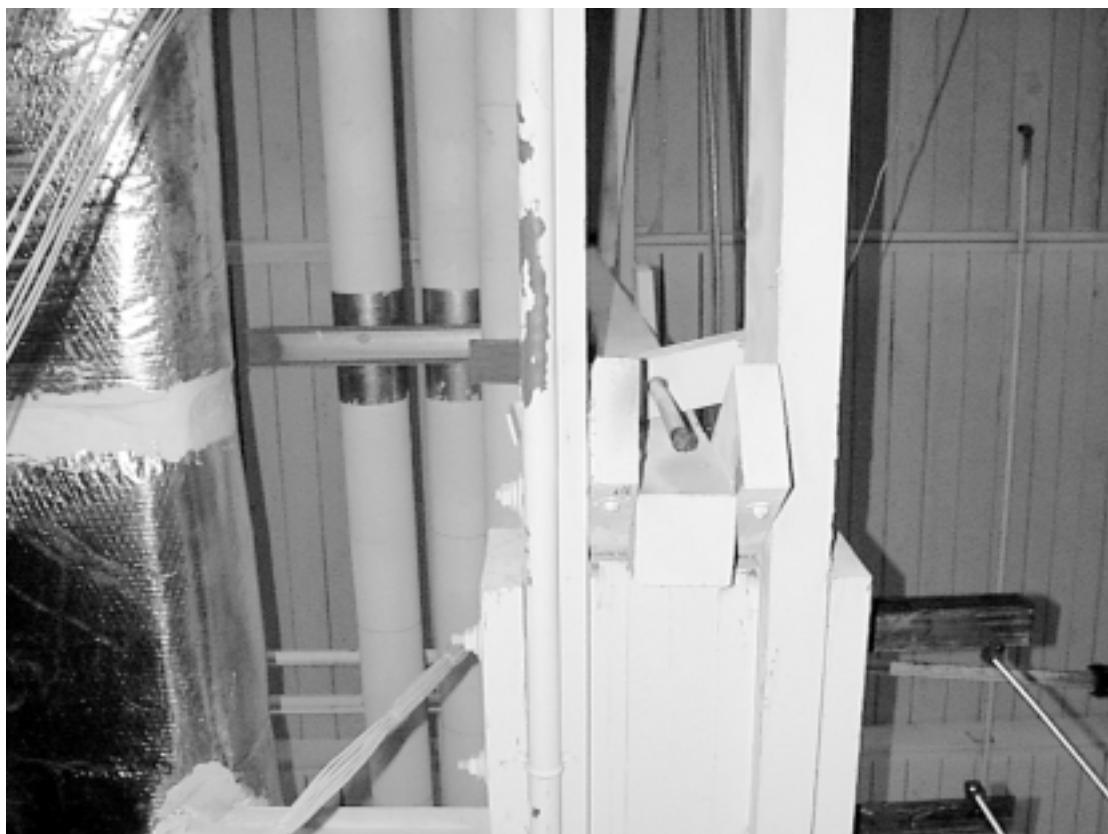
**Photo 18. Cantilever pipe support on diagonal members of Truss 34, Area A.**
