USACERL Technical Report 99/26  
February 1999

# Case Study: Structural Evaluation of Heavy Wood Trusses at Corpus Christi Army Depot, Texas

by Ghassan K. Al-Chaar, Dexter S. Yoon, and Pramod Desai

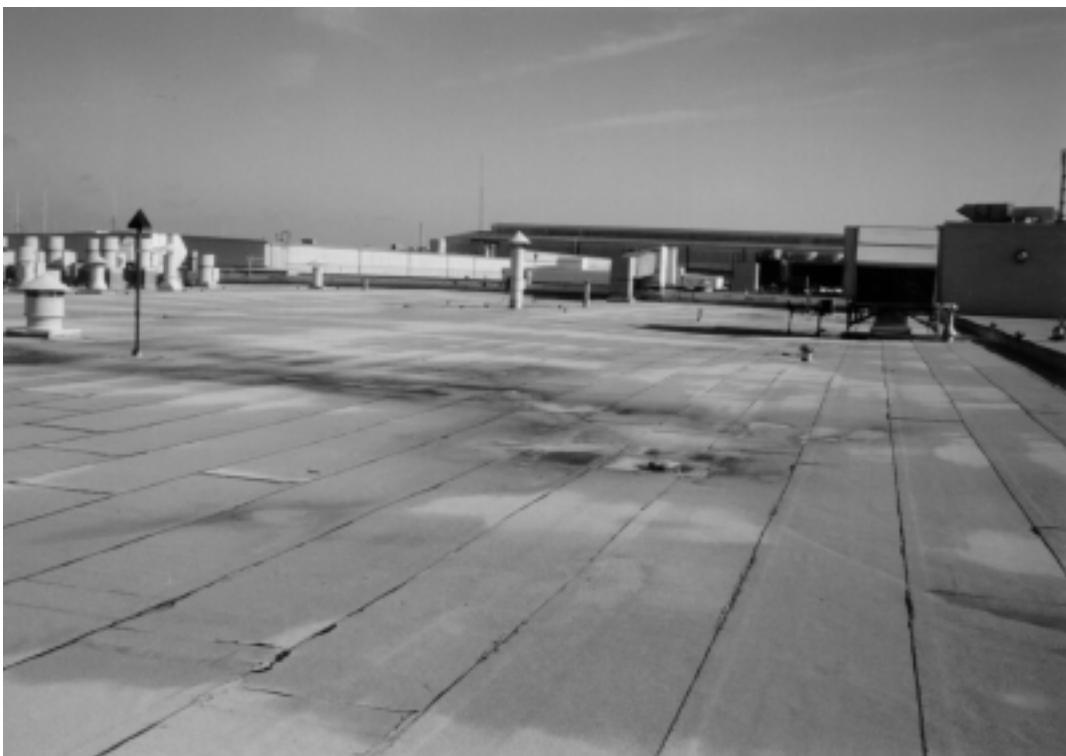
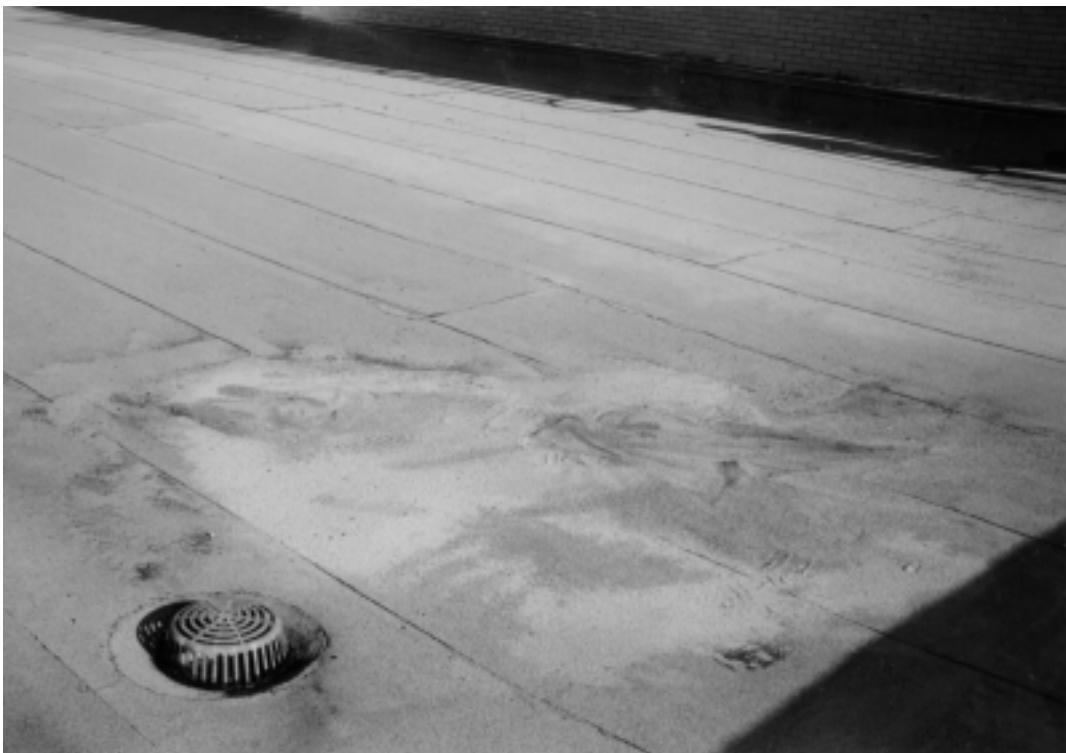
2. Major signs of roof leaks were observed in several areas. Some of the leaking areas of the roof may have been repaired, but surfaces on the roof are still collecting water and may be actively leaking, as shown in Photos 19 and 20. All traces of leaks observed from the inside of the structure and from the surfaces on the roof that are still collecting water are shown in Figures 5 and 6. Roof repair is recommended. Also, the roof should be inspected during heavy rain to ensure the protection of the wood members supporting the roof.

**Photo 19.** Water collected on the roof surface of Area B.

**Photo 20.** Pond and sag in the roof of Area D.

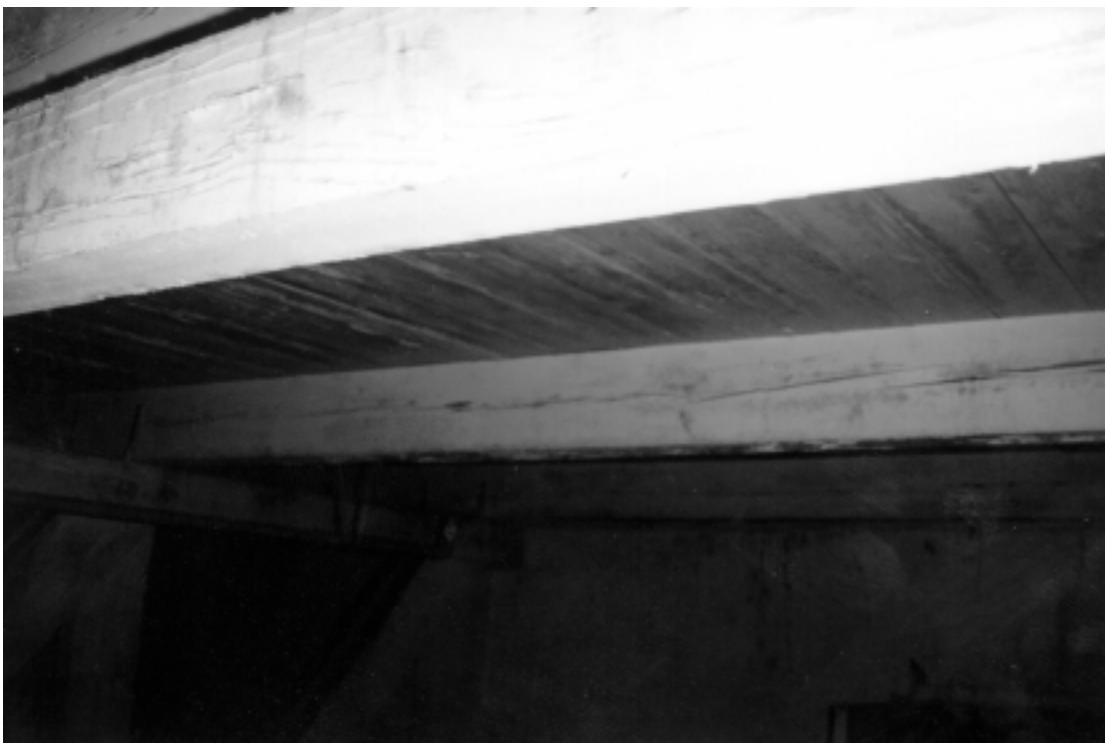
**Photo 21.** Over stressed purlin.

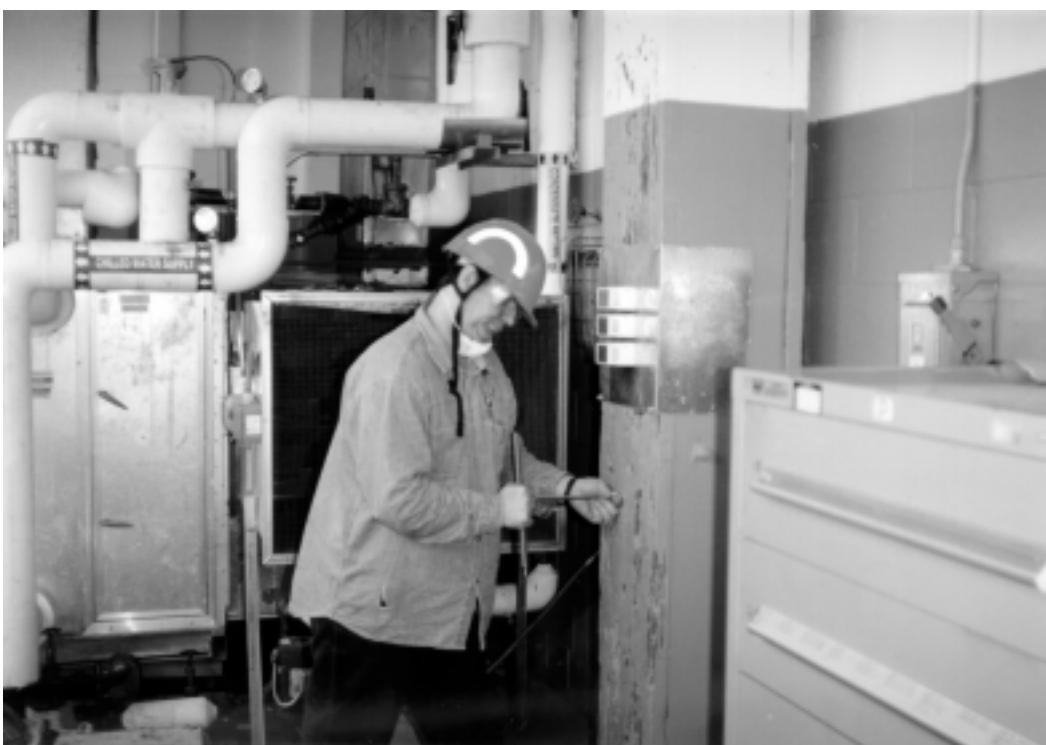
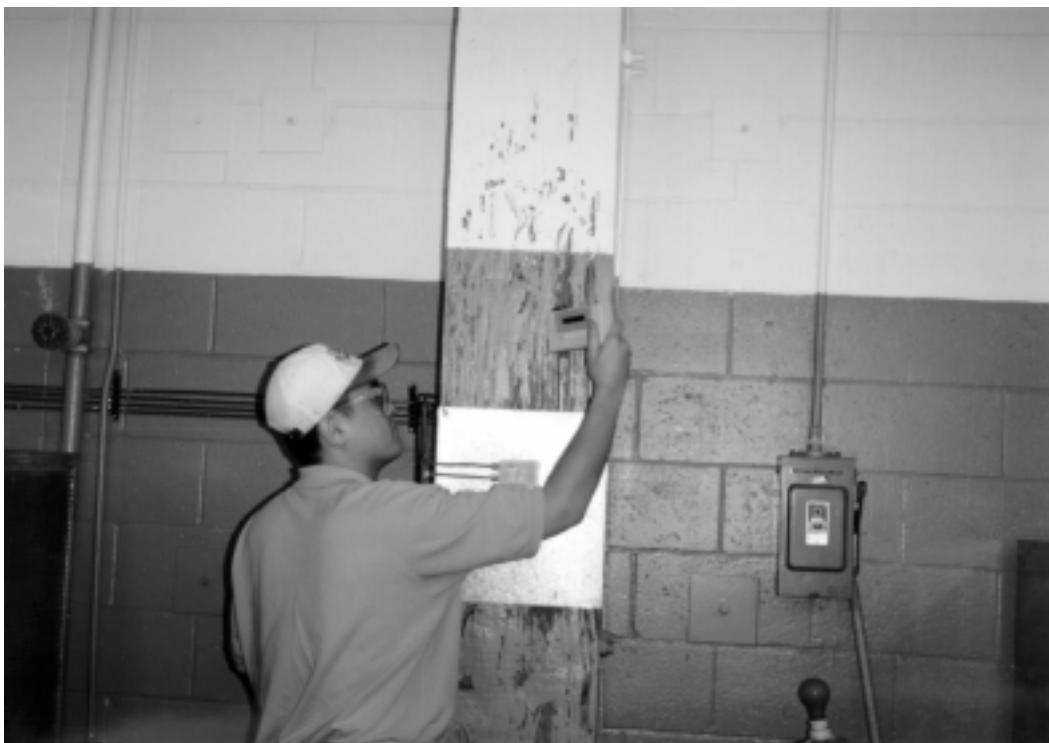
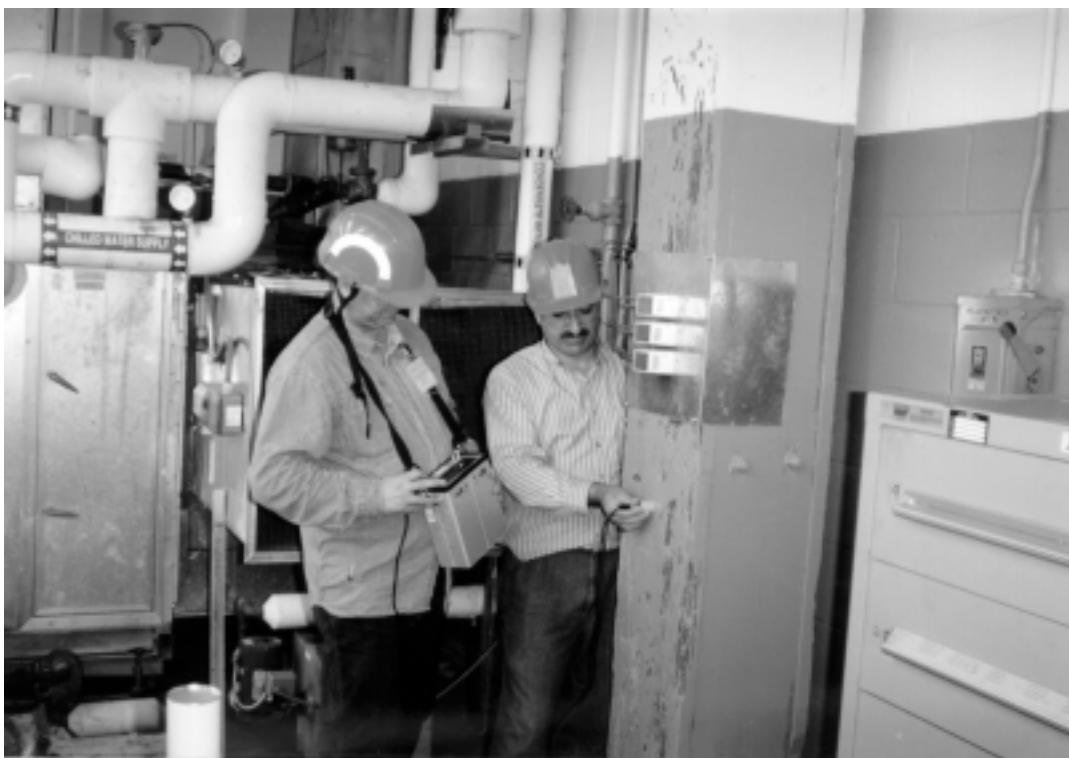
8. Column C63 exhibited termite damage, but termites were not seen. A nearby steamer was moved to another location. It may be inferred that the termites left after the steamer was moved because of the resulting reduction in moisture, which may have made the environment less attractive to termites. Photos 22, 23, and 24 show the condition of this column. Field tests were carried out to estimate the damage. See Chapter 6 for repair recommendations.

**Photo 22.** Using the coring on termite damaged column.

Photo 23. Using the moisture content meter on termite damaged column.

Photo 24. Using the V-Meter on termite damaged column.

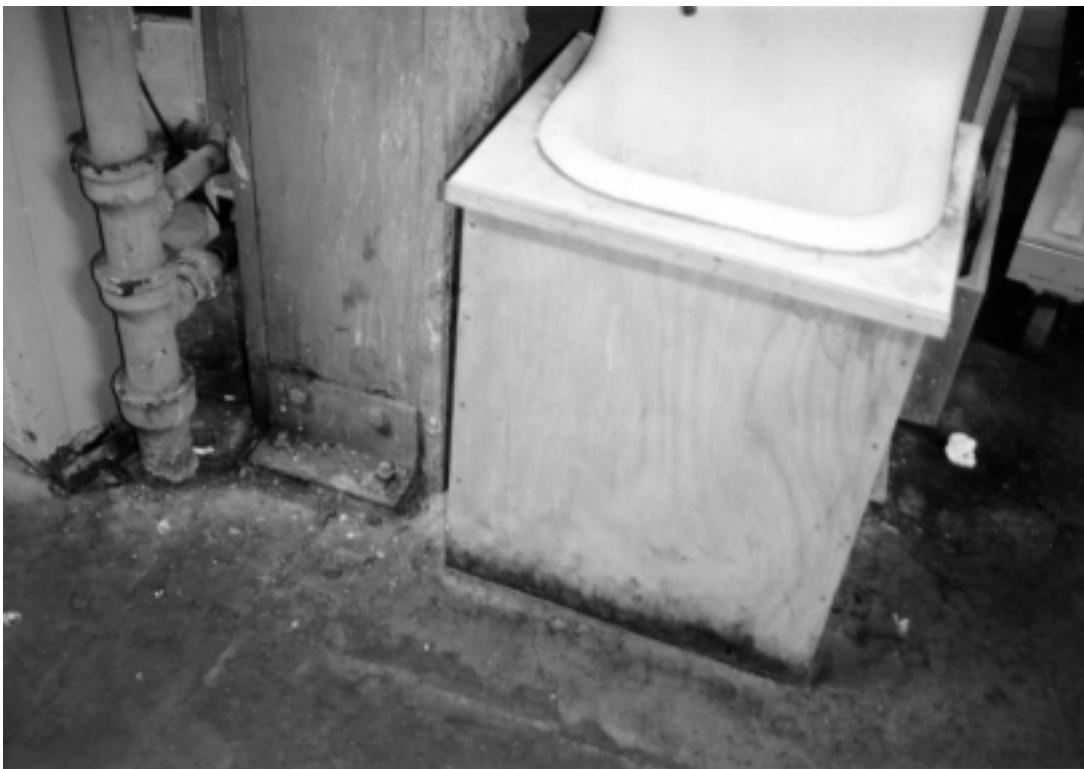
9. A sink in Area C, column line 53, will cause damage to the adjacent column, as shown in Photo 25. Isolating the sink from the column is recommended. Moisture content from 18% to 23% is a potential start for termites.
10. The truss in column line 40, between column line I and G, has a fracture in the top chord between joints J and K, as shown in Photo 26. See Chapter 6 for recommended repair.
11. There is a fractured member in a truss on column line 56, Area D, located on the lower chord of the truss, between Joints R and T, as shown in Photo 27. See Chapter 6 for recommended repair.
12. Diagonal member CT in Truss 63 of Area B was found fractured, as shown in Photo 28. See Chapter 6 for recommended repair.

Photo 25. Leakage from a sink that will damage a column.

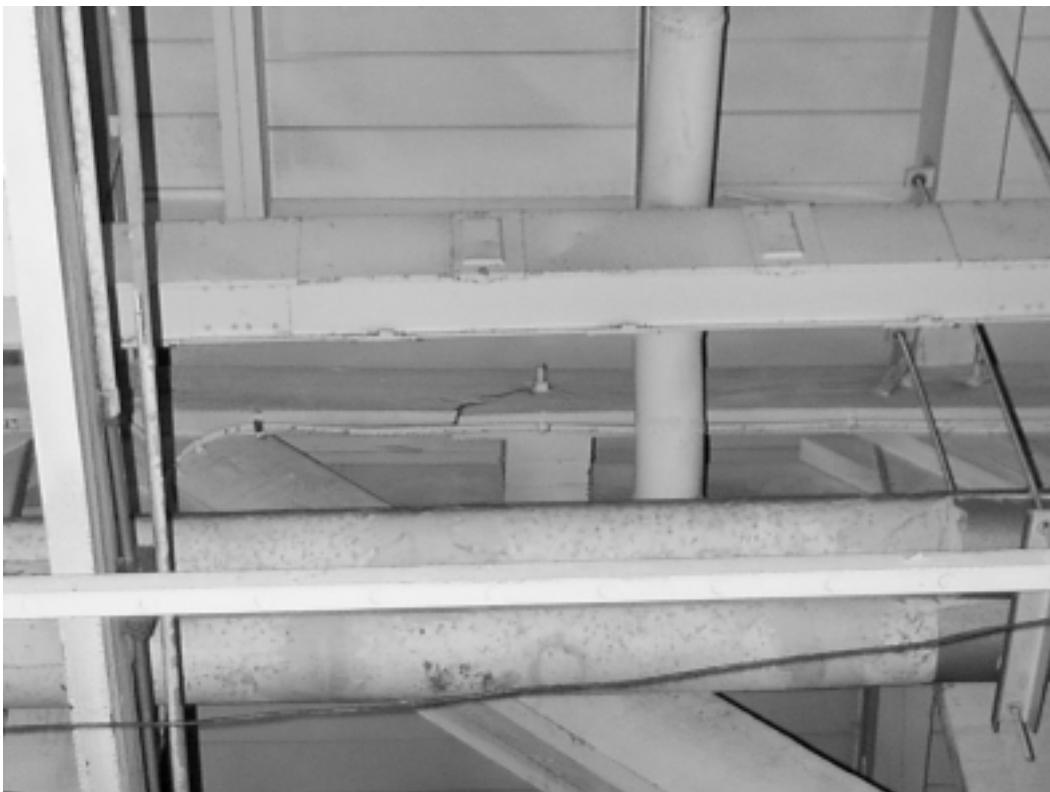
Photo 26. Fractured chord of Truss 40, Section IG, Area B.

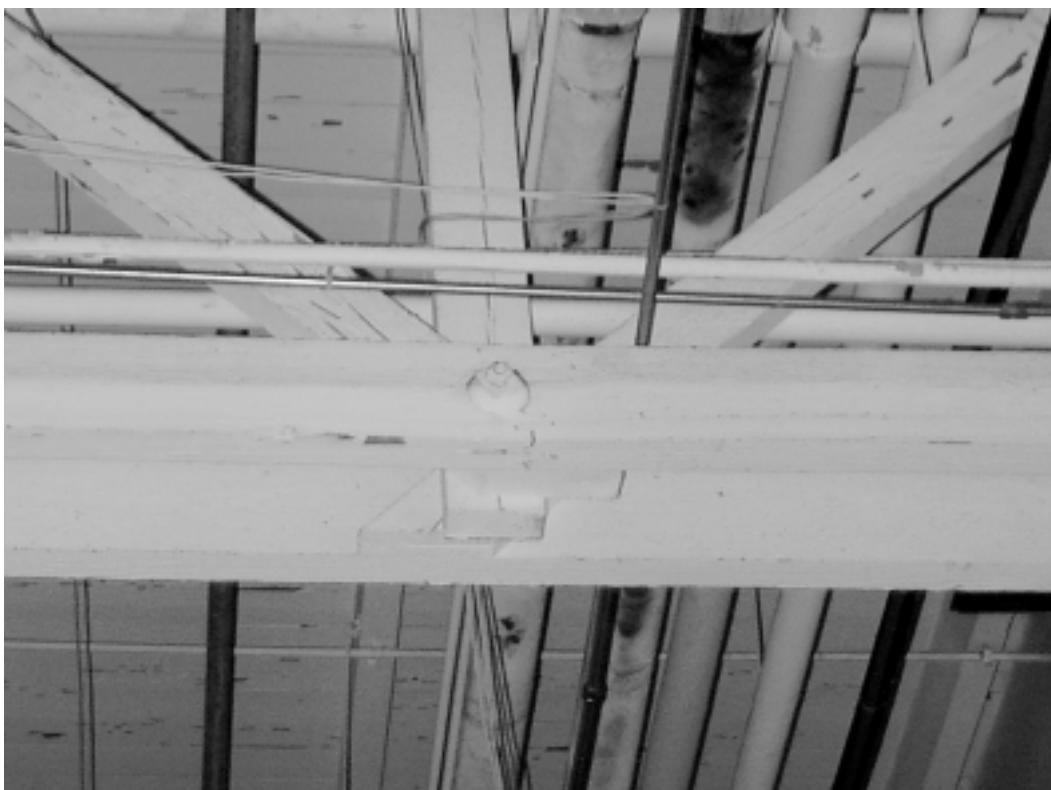
**Photo 27. Fracture in chord RT line 56, Area D.**

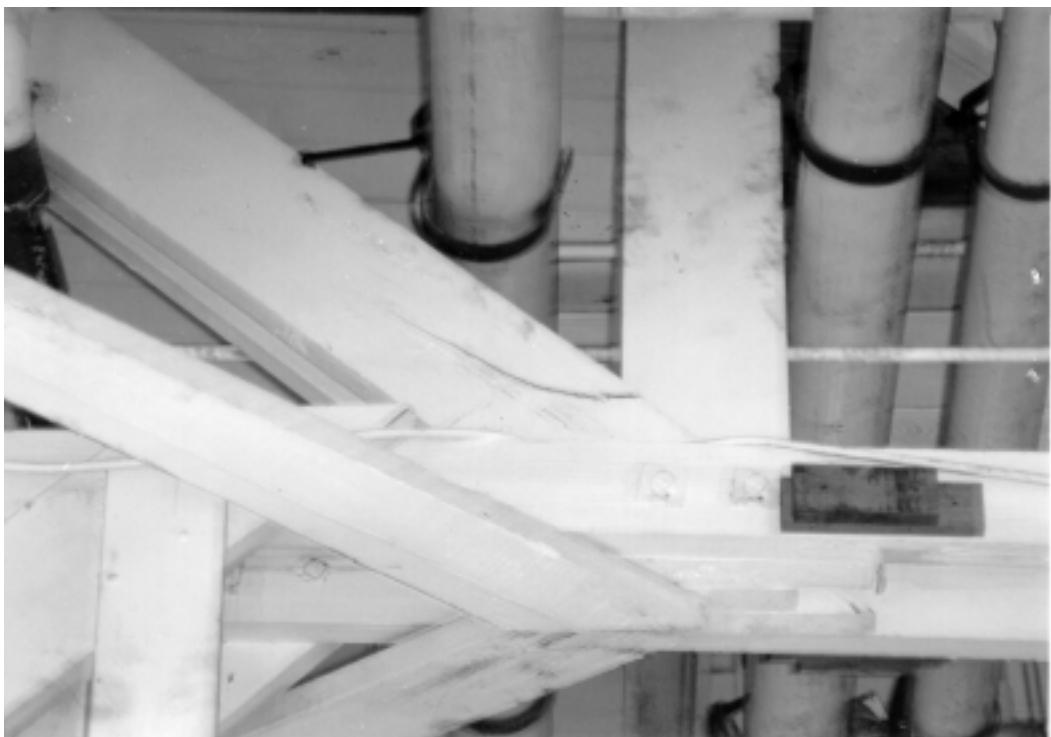
**Photo 28. Fracture on member CT of column line 63.**

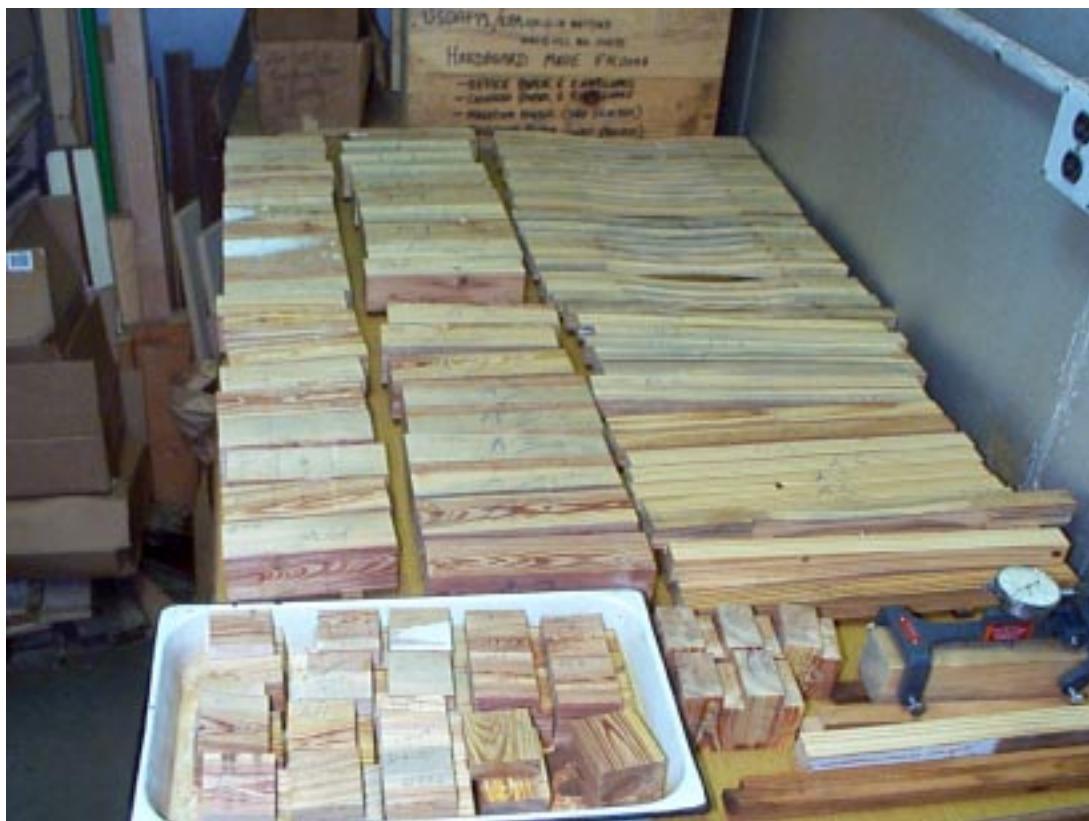
Table 8 shows the dimensions and specific gravities of the tested samples. Table 9 and Photo 29 show five different kinds of test specimens that were cut from the two sample sets, A and D. First, the specimens were conditioned at a relative humidity of 65% and a temperature of 68 °F for a period of at least 72 hours. They were then subjected to five mechanical tests using a universal testing machine, following standard ASTM D-143 test procedures (Reference 3). Both the average moisture content and specific gravity value for each specimen also were determined.

Photo 29. Specimens cut and conditioned in a chamber at 68 percent humidity and 67 °F.

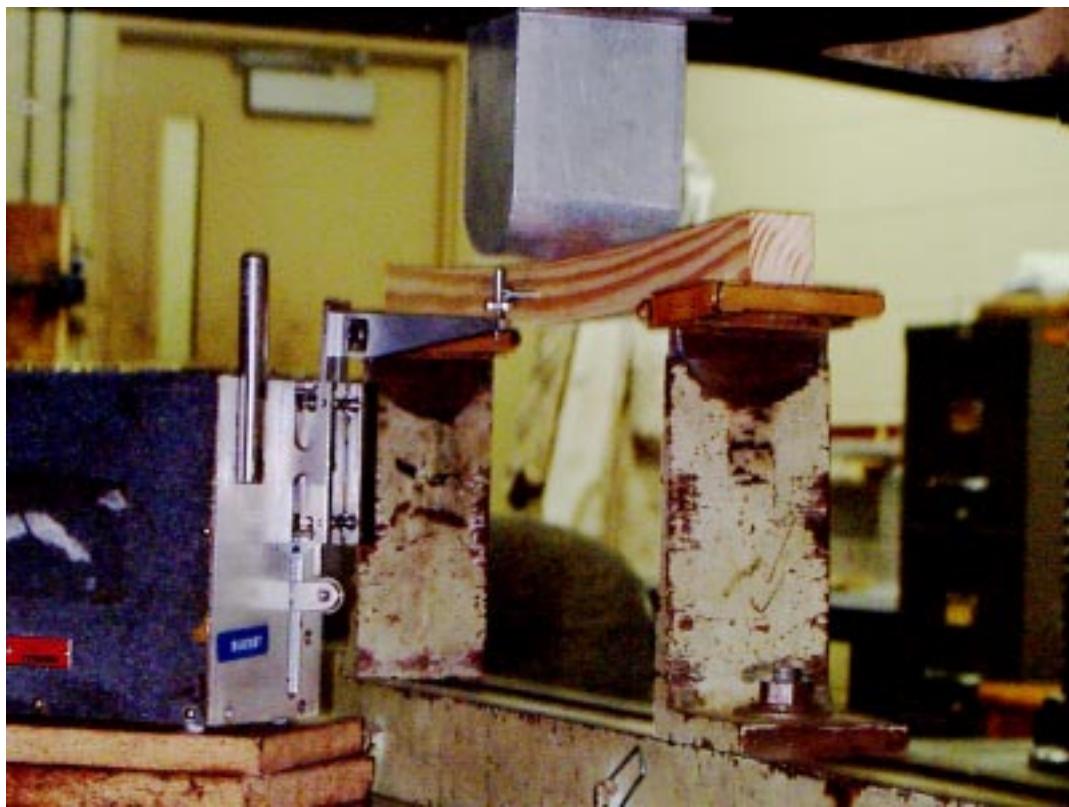
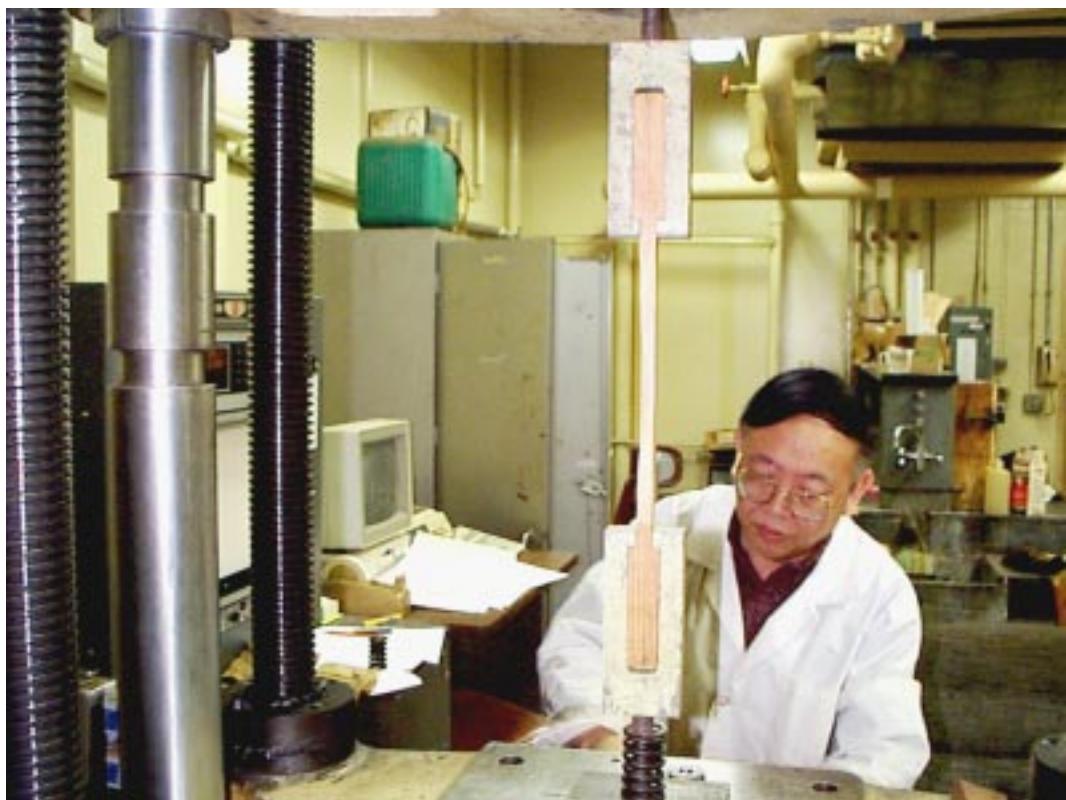
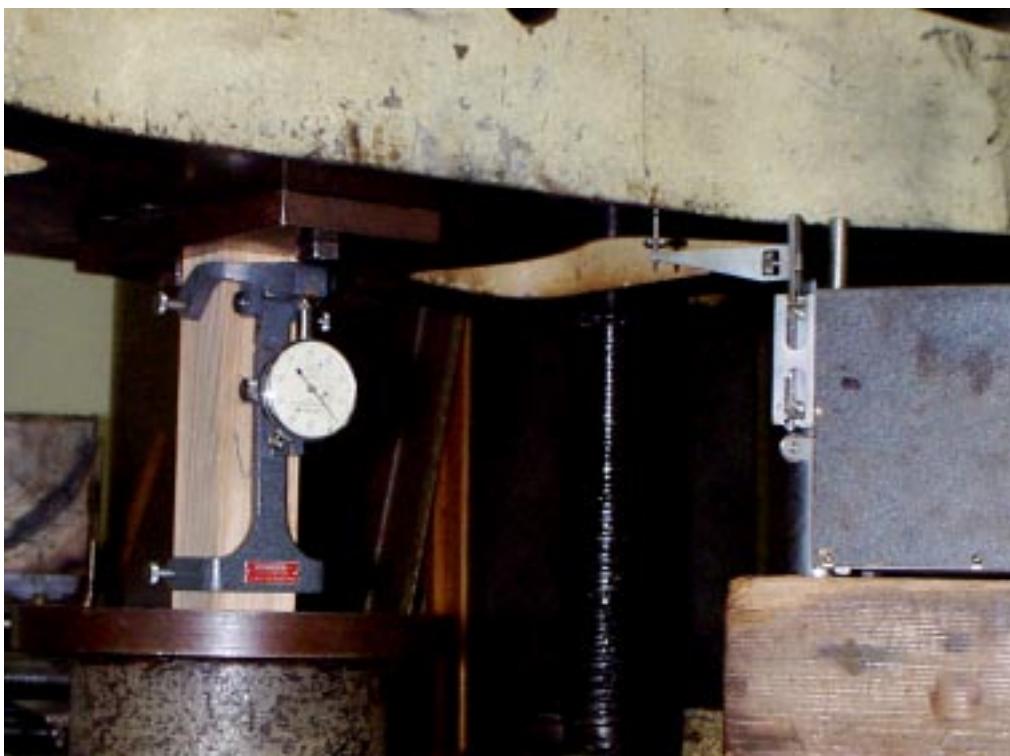
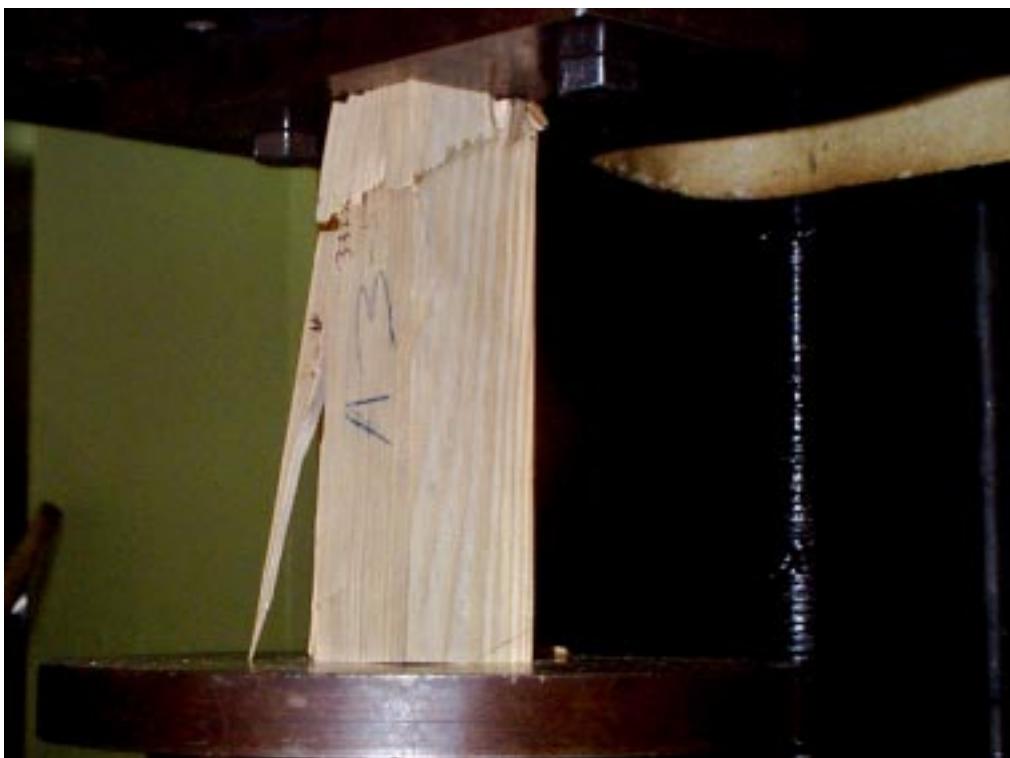
Almost all of the static bending tests showed a simple tension failure at mid-span of each specimen. In tension testing parallel to grain, more than 50% of the specimens did not fail at the mid-section. The mid-section is usually considered the weakest area because it tends to have a smaller cross-section than the ends. This result confirms that wood is not a homogeneous material. The test results for every specimen were recorded in a load-deflection chart.

Photo 30. Static bending test.

Photo 31. Tension parallel-to-grain test.

Photo 32. Shear parallel-to-grain test.

Photo 33. Typical failure for compression parallel-to-grain test.

Photo 34. Compression parallel-to-grain test with deformation gauge.

Photo 35. Compression perpendicular-to-grain test.

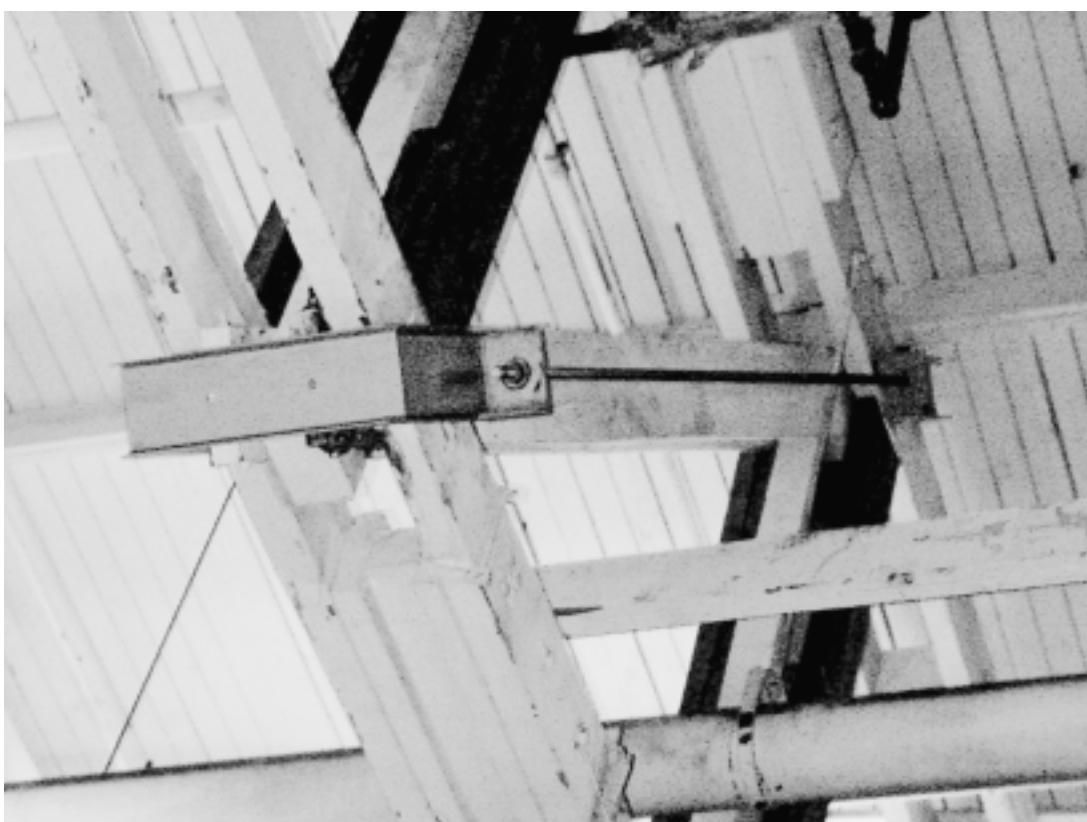
Photo 36. Endorsed repair for a fractured diagonal member.
