US Army Corps
of Engineers
Construction Engineering
Research Laboratories

USACERL Technical Report 99/25
SFIM-AEC-ET-CR-98009
February 1999

Evaluation of Two Washrack Recycle Treatment Systems

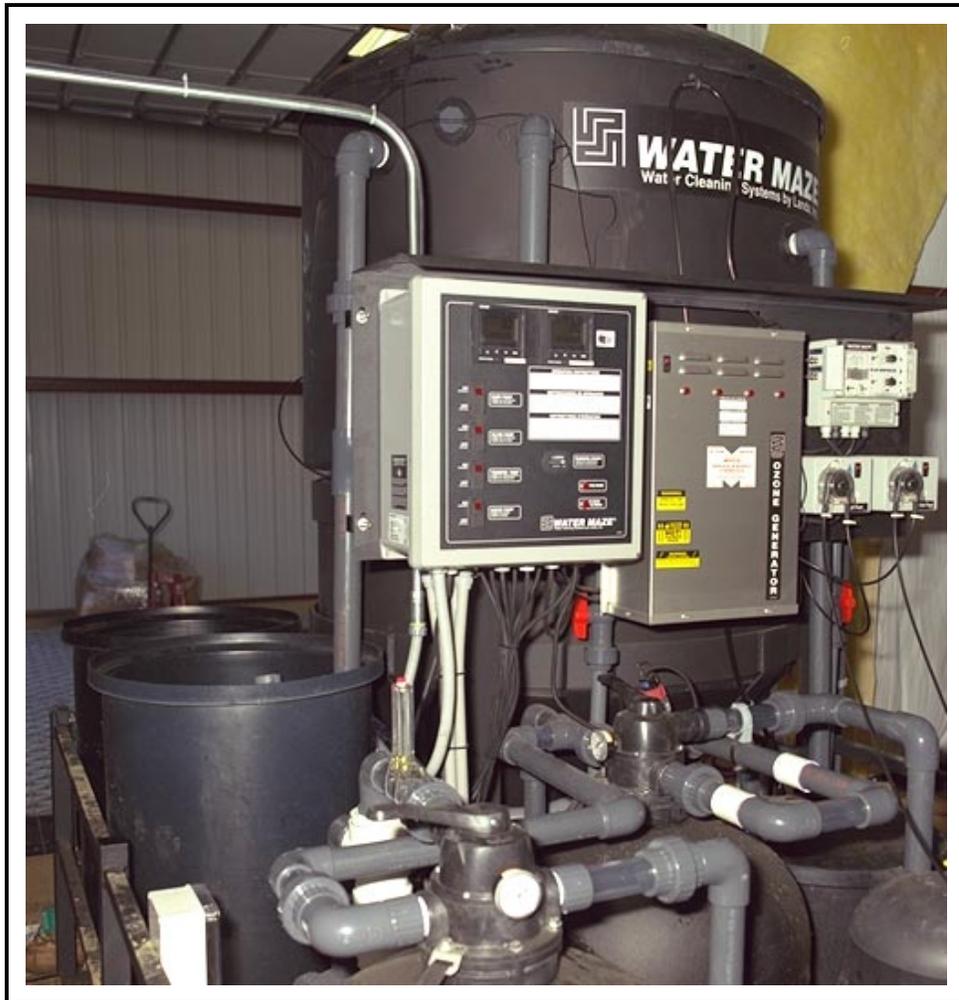
Figure 1. Landa system in Building 338, Aberdeen Test Center.

The Landa Model 7023A is a commercial off-the-shelf, self-contained, aboveground, washwater recycling system. The system is skid mounted and is fitted with various wastewater treatment components designed to remove contaminants typically found in heavy maintenance wash applications. Figure 1 shows the Landa system installed at the Aberdeen Test Center Building 338 washrack. Figure 2 shows the schematic of the Landa system being evaluated.

The major components are: 600-gal clarifier tank (CLP), coalescing plates, oil skimmer, Carbasorb Filter, Process Water Manifold System, Cartridge Filters, Multi-Media Filter, control panel, oxidation reduction potential (ORP)/pH controller, Series 400 Ozonator and pump assembly, sludge disposal system, and sump pump (Landa pamphlet).

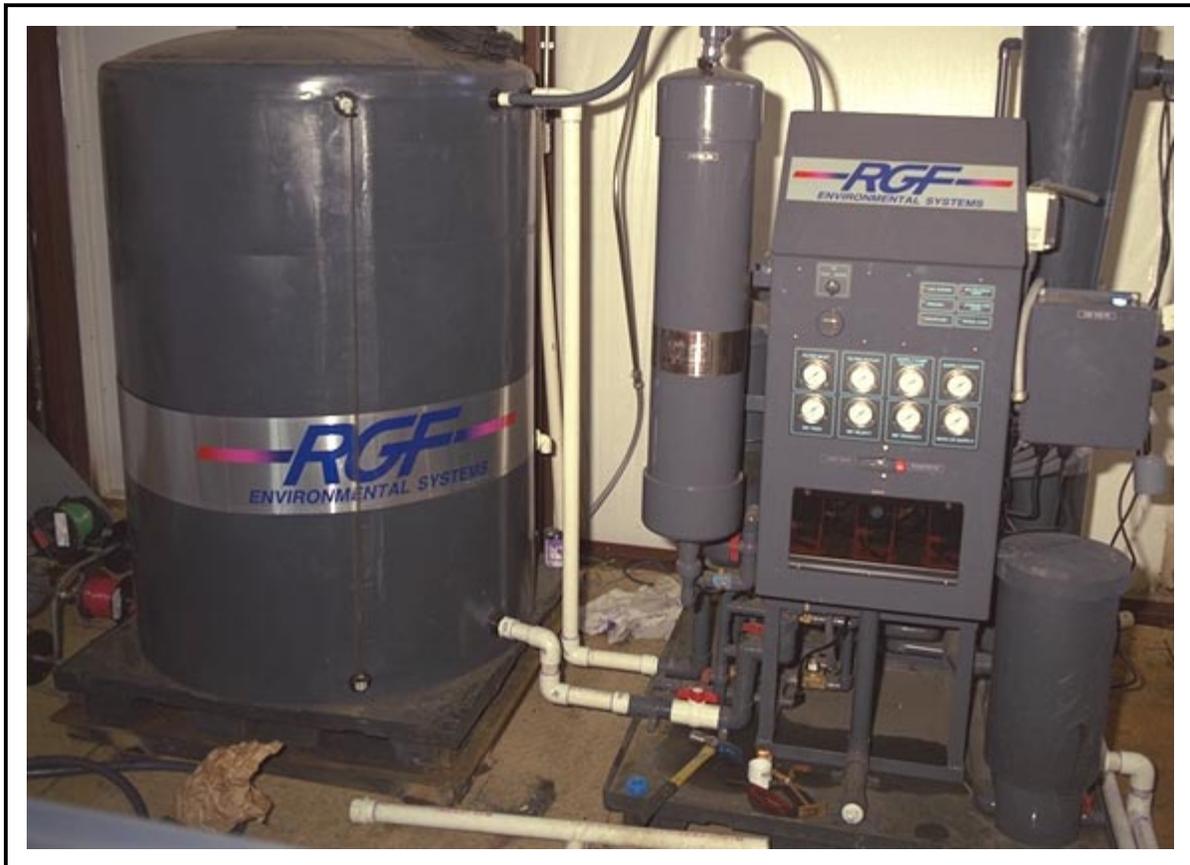
Figure 3. RGF system in Building 338 washrack, Aberdeen Test Center (Series I tank not shown).

The RGF Model ST² is a commercial off-the-shelf, self-contained, aboveground, washwater recycling system. The system consists of various wastewater treatment components designed to remove contaminants typically found in heavy maintenance wash applications and a storage tank for the cleaned/treated water. The major components are Series I Tank, Series II Skid, and Storage Tank.

1. The Series I Tank is of polyethylene construction and contains the following components: Aeration Tower, Oil Skimmer, Hydrocarbon Accumulator, Incline Polypropylene Tube coalescer, HCA-2 Absorber, Micro-Matrix coalescer, and Multi-Media Filter.
2. The Series II Skid contains the following components: Process Pump, MS³ Membrane (optional, not used during this test), two CFC System Pumps, XL UV Catalytic Chamber, XL Turbohydrozone®, Chemical Injection Pump, pH Controller (optional), Hydrocarbon Absorber, Control Panel, and Coalescing Centrifugal Separator.
3. The Storage Tank is steel-reinforced, poly construction with a 550-gal capacity. The tank is fitted with a Manway and Tank Level Sight Tube. The tank is skid mounted.

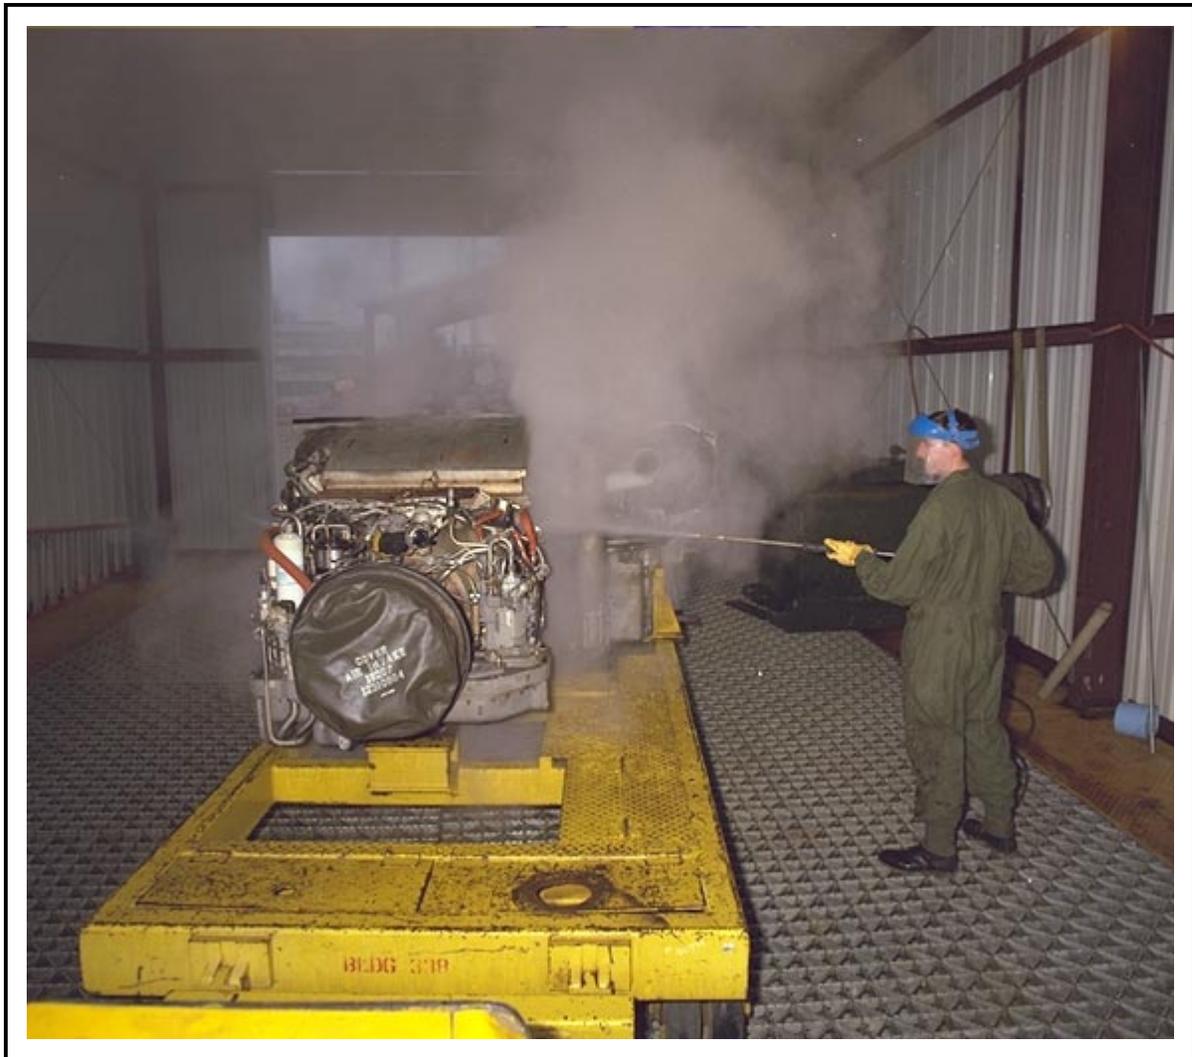
Figure 5. Washing equipment at Building 338 washrack.
