Gate #2 test area

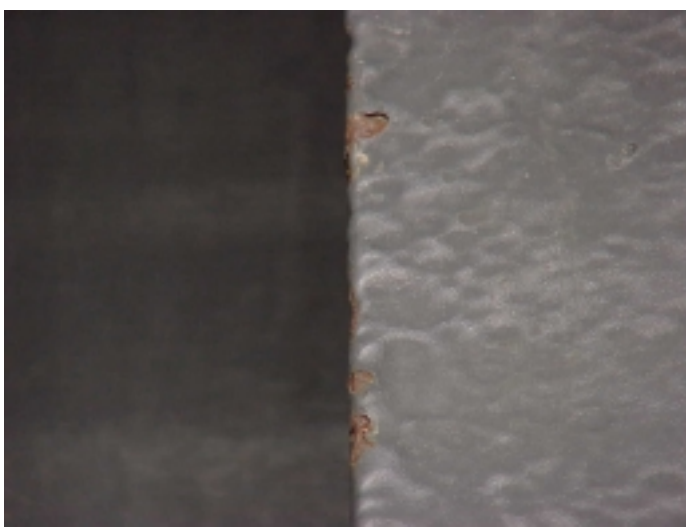
Eroded edge on angle brace due to debris
