ERDC/CERL MP-04-1

Fury: Robotic In-Situ Inspection/ Condition Assessment System for Underground Storage Tanks

March 2004

Final Report

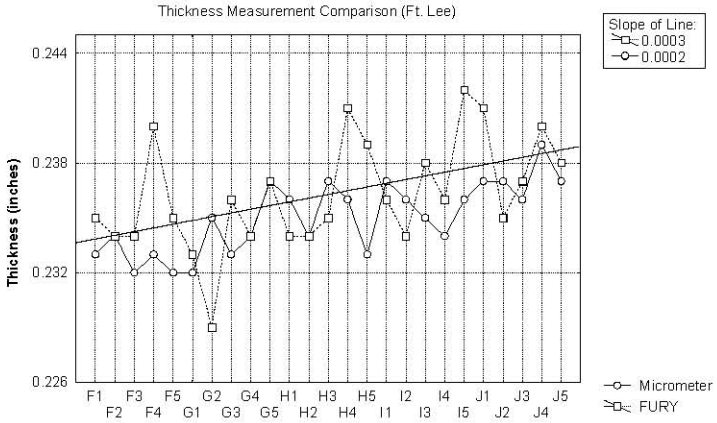
Figure 3. Mechanical vs. Fury Thickness Measurement (Bottom, Middle)

The in-situ *Fury* and ex-situ micrometer measurements are shown in Figures 3 through 5. Laboratory analyses of the three 5x5 grid pattern readings were performed in accordance with ASTM G46 [8]. In addition, MRI performed independent ultrasonic measurements on a different grid system in accordance with an EPA procedure for the field evaluation of USTs. The comparison of the measurements is given in Table 1. The external hand-held ultrasonic measurements taken by MRI [9], which were almost identical to those called for by NLPA 631[4], were, when considered alone, inadequate to determine the tank's condition. In fact, no measurement indicating a remaining wall thickness less than 50% of the original value (nominal 0.375 in.) was found. *Fury*, however, found several locations with wall thicknesses below 0.15 in. (see Figure 6).

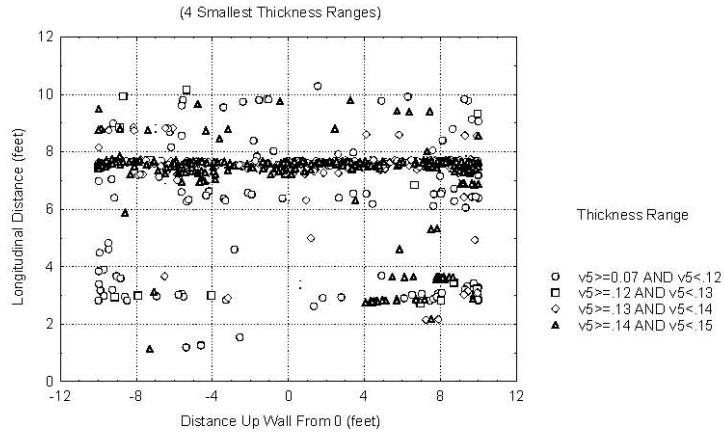
Figure 6. Location Distribution of 1,000 Thinnest Wall Thickness Measurements

One of the main advantages of the *Fury* robotic system is its ability to rapidly collect data while the unit is in motion. Virtually all of the data from Fort Lee were taken during the last day of a week-long effort after a number of other validation tasks had been completed. Table 2 shows the results of a statistical analysis for the full data set as separated into tank wall and end caps (which typically have a larger initial wall thickness). The *Fury* data can be displayed in a number of ways. With position coordinates associated with each measurement, the positions of the thinnest measurements can be displayed. Figure 6 shows the four thinnest ranges of measurement for the curved tank wall (displayed as if viewed from above and opened to each side from a longitudinal top seam). A feature along a lower circumference approximately 8 feet from the southern end cap is evident.

This feature was visually confirmed after the tank was removed. One possible explanation is that, during installation, a lifting strap caused some initial damage, which over time led to differential corrosive attack.

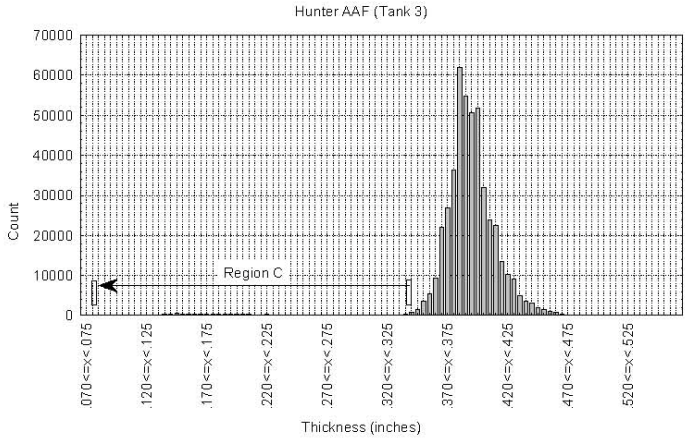
Figure 7. Tank 3 Thickness Distribution

The *Fury* inspection showed that tanks 3 and 4 were in good shape while tank 5 clearly showed a large number of observations at the lower thickness ranges. These observations combined with the findings from the external corrosion evaluation procedures, as required by ASTM ES40-94 [5], indicated that tanks 3 and 4 were considered suitable for upgrade while tank 5 was not. From a corrosion engineering viewpoint, the character of the wall thickness histograms is intriguing. It may be that, as a tank undergoes the accumulated damage of corrosive degradation, the condition represented by Figures 8 and 10 evolves more toward a condition represented by Figure 12.
