ERDC/CERL TR-01-11

Structural Evaluation of Aircraft Hangar 46, Corpus Christi Army Depot

Ghassan K. Al-Chaar, Daniel J. Randolph,
Gregory E. Lamb, and Pramod J. Desai

February 2001

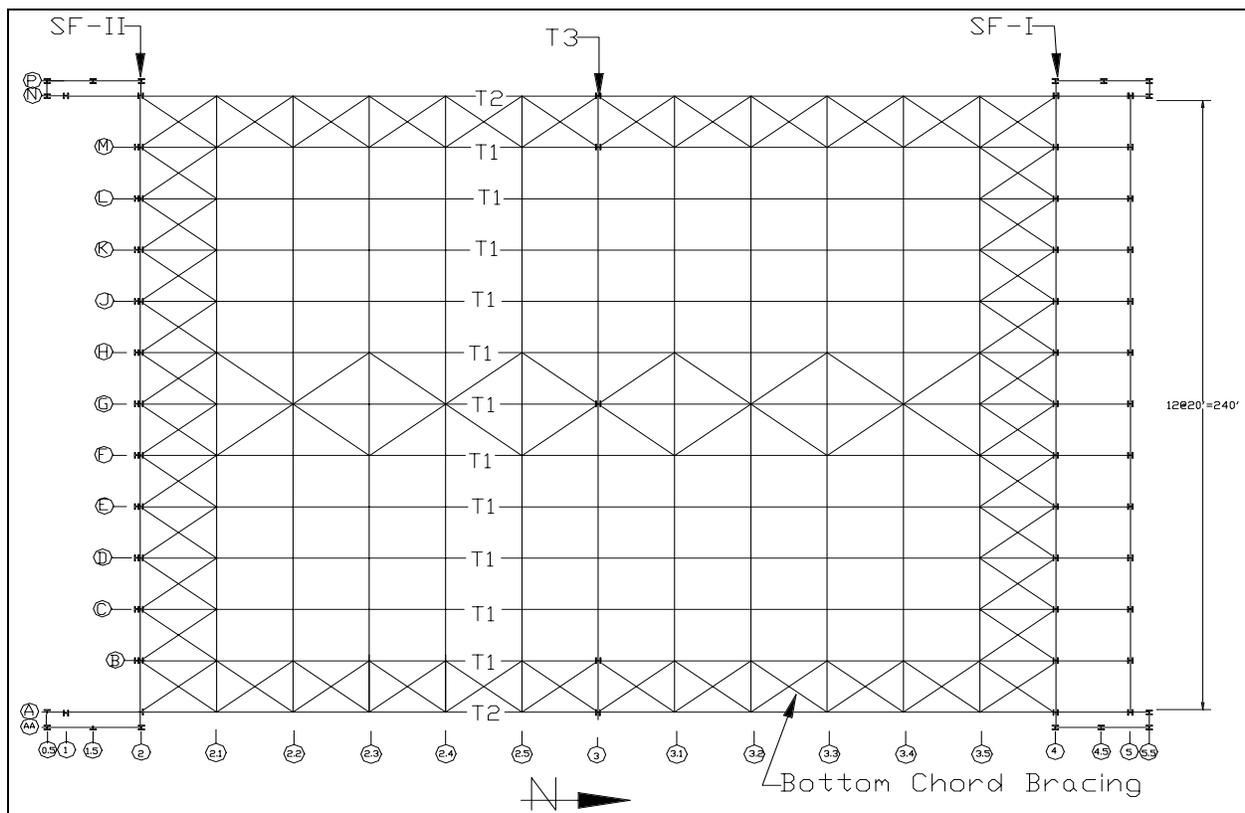
Figure 4-1. Plan view and location of truss types.

There are five different typical trusses in Hangar 46. The locations of the trusses in plan for the hangar were taken from NAVFAC drawing 1353171. There are 11 trusses called T1 in the main interior that run north-south. Two type-SF trusses, one at each end, and one type T3 truss run perpendicular to the T1 type trusses. The T1 trusses span from SF at the north and south ends of the hangar area to the center truss called T3. There are two T2 trusses, again spanning from SF to T3, on the exterior edges above the hangar doors. The north end of T1 and T2 trusses are braced with moment-resisting frames. T3 vertically supports all T1 and T2 trusses at their center and provides lateral bracing. The SF trusses support the T1 and T2 trusses at each end, vertically and laterally in the east-west direction. The T1 and T2 trusses are laterally braced at the bottom chord members by horizontal diagonal bracing and channel sections, as seen in NAVFAC drawing 1353171. There are two types of SF trusses, SF-I and SF-II. Both the loading and structure of each type is distinct. SF-I is found at the north end, where there are braced bays with offices and storerooms; SF-II is found at the south end, where there are no braced bays, just an outside wall. Figure 4-1 shows the plan view of Hangar 46.

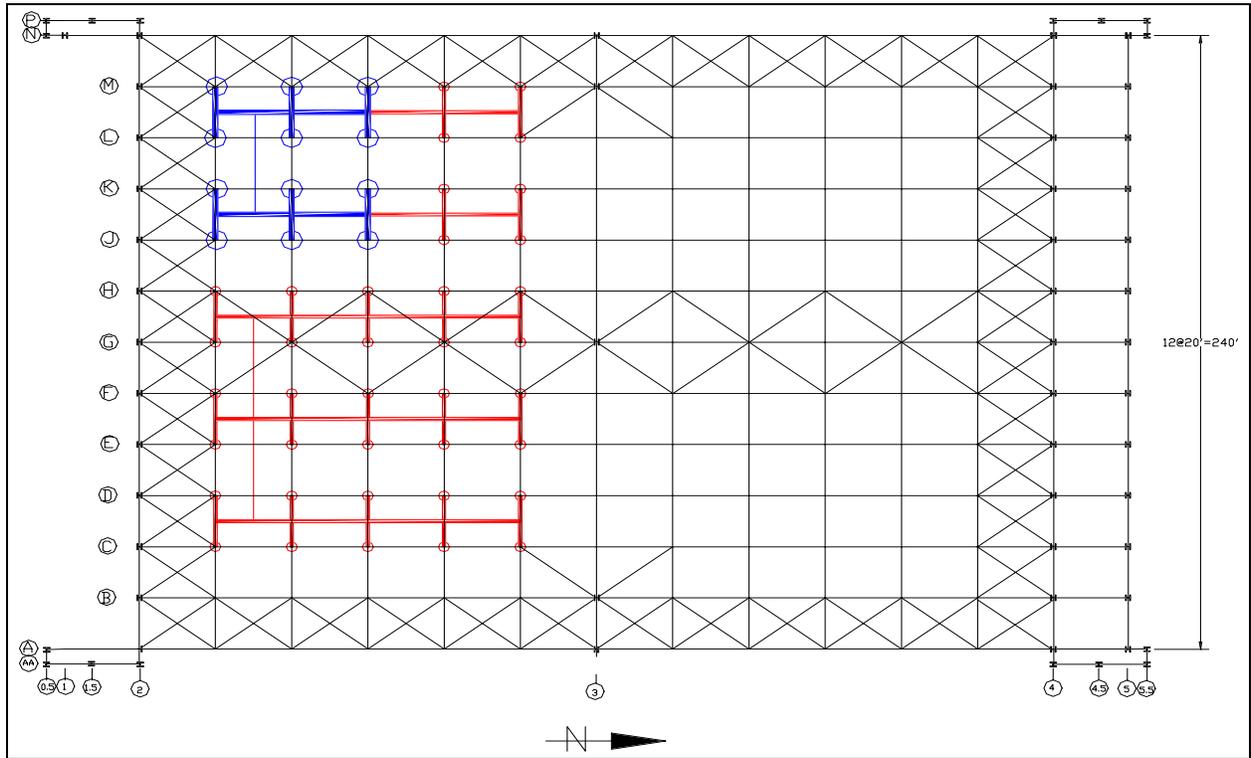
Figure C-1. Location of current and proposed railway crane.

Attached as Appendix C is a memorandum pertaining to the crane installation in Hangar 46, including a diagram of the current and proposed crane locations and a photograph of the current system in Hangar 46. It was submitted by the project team's structural engineer as an initial opinion on the safety of expanding the crane system. The recommendations were based on the assumption that the existing crane system is safe according to current codes. However, after structural analysis it was determined that Hangar 46 requires some structural rehabilitation because the old crane system puts stresses on trusses T1 and T3 that exceed AISC ASD 89 allowable limits. Therefore, retrofit as proposed in Chapter 8 is necessary.
