**US Army Corps
of Engineers**

USACERL Technical Report 96/77
July 1996

Investigation of Preapproved Underground Heat Distribution Systems

by
Charles P. Marsh, Nicholas M. Demetroulis, and James V. Carnahan

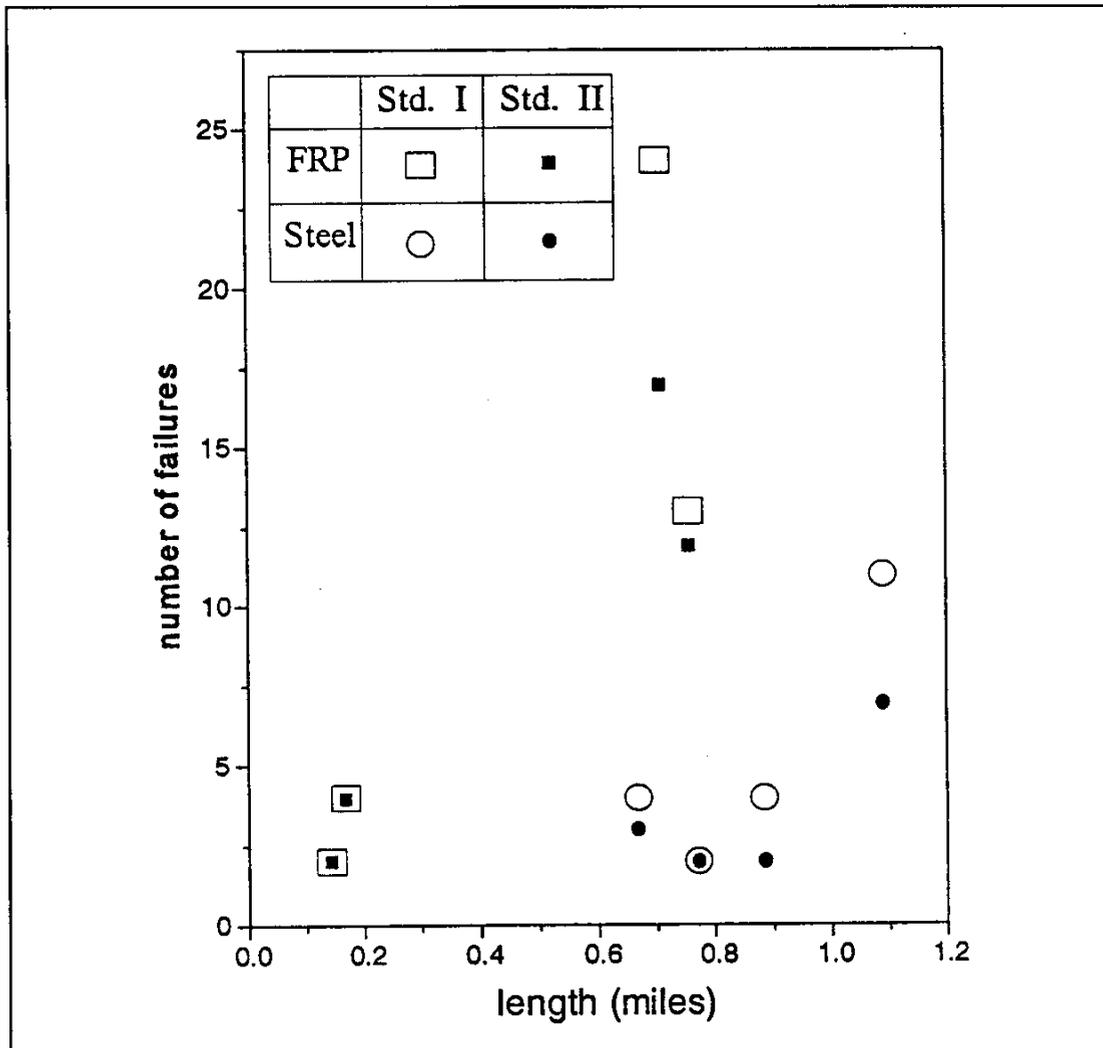
Figure B2. Number of failures versus lengths.

Time frame	Steel				FRP			
	Age (years)	Length (mi)	Failures		Age (years)	Length (mi)	Failures	
			I	II			I	II
1981-83	11.40	0.88	4	2	10.00	0.14	2	2
1984-86	8.13	1.09	11	7	7.68	0.17	4	4
1987-89	4.78	0.67	4	3	5.78	0.70	24	17
1990-92	2.87	0.77	2	2	3.00	0.76	13	12.00

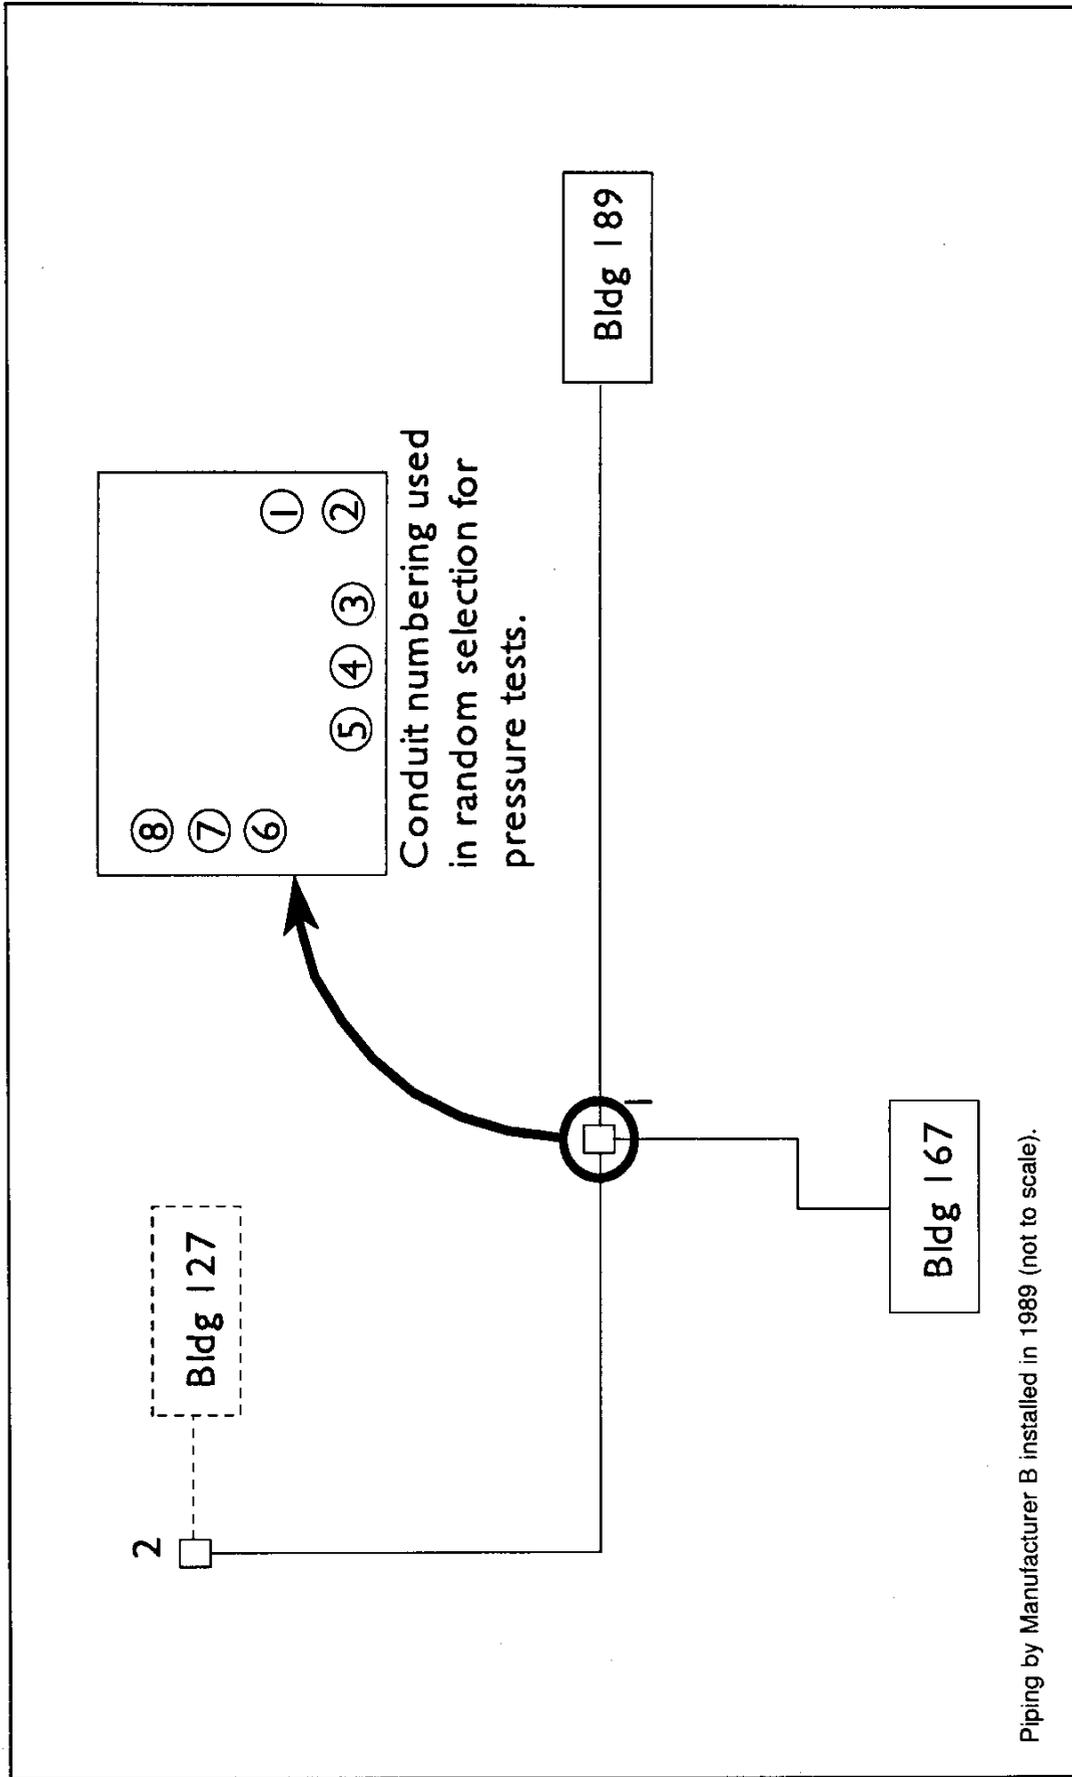
Figure D1. Schematic diagram of System 3 at Wright-Patterson AFB, OH.

This system consists of piping from Manufacturer B and has a steel conduit (Figure D1). The work was done under Project No. 149-7 dated 27 December 1988 entitled "Replace Steam Supply and Return Line." The contract was for the replacement of high- and low-pressure condensate return lines and steam lines between two manholes and Buildings 167 and 189. The lines connecting Building 127 to the system were not part of this contract. The system drawings show a cathodic protection system containing 12 sacrificial magnesium anodes.

- a. Equipment Room - Building 189—Steam and condensate lines were contained in individual conduits. The steam conduit casing did not extend through the wall into

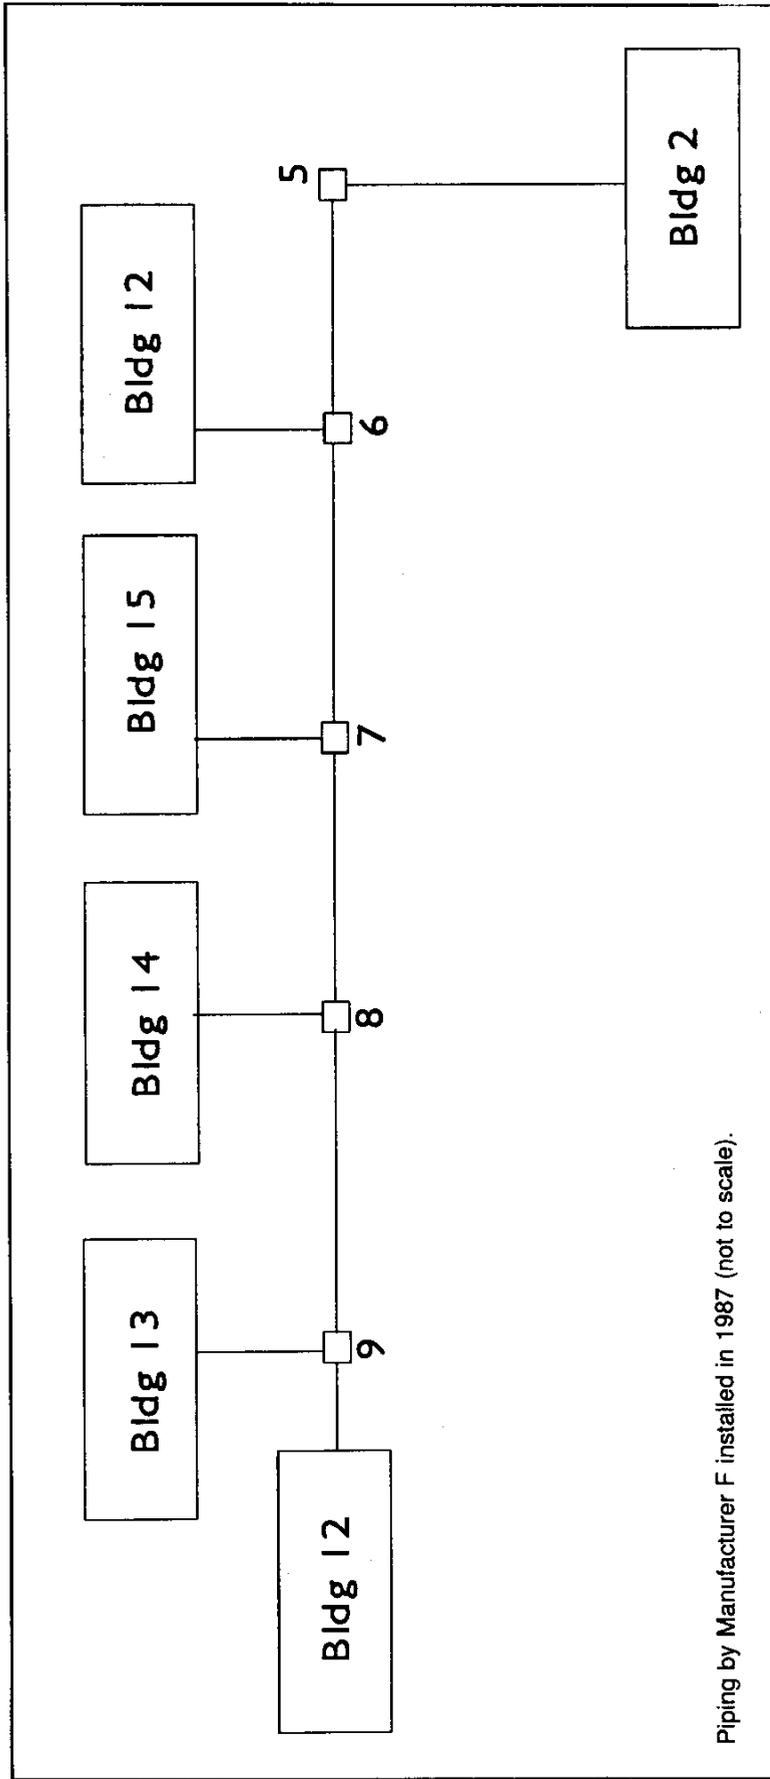
Figure E1. Schematic diagram of System 8 at VA-Bedford, MA.

This system consists of piping from Manufacturer F and has an FRP conduit (Figure E1). It was installed in 1987. The design done by Trimont Engineering Co. was "Replacement Steam Distribution System - Phase III" (Project No. 518-83-112, Project No. 013-01). The project serves six buildings in a residential complex.

a. Manhole 5—This manhole was round with a 6-ft diameter, was 9-ft deep, and was a solid concrete top design with a 30-in. manhole cover. No sump pump or means for ventilation were provided, and the manhole contained 3 in. of standing water. A

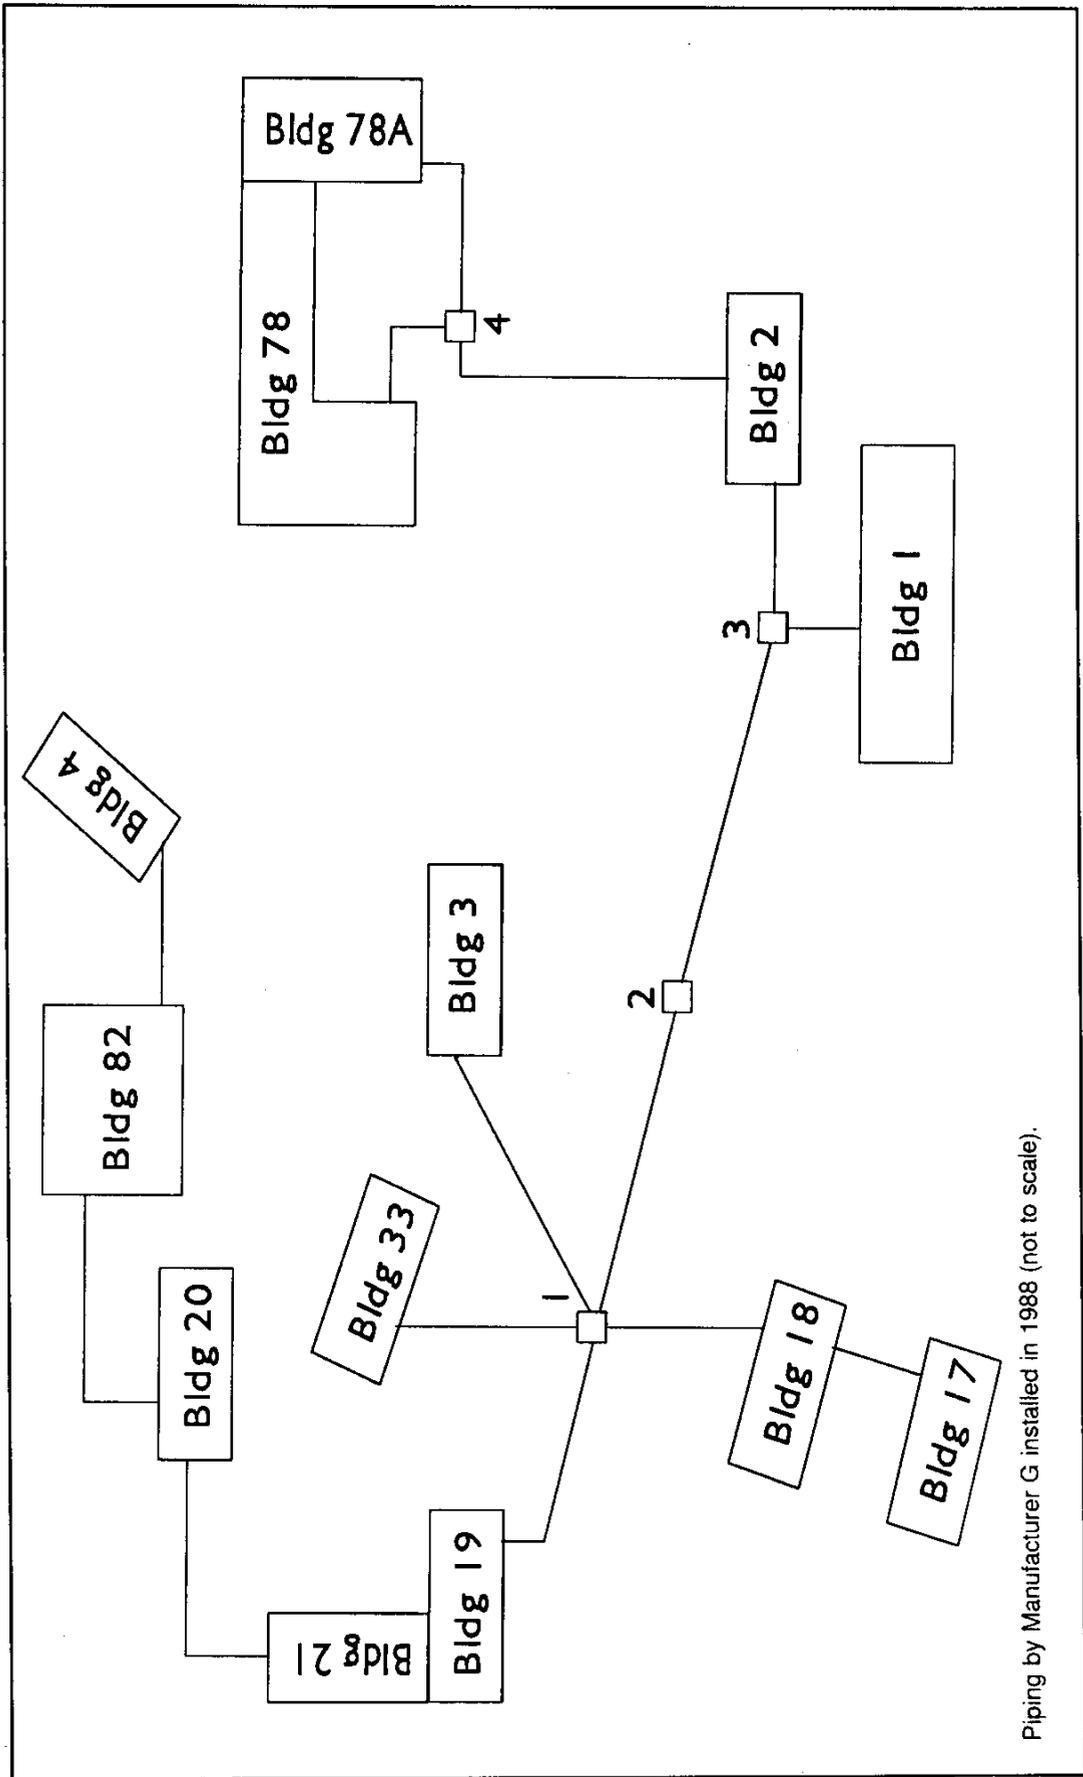
Figure E2. Schematic diagram of System 9 at VA-Bedford, MA.

a. Manhole 1—This manhole was round with an 8-ft diameter, was 11-ft deep, and was a solid concrete top design with a steel access cover. No sump pump or means for ventilation were provided. One ladder rung was missing. A drip type leak was observed at the condensate conduit coming from Building 19, and 4 in. of standing water was present in the manhole. None of the ten casing vents was steaming. All conduit penetrations were caulked and all end plate assemblies contained gland seals.

b. Manhole 2—This manhole was 4 ft x 5 ft x 4 ft deep and was a solid concrete top design with a steel access cover. No sump pump or means for ventilation were provided. The manhole was dry, and no steaming was observed from four conduit

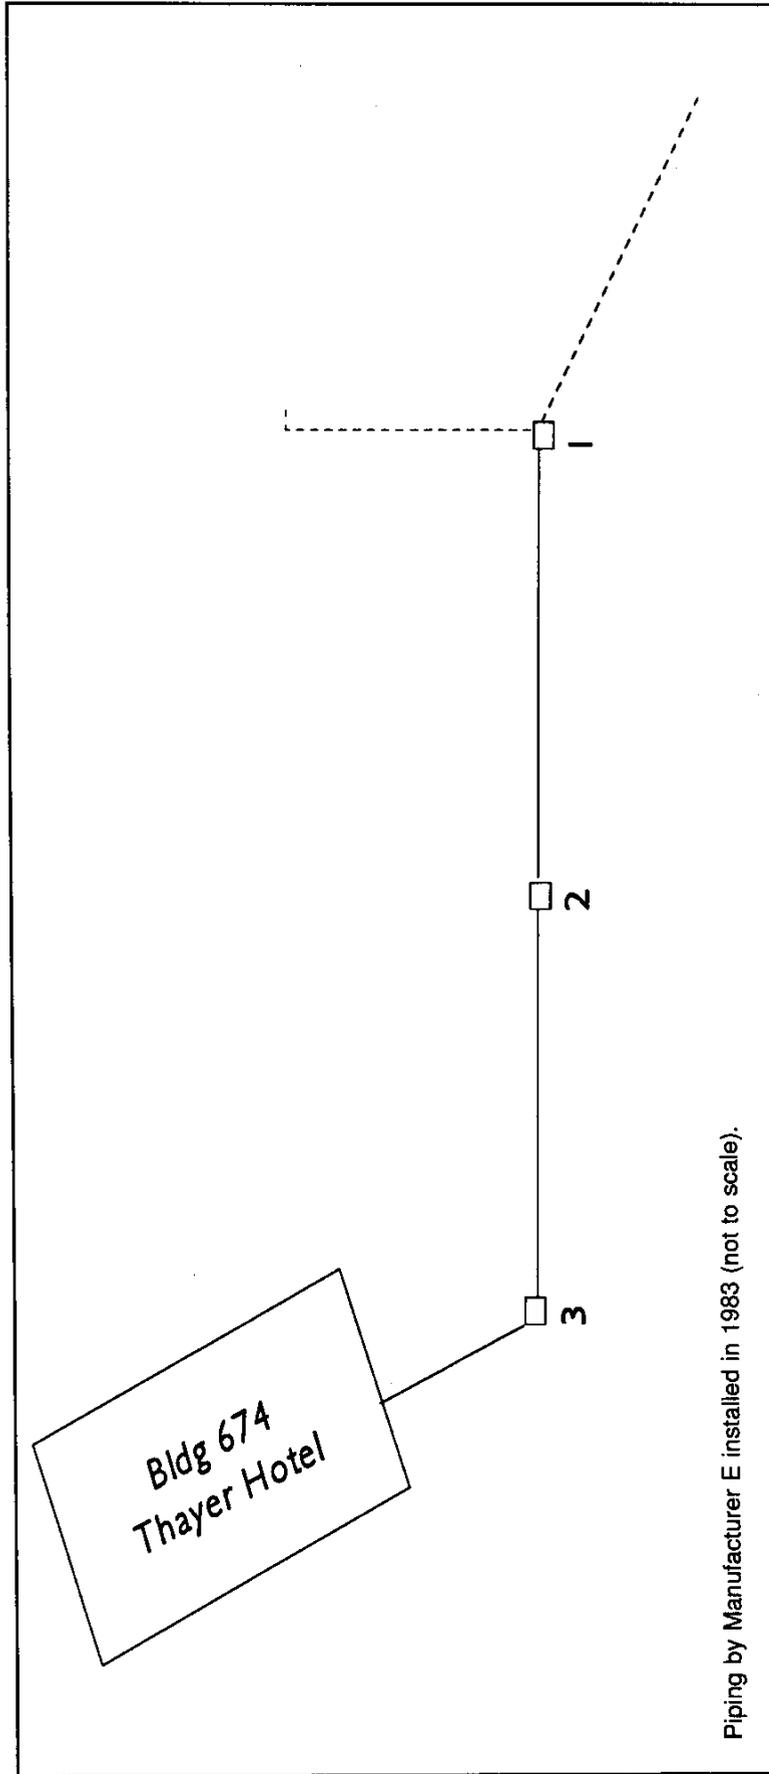
Figure F1. Schematic diagram of System 10 at USMA, West Point, NY.

a. Manhole 1—This manhole was 18 ft × 12 ft × 8 ft deep, was of the solid concrete top design, and had two 3 ft × 2 ft steel plate access hatches. The manhole was served by a steam ejector type sump pump. Steaming was observed from a 6-in. manhole vent pipe. This steaming was caused by a 1-in. discharge line from pressure regulating station relief valves being routed out of the vent pipe. The manhole was dry. Wall penetrations consisted of neatly drilled holes in the manhole walls for the installation of link seals between the conduit casings and the concrete. No conduit vents or drains were observable on runs from Manhole 2 because the end plate assemblies were buried outside of the manhole.

b. Manhole 2—This manhole was 6 ft × 9 ft × 8 ft deep, was of the solid concrete top design, and had a 3-ft-diameter steel manhole cover and an 18-in. steel covered

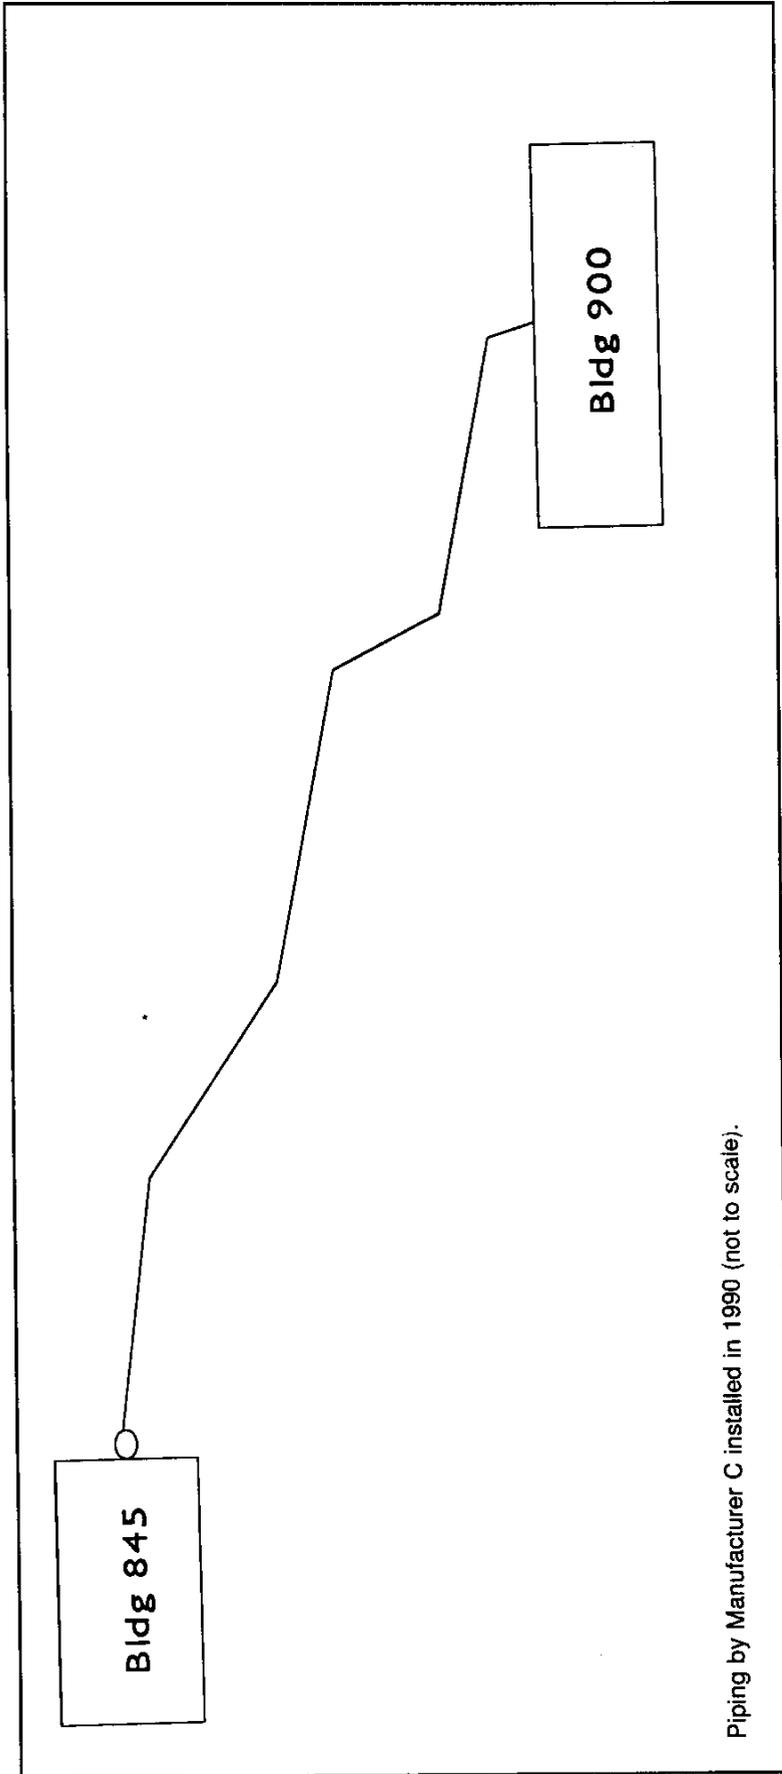
Figure F2. Schematic diagram of System 11 at USMA, West Point, NY.

b. Building 845 Entry—Both the plastic cased condensate line and the steel cased steam line rose vertically outside the building. The casings terminated about 5 ft above grade and insulated piping continued to the roof of the building. The condensate conduit riser was sealed with a shrink sleeve, while the steel conduit had a rain cap instead of a welded end plate. The unwelded rain cap prevented a pressure test of the system. The dielectric isolation flange assembly was about 1 ft above the rain cap. Both steam and condensate pipe and casings were in excellent condition with no rusting or plastic deterioration.

c. Cathodic Protection—The steel conduit had an installed cathodic protection system consisting of buried zinc anodes. The isolating flange assembly was found to lack the necessary dielectric washers and bolt sleeves needed to achieve electrical isolation. A test station was located about 10 ft from the riser at Building 845. The pipe potential was found to be -0.66V, which was insufficient and above the standard of -0.85V. An anode potential reading of 1.86V indicated plenty of remaining anode life.

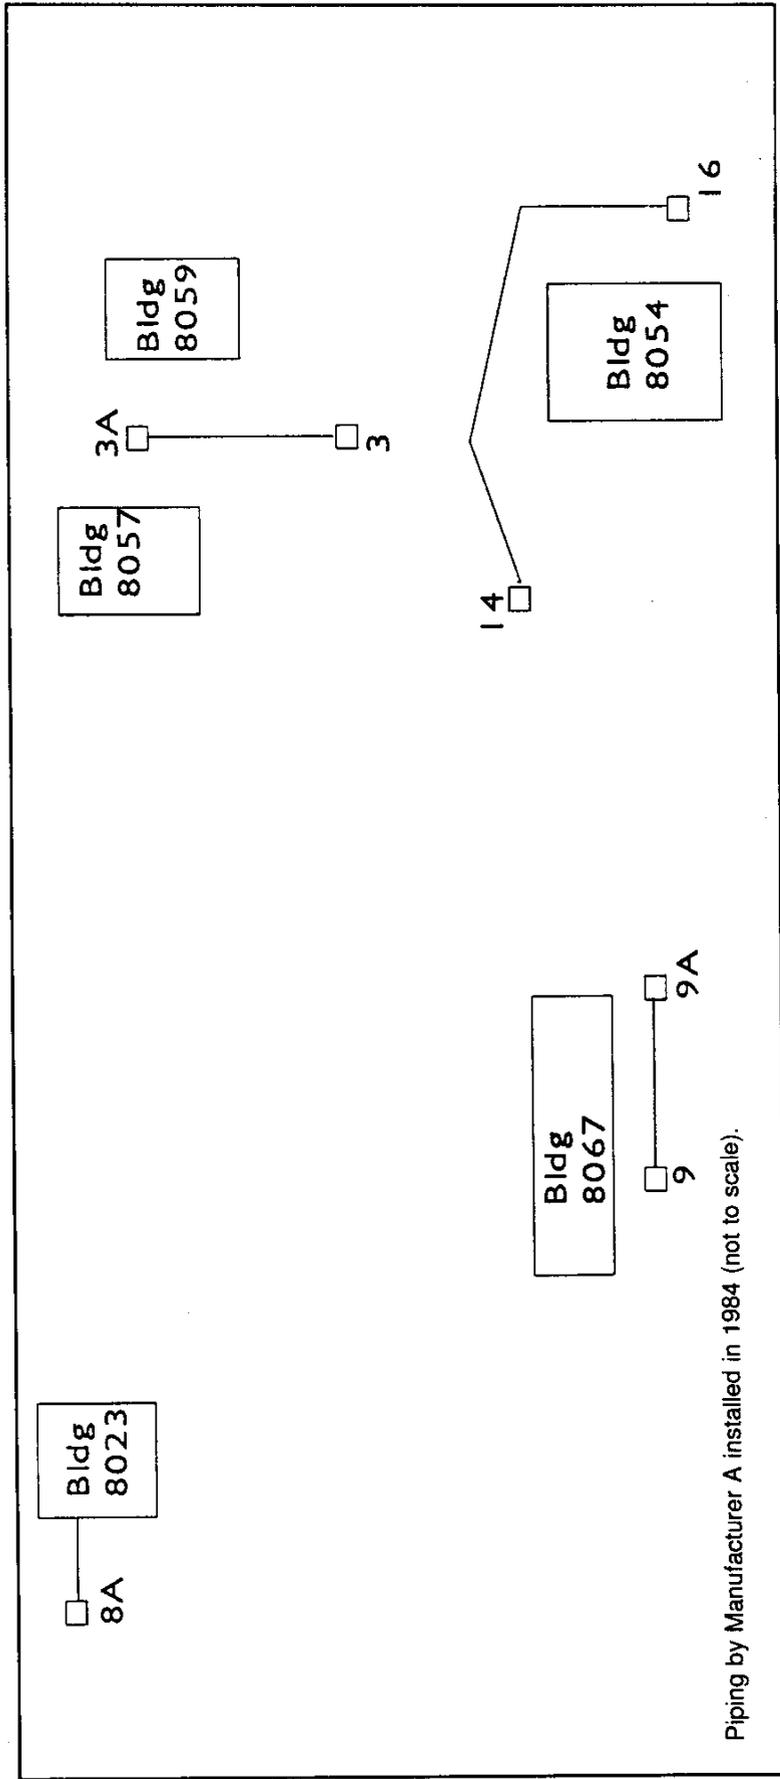
Figure G1. Schematic diagram of System 12 at Fort Riley, KS.

This system consists of piping from Manufacturer A and has a steel conduit (Figure G1). The piping was installed in 1984 and is in the Custer Hill area. Approximately 95 percent of the piping contains both steam and condensate in a common conduit. Cathodic protection has been provided, but many of the isolating flange gasket kits are incomplete. The manhole penetrations for the conduit are sealed only with caulking material.

a. Manhole 3—This manhole was 6 ft × 6 ft × 13 ft deep and was a raised top design with steel plate covers. The transition from a shallow trench system in one wall was made to buried conduits to the other three walls. Each conduit contains both steam and condensate piping. The end plate of the conduit from Manhole 4 was recessed into the manhole wall. All end plates showed minor general corrosion. The manhole was dry, and the sump pump was functioning properly. No evidence of water or steam in the conduits was found.

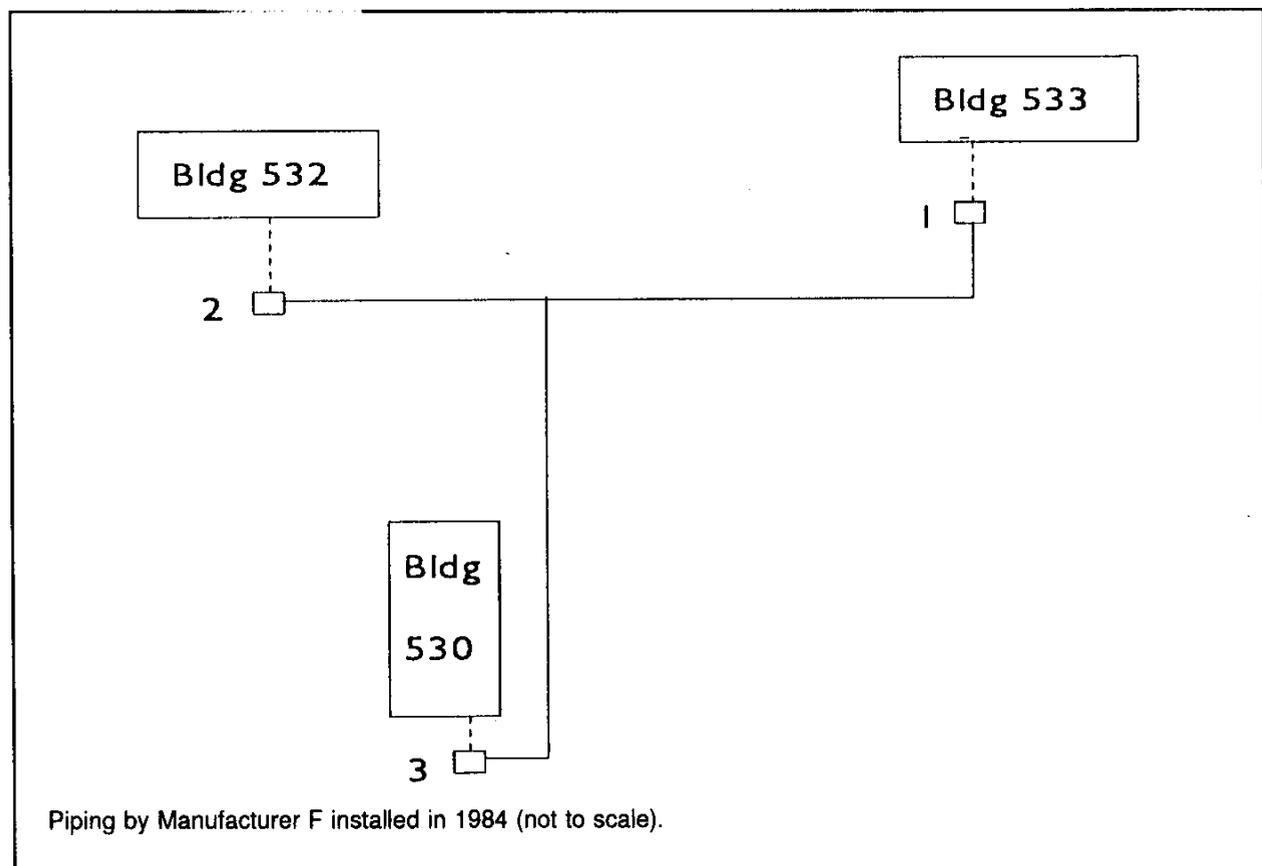
Figure H1. Schematic diagram of System 13 at Patrick AFB, FL.

a. **Street Crossing North of Boiler Plant**—This buried conduit section was about 60-ft long with risers on each end connecting to the above ground system. The supply and return lines were 6 in. and 3 in., respectively. The steam conduit riser was covered with a loose fitting 1/4-in. steel plate while the condensate riser was open. Insulation in the conduit risers appeared to be foam glass. Maintenance personnel indicated that a trap leak on the north riser required unearthing a portion of the conduit system to mount the trap assembly at a higher elevation. Neither of these conduits could be pressure tested.

b. **Along East Face of Building 312**—Here the system was above ground except for burial of condensate lines at doorways and for an extended run of 160 ft to a condensate return station. The condensate conduit risers were not sealed and appear to contain urethane foam insulation. No conduit sections could be pressure tested.

c. Building 330 to Building 400—The system transitioned from above ground to below ground without a manhole at the southeast corner of Building 330 and then ran east underground to Building 400. The riser at Building 400 was an old metallic conduit indicating that a connection was made underground with the FRP-cased system. Underground connections, especially a change in conduit material without a manhole, were not in accordance with the applicable brochure. The steam supply line was 6 in. and the condensate return was 3 in. The condensate riser southeast of Building 330 consisted of a standard end plate assembly with vent and drain openings on the casing portion of the assembly. One opening was plugged and the other was open. The steam riser was covered with a loose steel plate. The risers at Building 400 were of FRP conduit and contained end plate assemblies that were severely corroded through. The FRP material on the end plate assemblies was loose and very brittle. It was evident that the conduit runs could not hold air pressure.

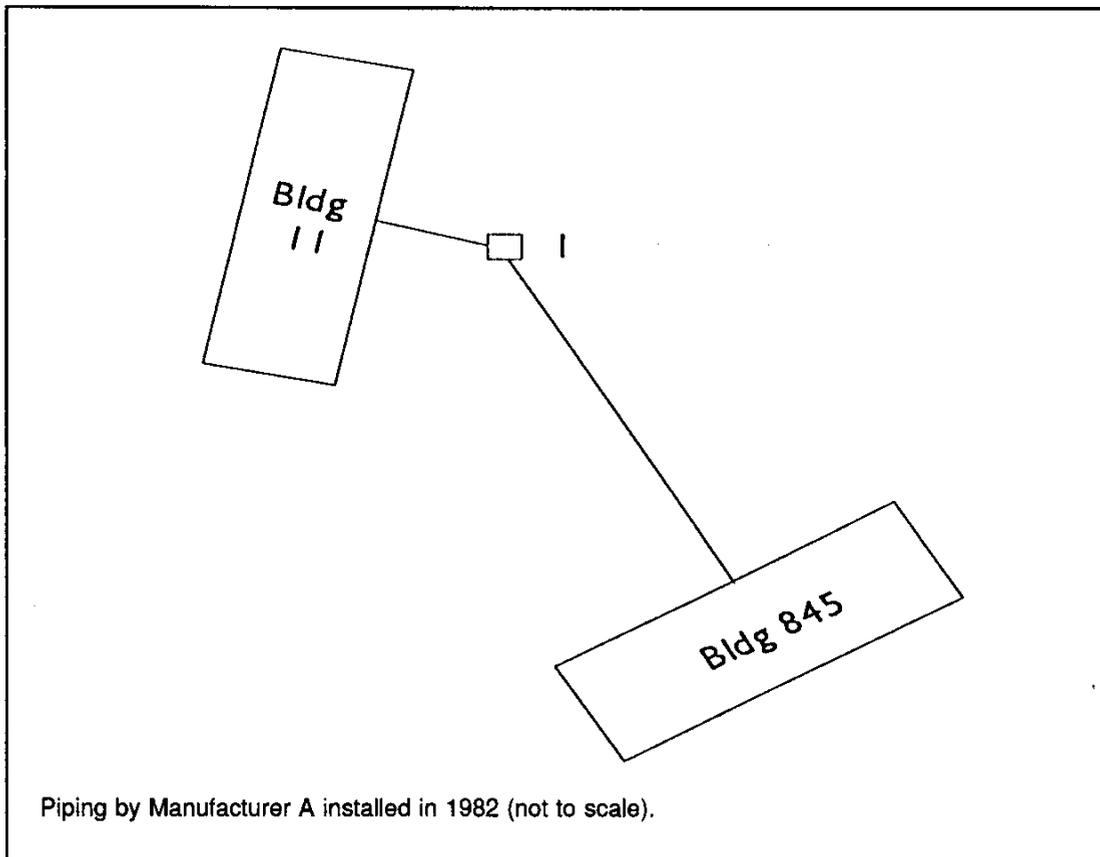
Figure 11. Schematic diagram of System 14 at Jacksonville NAS, FL.

This system consists of piping from Manufacturer A and has a steel conduit (Figure I1). The project, designed in 1982 by Architect-Engineer Evans and Hammond of Jacksonville, FL, was "Replacement of Steam Condensate Lines," Construction Contract N62427-2514 (Spec. 06-82-2514). This system is above ground except for street crossings and for service to Buildings 11, 845, and 855. Manholes were not provided at street crossing segments.

a. Transition Southeast of Building —Two side-by-side manholes are at the point where the above ground system transitions to below ground. Manhole A (7 ft × 7 ft × 5 ft deep) appeared to be part of an older system that was in use prior to 1983. The manhole top was covered with removable steel plates with no manhole vents. The manhole contained no sump pump and was dry. A 6-in. steam line and a 4-in. condensate line exited the manhole through a buried concrete trench. Maintenance personnel indicated that the 4-in. line has been abandoned and that the 6-in. line was being used for condensate return. The temperature of the 6-in. line was 170 °F. There

was evidence that a poured type insulation was used in conjunction with the buried concrete trench.

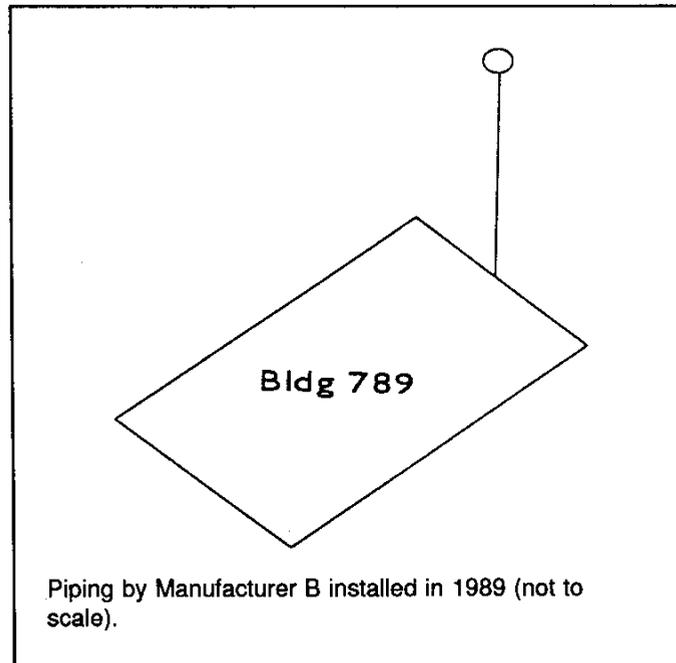
Figure 16. Schematic diagram of System 19 at Jacksonville NAS, FL.

This system consists of piping from Manufacturer B and has a steel conduit (Figure I6). It consists of a transition from above ground to below ground without a manhole. A single conduit containing both steam and condensate piping crosses Birmingham street and feeds Building 789. The riser had a loose water shed cap and the "Fostercoat" coating had some minor deterioration. The equipment room pit is 4 ft x 4 ft x 12 ft deep and has an electric sump pump. Gland seals were used at the end plates for both the steam and condensate piping. The single conduit drain was

plugged, but the vent was recessed into the pit wall and was full of concrete. The wall penetration was cemented and caulked, but slight water infiltration was noted. Some water seepage was also evident at an old wall penetration. A pressure test could not be performed because of the rain cap.

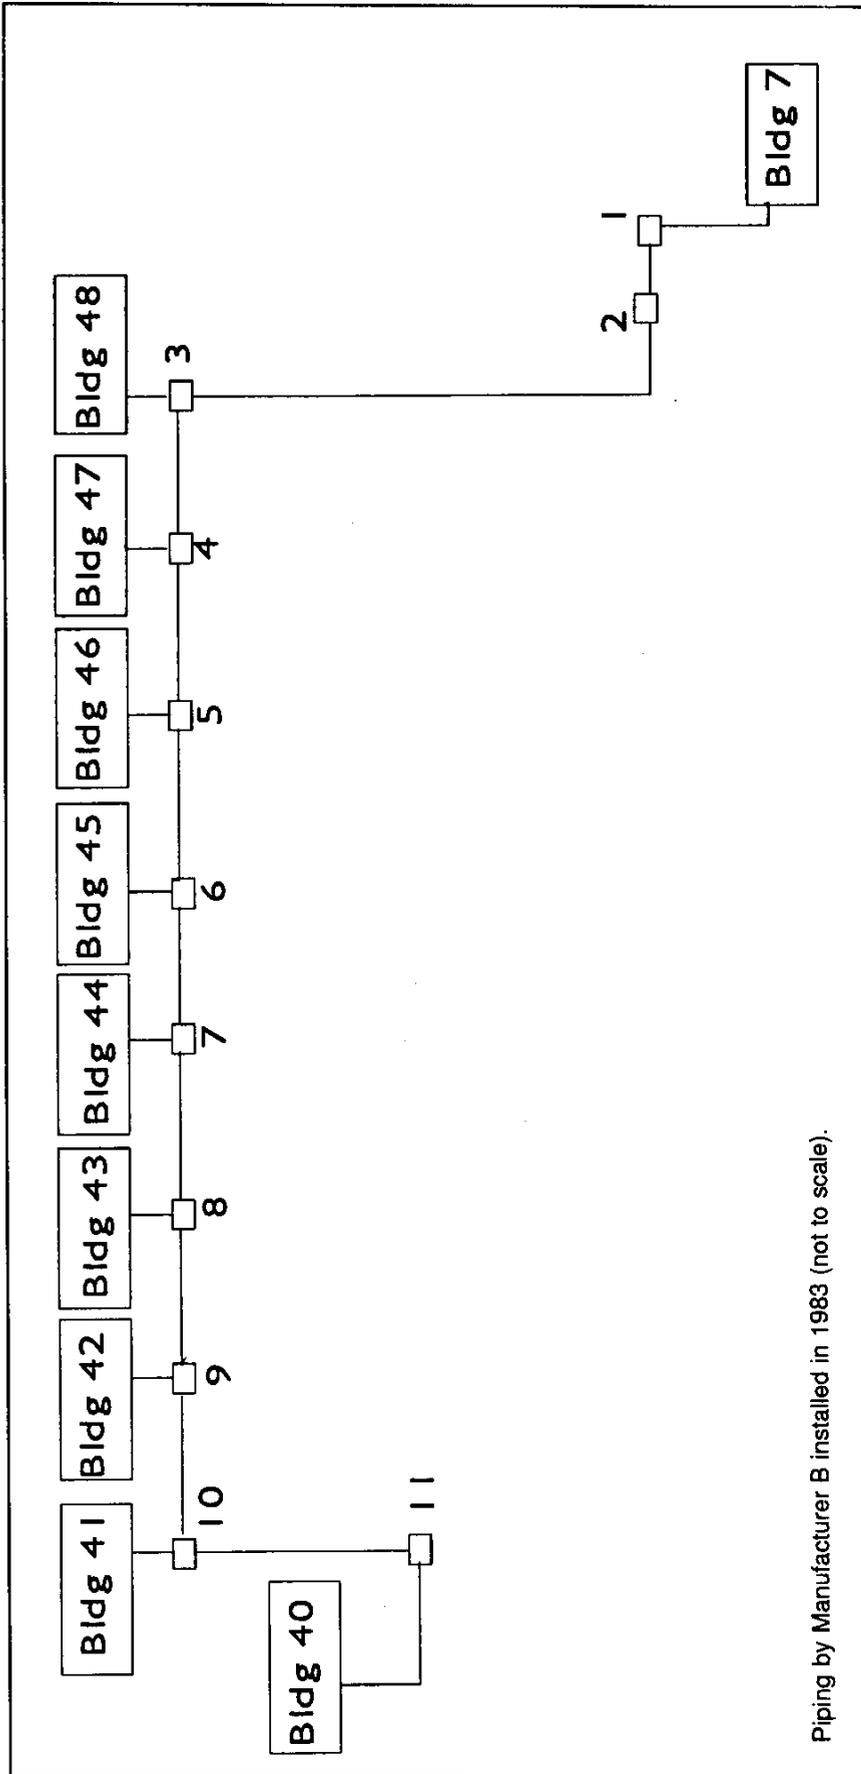
Figure J1. Schematic diagram of System 20 at Mayport Naval Station, FL.

a. Manhole 1—This manhole was 8 ft x 5 ft x 10 ft deep and was northwest of Building 7. The manhole had removable heavy steel plate tops with no manhole vents. No entry ladder was installed. Water in the manhole indicated that the steam jet sump pump was not operational. The 6-in. steam line was contained in a 13-in. conduit. A gland seal was installed at the conduit end plate. The manhole was extremely hot and could not be entered.

b. Manhole 2—This manhole was essentially identical to Manhole 1.

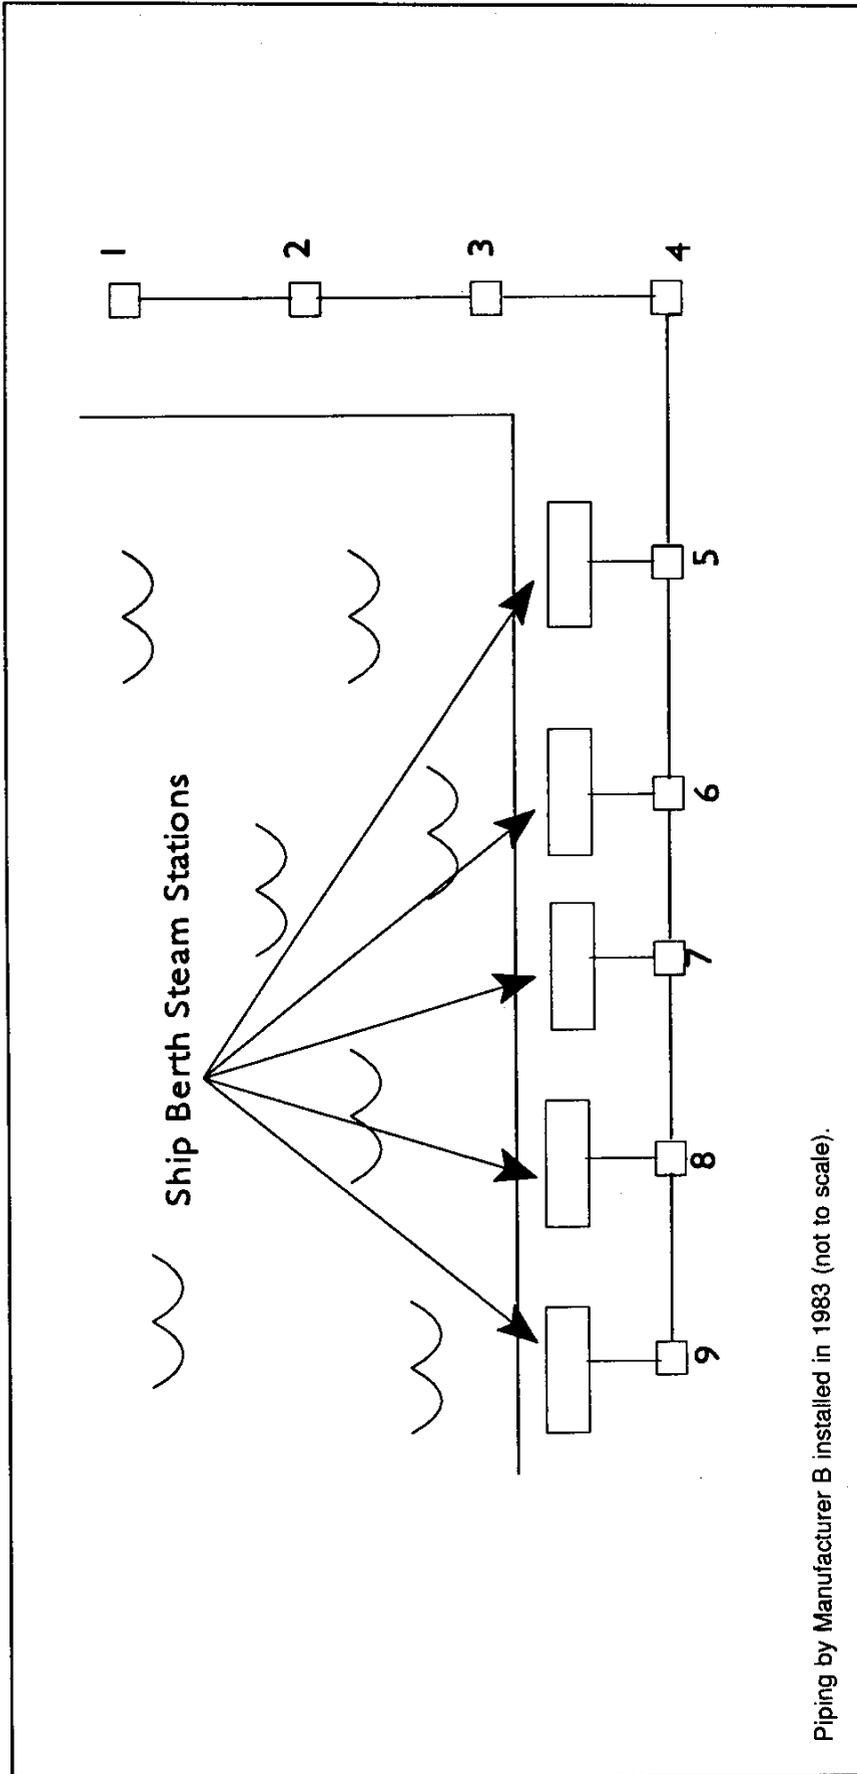
Figure J2. Schematic diagram of System 21 at Mayport Naval Station, FL.

Installed in 1983, this system consists of piping from Manufacturer B and has a steel conduit (Figure J2). A series of nine manholes serves a pier located about 800 ft north of Building 46. No condensate return piping was used. All manholes were of similar construction and design. The manholes were 6 ft × 6 ft × 10 ft deep, and most had one 6-in. manhole vent pipe. Each had solid concrete tops with 30-in.-diameter access with steel covers. No access ladders had been installed. Manhole wall penetrations were cemented and caulked. Gland seals were installed at the conduit end plates. The 8-in. steam line was contained in a 15-in. conduit. Light to very heavy steaming in all but the last manhole prevented entry for inspection. Steam escaping at a fitting was noted in Manhole 8. The last manhole at the end of the pier, Manhole 9, had no steaming but was still too hot to enter. A cathodic protection test station was found near the last manhole, but no dielectric flange connections had been installed.

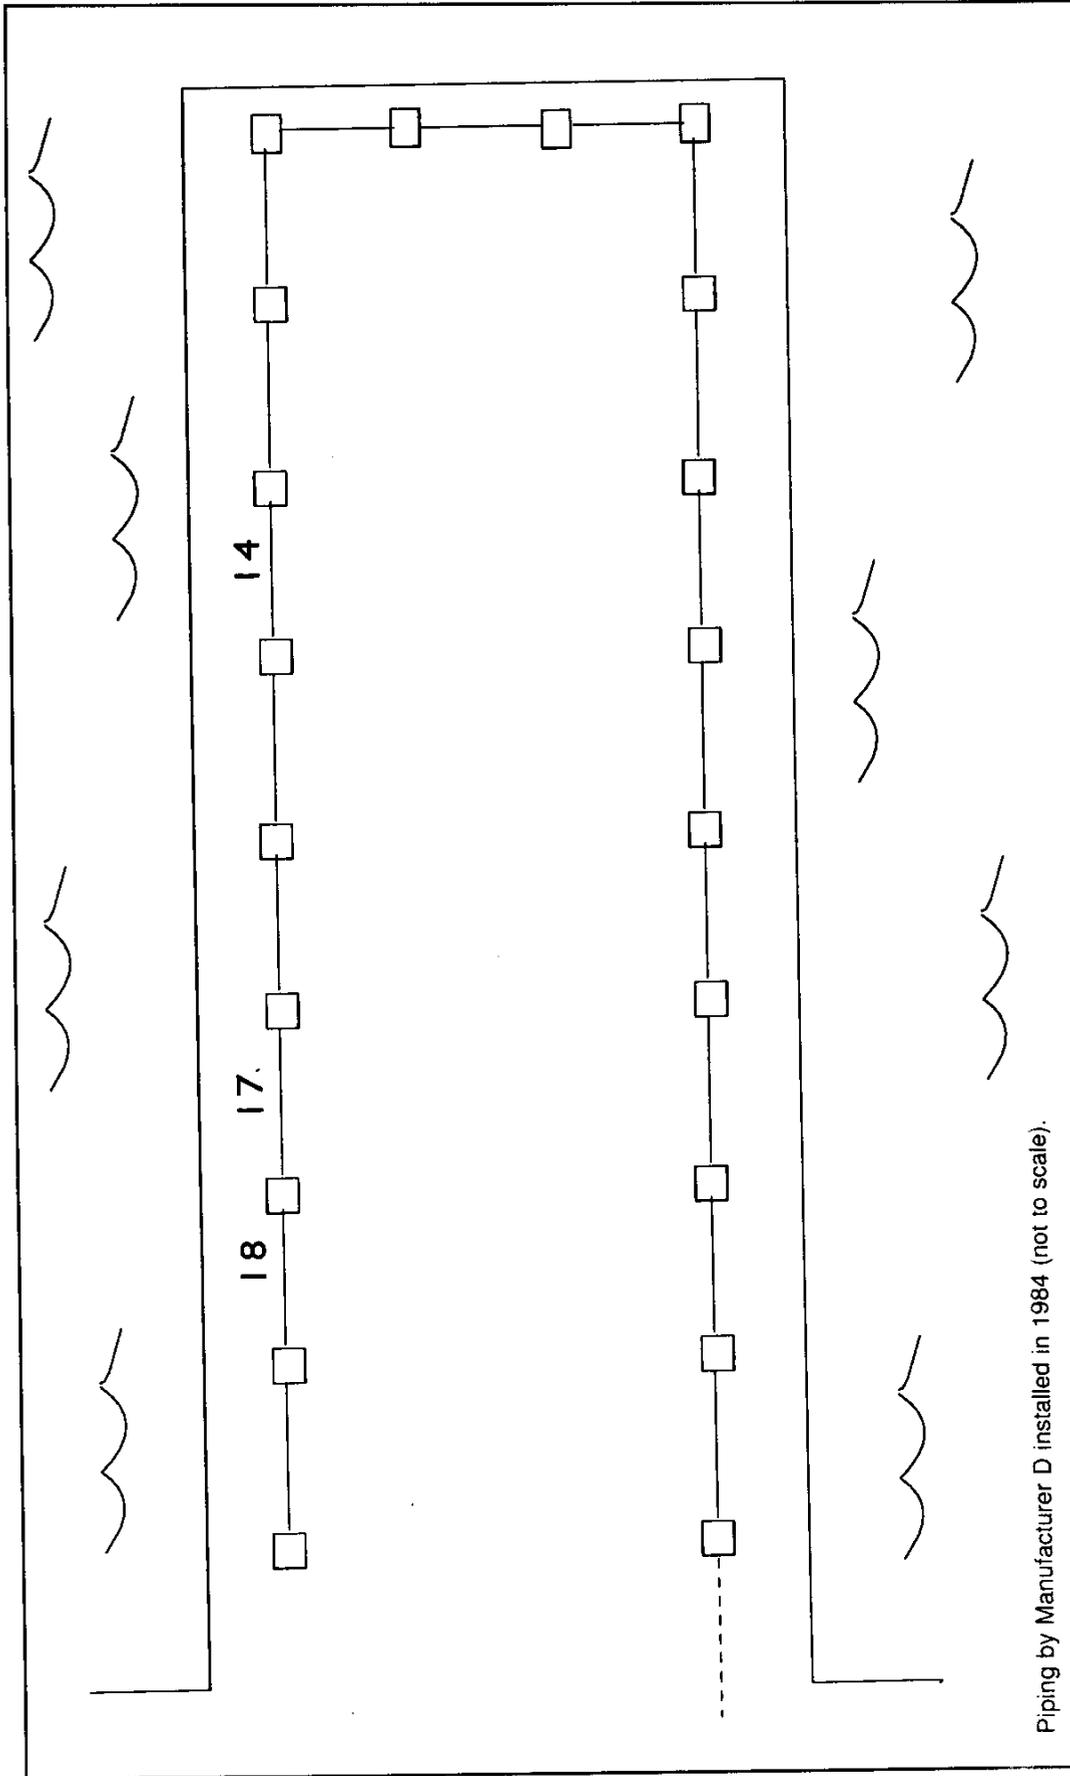
Figure K1. Schematic diagram of System 22 at Charleston Ship Yard, SC.

a. Pressure Test of Conduit Section 18—This conduit section was 226 ft long. Air pressure was initially applied at 3:00 PM. Significant air leakage occurred at both gland seals. One gland seal was effectively tightened, while the other seal had a broken bolt and a second bolt that could not be reached. Some leakage remained at the latter gland seal. The conduit was again pressurized and valved off at 3:12 PM. The pressure readings and times observed were:

3:12 PM — 15.0 psi
3:17 PM — 14.2 psi
3:22 PM — 13.1 psi
3:27 PM — 12.3 psi
3:32 PM — 11.5 psi
3:37 PM — 10.0 psi
3:42 PM — 9.3 psi
3:47 PM — 8.1 psi
