**US Army Corps
of Engineers**

USACERL Technical Report 96/77
July 1996

Investigation of Preapproved Underground Heat Distribution Systems

by
Charles P. Marsh, Nicholas M. Demetroulis, and James V. Carnahan

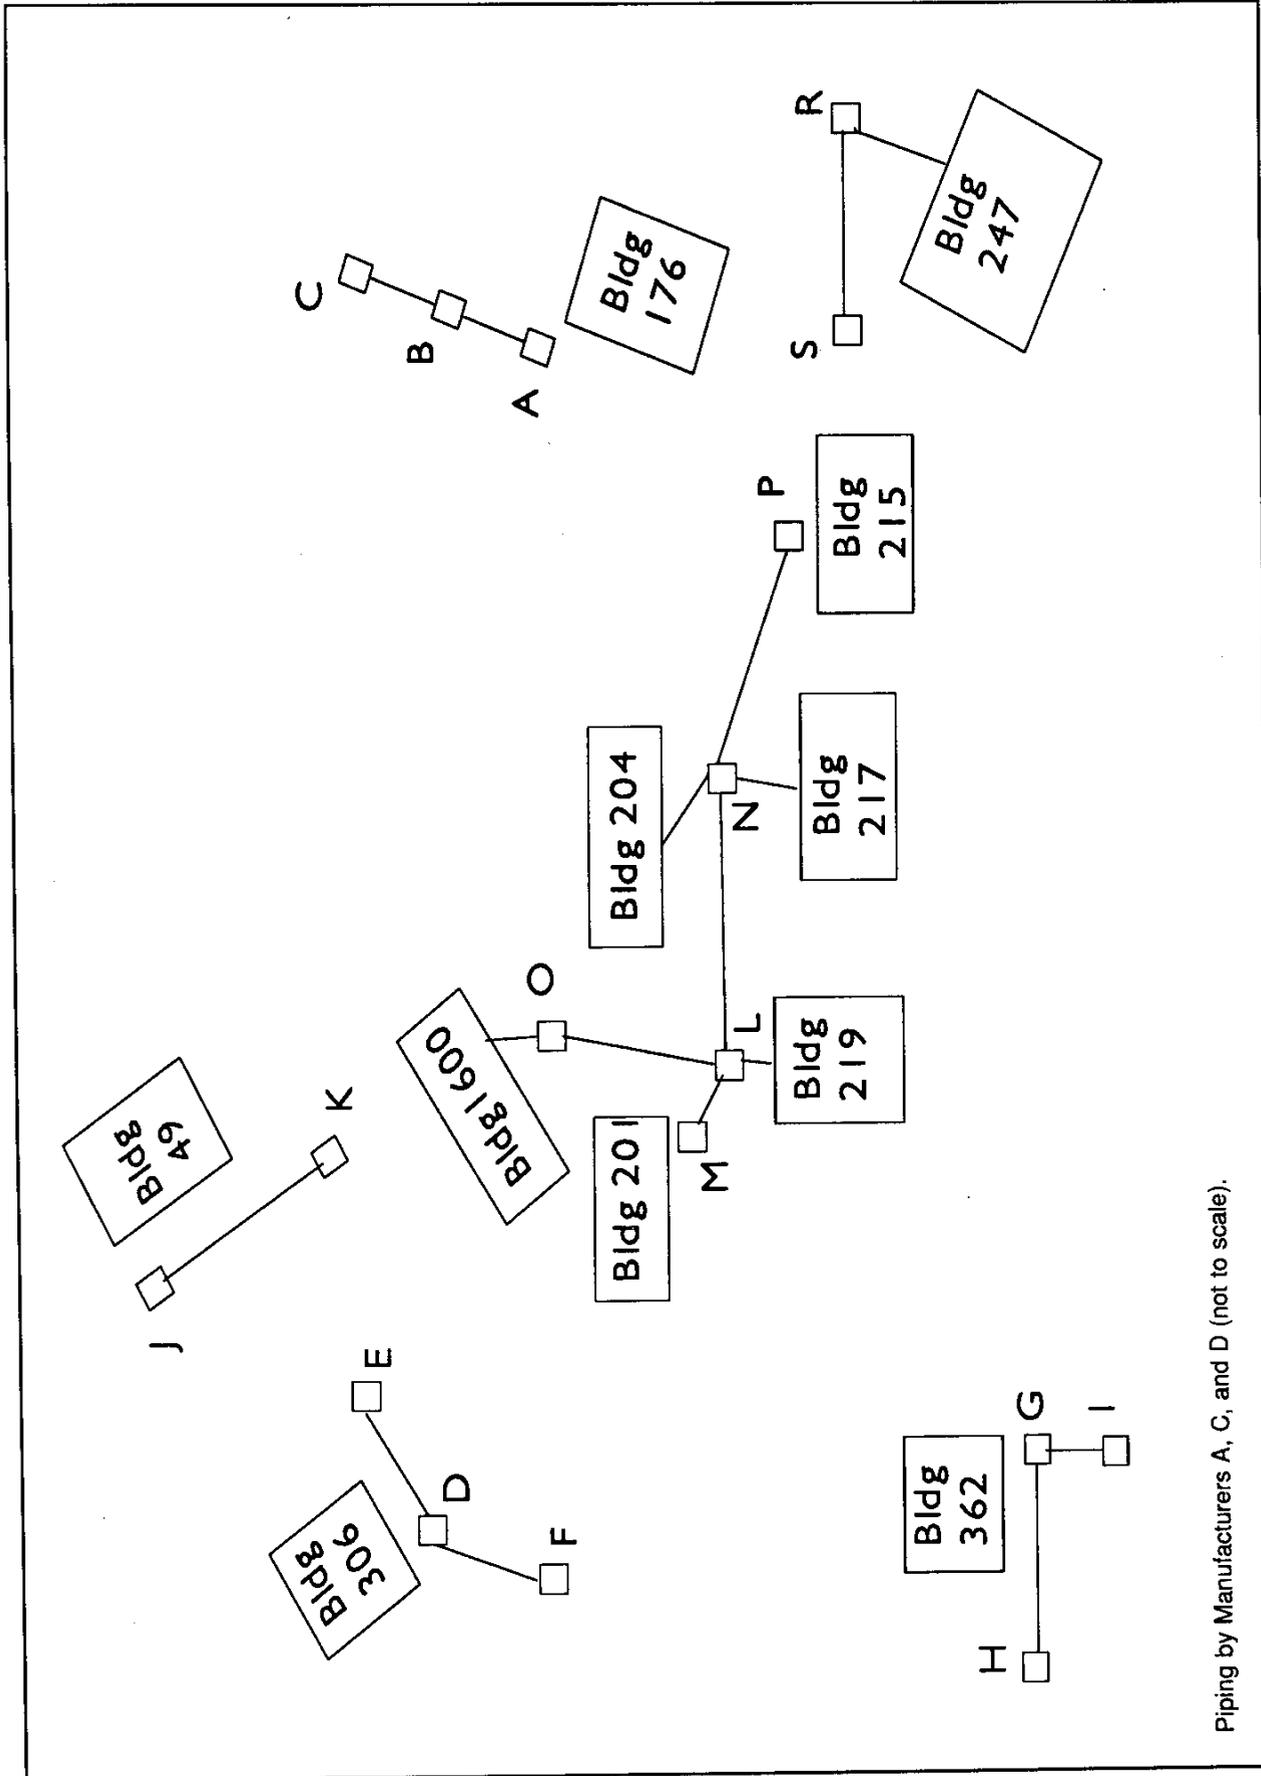
Figure L1. Schematic diagram of System 23 at Charleston AFB, SC.

c. Pressure Test 3—This conduit was installed in the middle 1980s, was supplied by Manufacturer A, and had a steel conduit. The conduit was 106 ft long and extended from Manhole B, described above, to a prefabricated steel manhole, Manhole C, 9 ft in diameter and 12-ft deep. The steel manhole was dry and contained an electric sump pump. The 6-in. line was contained in a 14-in. conduit, which was pressurized to 15.5 and valved off. The pressure readings and times observed were:

10:13 AM — 15.5 psi
10:18 AM — 15.0 psi

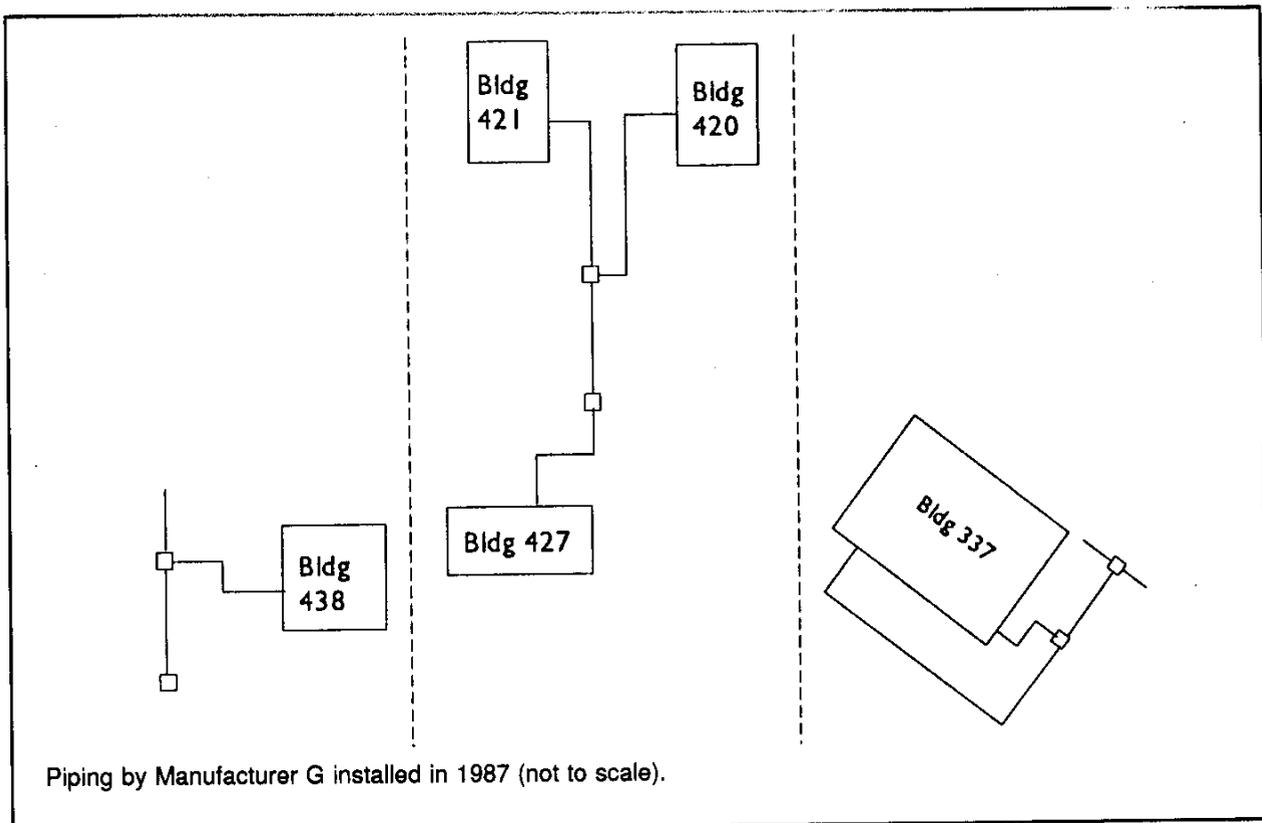
Figure M2. Schematic diagram of System 25 at Grissom AFB, IN.

b. Pressure Test 3—Conduits extend 200 ft from Manhole E at northwest corner of Bldg. 427 to Manhole F feeding Bldgs. 421 and 420. Both manholes were concrete with solid plate aluminum covers and caulked and cemented conduit wall penetrations. Manhole E was 10 ft x 5 ft x 10 ft deep, and Manhole F was 10 ft x 5 ft x 8 ft deep. Manhole E had a leak at the steam water ejector. No gland seals were present

at conduit end plates. The 12-in.-diameter steam supply casing contained a 3-in. steam pipe and the 6-in.-diameter condensate casing enclosed a 1-1/2-in. return line.

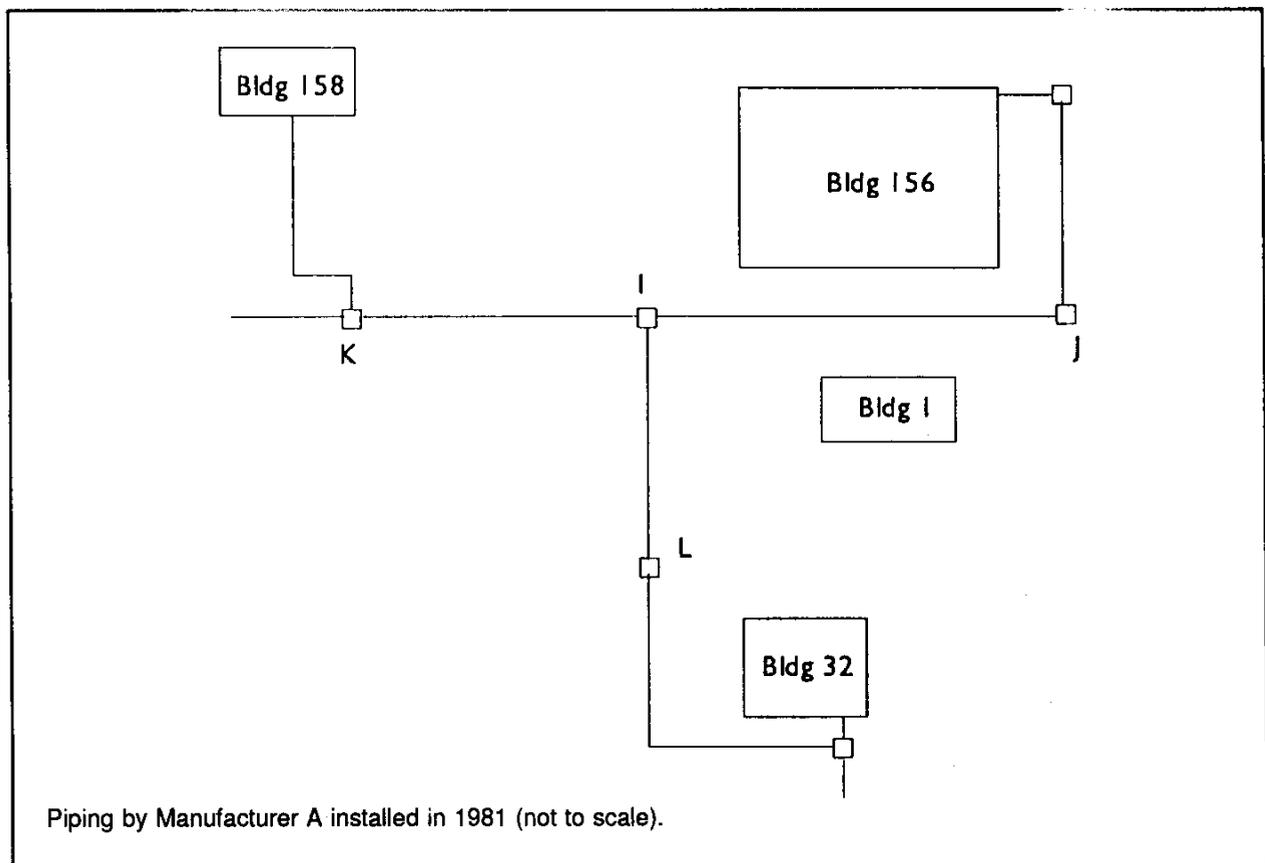
Figure M3. Schematic diagram of System 26 at Grissom AFB, IN.

a. Pressure Tests 1 and 2—Conduits ran from Manhole I to Manhole J—a distance of 480 ft. Manhole I was at the southwest corner of the intersection of Hoosier Boulevard and Constellation Street. Manhole I is 5 ft × 10 ft × 7 ft deep with top at grade. Half of the top was open grate and half was solid aluminum plate. The sump pump discharge line was plugged so the manhole was dewatered with a portable pump. The condensate piping was badly corroded and had a pinhole leak, and a valve gasket had a minor leak. Manhole J was 10 ft × 10 ft × 7 ft deep and had a solid aluminum top. The steam conduit casing was 16 in. in diameter and contained an 8-

11:13 AM — 15.0 psi
 11:18 AM — 15.0 psi
 11:23 AM — 14.8 psi
 11:28 AM — 14.0 psi
 11:33 AM — 13.5 psi
 11:38 AM — 12.8 psi
 11:43 AM — 12.2 psi
 11:48 AM — 11.8 psi

(2) Pressure Test 2 (Condensate Return)—The condensate conduit casing was pressurized to 14.0 psi at 10:10 AM and exhibited no pressure loss through 10:40 AM, when the test was terminated.

b. Pressure Test 3—Conduits extended from Manhole I, described above, to Manhole K—a distance of 400 ft. Manhole K was 5 ft × 10 ft × 7 ft deep with an open grate top. Water was pumped out of the manhole after adjustment of the sump pump float mechanism. There was heavy water infiltration into the manhole at a conduit wall penetration. The 20-in.-diameter steam conduit casing contained a 10-in. steam pipe. The 12-in.-diameter condensate conduit casing contained a 4-in. return line.

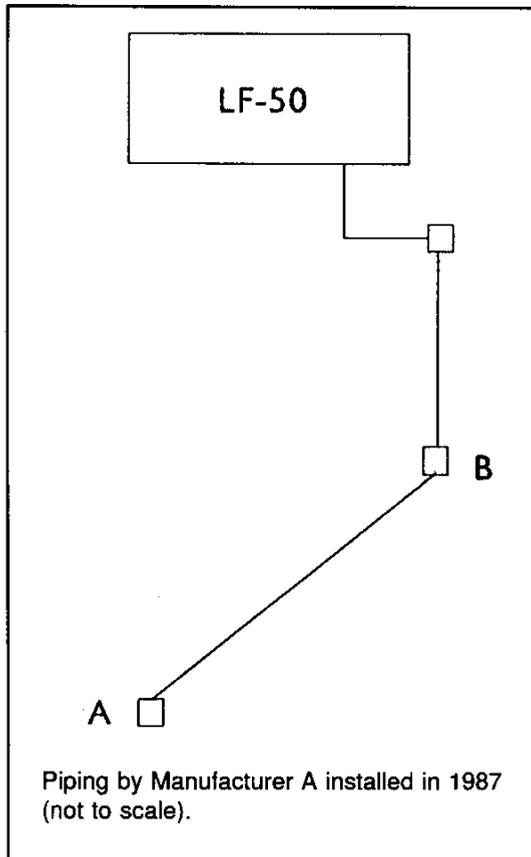
Figure N1. Schematic diagram of System 27 at Norfolk Naval Station, VA.

This system consists of piping from Manufacturer A and has a steel conduit (Figure N1). It was installed in 1987.

Pressure Test—This conduit section extended from Manhole A at the intersection of Toway and Avionics streets under Toway northward to Manhole B south of Building LF-50. The distance between manholes was 200 ft. Manhole A was in a parking area and was constructed of concrete with a solid concrete top flush with the pavement. The top contained 36-in.- and 24-in.-diameter access holes with steel plate covers. No manhole ventilation was provided. Manhole dimensions were 12 ft × 8 ft × 7 ft deep. A slight steam leak was present at the steam ejector sump pump. The heat carrying pipe had no insulation. Wall penetrations were caulked and cemented. Manhole B was concrete with walls extending about 1 ft above grade. The solid concrete top contained two access openings and two 6-in. vent pipes. Manhole dimensions were 9 ft × 12 ft × 8 ft deep.

Some minor leakage was observed at the

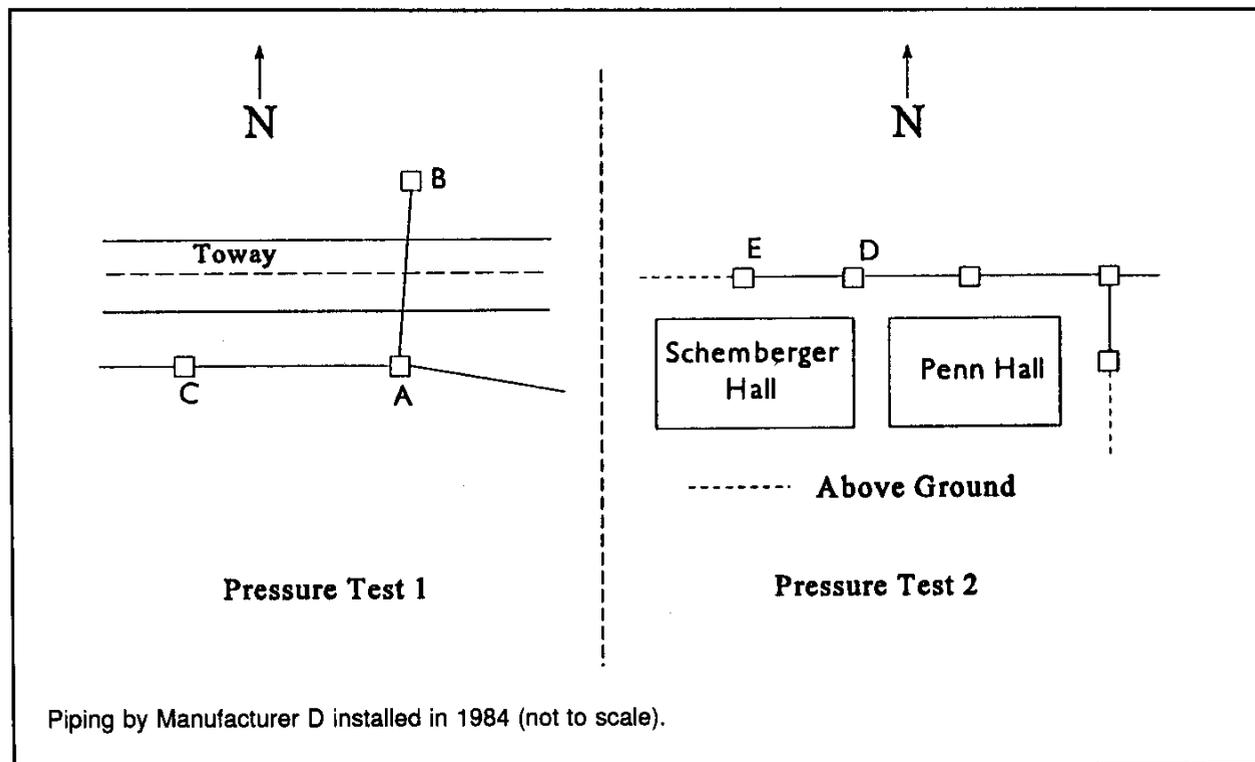
Figure N2. Schematic diagram of System 28 at Norfolk Naval Station, VA.

This system consists of piping from Manufacturer D and has a steel conduit (Figure N2). It was installed in 1984.

a. Pressure Test 1—This conduit section extended from Manhole A, described above, westward 170 ft to Manhole C. Manhole C was concrete with a concrete top flush with the parking lot pavement. The top had two access openings but no vent pipes. Manhole dimensions were 6 ft x 12 ft x 7 ft deep. Water was pumped out of this manhole and a portable fan was used to cool the manhole before entry. A gland seal was installed on the supply line at the manhole entry. The gland seal was tightened before pressure was applied to the conduit. One of the flanges on the dielectric flange assembly had been removed so the system was no longer electrically isolated. The conduit casing was 20-in. in diameter and contained a 12-in. steam line. Pressure to 15.0 psi was applied to the casing at 10:33 AM. Pressure readings were as follows:

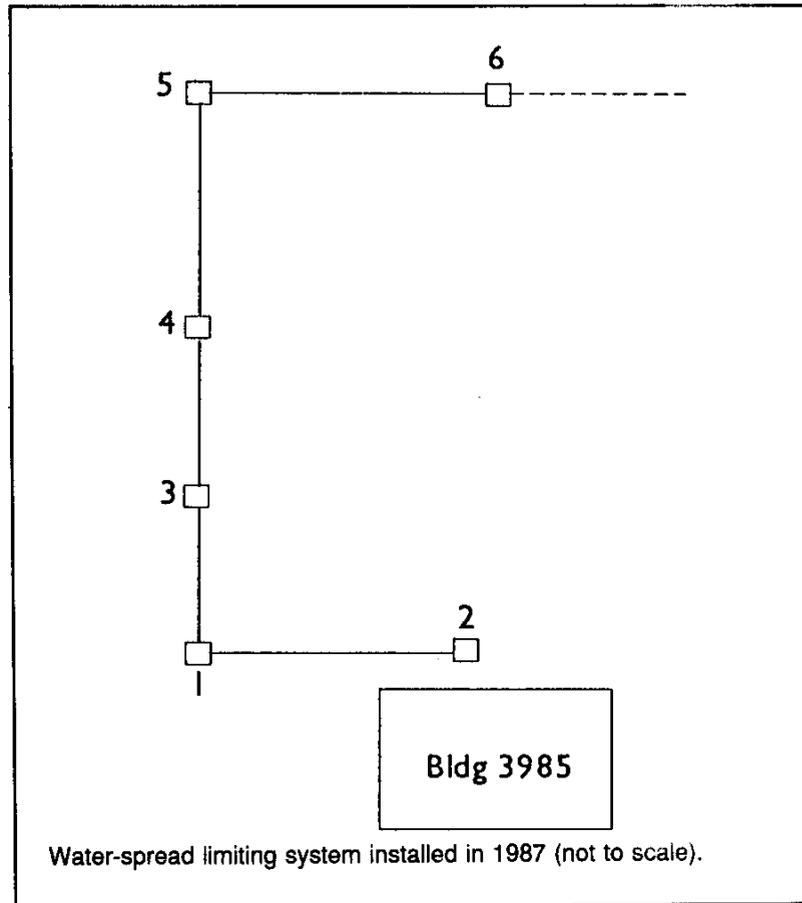
Figure O1. Schematic diagram of System 29 at Fort Lewis, WA.

This system is a 125 psi steam system with fiberglass return piping and was installed in 1984 (Figure O1). The steam supply uses a water-spread limiting system in which each section is sealed so that water cannot enter an adjoining section in the event of a pipe failure. The sections are joined with specially fabricated couplings with elastomeric rings that also serve as expansion-contraction joints. In Manhole 1, one of the conduits contained an end sleeve consisting of a rubberized plastic material bonded to the outer casing and extending to the heat carrying pipe. This material had dried out and cracked in two places and was very brittle in the area of the heat carrying pipe. This seal was not found on the ends of conduits at any of the other manholes. The lack of end seals exposes conduit insulation to water in the event of manhole flooding. Manholes inspected were as follows:

c. Manhole 3—Located 200 ft north of Manhole 1, this manhole was buried 2 ft below grade and was accessed through a 30-in.-diameter tube extending from grade to the manhole top. Manhole dimensions were 4 ft in diameter and 5 ft deep. Caulking at conduit wall penetrations was badly deteriorated.

d. Manhole 4—Located 300 ft north of Manhole 3, this manhole was buried 4 ft below grade and was accessed through a 30-in.-diameter tube extending from grade to the manhole top. Manhole dimensions were 6 ft × 8 ft × 7 ft deep. Manhole ventilation was provided by two 6-in. vent pipes. The manhole was dry and contained a sump and french drain.

e. Manhole 5—Located 600 ft north Manhole 4, this manhole was constructed of prefabricated concrete sections with concrete top at grade. Ventilation was provided by two 6-in. vent pipes. Manhole was dry and contained a sump and french drain. Manhole dimensions were 6 ft × 8 ft × 7 ft deep.

f. **Manhole 6**—Located 300 ft east of Manhole 5, this manhole was concrete with top at grade containing two 6-in. ventilation pipes. Manhole dimensions were 5 ft × 7 ft × 8 ft deep. The water-spread limiting system ended at this manhole with the conduit extending 2 ft into the manhole with no end seal. The manhole was dry with a gravity drain. Exit from this manhole was with a steel-cased conduit that continues to Manhole 7 located 100 ft east of Manhole 6. Manhole 7 provides for transition from buried conduit to concrete trench.

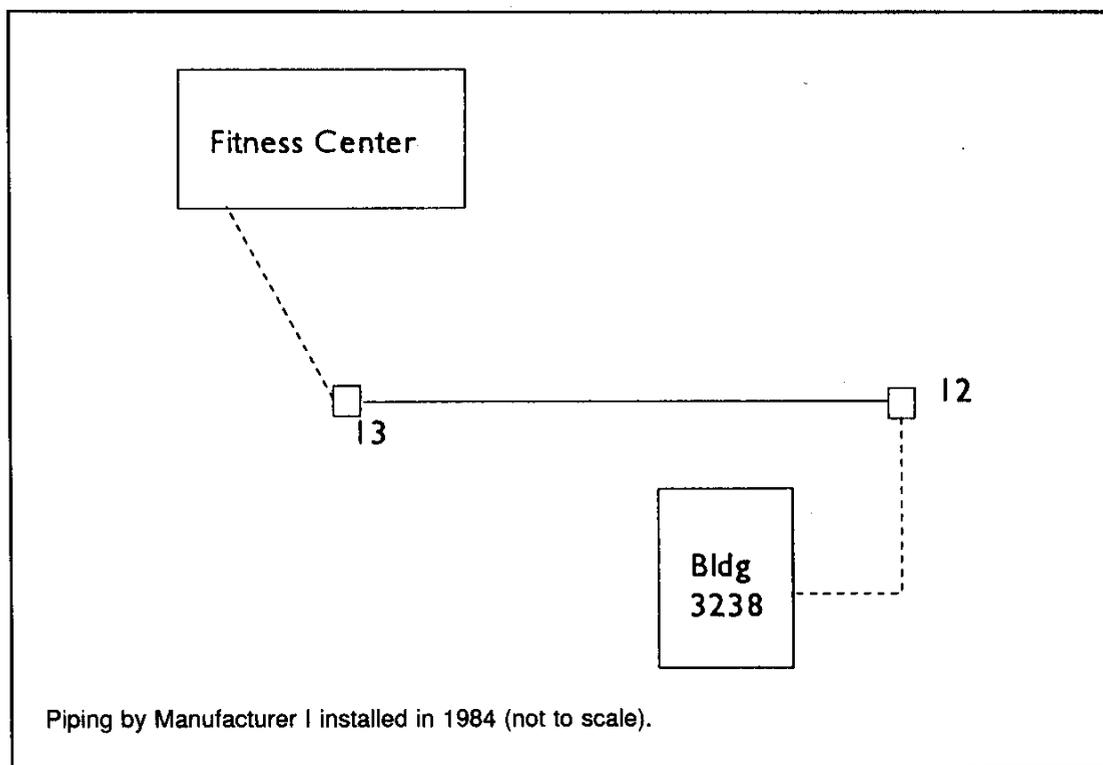
Figure O4. Schematic diagram of System 32 at Fort Lewis, WA.

(1) Manhole 12—This manhole was north of Bldg. 3238 and was concrete with concrete top at grade and dimensions of 7 ft x 7 ft x 8 ft deep. Manhole ventilation was provided by two capped 6-in. vent pipes. The manhole was dry at the time of inspection, and conduit wall penetrations were caulked and cemented. Access was through a 30-in.-diameter opening with a steel manhole cover.

(2) Manhole 13—This manhole was 500 ft west of Manhole 12. Construction was concrete with concrete top at grade containing a 3-ft square access opening with solid aluminum cover. Ventilation is provided by two capped 6-in. vent pipes. The manhole was dry at the time of inspection, and conduit wall penetrations were caulked and cemented.

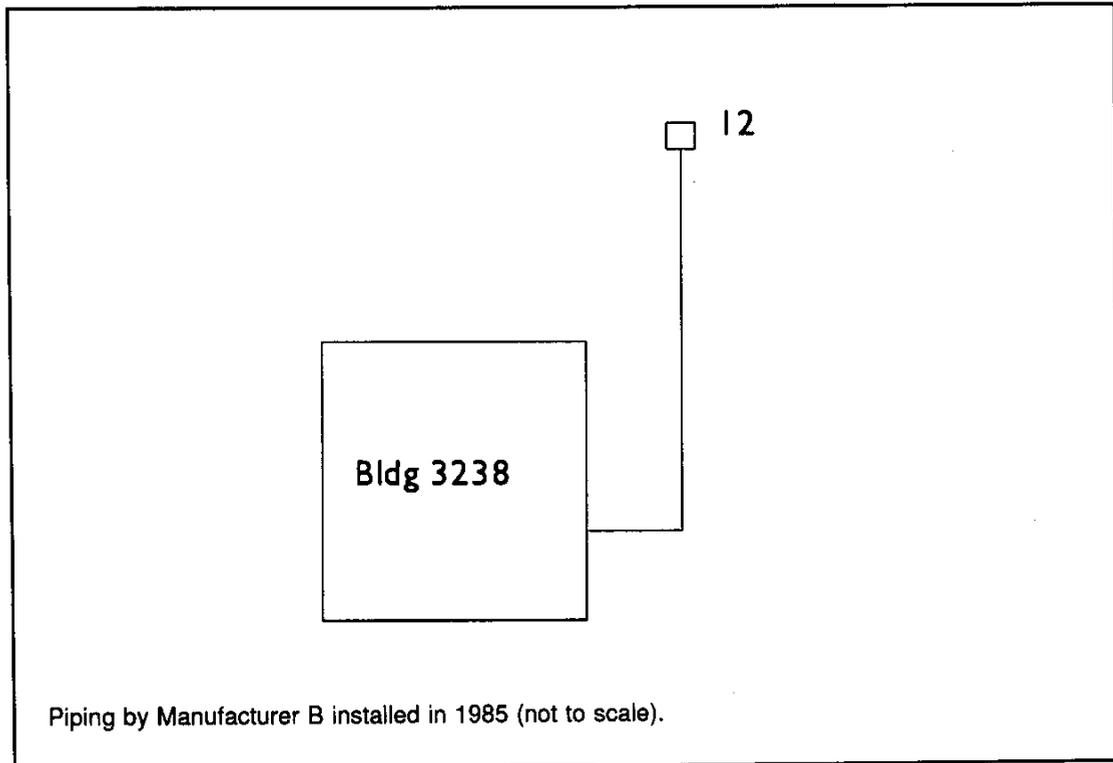
Figure O5. Schematic diagram of System 33 at Fort Lewis, WA.

(1) Manhole 12 to equipment room of Bldg. 3238—This run consisted of a single conduit casing enclosing both the supply and return piping. The conduit casing was 14-in. in diameter and each of the internal pipes were 4 in. Each of the 4-in. pipes have a gland seal at the end plate in the equipment room. The length of the conduit run is 180 ft. One of the gland seals in the equipment room could not be completely tightened and leaked slightly during the test. Pressure readings were as follows:

2:42 PM — 15.0 psi
 2:47 PM — 15.0 psi
 2:52 PM — 14.5 psi
 2:57 PM — 14.2 psi
 3:02 PM — 14.1 psi
 3:07 PM — 14.0 psi

3:12 PM — 13.5 psi
3:17 PM — 13.3 psi
3:22 PM — 13.1 psi

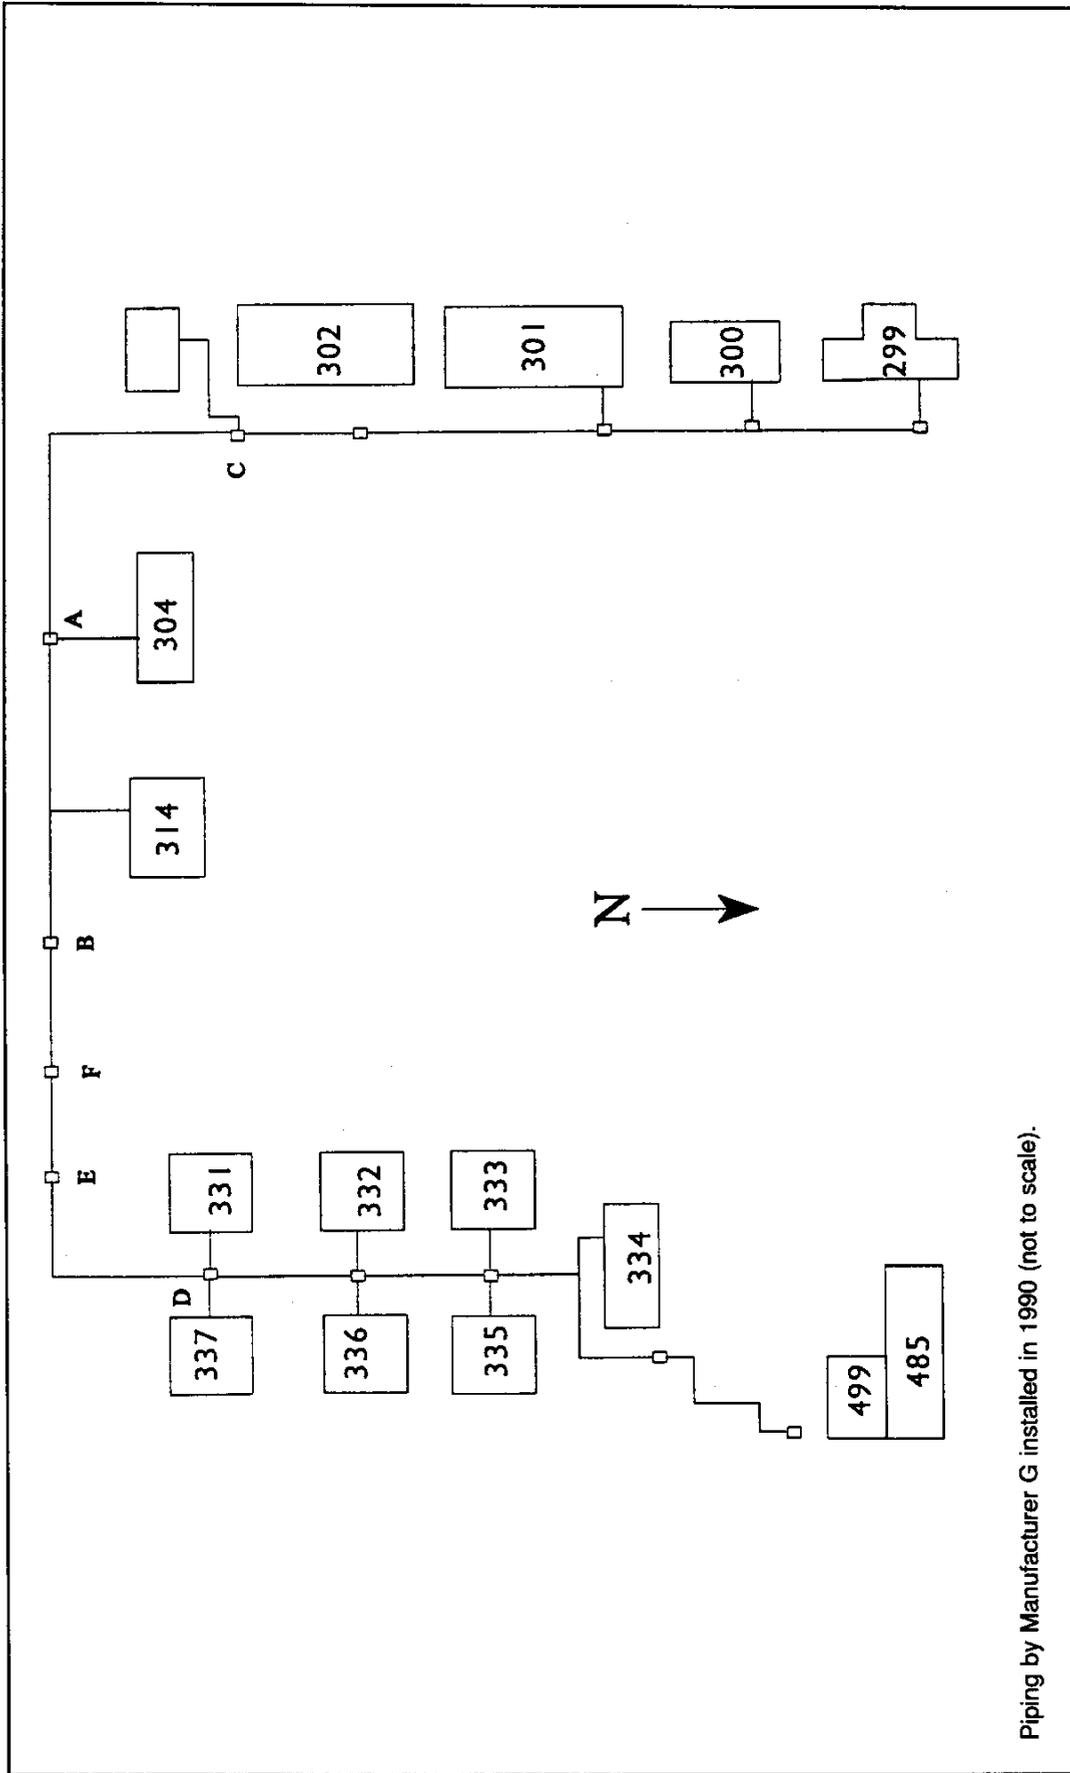
Figure P1. Schematic diagram of System 34 at San Diego Naval Training Center, CA.

a. Pressure tests - Manhole A to Bldg. 304—The supply and return conduits extended 30 ft from Manhole A to risers just outside of Bldg. 304. Manhole A was directly south of the building and had a raised, fabricated metallic top extending about 18-in. above grade. The top had louvered side panels for ventilation. The manhole was concrete with dimensions of 12 ft x 7 ft x 8 ft deep and was served by a steam jet sump pump located in a corner pit. Conduit wall penetrations were caulked and cemented. The steam line had a small flange gasket leak. Gland seals were installed on the piping both in the manhole and at the building risers. All gland seal nuts were loose and had to be tightened before pressure testing. The steam conduit casing was 9 in. in diameter and contained a 3-in. pipe. The condensate conduit casing was 6 in. in diameter with a 2-in. return line.

10:00 AM — 15.0 psi
 10:05 AM — 7.5 psi
 (Leak at vent - Repressurized)
 10:23 AM — 15.0 psi
 10:28 AM — 12.0 psi
 10:33 AM — 9.5 psi
 10:38 AM — 7.7 psi
 10:43 AM — 6.2 psi
 10:53 AM — 3.7 psi

b. Pressure tests - Manhole A to Manhole B—Conduits ran 500 ft east from Manhole A to Manhole B. An underground take-off between the manholes extends to risers outside the building. Manhole B is concrete with concrete top at grade.

Piping by Manufacturer G installed in 1990 (not to scale).

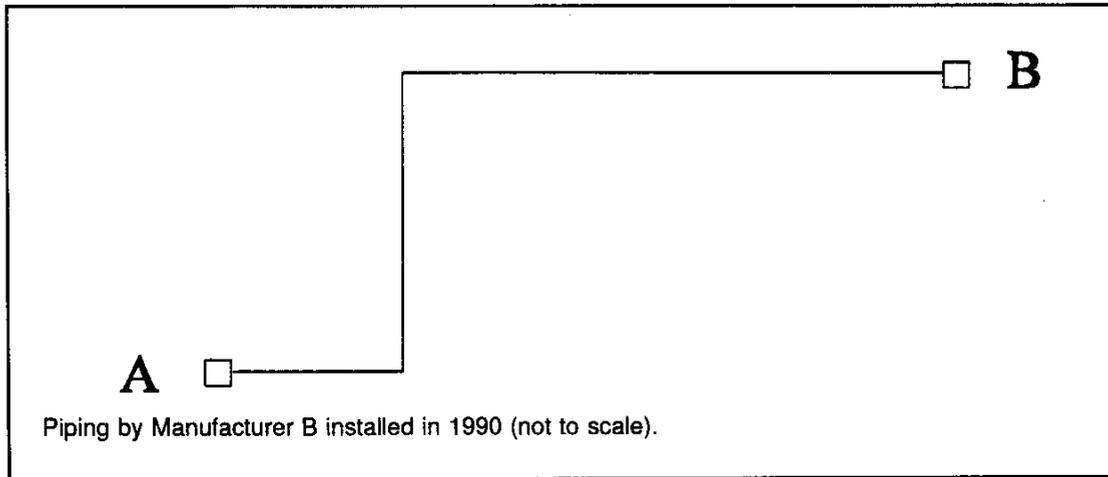
Figure P2. Schematic diagram of System 35 at San Diego Naval Station, CA.

Manhole B was in the street and the top contained two 36-in. slotted manhole covers that provide both access and ventilation. The manhole was concrete, and the dimensions are 18 ft × 12 ft × 7 ft deep. The manhole was dry and was served by a steam jet sump pump. The wall penetration was the same as in Manhole A described above. The conduit end plate was standard with no gland seal.

Pressure was applied to the casing at 1:25 PM, and it slowly rose to 3 psi but would not rise further. The gland seal and gauge and compressor connections were thoroughly checked for leakage and were found to be sound. The compressor was operated for an additional 50 minutes, but no additional increase in pressure was evident. When the conduit casing was sealed by valving off the compressor, the pressure immediately dropped to zero.
