Condition Assessment of Building 6237, Old Hospital Complex, Fort Carson, CO

by Thomas R. Napier and Sheila A. McCarthy

August 2000

ERDC/CERL TR-00-24
August 2000

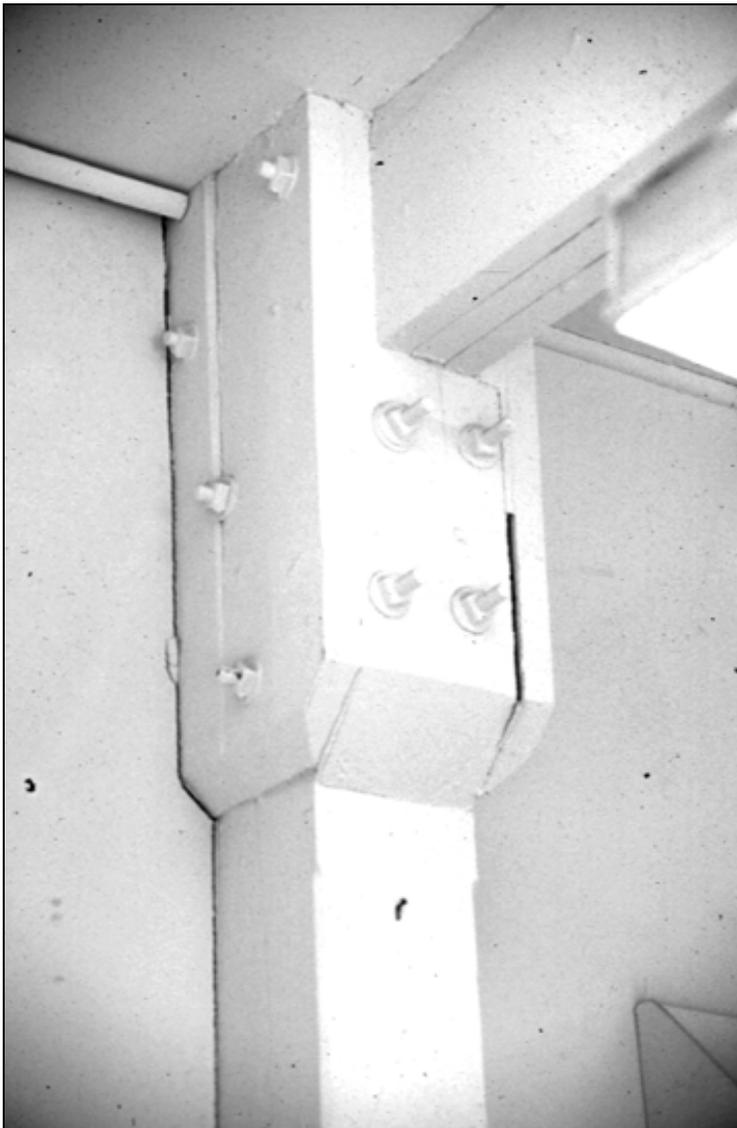
Figure 3-9. Beam pocket detail.

umn tops. A “beam pocket” is created by lapping 2 X 8s over the outer surfaces of the column; the beams are bolted through this beam pocket (Figure 3-9). Within the center core of the building, joists are carried by load-bearing 2 X 4 stud walls. Solid blocking between joists at the beams and bearing walls prevents overturning. There is one row of cross bridging within each span. Floor sheathing consists of nominal 1-in. boards placed diagonally across the joists.

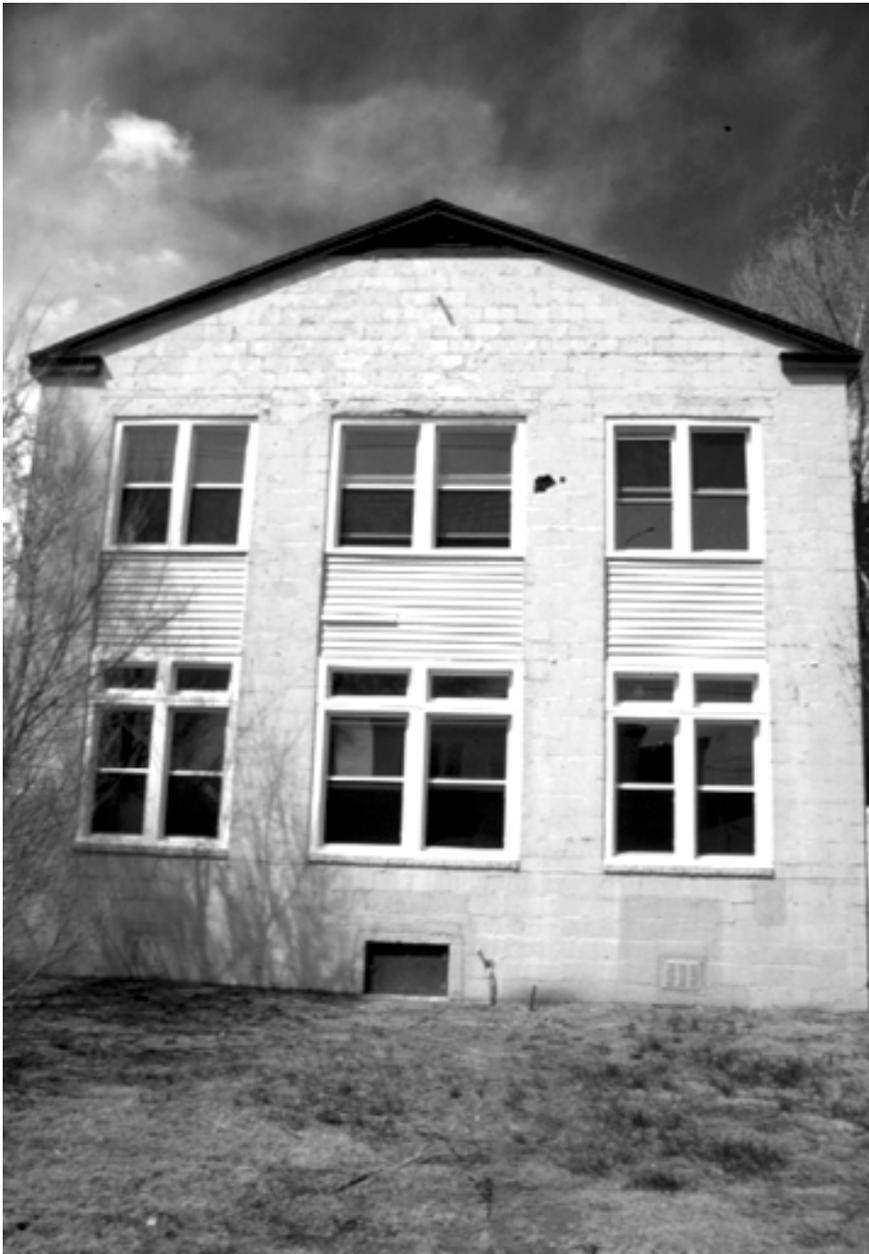
Figure 3-13. Gable end.

When viewed from the ground, each side of the gable appears to be quite flat and straight (Figure 3-13). The ridge appears to be flat and straight. No sagging was evident in any part of the roof. No further inspection was conducted from the outside.

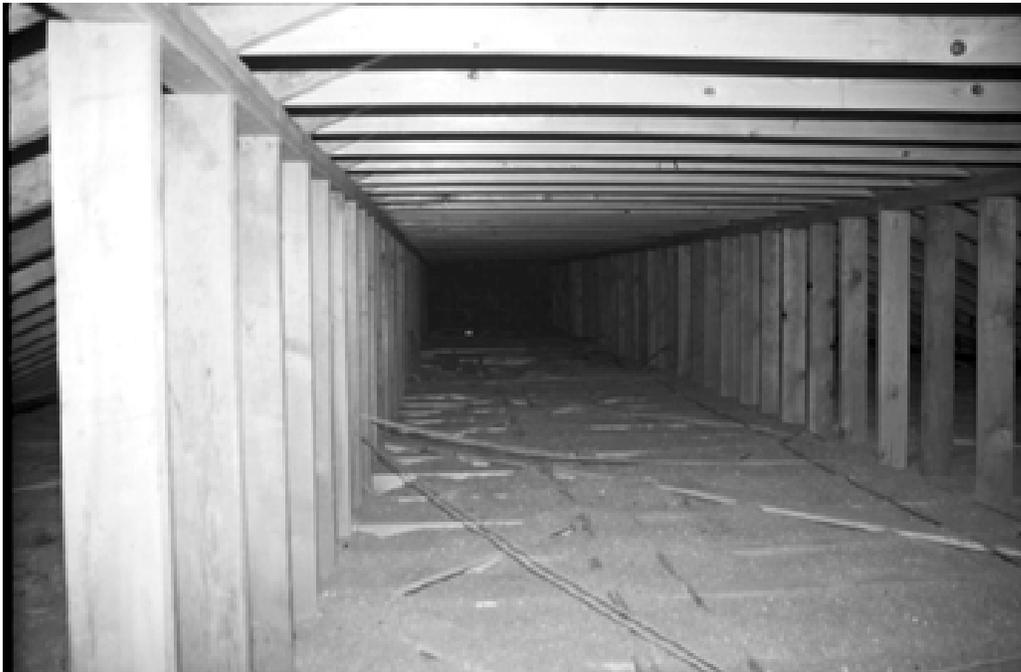
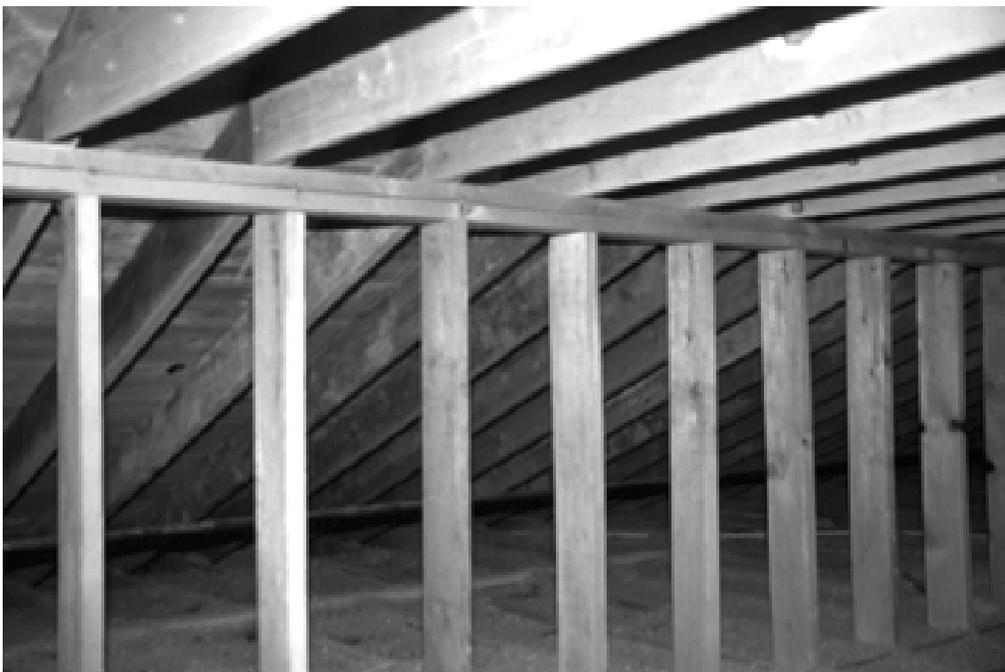
When viewed from below (from the attic spaces), the roof framing system appeared to be straight and true (Figures 3-14 and 3-15). Rafters were generally free from checks and knots. Pencil marks were observed, presumably made during construction, and members were still aligned with the marks. Structural members and sheathing appeared to be clean, with no evidence of water damage, or even staining. The bottom edges of rafters, in all locations, were aligned, with no saddles or sagging observable. There was no visible nail pulling, splitting, dislocation, or other sign of distress to suggest excessive uplifting at the eaves. Ridge boards were level and straight. The only irregularity observed in ridge boards was due to the slightly different dimensions of each individual 2 X 8. Knee walls were plumb, with no dislocation observed. Several ceiling joists were tested for level in several locations within each building bay. Some cracking was observed in ceiling surfaces (see "Ceiling Finishes" under Interior Construction). The joists above, however, were found to be level, with no signs of deflection or deformation.

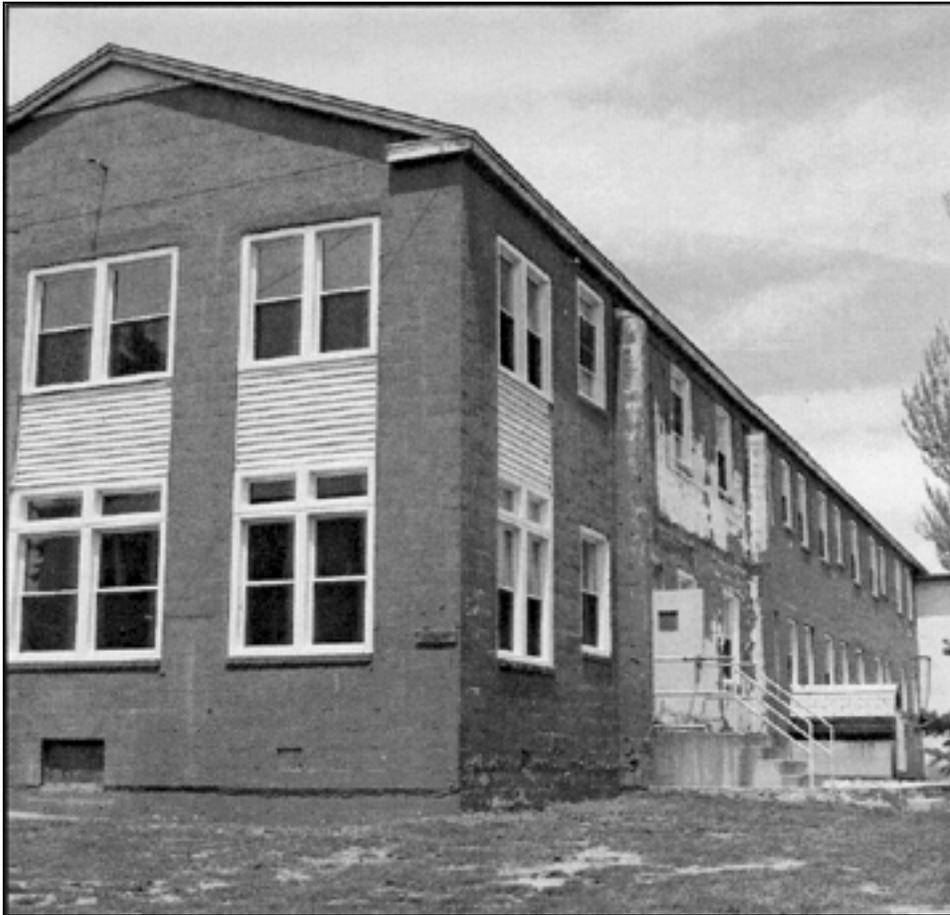
One of the few architecturally defining features of the building is the panels between first and second floor windows at the stairwells. They are presently covered in vinyl siding. However, wood clapboard siding is present in similar buildings in the complex. This siding is framed into openings (similar to window framing) in the masonry wall (Point S and Figure 3-29). The vinyl would have to be removed and the original clapboard siding restored or replaced with a historically correct profile.

Figure 3-29. Original clapboard siding in stairwells.

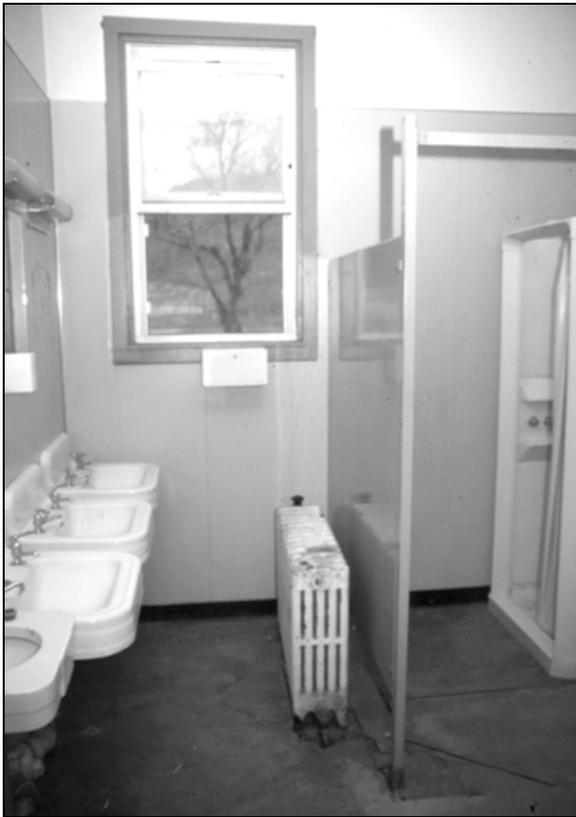
Figure 3-33. Group bathroom.

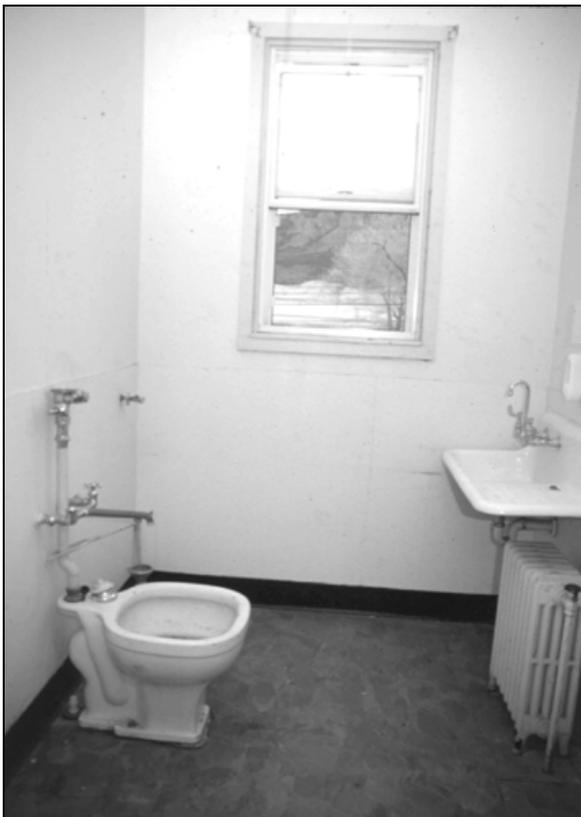
Figure 3-34. Lavatory room.

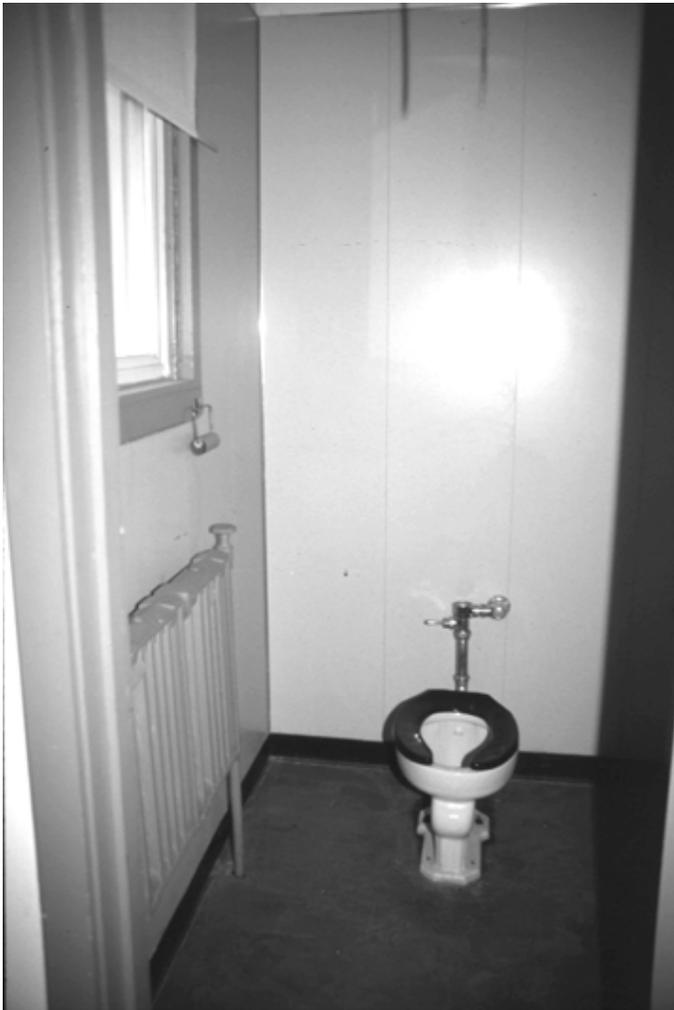
Figure 3-35. Private bathroom.

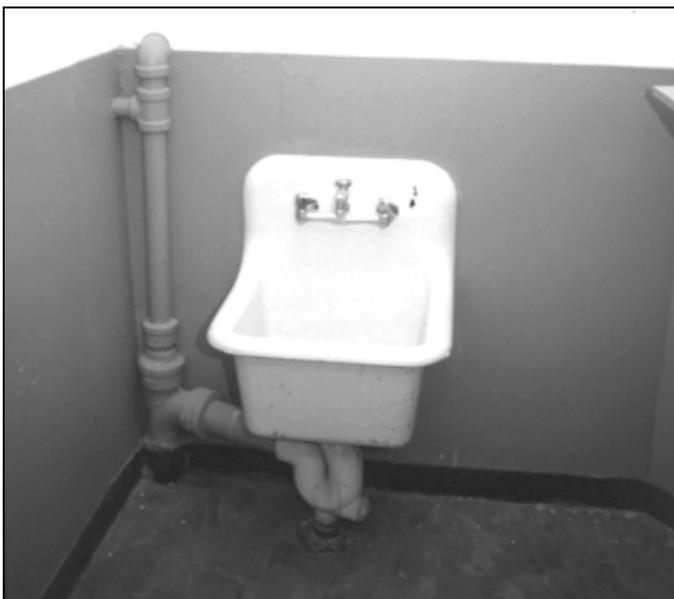
Figure 3-36. Service closet.
