DEMONSTRATION AND VALIDATION OF THERMAL SPRAY VITRIFICATION OF LEAD-CONTAINING PAINT ON STEEL STRUCTURES

CERL TR 99/61

July 1999

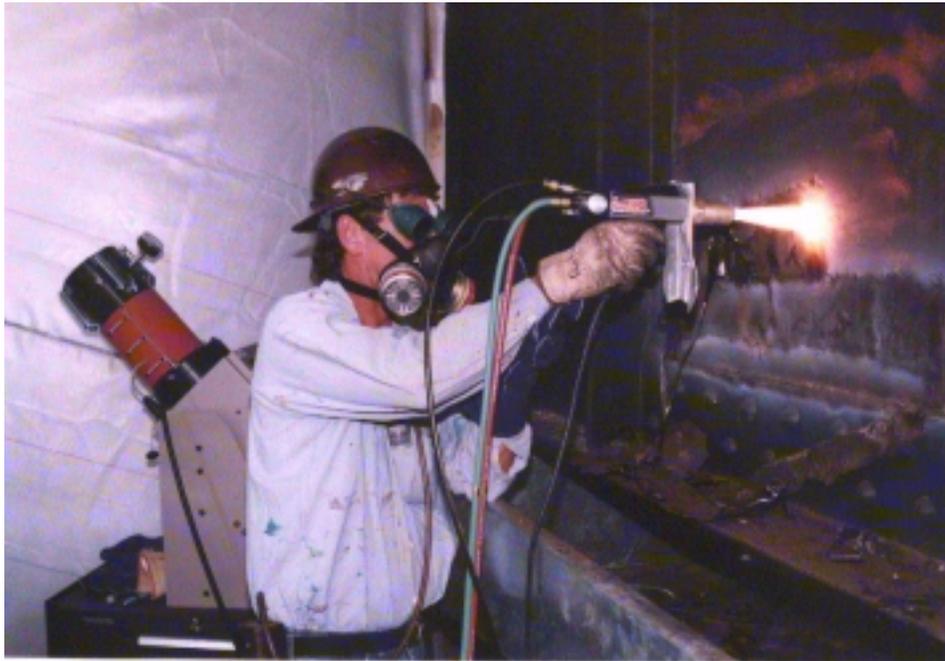
Figure B- 2. Application of TSV process to Viaduct Bridge at the Rock Island Arsenal.

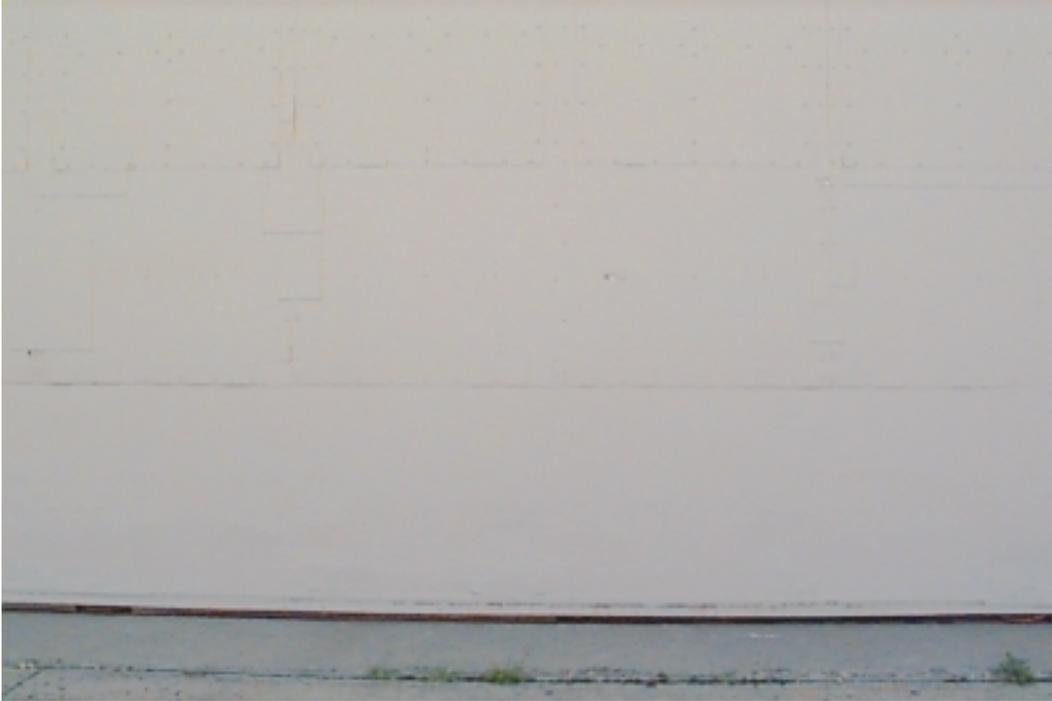
Figure B- 11. Photograph of the hangar door exterior before TSV application.

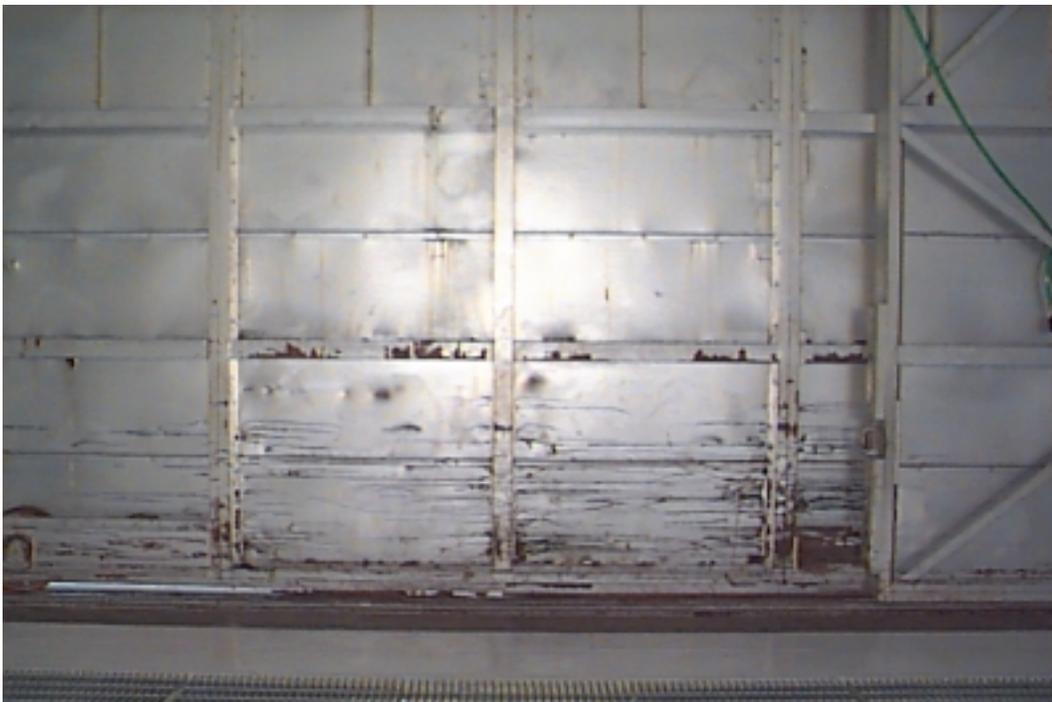
Figure B- 12. Photograph of interior of hangar door before TSV application.

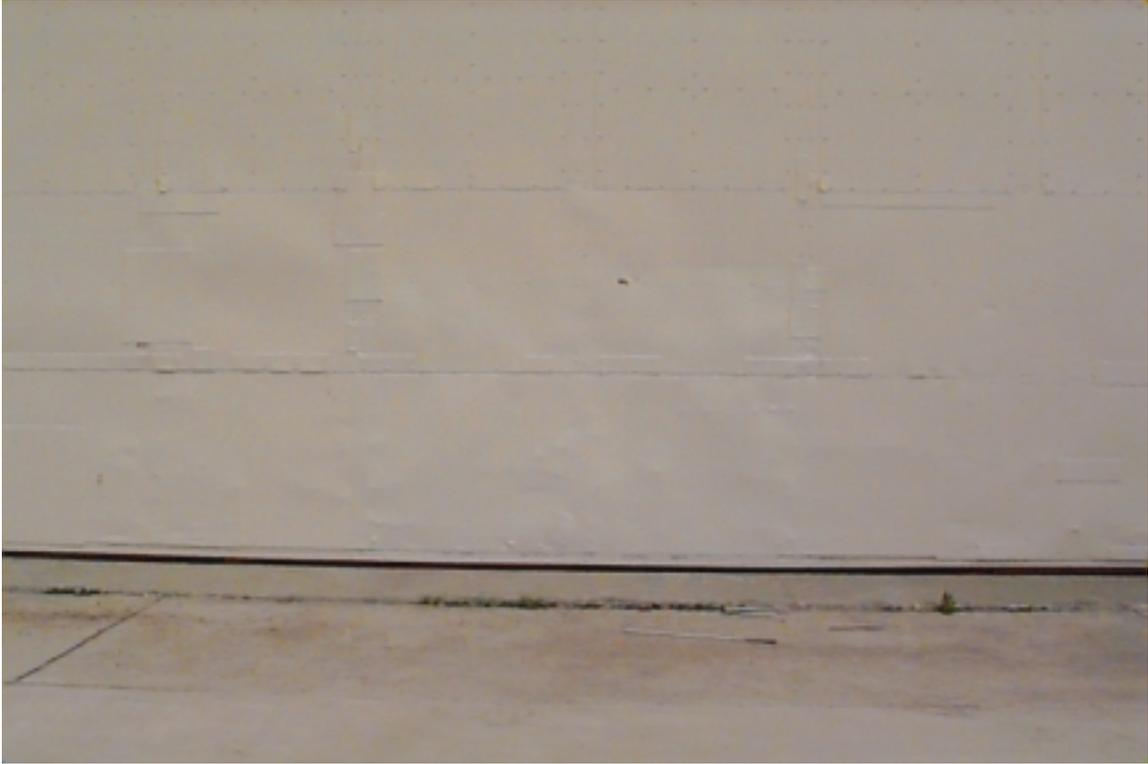
Figure B- 15. Photograph of exterior of hangar door after TSV and repainting.

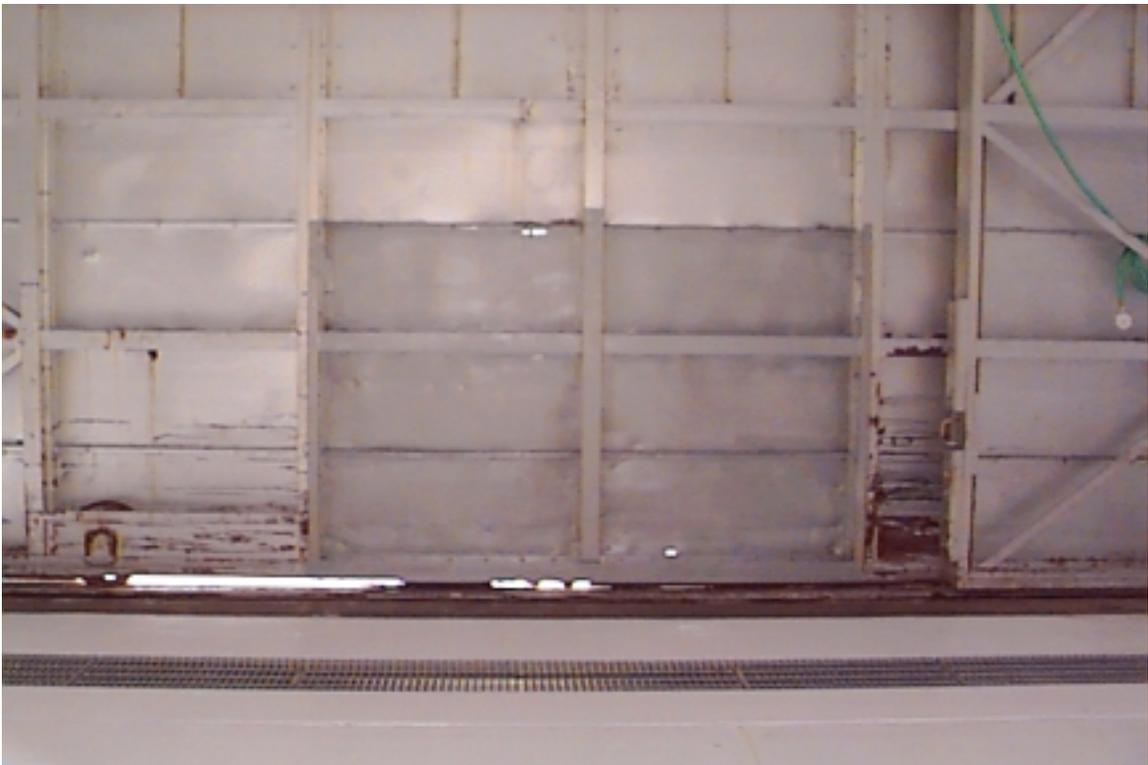
Figure B- 16. Photograph of interior hangar door after TSV and repainting.

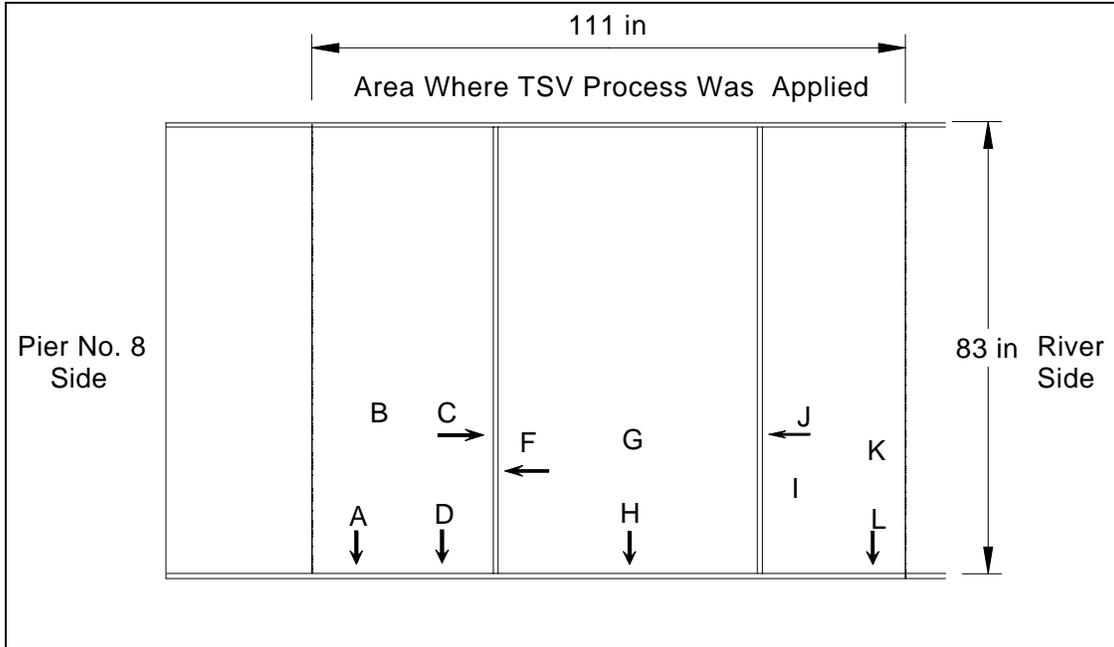
Figure C-1. Location of thickness measurements of existing paint system before application of TSV, east side.

Location	Measured Thickness (mils)	Measured Thickness (mils)	Measured Thickness (mils)	Average Thickness
A	11.8	10.4	9.5	10.6
B	4.7	4.3	4.4	4.5
C	6.7	7.1	7.3	7.0
D	5.0	5.5	6.3	5.6
E	3.5	3.2	3.1	3.3
F	2.3	2.2	2.6	2.4
G	5.5	6.7	5.4	5.9
H	18.1	19.6	15.7	17.8
I	7.1	6.0	6.4	6.5
j	6.3	8.3	7.6	7.4
K	9.8	9.0	7.6	8.8

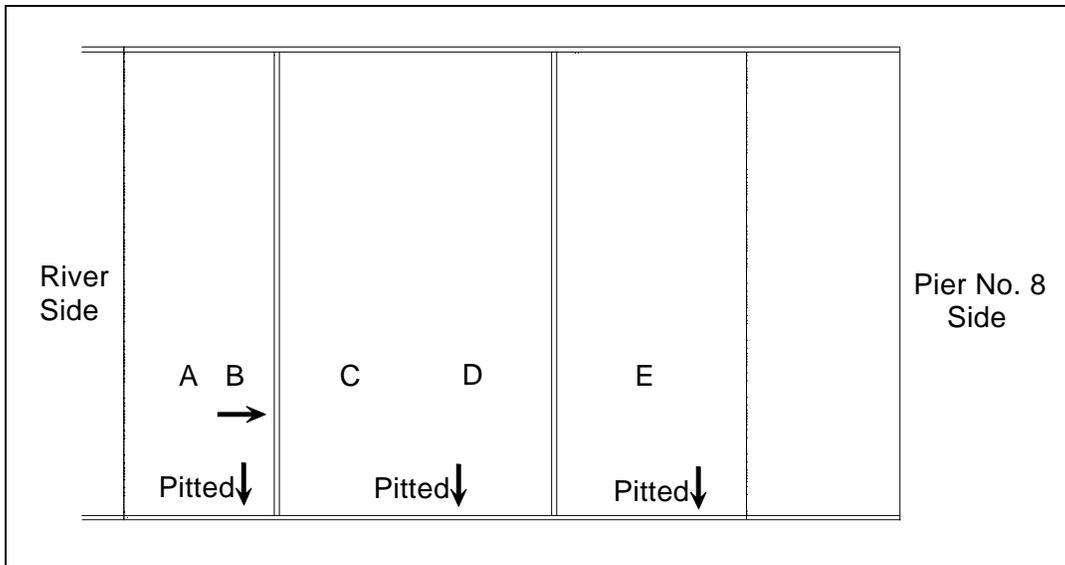
Figure C-2. Location of thickness measurements of existing paint system before application of TSV, west side.

Location	Measured Thickness (mils)	Measured Thickness (mils)	Measured Thickness (mils)	Average Thickness
A	3.4	3.1	3.5	3.3
B	7.2	6.4	4.6	6.1
C	4.3	4.4	4.1	4.2
D	3.5	3.1	3.2	3.3
E	3.1	3.3	3.5	3.3

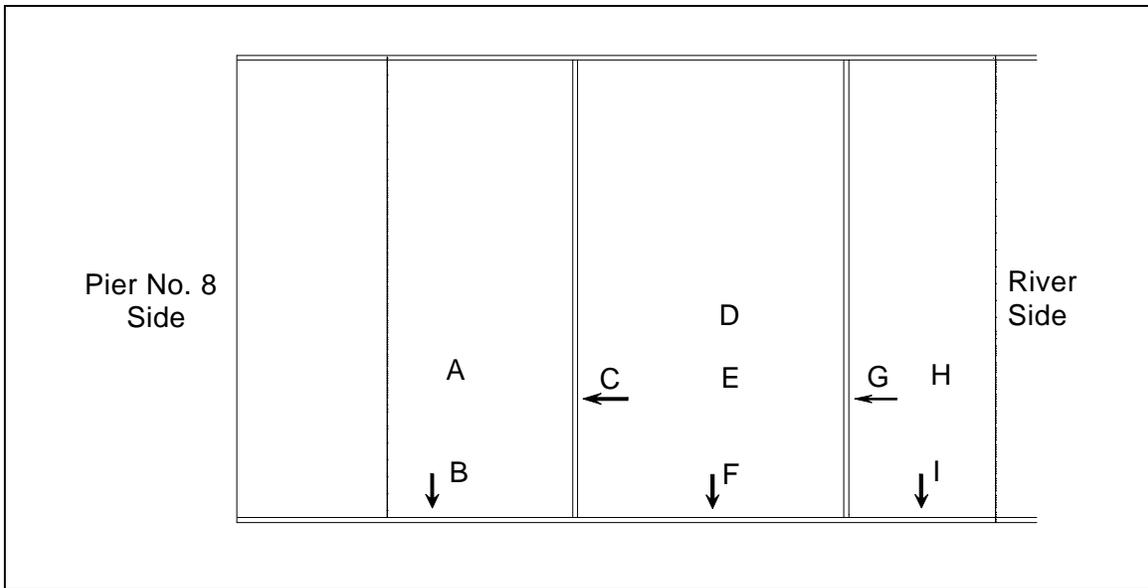
Figure C- 7. Location of primer thickness measurements after TSV application, east side.

Location	Thickness (mils)	Thickness (mil)	Thickness (mils)	Average
A	2.4	2.2	1.9	2.2
B	4.3	4.4	4.7	4.4
C	2.6	2.5	2.0	2.4
D	1.5	1.8	1.8	1.7
E	2.5	2.4	2.7	2.5
F	4.3	3.6	2.4	3.4
G	3.3	3.2	3.9	3.4
H	2.5	2.1	2.8	2.5
I	1.7	1.8	2.1	1.9

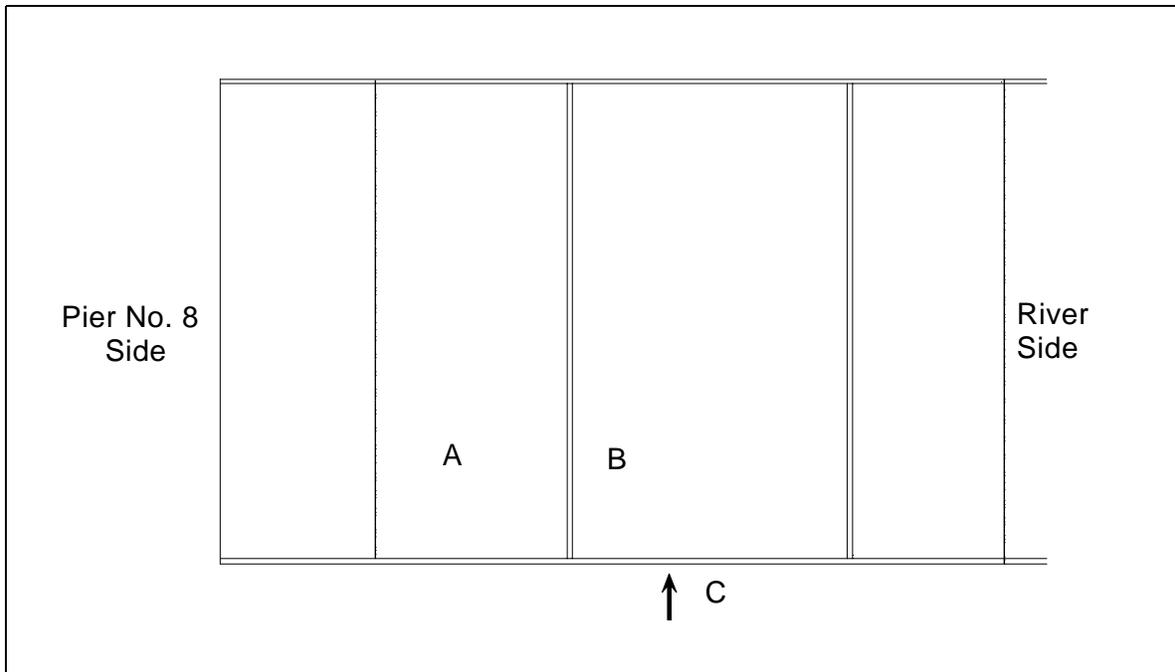
Figure C- 12. Location of lead-concentration measurements after TSV application.

Location	Instrument Sample No.	Lead Concentration. (mg/cm ²)
A	107.2	1.03
B	107.3	2.32
C	107.5	1.46

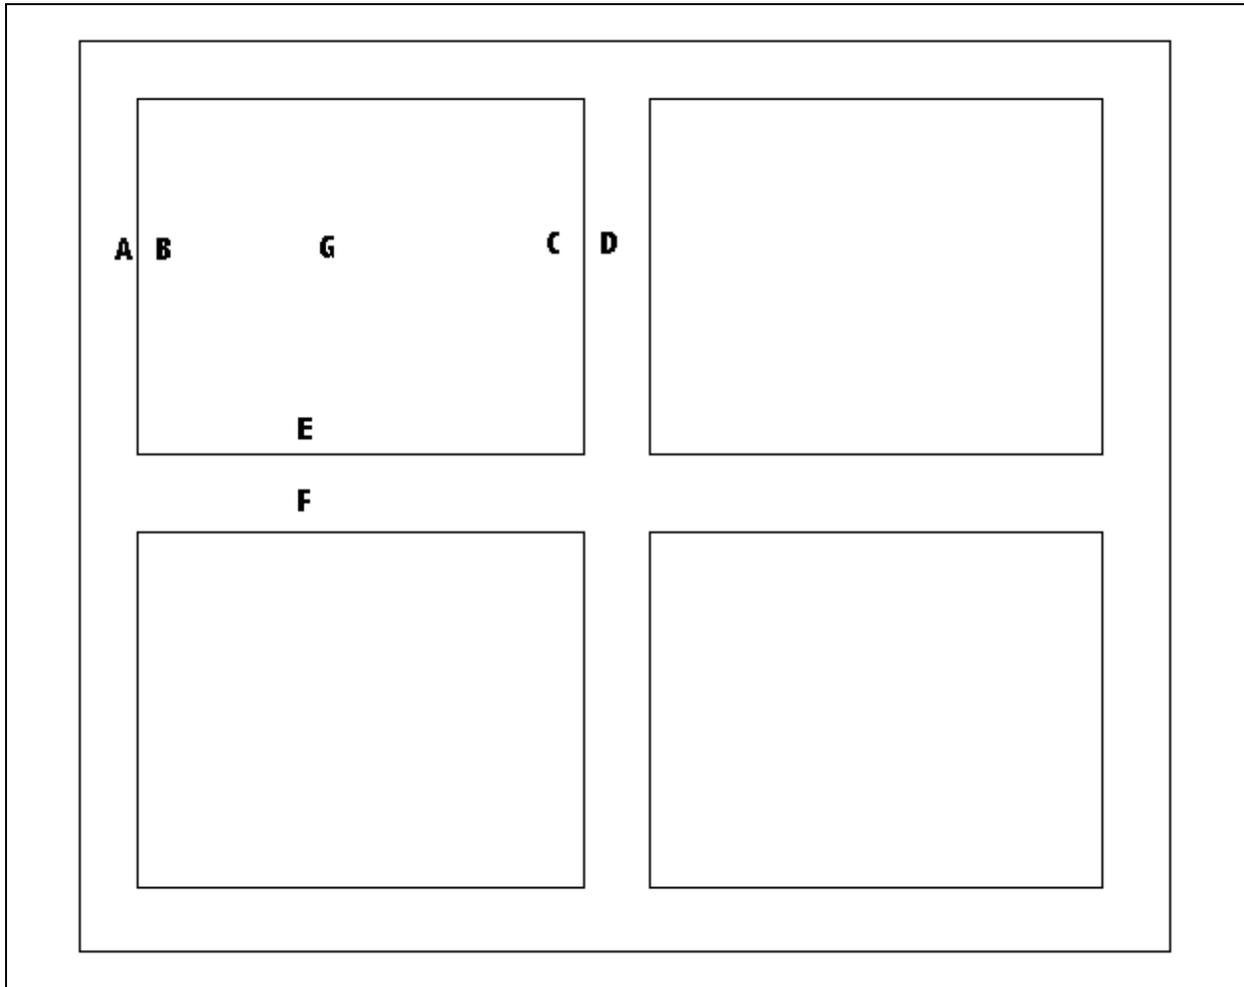
Figure D- 1. Locations of steel thickness measurements.

Location	Component	Thickness, inches
A	Vertical Beam – Web	0.248
B	Vertical Beam – Flange	0.304
C	Vertical Beam – Web	0.274
D	Vertical Beam – Flange	0.349
E	Horizontal Beam – Web	0.202
F	Horizontal Beam – Flange	0.215
G	Skin Plate	0.139

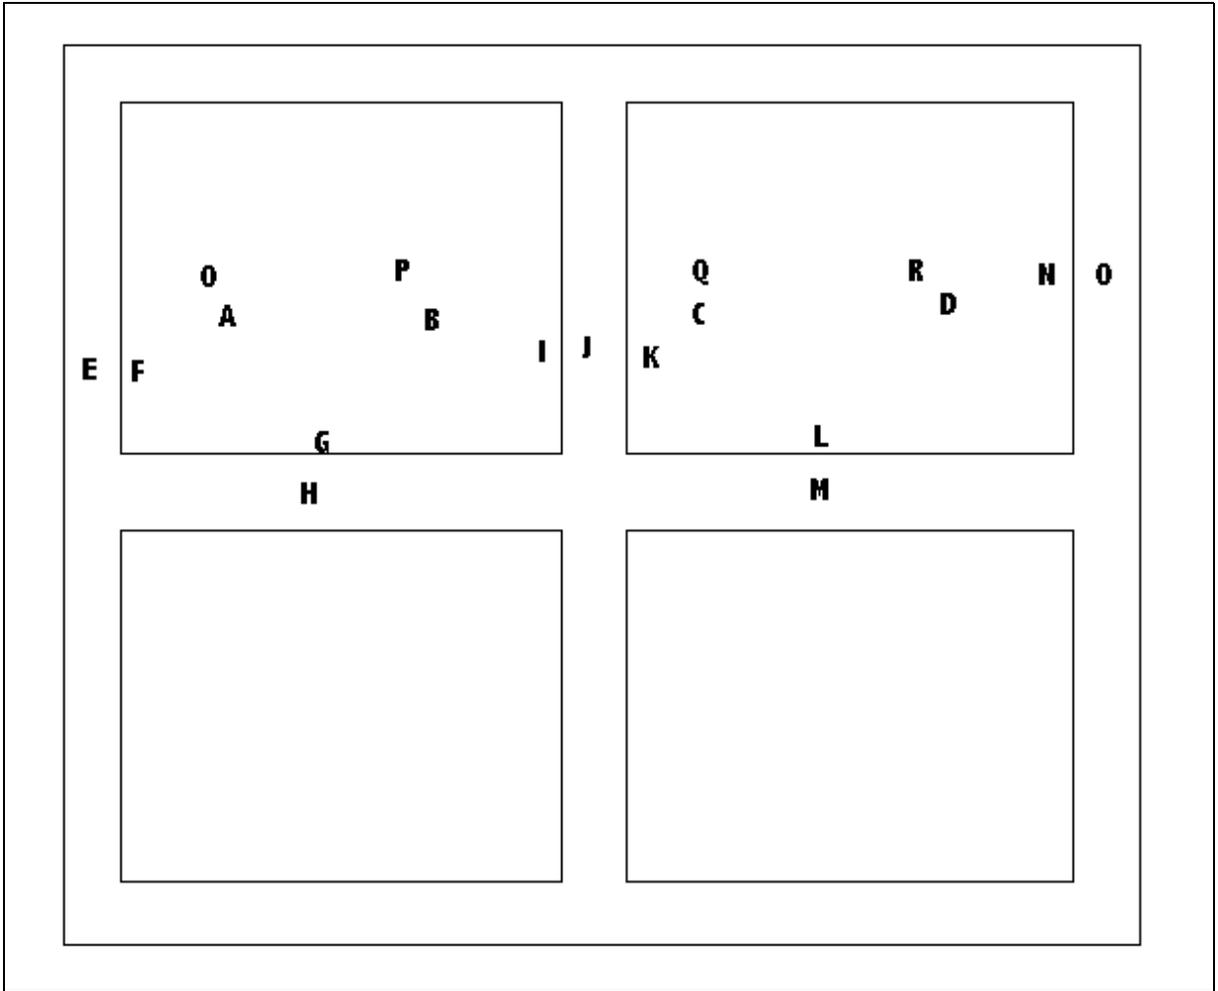
Figure D- 3. Locations of XRF measurements before TSV.

Outside Skin	Lead, mg/cm ²	Inside Skin	Lead, mg/cm ²	Framing	Lead, mg/cm ²
A	1.72	O	4.27	E	19.95
B	2.77	P	9.07	F	12.29
C	1.43	Q	5.37	G	14.42
D	4.39	R	3.06	H	2.79
				I	16.57
				J	13.31
				K	13.76
				L	12.5
				M	9.44
				N	13.25
				O	11.5

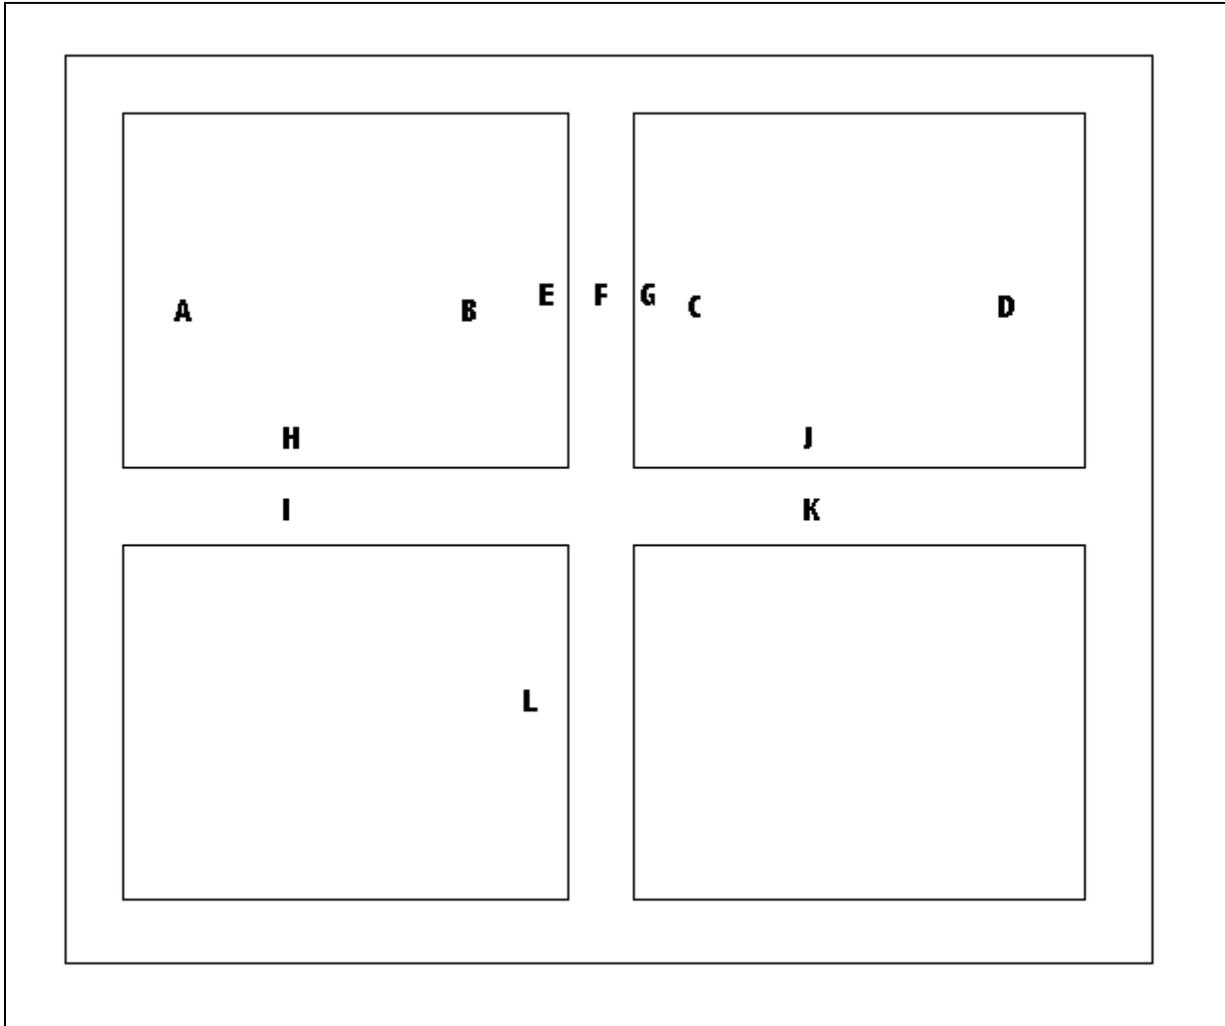
Figure D- 4. Location of XRF measurements after TSV and before needle gun cleanup.

Inside Skin	Lead, mg/cm ²	Framing	Lead, mg/cm ²
A	0.14	E	1.82
B	2.88	F	1.10
C	1.9	G	5.63
D	0.94	H	1.59
		I	2.95
		J	3.33
		K	1.29
		L	3.51

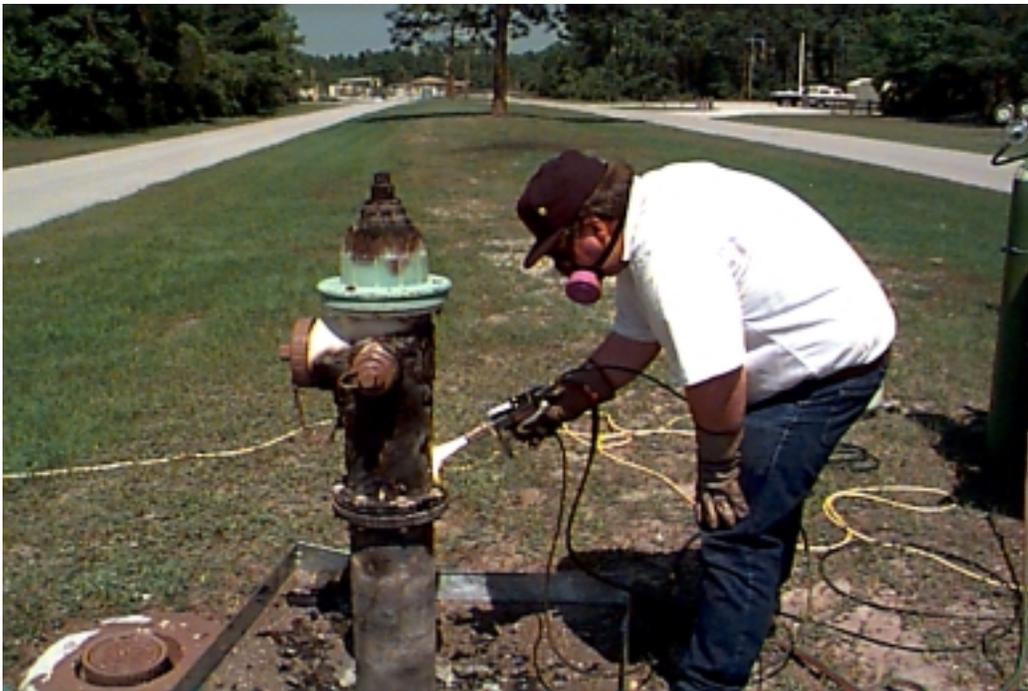
Testing of the hydrants after cooling by opening the valve and filling the body with water under pressure showed that the seals and gaskets on the first hydrant were adversely affected by the heat of vitrification. Repair of the hydrant will require about \$60 worth of gaskets and seals and about 2 man-hours of labor. The second hydrant was tested and no damage to the gaskets or seals was found. An analysis of the procedures used on each hydrant showed that the first hydrant was overheated because of improper gas pressure for the glass feed system. As a result, heating was not uniform throughout the hydrant. The feed gas pressure was properly set for the second hydrant from the beginning.

Figure F- 6. TSV application on hydrant near Building 6029.
