**REPAIR, EVALUATION, MAINTENANCE, AND
REHABILITATION RESEARCH PROGRAM**

TECHNICAL REPORT REMR-OM-13

REMR MANAGEMENT SYSTEMS—NAVIGATION STRUCTURES

**CONDITION RATING PROCEDURES
FOR SECTOR GATES**

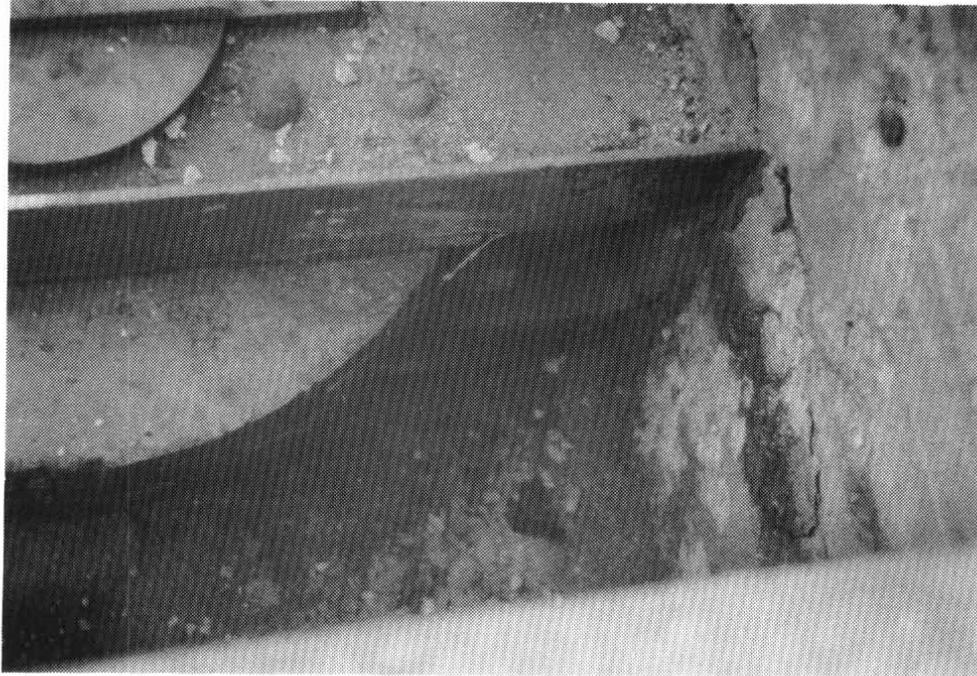
Figure 10. Anchorage

(a) Side view

(b) Cracked and spalled concrete region

The experts judged that motion greater than this could indicate a significant structural problem. For flexible anchorage systems (Figure 10), the maximum elastic motion has been selected as:

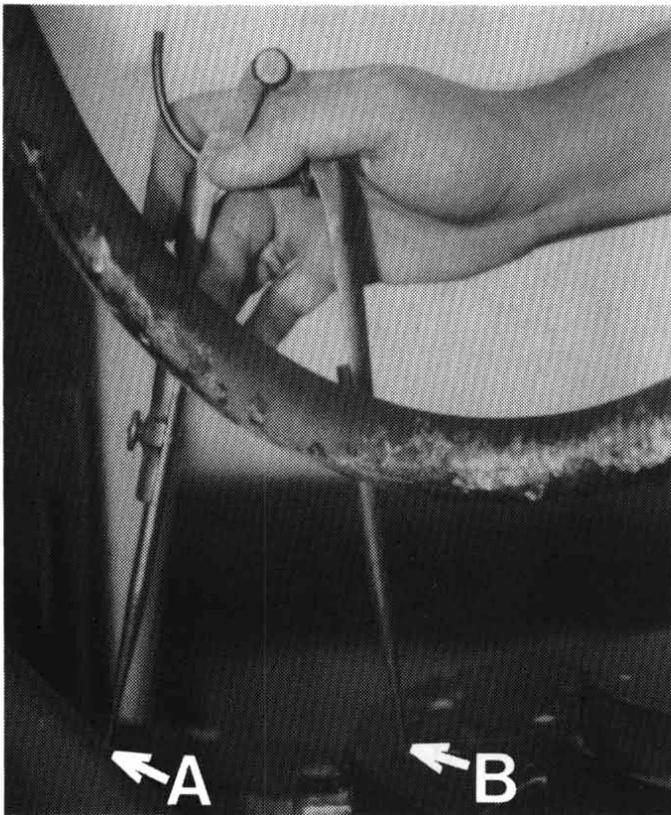
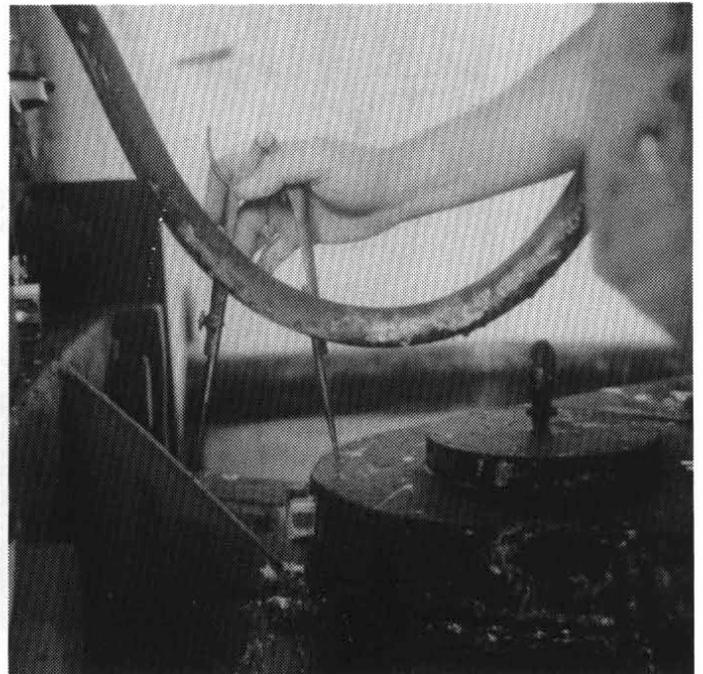
Figure 11. Hinge wear

(a) Plan view

(b) Side view closeup (using calipers)

(c) Side view (using calipers)

44. Hinge wear is the total amount of wear in the hinge pin casting and bushing. Typically, each gate has a similar two-piece anchorage configuration: a hinge bracket casting on the gate and a bracket attached to the embedment assembly (Figure 11). Hinge wear can be caused by several factors:

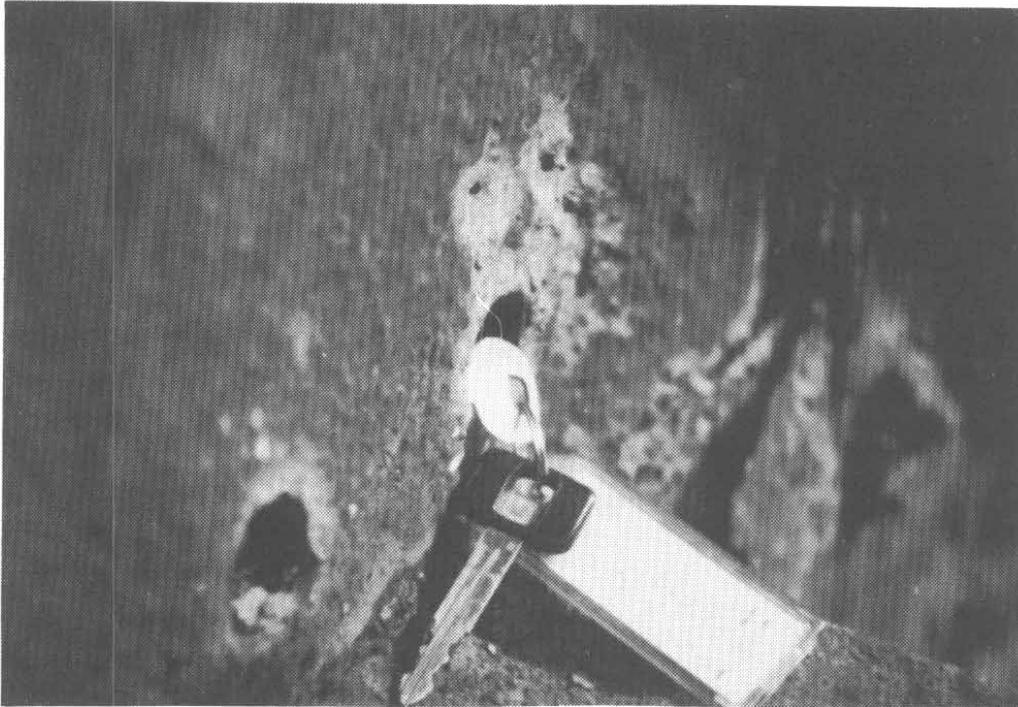
Figure 12. (Sheet 3 of 3)

(e) Level 5: Holes due to thickness reduction and general thickness reduction
