TECHNICAL REPORT REMR-OM-14

REMR MANAGEMENT SYSTEMS—NAVIGATION STRUCTURES

**CONDITION RATING PROCEDURES
FOR TANTER AND BUTTERFLY VALVES**

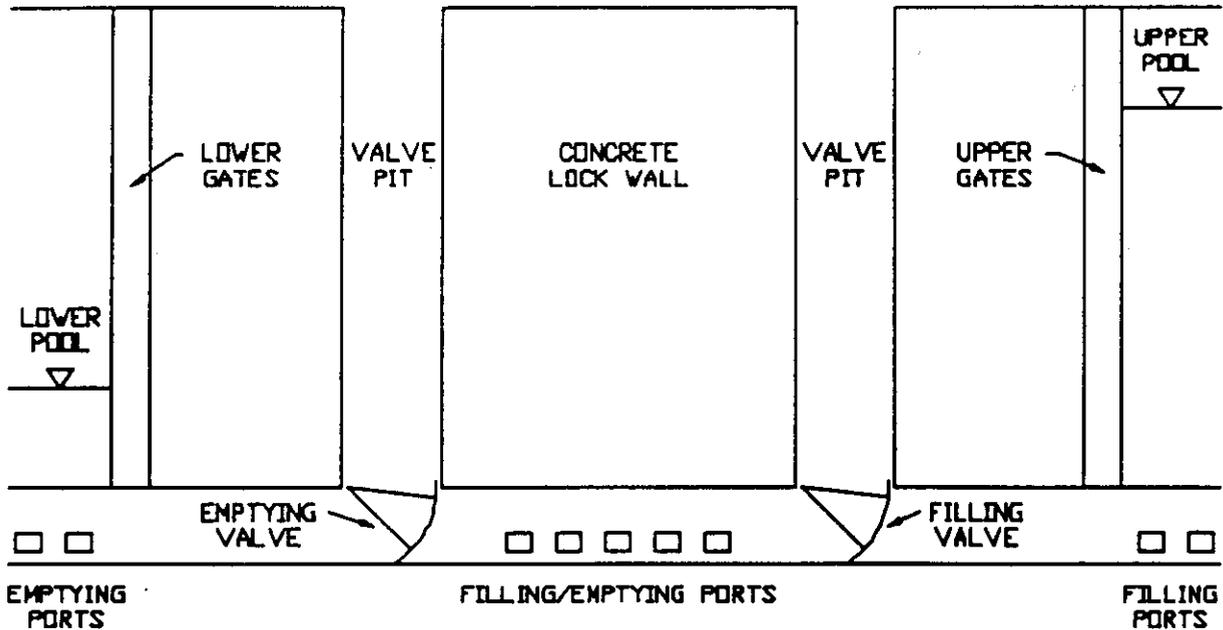
Figure 2. Lock chamber schematic

12. Valves are used inside the culverts of the filling and emptying systems of lock structures (Figure 2). Two valves are necessary in each longitudinal culvert. A filling valve is located between the upper pool intake and the chamber intake ports. An emptying valve is located between the chamber outlet ports and the lower pool discharge.

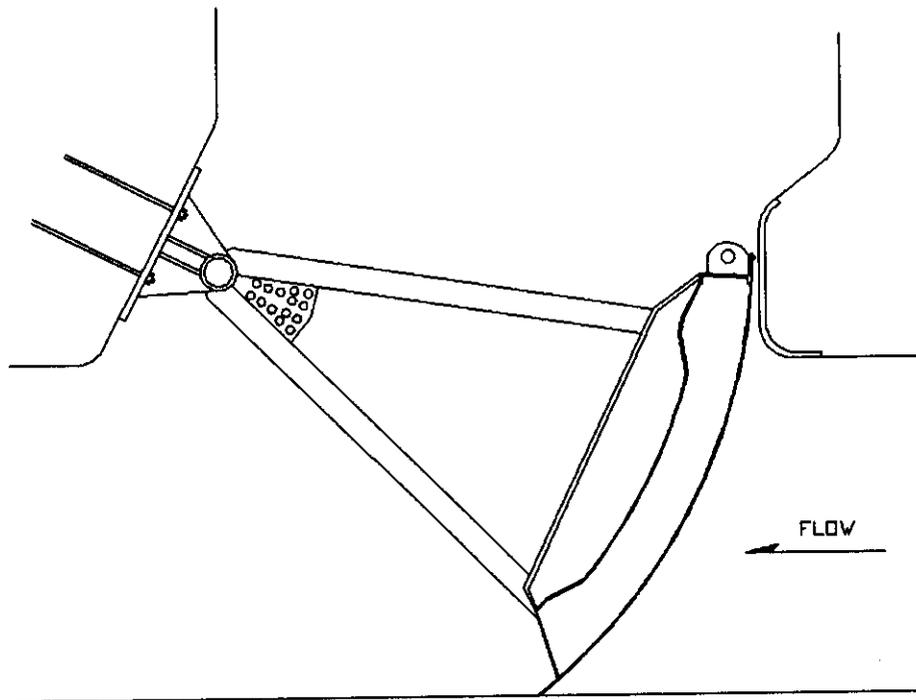
Figure 3. Conventional tainter valve

14. Initially, tainter valves were designed similar to the spillway tainter gates used on dam structures. These valves were oriented with the trunnions downstream of the skin plate causing the convex surface of the skin plate to face the flow and seal along the upstream end of the valve pit (Figure 3). After studies showed that this design could cause air to be pulled into the culvert, a reverse tainter valve design was introduced (US Army Corps of Engineers, 1975). This orientation placed the trunnions upstream of the skin plate with the convex surface of the skin plate facing downstream and sealing against the downstream end of the valve pit (Figure 4). Valves of this general design have been used on most locks constructed by the Corps of Engineers in recent years.

15. A tainter valve is generally anchored to the concrete with an anchor plate and a trunnion bearing bolted to an embedded frame. Because the trunnion assembly of a tainter valve is downstream, the strut arms are in compression (Figure 3). In the case of reverse tainter valves, there are two distinct types of anchorage design. The first and more common design uses a

Trunnion Assembly: The trunnion assembly consists of a set of components that make up the hinge system of the valve. It transfers load from the strut arms into the embedded anchorage system in the culvert walls. Specific arrangement of components varies, depending on the configuration of the anchorage design (Figures 3, 4, and 5).

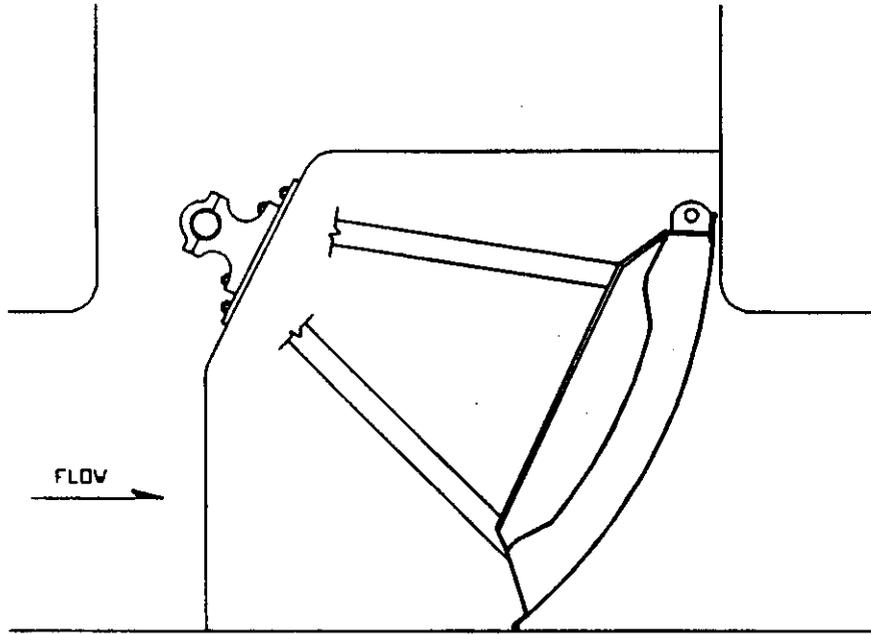
Figure 4. Reverse tainter valve

bearing plate arrangement anchored on a concrete shelf on each side of the culvert (Figure 4). The strut arms are in tension. Anchor bolts are connected to an embedded framework inside the culvert walls. In this design, the anchorage assembly is in compression. The second design, uses U-bolts to anchor the valve to the concrete (Figure 5). The U-bolts are connected to an embedded trunnion girder. This type of design puts the anchorage assembly in tension.

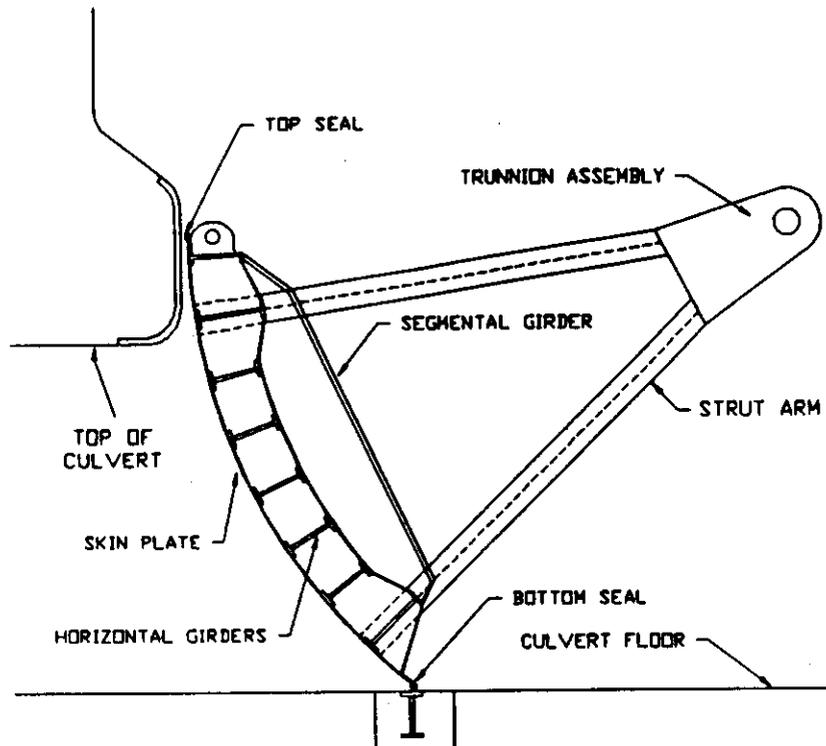
Figure 6. Tainter valve components

Skin Plate: A skin plate is welded to the horizontal girders to provide stiffness to the structure (Figure 6). It dams the water and transfers load to the girders.

Horizontal Girders: Horizontal girders span the width of the valve and transfer load from the skin plate to the segmental girders (Figure 6).

Segmental Girders: These girders are positioned on each side of the valve, perpendicular to the horizontal girders. They transfer load from the horizontal girders to the strut arms (Figure 6).

Strut Arms: Strut arms are the steel girders that transfer load from the segmental girders to the trunnion assembly (Figure 6).

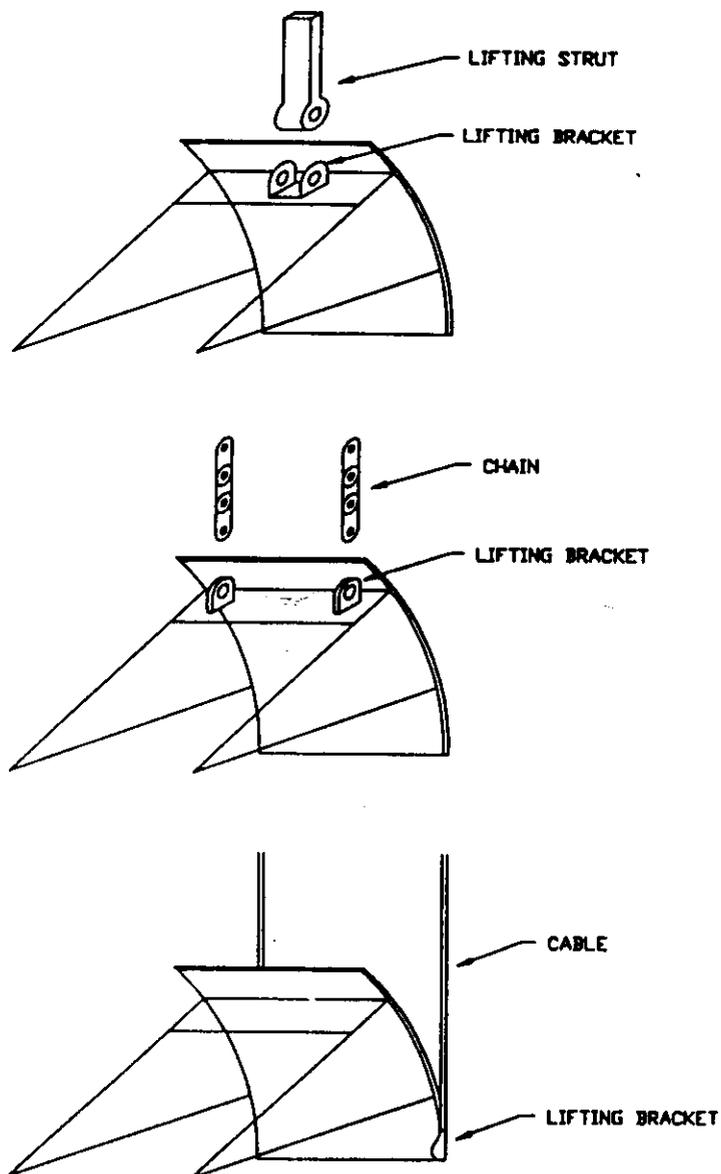
Figure 7. Tainter valve lifting methods

Lifting Strut: The lifting strut connects the operating machinery with the valve structure (Figures 7 and 8). It extends down into the valve pit and moves the valve between its open and closed positions.

Lifting Chain or Cable: Sometimes the valve is lifted by a chain or cable rather than a strut (Figure 7). Its function is the same as a lifting strut.

Lifting Bracket: The lifting bracket is usually located on the top side of the valve and connects the lifting strut to the valve structure (Figure 7). In the case of a cable-lifted valve, the cables connect to the bottom of the valve arch (Figure 7).

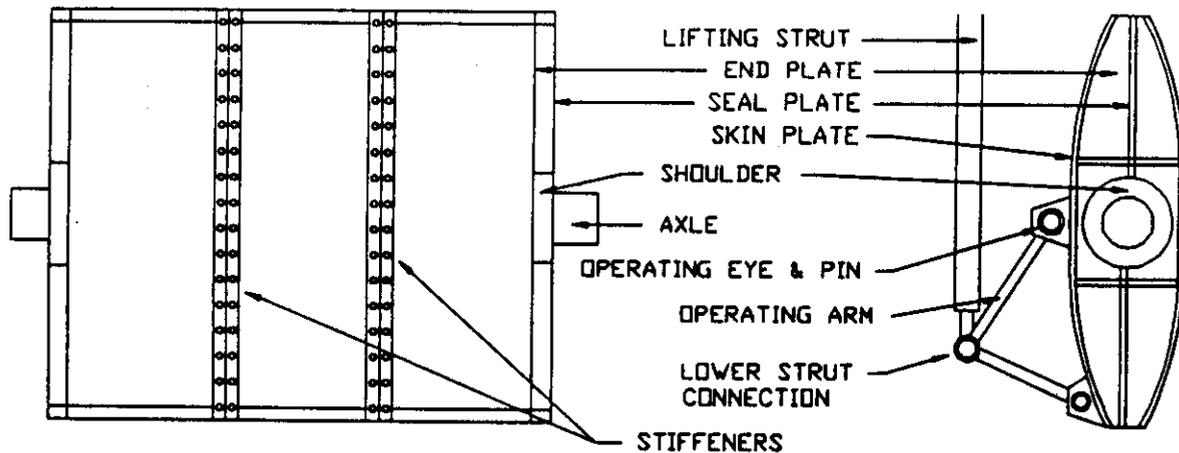
Figure 9. Butterfly valve components

End Plate: End plates are welded onto the sides of the valve to enclose the ends of the valve and transfer load to the axle (Figure 9).

Seal Plate: Seal plates are attached to the perimeter of the valve to provide a sealing surface (Figure 9). Either rubber seal strips are attached, or the steel-to-steel contact will provide an adequate seal.

Shoulder: The shoulder is a spacer surrounding the axle that absorbs the lateral thrust and centers the valve in the culvert (Figure 9).

Lifting Strut: The lifting strut connects the operating machinery with the valve structure (Figure 9). It extends down into the valve pit and moves the valve between its open and closed positions.

Lower Strut Connection: This is the bottom connection point of the strut to the operating arms (Figure 9).

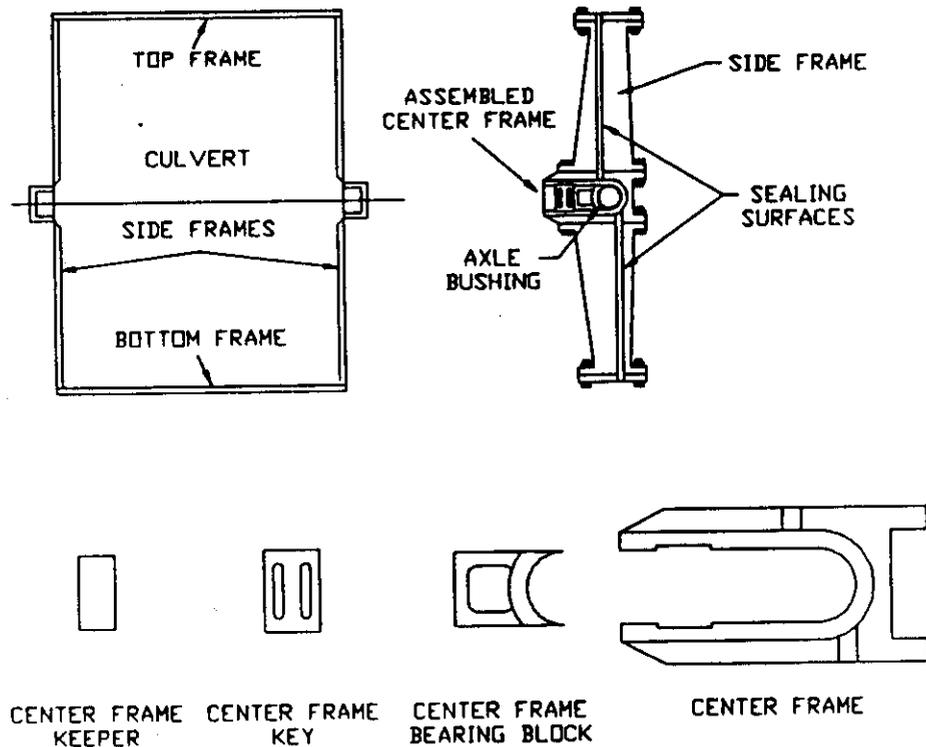
Figure 10. Butterfly valve anchorage assembly

Axle Bushing: This is a bronze bushing mounted inside the center frame (Figure 10). It provides a wearing surface for the valve axle and transfers load from the axle to the center frame.

Valve Frames: The valve frame is embedded in the walls of the culvert around the perimeter of the valve (Figures 10). It is comprised of several components that provide a pivot point, perimeter sealing surfaces, and a means of removal for repair. Components include the top and bottom frames, side frames, center frame, center frame bearing block, center frame key, and center frame keeper.

Center Frame: The center frame is an embedded framing on the sides of the culvert (Figure 10). It is bolted to the side frame and is shaped to provide a means of valve removal. It houses the axle bushing and transfers load from the bushing into the side frame.

Center Frame Bearing Block: This slotted bearing block fits in the center frame and provides an upstream bearing surface for the bushing (Figure 10).

Center Frame Key: The center frame key is slotted perpendicular to the bearing block and prevents the bearing block from sliding out of the center frame (Figure 10).

Center Frame Keeper: The keeper is an end block that holds the center frame assembly together by means of screws spanning through the key and into the bearing block (Figure 10).

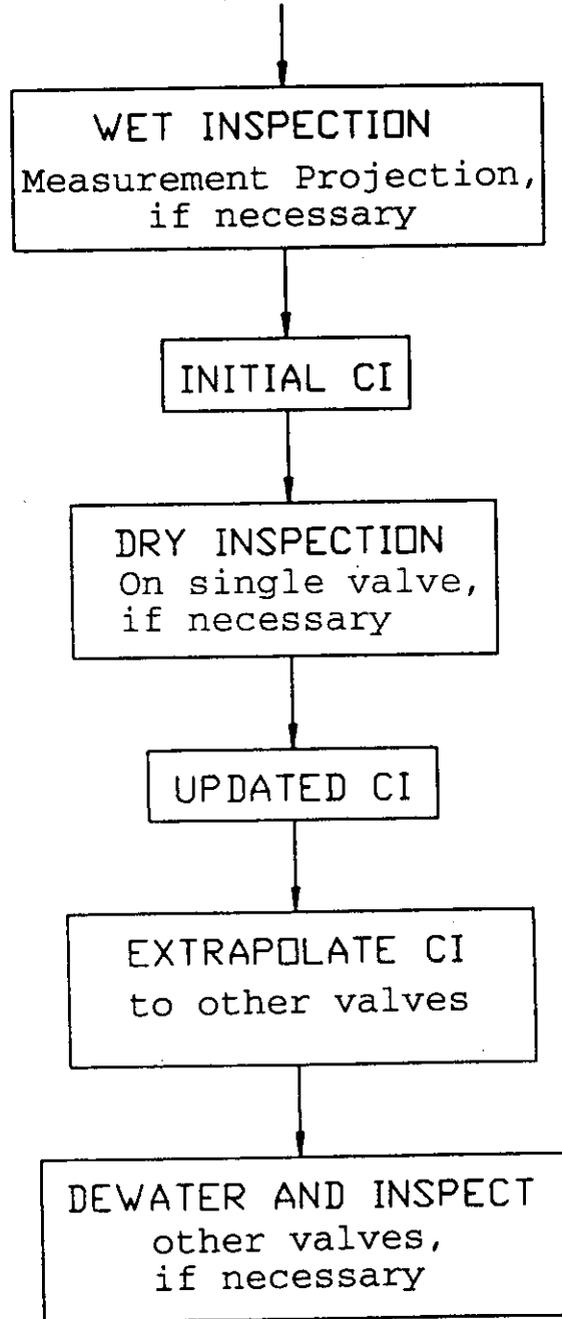
Figure 11. Inspection procedure

28. The overall inspection procedure is illustrated schematically in Figure 11. Many Corps districts currently follow an annual or biannual dive schedule to inspect valves. Working within this established schedule, without dewatering the valve, a wet inspection is the initial procedure in the evaluation process. The information from a wet inspection is used to calculate an initial condition index. If measurement projections are available, they can be used to supplement the diver's inspection. Consecutive wet inspections are performed until the entire lock is dewatered for maintenance or the initial CI value becomes low enough to warrant a further investigation. Wet inspections are intended to minimize the number of routine dry inspections. To get a more accurate condition assessment, a dry inspection could be required to acquire an updated CI. Where appropriate, this updated value can be extrapolated to similar valve structures considering age, type, number of lockages, and water conditions. Other valves with similar conditions may be dewatered.

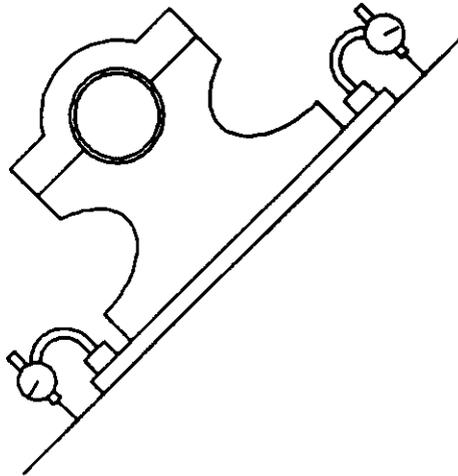
Figure 12. Anchorage movement measurement

ANCHORAGE ASSEMBLY DETERIORATION: If anchorage movement becomes significant, it can be detected by visually examining the concrete interface for a line where the corrosive buildup is broken. Indicate the presence of excessively cracked or spalled concrete at the interface around the anchorage connections. Excessive concrete spalling may indicate a displacement occurred at this location at some time and may or may not show up in the current inspection. Small hairline cracks, probably caused by thermal expansion or contraction of the concrete, should be ignored in this analysis. Indicate if the anchor or casting bolts and nuts are significantly corroded. Significant corrosion refers to an approximate 10 percent volume reduction. Indicate if anchor and casting nuts are tightened properly. This is done with a torque wrench or by visual inspection for signs of movement between the bolted components during operation. Indicate if there are any broken or missing anchor or casting bolts and nuts. Measurements of relative movement between the concrete and steel are taken on the top and bottom of each anchorage, with the valve in two positions: (1) open (2) and closed. Measurements are made with a dial gauge attached to the steel and bearing on the adjacent concrete (Figure 12). Displacements should be recorded to 0.001 in.

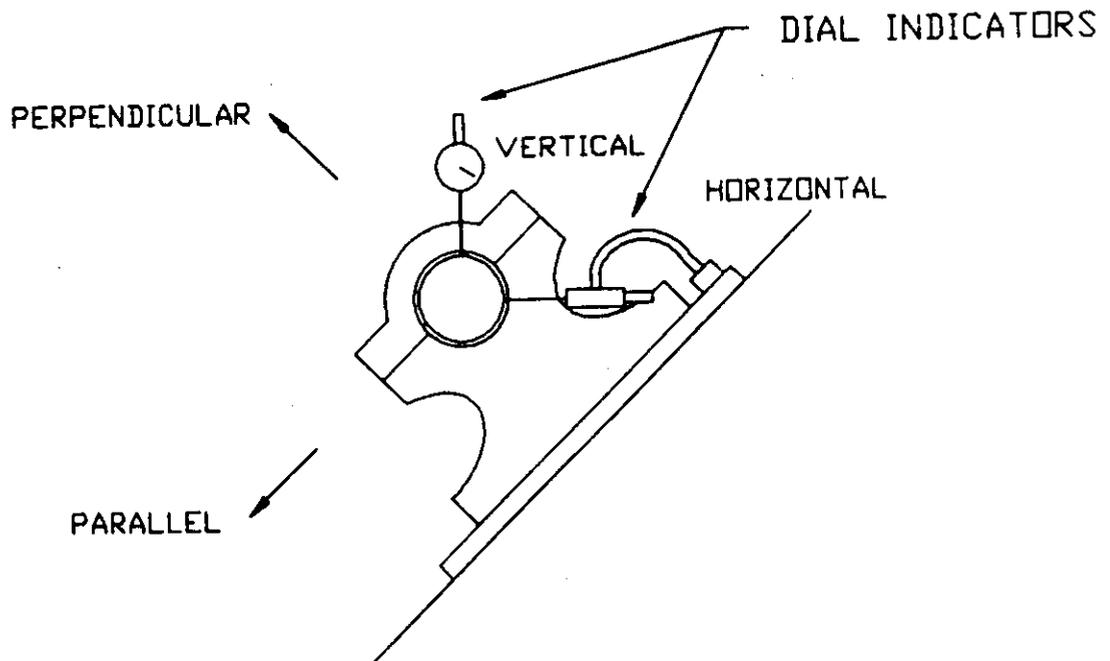
Figure 13. Trunnion assembly wear measurement

TRUNNION ASSEMBLY WEAR: Indicate if the lubrication system is functional. If a unique situation exists, such as a nonlubricated trunnion, circle NA. Indicate if the bushing rotates. If it does, indicate if the bushing is completely seized to the trunnion pin by monitoring the bushing as the valve is rotated through a full range of motion. Take wear measurements in horizontal and vertical directions, using dial gauges that monitor total displacement between the casting and the trunnion pin (Figure 13). First rotate the valve so the upper strut arm is approximately horizontal (Figure 14). Record measurements with the valve in four jacked positions: (1) initial position before jacking, (2) jacked downstream, (3) jack released, (4) and jacked upstream. Before the gate is jacked in either direction, take an initial baseline reading. Then place a jack between the upstream wall of the valve pit and the trunnion girder (Figure 14), approximately in line with the horizontal strut arm. Jack the valve downstream and take a second set of readings. Release the jack and take a third set of measurements. The jack can then be placed between the downstream wall of the valve pit and the downstream skin (Figure 15). The valve is jacked upstream and the final set of horizontal and vertical measurements is recorded.

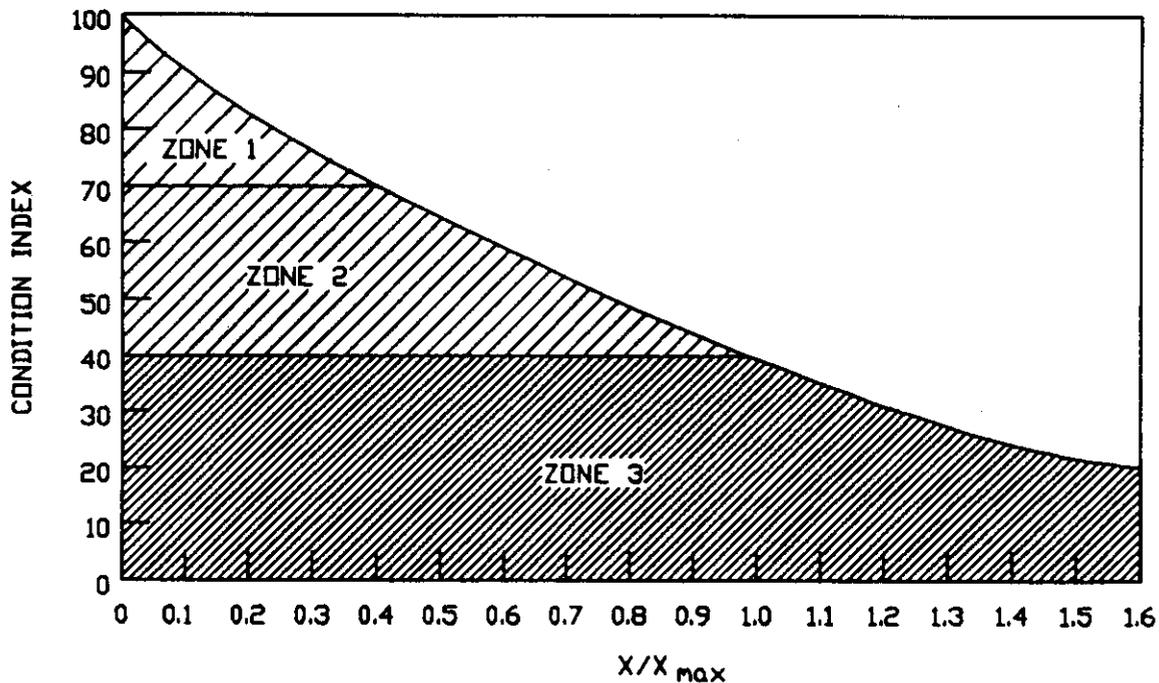
Figure 16. Condition index related to X/X_{max}

38. Measurement of X and limiting X_{max} values for each distress are also described in the following sections. Often, tainter and butterfly valves have the same measurement and limiting value, such as corrosion/pitting/

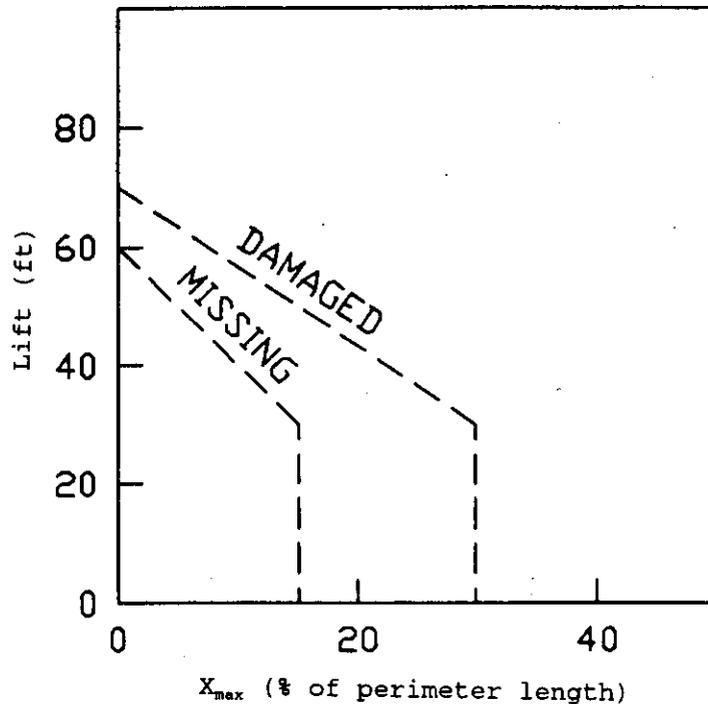
Figure 17. X_{max} for seal condition distress

57. The limiting lengths for damaged and missing seals are based on the normal amount of lift at a particular site and are defined as a percentage of the total perimeter length of seal (Figure 17). For missing sections, at locations that have a normal head less than 30 ft,

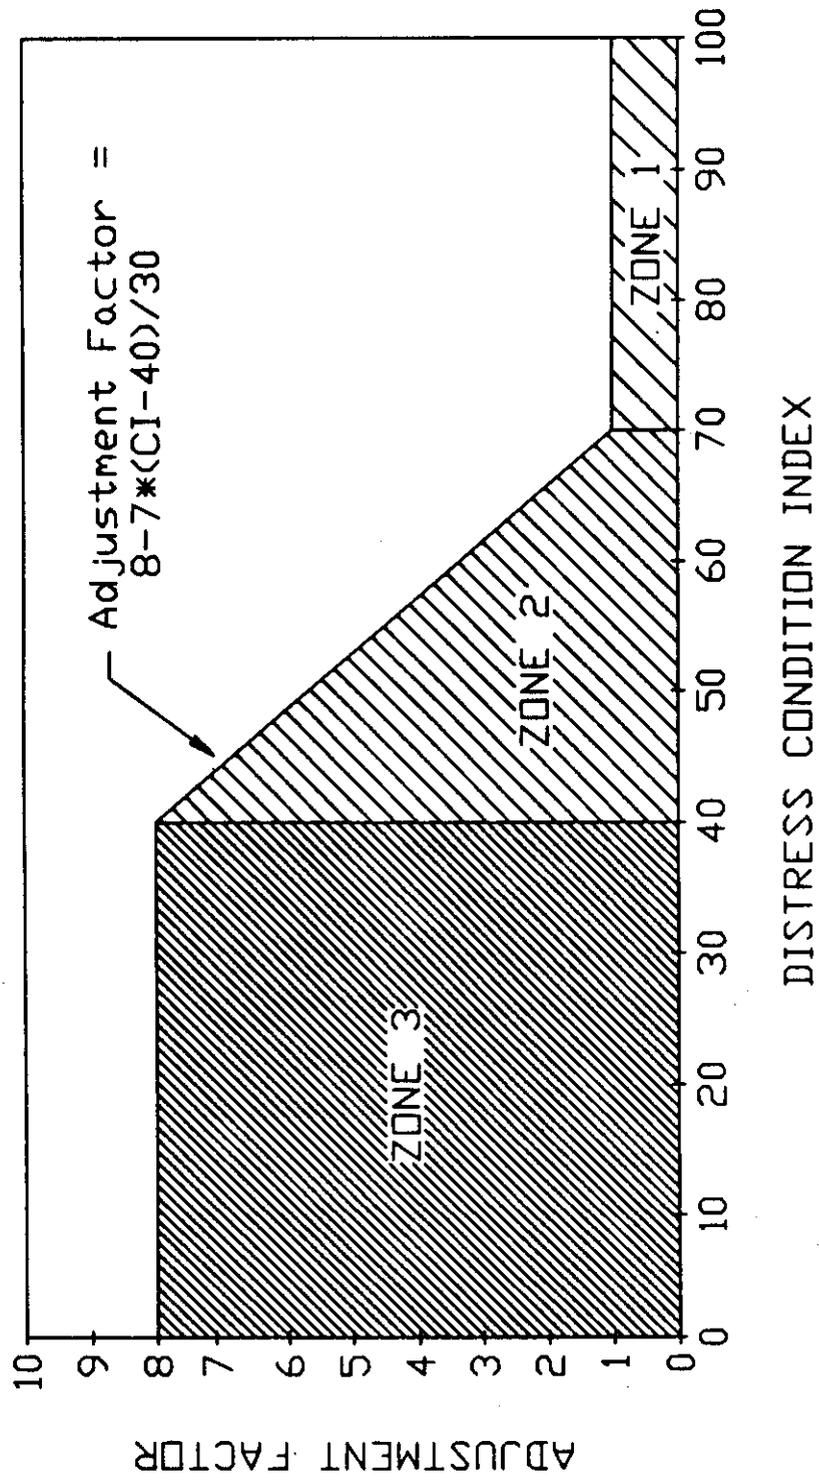
Figure 18. Weight adjustment factor for condition index

88. Based on similar work done by the ISU project team (Greimann and Stecker, 1989), the concept was established that, as a distress became more severe, its relative importance became larger. To account for this, a variable adjustment factor was introduced to increase the distress weighting factor w_i as its CI approached Zone 3. The adjustment factor plotted in Figure 18 has a maximum value of eight; that is, if a distress has a CI less than 40, its importance increases eight times.

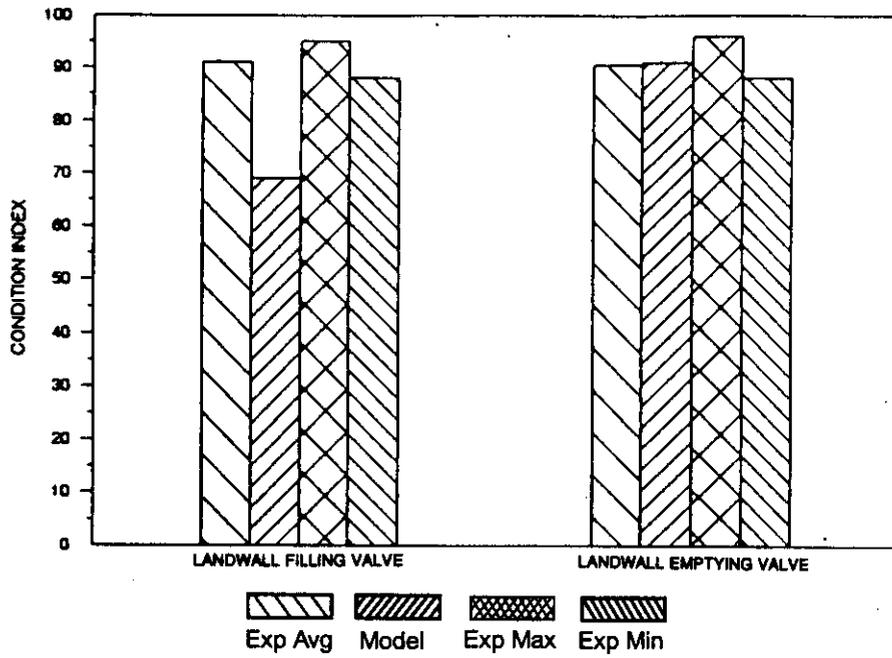
Figure 19. Anchorage assembly deterioration

Anchorage Assembly Deterioration (Figure 19)

94. The calculated anchorage assembly CI for the emptying valve closely approximated the expert average. The calculated CI for the filling valve was 22 points lower than the expert average. After the experts had expressed their subjective ratings, a lengthy discussion concerning the significance of anchorage movement resulted in lowering the X_{max} value to 0.005 in. In other words, the experts judged that almost any measurable movement of the anchorage is a concern. After this discussion and modification, the experts did not

return to modify their subjective evaluations to reflect their reduced X_{max} . Therefore, the calculated CI was lower than the expert average.

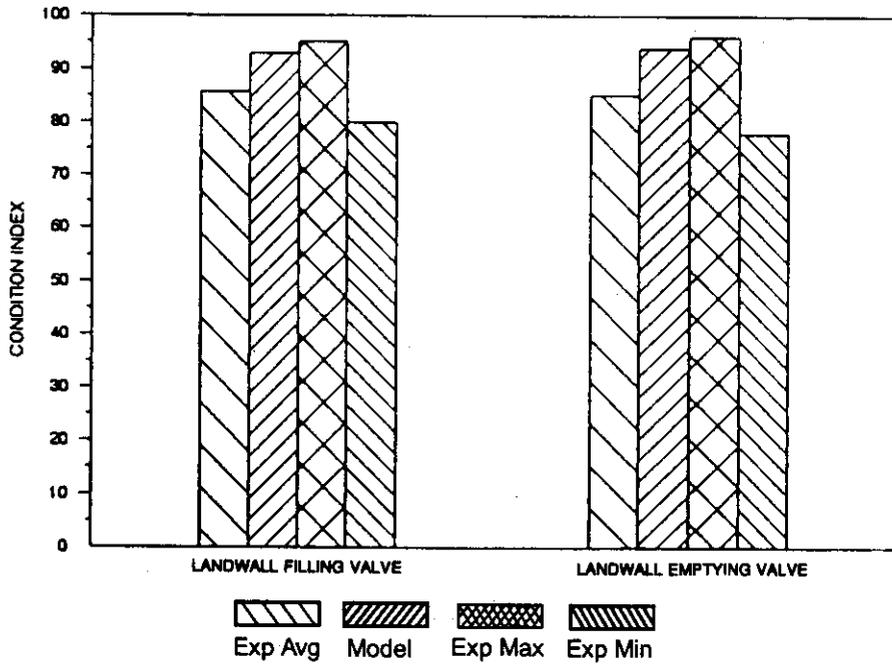
Figure 20. Trunnion assembly wear

Trunnion Assembly Wear (Figure 20)

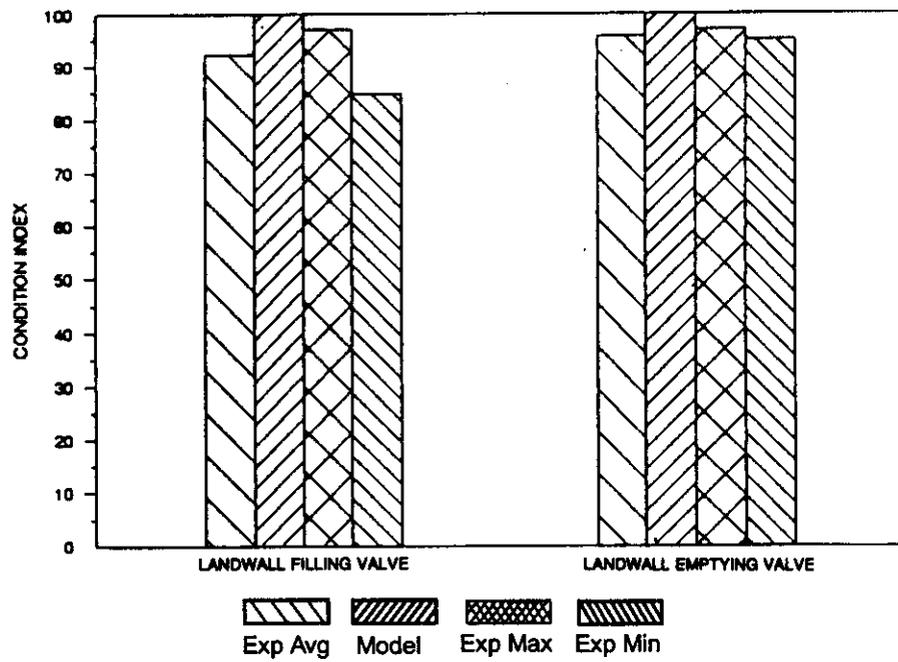
Figure 21. Seal condition

Seal Condition (Figure 21)

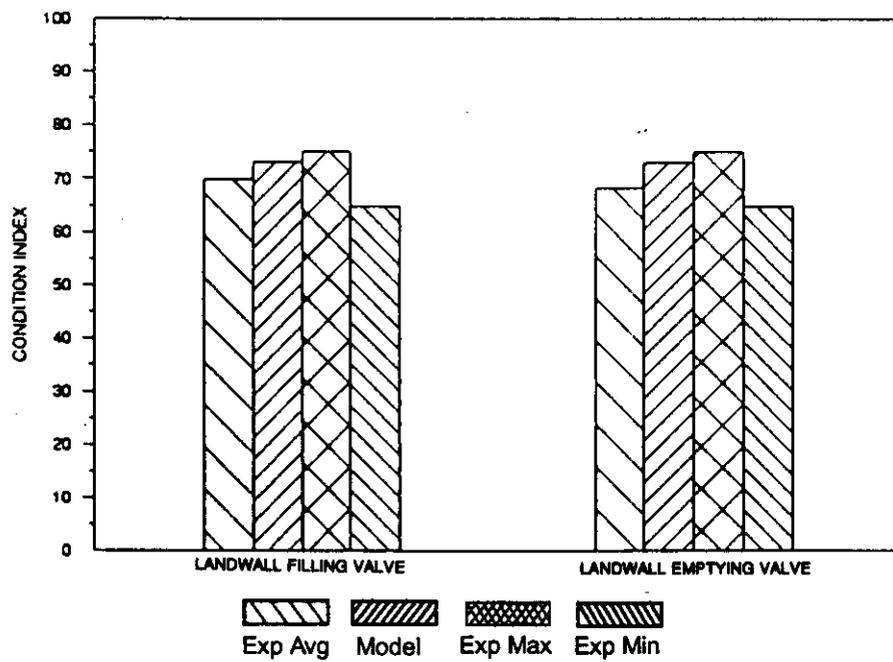
Figure 22. Corrosion

Corrosion (Figure 22)

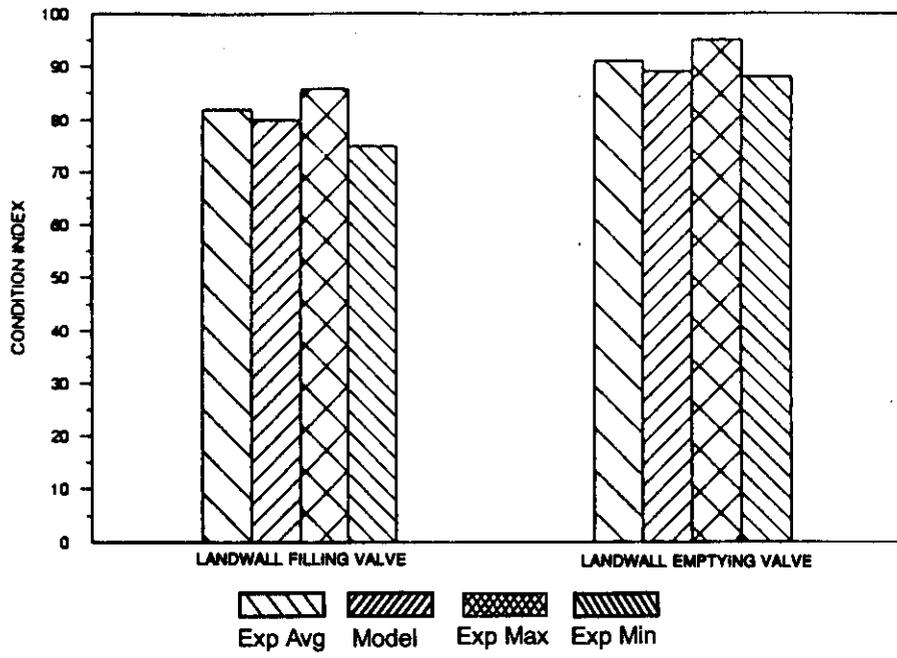
Figure 23. Lifting bracket bushing wear

Lifting Bracket Bushing Wear (Figure 23)

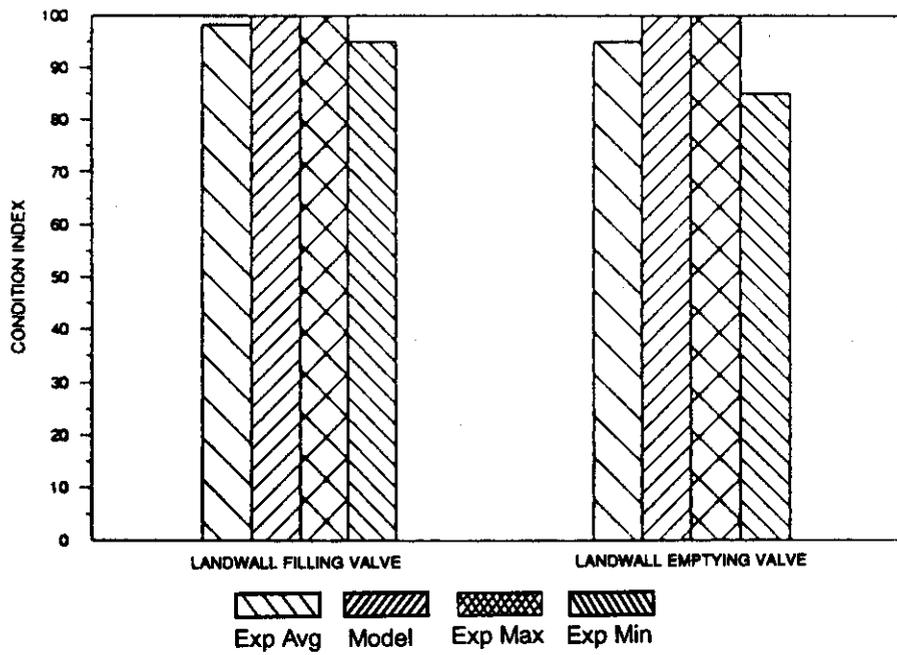
Figure 24. Cracking

Cracking (Figure 24)

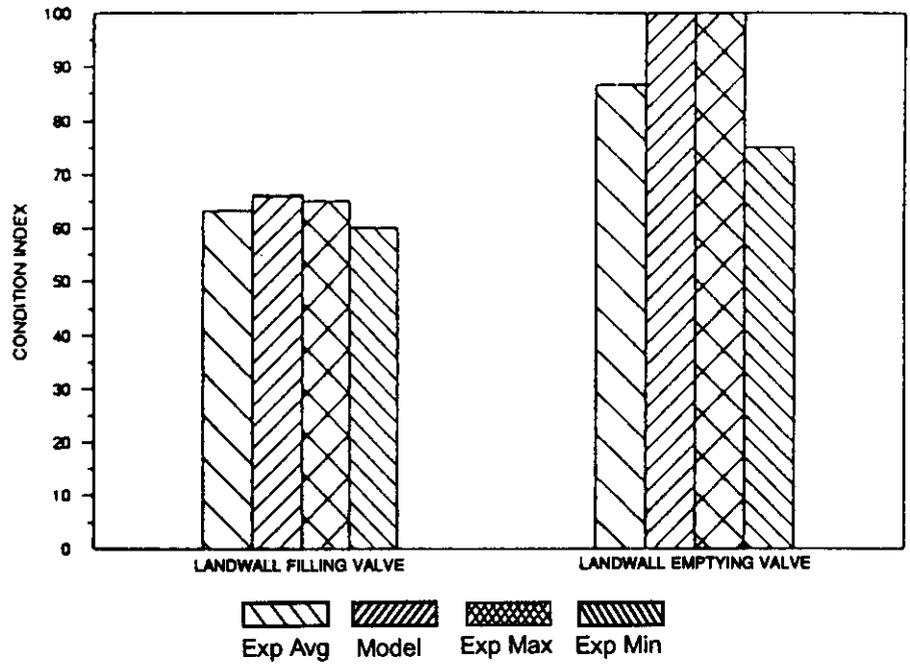
Figure 25. Cavitation/erosion/abrasion

Cavitation/Erosion/Abrasion (Figure 25)

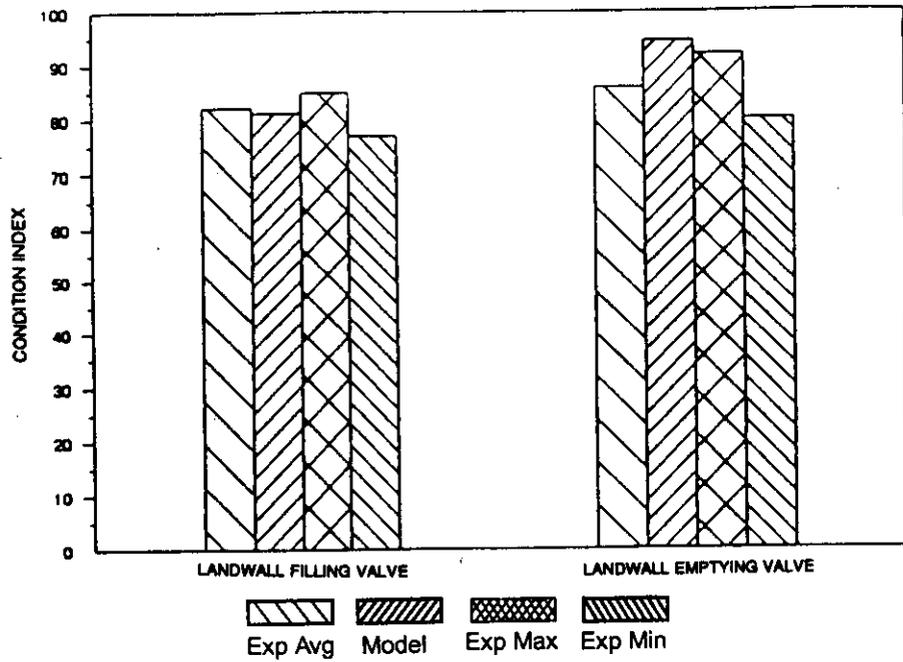
Figure 26. Overall ratings for the valves

Overall Valve Ratings (Figure 26)
