US Army Corps
of Engineers
Construction Engineering
Research Laboratories

Technical Report REMR-OM-19
June 1997

REMR Management Systems—Navigation and Flood Control Structures, Condition Rating Procedures for Lock and Dam Operating Equipment

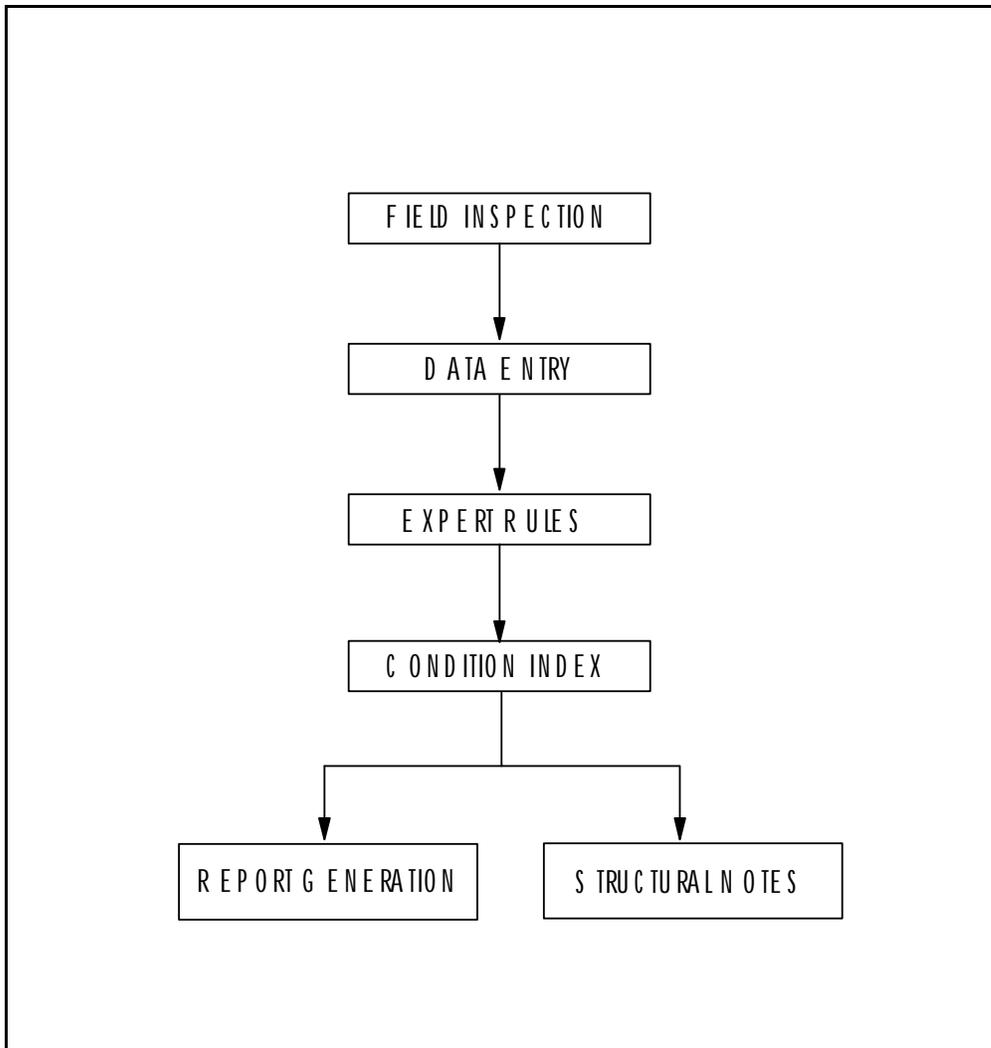
Figure 1. Inspection and rating procedure

The inspection and rating procedure is illustrated schematically in Figure 1. The entire process is based on a field inspection of the operating equipment.

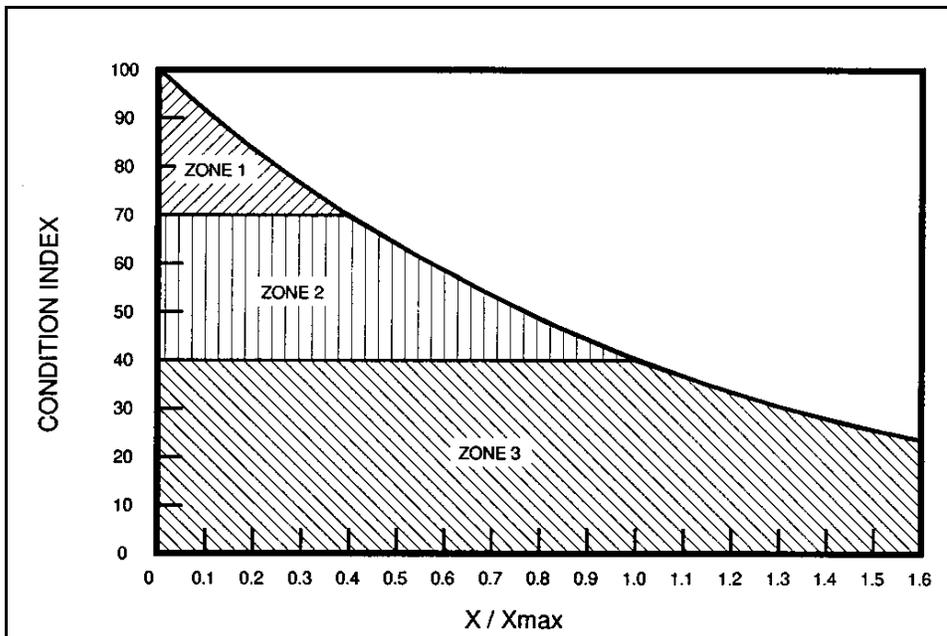
Figure 2. Condition index related to X/X_{MAX} .

where X_{MAX} is some limiting value of X. Figure 2 illustrates the equation and the previously mentioned zones (Table 2). Experts selected X_{MAX} to be the point at which the operating equipment requires immediate repair or at least a more detailed inspection and CI evaluation. In other words, it corresponds to a CI of 40 and is a potentially hazardous situation.

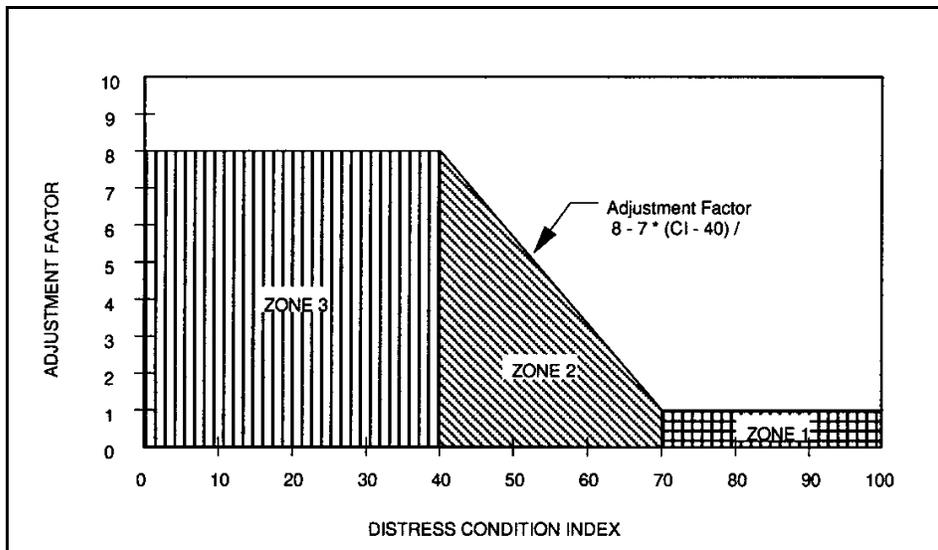
Figure 3. Weight adjustment factor for condition index.

Figure 3 shows the value of the adjustment factor versus the CI_i .

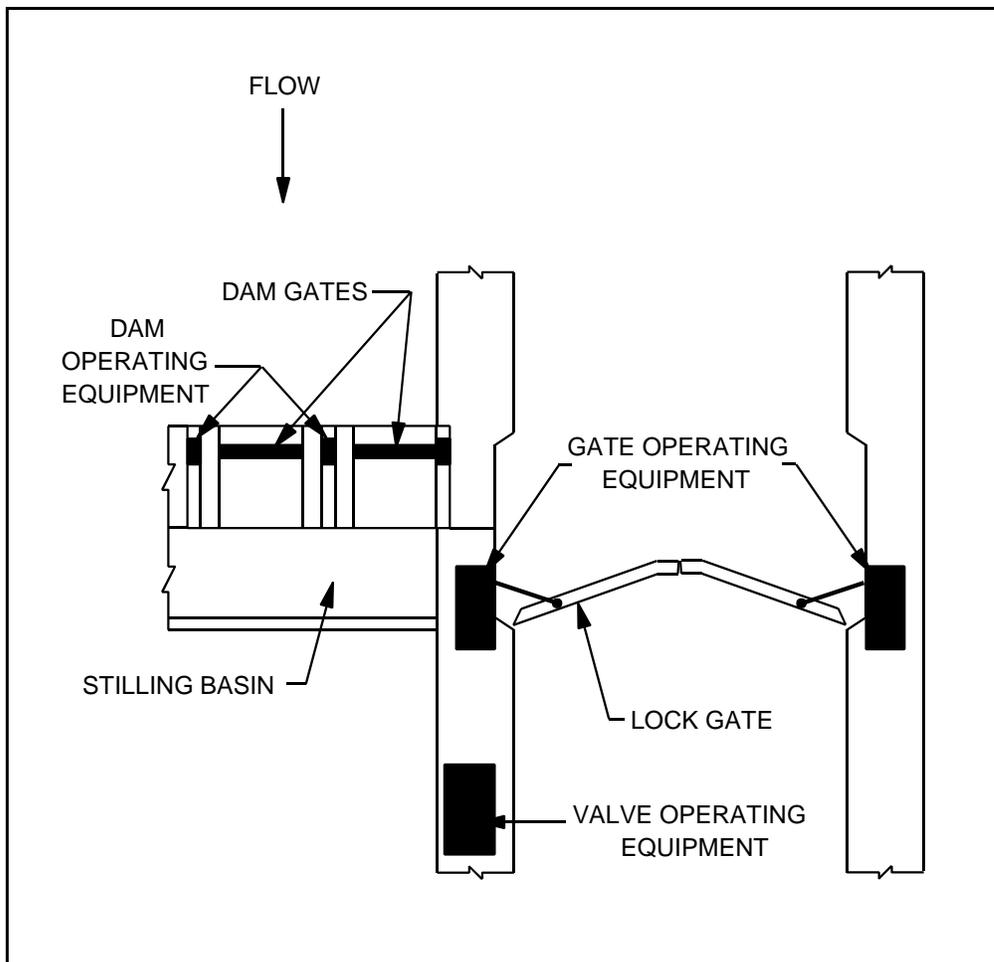
Figure 4. Lock and dam schematic.

This chapter contains pages 1 and 2 of the inspection forms for: (1) lock gate, (2) valve, and (3) dam gate operating equipment. The side-by-side arrangement of the opposing pages displays specific explanations (right side) adjacent to the entry on the inspection form (left side). The chapter begins with a brief description of lock gates, valves, and dam gates. An overall view of a lock and dam facility is shown in Figure 4, in which various operating equipment areas are highlighted.

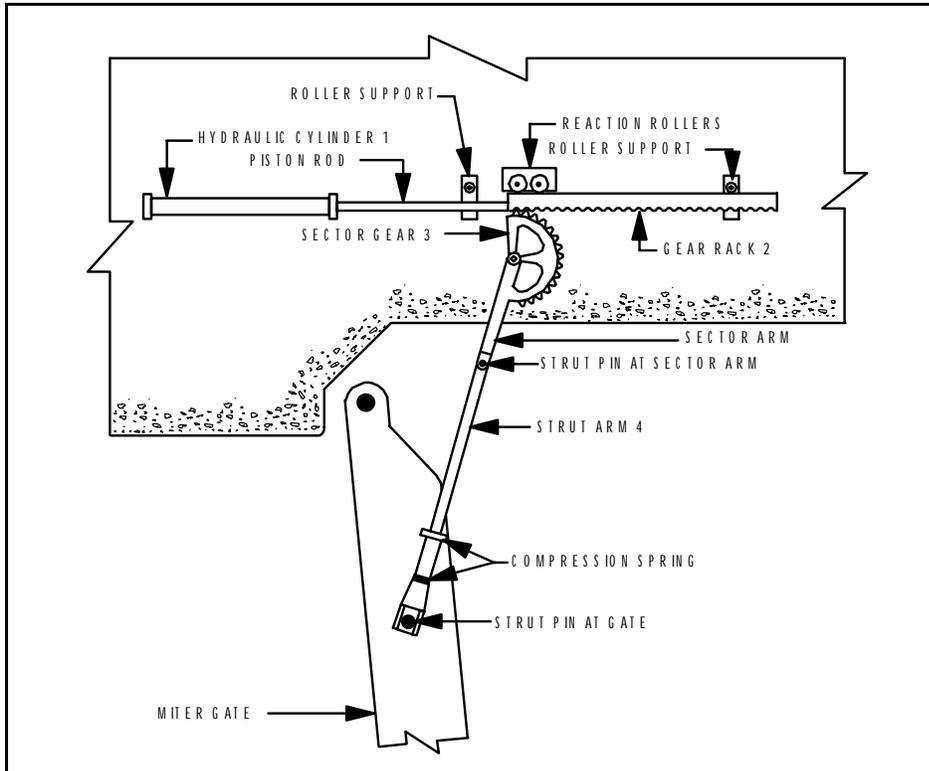
Figure 5. Plan view of miter lock gate operating equipment.

The appropriate inspection Parts 1 and 2 for the selected assemblies will then be completed and combined with pages 1 and 2 for a complete set of inspection forms. If the gate shown in Figure 5 were inspected, one hydraulic cylinder Parts 1 and 2, one gear rack Parts 1 and 2, one exposed gear Parts 1 and 2, and one strut page must be added to the pages 1 and 2 for a complete set.

The rack consists of a set of teeth arranged in a linear or slightly curved fashion. Teeth on the rack mesh with matching teeth on the corresponding gear. The rack transfers force from the hydraulic cylinder to the sector gear when used to operate a miter gate (Figure 5). When used to operate a sector gate, the rack is attached rigidly to the top of the gate and transfers force from a gear to the gate (Figure 8). Racks are sometimes designed to perform as strut and rack assemblies simultaneously. These rack/strut members are used to operate sector lock gates and tainter dam gates.

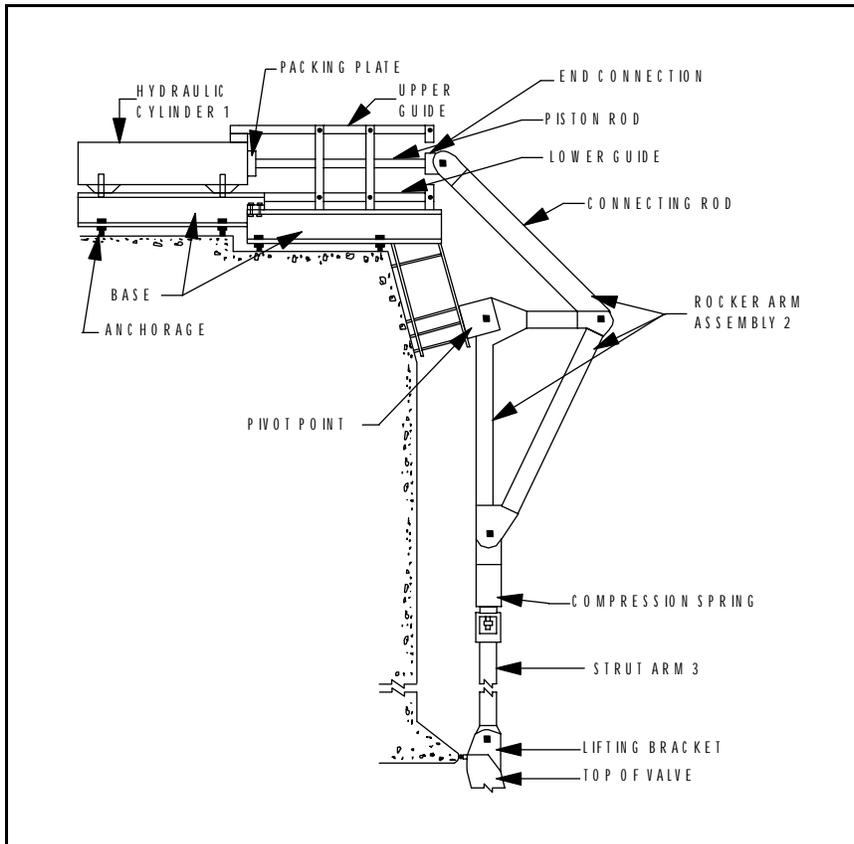
Figure 6. Side view of tainter valve operating equipment.

The appropriate inspection pages for the selected assemblies will then be completed and combined with pages 1 and 2 for a complete set of inspection forms. If the valve shown in Figure 6 were inspected, one hydraulic cylinder Parts 1 and 2, one rocker arm page, and one strut arm page must be added to pages 1 and 2 for a complete set.

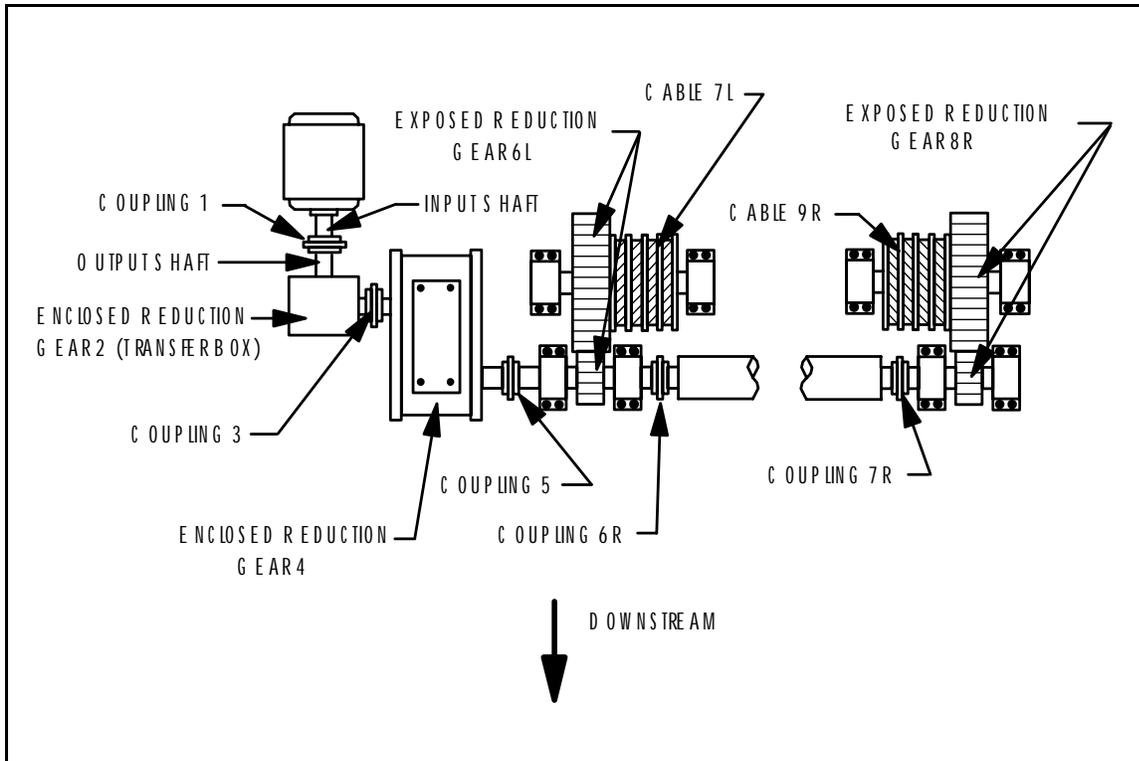
Figure 7. Plan view of dam gate operating equipment.

Example: One Page 1 can be used for any combination of assemblies used to operate a dam gate. The gate type should be indicated by circling the appropriate type. The order of power transfer of the assemblies in the structure should be numbered; for example, the order in Figure 7 is: (1) Coupling, (2) Enclosed gears, (3) Coupling, (4) Enclosed gears, (5) Coupling, (6L) Exposed gears, (6R) Coupling, (7L) Cable, (7R) Coupling, (8R) Exposed gears, and (9R) Cable. The numbering for this example is shown below.

The appropriate inspection Parts 1 and 2 for the selected assemblies will then be completed and combined with pages 1 and 2 for a complete set of inspection forms. If the dam gate operating equipment shown in Figure 7 were inspected, five coupling pages, two enclosed gear Parts 1 and 2, two exposed gear Parts 1 and 2, and two cable Parts 1 and 2 must be added to pages 1 and 2 for a complete set.

Reduction gears are a series of gears used to lessen the torque required to open and close or raise and lower gate or valve structures, respectively. As a result, the structure moves at a slower rate of speed than the motor rotates (Figures 7 and 8). Enclosed reduction gears are in a gear box and can sometimes be seen by removing the cover plate. The gears in the gear box are lubricated with an oil or grease bath.

The transfer box is a set of reduction gears that redirects the rotating shaft by 90 degrees (Figure 7). This is accomplished with the use of a worm and a worm gear (Figure 9) or with bevel gears.

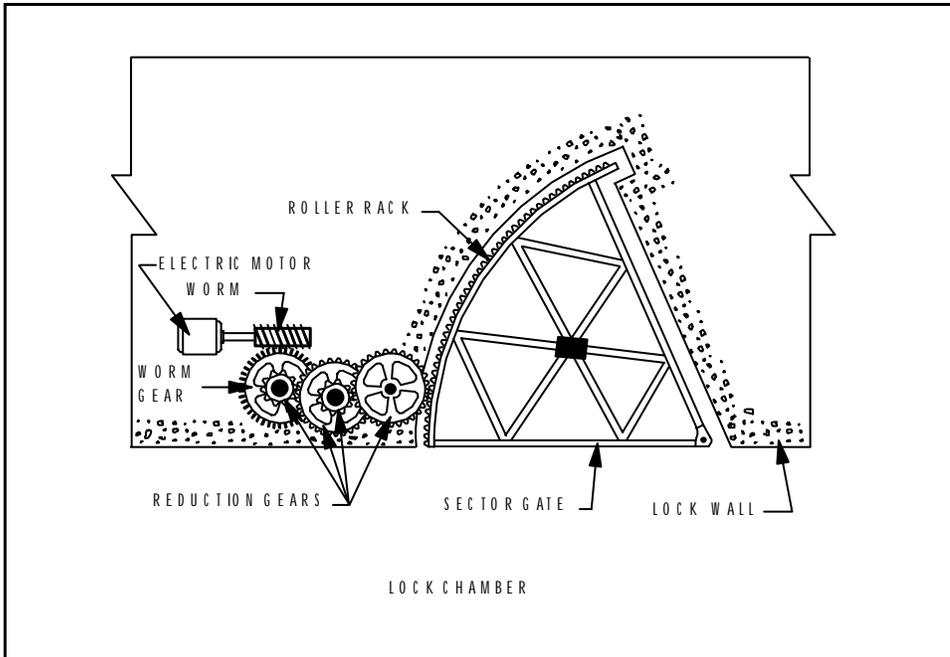
Figure 8. Plan view of sector lock gate operating equipment (gear and rack).

The gear and pinion are a set of reduction gears, with the pinion substantially smaller than the gear.

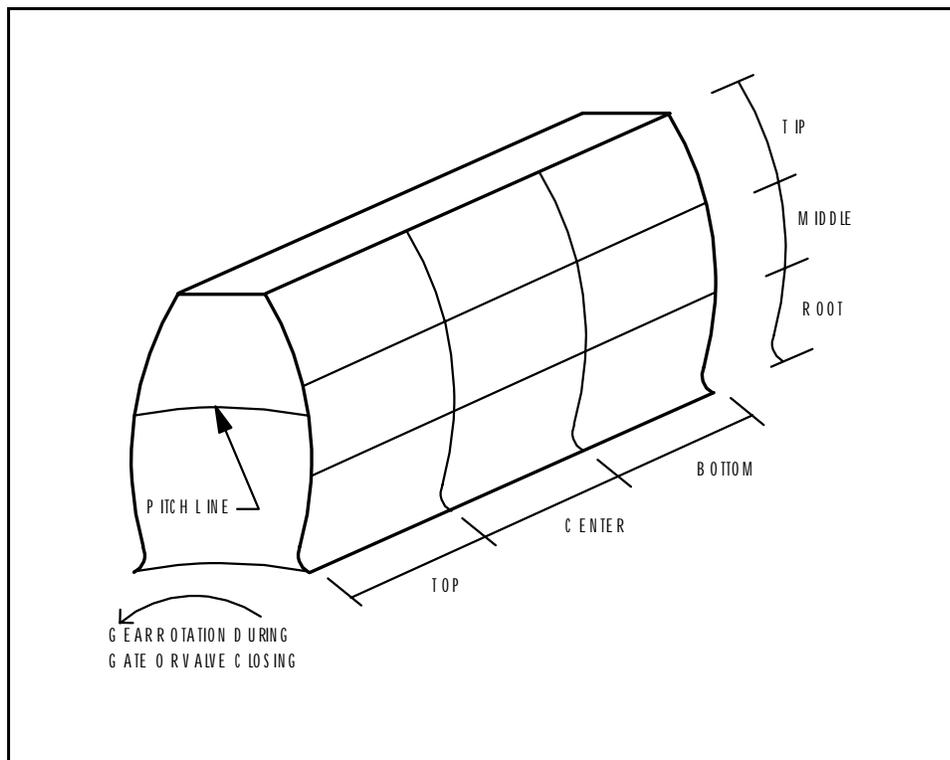
Figure 11. Tooth contact location.

Record the LOCATION of the damaged teeth. The location of the tooth is described by a number. On a sector gear, the first tooth on the side where the sector arm is connected is tooth number one and will be numbered from there. For bull gears that engage the sector gate rack, the gear tooth that is fully in contact with the rack when the gate is in the open position is numbered one and the remaining teeth will be numbered in counter-clockwise direction from tooth one. For exposed reduction gears, the meshing tooth between the gears that are fully in contact when the gate or valve is in the open position is numbered one. The remaining teeth are numbered in order starting at tooth one and going in the direction the gear turns as the gate or valve is being closed.

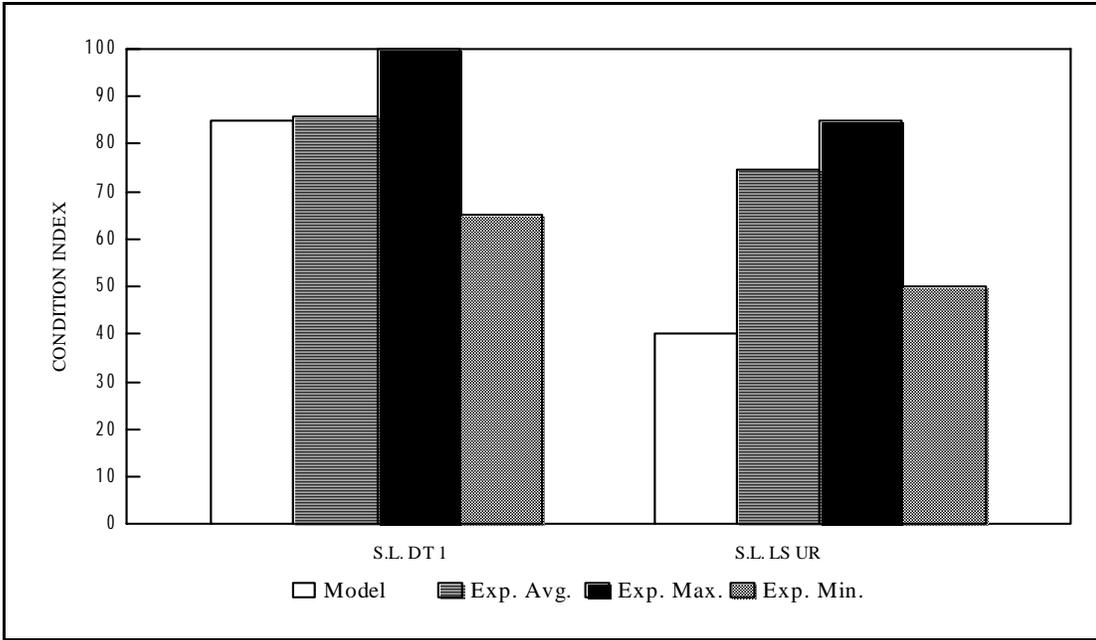
Figure 12. Anchorage movement/deterioration: exposed gear assembly.

Twenty exposed gear assemblies were observed during the field tests. The bar charts in Figures 12, 13, and 14 compare the experts' subjective CI during the various field tests with the CI calculated from the rules in Section 4.3 for three exposed gear distresses. Assemblies with no distresses are not plotted. Comparisons between the calculated and experts' CIs are summarized in the remainder of this chapter.

Anchorage Movement/Deterioration: Figure 12

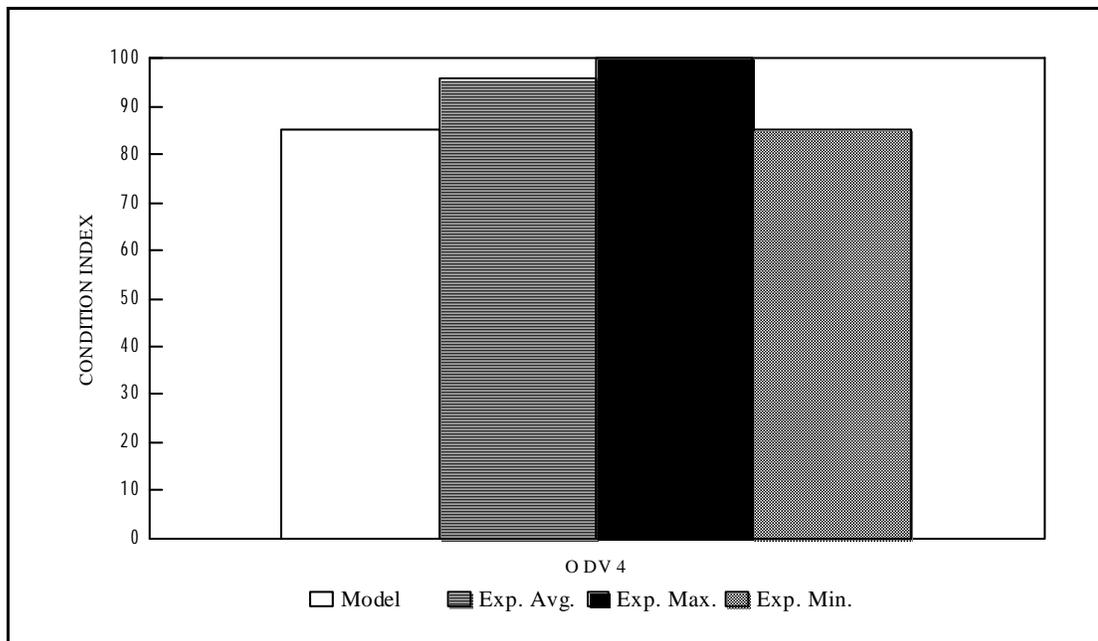
Figure 15. Exposed gear assembly CI.

The assembly CI for exposed gear assembly was calibrated for three assemblies. In each case, the model CI was somewhat higher than the experts' average CI. Although the model CIs were higher, the experts' average CIs and the model CIs were all in Zone 1.

Assembly CI: Figure 15

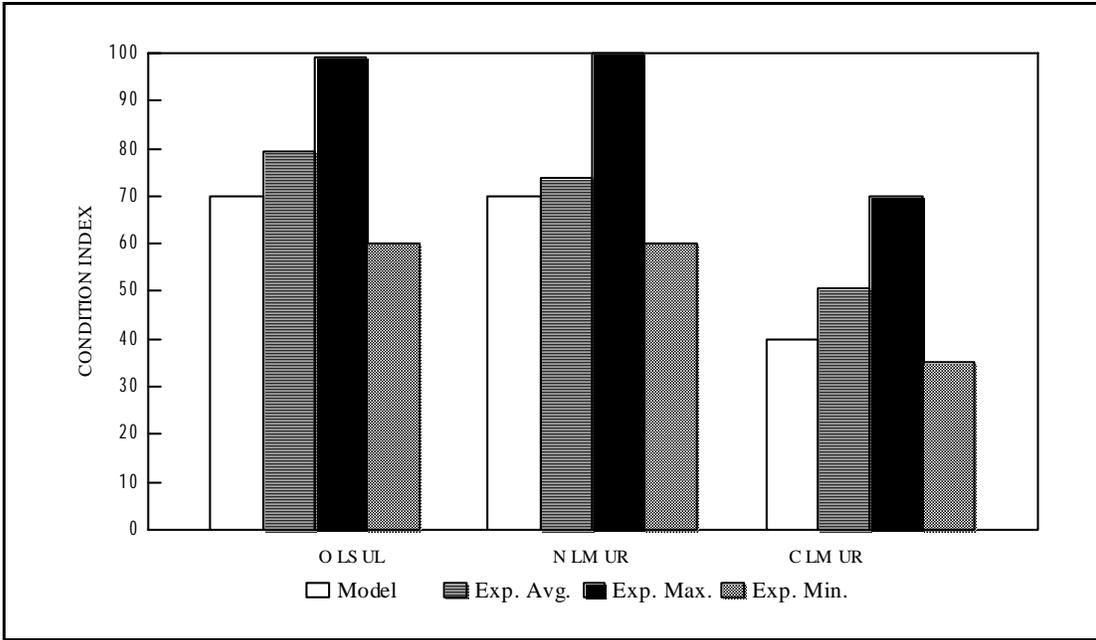
Figure 16. Noise, jumping, and vibration: enclosed gear assembly.

The calculated noise, jumping, and vibration CIs closely approximated the experts' averages. In 12 of the 15 observed exposed gear assemblies, this distress was not observed; therefore, the calculated CIs were 100 and the experts' average CIs were above 90. In one case (Upper Right Lock Gate Moore Haven), a thumping noise was heard in the gear box. The calculated CI was 70, while the experts' average CI was 80. In another case, jumping was observed (Upper Right Lock Gate St. Lucie); therefore, the calculated CI was 70. The experts' average CI was 74. The enclosed gear used to operate Dam Gate #1 on the St. Lucie Dam was observed to make a noise and vibrate. The calculated CI for noise and vibration is 40. The experts' average CI dropped to 51.

Fifteen enclosed gear assemblies were observed during the field tests. The bar charts in Figures 16 to 21 compare the experts' subjective CI to the CI calculated from the rules in Section 5.3 for six enclosed gear distresses that were observed during field tests. Comparisons between the calculated and experts' CIs are summarized below.

Noise, Jumping, and Vibration: Figure 16

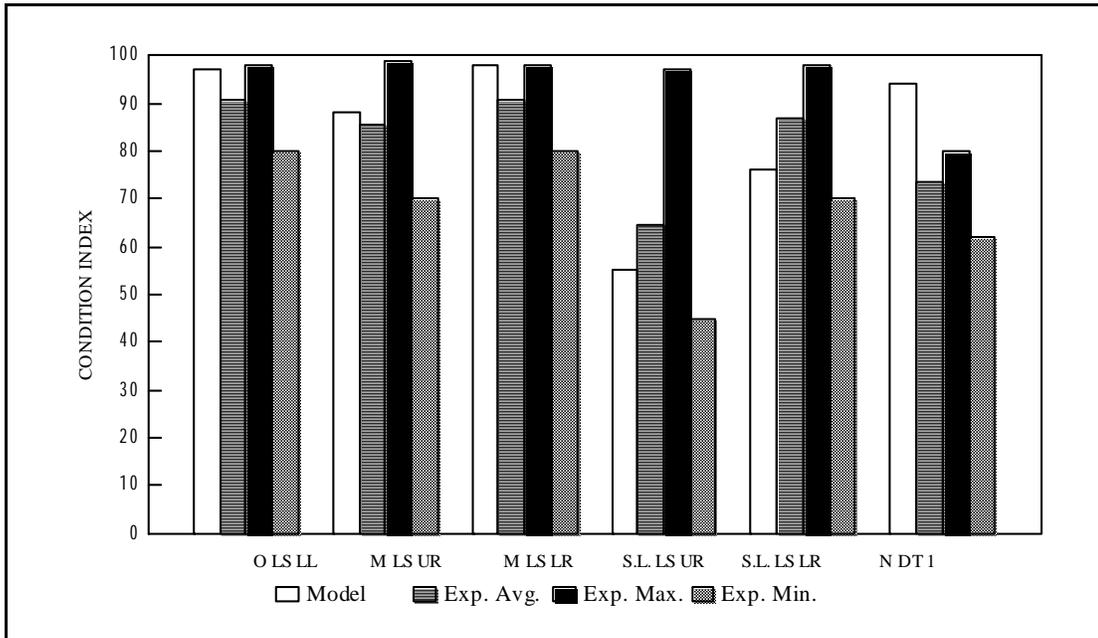
Figure 22. Enclosed gear assembly.

The assembly CI for the enclosed gear assembly was calibrated for six assemblies. For four of the assemblies, the model CIs were above the experts' average CIs, and for the remaining two assemblies the model CIs were slightly lower. In only one case (Tainter Dam Gate #1 Newburgh) was the model CI significantly different from the experts' average CI. The corresponding model CIs and experts' average CIs were in the same zone for each of the six calibrated assemblies.

Assembly CI: Figure 22

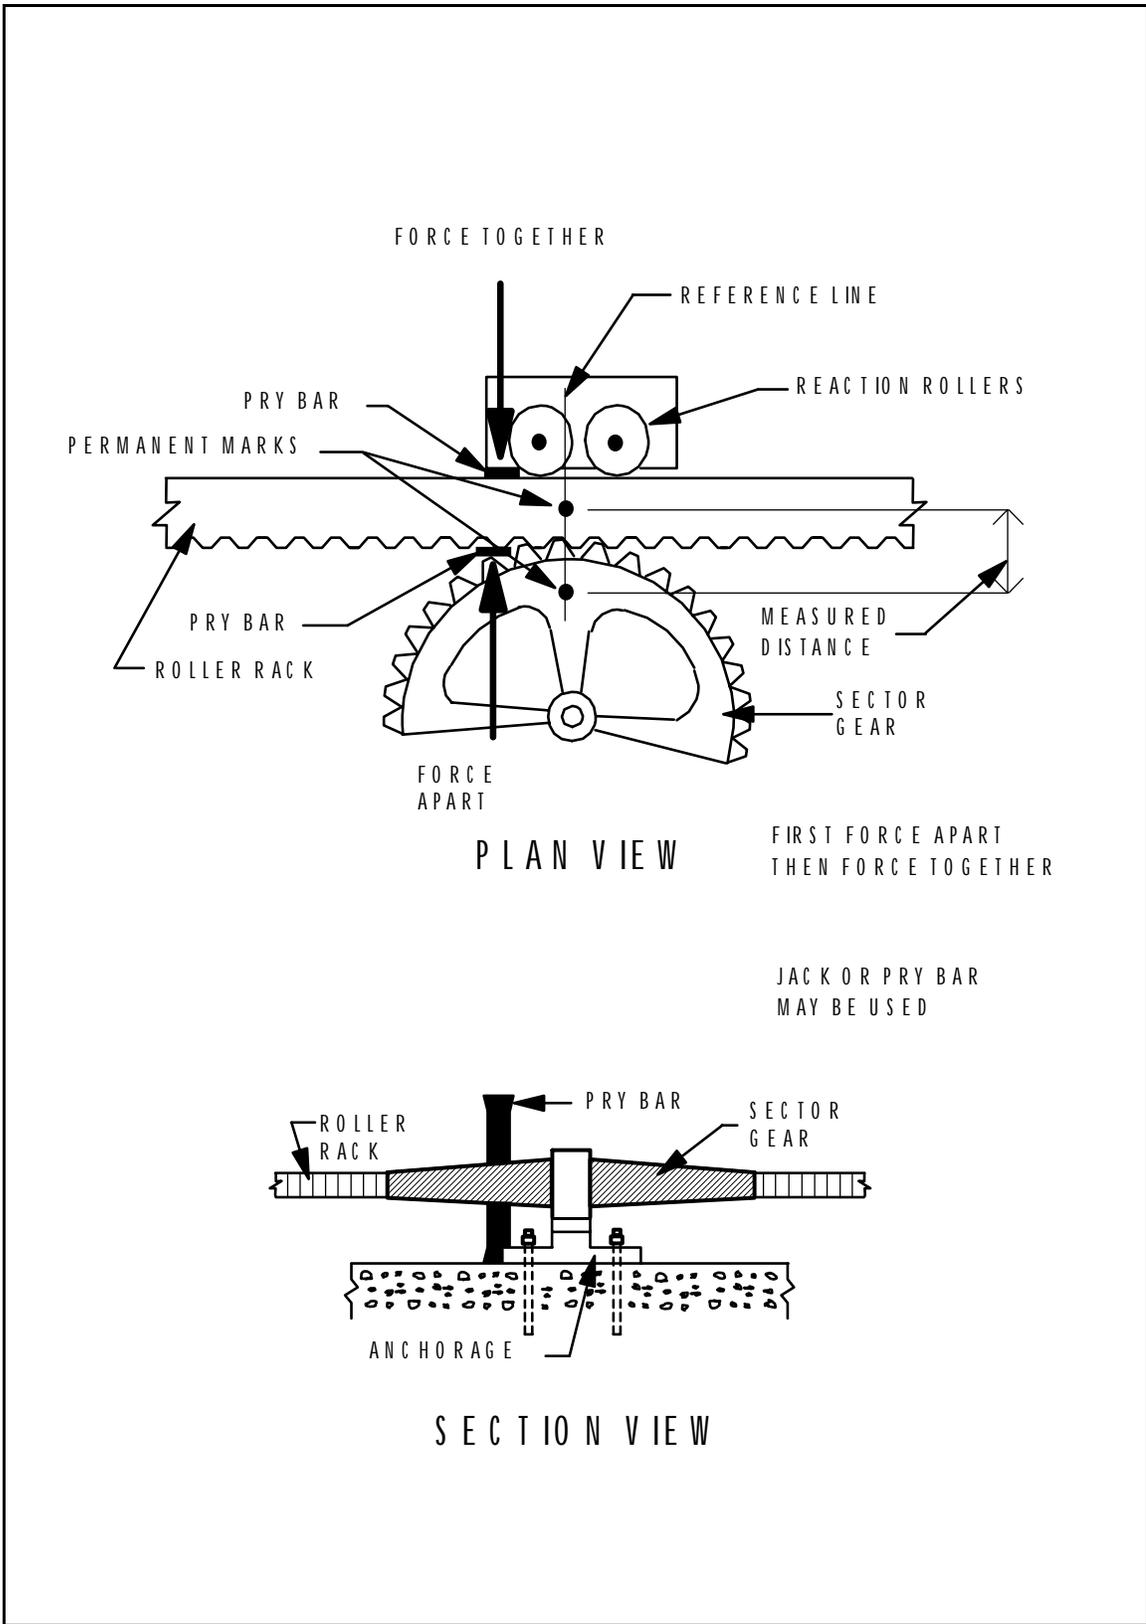
Figure 23. Gear/rack displacement measurement.

Excessive lateral DISPLACEMENT of the ROLLER RACK is an indication that a problem is developing in the equipment. The movement can be quantified by placing permanent marks on the gear and rack (Figure 23). The distance between these two points is recorded when the gear and rack are JACKED or pried APART and when JACKED or pried TOGETHER. The pry bar is placed between the gear and the rack to force the roller rack and gear apart and the first measurement is taken (Figure 23). A jack can also be placed in a position to force the gear and roller rack apart. The second measurement is taken after the pry bar or jack are placed on the opposite side and used to force the gear and roller rack together. These measurements should be taken when the gate is OPEN and CLOSED. The difference between these two measurements indicates the “play” in the system. This measurement is not applicable to racks attached to sector gates.

Measurement and limits. Measurements are recorded when the rack is moved to the right and left with a crow bar (pry bar) or a jack (Figure 23).

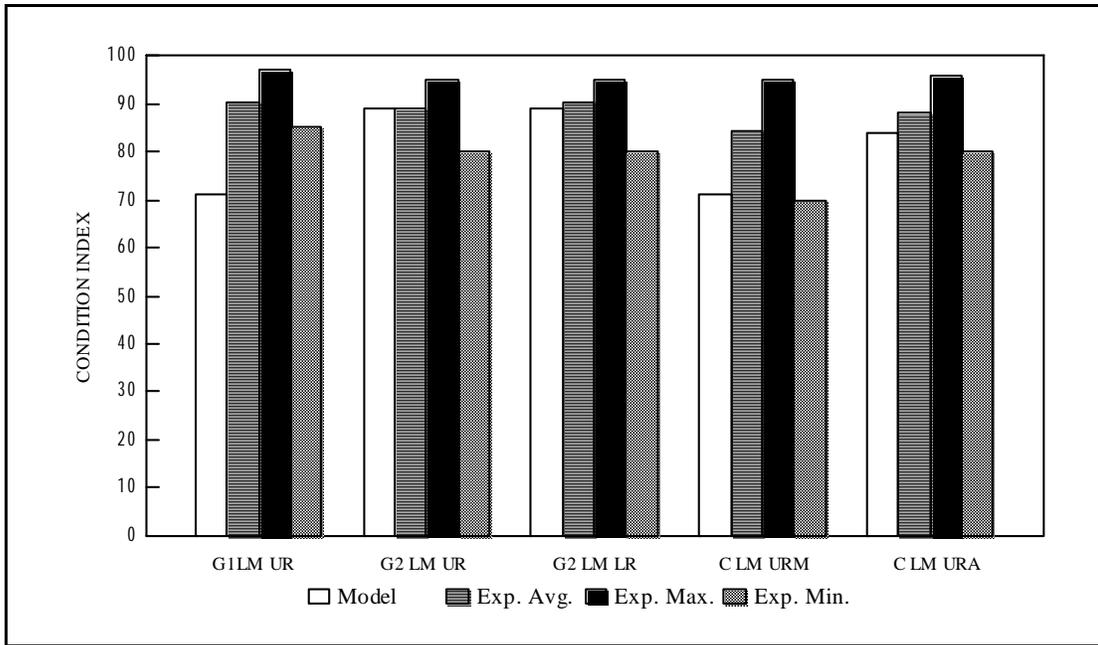
Figure 24. Reduced tooth contact: gear rack assembly.

The bar charts in Figures 24 and 25 compare the experts' subjective condition index during the field tests to the condition index calculated from the rules in Section 6.3 for two rack distresses. Only data from assemblies with observed distresses are plotted. Comparisons between the calculated and experts' CIs are summarized below.

Reduced Tooth Contact: Figure 24

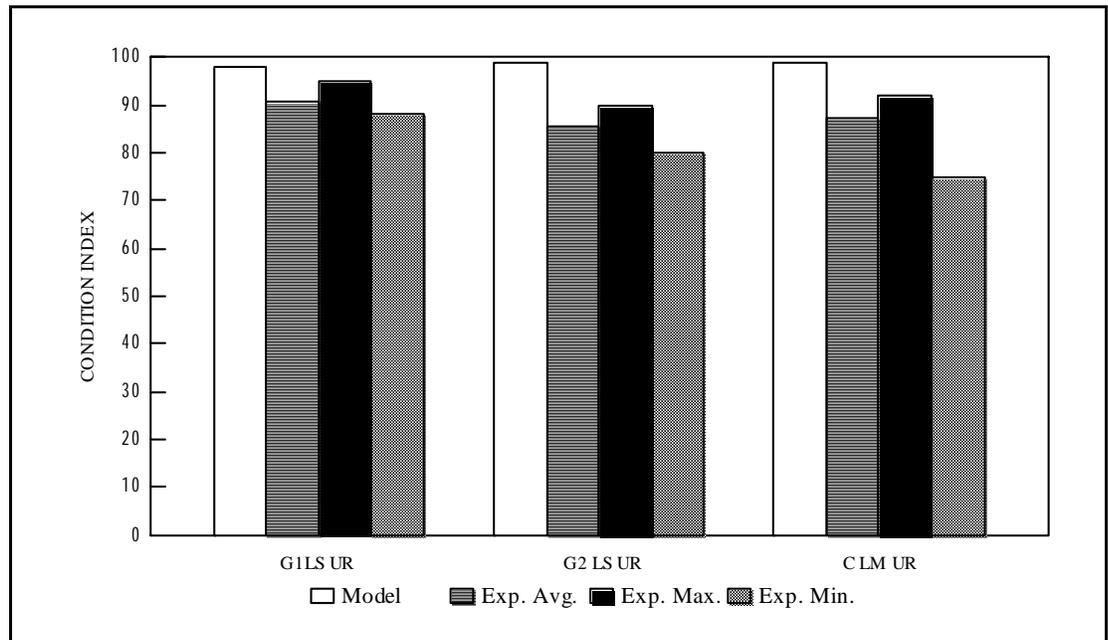
Figure 26. Gear rack assembly CI.

The assembly CI for the rack assembly was calibrated for three assemblies. In each case the model CI was slightly higher than the experts' average CI. Although the model CIs were higher, the experts' average CIs and the model CIs were all in the upper part of Zone 1.

Assembly CI: Figure 26

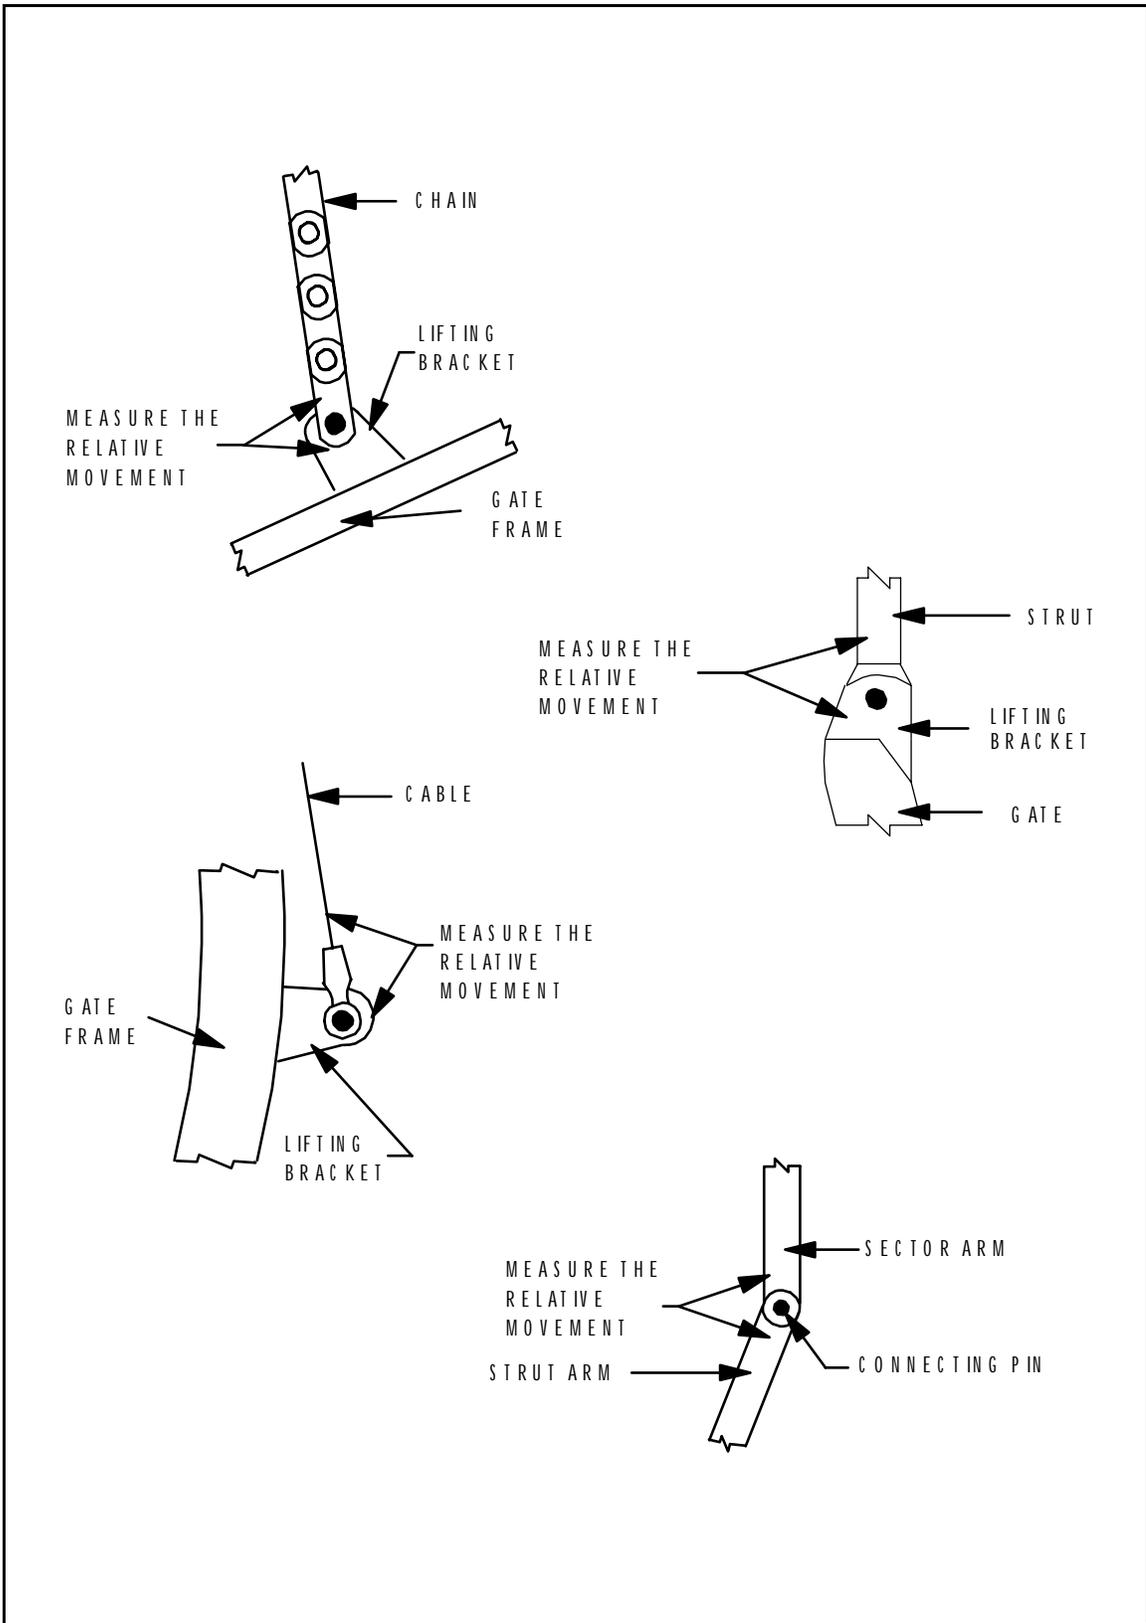
Figure 27. End connection movement distress.

Record the relative MOVEMENT in the END CONNECTION between the strut arm and the attached component or structure. Estimate the movement to the nearest 1/8 in. To further enhance the visual observation, place a dial gage at this location. Record the readings while the operating equipment is in the OPEN and CLOSED positions. Movement should be recorded for both the POWER END and the OTHER END of the strut arm (Figure 27). The END CONNECTION MOVEMENT at the bottom of the valve strut is inspected during the valve inspection (leave OTHER END blank).

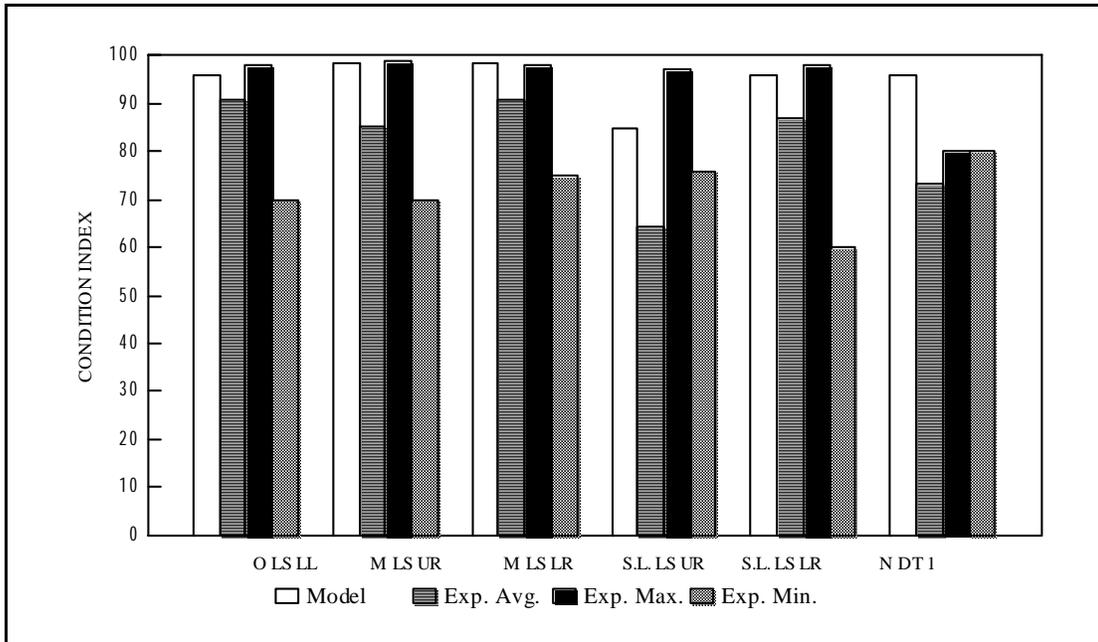
Figure 30. Strut arm assembly CI.

The assembly CI for strut arms was calibrated for six assemblies. In each case, the model CI was higher than the experts' average CI. Although the model CIs were higher, the experts' average CIs and the model CIs were all in Zone 1.

Assembly CI: Figure 30

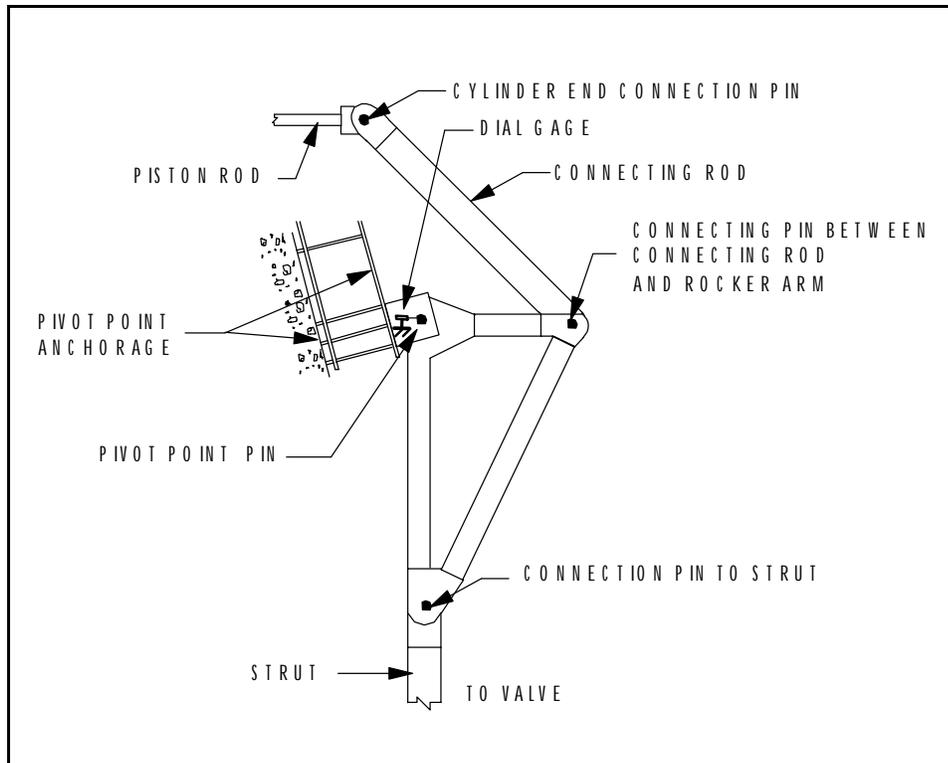
Figure 31. Rocker arm distress measurements.

The presence of CRACKS on the rocker arm assembly is usually not tolerated. Record the NUMBER OF CRACKS found by visual observation of the rocker and connecting rod. Many times a crack will show up as corrosion under the painted surface. Also record the LOCATION of any cracks.

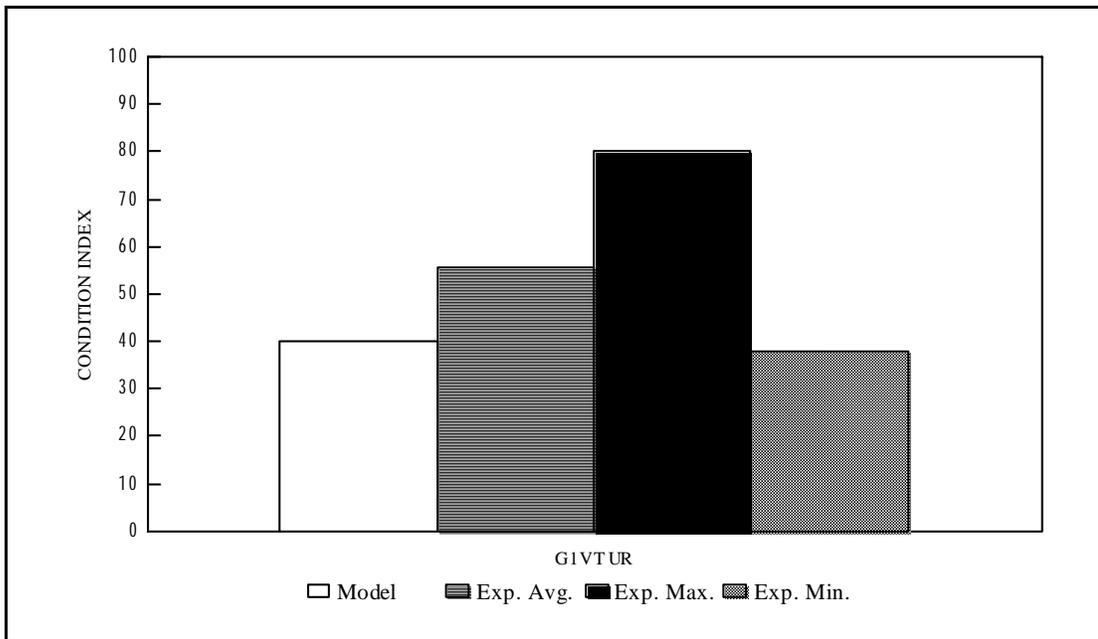
Figure 32. Pivot point anchorage movement/deterioration: rocker arm assembly.

The pivot point anchorage movement/deterioration distress was observed on a filling valve at Green River #1 Lock. The experts' average was 15 points higher than the calculated CI of 40.

Pivot Point Anchorage Movement/Deterioration: Figure 32

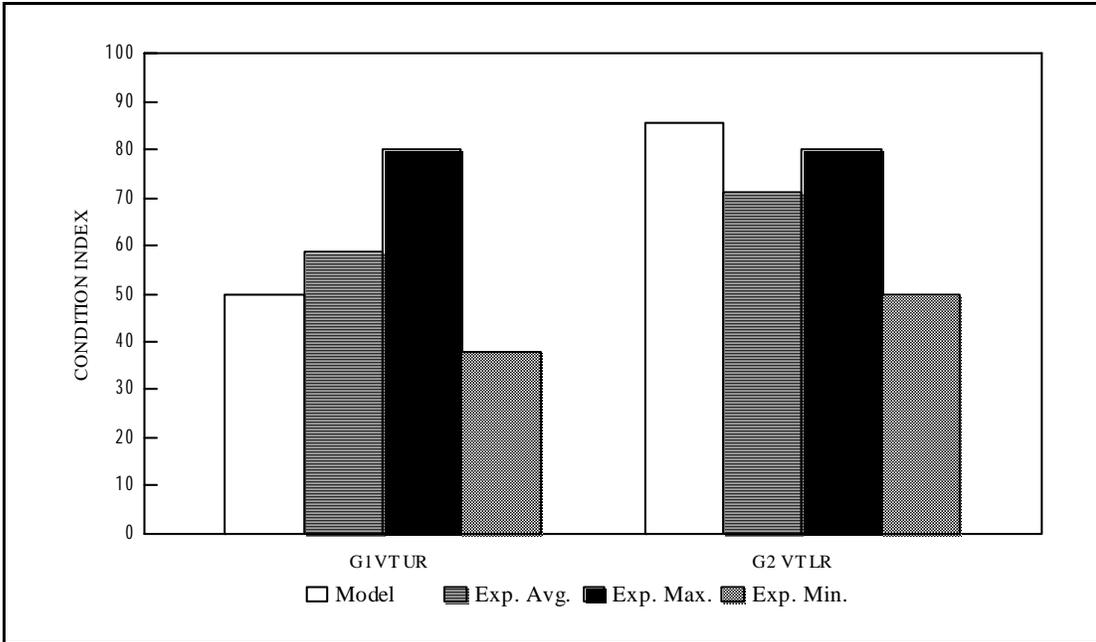
Figure 34. Rocker arm assembly CI.

The assembly CI for rocker arms was calibrated for two assemblies. The model CI was slightly lower than the experts' average CI for the case in Zone 2 (Upper Right Valve Green River #1), and was higher than the experts' average CI for the case in Zone 1 (Lower Right Valve Green River #2).

Assembly CI: Figure 34

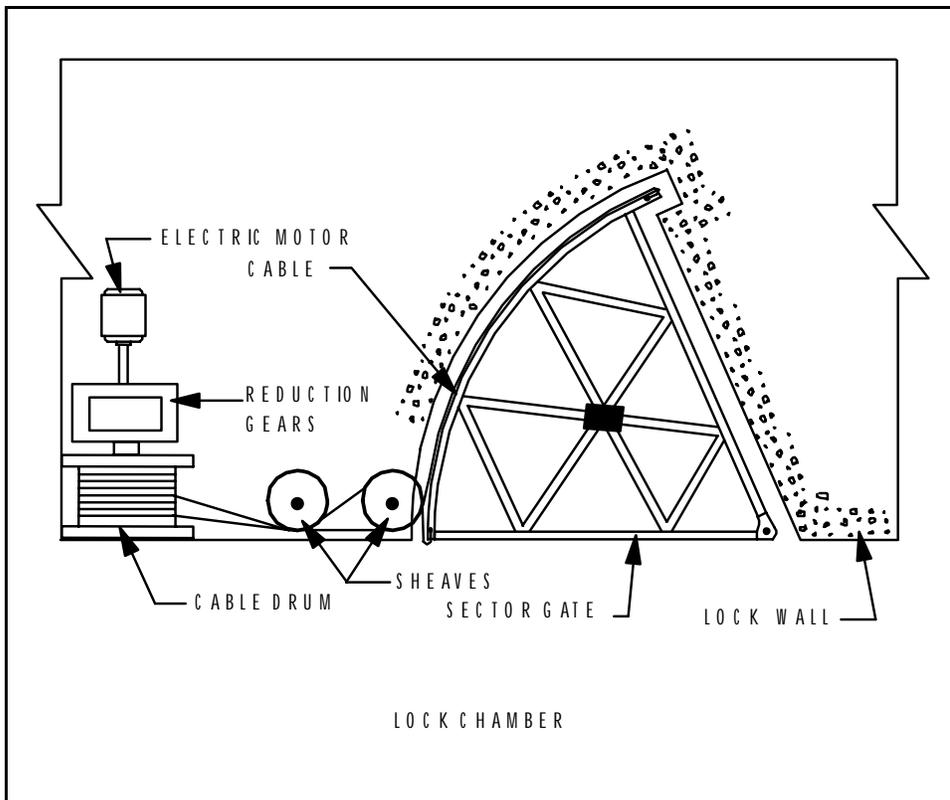
Figure 35. Plan view of sector lock gate operating equipment.

The cable drum is the component around which the cable is wound as the valve structure is raised and lowered or the gate is moved (Figures 35 and 39).

The sheave is a wheel with a grooved rim. It is used to redirect the cable (Figures 35 and 37).

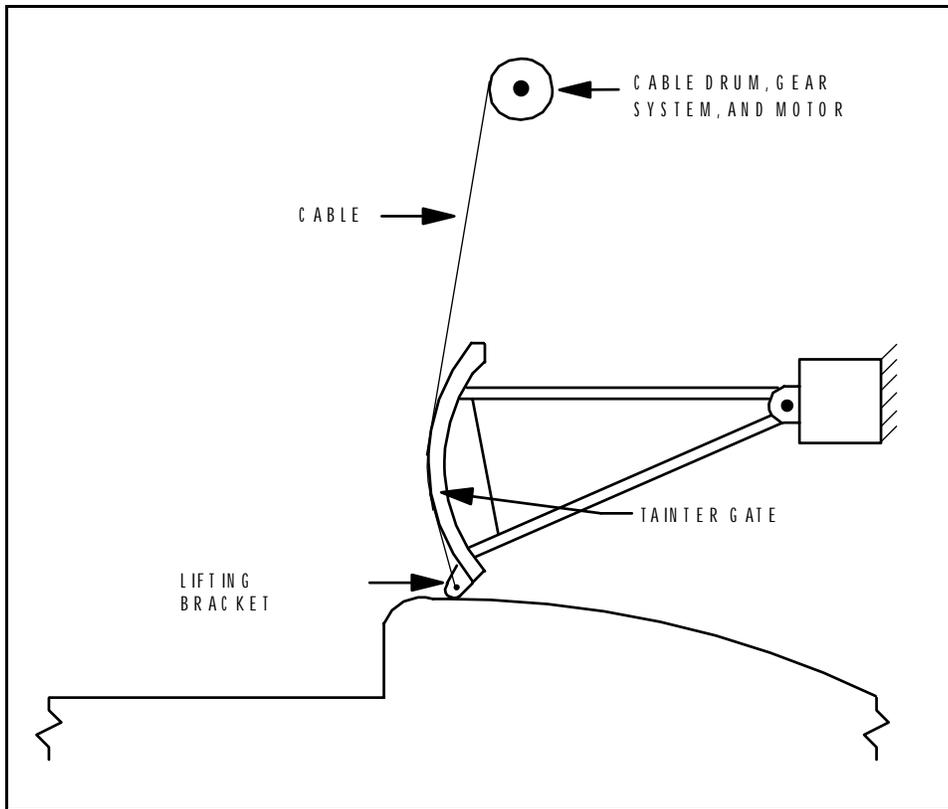
Figure 36. Side view of tainter dam gate operating equipment.
