US Army Corps
of Engineers
Construction Engineering
Research Laboratories

Technical Report REMR-OM-19
June 1997

REMR Management Systems—Navigation and Flood Control Structures, Condition Rating Procedures for Lock and Dam Operating Equipment

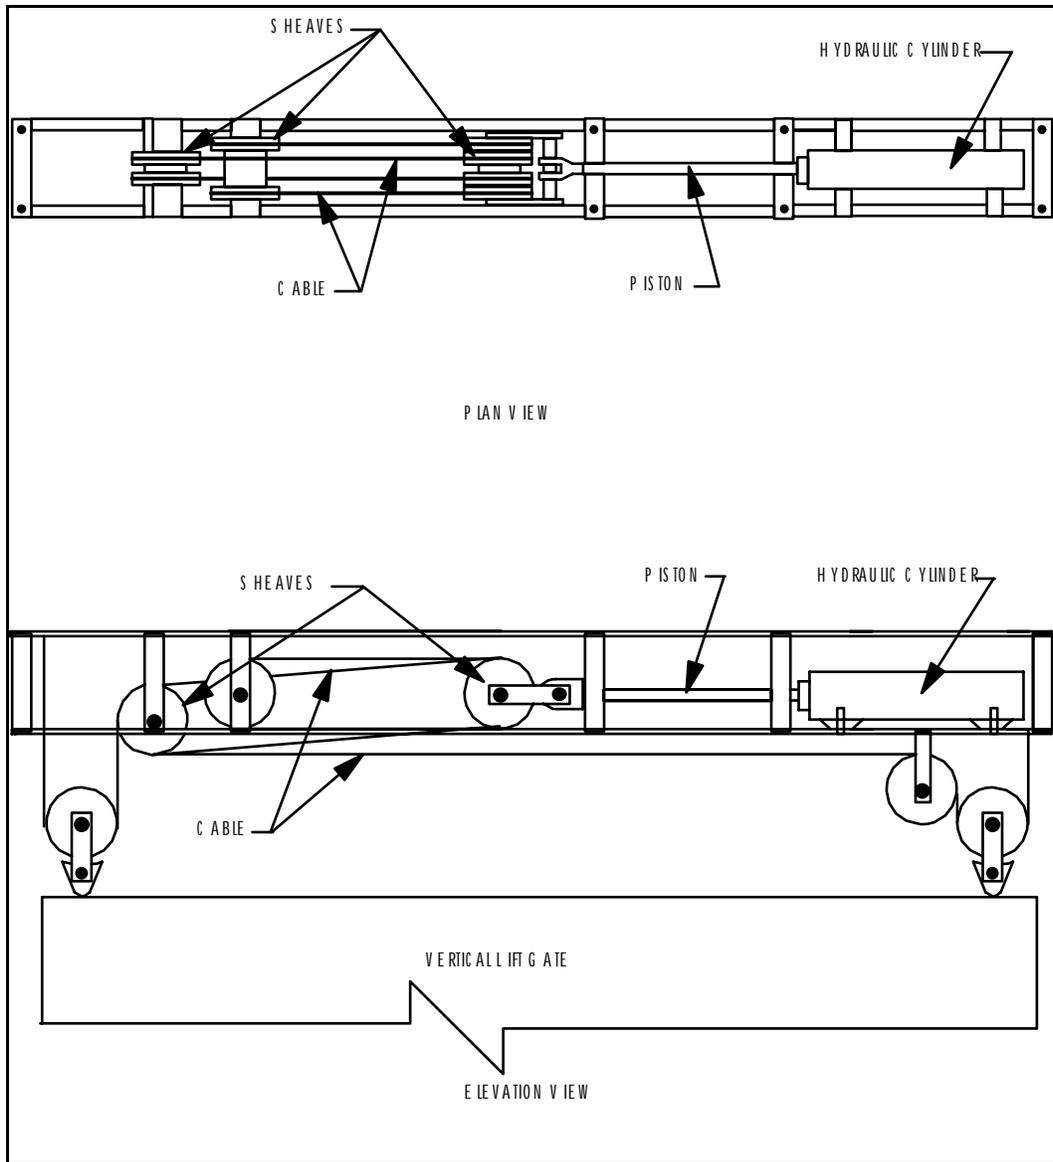
Figure 37. Vertical lift gate operating equipment.

The sheave is a wheel with a grooved rim. It is used to redirect the cable (Figures 35 and 37).

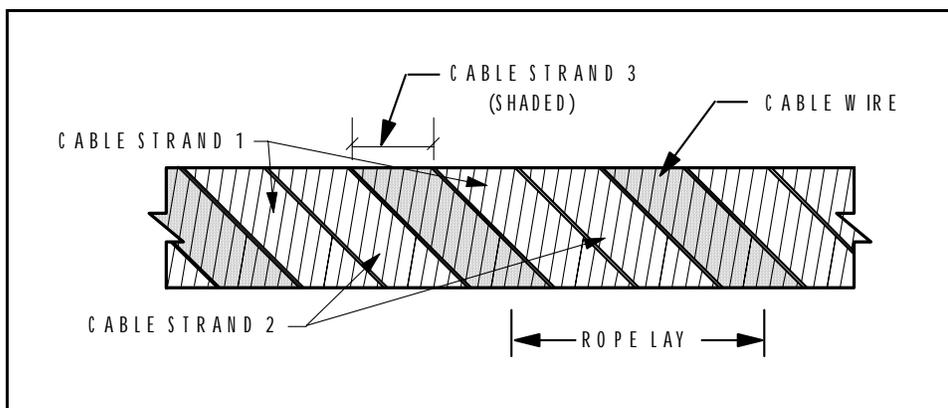
Figure 38. Cable schematic.

The cable is made up of several strands (Figure 38) usually wound in one of two ways: regular or lang lay. The wires of a regular lay are twisted to make the strands, and the strands are then twisted in the opposite direction to make the rope. The wires in the regular lay end up running in the longitudinal direction. Figure 38 shows a lang lay, where the wires and strands are twisted in the same direction.

The cable strand is composed of several wires wrapped together in various arrangements (Figure 38).

The smallest component of the cable is the single steel wire (Figure 38).

The cable lay is the length of cable in which a strand makes one complete revolution of the cable (Figure 38).

Record the maximum number of BROKEN WIRES in all strands of any ONE ROPE LAY (Figure 38). Also indicate the LOCATION of the broken wires from the power end of the cable (Figure 40).

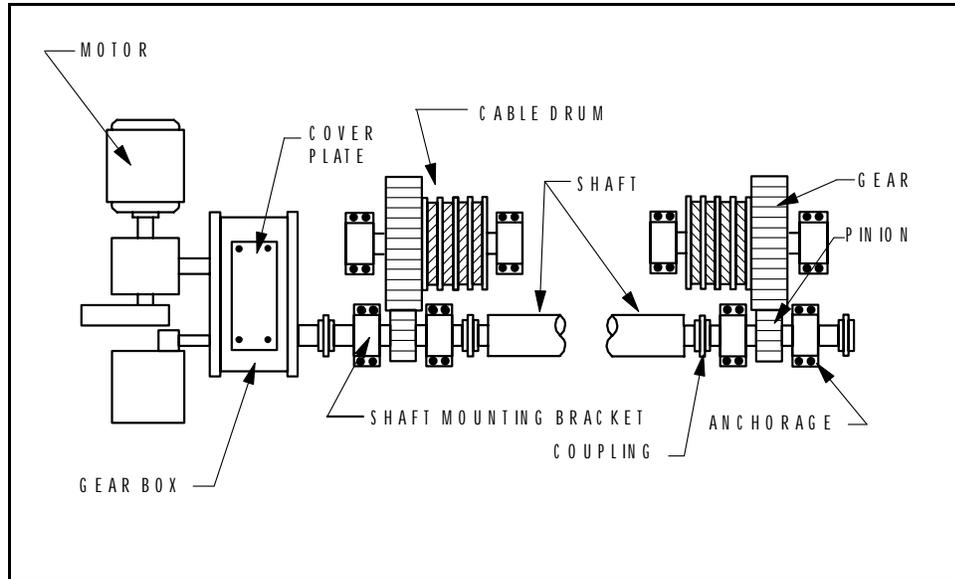
Figure 39. Plan view of tainter gate operating equipment.

The cable drum is the component around which the cable is wound as the valve structure is raised and lowered or the gate is moved (Figures 35 and 39).

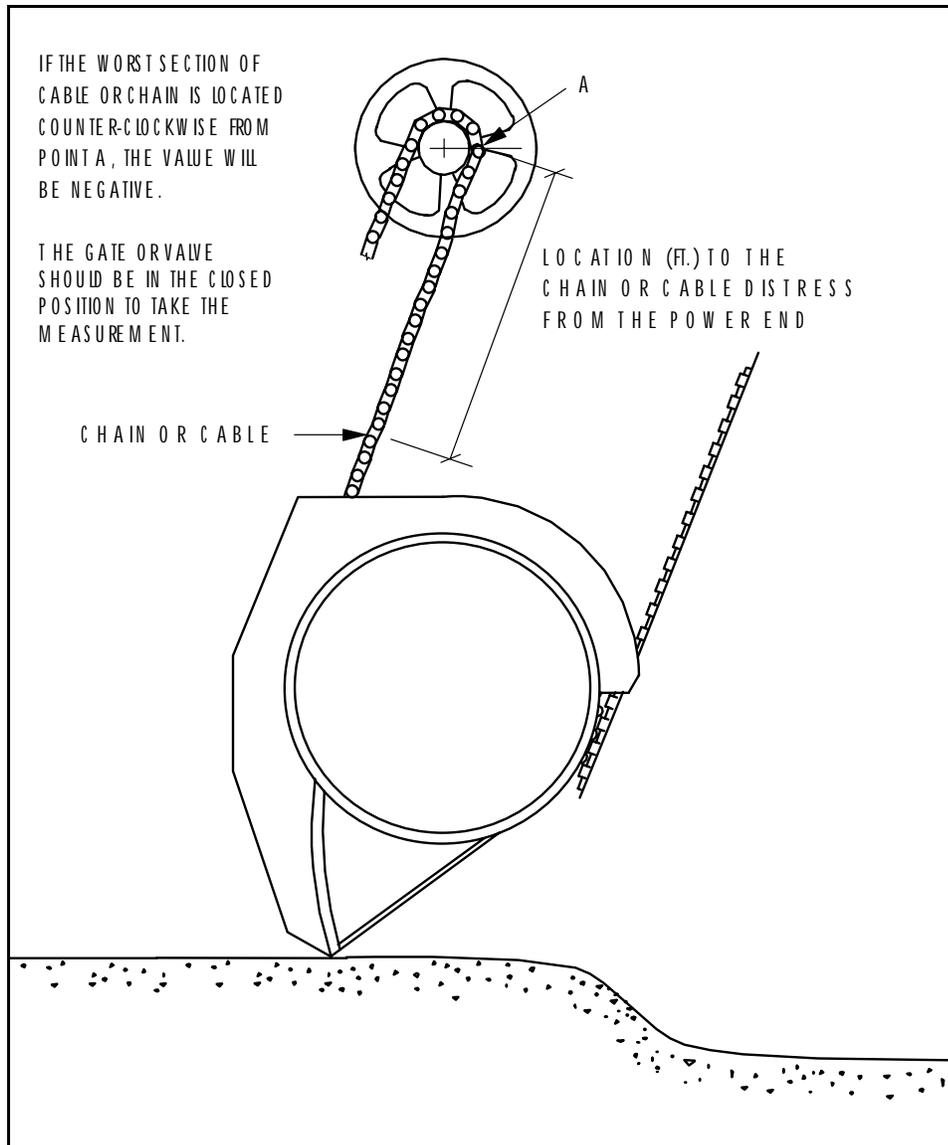
Figure 40. Location identification for cable and chain distresses.

Record if a WORN PORTION of the outer cable WIRES is evident. If wear is evident, record the average PERCENTAGE of WEAR of the wire diameter on the outer wires. The wear would most likely occur near the drum when the gate is in the opened or closed position. Also indicate the LOCATION of the worn section from the power end (Figure 40*).

Record the NUMBER OF CRACKS in the chain links. Also record the LOCATION of the cracked links from the power end (Figure 40).

Many times after a structure has been in the same position for some time, the links will lock together and not bend around the sprocket. Record a yes (Y) if the chain will not bend around the sprocket or, in other words, the chain LINKS are FROZEN. If links are frozen, they will often remain bent in the shape of the sprocket after they have been loaded. If there are frozen links, record whether they cause LIMITED OPERATION of the structure. The structure may have to be raised higher than normal to check the probable problem links. Also record the LOCATION of the frozen links from the power end (Figure 40).

The presence of excessive CORROSION on the chain is a potential problem. Record YES if there is SIGNIFICANT CORROSION (more than general scaling). If yes, indicate if there is SEVERE PITTING (1/8 in. pits or greater) in a dense pattern or GENERAL THICKNESS REDUCTION of 10% or greater in local areas. Also record the LOCATION of the corrosion from the power end (Figure 40).

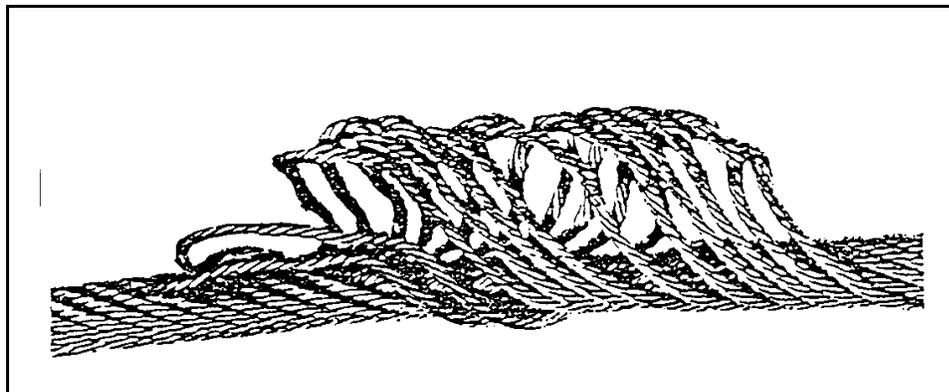
Figure 41. Cable bird cage.

Definition and causes. A bird cage is a local area of severely unraveled cable (Figure 41). Bird cages form when slack develops in the cable and that slack is suddenly removed. Bird cages can also be formed when the cable is wrapped too tightly around drums. Kinks are permanent distortions caused by loops being drawn too tightly. A protruding core occurs when the center strand protrudes through the outer strands (Figure 42).

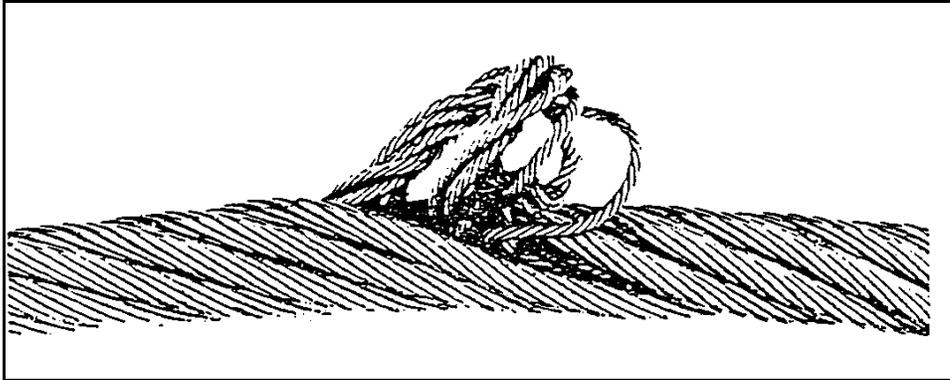
Figure 42. Cable protruded core.

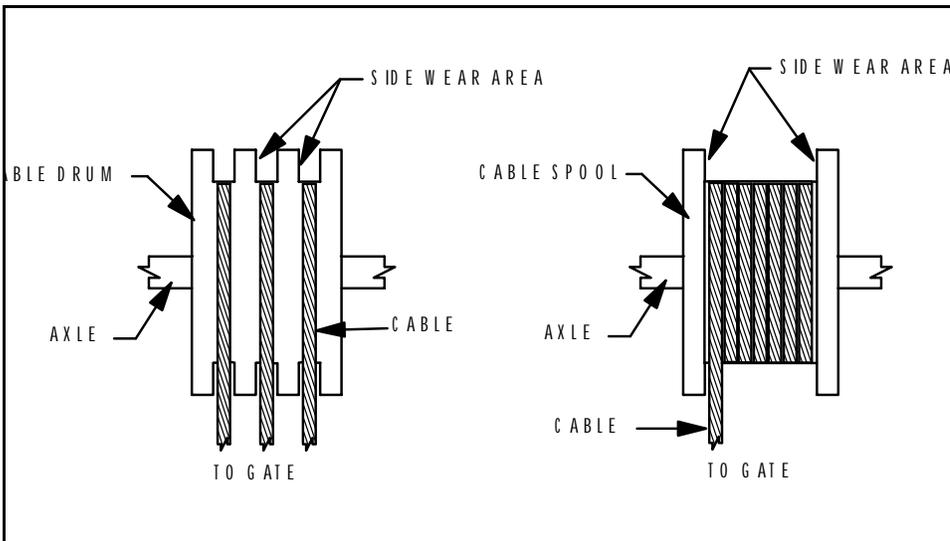
Figure 43. Cable drum wear.

For DRUMS, record if there is VISIBLE GROOVE WEAR. Groove wear is the wearing of the bottom of the grooves. If there is groove wear, estimate the DEPTH OF the GROOVE WEAR in percentage of the CABLE DIAMETER. If the estimate of groove wear is GREATER THAN 10% of the cable diameter, use an appropriate method to MEASURE the groove wear. Groove wear can be measured by placing a cable groove template into the groove and observing the gap between the bottom of the groove and the template. A similar procedure that can be used is to place a piece of new cable into the groove and to measure the gap. Indicate whether there is SIDE WEAR on the drum. If the cable is misaligned, the guide plates will show the imprint of the cable (Figure 43).

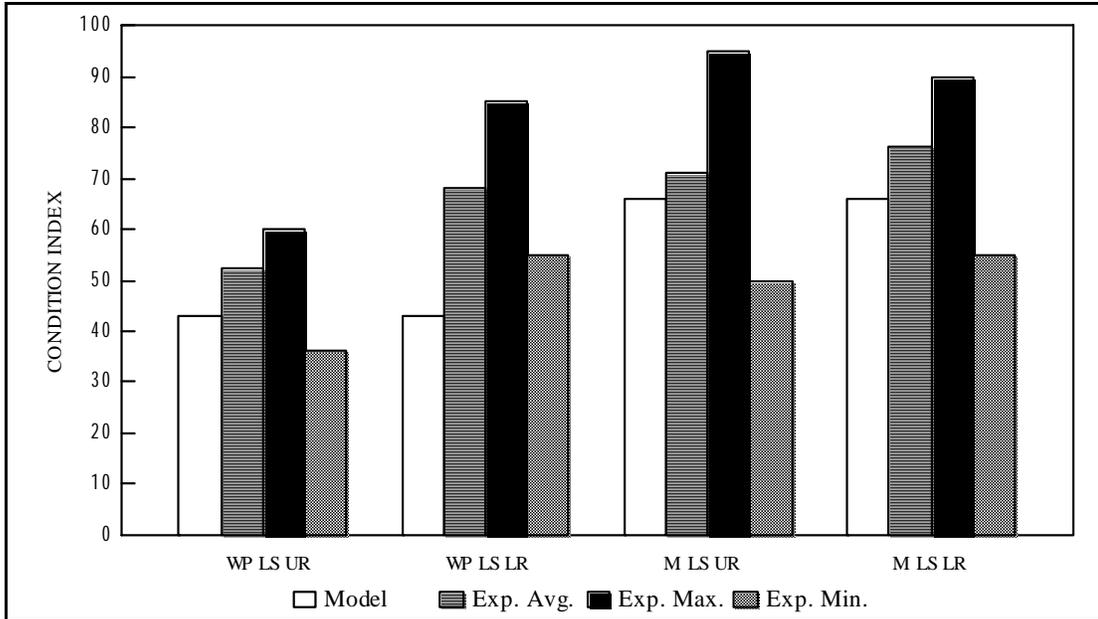
Figure 44. Outer wire wear: cable assembly.

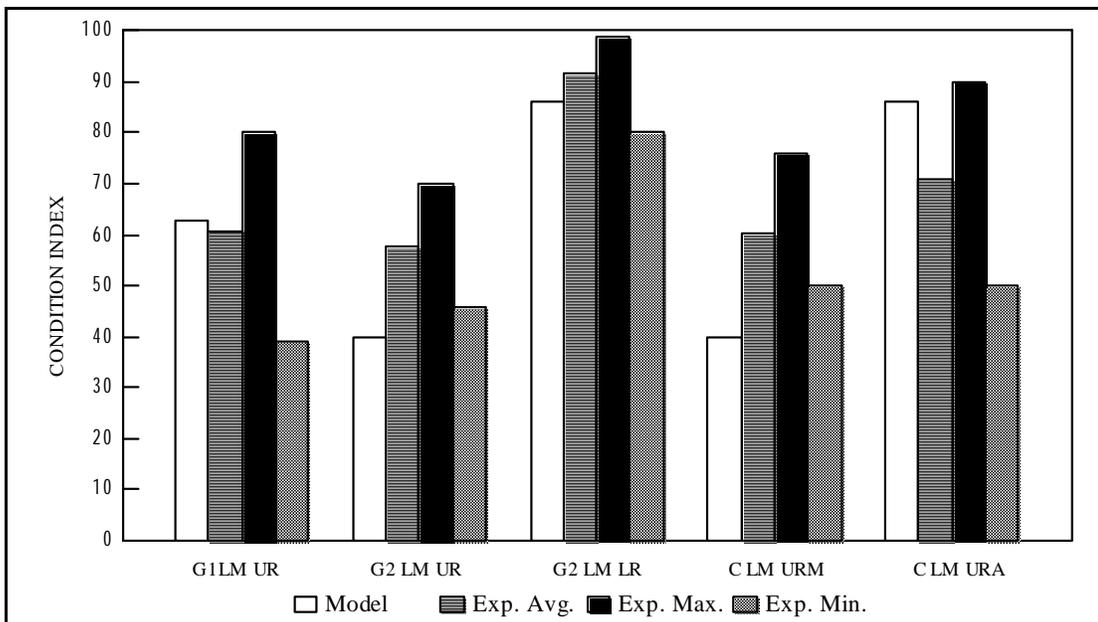
Figure 45. Wire breakage: cable assembly.

Wire Breakage: Figure 45

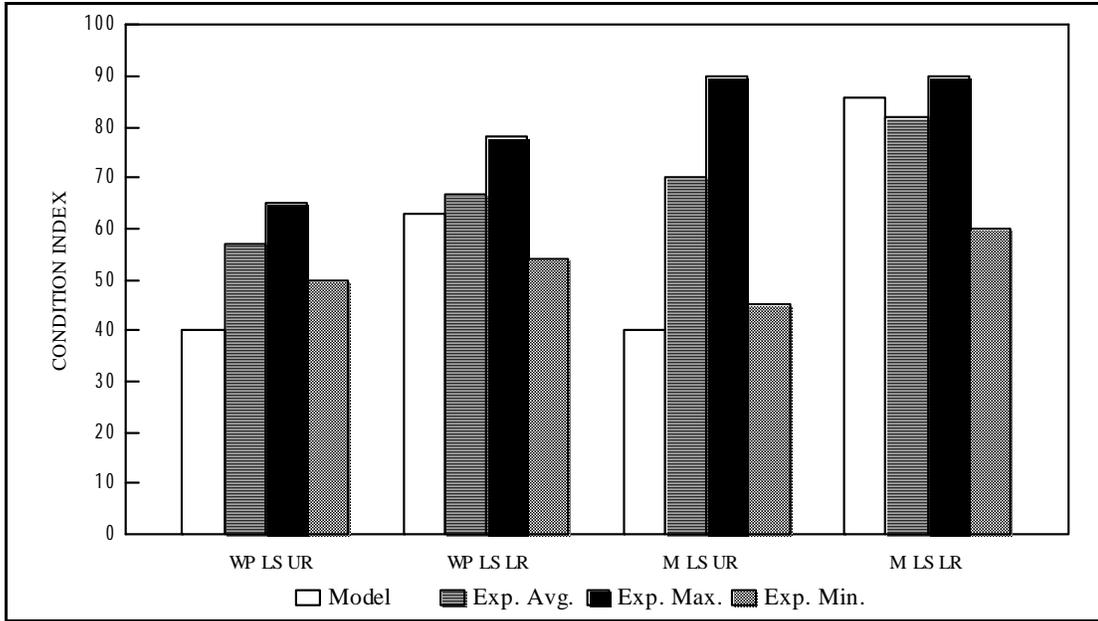
Figure 46. Cable assembly CI.

Assembly CI: Figure 46

The assembly CI for the cable assembly was calibrated for four assemblies. For two of the assemblies, the model CIs were significantly lower than the experts' average CIs, and for the other two calibrated assemblies, the model CIs closely approximated the experts' average CIs. In only one case (Upper Right Sector Lock Gate Moorehaven) did the model CI and the experts' average CI fall into a different zone. In all four cases, wire breakage (a critical distress) controlled the assembly CI.

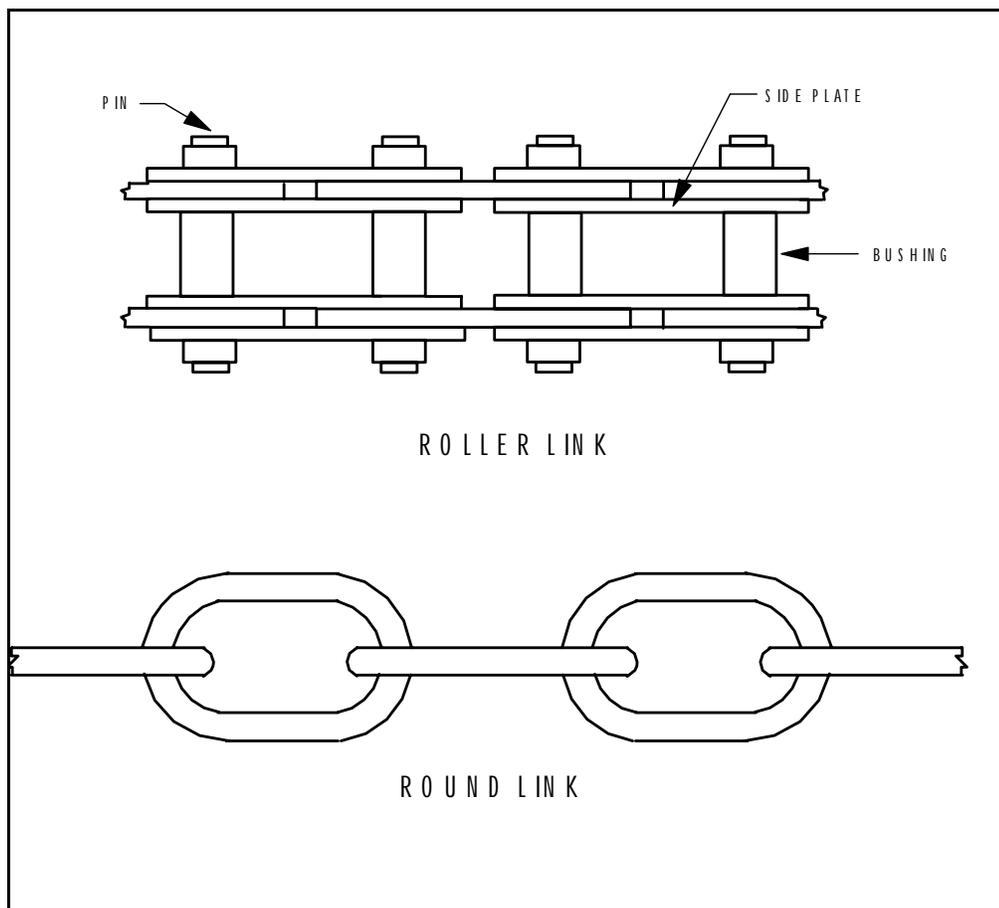
Figure 48. Chain link schematic.

A roller chain consists of roller bushings, side plates, and pins (Figure 48). The roller bushings turn on the pins, thereby reducing the friction between the chain and the sprocket. The rollers fit between the sprocket teeth.

The links of this chain are oval shaped and permanently fitted into one another (Figure 48).

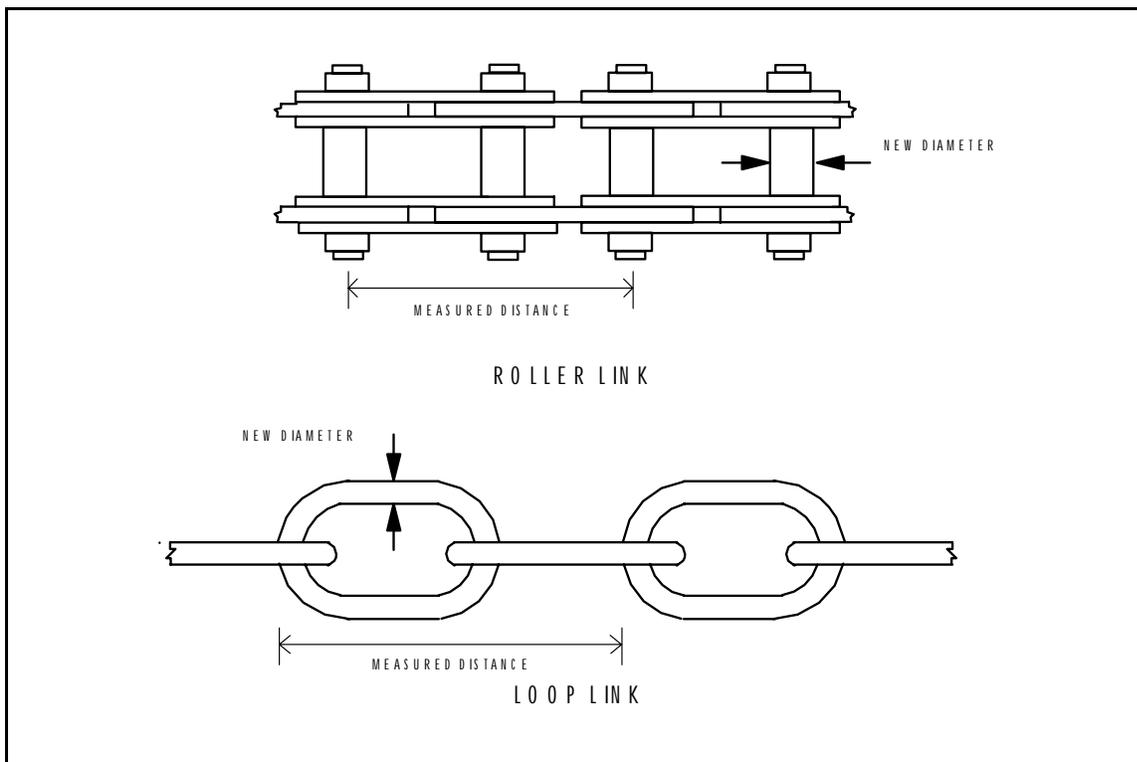
Figure 49. Chain linkage wear.

LINKAGE WEAR/ELONGATION of the chain occurs between the links of the chain (Figure 49). Record the LENGTH OF WORN/ELONGATED LINKS. This distance can be measured on a roller link chain by placing a tape measure along the loaded chain and measuring from the center to center of several consecutive link pins (Figure 49). For a round link, measure from end to end of the links while the chain is loaded (Figure 49). To get a more accurate estimate of total wear and elongation, measure 10 to 20 consecutive links and divide the measured distance by the number of links. The worst worn or elongated links will most likely be those that ride on the sprocket most frequently, if the gate operates at a relatively constant elevation. Also record the LENGTH OF NEW LINKS. This distance can be obtained from construction drawings. If construction drawings are not available, measure the distance between links that get little use, and use this distance as an estimate of the distance between new links.

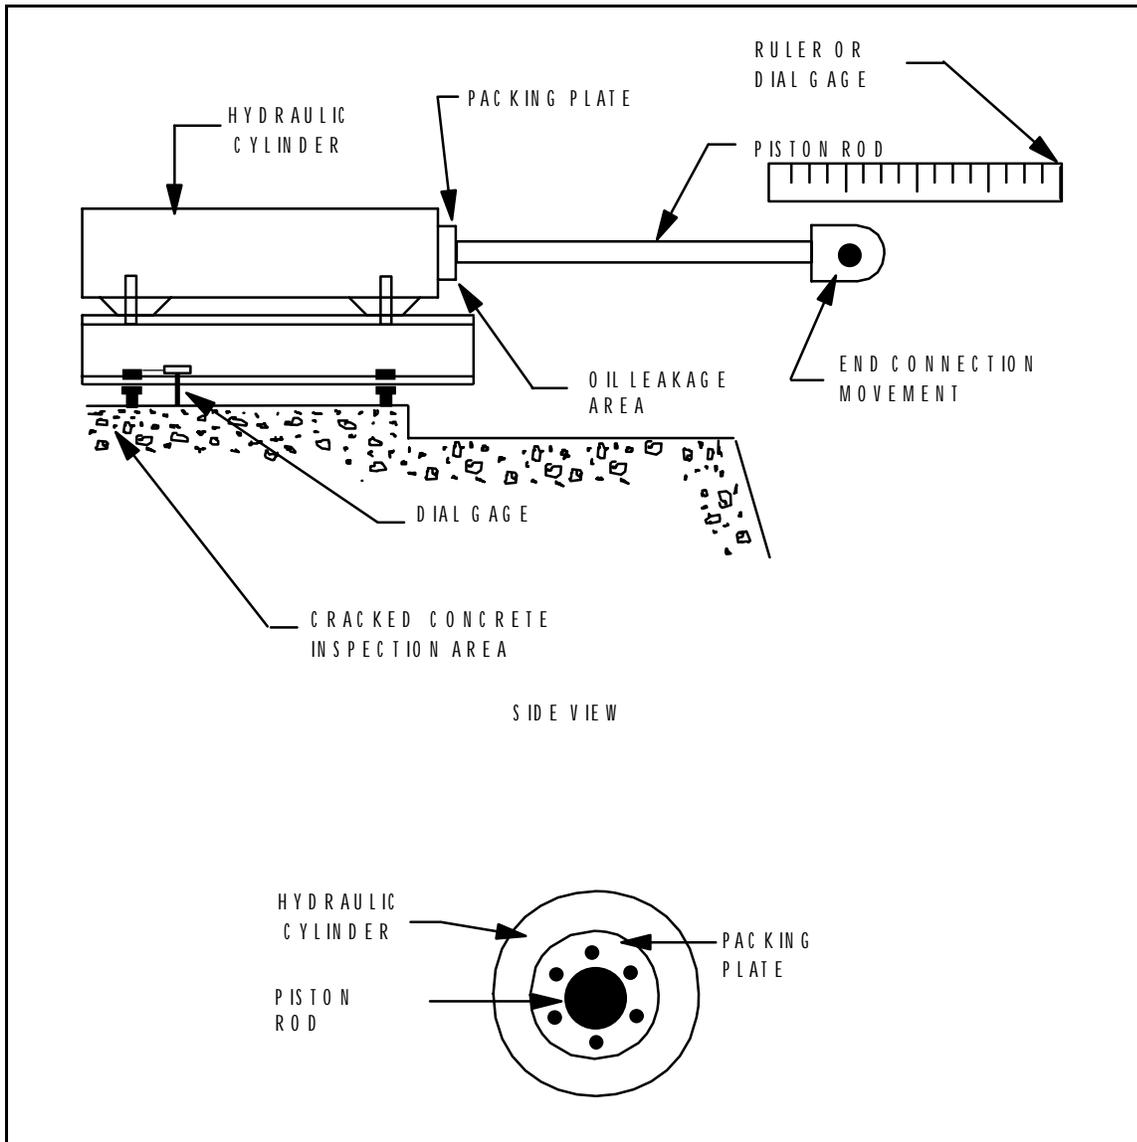
Figure 50. Hydraulic cylinder assembly distress measurements.

Record any evidence of MOVEMENT greater than 0.002 in. at the ANCHORAGE as the gate or valve is opened and closed. Evidence of movement can be observed visually or enhanced by placing a dial gage to monitor any movement (Figure 50). Excessive concrete spalling may indicate a displacement occurred at this location at some time. Also, record the presence of any CORROSION (10% volume loss) of the steel portion or any CRACKED CONCRETE at the interface of the embedment. Small hairline cracks, probably caused by thermal expansion or contraction of the concrete, should be ignored. Indicate if there are any CORRODED (10% volume loss), MISSING OR BROKEN, or LOOSE nuts at this connection if the BOLTS are EXPOSED.

Record any EVIDENCE OF RECENT OIL LEAKAGE. Record the NUMBER OF OIL DROPS that leak from the packing seal interface during one full STROKE (Figure 50). Many times this can be accomplished by placing a sheet of paper below the cylinder end.

Record the amount of DRIFT or movement of the hydraulic rod. When the hydraulic cylinder is used for valve or dam gate operation, the valve or dam gate should be in the open position. When the hydraulic cylinder is used to operate a lock gate, the lock gate should be in the open position. Isolate the cylinder by closing all oil valves and measuring the drift in a 15-min interval with a ruler or a dial gage (Figure 50).

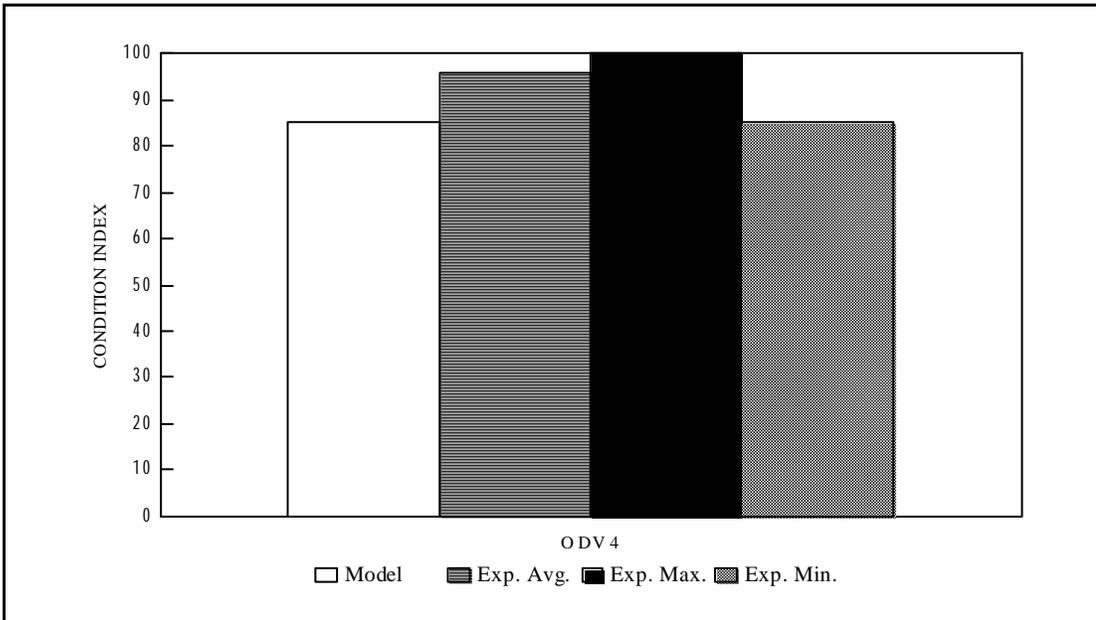
Figure 51. Anchorage movement/deterioration: hydraulic cylinder assembly.

Anchorage Movement/Deterioration: Figure 51

In only one case (Ortona Vertical Lift Gate #4) was any anchorage deterioration observed (corrosion of nuts). The calculated CI was 85. For the other hydraulic cylinder assemblies, no deterioration was recorded by the experts and the calculated CI was 100.

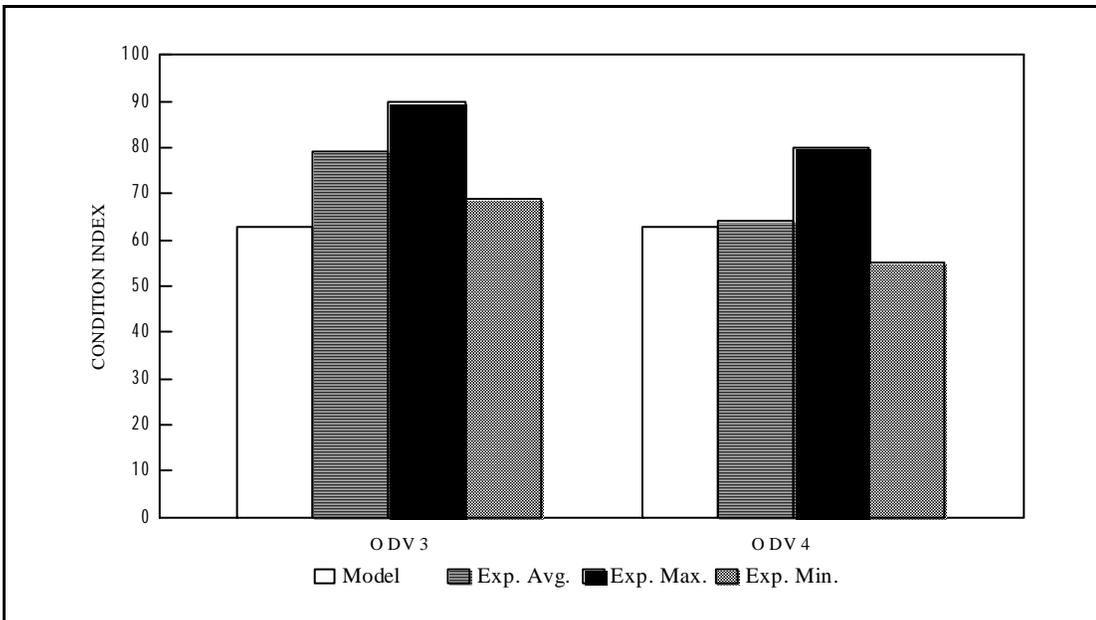
Figure 52. Corrosion/pitting of rod: hydraulic cylinder assembly.

Corrosion/Pitting of Rod: Figure 52

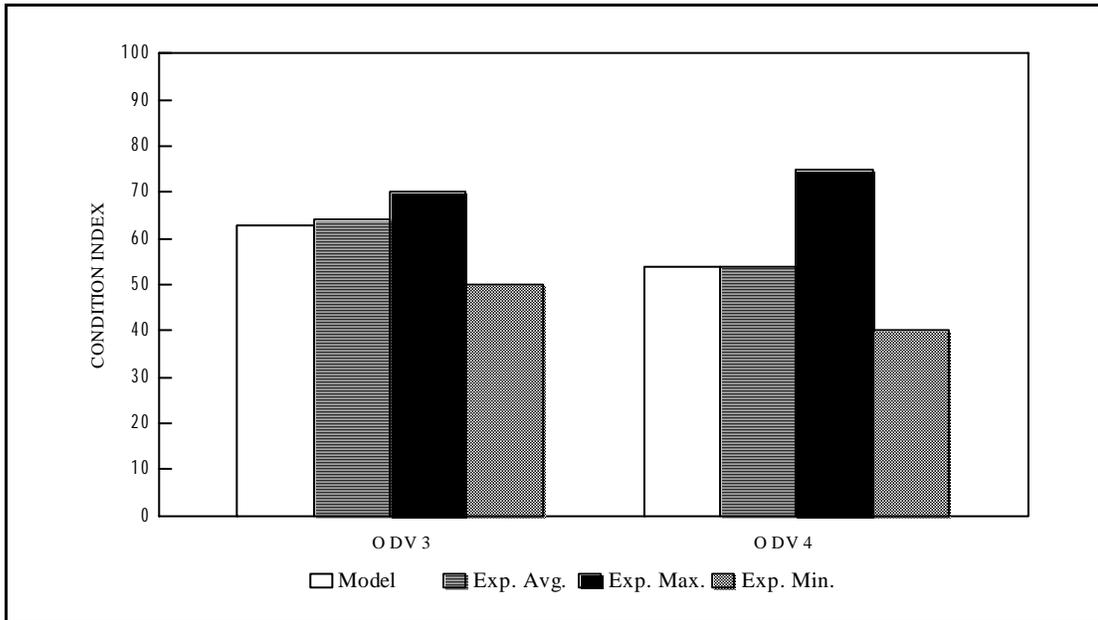
Figure 53. Oil leakage: hydraulic cylinder assembly.

Oil Leakage: Figure 53

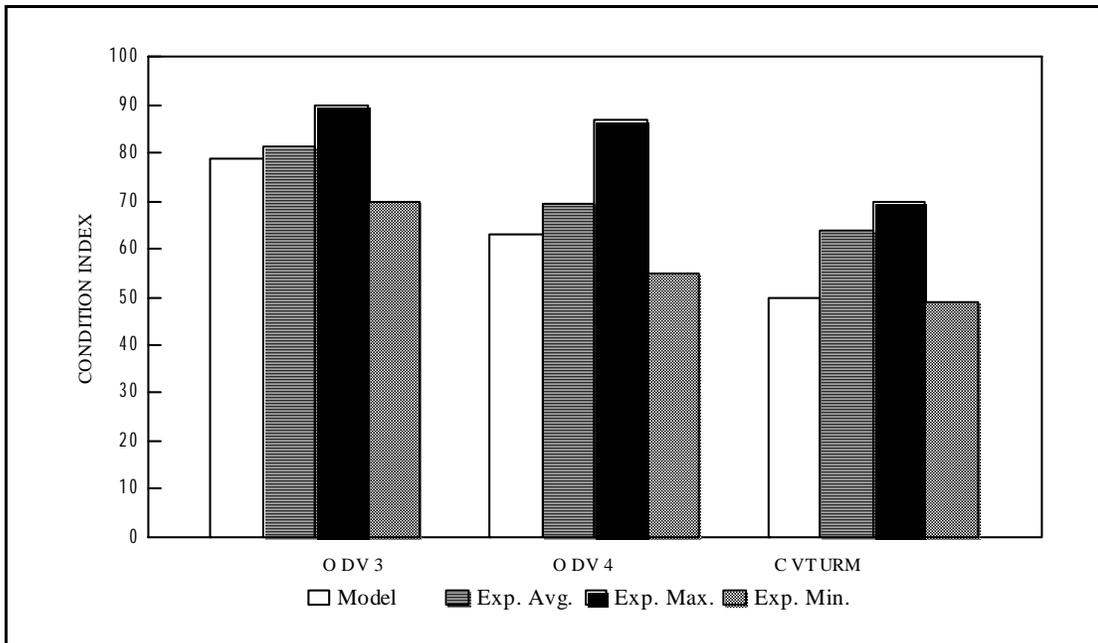
Figure 54. Drift: hydraulic cylinder assembly.

Drift: Figure 54

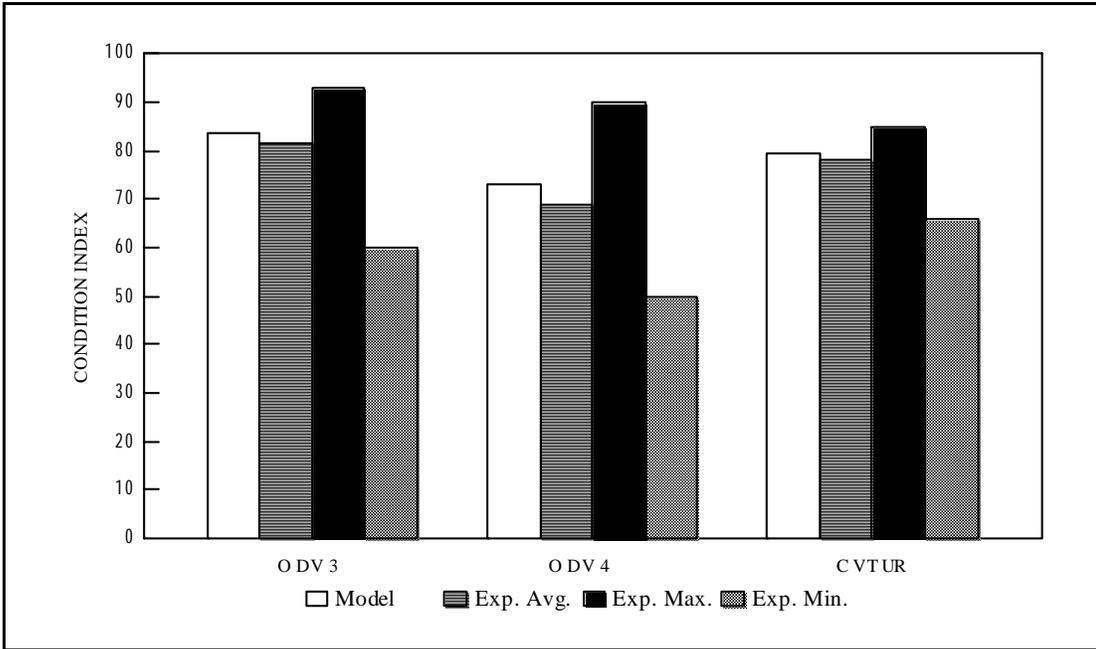
Figure 55. Hydraulic cylinder assembly CI.

Assembly CI: Figure 55

The assembly CI for the hydraulic cylinder assembly was calibrated for three assemblies. The model CIs closely approximated the experts' average CIs for all three calibrated assemblies.

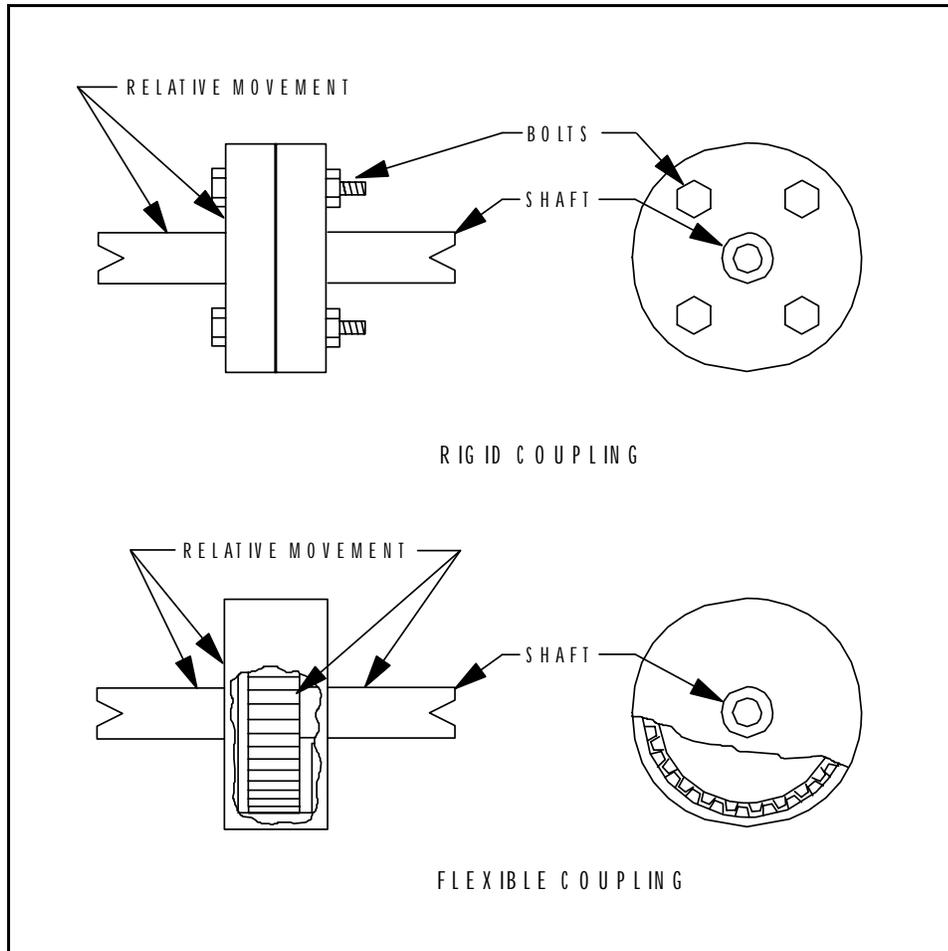
Figure 56. Coupling relative movement measurement.

A FLEXIBLE COUPLING is an internal gear (Figure 56). A small amount of lateral movement of the coupling may occur in a flexible type coupling. A RIGID COUPLING is one for which no movement should occur, either in the lateral direction or with respect to the shaft. Rigid couplings are often bolted together.

Observe the shaft and hub when the operating equipment starts and stops. Record if there is any RELATIVE MOVEMENT BETWEEN THE INPUT SHAFT AND the HUB. Also record any RELATIVE MOVEMENT BETWEEN THE OUTPUT SHAFT AND the HUB. If either distress is marked yes, record if THE MOVEMENT IS EXCESSIVE. If the coupling has a keyway, and the key is loose or there is obvious long-term movement, the movement is excessive.

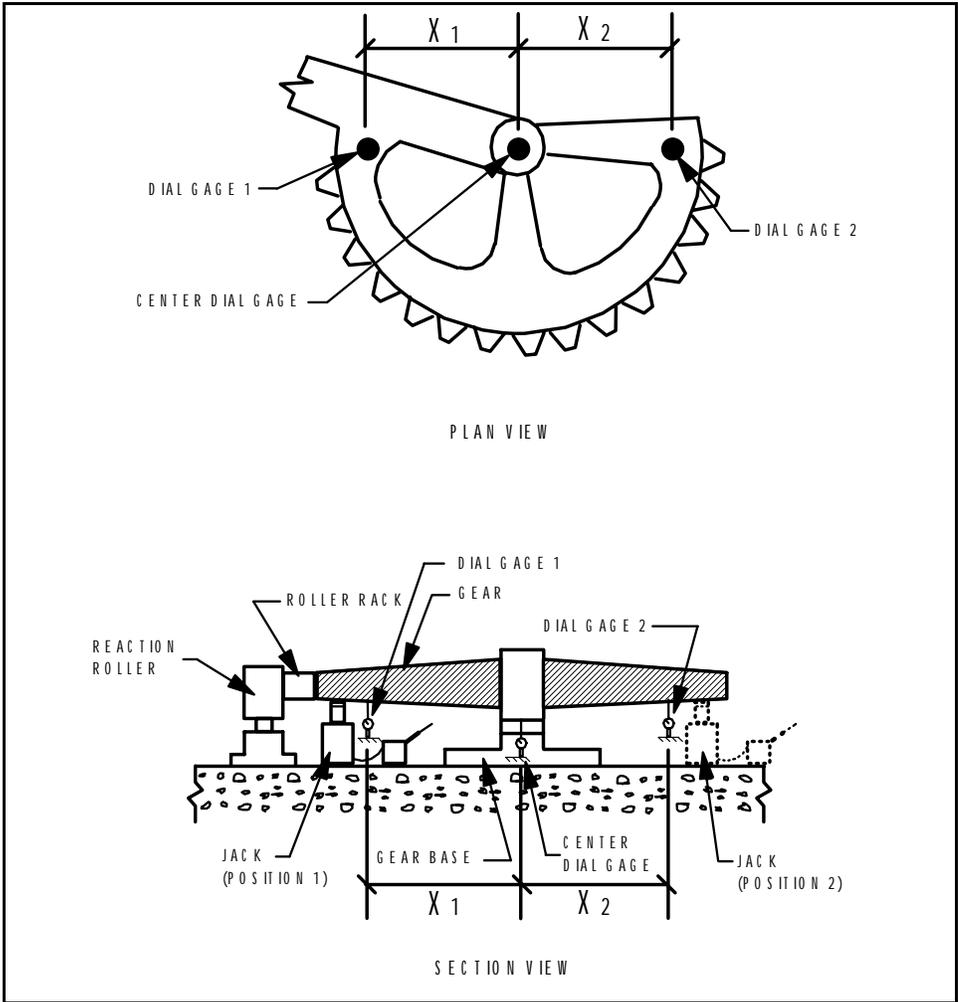
Figure A1. Bushing wear measurement.

Place three dial gages to measure the vertical displacement in the gear (Figure A1). Place one dial gage at the center of the gear. The remaining two dial gages should be placed an approximately equal distance, X_1 and X_2 , from the center of the gear and as close to 180 degrees from each other as possible (Figure A1). To prevent errors in readings, place all dial gage plungers in the same direction. Record the initial dial readings for all dial gages. Place a jack near one of the dial gages and begin jacking. Precaution should be taken while jacking the gear to ensure overloading does not occur. Record the dial gage readings after jacking (Figure A2). Next, release the jack and again take the dial gage readings. Place the jack 180 degrees from the initial position (near the other dial gage) and again jack and record the dial gage readings (Figure A3). Release the jack and record the dial gage readings.

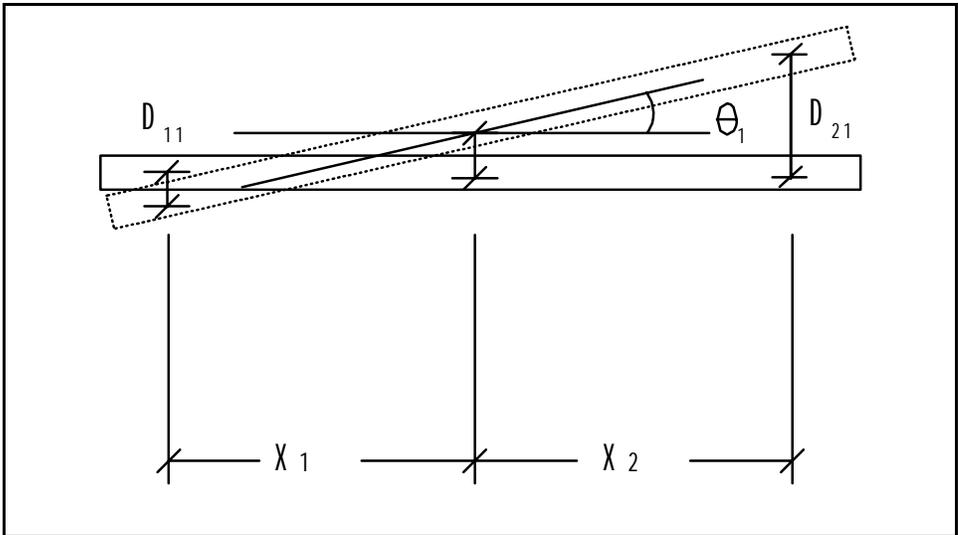
Figure A2. Vertical displacements when jacked on Side 1.

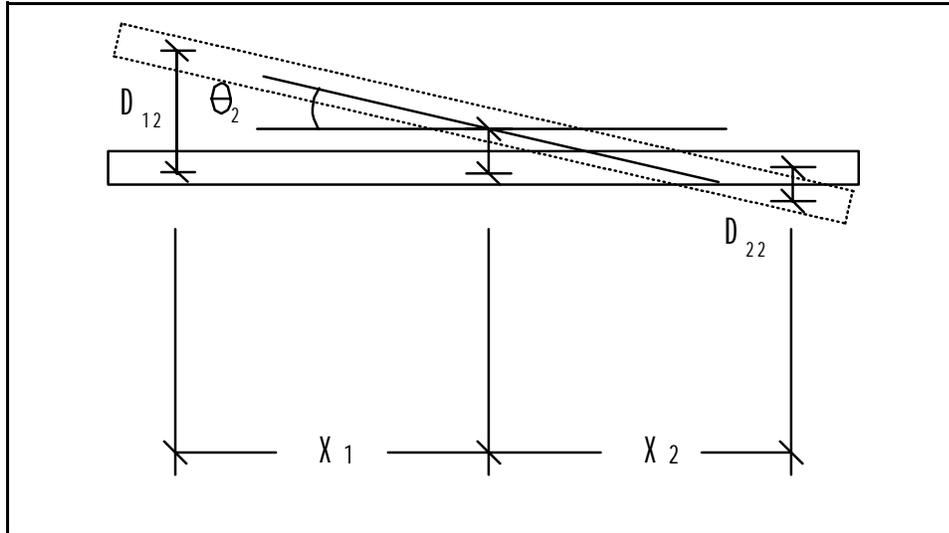
Figure A3. Vertical displacements when jacked on Side 2.

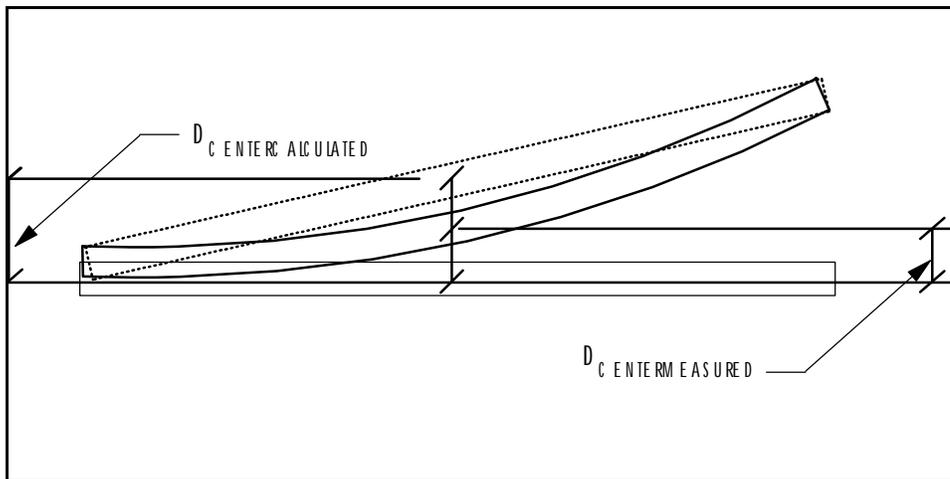
Figure A4. Displaced shape of gear (bowed and unbowed).

The limiting value for vertical displacement of an exposed gear that rotates on a bushing is 1/16 in. per foot of gear radius. This corresponds to an angle of rotation of 0.0026 radians or 0.15 degrees.

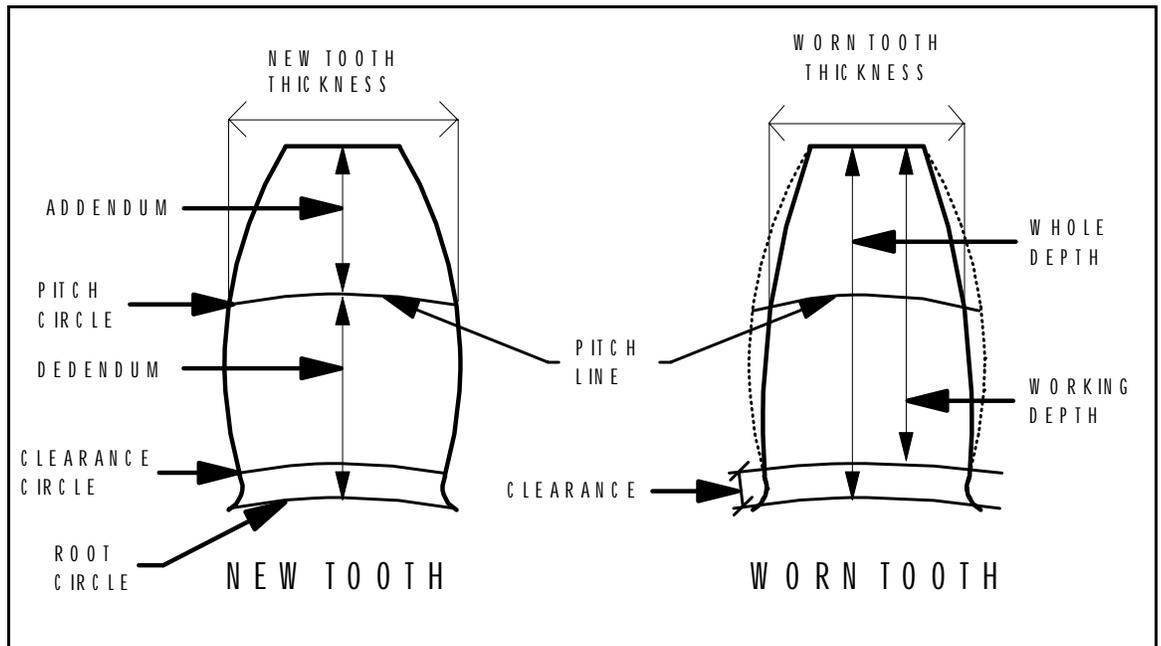
Figure B1. Gear tooth dimensions and wear measurement.

To inspect and rate gear and rack tooth wear, familiarity with the nomenclature used in describing gear and rack teeth is necessary; definitions for the various tooth relationships are presented in the following paragraphs and shown in Figure B1.

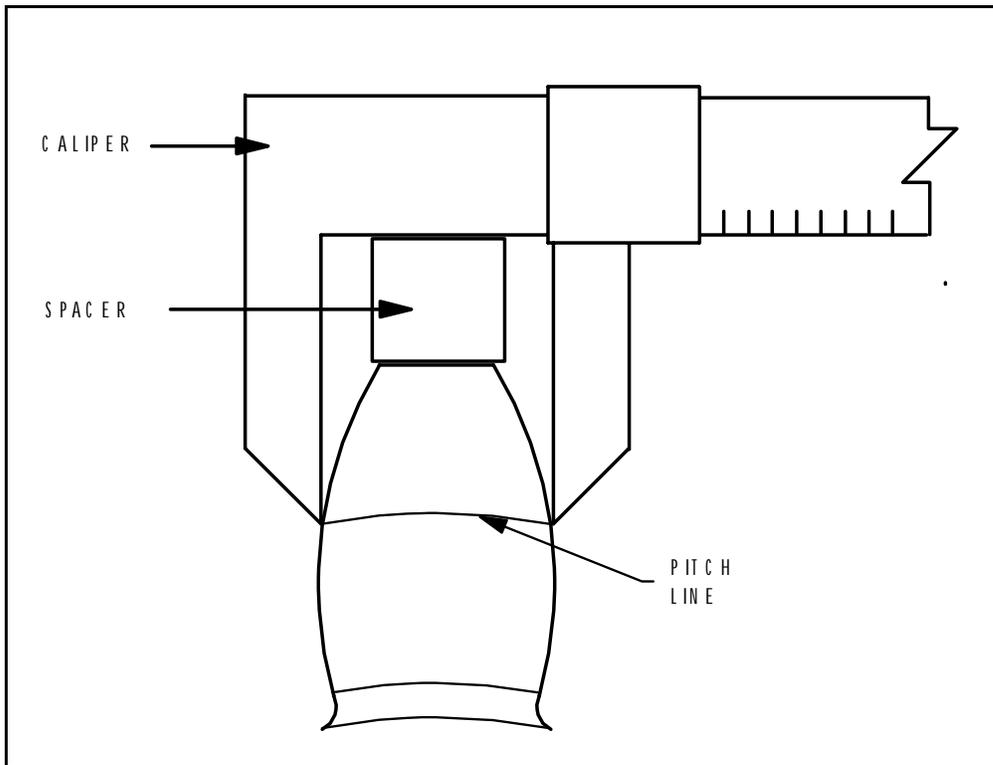
Figure B2. Gear tooth wear measurement: Procedure 1.

above. Next, calculate the new tooth thickness. The new tooth thickness can be calculated from the DP, which can be found in construction drawings, and Table B1. In some cases, the CP may be listed in the construction drawings instead of the DP. The relationship between the CP and the DP can be found in the gear tooth definitions.
