ERDC/CERL TR-03-10

Investigation of Fiber-Reinforced Polymer for Seismic Rehabilitation of Concrete Structural Frames With Unreinforced Masonry Infill

Ghassan K. Al-Chaar, Justin B. Berman,
and Steven C. Sweeney

May 2003

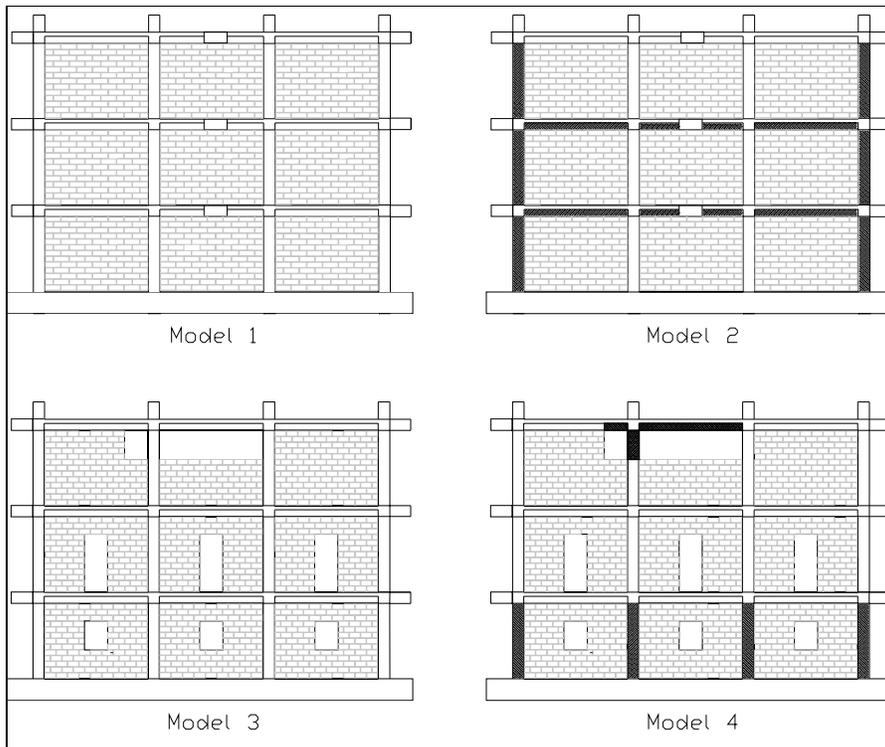
Figure 3.1. The four experimental models.

This chapter describes the experimental test program that was carried out by ERDC/CERL to evaluate the performance of a three-bay, three-story reinforced concrete frame structural system with masonry infill panels. The testing program utilized four experimental models, which are shown in Figure 3.1.

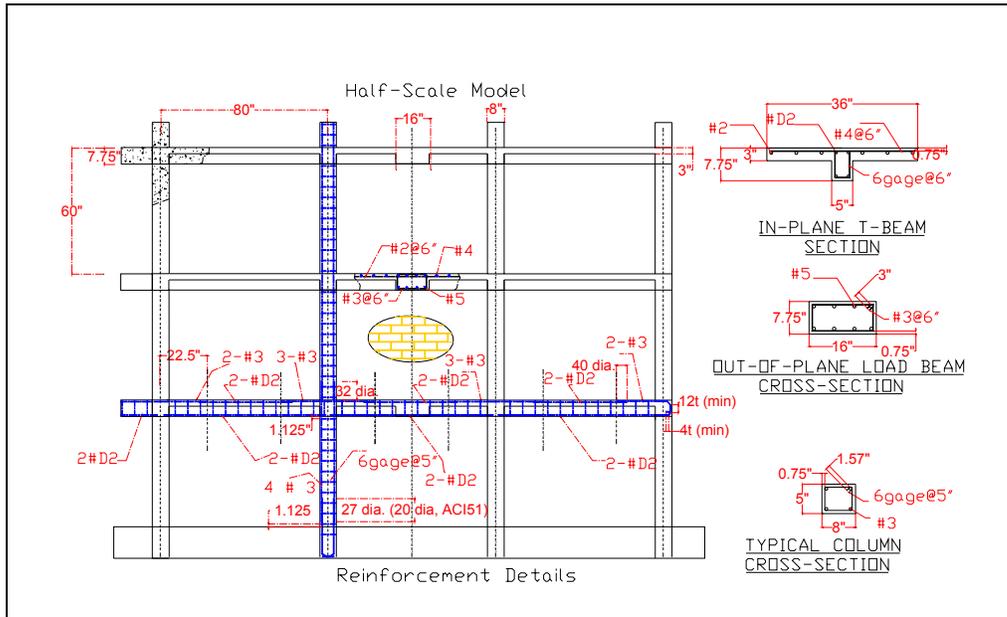
Figure 3.6. Half-scale experimental Model 1 and 2 plans.

Considering all of these scaling methods, the final design of the half-scale R/C frame for Model 1 (and 2) is shown in Figure 3.6. The final design of the half-scale R/C frame for Model 3 (and 4) is shown in Figure 3.1. A photograph of Model 1 is shown in Figure 3.8.

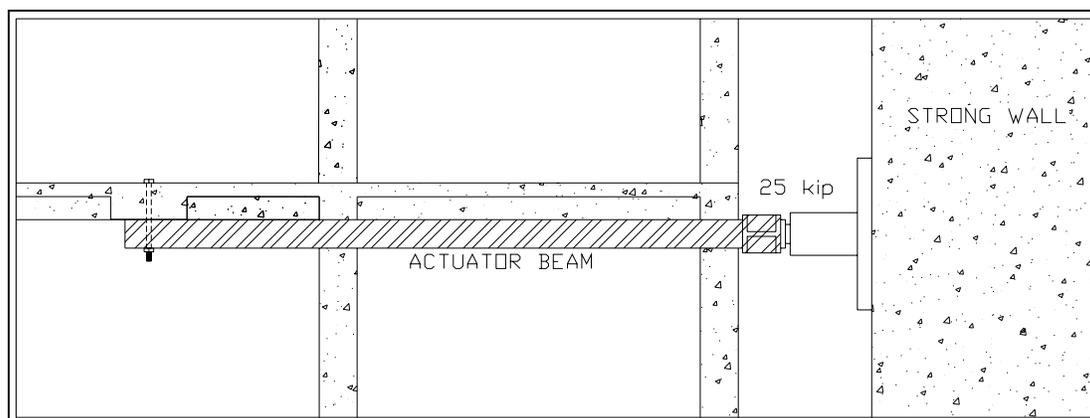
Figure 3.9. Actuator beam assembly.

The three-bay, three-story models were constructed on a stiff reinforced concrete base beam that was bolted to the strong floor of the ERDC/CERL high-bay laboratory. The reinforced concrete frame was cast in a series of three lifts, one lift per floor. After the concrete frames were allowed to cure, the masonry infill was laid in place. The concrete masonry units (CMUs) of Model 1 (and 2) were laid in place with a full mortar bed and were ungrouted. The CMUs for Model 3 (and 4) were fully grouted. Actuators were installed at each floor of the models. The first two floors had 25-kip actuators and the third floor had a 50-kip actuator. Each of the actuators was bolted to two actuator beams. These actuator beams were through-bolted to a thickened section of the floor beams at each side and in the center of the model. An illustration of the model loading assembly is presented in Figure 3.9. Slippage was minimized between the connected elements of the actuator assembly. A reinforced concrete strong wall supported each of the actuators, and the models were braced to prevent any out-of-plane movement.

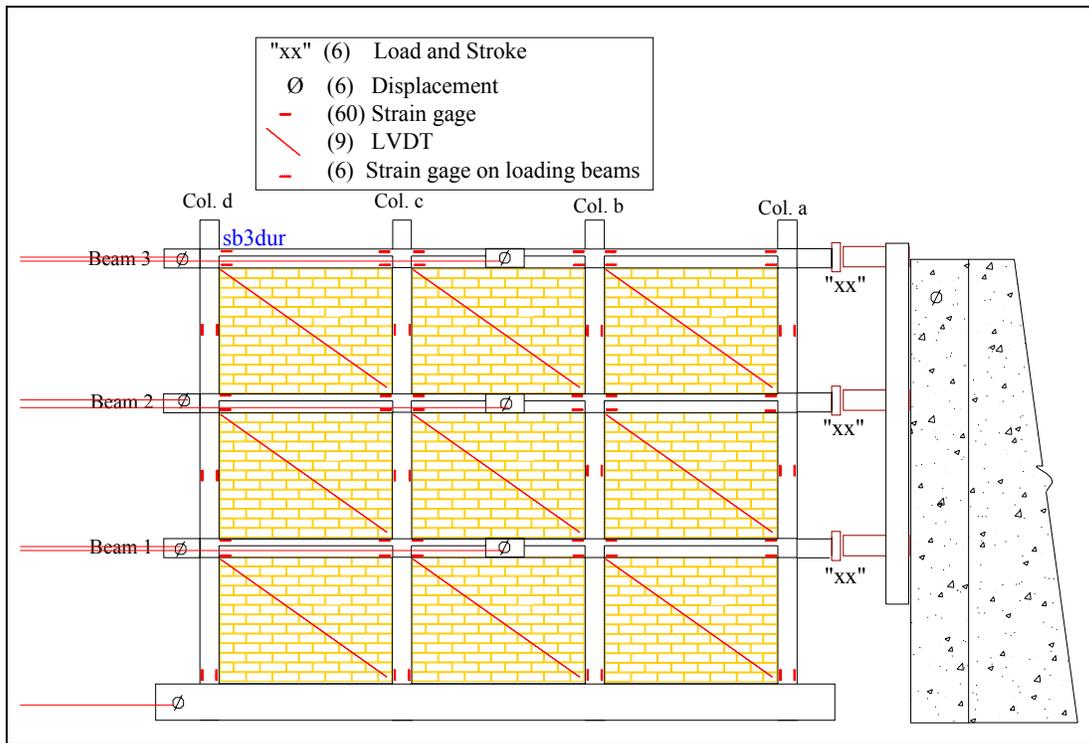
Figure 3.10. Instrumentation location diagram for Test 1 and 2.

Three types of instruments were employed during the tests to measure the response of the experimental model: electrical resistance strain gages, linear variable displacement transducers (LVDTs), and linear resistive displacement transducers (LRDTs). Six LRDTs were used to measure the displacement at the middle and end of the test specimen for each floor. Two LRDTs were employed to measure any unforeseen displacement in the base beam or the strong wall. Nine LVDTs were used to measure the diagonal shortening and lengthening of each masonry panel experienced during testing. Six strain gages were attached to each load beam in order to measure the strains induced during the experiment. Twenty-four strain gages were attached to the reinforcing bar in the columns and thirty-six strain gages were attached to the steel in the beams in order to detect the strain distributions in the frame elements during the test. The applied load and displacement of the three hydraulic actuators were also measured. Table 3.5 shows the instrumentation plan. Figure 3.10 and Figure 3.11 illustrate the location of the instrumentation on the test specimens.

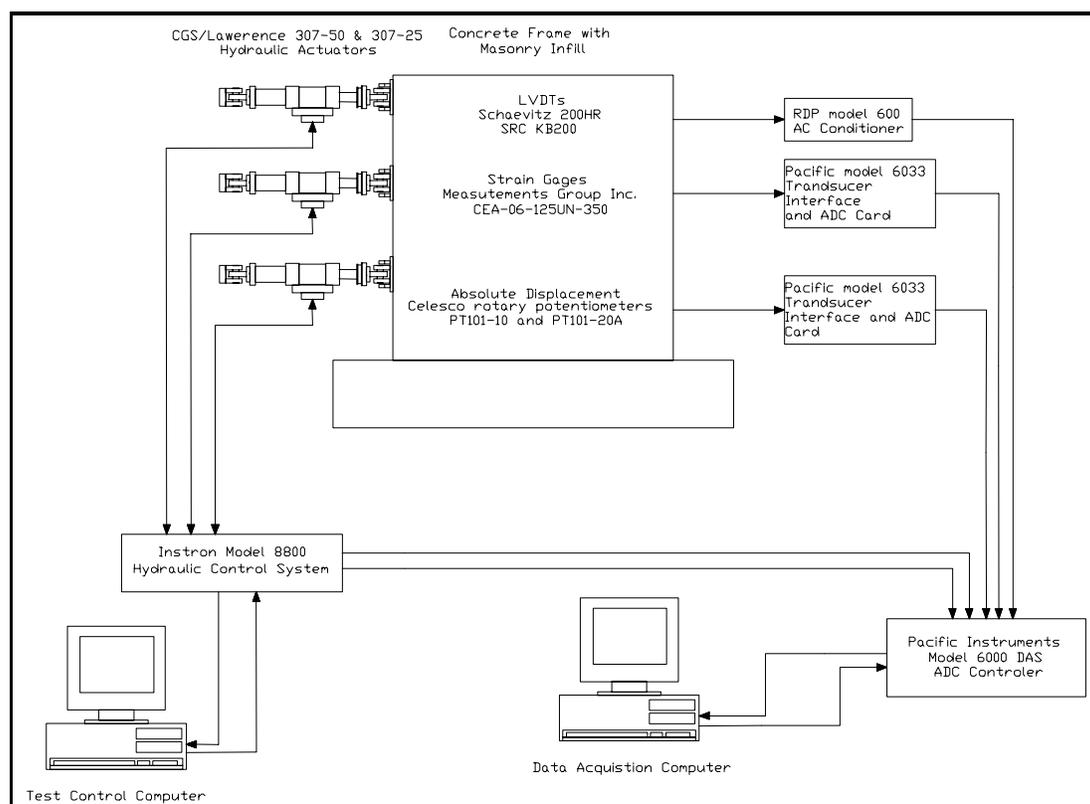
Figure 3.12. Functional block diagram of instrumentation, data acquisition, and test control systems.

Figure 3.12 is a functional block diagram of the instrumentation, data acquisition, and test control systems. All of the transducer output signals were connected to Pacific Instruments Model 6000 DAS ADC Controller.* The system was controlled by a desktop computer through an instrument controller interface bus. The record channels were scanned at a predetermined sampling rate, and the data were recorded as text files on the desktop computer.

The loading system consisted of three CGS/Lawrence† Model 307-25 electrohydraulic actuators controlled by closed-loop servo controllers and a function generator. The top actuator was operated in a displacement control mode. The first- and second-floor actuators were operated in a load control mode. The actuators also include load transducers that measure the applied load.

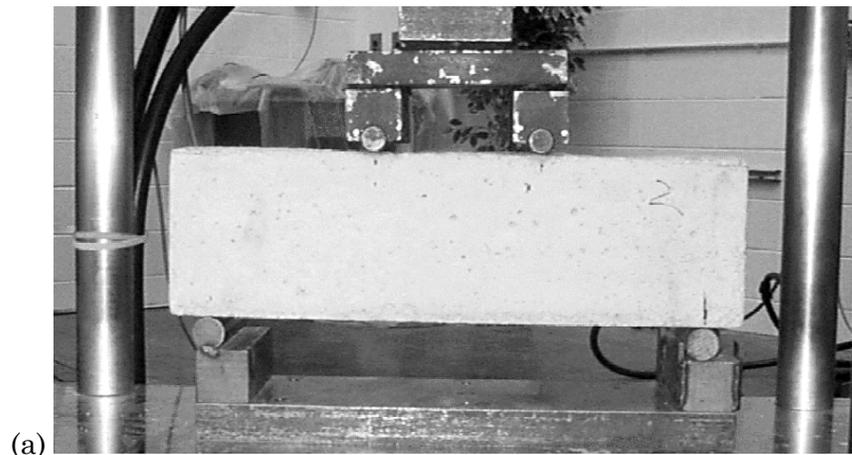
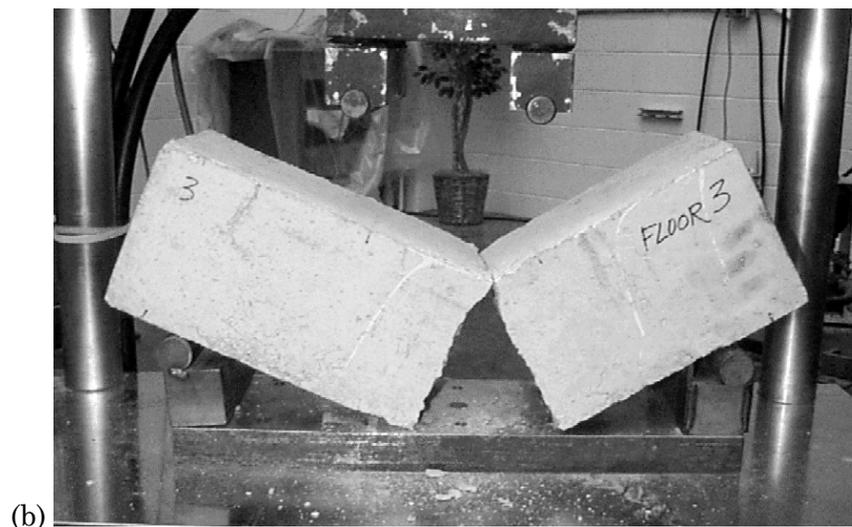
The concrete modulus of rupture was determined according to ASTM C78-94. All specimens failed within the center third of the beam. Before and after photos of one of these test specimens are shown in Figure 3.13. A summary of concrete flexural strength is presented in Table 3.7.

**Figure 3.13. Concrete flexural specimen for 4-point bending test (a) before test and (b) after test.**

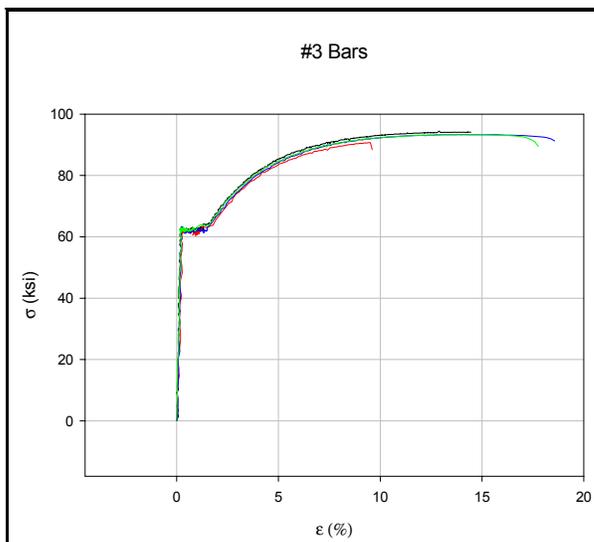
Figure 3.14. Stress/strain curve for #3 bars.

Steel reinforcement was tested according to ASTM A615/A615M-96a and ASTM E8-98. Four different sizes of reinforcing steel were used in the experimental model: D2, #2, #3, and 6 gage. The D2, #2, and #3 bars were used for longitudinal reinforcing while the 6 gage bars were utilized for stirrups. All bar sizes were tested for yield strength, ultimate strength, and modulus of elasticity. These properties, along with the nominal area for each bar size, are summarized in Table 3.8. For the 6 gage reinforcing bar, the yield stress was found from a 0.02% offset since a well-defined yield point was not present; these values were taken in the stress range of 20 – 40 ksi. For the remaining reinforcing bars, the values for yield stress and modulus of elasticity were found using conventional techniques. The stress/strain curves for the #3, D2, 6 gage reinforcing bar, and #2 are given in Figures 3.14, 3.15, 3.16, and 3.17, respectively.

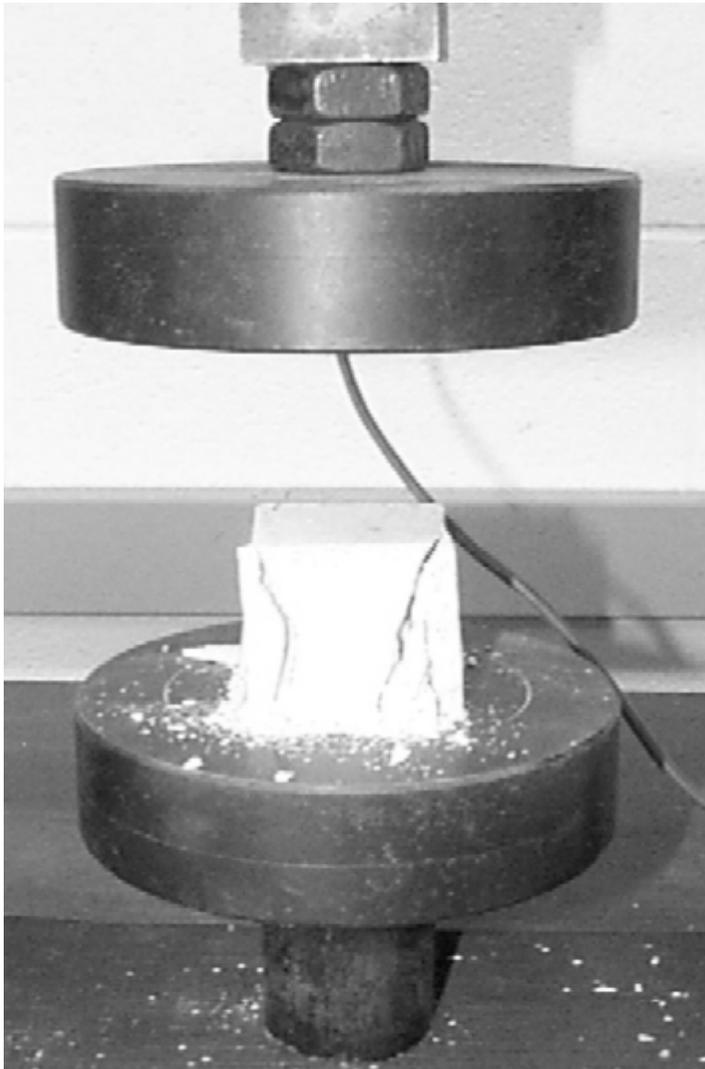
Figure 3.18. Photo of mortar cube test failure.

The compressive strength tests of the mortar were executed following ASTM C109/C109M-99. The cone failure mode was typical of all cubes tested; a picture of this failure mode is shown in Figure 3.18. Compressive strength and age at testing of the mortar are summarized in Table 3.9.

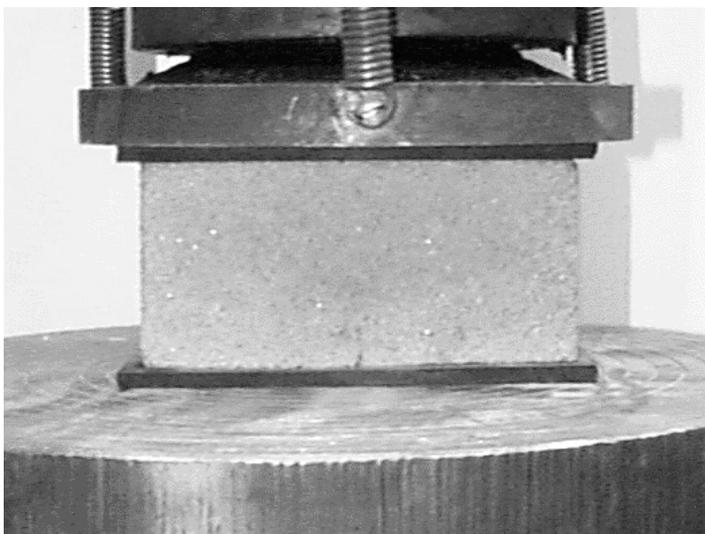
Figure 3.19. Photo of CMU test setup.

The compressive strength tests of the CMU were performed in accordance with ASTM C140-99b; a picture of the test setup is shown in Figure 3.19. The average weight of the CMU used for Model 1 (and 2) was 2.88 lb. The average weight of the CMU used for Model 3 (and 4) was 3.72 lb. This increase in density resulted in higher compressive strength for the CMU used in Model 3 (and 4). Compressive strength was calculated using the average net area of the block (15.13 sq in.); this value was found to be 774 psi for Models 1 and 2, and 852 psi for Models 3 and 4.

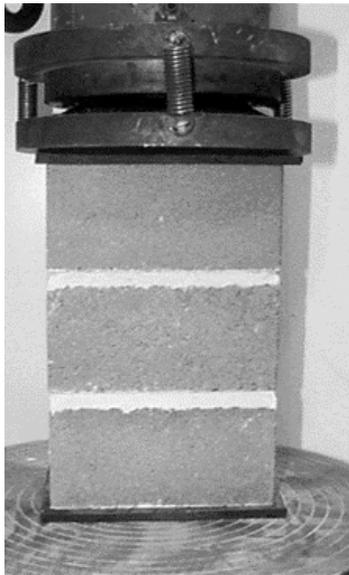
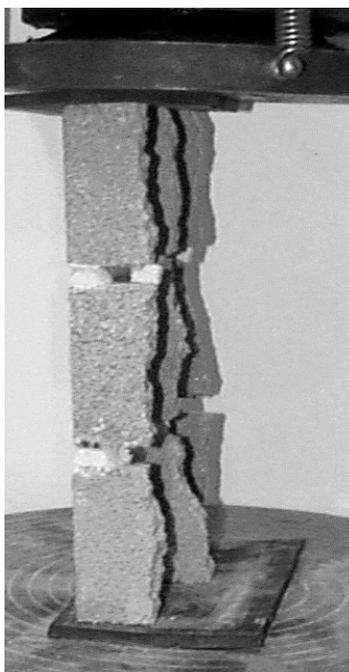
Prisms for each floor were constructed and tested according to ASTM C1314-00. The age, compressive strength, and modulus of elasticity for each floor for each model are summarized in Table 3.10. Compressive strength was calculated using a net area of 10.5 sq in. The modulus of elasticity was calculated as $E_m = 750 f_m$. All specimens failed from a single tensile crack that propagated down the center of the prism, which was oriented in the longitudinal direction of the CMU. Pictures of the test setup and mode of failure for the masonry prism are shown in Figure 3.20.

**Figure 3.20. Compression test setup and failure mode for masonry prisms.**

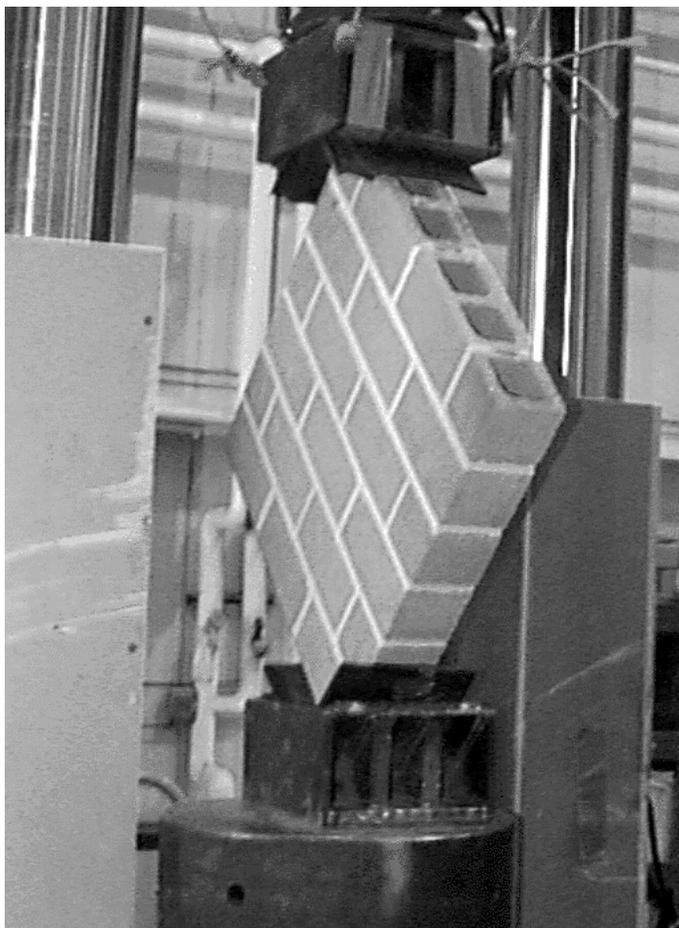
Figure 3.21. Diagonal tension test setup for masonry prism.

Diagonal tension testing on a 24 x 24 in. specimen was conducted per ASTM E519-81 (reapproved 1999); a picture of this test setup is shown in Figure 3.21. The CMU and mortar samples were from the second floor of Model 1. The tests were performed at 129 days of age and the average shear strength was found to be 117 psi. The shear strength was calculated using an effective thickness of 1.375 in. and a net area of 46.67 sq in.

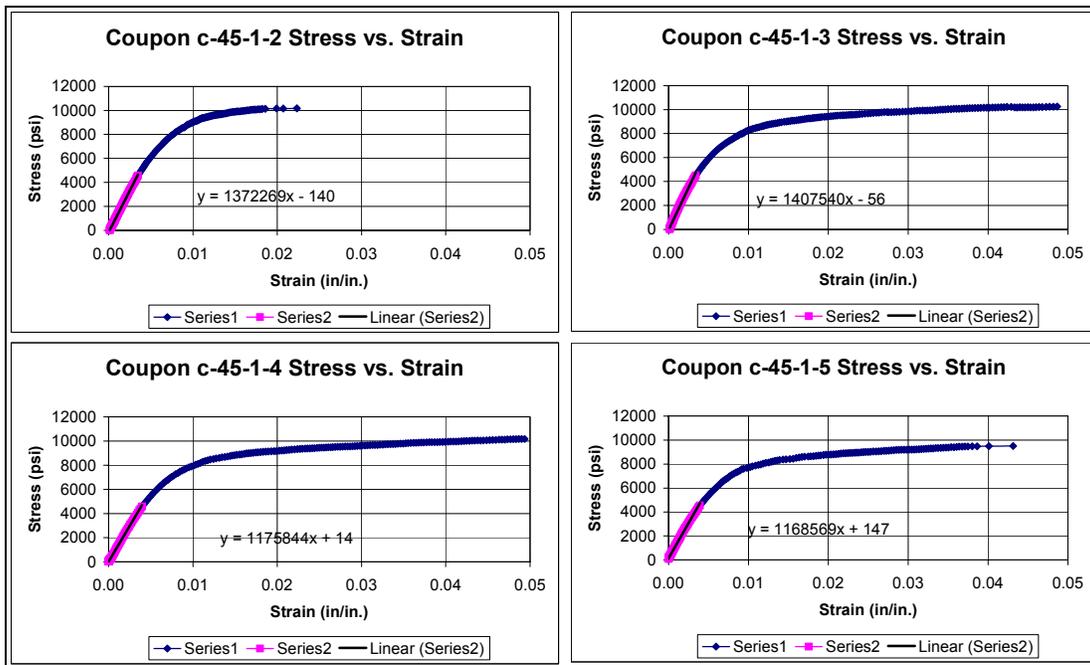
Figure 3.22. Stress vs strain relationships for Model 2 CFRP coupons.

As described previously, CFRP with a +45 / -45 degree fiber orientation was used to strengthen the R/C frame of Model 1 and Model 3 after testing. Each model was rehabilitated according to the extent of the damage. The goal of the CFRP rehabilitation was to enhance the original ultimate moment and shear capacities of the beams and columns in the undamaged frame. CFRP thickness, tensile strength, and modulus of elasticity are shown in Table 3.11. Stress-versus-strain relationships were observed for four CFRP coupons, with the average values for ultimate stress and modulus of elasticity taken to represent all CFRP used for rehabilitation of the model. The stress-versus-strain relationships are illustrated in Figure 3.22 and Figure 3.23 for each of the four CFRP coupons tested.

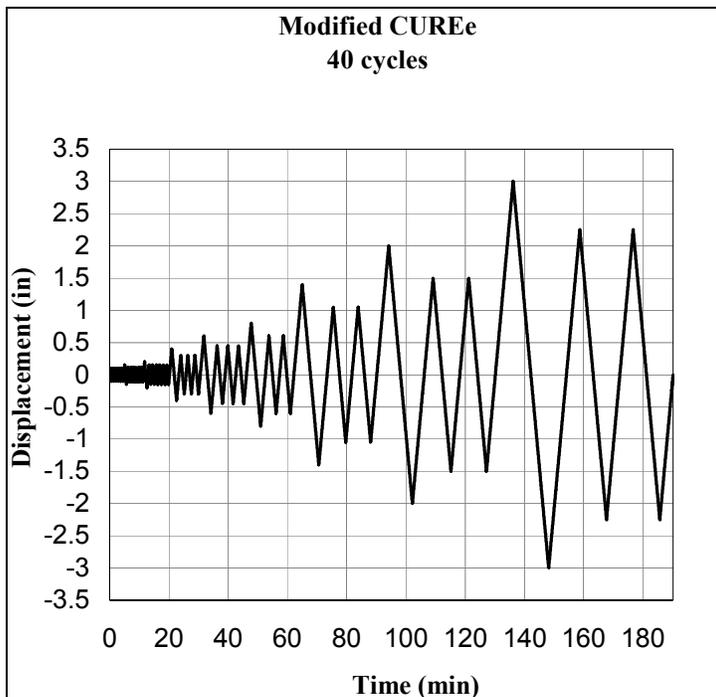
Figure 3.24. Modified CUREE loading history.

A few modifications of the CUREE method were implemented to meet the needs of the current testing program. Adjustments were made to allow for a 3-hour test duration and a 3 in. maximum third floor displacement while maintaining the 40 cycles specified by CUREE. The 3 in. maximum third floor displacement was incorporated to ensure that sufficient degradation of strength had occurred by the completion of the test. The 3-hour test length was specified to allow adequate time to monitor test data and specimen performance during the test. In order to keep the total number of cycles equal to 40 while increasing the length of the test, the duration of each cycle was changed. Rather than maintaining a constant cyclic frequency, a constant displacement velocity of 0.5 in./minute was used. This displacement velocity substantially increased the time needed to complete the largest cycles. This enabled researchers ample time to document model behavior during the cycles that caused the most damage. The resulting cyclic loading history is presented in Figure 3.24. The drift ratio, as used in this figure, refers to the third floor displacement over the entire height of the half-scale model.

Model 3 used the same beam, column, and bay identification scheme employed for Model 1 (Figure 7.1). In basic form this model was similar to Model 1. However, the infill panels were designed with openings to represent windows, doors, and other apertures typically found in this type of construction (illustrated in Figure 7.2 and others). Also unlike Model 1, the CMUs were grouted in place. Other differences were the use of concrete with higher compressive strength and larger longitudinal positive reinforcement and spacer reinforcement — #2 instead of D2 (see Figure 3.7). As in the previous two tests, Model 3 was loaded using the modified CUREE method described previously (see Figure 3.24).

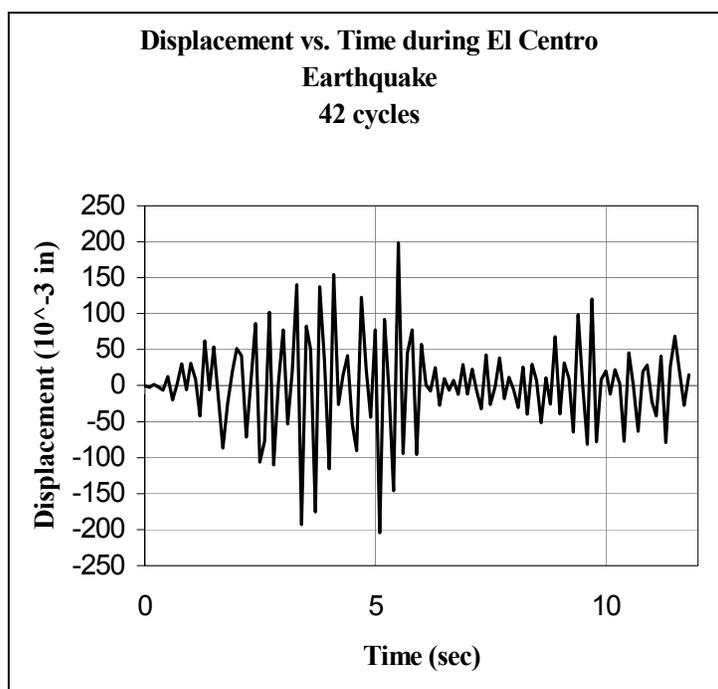
Figure 3.25. El Centro, plot of displacement vs time.

In Figure 3.25, a graph illustrating the results of a dynamic analysis is presented. A finite element model of the physical model was created. The computer model was then subjected to the accelerations recorded during the benchmark El Centro, CA, earthquake of 18 May 1940. The peak displacements from that earthquake occurred within the first 12 seconds. Most damage to the model occurred during these 40 cycles. Therefore, the proposed loading history of 40 cycles is representative of an actual earthquake.

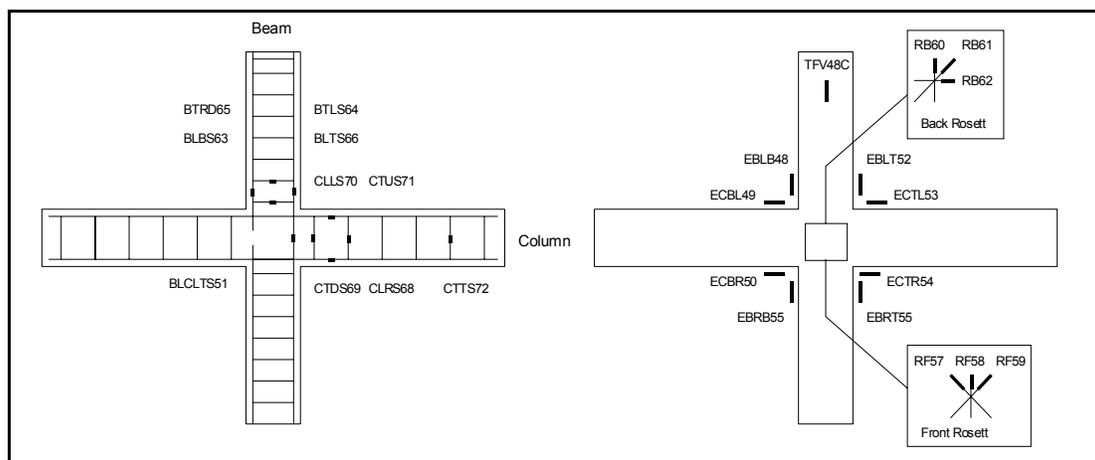
Figure 4.1. Instrumentation on a typical beam-column joint.

Strain gages and rosettes were mounted at critical locations to measure the strain. The layout of strain gages and rosettes for a typical beam-column joint is shown in Figure 4.1. LVDTs were installed to measure the displacements. Beam specimens were tested using four-point loading, as shown in Figure 4.2 and Figure 4.3. Load was applied in a displacement-control mode at a rate of 0.01 in. / minute. Columns were subjected to axial loading as shown in Figure 4.4. In beam-column joint testing, the loading pattern was a cyclic type with alternating displacement reversals (Figure 4.5). The beam was connected to an actuator and subjected to push and pull; the column was simultaneously subjected to a constant axial load of 50 kips, which is about 20% of the ultimate compressive load for the column. The test setup and failure mode for typical beam-column joint is shown in Figure 4.6. Load, deflection, and strain readings were recorded, and crack development and mode of failure were monitored throughout the tests.

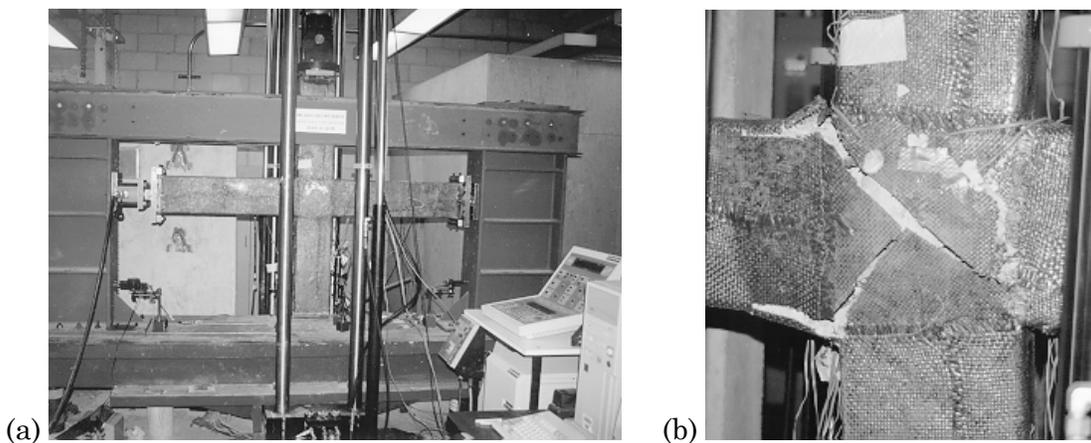
Figure 4.6. Test setup (a) and failure mode (b) of wrapped beam-column joint.

layer of CFRP sheet was added in wrapping the joint. The ultimate failure in the unwrapped joint specimen was due to shearing of the beam, while in the case of wrapped joint, the ultimate failure was within the joint at an angle of 45 degrees, as shown in Figure 4.6(b). It was observed that wrapped specimens could resist more loading cycles than unwrapped specimens. It was also observed that the wrapped specimen could undergo 86% more displacement than the unwrapped specimen, as illustrated in Figure 4.9 and Figure 4.10. The observed ductility for the wrapped specimen was 4.3, while for the unwrapped specimen, the ductility was 3.02. It is worth noting that the beam-column joints employed in this study were well confined by ties and shear reinforcement.

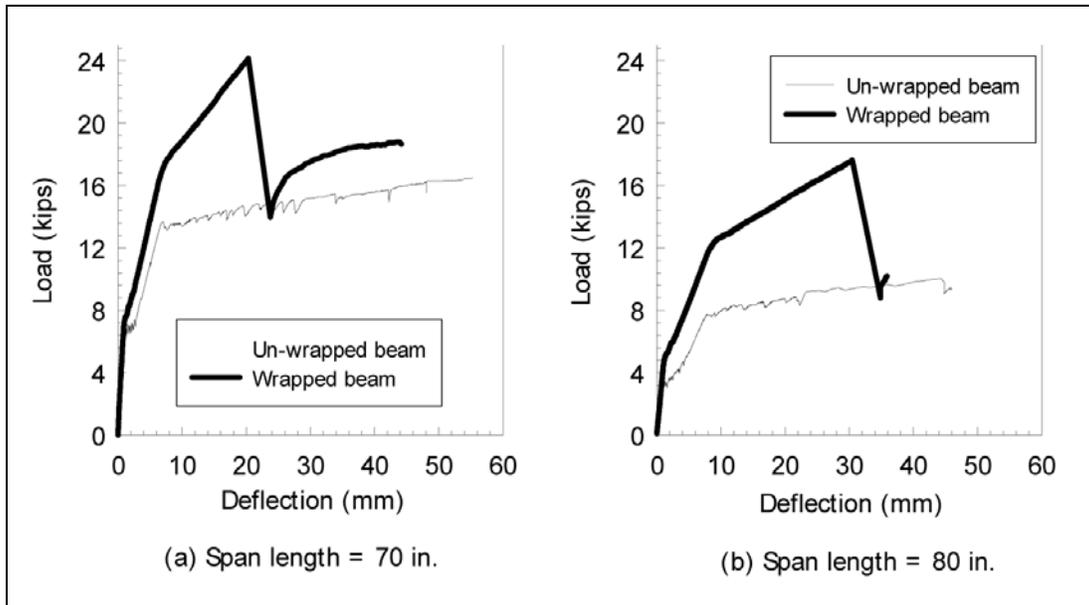
Figure 4.7. Load/displacement response of wrapped and unwrapped beams.

The observed results were analyzed and compared. The load/displacement response of CFRP-wrapped and unwrapped beams are shown in Figure 4.7. For the wrapped specimens, the increase in ultimate load was 75% for beams with shear span-to-depth ratio (a/d) of 2.7, and 45% increase for those with a/d ratio of 1.8. Failure occurred due to tension in the flexural zone of the concrete, and there was tensile failure in the CFRP laminate after the concrete was crushed under the loading points.

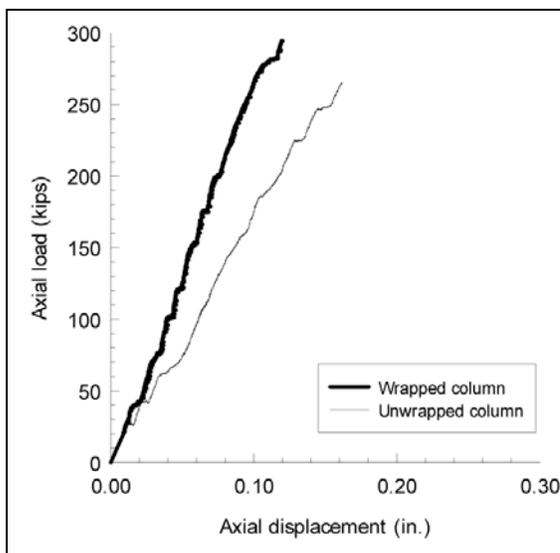
Figure 4.8. Axial load/displacement response of wrapped and unwrapped columns.

The comparison of the test results for wrapped and unwrapped columns is shown in Figure 4.8. The confinement due to the wrapping of CFRP sheets was clearly manifested. The ultimate load for the wrapped column was 12% higher than for the unwrapped column with only one thin layer of CFRP applied. By comparison, the CFRP made a significantly greater strength contribution to the wrapped compressive test cylinder specimens, which registered a 50 percent compressive strength increase over the unwrapped specimen. This higher performance is attributed to

the fact that a circular cross section member wrapped with CFRP fails with less stress concentration on the CFRP fibers, and therefore it can resist a greater load than a CFRP-wrapped rectangular cross section.

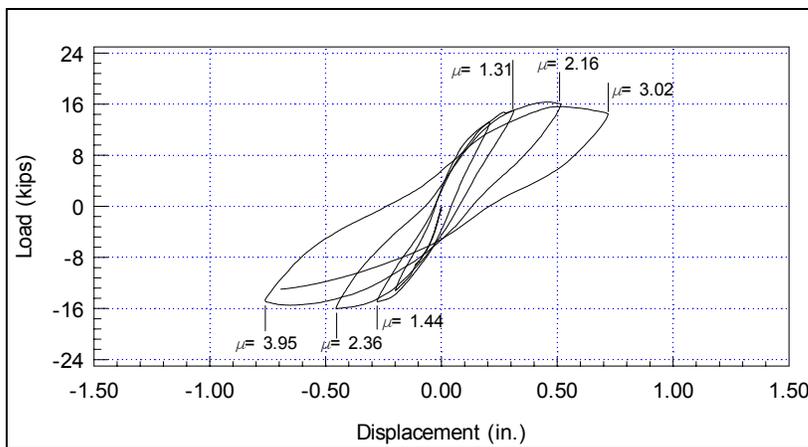
Figure 4.9. Load vs displacement response of unwrapped beam-column joint.

The load/displacement hysteresis curves for unwrapped and wrapped beam-column joints are shown in Figure 4.9 and Figure 4.10, respectively. During testing, more damage was noticed in the pull cycle than in the push cycle for the same level of load. This difference is attributed to the extra confinement on the compression side during push loading. The shearing strength of the wrapped joint was 13% higher than that of the unwrapped joint. It is necessary to keep in mind that a very thin

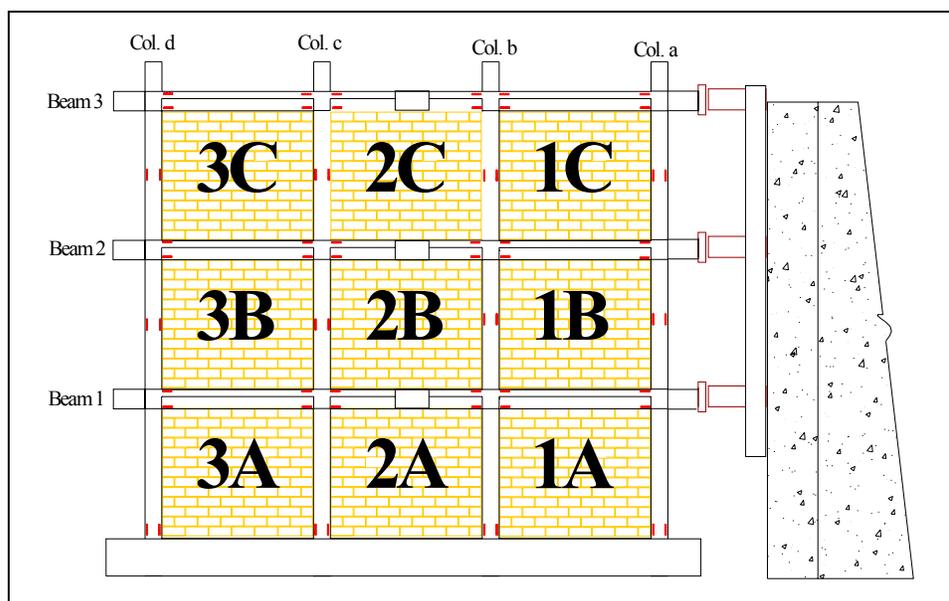
Figure 5.1. Identification scheme.

Using the identification scheme shown in Figure 5.1, Model 1 was loaded using a modified CUREE method, cracking the wall throughout 40 cycles spread over 3 hours. The first cracks appeared during the positive stroke of cycle 21 at a maximum test load of 14.17 kips on the top floor. All but one of the cracks occurred on the second level, and most of those were diagonal cracks on the left half of the three panels, as shown in Figure 5.2. A number of the diagonal cracks were a combination of stair-stepping cracks through the mortar and cracked CMUs — mostly at an angle through corners. At this time, the first indication of the masonry separating from the column appeared in the upper-right corner of panel 2B, where a vertical crack formed between column B and the CMUs. Throughout the rest of the test the second floor continued to crack the most, with the highest crack propagation occurring in the corners of the bottom six panels and along bed joints.

Strain distribution in the masonry panels is examined in order to infer the distribution of lateral force. Location of panels with large diagonal deformations will be found from the data. Strain distributions in the masonry panels at peak load and cycle 29 are presented. Cycle 29 imposed panel displacements of 0.2 in., which was the maximum range of the LVDTs. Therefore, readings after Cycle 29 were inconclusive. Because only one LVDT was used for each panel, compressive displacements were obtained only in the positive stroke direction. Therefore, only masonry panel strain distributions in this direction are discussed here. The values of panel strain are normalized to the panel that had the largest displacement during that cycle. A value of 100% represents the panel that had the largest displacement, and a value of 50% signifies a diagonal panel displacement of half of the maximum value during that cycle. The masonry panel identification scheme used in the following discussion is shown in Figure 5.1, and the location of the strain gages and the LVDTs is illustrated in Figure 5.12.

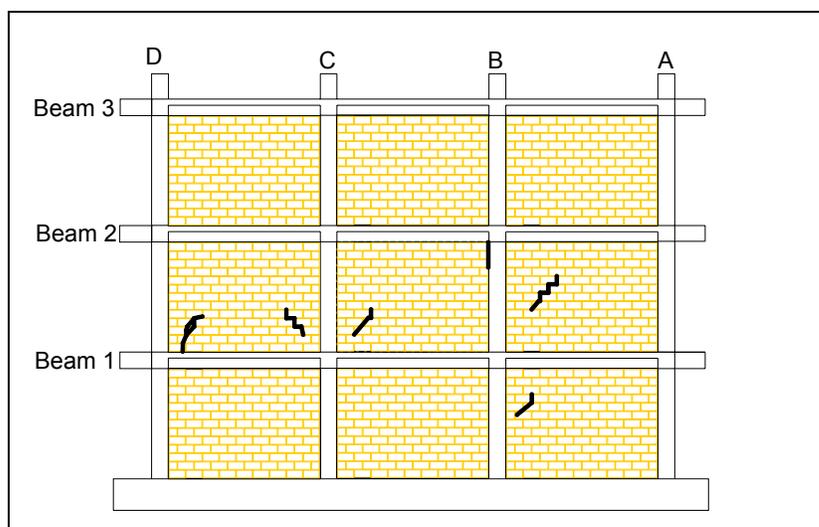
Figure 5.2. First cracks, cycles 21 through 24.

Two forms of data are available to correlate cracking with loading: LVDT data and drift ratios. LVDT readings show that panel 2A was the most strained panel, at 0.06 in., during cycle 21. The rest of the second floor LVDT readings reached at least 72 percent of the value panel 2A. The first and third floors had much less diagonal strain, reaching a maximum of about 60% of panel 2A. The drift ratios are also an indication of why the second floor cracked first. The second floor had a drift ratio of 0.21%, more than twice as much as the first floor (0.098%) and nearly three times as much as the third (0.07%). The higher drift ratio means more localized displacements that translated into higher strains and corresponding damage.

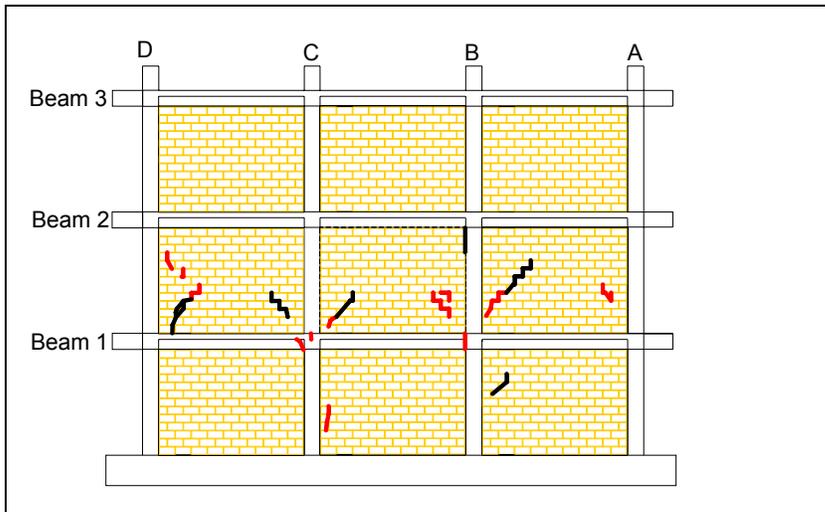
Figure 5.3. Cracks appearing during cycles 25 through 28.

As the test progressed from cycle 25 – 28, the cracking pattern remained mostly in the same panels and quadrants as the earlier cycles. Again the majority of cracks were stair steps, either continuations of existing cracks or new ones. They were typically found in the bottom half of the panels moving upward toward the center, visually indicating strut action of the CMUs. Figure 5.3 shows how the cracks had propagated toward the toe of the second-floor panels during the negative stroke. These cracks would not propagate any further during the test. During these cycles, the first slab and beam cracks formed at the middle two joints along the second floor, where the stress concentrations were highest.

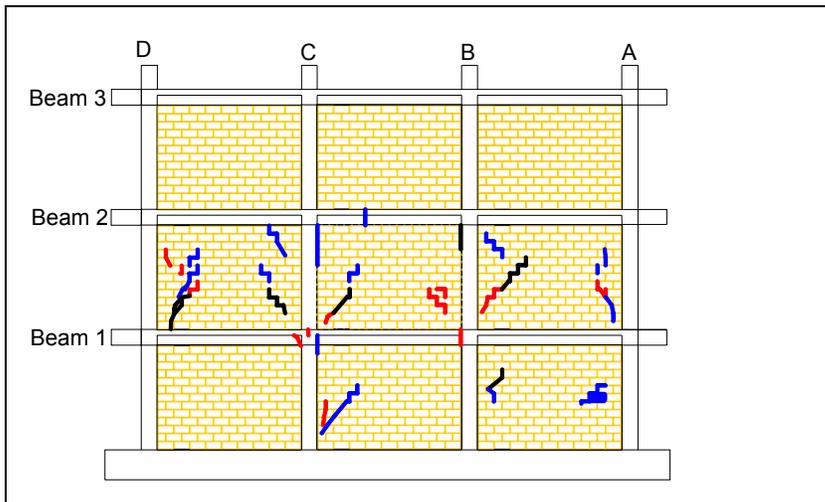
Figure 5.4. Cracks appearing during cycles 29 through 31.

Cycle 29 was the last cycle for which LVDT data are available. During this cycle, every second-floor panel achieved 0.2 in. of diagonal displacement, the maximum reading available for the LVDTs. Average readings for the first and third floor were approximately one half and one tenth, respectively, of the second floor value, as reflected by the relative amount of cracking on each floor at this time. Floor three had yet to crack and the first floor sustained minimal damage, with the exception of a spalled CMU block in panel 1A, depicted in Figure 5.4. Drift ratio data again corresponded to the damage: the first and third floors had drifted 0.338% and 0.136%, respectively, while the second floor drifted 0.56%. Note how most of the damage through cycle 31 was located on the outside perimeters of the damaged panels. At this point, no evidence of bed joint sliding or crushing of the toe was observed, and the center region was acting as a ‘survival zone.’

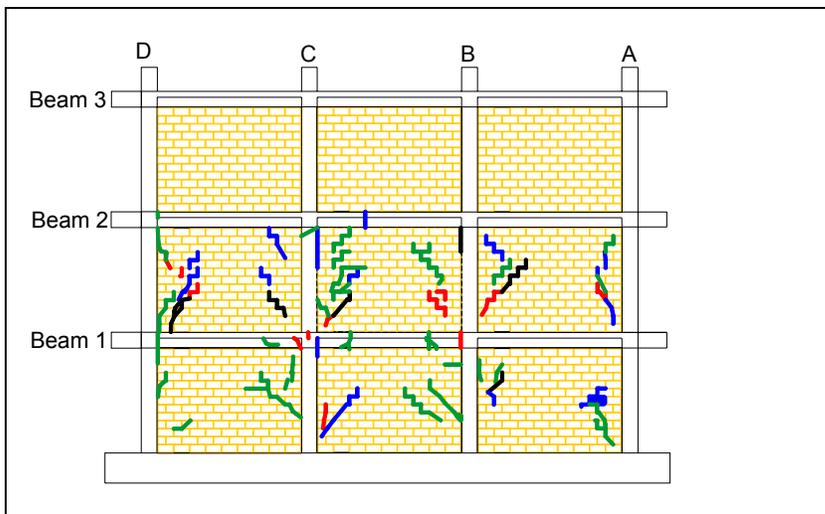
Figure 5.5. Cracks appearing during cycles 32 through 34.

The next major peak, cycle 32, cracked all the panels on the first floor and continued to damage the second floor, as depicted in Figure 5.5. The increased stair-stepping and CMUs cracking correlated to drift ratio values that were almost double those measured during cycle 29. Despite the second story drifting more than 1% during the positive stroke of cycle 32, there was no loss of strength to the frame, and in fact the load capacity increased slightly compared to cycle 29.

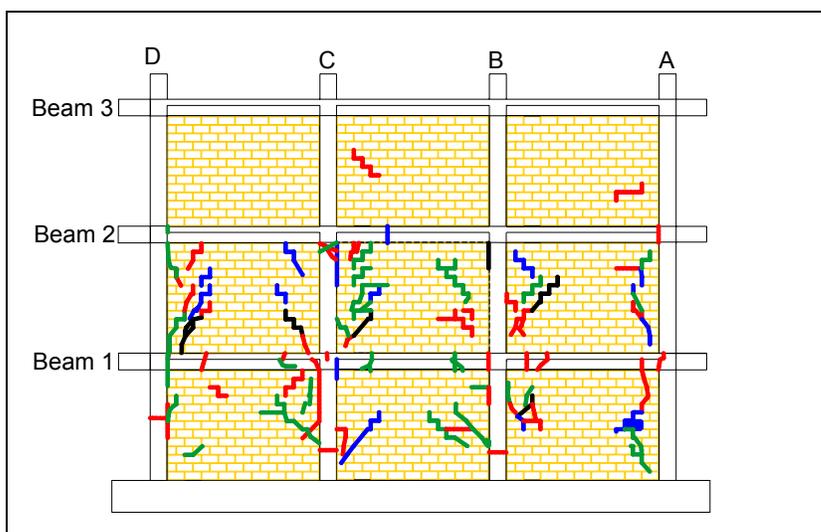
Figure 5.6. Cracks appearing during cycles 35 through 37.

The following series of cycles, 35 – 37, continued to damage the infilled frame. With the drift ratios over 1% in both the first and second floors, the load capacity dropped from 13.48 kips in the positive stroke of cycle 32 to 12.02 kips in the positive stroke of cycle 35 for the third story, the largest drop in load yet. During this series, stair-stepped cracks in the third-story CMUs were observed while columns 1B, 1C, and 1D sustained flexural cracks (Figure 5.6). The top of column 2C, which was initially cracked in shear during cycle 32, accumulated further damage. There was also some evidence of bed joint sliding in the bottom six panels, but none of these cracks had propagated farther than two or three CMU lengths. The last major change was the development of cracks in the first and second beams. The first beam cracks took place early, during cycle 29, and four more major cracks appeared after cycle 32.

After cycle 35, however, the Beam 1 crack continued into the CMU in the upper-right quadrant of panel 1A. The beam cracks were largest near columns A and D, but are also of considerable size in other places. The cracks that appeared close to interior columns were all at similar locations, most likely where the rebar cutoffs occurred and stress concentrations were the highest. The continuation of the beam crack into the CMU block denotes that composite action between frame and infill was still taking place this late in the test.

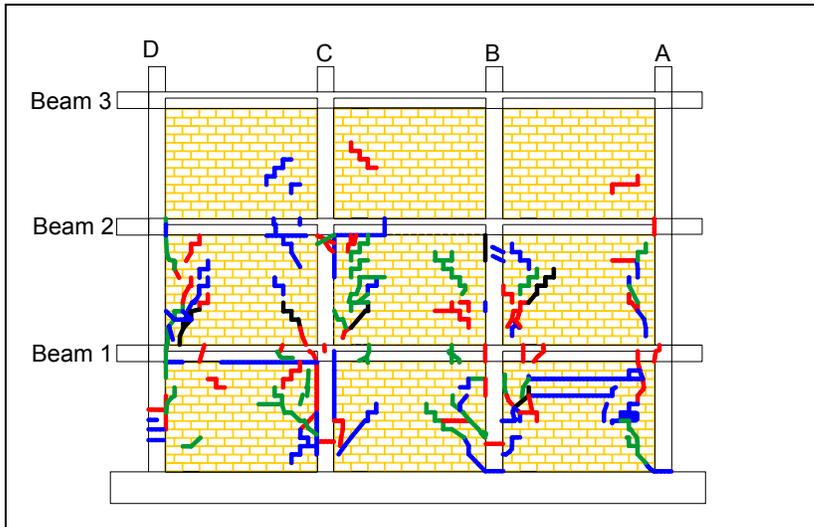
Figure 5.7. Cracks appearing during cycles 38 through 40.

The damage from the last series of cycles, shown in Figure 5.7 and Figure 5.8, was fairly significant. At a maximum third floor displacement of 3 in., the drift ratios of first and second floors were over 2%, and the third floor drift ratio approached 0.5%. Columns 1C and 1D sustained more flexural cracking at mid-height, and columns 1A and 1D cracked at the base. Panels 1C, 2B, 2C, 3B, and 3C started to separate from the frame, and the second beam continued cracking above panel 2C. Bed joint cracks were found after the test in every panel; the first and second floor panels were so severely damaged that the masonry was loose to the touch. Load capacity continued to drop with increased deflection. Cycle 38, the peak displacement cycle, had a load capacity of 10.94 kips at the third story, over 3 kips less than peak load. Although column and beam joints remained intact and the frame preserved its original shape, damage of the overall structure could be described as severe. The masonry had lost most of its cohesiveness and almost all the mortar was cracked. Only panel 3A remained partially solid.

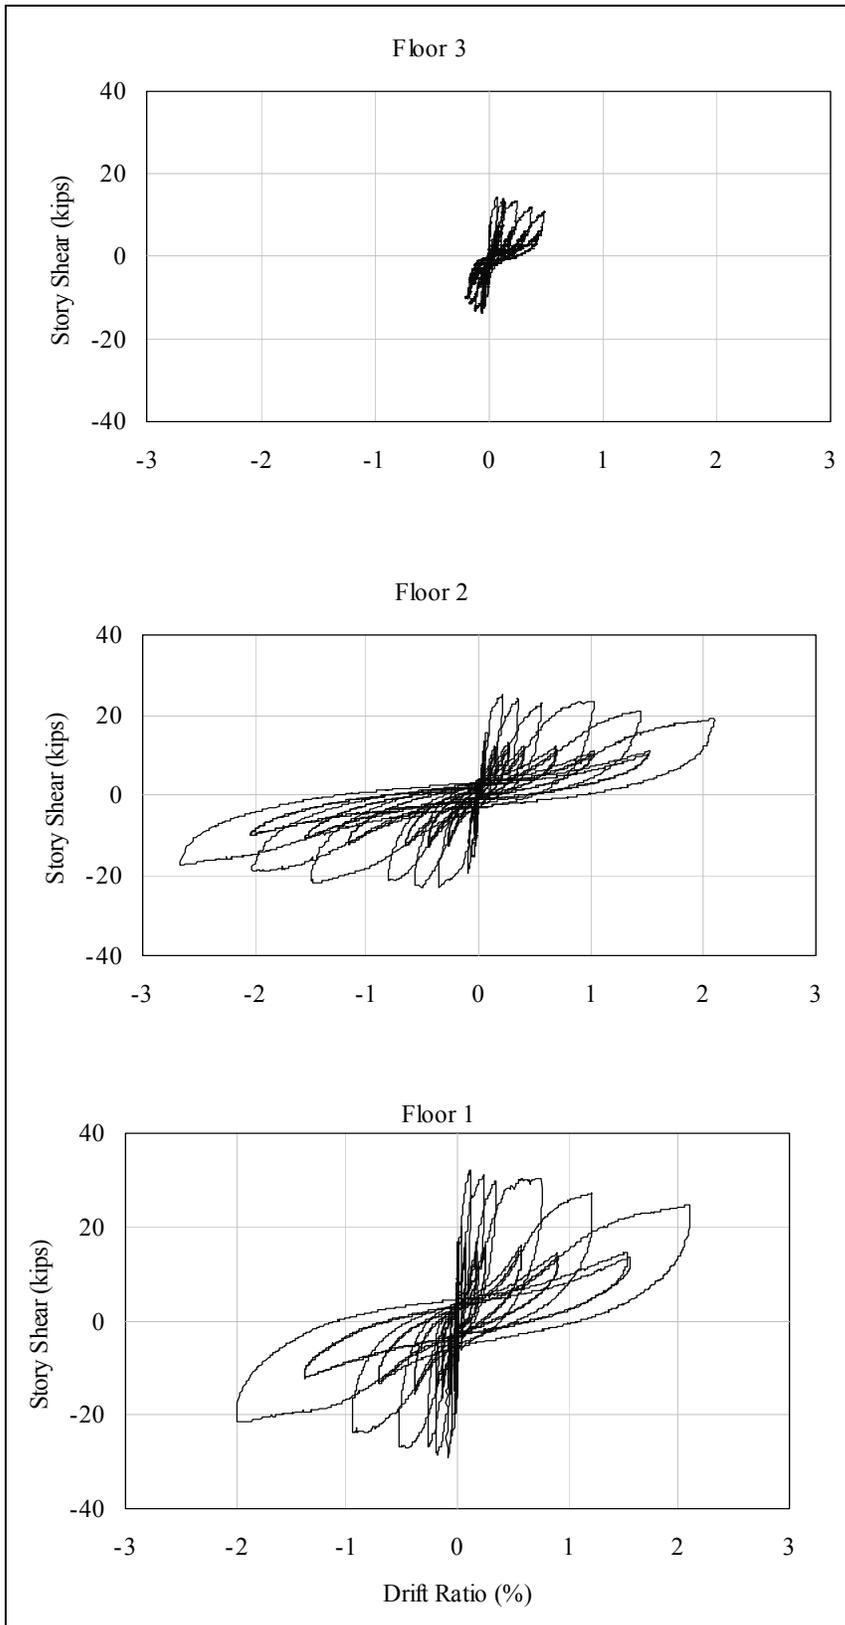
Figure 5.9. Story shear vs drift ratio behavior for each floor.

Applying the modified CUREE loading protocol to the test specimen resulted in the load/displacement behavior plotted in Figure 5.9. The load plotted on the ordinate is the accumulated story shear for each level. The drift ratio, plotted on the abscissa, is defined as the interstory displacement divided by the story height. The hysteresis for each floor is discussed in order to explain the behavior of the test specimen.

The peak lateral load for the experimental model occurred during the cycle 21 at a corresponding first floor story shear of 32.21 kips. The second and third floors had story shears of 24.90 and 14.17 kips, respectively, during the positive stroke of this cycle. During the negative stroke, the story shears for the first, second, and third floors were 29.02, 23.08, and 13.90 kips, respectively. The corresponding drift ratios at peak load in the positive stroke direction were 0.12%, 0.22%, and 0.07%. For the negative stroke direction, values of 0.088%, 0.354%, and 0.054% drift ratio occurred in the first, second, and third floors, respectively. These drift ratios corresponded to absolute third floor displacements of 0.23 and -0.30 in. for each direction. The peak loads and corresponding story shears and drift ratios for each floor are summarized in Table 5.1.

From Figure 5.9, the drift ratio of the third floor after achieving the peak load was much lower than the values observed in the first or second floors. The main cause of this behavior was the prescribed inverse-triangular distribution of lateral forces specified in IBC 2000; the resulting story shear distribution is shown in Table 5.3. The story shear on the first and second floors was roughly double the value applied to the third floor. This load distribution caused the drift ratio of the first and second

The significant cracking in the first and second floors also caused the hysteresis of the third floor to become asymmetric, as shown in Figure 5.9. The negative drift ratio of the third floor hysteresis was much lower than the drift ratio in the positive direction. The main cause of this asymmetry was the effects of considerable cracking in the lower-left quadrant of the second floor masonry panels, as previously illustrated in Figures 5.2 through 5.8. These cracks near the toe of the masonry panels caused a considerable decrease in stiffness of the second floor in the negative stroke direction, away from the reaction structure. In effect, the second floor attracted the most interstory displacement in the negative stroke direction after cracking. This phenomenon left the third floor with little of the additional drift that was needed to comply with the specified displacement from the loading protocol.
