ERDC/CERL TR-03-10

Investigation of Fiber-Reinforced Polymer for Seismic Rehabilitation of Concrete Structural Frames With Unreinforced Masonry Infill

Ghassan K. Al-Chaar, Justin B. Berman,
and Steven C. Sweeney

May 2003

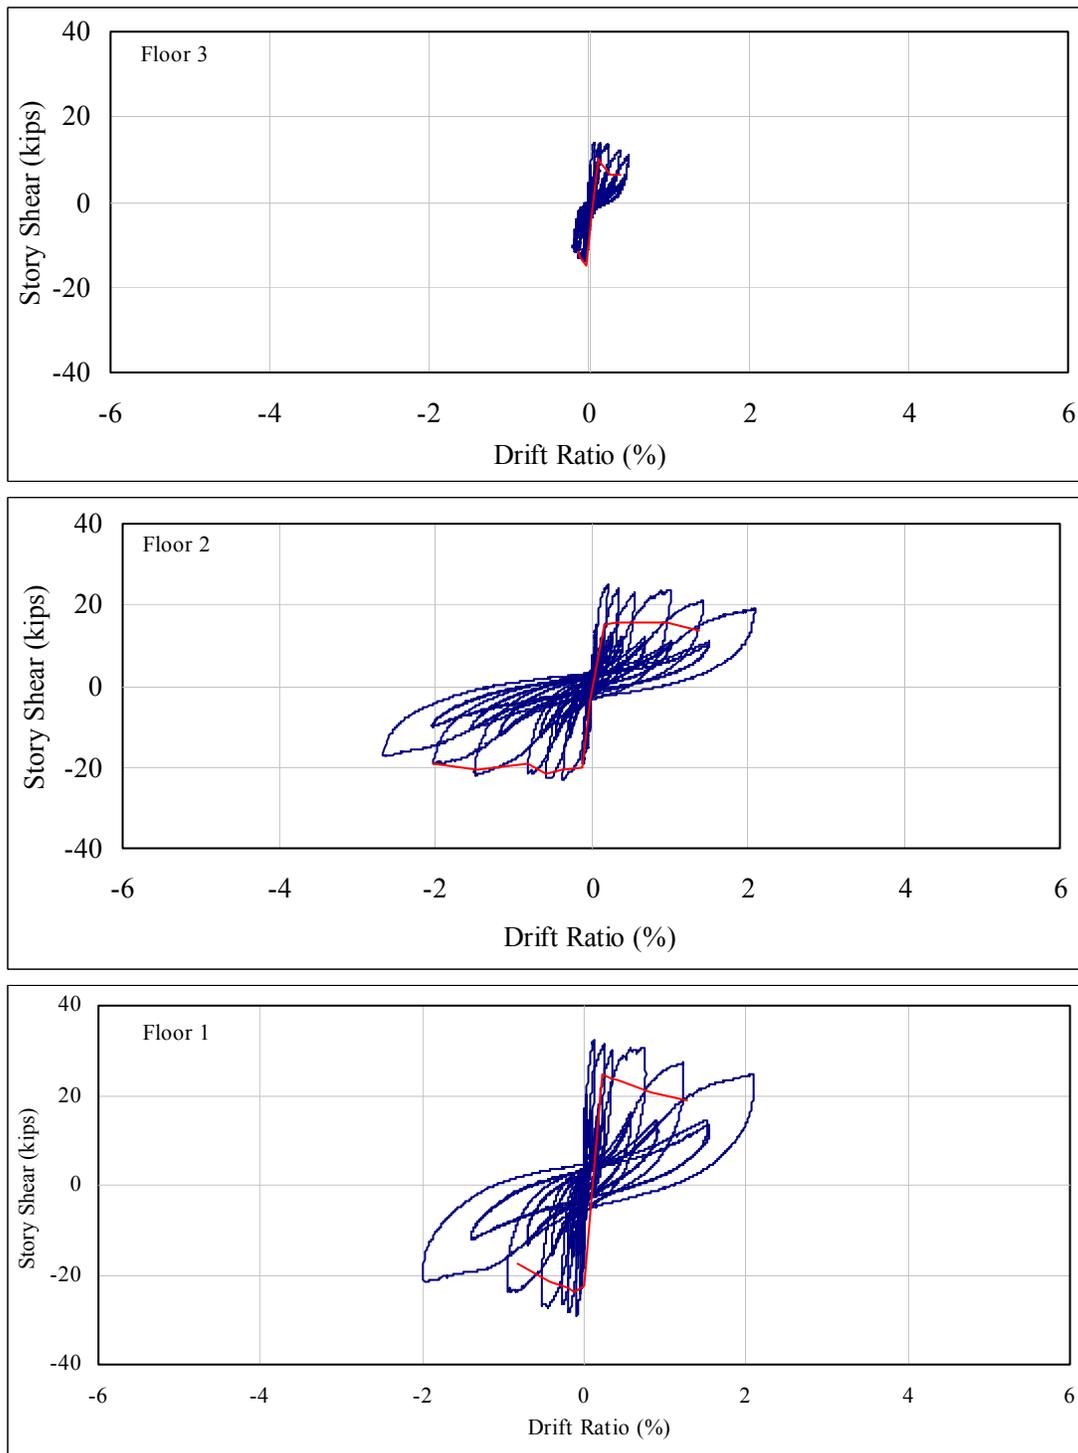
Figure 5.10. Hysteresis with backbone curves for each floor.

In Figure 5.10, backbone curves are plotted in red directly over the hysteresis curves for all three floors. The backbone curve is one way to view the stiffness degradation of a structural system. Backbone curves are typically drawn through the intersection of the first cycle curve for each deformation step with the second cycle curve of the previous deformation step for every step. However, following this procedure using the modified CUREE loading protocol resulted in an underestimation of load resistance. This observation was due to the small load values that occurred during the trailing cycles for each deformation step. Therefore, points on the backbone were plotted through the intersection of the first cycle (primary cycle) curve for each deformation step with the primary cycle curve of the previous deformation step for every step. Using this convention, a more reasonable and accurate portrayal of the structural system behavior was achieved.

The backbone curves for first and third floors are very similar in shape. After an initial linear portion, a peak value of load was achieved followed by a fairly smooth decline in load in which the residual strength was substantial although lower than the peak strength. Therefore, the R/C frame with URM infill acts as a ductile sys-

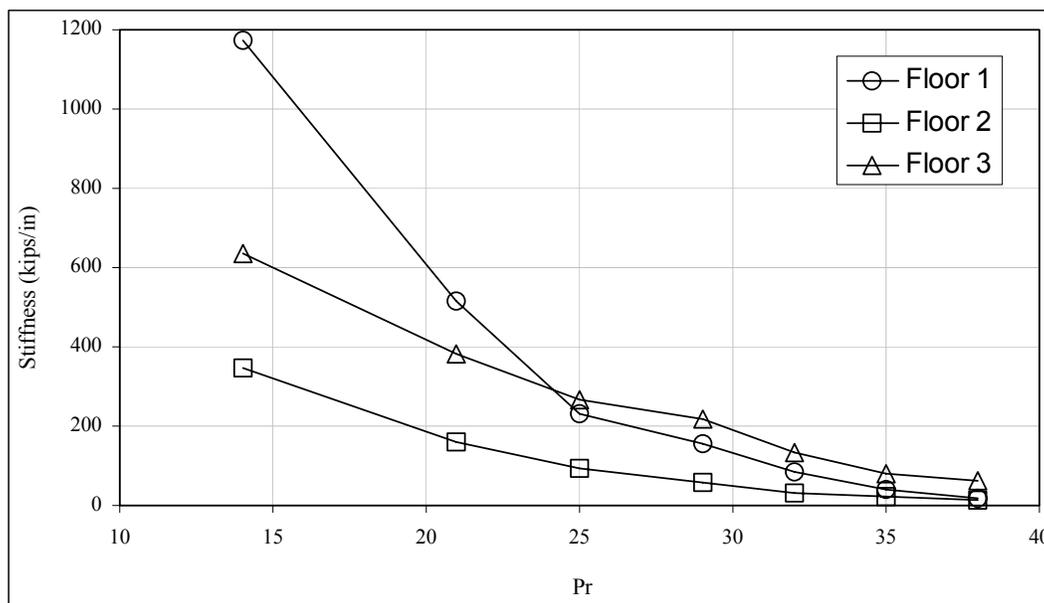
Figure 5.11. Stiffness degradation for each floor.

Besides examining the hysteresis curves, another method was used to examine the stiffness degradation. Stiffness for each primary cycle, starting with cycle 14, was calculated by measuring the slope of a straight line connecting the peak load during that cycle to the origin of a story shear versus interstory displacement plot. Using this method, values of 'stiffness' for each primary cycle, for both stroke directions, were computed and summarized in Table 5.5 as well as shown graphically in Figure 5.11. The average stiffness was computed as the average stiffness in the positive and negative directions.

This table illustrates the stiffness degradation that occurred over the duration of the test. All floors showed significant loss of stiffness by the completion of the test. The percentage of final stiffness remaining by cycle 38 for the first, second, and third floors were 1.4%, 4.5%, and 7.7%, respectively. This exemplifies the concentration of damage to the first and second floors, while the third floor remained mostly intact. One interesting note: the initial stiffness of the second floor is considerably lower than that of the first and third floors. No obvious explanation can be given in view of the fact that the material tests performed for the second floor showed no signs of weak materials.

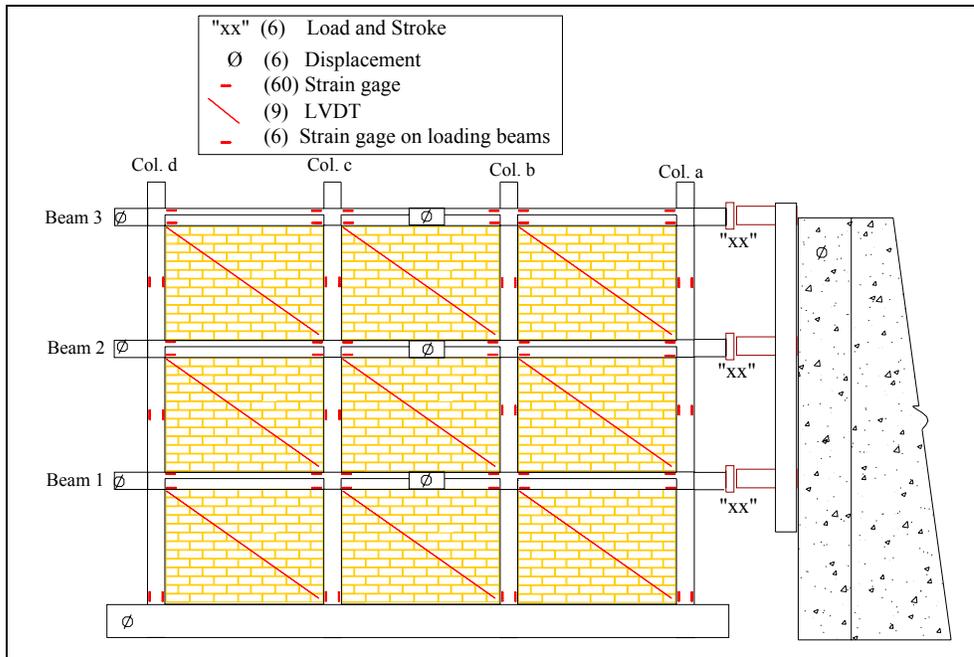
Figure 5.12. Location of strain gages and LVDTs.

Strain distribution in the masonry panels is examined in order to infer the distribution of lateral force. Location of panels with large diagonal deformations will be found from the data. Strain distributions in the masonry panels at peak load and cycle 29 are presented. Cycle 29 imposed panel displacements of 0.2 in., which was the maximum range of the LVDTs. Therefore, readings after Cycle 29 were inconclusive. Because only one LVDT was used for each panel, compressive displacements were obtained only in the positive stroke direction. Therefore, only masonry panel strain distributions in this direction are discussed here. The values of panel strain are normalized to the panel that had the largest displacement during that cycle. A value of 100% represents the panel that had the largest displacement, and a value of 50% signifies a diagonal panel displacement of half of the maximum value during that cycle. The masonry panel identification scheme used in the following discussion is shown in Figure 5.1, and the location of the strain gages and the LVDTs is illustrated in Figure 5.12.

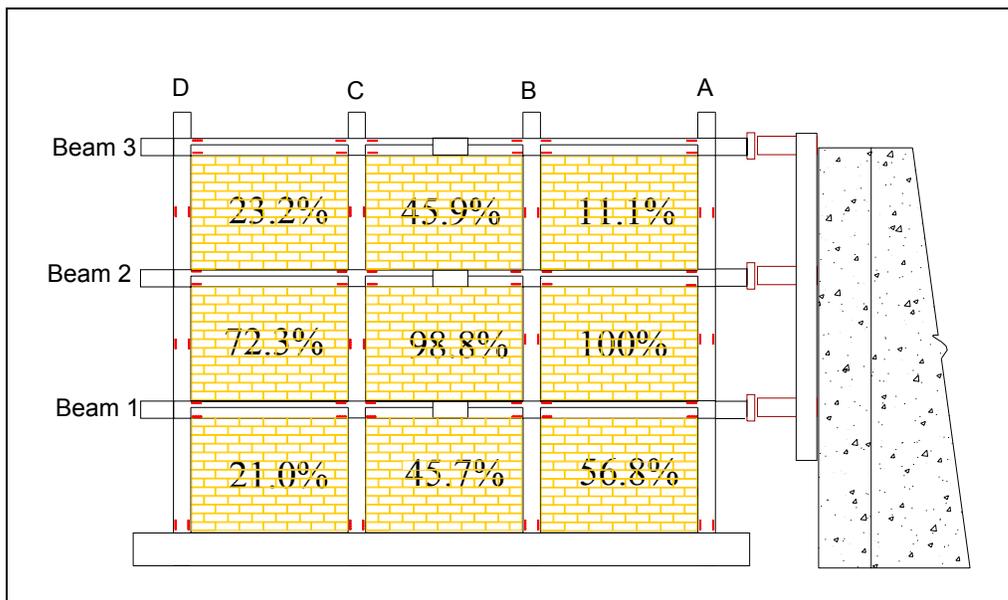
Figure 5.13. Panel strain distribution for Cycle 21.

From Figure 5.13, the panel strain distribution at peak load during the positive stroke cycle is shown normalized to panel 2A. The observation of the first cracks occurring in the second floor during this cycle, especially the center panel, was consistent with the large strains on this level. Another observation is that the strain in Bay A was larger in magnitude than the strain in Bay C in the first and second floors. This difference may be attributed to the overturning moment from the application of the loading sequence. The combination of vertical load, lateral force, and

overturning moment cause strains in the lower levels of Bay A to be appreciably larger than the corresponding strains in Bay C. The strain in Panel 2A was 38% larger than the value for Panel 2C. On the first floor, where the overturning moment was at a maximum, the strain in Panel 1A was roughly 170% larger than the value in Panel 1C. Conversely, in the third story, where the vertical and lateral load was at a minimum, the overturning moment was negligible, resulting in relatively similar strains in Panels 3A and 3C.

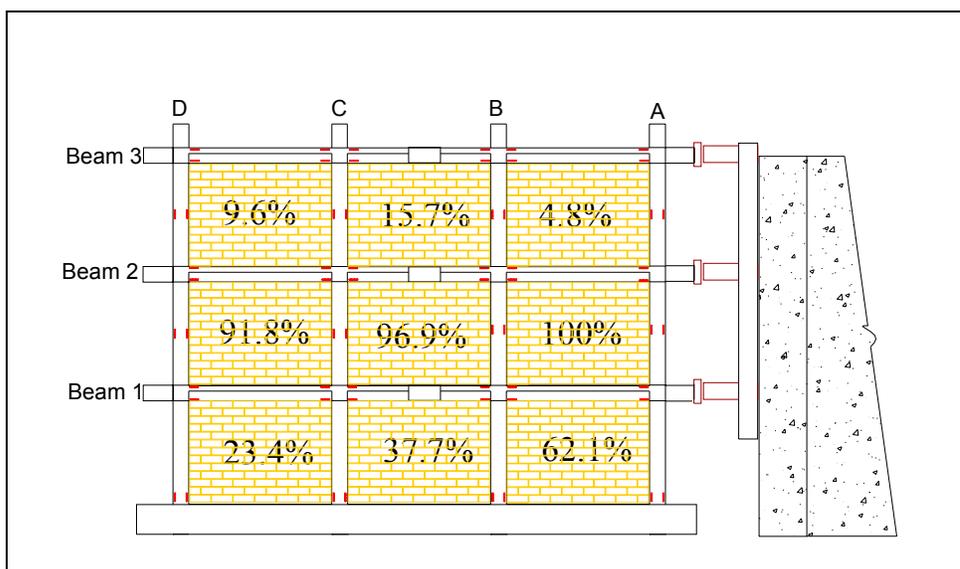
Figure 5.14. Panel strain distribution for Cycle 29.

Figure 5.14 gives the panel strain distribution for cycle 29. Diagonal panel displacements of 0.2 in., the maximum range of the LVDTs, were achieved during this cycle. The strain in each panel was normalized to panel 2A, which had the highest recorded displacement value.

The strain distribution during cycle 29 mimics the behavior seen during the peak load. The largest deformations once again occurred on the second floor. Furthermore, the lopsided distribution of panel strain due to overturning moment effects was also present. However, this effect was only appreciable in the first story during this cycle, where Panel 1A had almost three times the deformation of Panel 1C. At cycle 29 the third floor masonry panels still remain generally unaffected by the loading, exhibiting relatively small strains and no overturning moment effects.

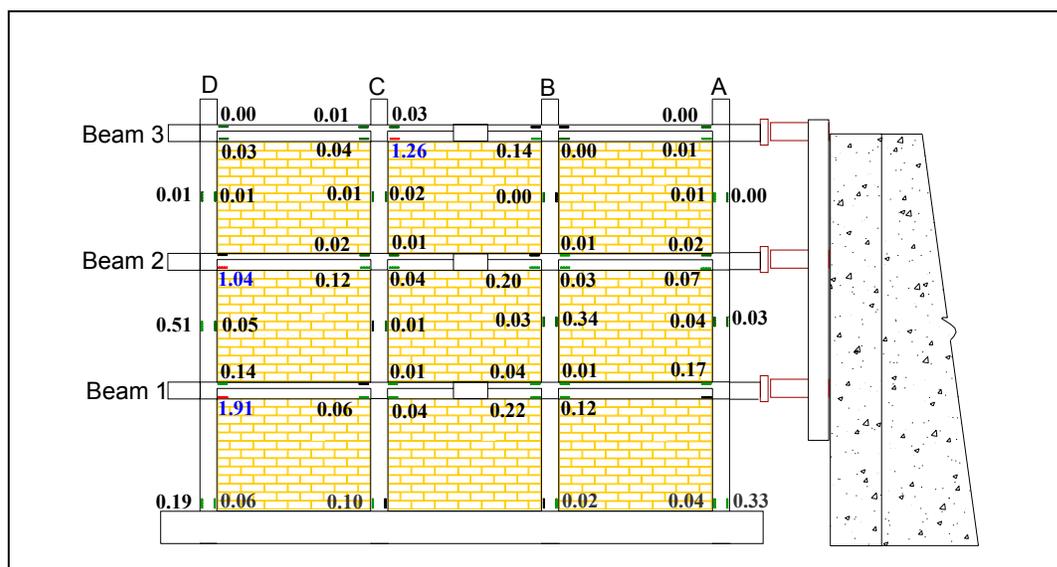
Figure 5.15. Reinforcement strain distribution at peak load, positive stroke.

ures is the location of the reinforcement steel that did yield. The bottom steel that yielded was in the beams located left of the load application point and on the right side of beam/column joints (Figure 5.15). These joints were under large positive moment due to the applied lateral force. Furthermore, the bars that yielded along column D in the first and second floors had higher positive moment due to overturning moment effects. This same type of behavior was observed for the negative stroke, as shown in Figure 5.16. However, since the stroke direction was reversed, the bars that yielded were on the right side of the load application point. Besides the bottom steel yielding, one of the top bars also yielded during the peak negative load. This bar was located on the right side of the beam/column joint on the second floor for column B. This region was under high stress from negative moment that caused the large strain. Most likely, this particular bar yielded due to local effects, i.e., its close proximity to the applied load and/or localized cracking, considering that no other top steel had yielded in either stroke direction.

The data were examined to locate the reinforcing bars that yielded. The strain distribution at peak load (cycle 21) and during the maximum displacement (cycle 38) are illustrated for the reinforcing bars. The strain values for the reinforcing steel were normalized to each bar's yield strength. Therefore, a value of 1.00 signifies a measured strain equal to the yield strain. Figure 5.15 and Figure 5.16 illustrate the strain distributions in the reinforcing steel at peak load for the positive and negative stroke, respectively. The values represent actual strain over yield strain. Therefore, a value greater than unity signifies that yielding has occurred. During the cycle in which the peak load was applied, few reinforcing bars yielded in either stroke direction. However, the more important information given by these two fig-

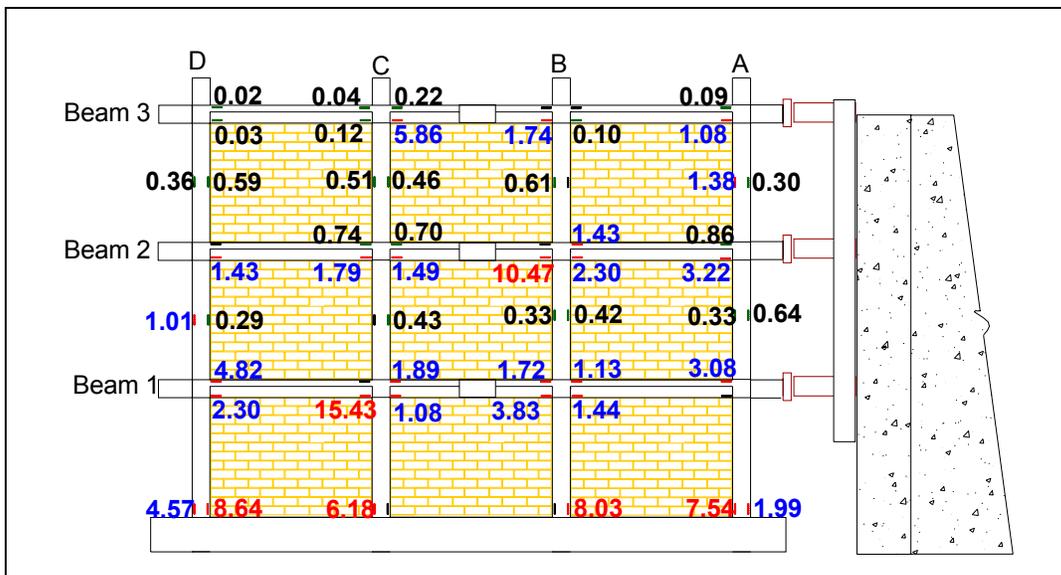
Figure 5.17. Maximum reinforcement strain distribution.

In Figure 5.17, the maximum strain that occurred in the reinforcing bars during loading is shown. By the completion of the test, nearly all of the reinforcement in the first and second floors had yielded. The first and second floors experienced the most story shear and were expected to have yielded by the end of the tests. The third floor, having less applied lateral and vertical force, did not experience as much strain in the beams and columns and, consequently, most of the reinforcement at this level did not yield. Surprisingly, the bottom reinforcement, which was discontinuous in the joints as was typical construction practice in the 1950s, achieved yielding. This reinforcement was expected to be susceptible to pullout and, therefore, not to reach its yield strength.

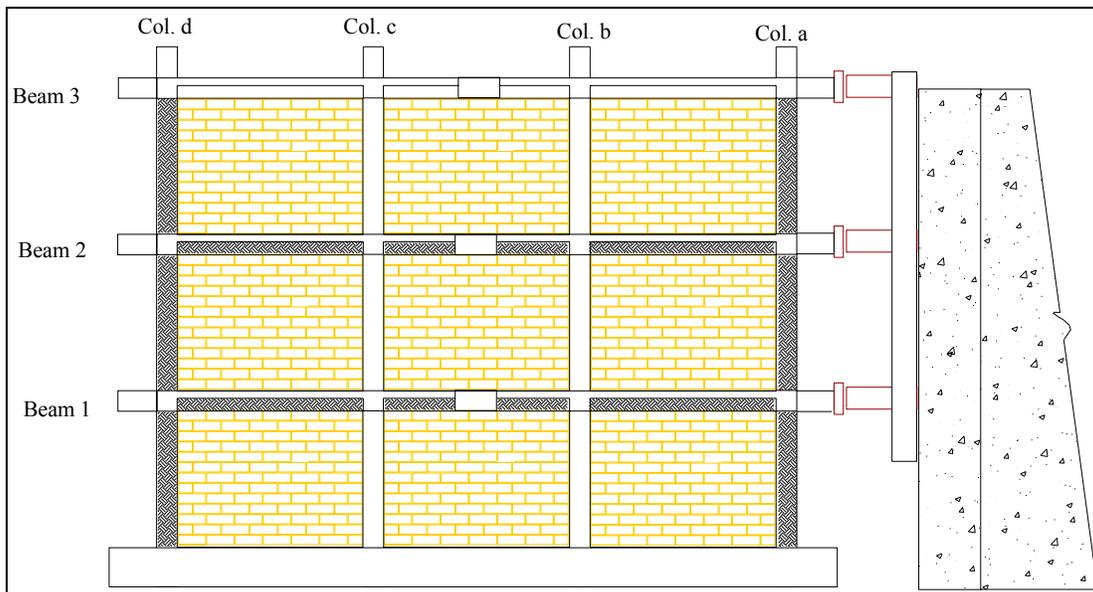
Figure 6.1. CFRP rehabilitation placement on Model 2.

CFRP was applied to the R/C frame as illustrated in Figure 6.1. At the first and second floors, the exterior columns were completely wrapped; at the third floor, the fabric was wrapped around the exterior columns in a U-shape because the infill on that level was not removed to accommodate complete wrapping. The stems of the first floor and second floor T-beams were wrapped as shown in Figure 6.2. As noted previously, the third story did not sustain significant damage to warrant infill removal or reinforcement of the horizontal beam.

As noted above, the outside columns were completely wrapped at the first two stories and U-wrapped around three sides at the third story.

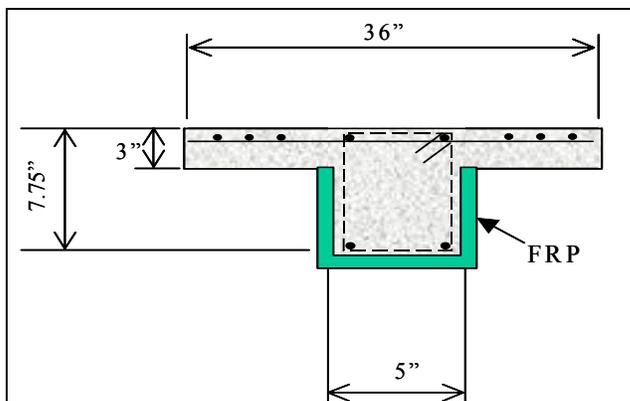
Figure 6.2. Dimensions and CFRP placement of T-beam section.

The goal of the CFRP rehabilitation was to regain the original ultimate moment capacities of the beams in the undamaged frame (on the order of 20 – 26 kip-in. depending on f'_c). Therefore, the moment capacities were calculated using Equation 6.1 for the damaged T-beams with stems wrapped using one ply of 0.037 in. thick CFRP (see Figure 6.2). The CFRP properties are shown in Table 6.1.

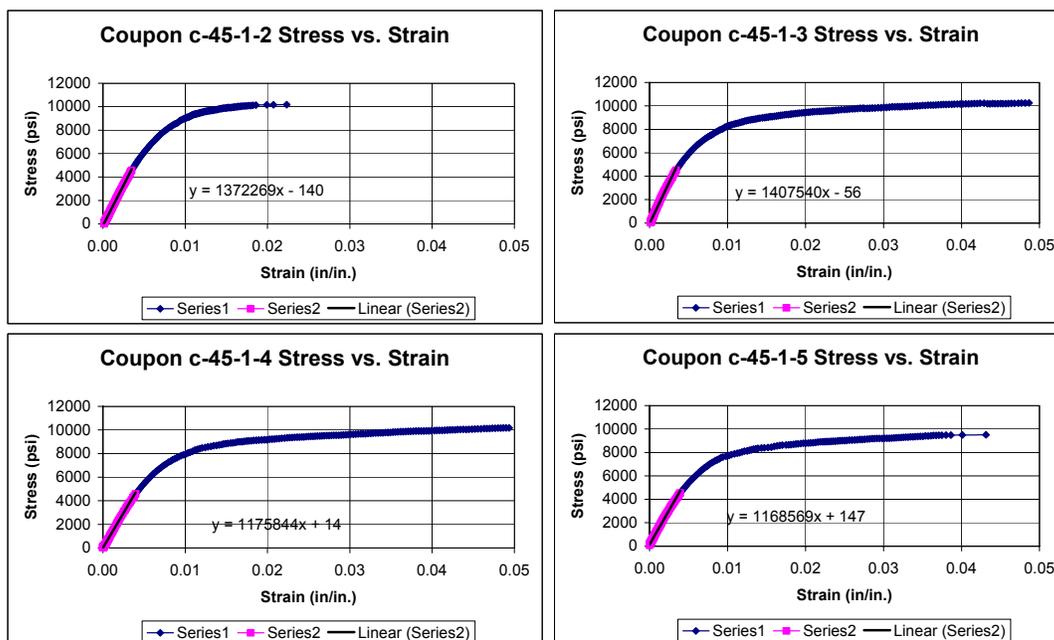
Figure 6.3. Stress vs strain relationships for CFRP coupons.

These properties were determined experimentally. Stress-versus-strain relationships were observed for four CFRP coupons, with the average values of ultimate stress and modulus of elasticity taken to represent all CFRP used for rehabilitation of the model. The stress-versus-strain relationships are plotted in Figure 6.3 for each of the four CFRP coupons tested.

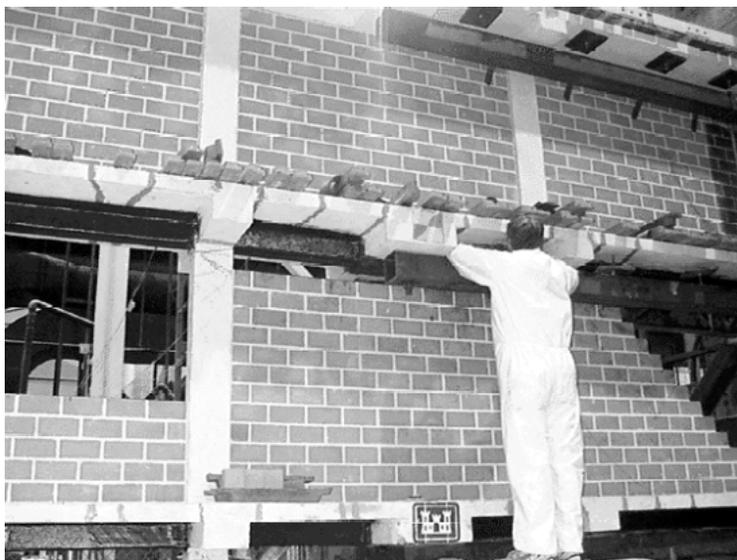
Figure 6.4. Photograph of stories two and three of the rehabilitated frame.

Figure 6.4 shows a photograph of a portion of the rehabilitated frame. The CFRP appears black and spans the lower portion of the beams, and the gray bands on the beams are the J-51 epoxy sealant. The J-56 injection epoxy is clear and not visible in the photograph.

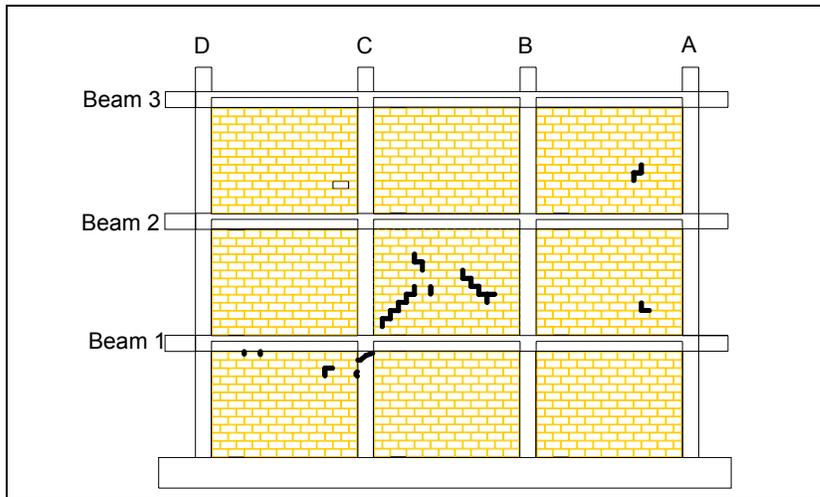
Figure 6.5. First cracks, cycles 21 through 24.

The first cracks appeared during the positive stroke of cycle 21, at a base shear of 16.63 kips. Cracks occurred on all three levels, but most of them were diagonal cracks forming in panel 2B, as shown in Figure 6.5. A number of the diagonal cracks were a combination of stair-stepping cracks through the mortar and cracked CMUs orientated at approximately 45 degrees. Throughout the rest of the test, the second floor continued to crack the most, with the highest crack propagation in the bottom six panels.

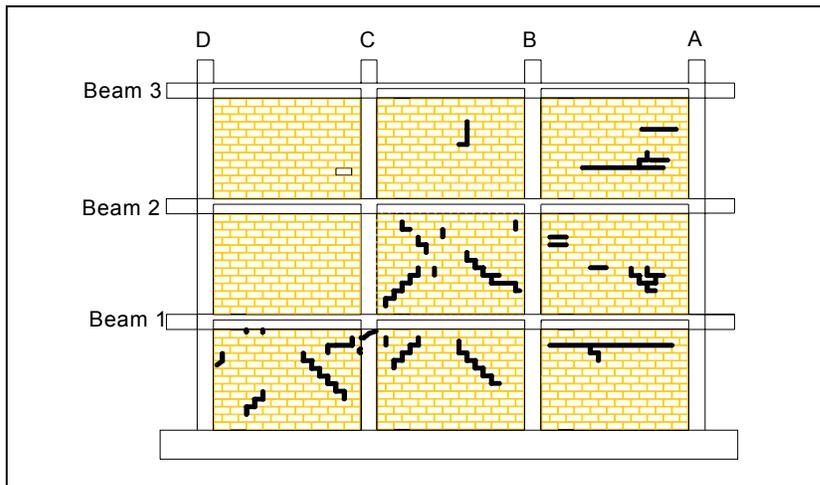
Figure 6.6. Cracks appearing during cycles 25 through 28.

As the test progressed from cycle 25 through 28, cracking occurred in all panels except 3C and 2C. Most cracks in the lower panels were stair-stepped, either continuations of old cracks or new formations. They were typically found in the corners of the panels moving toward the center, visually indicating strut action, as shown in Figure 6.6. During these cycles, the first appearance of bed joint cracking was seen in all three levels, mostly limited to bay A.

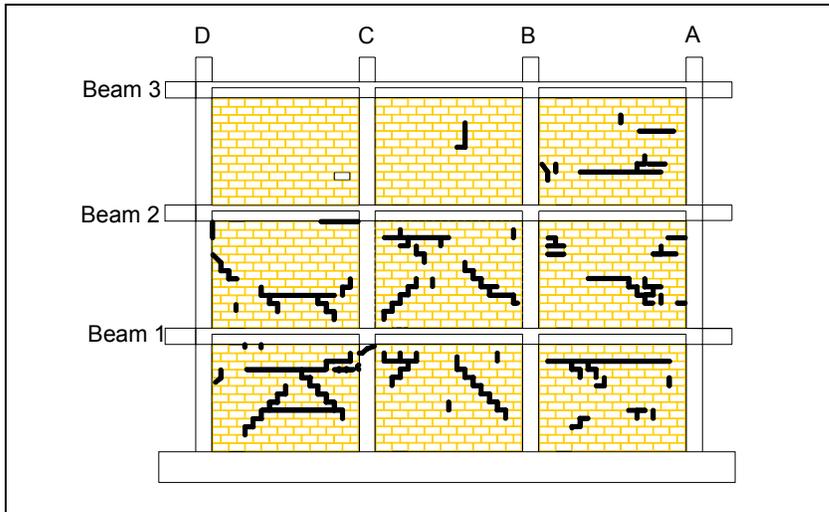
Figure 6.7. Cracks appearing during cycles 29 through 31.

During the positive stroke of cycle 29, LVDT readings in Panel 2B reached 0.185 in., a maximum value for this cycle. Although first floor LVDT readings were lower than those of the second floor, peaking at 0.15 in. in Panel 1B, cracking damage was similar. Both floors exhibited further propagation of both stair-stepped cracks and bed-joint cracks. The third floor sustained very little damage during this cycle. The second floor had the highest drift ratio at 0.42%, while third floor had the next-highest at 0.34%. Note how, as shown in Figure 6.7, most of the damage through cycle 31 was located on the outside perimeters of the damaged panels. At this point, crushing of the toe of the masonry panels had not been observed, and the center region of each panel was acting as a ‘survival zone.’

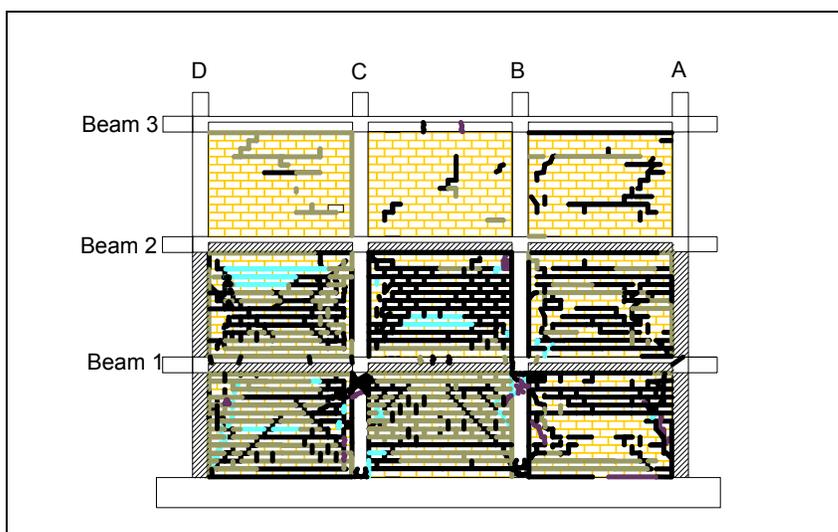
Figure 6.13. Cracks found after test of first story.

During the final three cycles, for the same reasons described in the previous paragraph, the second floor actuator was disengaged. This resulted in a lateral load being applied to the first floor only. Figure 6.13 illustrates the damage induced by these final cycles. A first floor load of 26.10 kips led to a maximum displacement exceeding 2.6 in., which corresponded to a drift ratio of almost 4.4%. Noticeable separation between the masonry and the overlaying beam occurred in the first floor. In addition, further damage to both the top and bottom of columns 1B and 1C was

observed, resulting in failure of both interior columns. By the conclusion of the test, the model had sustained extensive damage, nearly depleting its residual strength and stiffness.

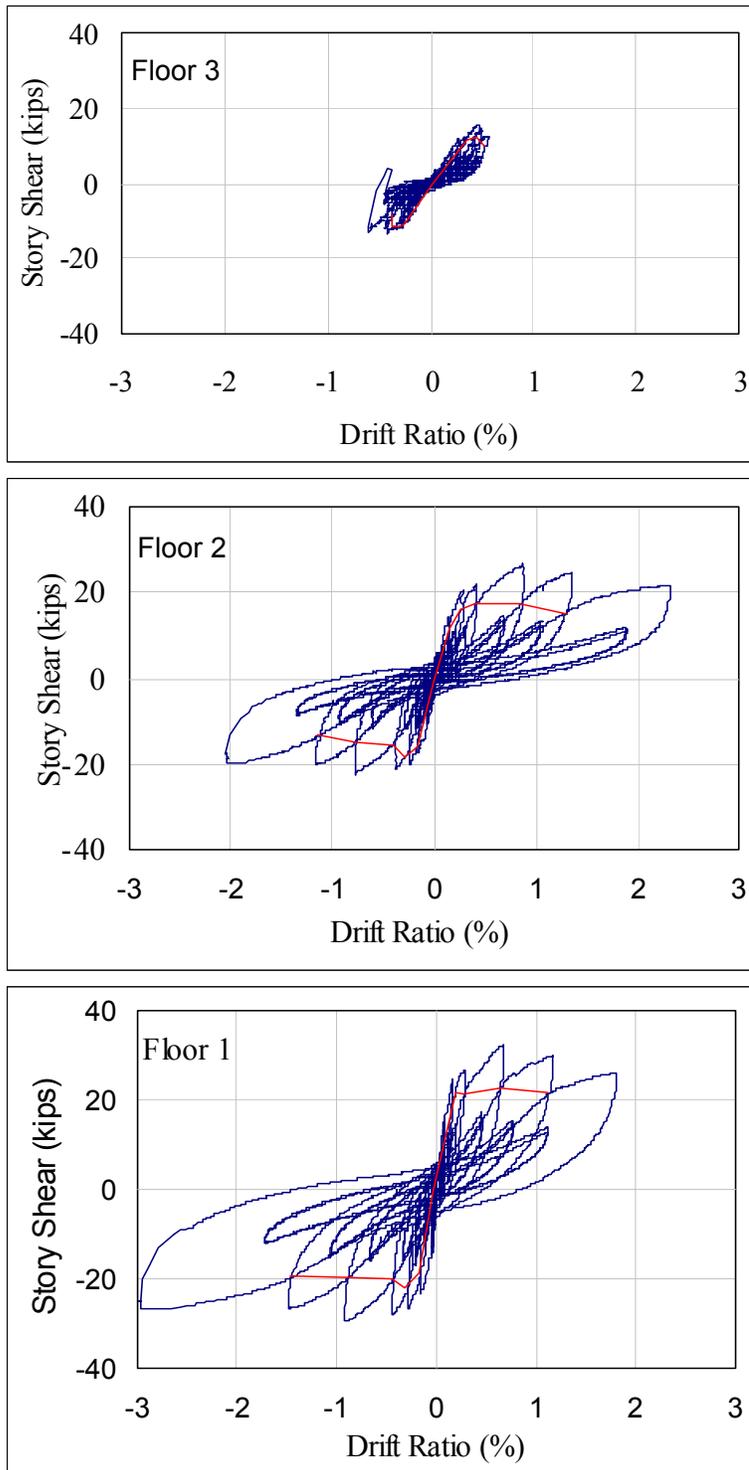
Figure 6.14. Load/displacement behavior for each floor of the rehabilitated model.

Also noticeable from Figure 6.14 is the relatively large first floor drift that occurred during the final negative primary cycle. This magnified first story translation could be attributed to a sharp decline in lateral stiffness resulting from severe shear cracking near the top of column 1C during the preceding positive stroke. Figure 6.15 shows the joint shortly after completion of Test 2 but before the third floor actuator was disengaged to extend load testing of the first and second floors.

The first and second floors of Model 2 regained some, but not all, of their initial stiffness in Model 1. Recall that these two floors were carefully rehabilitated with injected epoxy and CFRP reinforcements. The third floor, however, regained almost none of its initial stiffness, which was to be expected considering limited rehabilitative measures employed on that floor (i.e., three sides of the exterior columns were wrapped with CFRP). The most important factor affecting the initial stiffness of the third floor was the damaged CMUs that had been left in place. The CMUs contribute much to the frame's in-plane stiffness. As the number of cycles increased and approached the final primary cycle, the stiffness of all three floors nearly matched the stiffness inherent in the original model during those same cycles.

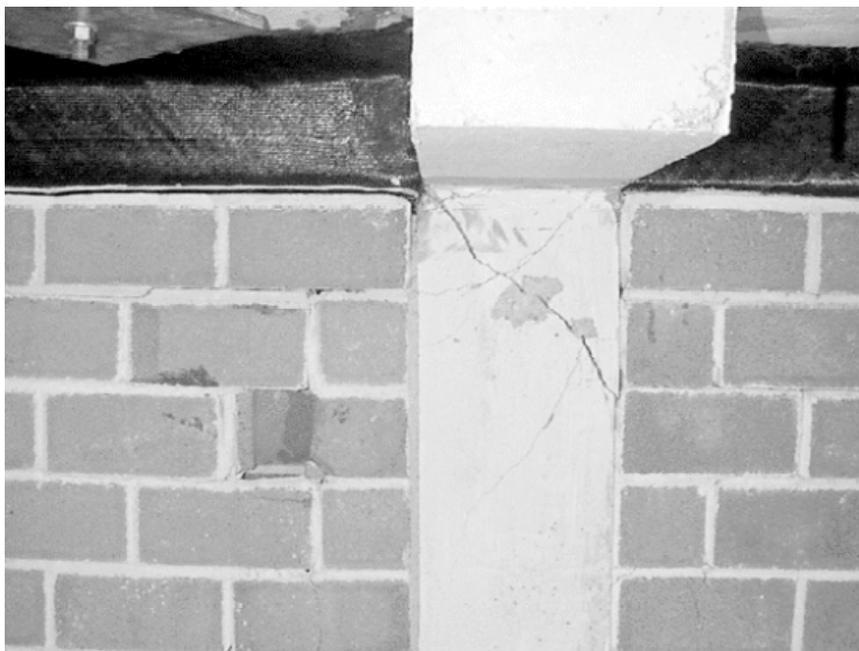
Figure 6.15. Joint 1c after main portion of Test 2.

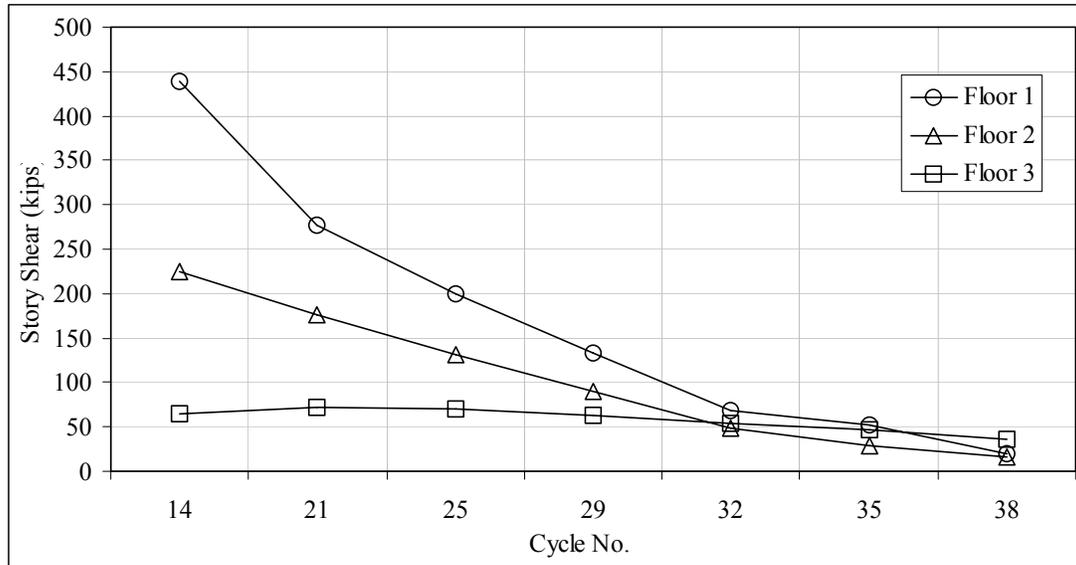
The stiffness of this structure is displayed in Table 6.6 and Figure 6.16. The stiffness for each primary cycle was calculated measuring the slope of a line connecting the peak load at that cycle to the origin of the story shear versus interstory displacement plot. Stiffness values for both stroke directions were found using this method and summarized on Table 6.6, and shown graphically on Figure 6.16. The average stiffness was computed by taking the average of the positive and negative directions stiffnesses.

Figure 6.16. Stiffness degradation for each floor.

Table 6.6 shows the stiffness degradation of the structure through the length of the test. All floors had significant loss of stiffness by the end of the test. The final percentage of original stiffness of each floor, at cycle 38, was 3.1%, 6.3%, and 42.9% for the first, second, and third floors, respectively. These values show that most of the damage occurred on the first and second floor, with much less damage on the third

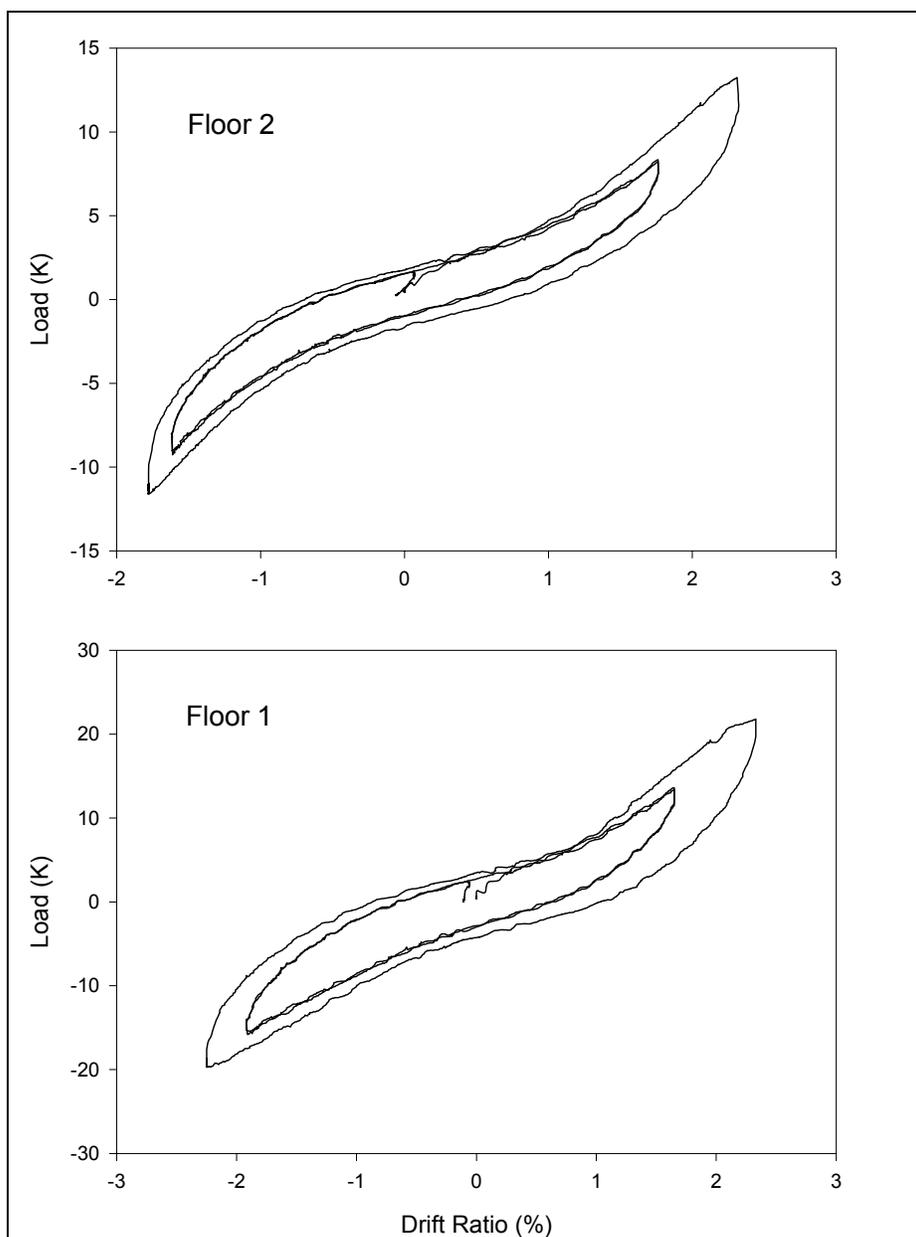
As explained previously, additional lateral load testing of Model 2 was conducted after completion of the 40-cycle modified CUREE loading protocol. The third floor actuator was disengaged in order to test the lower two levels at higher drifts, unconstrained by the displacement limits imposed on them by the third floor actuator. Keeping the ratio of force between the first and second levels constant at the same value as before, Model 2 was subjected to three additional cycles. The first cycle subjected the second floor to an absolute displacement of 3 in. The following two cycles were trailing cycles of smaller magnitude, in accordance with the modified CUREE loading protocol described previously. Figure 6.17 illustrates the hysteretic behavior of the first and second floors under these large demands. At this point, the rehabilitated model had lost much of its stiffness. The model can only resist considerable load at large drifts. When the lateral drift exceeded 2%, the rehabilitated model retained much of its residual strength by resisting a base shear of approximately 20 kips. The hysteresis curves of the second floor are especially pinched during these cycles signifying low energy dissipation.

Figure 6.17. Hysteretic behavior of the first and second floors at large drifts.

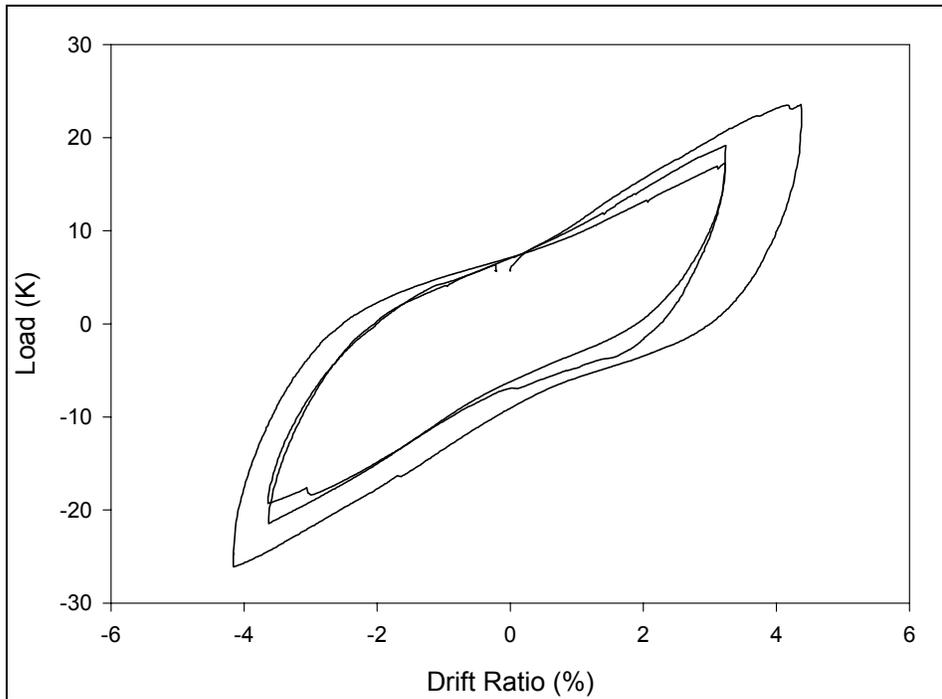
A similar procedure was followed in order to maximize demand on the first floor. The load/deformation behavior of the lower level during these three cycles is shown in Figure 6.18. During these cycles, a maximum drift ratio of approximately 4% was achieved along with a corresponding base shear of about 25 kips. Note that the hysteresis loops were fairly open for these three cycles, indicating considerable inelastic behavior. Significant damage to both the frame and the infill occurred during this time. After completing these three cycles, permanent inelastic deformation was evident in the first floor. Photographs showing the final damage to panels 1C and 1B (the most damaged regions in the model) are located in Figure 6.19 and Figure 6.20, respectively.

Figure 6.18. Hysteretic behavior of the first floor at large drifts.

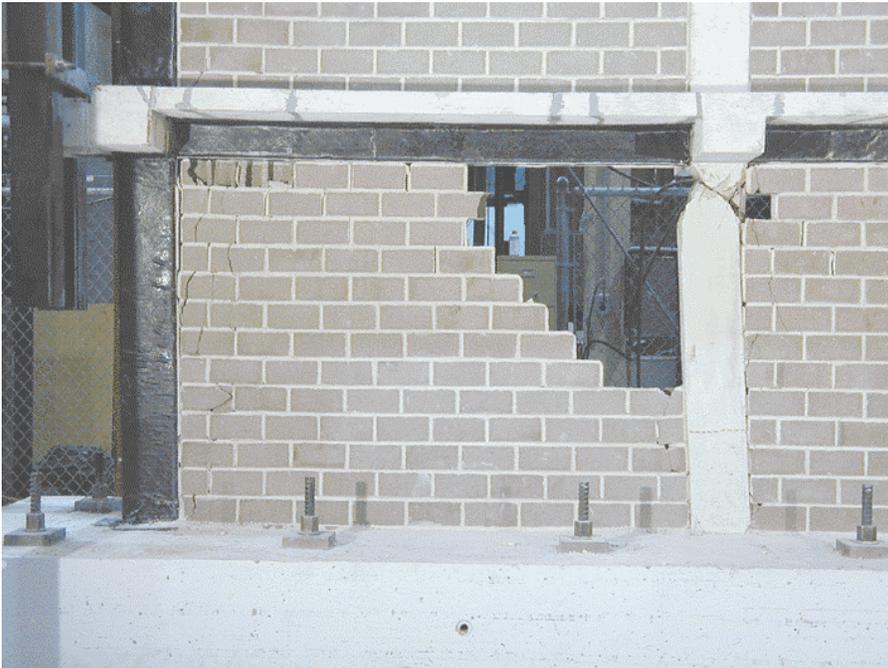
Figure 6.19. Panel 1C after completion of Test 2.

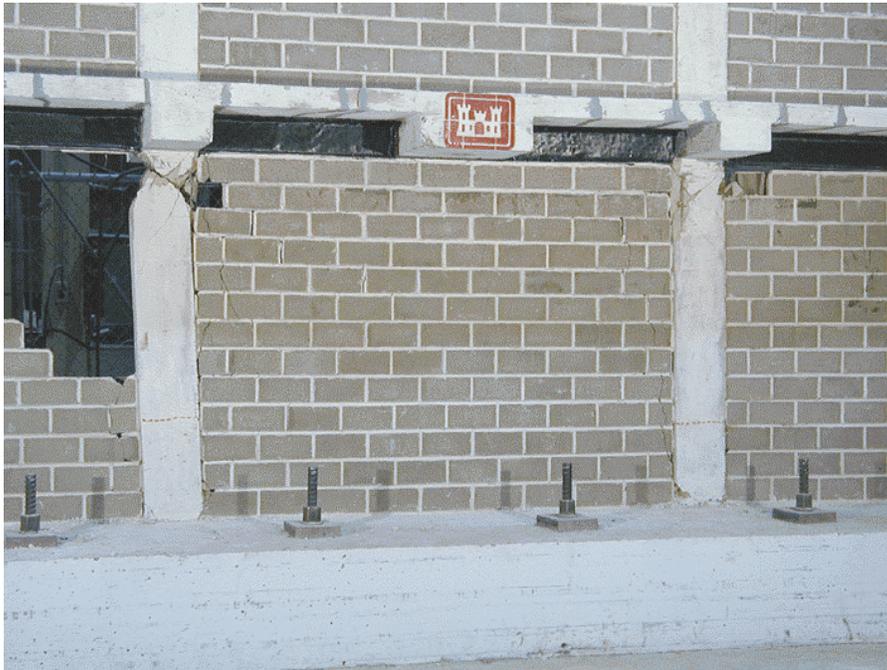
Figure 6.20. Panel 1B after completion of Test 2.

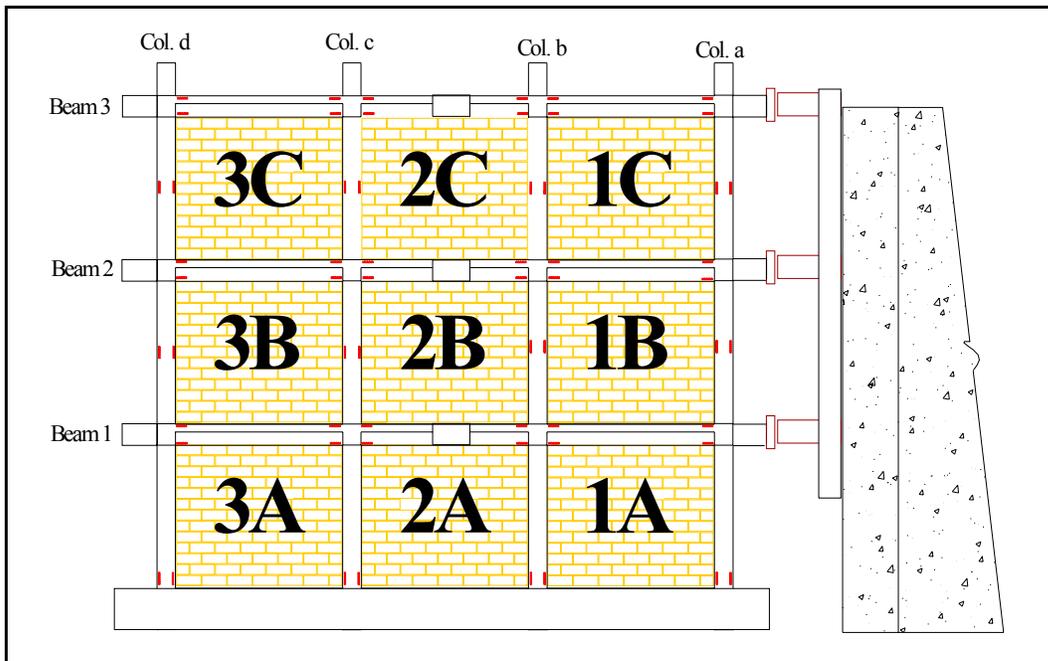
Figure 6.21. Masonry panel identification.

The strain distribution in the masonry panels of Model 2 were studied for purposes of inferring the lateral force distribution. The masonry panel identification scheme used in the following discussion is shown in Figure 6.21 and the location of the strain gages and the LVDTs is illustrated in Figure 6.22. Figure 6.23 illustrates the panel strain distribution at peak load (cycle 32) under the modified CUREE loading protocol, during the positive stroke cycle normalized to Panel 2B. The large strains on the first and second floors correspond to a significant increase in crack formation and propagation during this cycle.

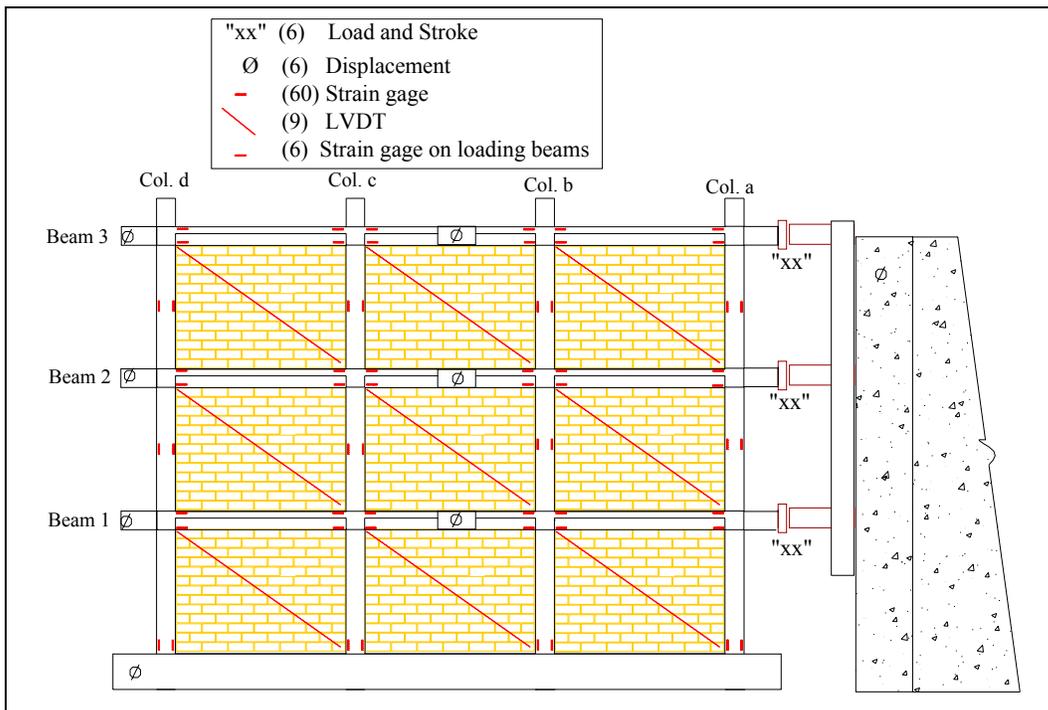
Figure 6.22. Location of strain gages and LVDTs.

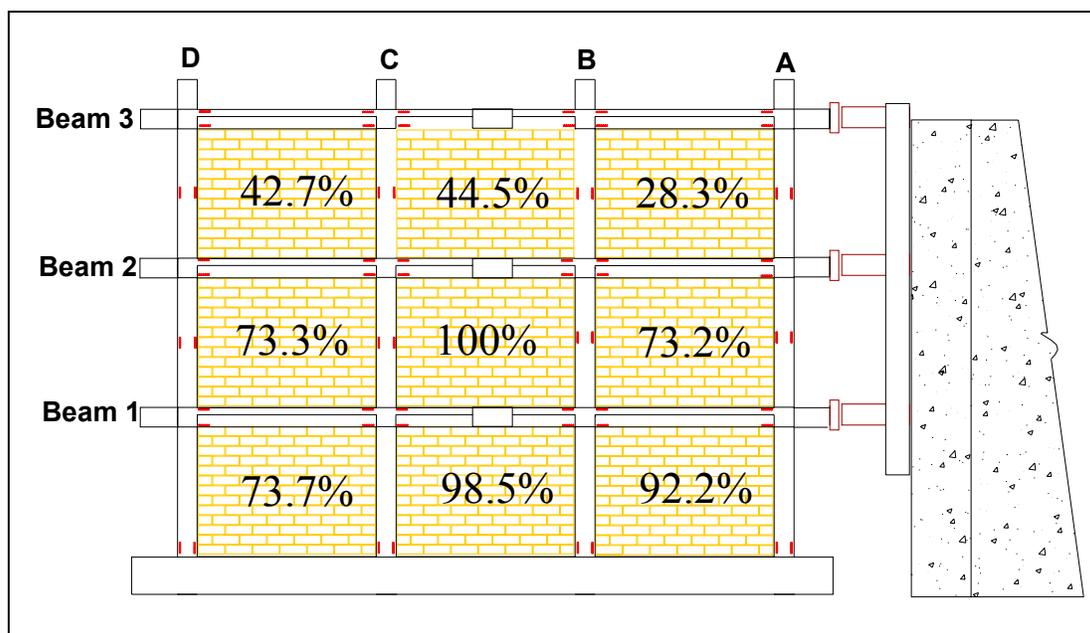
Figure 6.23. Panel strain distribution for cycle 32.

Diagonal panel displacement of 0.4 in., the maximum range of the LVDTs, was achieved during cycle 32. Therefore, the peak load panel strain distribution also reached its highest recorded value for diagonal panel displacement. Due to the large flexibility of Model 2, this maximum recorded value of displacement was achieved only three cycles later than that for the undamaged model even though the LVDTs used for Test 2 had twice the range of those used for Test 1.

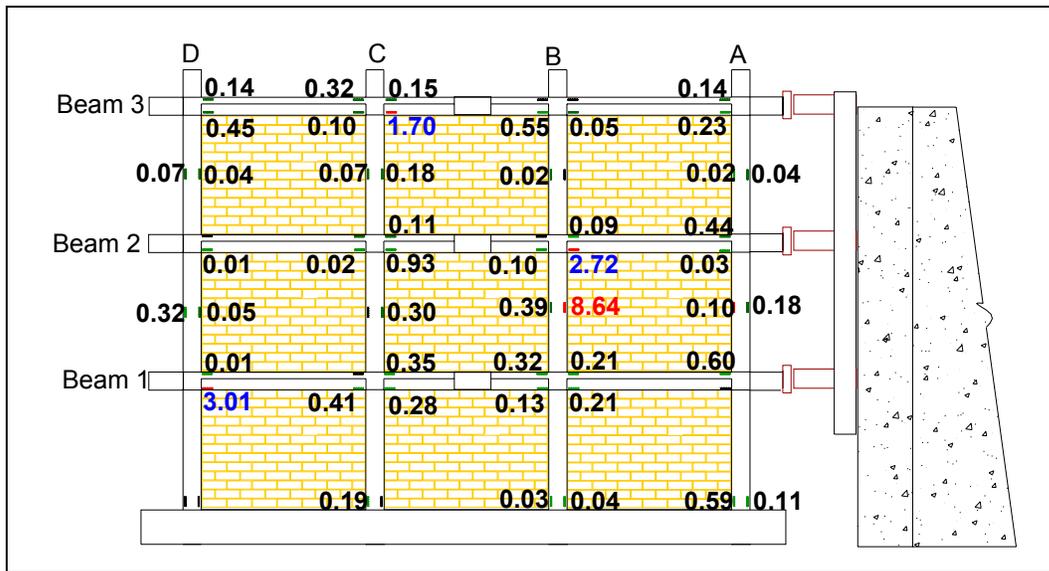
The reinforcing steel strain distributions at peak load are illustrated in Figure 6.24 and Figure 6.25 for the positive and negative strokes, respectively. The values again represent actual strain over yield strain. Therefore, a value greater than unity (illustrated in red and blue) signifies that yielding has occurred. Again, a limited number of bars in either stroke direction have yielded at this point. For the positive stroke, illustrated in Figure 6.24, the reinforcement that had yielded was located to the right of the beam/column joints. This yielding pattern signifies large positive moments arising from the applied lateral force.

Figure 6.24. Reinforcement strain distribution at peak load, positive stroke.
