ERDC/CERL TR-03-10

Investigation of Fiber-Reinforced Polymer for Seismic Rehabilitation of Concrete Structural Frames With Unreinforced Masonry Infill

Ghassan K. Al-Chaar, Justin B. Berman,
and Steven C. Sweeney

May 2003

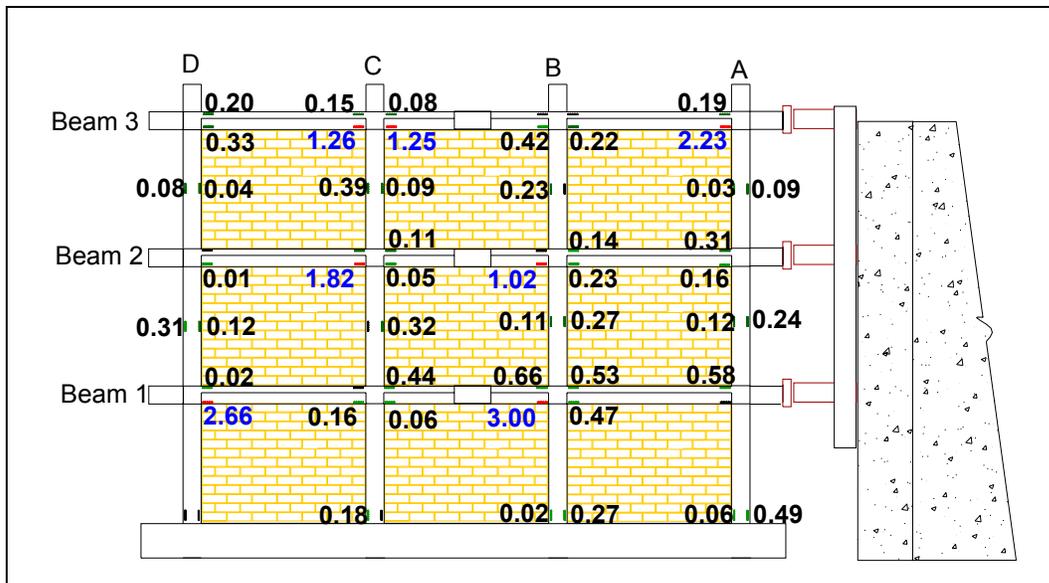
Figure 6.25. Reinforcement strain distribution at peak load, negative stroke.

Similar behavior was observed for the negative stroke case illustrated in Figure 6.25. However, since the stroke direction was reversed, the bars that yielded were on the left side of the beam/column joints. In addition, bottom steel to the right of the beam/column joints also yielded on the first floor of column D and the third floor of column C. These two steel reinforcing bars most likely experienced permanent deformations greater than the yield strain due to the large inelastic strains that occurred during the preceding positive stroke cycle.

The reinforcing steel strain distributions at peak load are illustrated in Figure 6.24 and Figure 6.25 for the positive and negative strokes, respectively. The values again represent actual strain over yield strain. Therefore, a value greater than unity (illustrated in red and blue) signifies that yielding has occurred. Again, a limited number of bars in either stroke direction have yielded at this point. For the positive stroke, illustrated in Figure 6.24, the reinforcement that had yielded was located to the right of the beam/column joints. This yielding pattern signifies large positive moments arising from the applied lateral force.

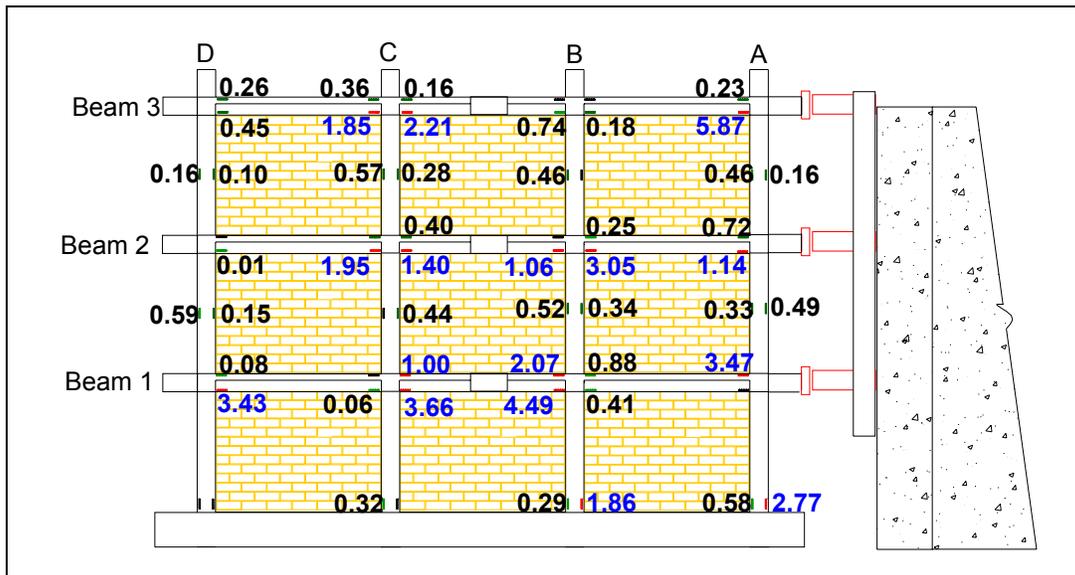
Figure 6.26 illustrates the maximum strain that occurred in the reinforcing bars throughout the duration of the entire modified CUREE loading protocol for all three

floors. By completion of the test, nearly 42% of the reinforcement steel in the first and second floors had yielded, considerably less than in Test 1. This result was expected because steel reinforcement damage that occurred during Test 1 could not be repaired when rehabilitating the damaged model for use in Test 2. The permanent deformations of the reinforcing bars resulting from yielding during the previous test allowed for similar frame deflections to be reached at lower strains. In general, the location of yielding was consistent with expectations for both loading directions, even after completion of the cycles.

Figure 6.26. Maximum reinforcement strain distribution.

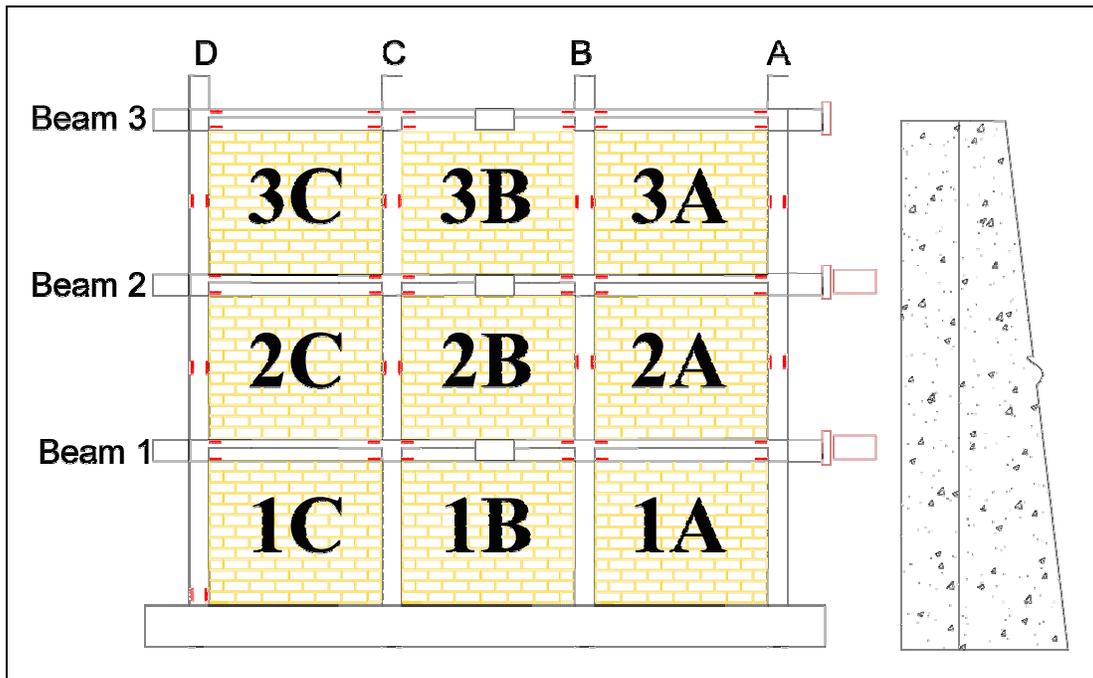
Model 3 used the same beam, column, and bay identification scheme employed for Model 1 (Figure 7.1). In basic form this model was similar to Model 1. However, the infill panels were designed with openings to represent windows, doors, and other apertures typically found in this type of construction (illustrated in Figure 7.2 and others). Also unlike Model 1, the CMUs were grouted in place. Other differences were the use of concrete with higher compressive strength and larger longitudinal positive reinforcement and spacer reinforcement — #2 instead of D2 (see Figure 3.7). As in the previous two tests, Model 3 was loaded using the modified CUREE method described previously (see Figure 3.24).

Figure 7.1. Model 3 beam, column, and bay identification scheme (panel openings not shown).

The strain distribution in the masonry panels allows assessment of the distribution of lateral forces. Location of panels with large diagonal deformations was determined from the data. Compressive displacements were obtained only in the positive stroke direction since only one LVDT was used for each panel. Therefore, only masonry panel strain distributions in this direction are discussed. The values of panel strain are normalized to the panel that had the largest displacement during that cycle. A value of 100% represents the panel that had the largest displacement, and a value of 50% signifies a diagonal panel displacement of half the maximum during that cycle. The masonry panel identification scheme used in the following discussion was shown previously in Figure 7.1, and the locations of the strain gages and the LVDTs are illustrated in Figure 7.11.

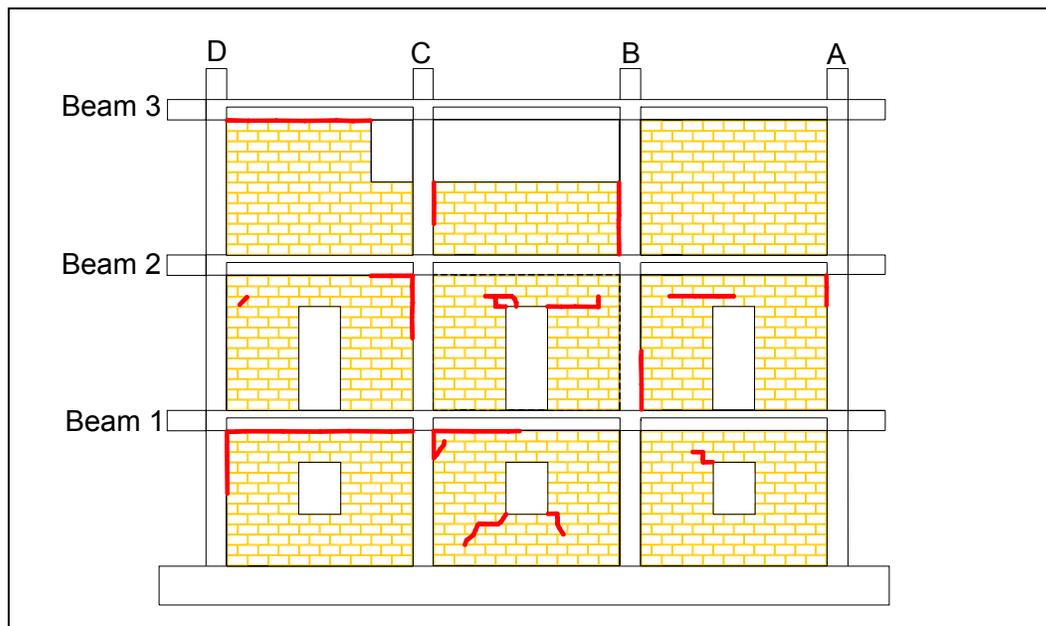
The first cracks appeared during cycle 25 with a maximum load of 23.0 kips on the third floor. Figure 7.2 shows that cracks appeared in all but panel 3A. Most of the cracks occurred in the mortar. Cycle 25 is also when the masonry started to separate from the columns and beams in panels 1B, 1C, 2A, 2C, 3B, and 3C. Throughout the remainder of the test, the first floor cracked the most, with a majority of these cracks initiating out of the corners of the window openings.

Figure 7.2. First cracks, cycles 25 through 28.

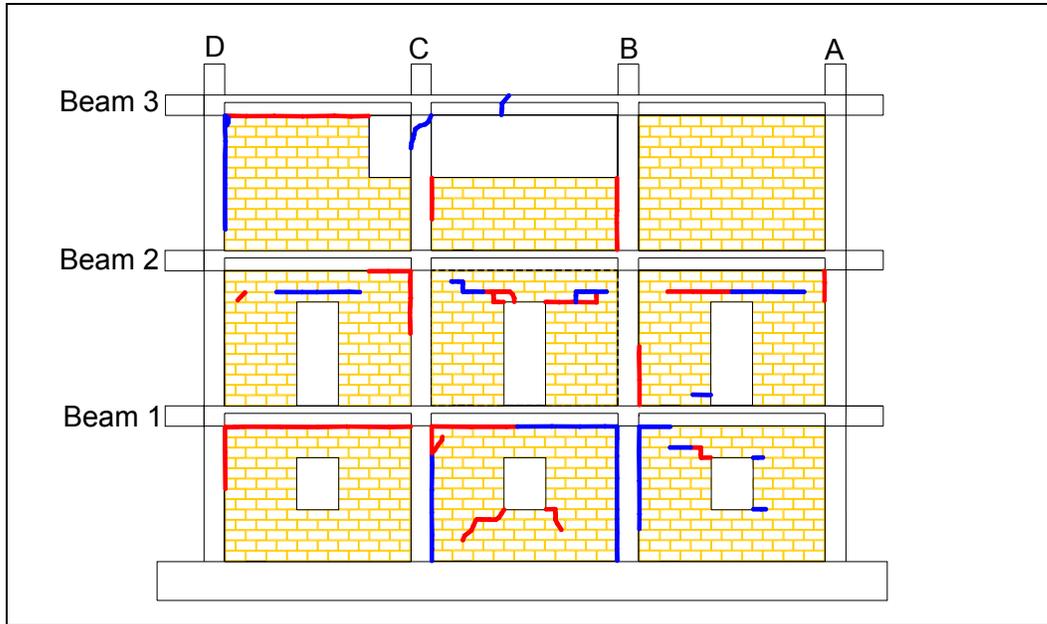
As the testing continued through cycle 29, the damage propagated in a similar manner: more masonry separated from the concrete frame and more cracks formed and grew in the mortar. The cracks were typically found near the corners of the openings, where the stress concentrations were large. Figure 7.3 shows the first cracks forming in the concrete frame, and these appear to be shear cracks. These

cracks appeared in concrete contiguous to bays 3B and 3C at points where there was no masonry to help support the concrete.

Figure 7.3. Cracks appearing during cycles 29 through 31.

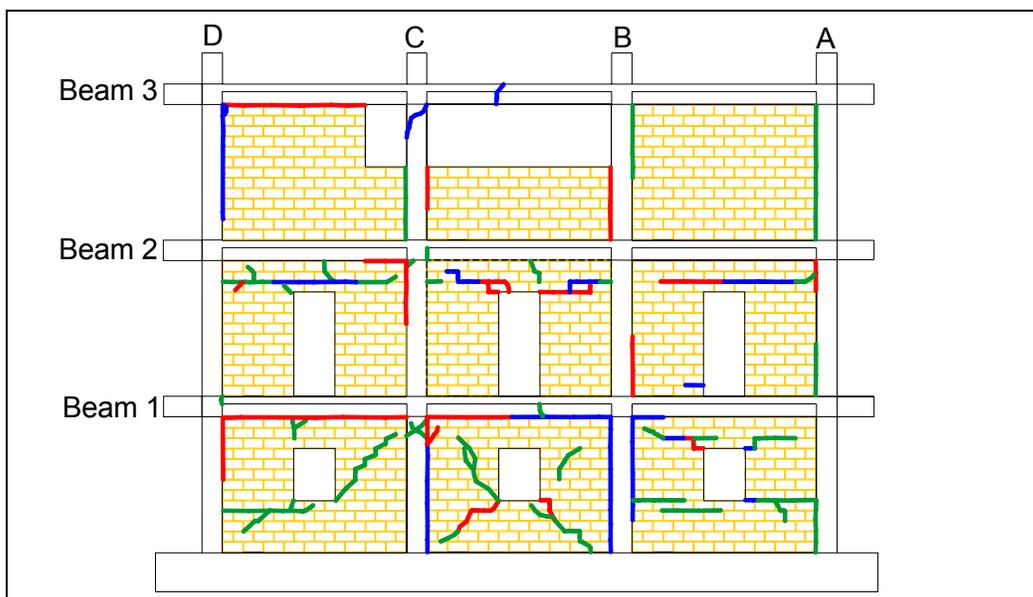
New cracks formed in the panels through cycle 32. At this point many of the new cracks, and extensions of the existing ones, started to propagate through the bricks instead of following the mortar joints. The first floor had the greatest number of new cracks (Figure 7.4) due to the rapid increase in the strain in the panels. While the first and second floors had of cracks forming in the panels, the third floor had slight separation of the panels from the concrete frames. The third floor did not have enough strain to initiate any cracks in the masonry panels, but the drift ratio of the third floor was about 0.05% — enough to cause the panels to separate from the concrete frame.

Figure 7.4. Cracks appearing during cycles 32 through 34.

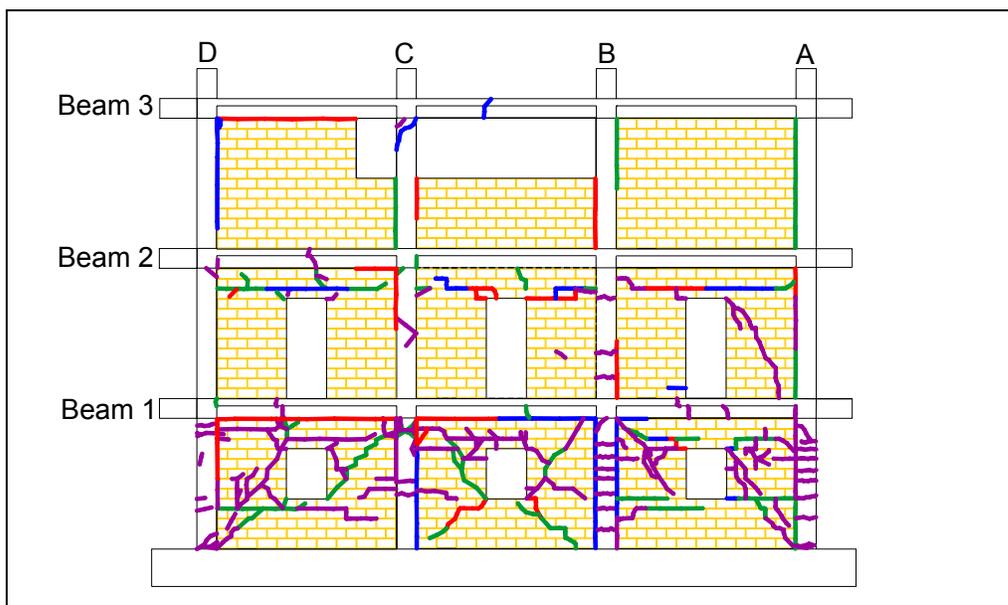
Figure 7.5 shows the cracks up through cycles 35-37. Here the first floor sustained heavy cracking. Multiple new cracks were formed, starting at the corners of the openings and traveling through the mortar and the bricks. The columns of the first floor sustained heavy cracking as well. This is due to the high levels of shear stress and strain that the first floor exhibited, which formed the horizontal cracks in the columns and mortar. The strain levels were higher than what the LVDTs could record on the first floor, while the second floor strain was around 0.4%. Also, the new LVDTs (LI1bc and LI1bb) recorded their maximum values during this group of cycles, indicating significant strain on the first floor walls near the windows.

Figure 7.5. Cracks appearing during cycles 35 through 37.

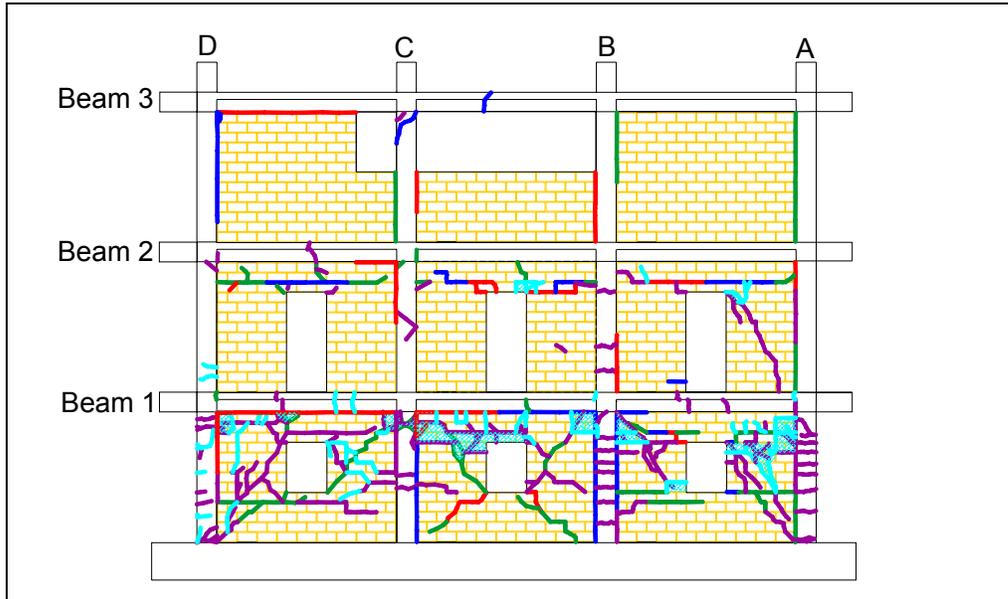
The first floor panels continued to crack during cycles 38 – 40, as shown in Figure 7.6. While the strain on the first floor was still greater than what the LVDTs could record, it was not as severe as before and there was less cracking. The second floor also had new cracking because of the high levels of stress (around 0.39%). Several of the new cracks caused sections of the panel to fall out, and the masonry was loose to the touch in many of the panels. The load capacity continued to drop with the increased deflections. At peak displacement of 2.76 in., the load carried by the top floor was only 19.3 kips — much less than the maximum carried load of 32.2 kips. Although the frame was still in its original shape, the damage done to the structure as a composite was severe: the masonry had lost most of its cohesiveness and the mortar was cracked. Only the third floor panels remained intact, although they had partially detached from the concrete frame in many places.

Figure 7.6. Cracks appearing during cycles 38 through 40.

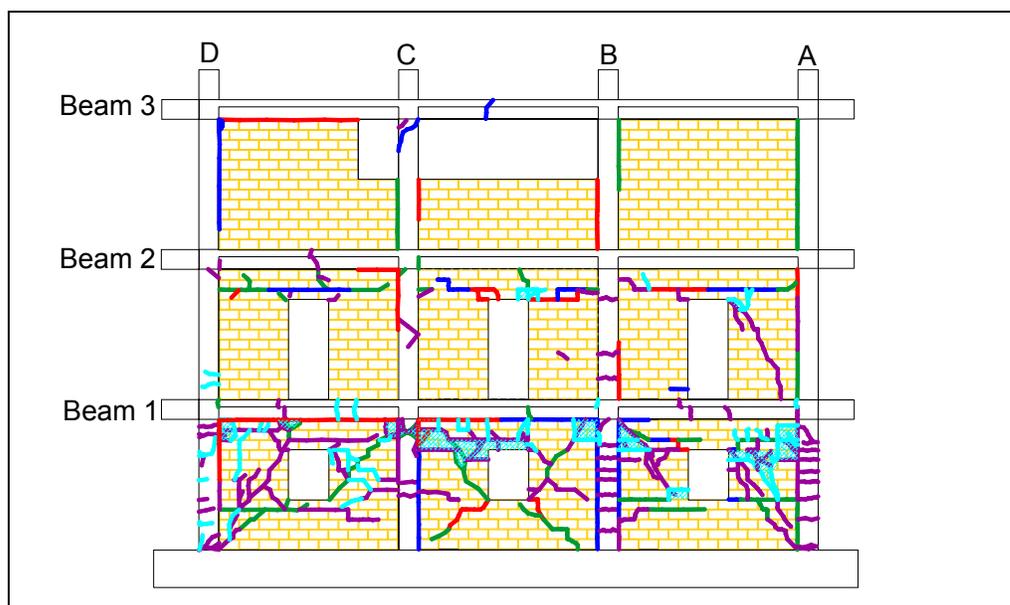
Figure 7.7. Cracks found at the completion of the test.

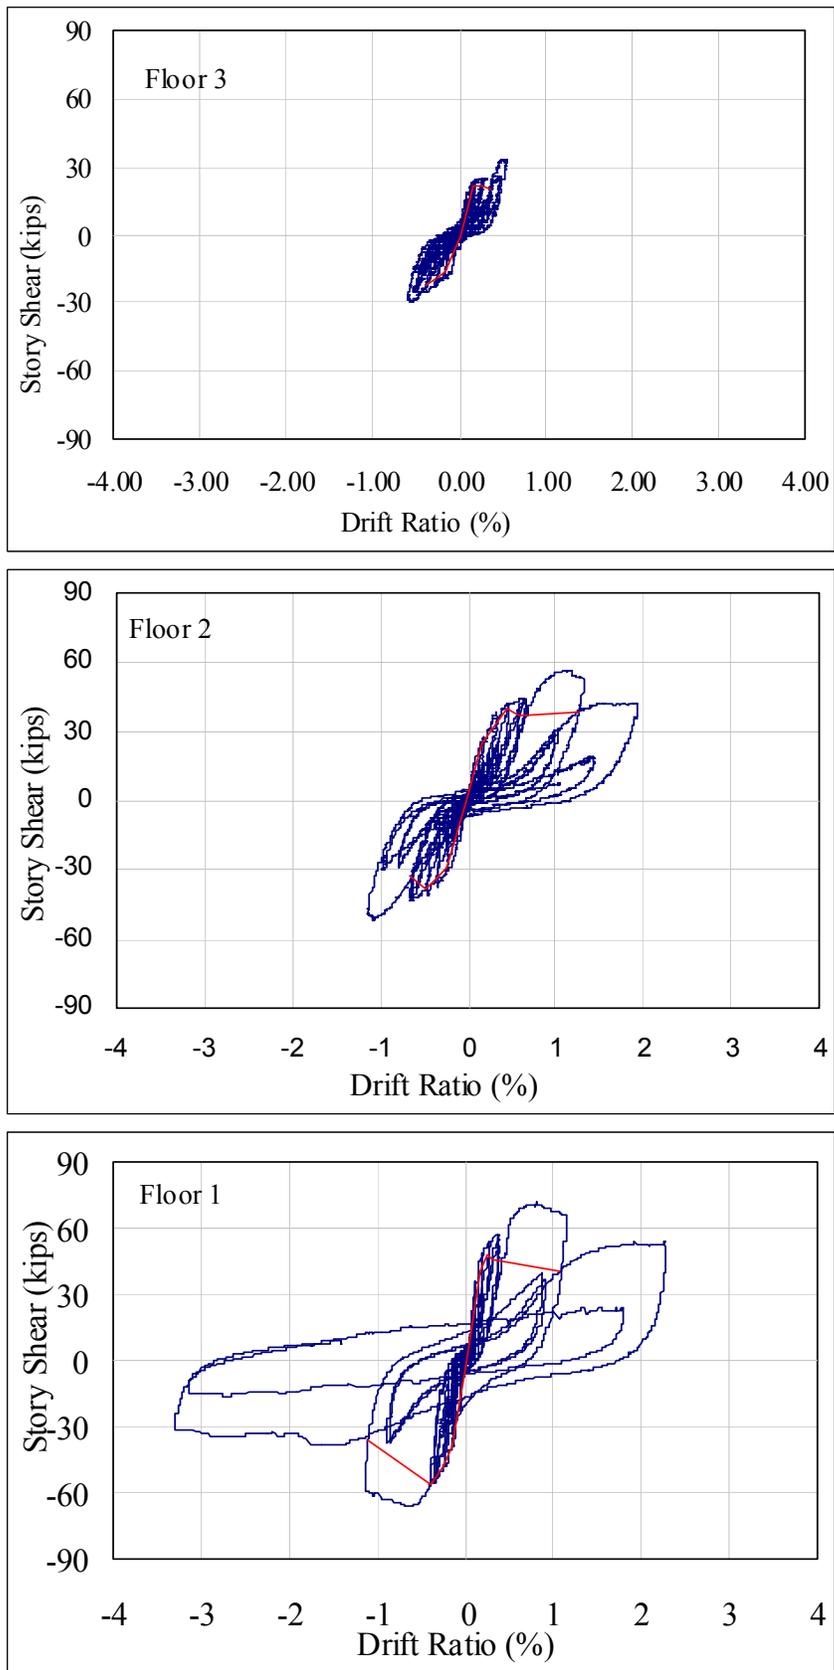
The test specimen load/displacement behavior with the modified CUREE loading protocol is plotted in Figure 7.8. The load plotted on the ordinate is the story shear for each level. The drift ratio, plotted on the abscissa, is defined as the interstory displacement divided by the story height. The hysteresis for each floor is discussed to help explain the behavior of the test specimen.

The peak lateral load for the model occurred during the 35th cycle with a first floor peak story shear of 71.6 kips in the positive stroke. The second and third floors had story shears of 56.5 kips and 33.6 kips in the positive stroke, respectively. The negative stroke story shears of the first, second, and third floors were 66.08 kips, 51.49 kips, and 30.07 kips, respectively. The drift ratios for the associated peak loads in the positive stroke direction were 0.8%, 1.2%, and 0.53% for the first, second and third floor, respectively. For the negative directions, the drift ratio of the first, second, and third floors were 0.6%, 1.1%, and 0.55%, respectively. The third floor absolute displacements were 1.67 in the positive stroke and -1.61 in the negative stroke. The peak loads and corresponding story shears and drift ratios are summarized in Table 7.1

Figure 7.8. Load/displacement behavior for each floor for Model 3.

Figure 7.8 shows that the drift ratio for the third floor after reaching peak load was less than for the first and second floors. The main cause for this behavior was the inverse triangular distribution of lateral forces prescribed by IBC 2000. The story shear of the first and second floor was roughly double that of the third floor (Table 7.2). These relatively high values of drift for the first and second floor were what caused these panels to crack first. After they had cracked, the difference in the drift ratios between the third floor and the first and second floor was amplified.

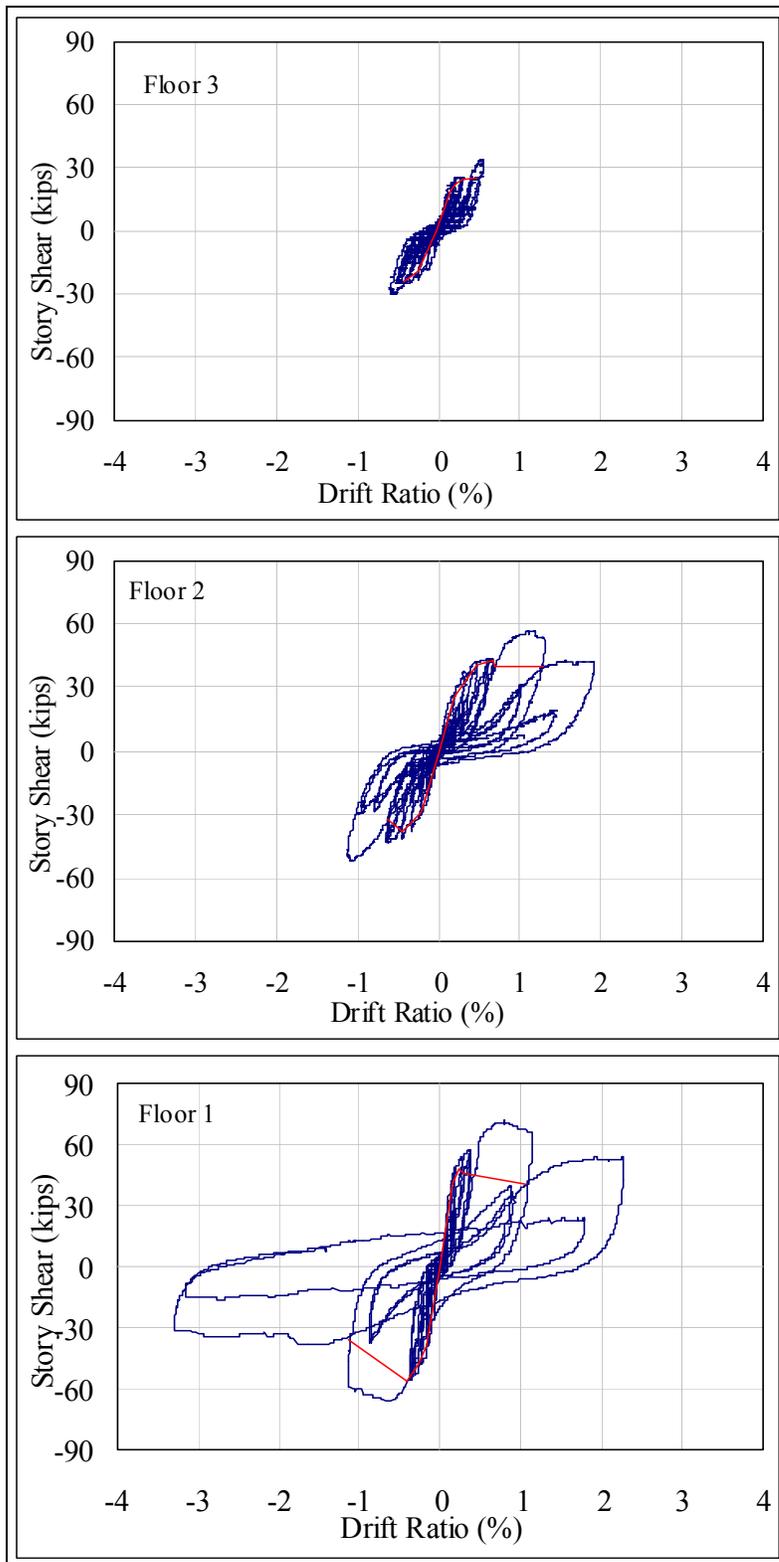
In Figure 7.9, backbone curves are plotted directly on the hysteresis curves for each floor. As in Test 1 (see page 68), when used with the modified CUREE protocol, the standard technique for plotting backbone curves resulted in an underestimation of load resistance due to the small load values that occurred during the trailing cycles for each deformation step. Therefore, as for Test 1, points on the backbone were plotted through the intersection of the first cycle (primary cycle) curve for each deformation step with the primary cycle curve of the previous deformation step continued for every step. Using this convention, a more accurate portrayal of the structural system behavior resulted.

The backbone curves for the first and second floors are similar in shape. After an initial linear portion, a peak value load is achieved, followed by a decline in load where the residual strength is less than the peak load but still substantial. Therefore, Model 3 acts as a ductile system that is capable of absorbing significant amounts of energy, which is significant because of the lack of ductile reinforcement detailing in the R/C frame. This behavior is represented as a Type 1 general component behavior curve per FEMA 273, with the first floor being deformation-controlled and the second floor being force-controlled.

Figure 7.9. Hysteresis with backbone curves for each floor of Model 3.

The shape of the third floor backbone curve is different than those of the other two floors. After an initial peak load the backbone curve drops off. There is some strain

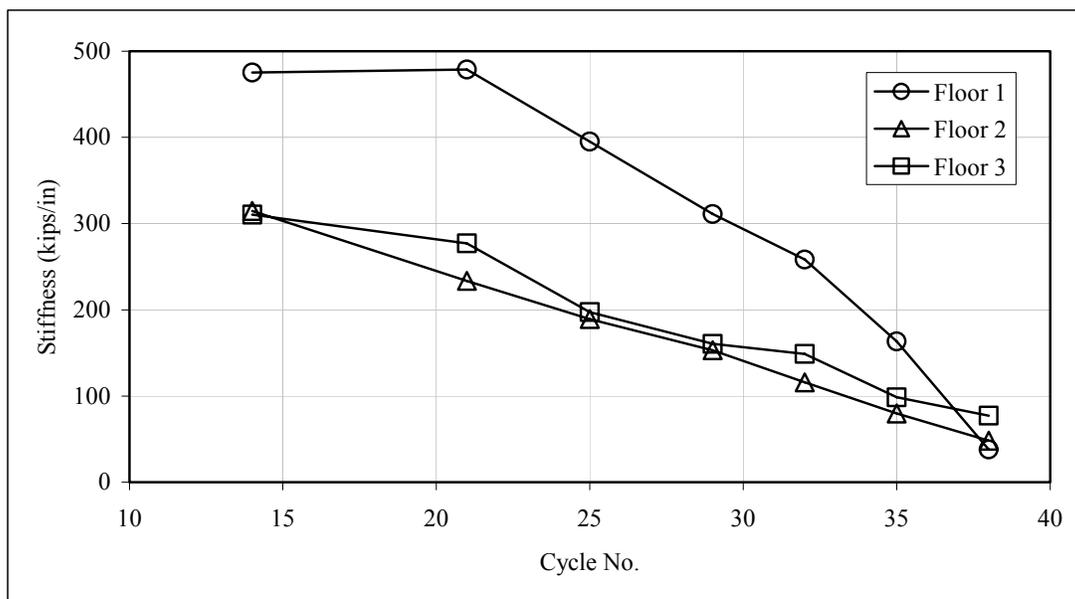
The stiffness degradation was examined along with the hysteresis curves. The stiffness for each primary cycle, starting with cycle 7, was calculated by measuring the slope between the peak load during that cycle to the origin of the story shear versus interstory displacement plot. Using this method, values of the ‘stiffness’ for each primary cycle, in both the positive and negative directions, were computed and summarize in Table 7.4, as well as shown in Figure 7.10.

Figure 7.10. Stiffness degradation for each floor.

Table 7.4 shows the amount of stiffness degradation that occurred during the length of the test. All of the floors showed significant loss in stiffness by the completion of the test. By cycle 38 the final stiffness percentages, as compared with the initial

stiffness, were 9.6%, 15.6%, and 19.1%, respectively. These percentages illustrate how the damage concentrated mainly in the first floor.

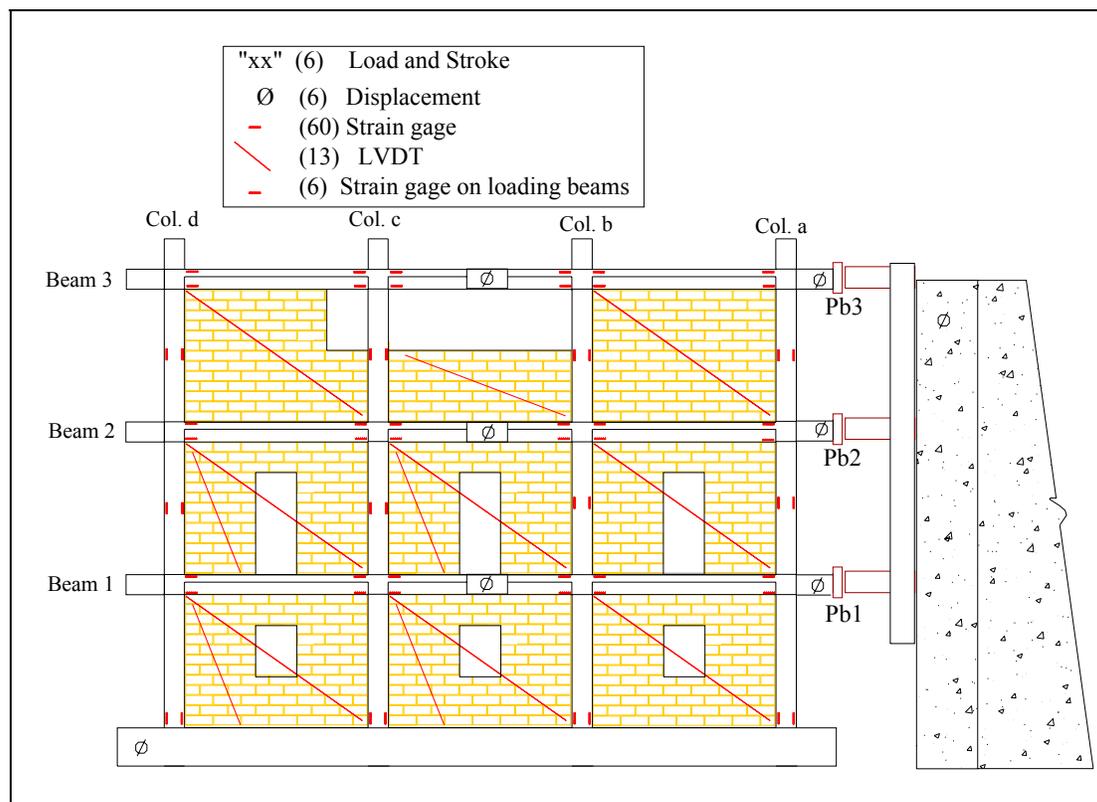
Figure 7.11. Location of strain gages and LVDTs in Model 3.

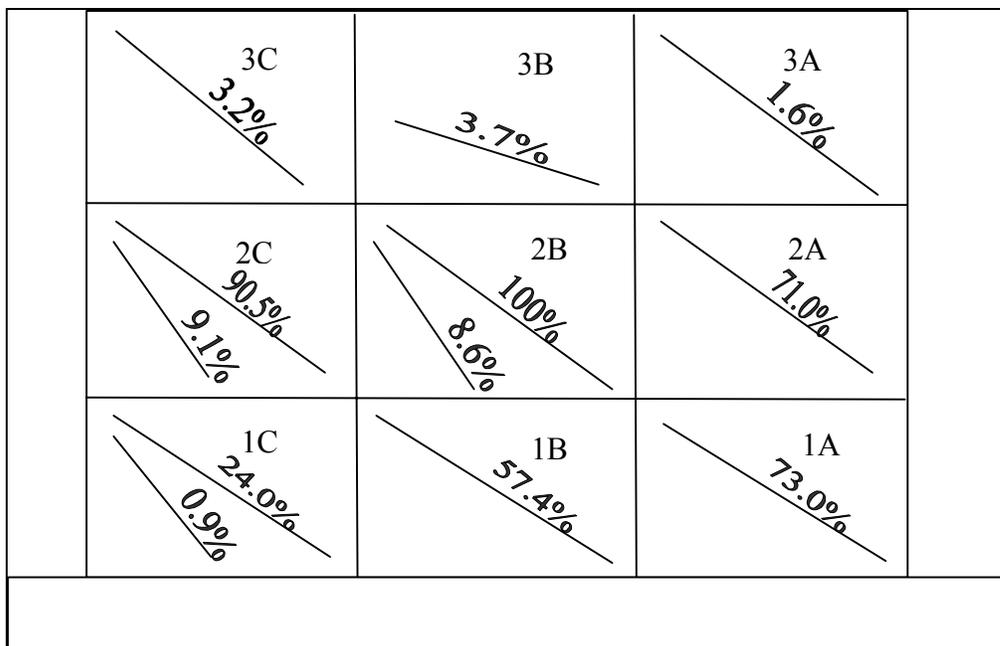
Figure 7.12 shows the panel strain for the peak load during cycle 35, normalized to panel 2B. Even though the second floor exhibited the greatest amount of strain, the

first floor had the most crack propagation. This is probably an effect arising from the openings in the panels. Most of the cracks on the second floor appeared at the corners of the doors, thus allowing the panels to become more flexible and undergo greater displacements with fewer cracks. On the first floor, however, the windows did not allow much flexibility in the panels; instead the corners of the windows created stress concentrations that led to an increase in the number of cracks.

Figure 7.12. Panel strain distribution for cycle 35.

The strain distribution was also different between the first floor and the second and third floors. On the first floor the level of strain decreased the farther away from the actuator the measurement was made. On the second and third floors, the lowest amount of strain was recorded in bay A and the highest amount was recorded in bay B, while bay C had the second highest amount of strain. The third floor showed a very small amount of strain compared with the other two floors, either because of the amount of cracking in the lower floors or because the third floor required very little displacement to reach the target of 3 in. of displacement.

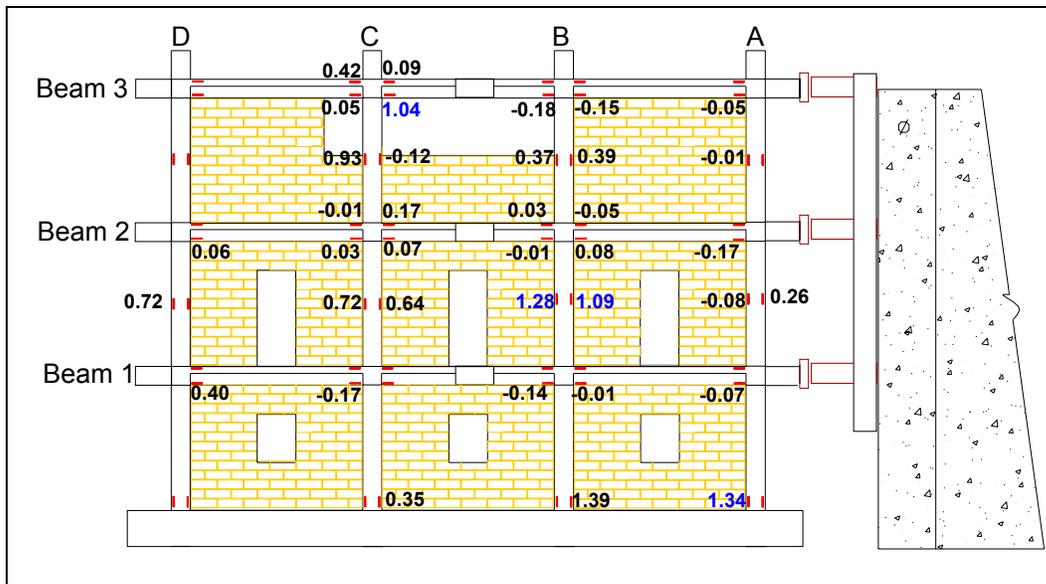
Figure 7.13. Strain distribution of reinforcement in cycle 35 positive stroke.

The location of the yielding reinforcing bars was observed from the data. The strain distribution at peak load, cycle 35, and at peak displacement, cycle 38, is illustrated for the reinforcing bars in Figure 7.13 and Figure 7.14. The strain values for each bar are normalized to the yield strength of the bar. A value of 1 indicates a measured strain equal to the yield strain while a value greater than 1 indicates yielding

has occurred. During the peak load few bars yielded, but the interesting information is the placement of those bars that did yield. In Figure 7.13, the steel that did yield was in the columns, along the right side of the structure. Possibly this is because of the uplifting force the applied load had on the structure. A reinforcing bar on the bottom of the third beam also yielded, possibly due to local influences. The cracks in the column or the lack of masonry close by could also have contributed to the yielding. Figure 7.14 shows the yielding during the negative stroke at peak load. The majority of the bars that yielded were along the outside columns and beams. This stroke also caused the bars to pull out from the concrete, and this can be seen in the rest of the cycles.

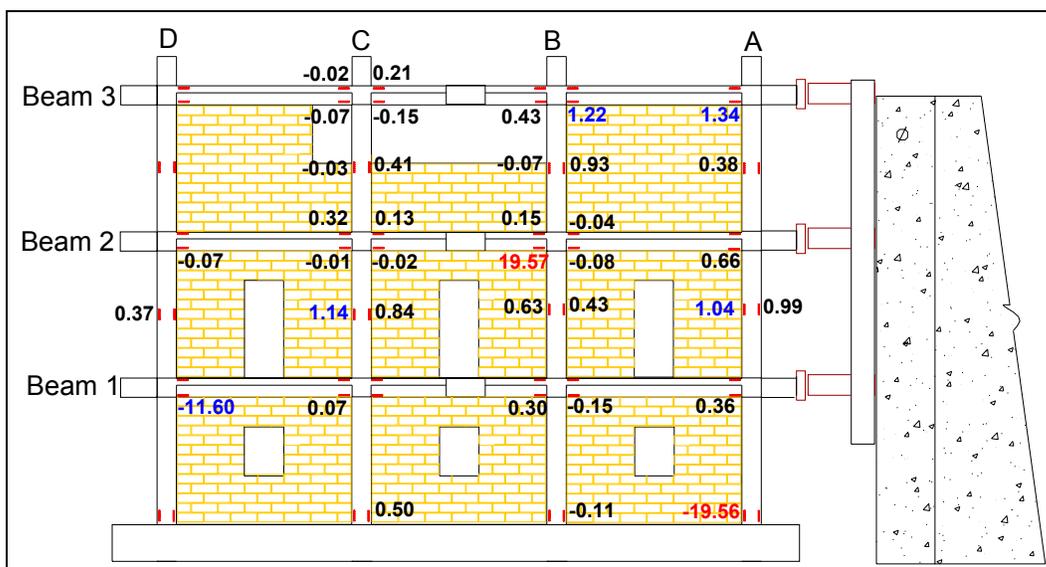
Figure 7.14. Strain distribution of cycle 35 negative stroke.

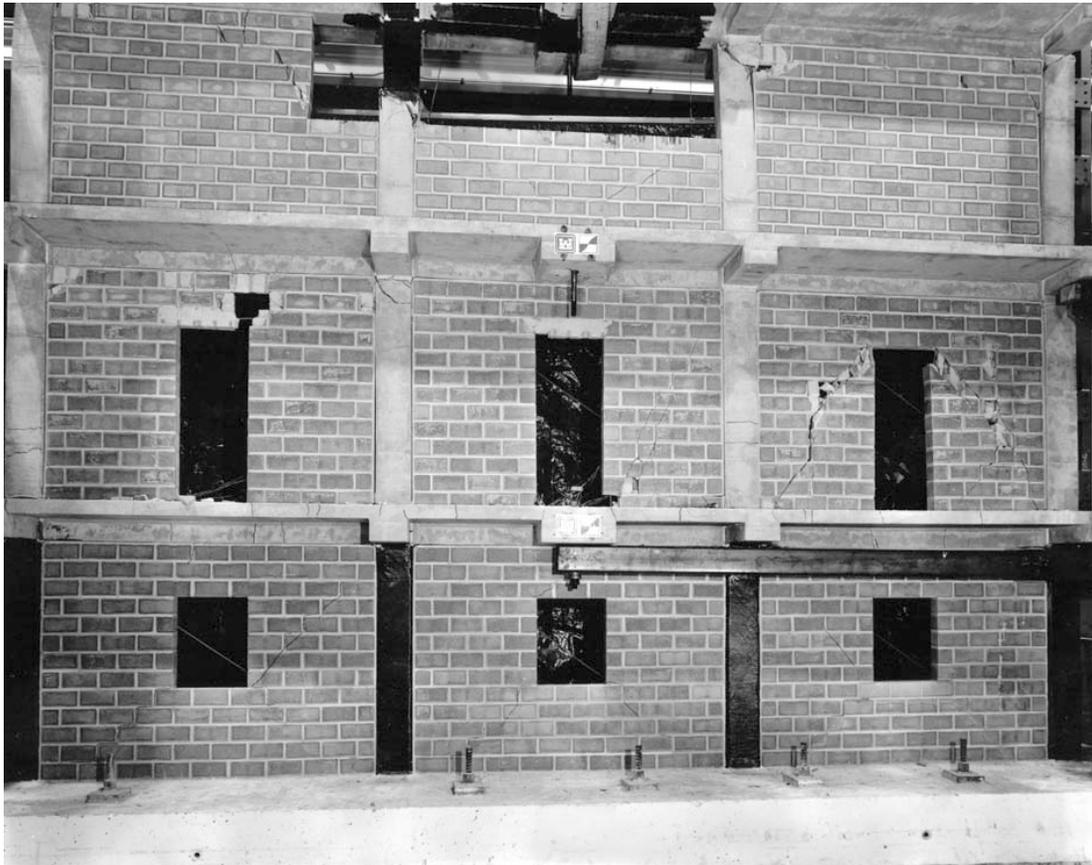
Figure 8.1. Rehabilitation of whole structure.

Before application of the CFRP, the flexural and shear cracks in the beams were repaired using the techniques described in Chapter 6, Section 6.2, which comply with applicable portions of ASTM C-881. Figure 8.1 and Figure 8.2 show photographs of portions of the rehabilitated frame. The CFRP is the black material covering the beams, and the J-51 sealant is the gray material covering the beam cracks.

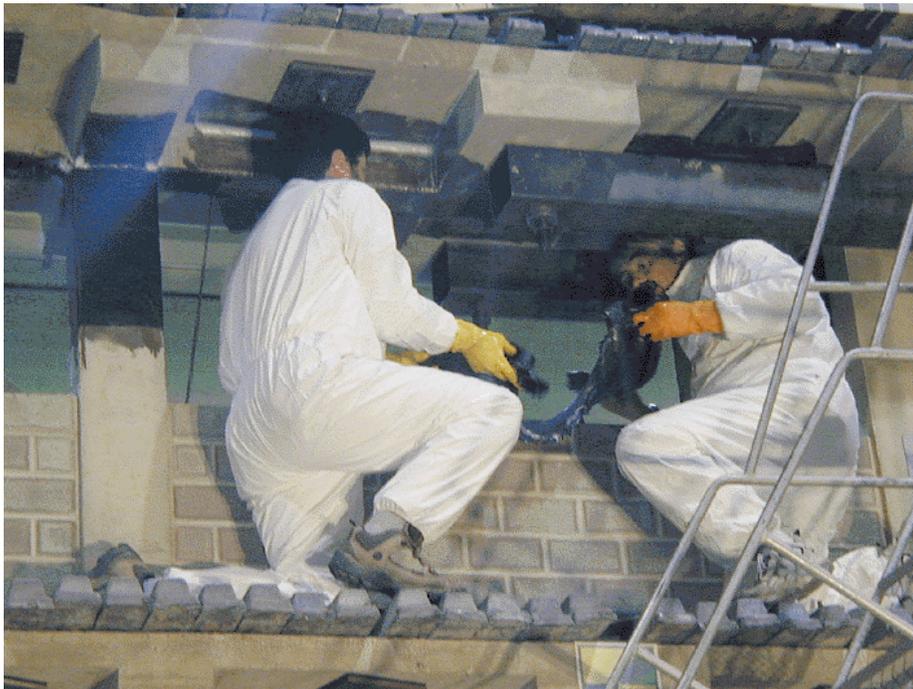
Figure 8.2. Repairing of the third story column and beam.

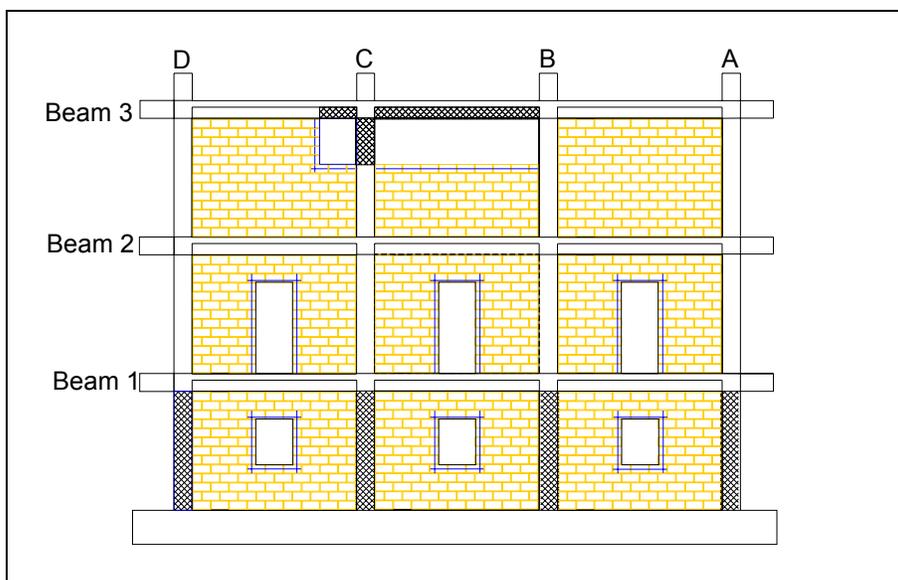
Figure 8.3. Location of frame elements where CFRP was applied.

CFRP with a fiber orientation of $+45/-45$ degrees was used to strengthen the R/C frame according to ACI 440-00, as illustrated in Figure 8.3. The first floor columns were completely wrapped, along with the top half of Column C on the third floor. Also, the stem of Beam 3, a T-beam, was wrapped adjacent to the openings in masonry panels 3B and 3C.

The first floor and the third floor columns were completely wrapped, while beam 3 was U-wrapped around the three sides of its stem. Calculations were not performed to determine the rehabilitated shear, bending, or axial strengths, but it is reasonable to assume that these values for Model 4 should exceed the undamaged capacities of Model 3 (from which Model 4 was reconstructed). After the frame itself was rehabilitated with CFRP, the first floor CMU infill panel was replaced.

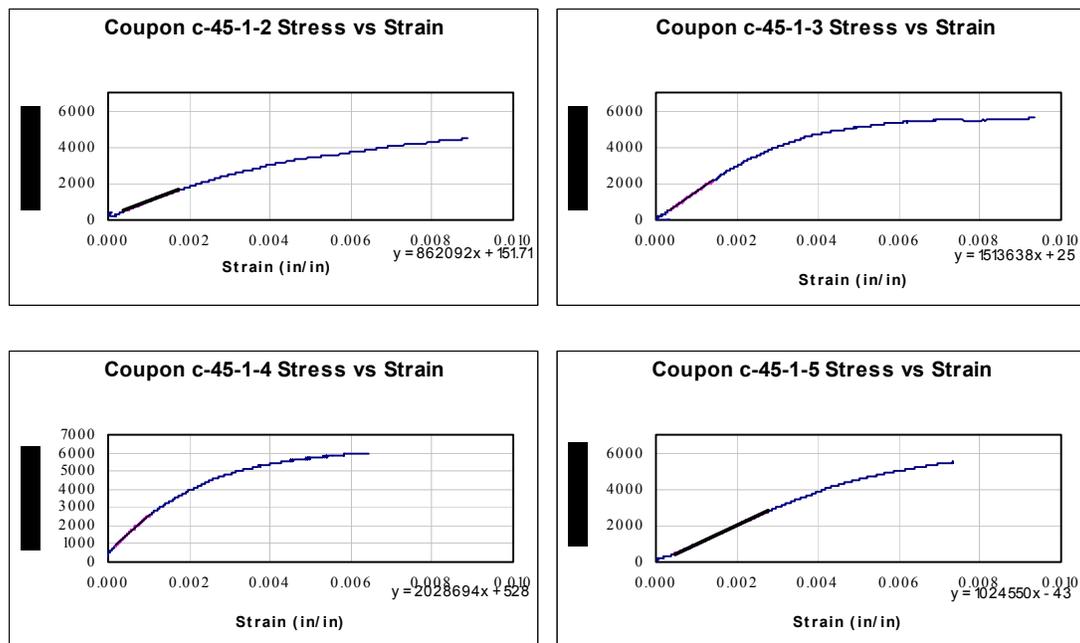
Figure 8.4. Stress vs strain relationship for CFRP coupons.

The CFRP was applied using a wet lay-up system. The dry carbon-fiber sheets were cut to the correct dimensions and impregnated with a saturating resin. The saturating resin, along with the compatible primer and putty, was used to bond the carbon fiber to the concrete surface. The primer was used to penetrate the surface of the concrete providing improved adhesive bond for the saturating resin. The putty filler was utilized to smooth rough corners and fill voids in the concrete in order to provide a more reliable bond between the carbon fiber and the concrete. The saturating resin provides a load path between the concrete and the carbon fibers as well as between the fibers themselves. The stress versus strain relationships for each of the four coupons tested are shown in Figure 8.4.

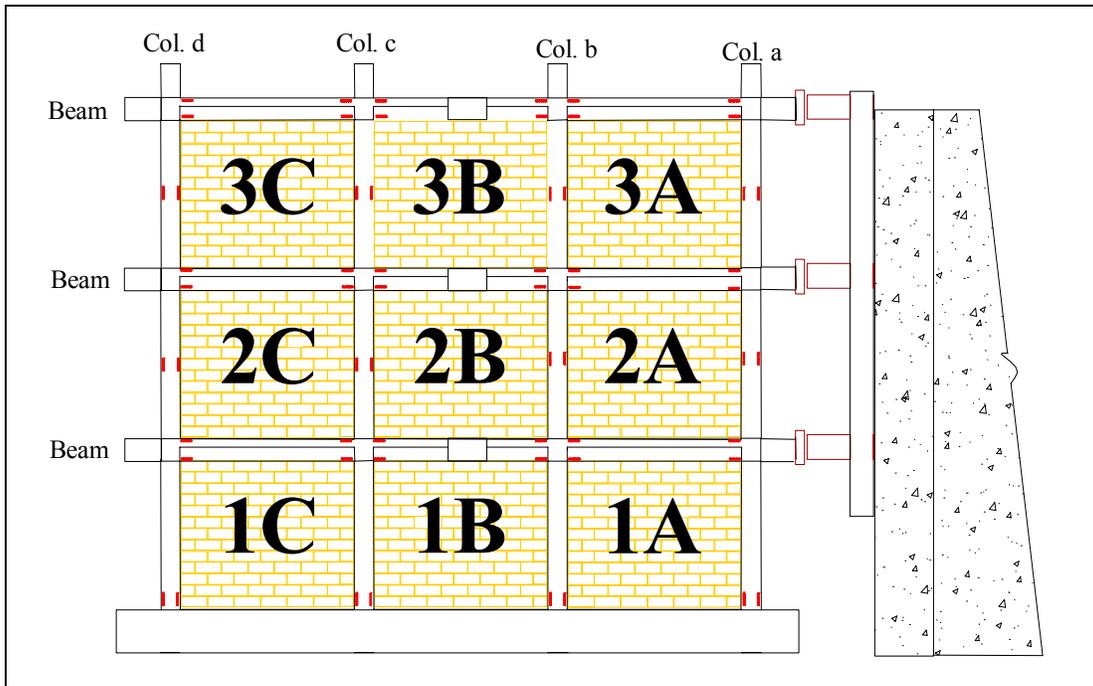
Figure 8.5. Identification scheme for Model 4.

Model 4 is discussed in terms of the element identification scheme illustrated previously and repeated in Figure 8.5. As in Tests 1 – 3, the model was loaded using the previously described modified CUREE protocol. The first cracks appeared during cycle 21, with a maximum load of 9.2 kips acting on the third floor. Figure 8.6 shows the cracks appearing at the joints between column B and beam 2, and between column C and beam 2. Throughout the rest of the test, the second floor continued to form a majority of the cracks.

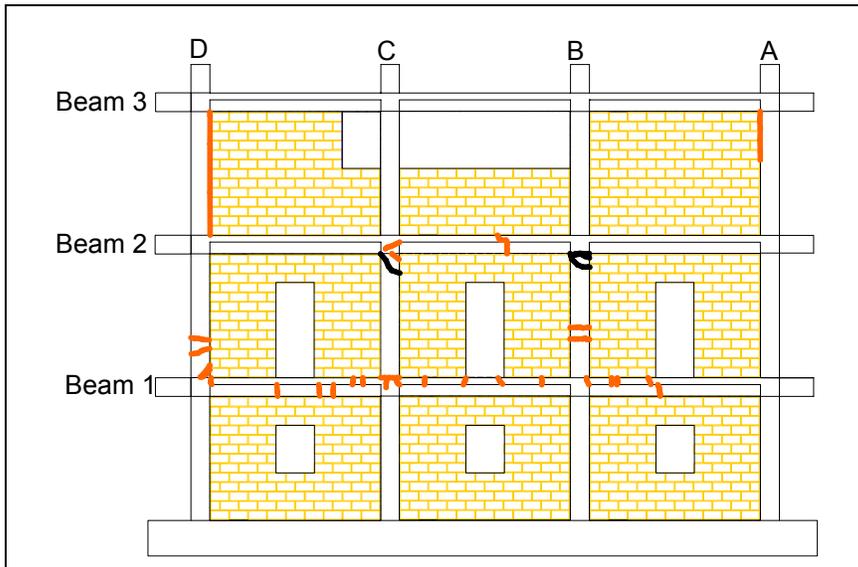
Figure 8.6. First cracks, cycles 21 through 24.

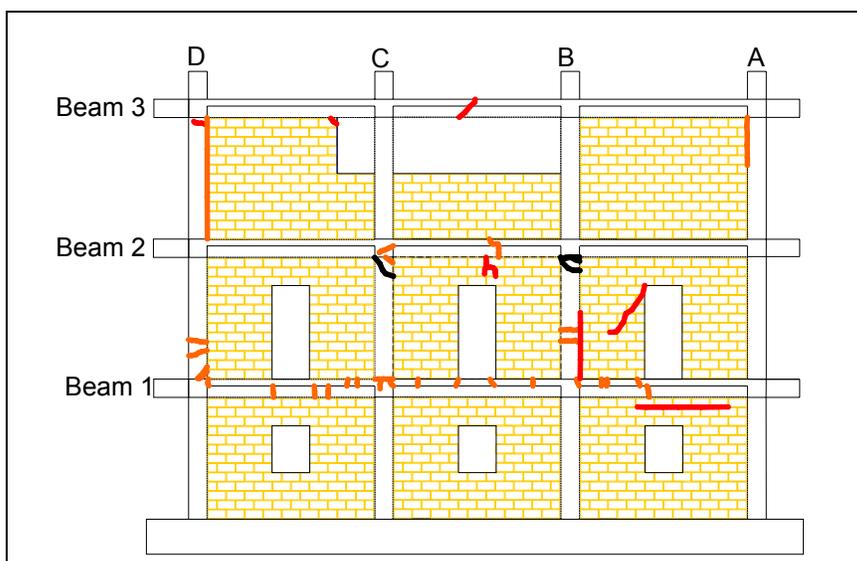
Figure 8.7. Cracks appearing during cycles 25 through 28.

Figure 8.7 shows the cracks that formed during cycles 25 through 28. Panels 1A, 2A, 2B, 3C all cracked, and most of these cracks traveled along the mortar joints. However, in panel 2A the crack propagated through bricks as well as mortar. Also the lower left side of panel 2A disconnected from the concrete frame. The concrete frame also formed two new cracks — one in Beam 3 above panel 3B, contiguous to the opening, and one at the top of column D.

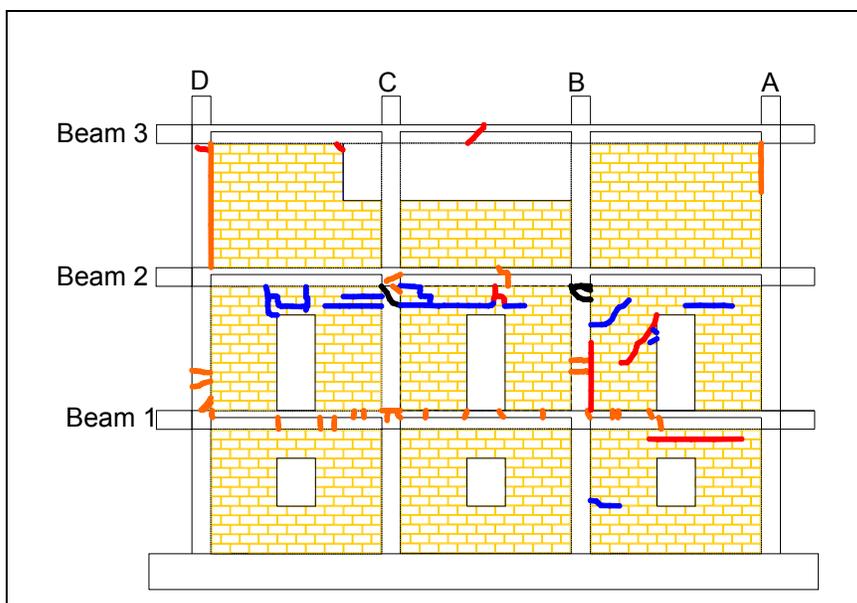
Figure 8.8. Cracks appearing during cycles 29 through 31.

The cracks that appeared during cycles 29 through 31 are shown in Figure 8.8. Here the second floor received most of the new cracks, with the only other crack appearing in panel 1A. Two of the cracks in the second floor were continuations of previous cracks, but there were also new cracks. Panel 2C cracked for the first time above the doorway, while in panel 2B all the cracks that occurred previously joined together.

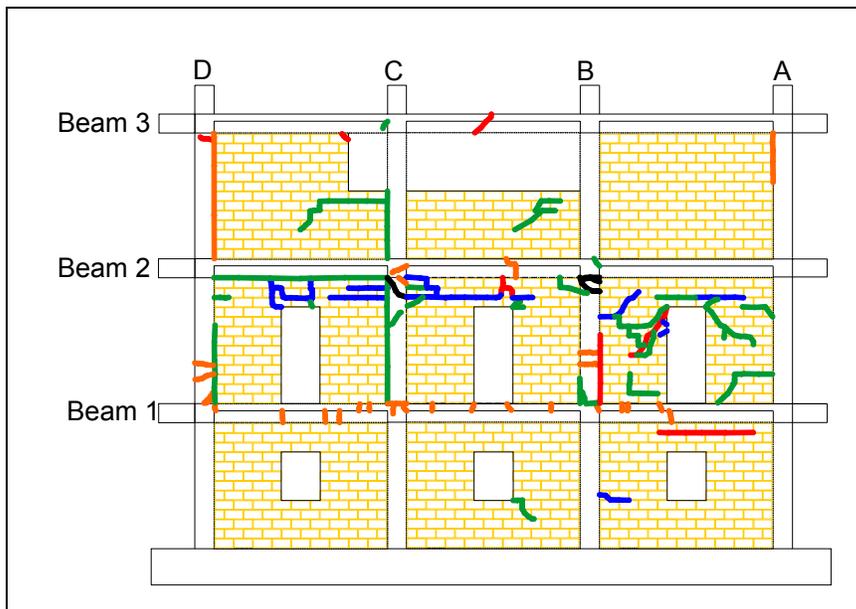
Figure 8.9 shows the crack propagation during cycles 32 through 34. During this test the second floor had an increase in the number of cracks. All three panels developed new cracks, with most of these occurring in panel 2A around the corners of the doorway, where stress concentrations were very high. Most of the cracks in panel 2C occurred along the border between the panel and the concrete frame. Two panels, 3B and 1B, cracked for the first time, with the cracks traveling through both mortar and brick. Also the concrete frame developed a number of new cracks, most of them near joints.

Figure 8.9. Cracks appearing during cycles 32 through 34.
