ERDC/CERL TR-03-10

Investigation of Fiber-Reinforced Polymer for Seismic Rehabilitation of Concrete Structural Frames With Unreinforced Masonry Infill

Ghassan K. Al-Chaar, Justin B. Berman,
and Steven C. Sweeney

May 2003

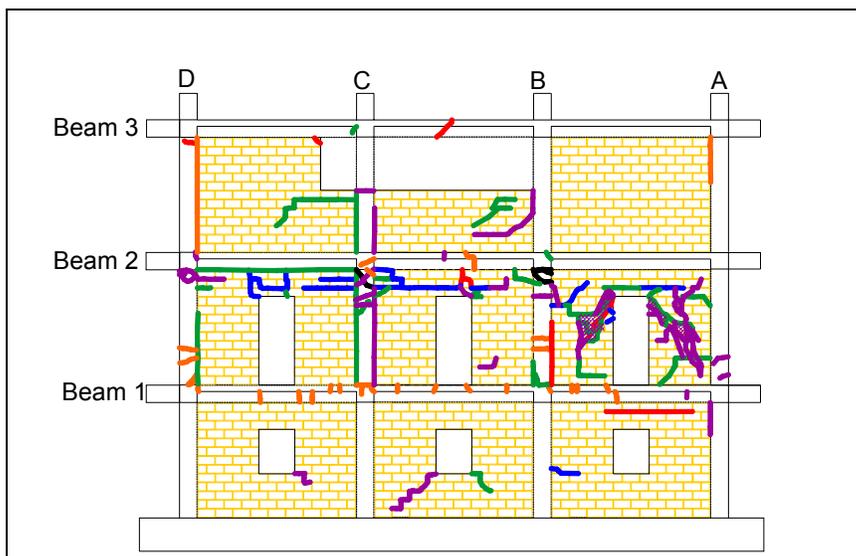
Cycles 35 through 37 (Figure 8.10) show more new cracks, with many of them occurring in panel 2A. Here the cracks occurred in the same places as previously; only the density of cracks increased. Also, the first floor had an increase in the number of cracks, with some panel separation happening in panel 1A, a new stair-step crack happening at the window corner in panel 1B, and panel 1C having its first crack at the corner of a window. Panel 3B showed some separation from the frame on both sides, along with a new crack at the right side. Also, the joints at columns B and C and beam 2 had a large number of cracks occur.

Figure 8.10. Cracks appearing during cycles 35 through 37.

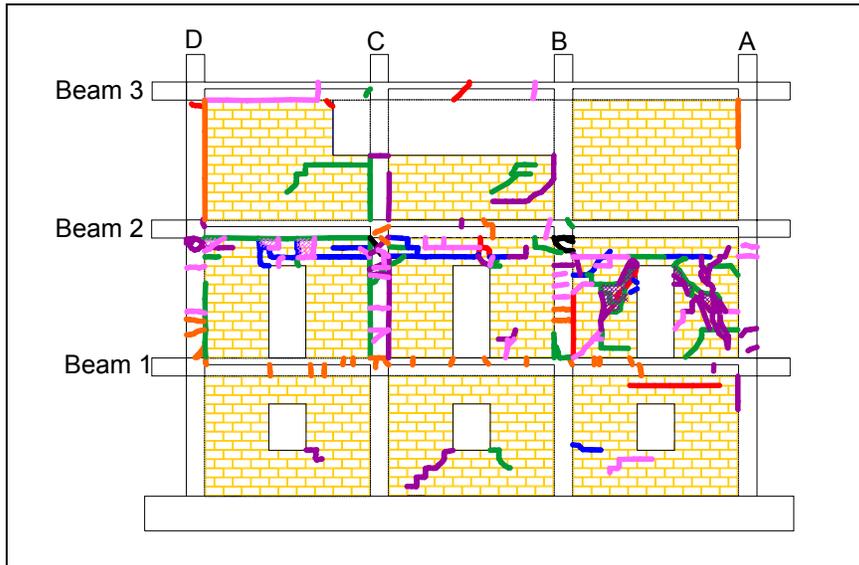
Figure 8.11 displays the cracks occurring during cycles 38 through 40. Most of the cracks were near the top of the panel, or they were continuations of previous cracks. Panel 1A developed a new crack. Most of the cracks that formed were in the columns along the second floor, with some in beams 2 and 3.

Figure 8.11. Cracks appearing during cycles 38 through 40.

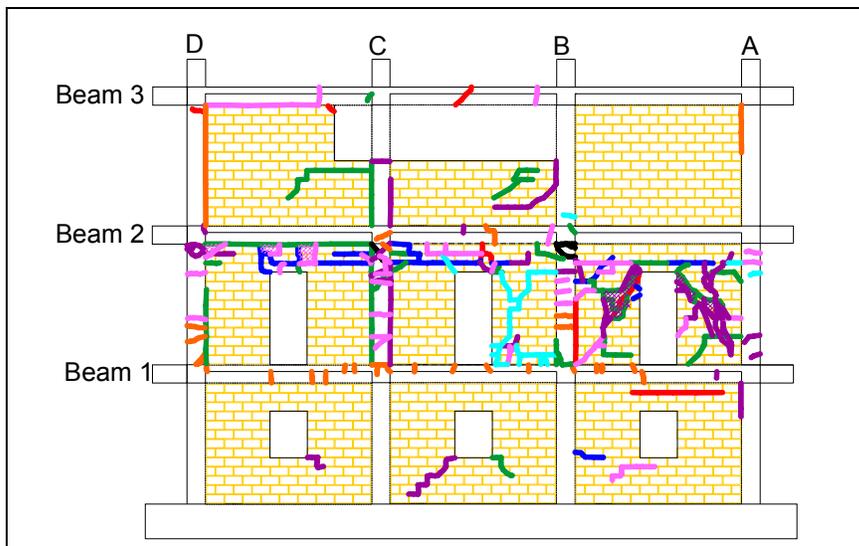
Figure 8.12 shows all the cracks found at the completion of the test. Only a few new cracks were discovered. All the new panel cracks formed in the second floor. Panel 2B had the most new cracks, with the right side of the panel showing large new cracks while panel 2A had only one small new crack. Also, the columns showed some new cracks near the joints. Column A had a crack near its joint with beam 2, and column B had a crack near beam 2 as well.

Figure 8.12. Cracks found at the completion of the test.

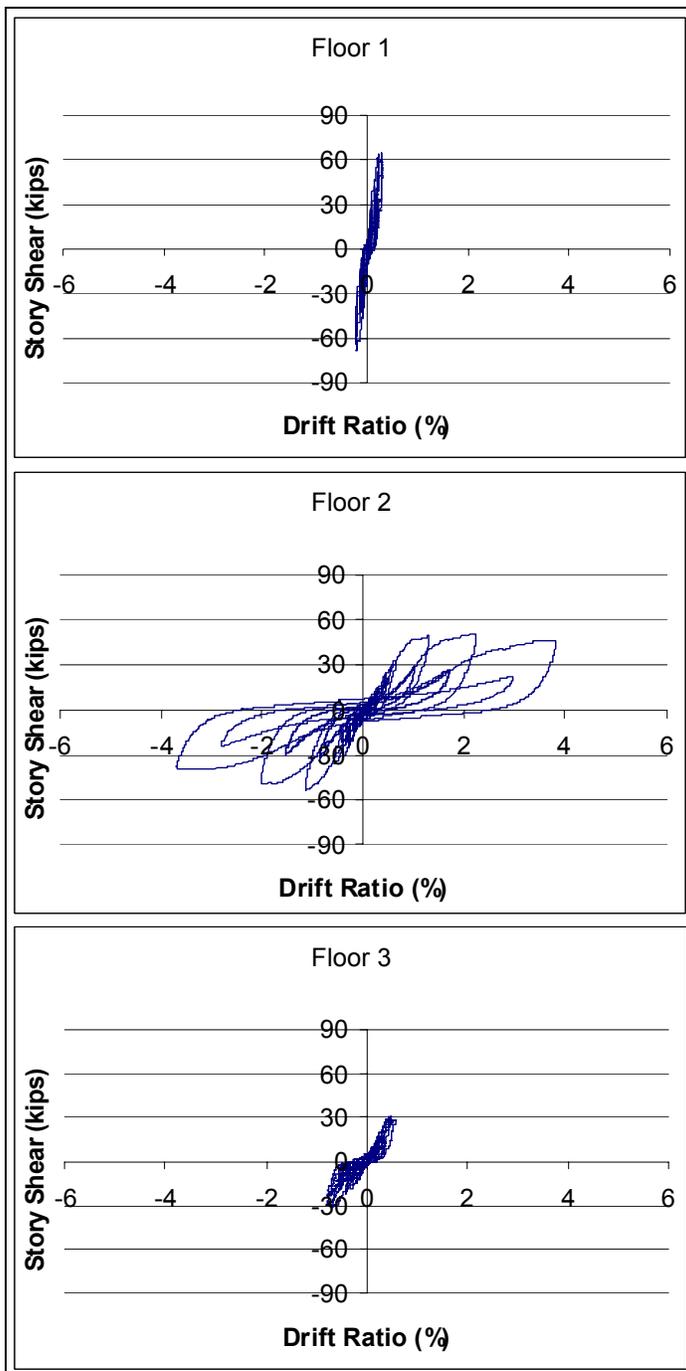
The load/displacement behavior of Model 4 under the modified CUREE loading protocol is plotted in Figure 8.13. The load plotted on the ordinate is the story shear for each level. The drift ratio, defined as the interstory displacement divided by the story height, is plotted on the abscissa. The hysteresis for each floor is discussed in order to explain the behavior of the model.

Figure 8.13. Load/displacement behaviors for each floor of Model 4.

The peak lateral load for the model occurred during the 35th cycle, with a peak story shear of 64.6 kips on the first floor, 50.5 kips on the second floor, and 30.4 kips on the third floor, all in the positive stroke. The negative stroke story shear was 63.5 kips for the first floor, 50.0 kips for the second floor, and 29.0 kips for the third floor. The drift ratios for the associated peak loads in the positive direction were 0.288% for the first floor, 2.205% for the second floor, and 0.477% for the third floor. For the negative stroke, the drift ratios were 0.212% for the first floor, 2.01% for the second floor, and 0.767% for the third floor. The third floor had an absolute displacement of 1.78 in. in the positive stroke and 1.79 in. in the negative stroke. The peak loads and associated story shears and drift ratios are summarized in Table 8.1.

Figure 8.13 shows the drift ratio of the third floor at peak load to be lower than that of the second and first floors. The main cause for this behavior is inverse triangular distribution of lateral forces specified by IBC 2000. From this loading distribution the resulting story shear distribution is shown in Table 8.2 with the story shears of the first and second floors roughly double that of the third floor. These relatively high values of drift for the first and second floors indicate why these panels were the first to crack.

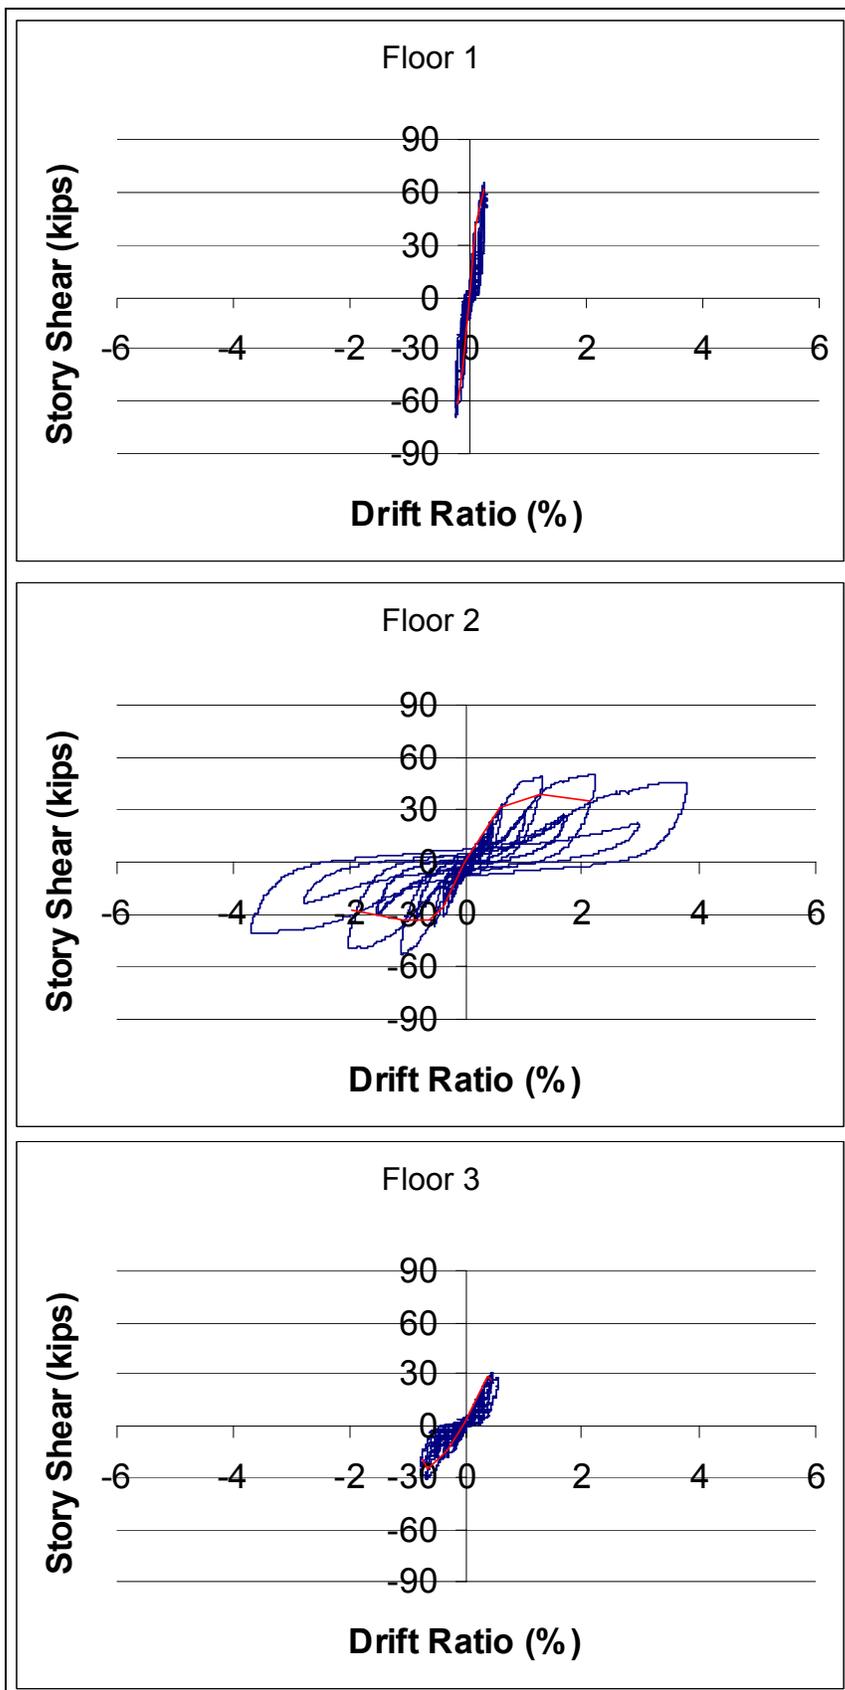
Figure 8.14. Hysteresis with backbone curves for each floor.

Figure 8.14 shows the backbone curves plotted directly on the hysteresis curves for all three floors. As in the previous tests, the backbone curve method was modified to avoid underestimation of load resistance. Points on the backbone were plotted through the intersection of the first cycle (primary cycle) curve for each deformation step, with the primary cycle curve of the previous deformation step for every step. Using this convention, a more accurate representation of structural system behavior was developed.

The backbone curve for the first and third floors are similar in shape. After an initial linear portion, a peak value load is achieved, followed by a rapid drop. Therefore, the R/C frame with URM infill behaved in a brittle manner on the first and third floors, represented by a Type 3 general component behavior curve per FEMA 273, with the floors being force-controlled.

The backbone curve shape of the second floor is different from the other two floors. After an initial linear portion and peak load, the curve indicates some strain hardening before strength decreases. Therefore, on the second floor, the R/C frame with URM infill behaved as a ductile system that is capable of absorbing significant amounts of energy. This is significant because of the lack of ductile reinforcement detailing in the R/C frame. This behavior is represented by Type 1 general component behavior curve per FEMA 273, with the floor being deformation-controlled.

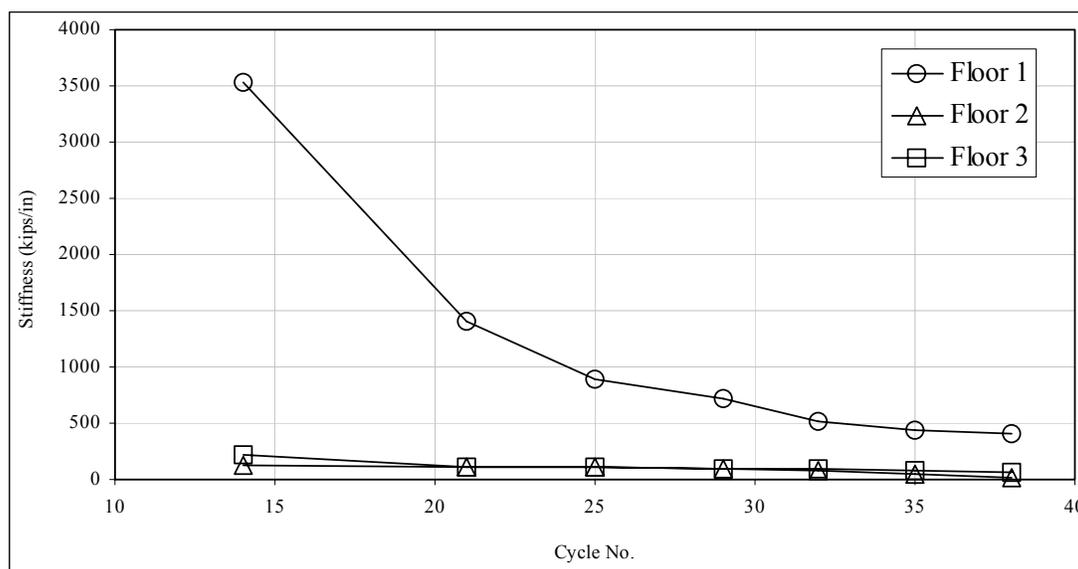
Figure 8.15 Stiffness degradation for each floor.

Along with the hysteresis curves, stiffness degradation was examined. The stiffness for each primary cycle, starting with cycle 7, was calculated by measuring the slope between the peak loads during that cycle to the origin of the story-shear-versus-interstory-displacement plot. Using this method, values of the stiffness for each primary cycle in both the positive and negative direction were computed and summarized in Table 8.4 as well as Figure 8.15.

Table 8.4 shows the amount of stiffness degradation that occurred during the length of the test. The first floor showed significant loss in stiffness by the completion of the test; the second and third floor stiffness also decreased, but not as much. At cycle 38, the final percentage of stiffness for each floor compared to their initial stiffnesses were 28.9%, 17.6%, and 33.0%, respectively. These values illustrate the concentration of damage mainly to the second floor.

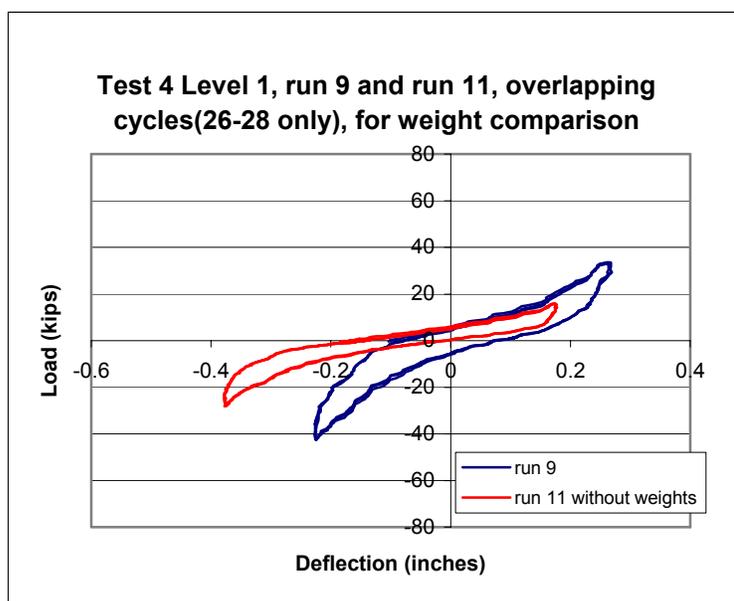
Figure 8.16. Load/displacement with and without lead weights.

To understand the effect of removing the lead weights, the load/displacement curves from run 9 and run 11 are compared. Run 9 included the weights and run 10 did not. Run 9 included cycles 25 – 31, which were not completed. The 50 kip actuator stalled out at 60 kips on cycles 25 and 29, which are the 0.6 in. and 0.8 in. cycles, respectively. Run 10 included cycles 25 – 32. The actuator again stalled at 60 kips, and the cycles did not reach their target displacements. However run 9 and run 10 can be used to examine the effect of removing the lead weights. The successful cycles in each run also can be compared (i.e., cycles 26, 27, and 28). After comparing the hysteresis curves of the runs it was determined that by removing the lead weights, the capacity of the model decreased by 43.8% (see Figure 8.16).

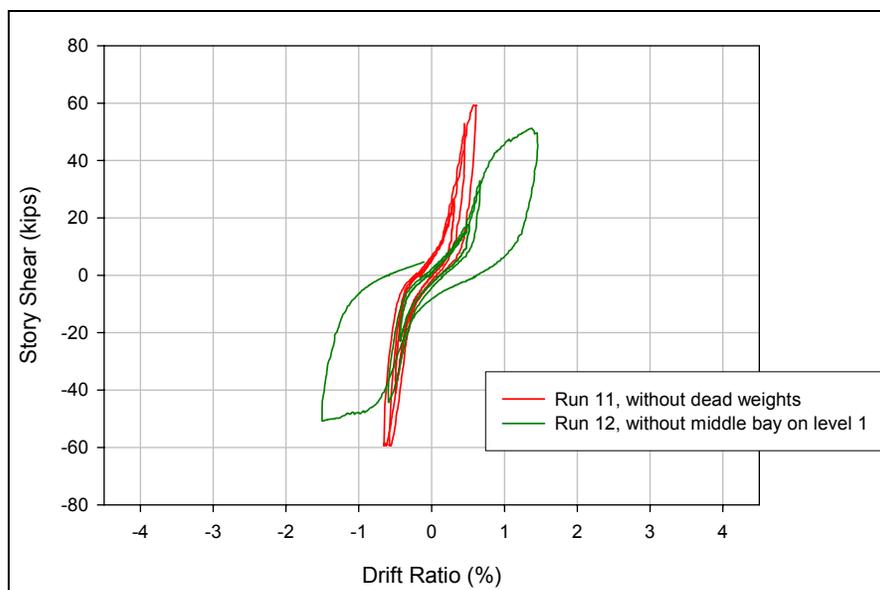
Figure 8.17. Load/displacement with and without center first floor bay.

The effect of removing the infill from bay 1B was a significant reduction in the capacity of the structure. Three different methods were used to determine the effect. The first method was to compare the load/displacement curves of the overlapping cycles from runs 11 and 12. The cycles that overlap were cycles 29 – 32. Run 11 was before the center panel was removed and run 12 was after the center panel was removed. By comparing these load/displacement curves it was calculated that the capacity of the model was reduced by approximately 14% (see Figure 8.17).

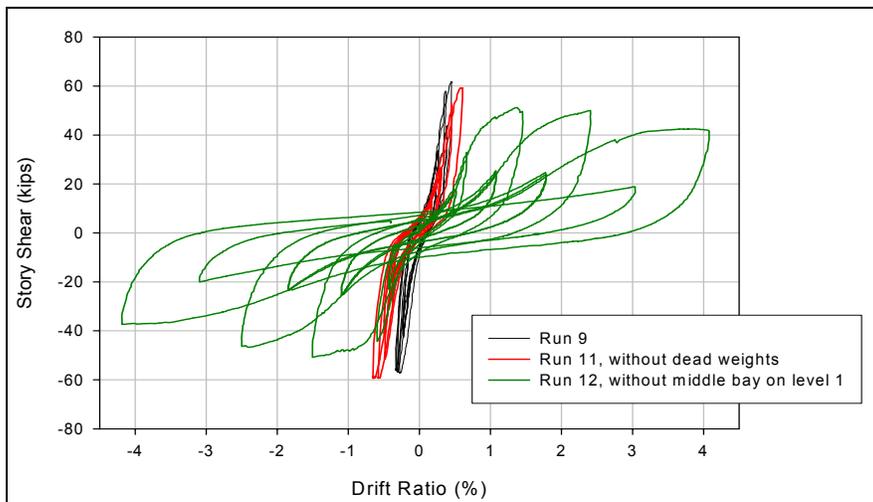
Figure 8.18. Combined load/displacement without modification.

Based on observations and the results from these analyses, the load/displacement curves for run 11 are magnified 18.6% and the load/displacement curves for run 12 are magnified by a total of 40.1% to account for the removal of the lead weights and the removal of the first floor center bay. The original and modified hysteresees are presented in Figure 8.18 and Figure 8.19, respectively. Peak load and corresponding story shear and drift are summarized in Table 8.5. Maximum drift ratio and corresponding story shear are summarized in Table 8.6.

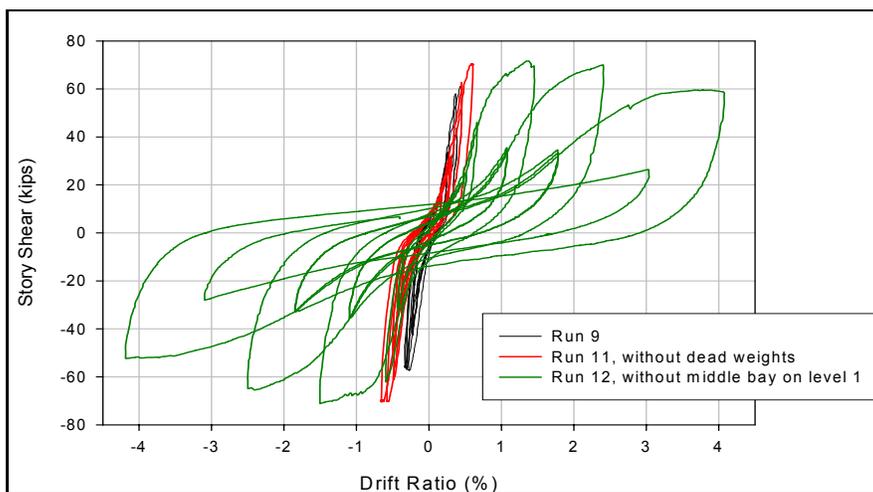
Figure 8.19. Combined load/displacement with modification.

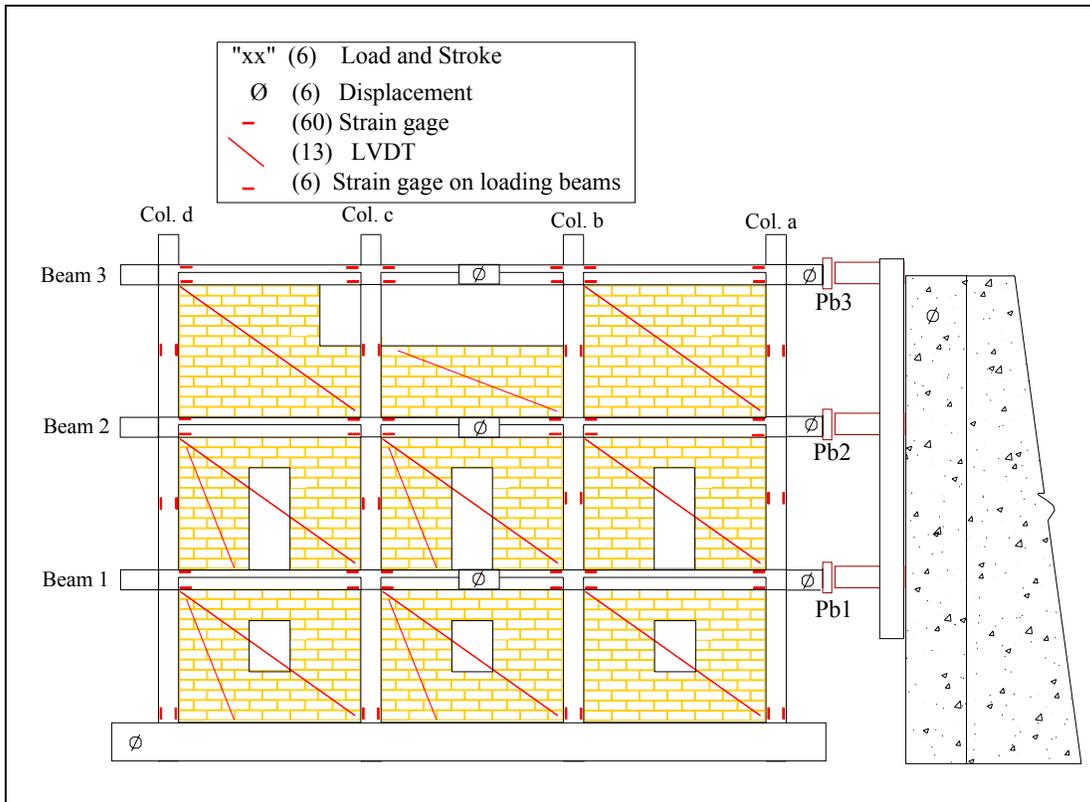
Figure 8.20. Location of strain gages and LVDTs.

The strain distribution in the masonry panels is discussed in order to infer the distribution of lateral force. The data were used to determine the location of panels with large diagonal deformations. Strain distributions in the masonry panels at peak load are presented. Because only one LVDT was used for each panel, compressive displacements were obtained only in the positive stroke direction. Therefore, only masonry panel strain distributions in this direction are discussed. The values of panel strain are normalized to the panel that had the largest displacement during that cycle. A value of 100% represents the panel that had the largest displacement, and a value of 50% signifies a diagonal panel displacement of half of the maximum during that cycle. The masonry panel identification scheme used in the following discussion was shown in Figure 8.1, and the location of the strain gages and the LVDTs is illustrated in Figure 8.20.

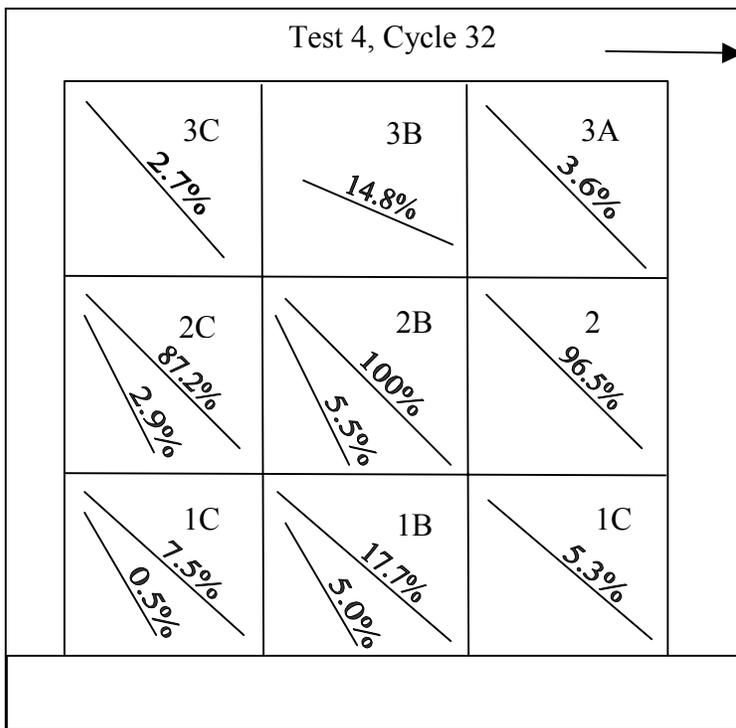
Figure 8.21. Panel strain distribution for peak load at cycle 32.

Figure 8.21 shows that the panel strains for the peak load during cycle 32 were normalized to panel 2B. This result indicates that the second floor, which had the greatest amount of crack propagation, also had the most panel strain. Another observation is that panel 2B may have had more strain compared with panels 2A and 2C because it was affected equally by both positive and negative strokes.

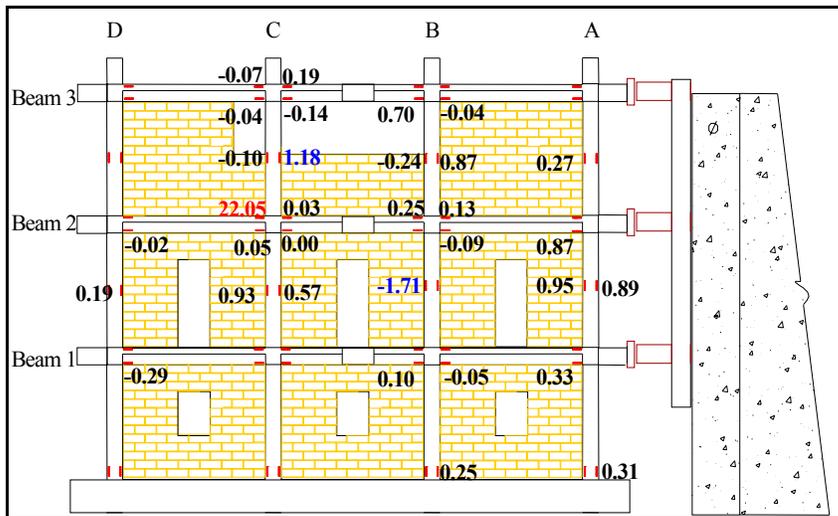
Figure 8.23. Strain distribution during peak load negative stroke.

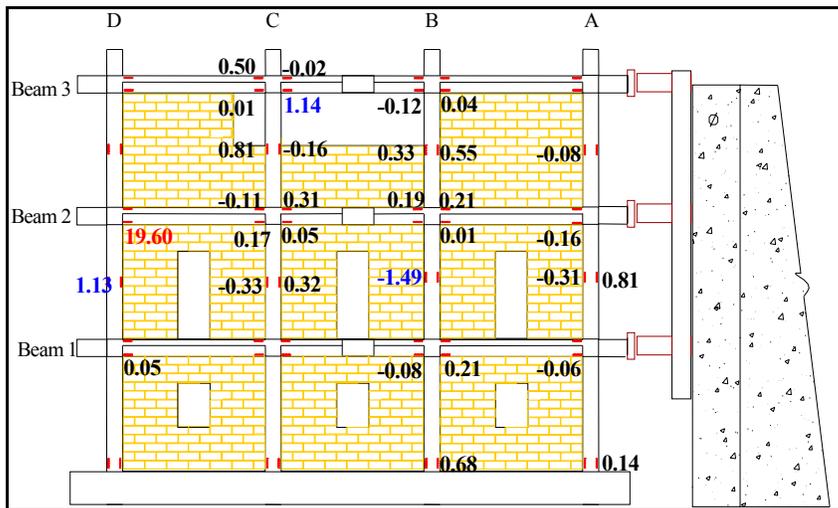
Figure 8.24. Strain distribution during peak deflection positive stroke.

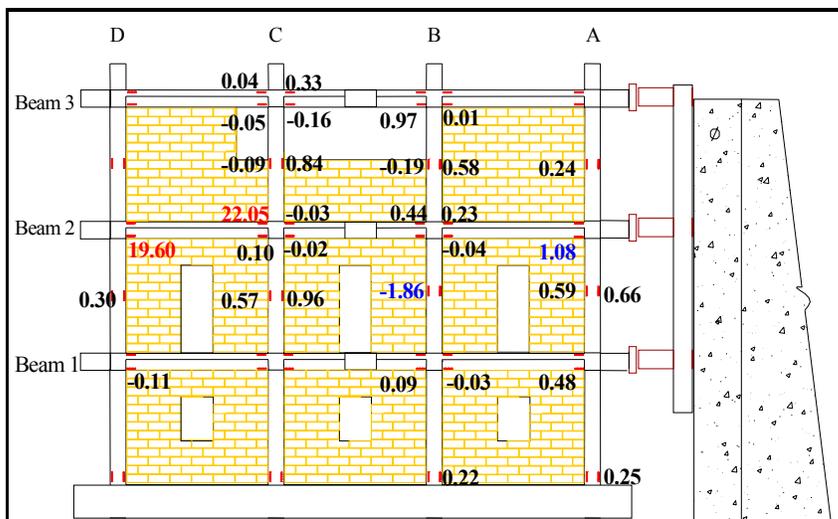
Figure 8.25. Strain distribution during peak deflection negative stroke.

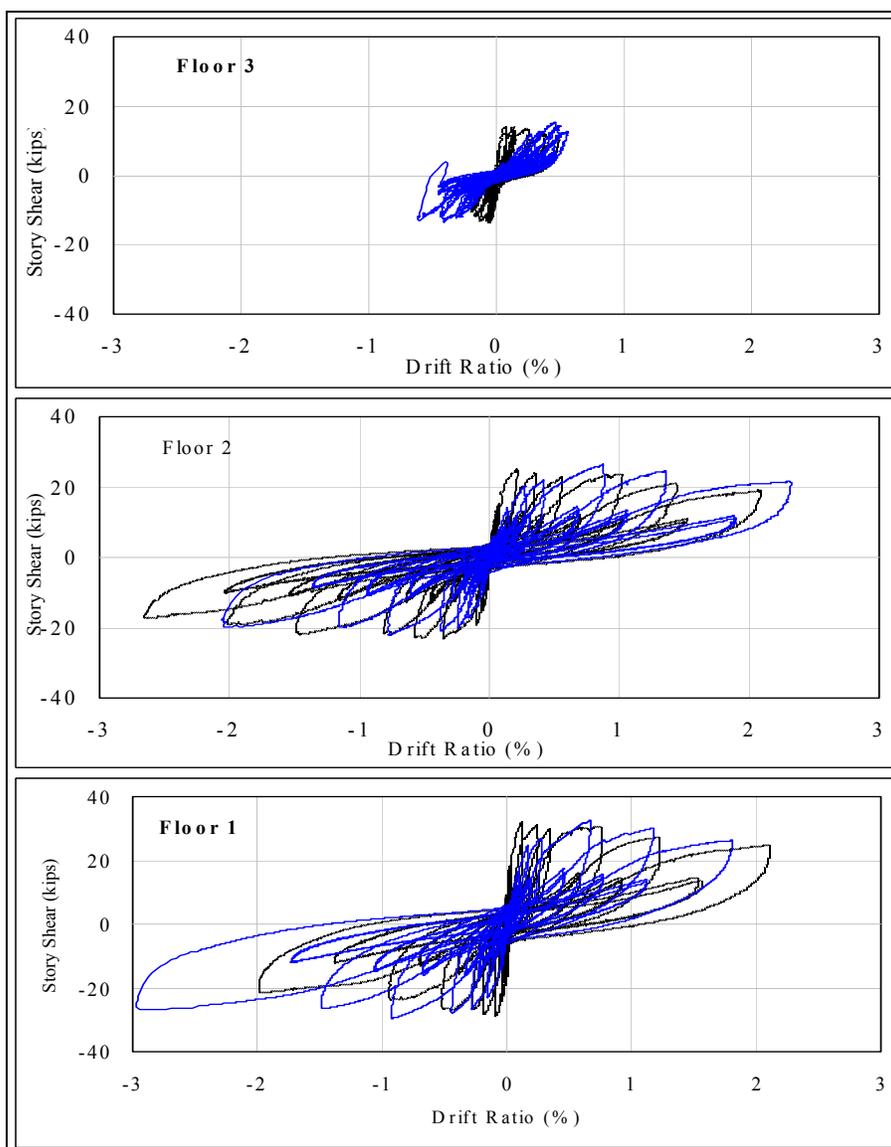
Figure 9.1. Load/deformation behavior for each story of Models 1 and 2.

The hysteretic behavior of Models 1 and 2 is presented in Figure 9.1. The blue lines represent the load/displacement response of Model 2 and the black lines illustrate the behavior of Model 1. The peak lateral load for Model 2 occurred during cycle 32 at a corresponding base shear of 32.39 kips in the positive stroke direction. In the negative stroke direction for Model 2, a slightly smaller base shear of 29.53 kips was observed. These values were slightly higher than for Model 1, where the peak values for base shear in each direction were 32.21 kips (positive) and 29.02 kips (negative). However, during Test 1, the peak lateral load occurred during cycle 21, with corresponding absolute third floor displacements of 0.234 and -0.298 in. for the positive and negative directions, respectively. Conversely, the displacements of Model 2 during peak load were 1.206 and -1.263 in., representing approximately a fivefold increase over third floor displacement before reaching the maximum base shear. The reason the peak load for Model 2 occurred so late in the test sequence, as compared with Model 1, is that the rehabilitation did not fully restore Model 1's initial stiffness or strength. Table 9.1 summarizes the values of applied lateral load, story shear, and drift ratio during the cycles when the peak load and maximum drift occurred for both Models 1 and 2.

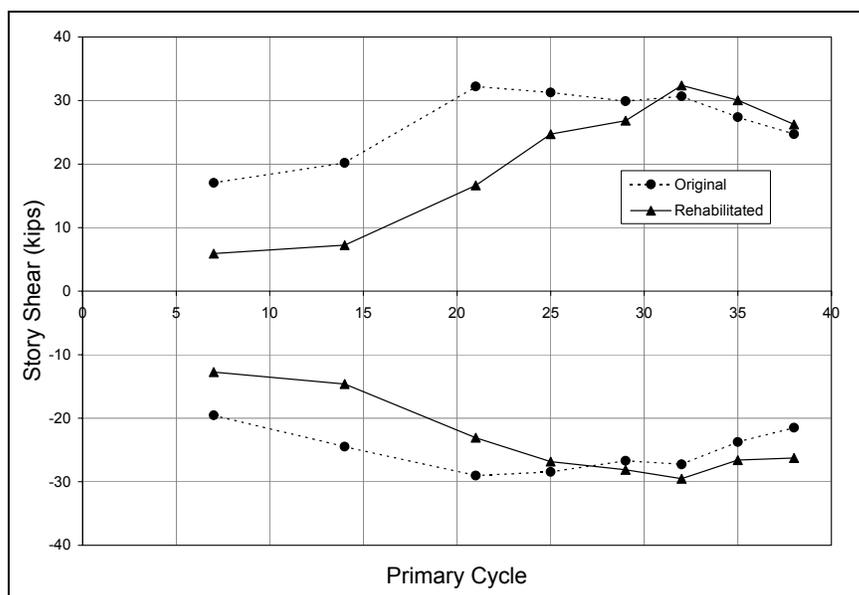
Figure 9.2. Base shear during each primary cycle for both the original and the rehabilitated test structures.

The values for base shear during each primary cycle for Models 1 and 2 are shown in Figure 9.2. This graph shows that Model 1 achieved peak load during cycle 21 while Model 2 did not reach ultimate load until cycle 32. Furthermore, the lack of initial stiffness in Model 2 is also evident by the fact that the base shear values recorded for the primary cycles up to cycle 29 are lower than those recorded for Model 1. Also, during the last primary cycle (cycle 38), Model 2 had more residual strength than Model 1. This observation is directly related to how late in the loading protocol the peak load occurred for Model 2 because after that point very few cycles remained to erode the value of peak load. Apart from the loss of initial stiffness, the overall load/displacement behavior of Model 2 was quite similar to that of Model 1. For example, the peak load in either direction was within 2% of the original value. Therefore, the CFRP rehabilitation was successful in terms of strength.

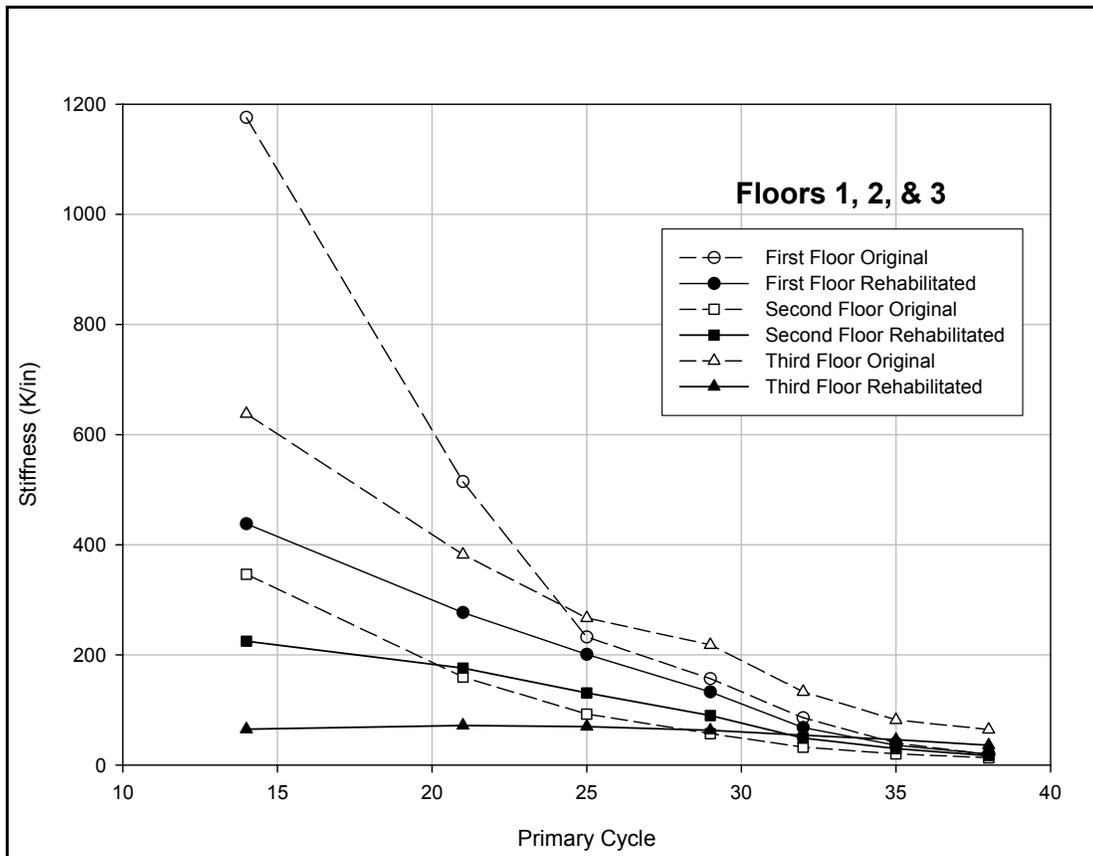
Figure 9.3. Stiffness of each floor during primary cycles for both the original and rehabilitated test structures.

The small values of initial stiffness relative to Test 1 are illustrated in Figure 9.3 and given in Table 9.2. In Figure 9.3, the stiffness of each story during primary cycles is shown for both Models 1 and 2. The first and second floors of Model 2 regained some of their initial stiffness, but not all of it. As described in Chapter 6, the cracks in those two floors were sealed with epoxy, the masonry infill was replaced, exterior columns were fully wrapped with CFRP, and the undersides of the T-beams wrapped with CFRP. The third story regained almost none of its initial stiffness, which is consistent with the limited rehabilitative measures employed on that floor. As explained in Chapter 6, the only rehabilitation performed on the third floor was wrapping the exterior columns on three sides with CFRP, but the most important factor affecting the initial stiffness of the third story of Model 2 was the damaged CMU infill that was left in place. Figure 9.3 confirms that Model 2 began its testing cycle with considerably less stiffness than Model 1. However, by the final cycles of Test 2, the stiffness values for all three stories nearly matched the values returned during those same cycles of Test 1. In other words, Model 1 was inherently stiffer than Model 2, but it also lost its initial stiffness considerably sooner in the modified CUREE testing sequence than Model 2 — especially in the first and third stories.

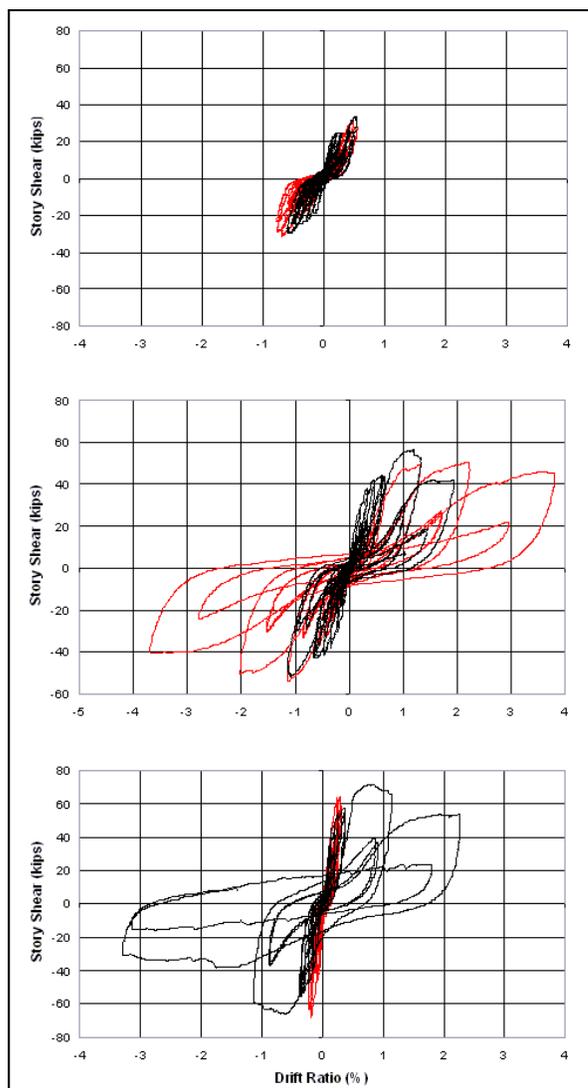
Figure 10.1. Load/deformation behavior for each story of Model 3 and Model 4.

The hysteretic behavior of Models 3 and 4 is presented in Figure 10.1. The red lines represent the load/deformation response of Model 3 and the solid lines illustrate the behavior of Model 4. The peak lateral load for Test 3 occurred at cycle 35 at a corresponding base shear of 71.5 kips in the positive stroke direction. The peak value of base shear in Test 4 was 68.6 kips, which occurred during the negative stroke of cycle 32. The corresponding absolute third floor displacement in Test 3 was 1.51 in. Similarly, the third floor displacement of Model 4 during peak load was 1.21 in. The maximum load for the rehabilitated Model 4 occurred at an earlier cycle and with slightly less displacement when compared with Model 3. Table 10.1 summarizes the values of applied lateral load, story shear, and drift ratio during the cycles when the peak load and maximum drift occurred for both Models 3 and 4.

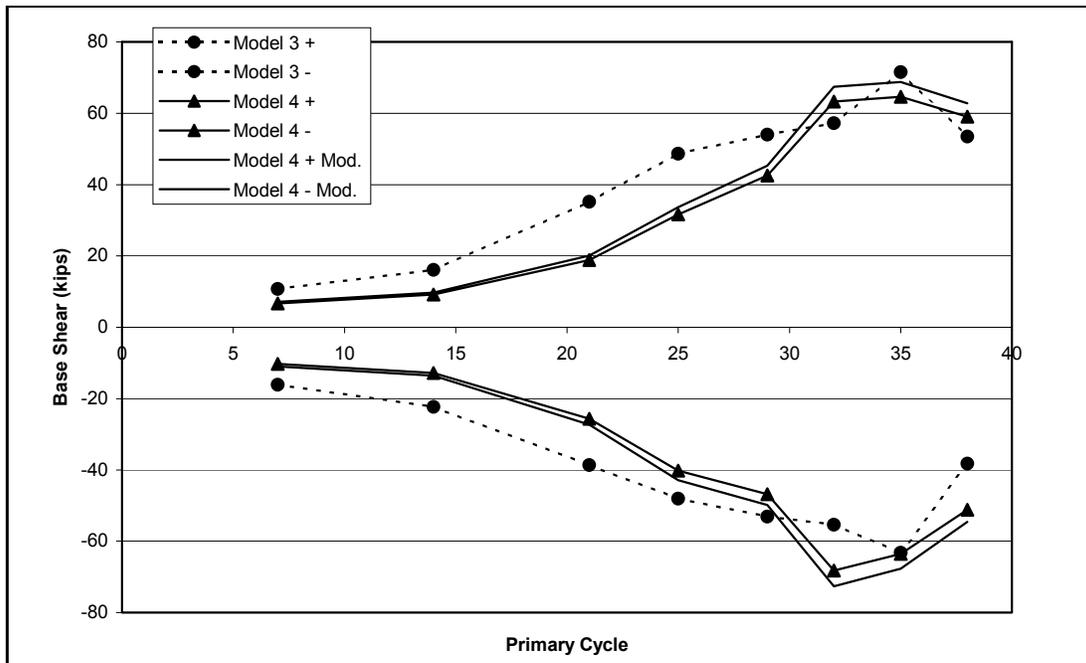
Figure 10.2. Base shear during each primary cycle for Models 3 and 4.

The base shears for Models 3 and 4 during the positive and negative stroke for each primary cycle are plotted in Figure 10.2. This plot illustrates that the peak load for Model 3 was achieved during cycle 35 and the peak load for Model 4 was achieved during the negative stroke of cycle 32. However, in the positive strokes up to cycle 35, Model 4 continued to resist more load. It is clear that the initial stiffness of Model 4 was lower than that of Model 3. The strength of the rehabilitated Model 4 exceeded the ultimate strength of Model 3 in the negative stroke direction but did not quite reach the capacity of Model 3 in the positive stroke direction.

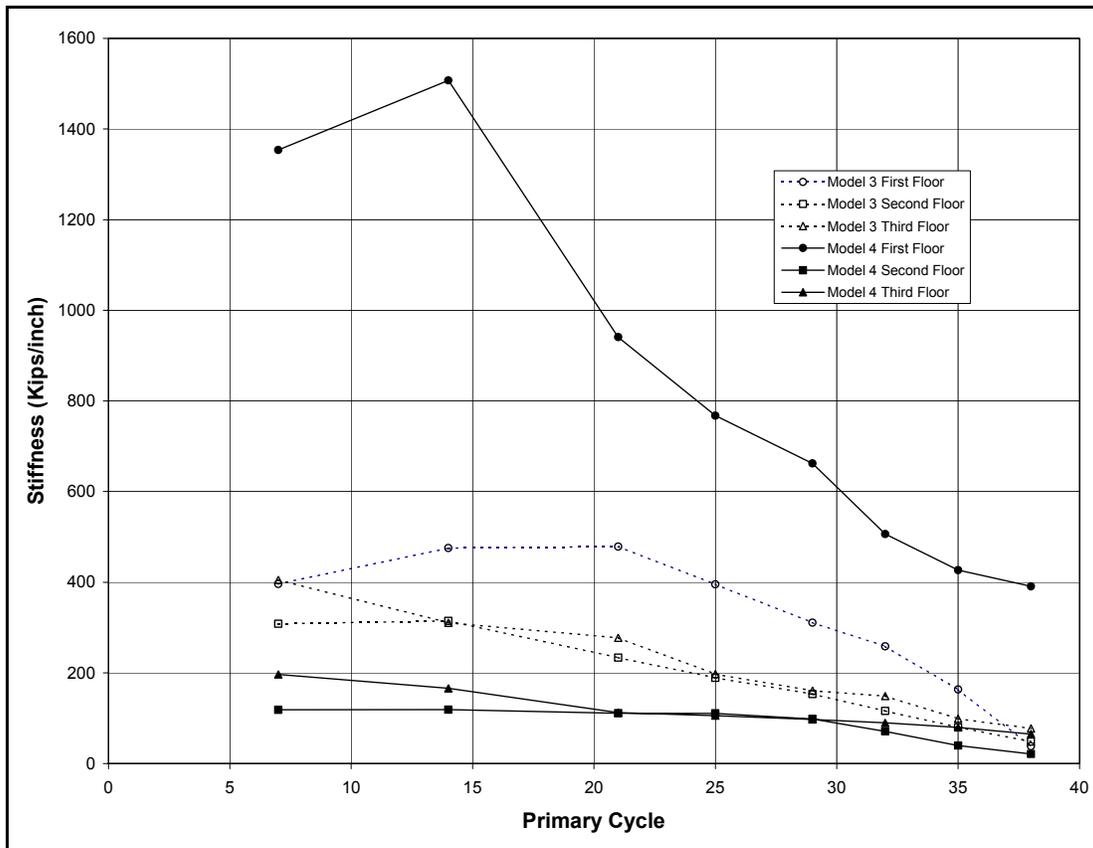
Figure 10.3. Stiffness of each floor during primary cycles for Models 3 and 4.

more as a result of wrapping the columns with CFRP and replacing the masonry infill. The second and third floors were not rehabilitated as extensively as the first floor. Figure 10.3 reflects this by illustrating that the initial stiffness of the second and third floors is only half of the original stiffness of Model 3. After Test 4, the stiffness of the second and third floors essentially matched the stiffness of Model 3. The first floor of Model 4 remained relatively stiff after the 40 cycle loading protocol.

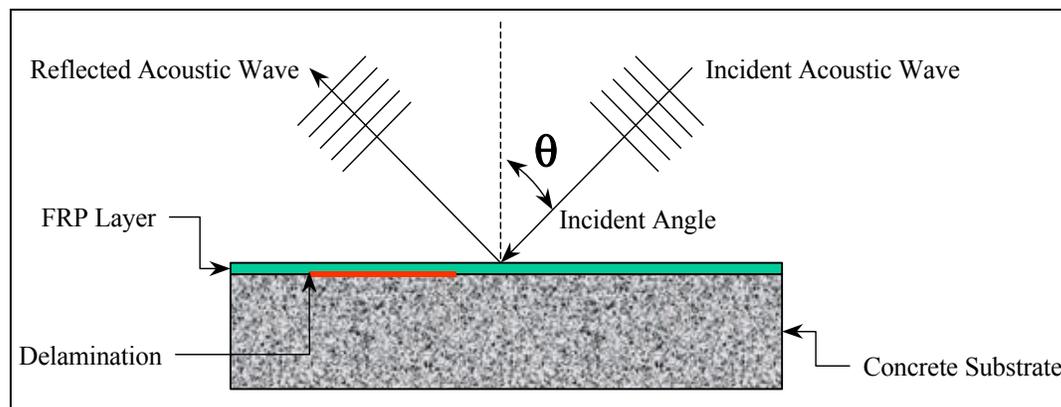
Figure A.1. Setup used for the theoretical simulation of wave propagation on FRP/concrete structures.

Figure A.1 shows the experimental setup in which the model is based. The system is an FRP layer of 0.118 in. thickness laid on top of a 3.94 in. concrete substrate, with a delamination located between the layer and the substrate.

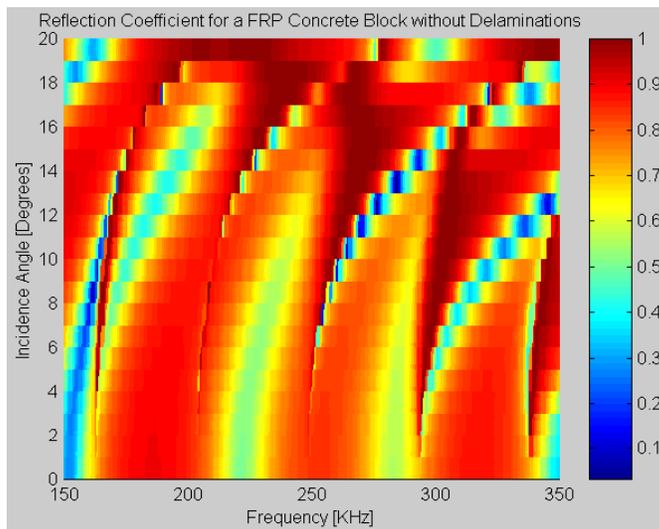
Figure A.2. Reflection coefficient of an FRP/concrete layered structure without delaminations (wave propagation along fiber direction).

In this first simulation, the propagation direction was selected to be along the fibers of the FRP. In this plot, the areas in bright red indicate a very high reflection coefficient, with a maximum value of 1.0, and the dark blue areas indicate very low reflection. Acoustic waves with a combination of frequency-incidence angle that lie on the bright red areas will be reflected almost completely whereas acoustic waves with a combination of frequency-incidence angle that lie on the blue spots will not present a high reflection. This type of plot is very useful when analyzing the changes in the reflection coefficient produced by the presence of a delamination in the structure. Figure A.3 shows a similar plot but this time a delamination was introduced between the layer of FRP and the concrete substrate. The delamination is introduced in the model as an intermediate layer of a material with very low strength between the FRP and the concrete, usually a fluid with low density and thickness of 0.004 in.

Although there are changes in the reflection coefficient due to the delamination of FRP from concrete, these are not dramatic, which would result in very limited sensitivity when trying to experimentally detect the delamination. Perhaps a better way to visualize the small differences between Figures A.2 and A.3 is to take ‘slices’ of these figures at fixed angles. Figure A.4 presents such slices taken at 5, 10, 15, and 20 degrees from the normal to the surface. The frequency range was limited to 150 – 250 kHz.

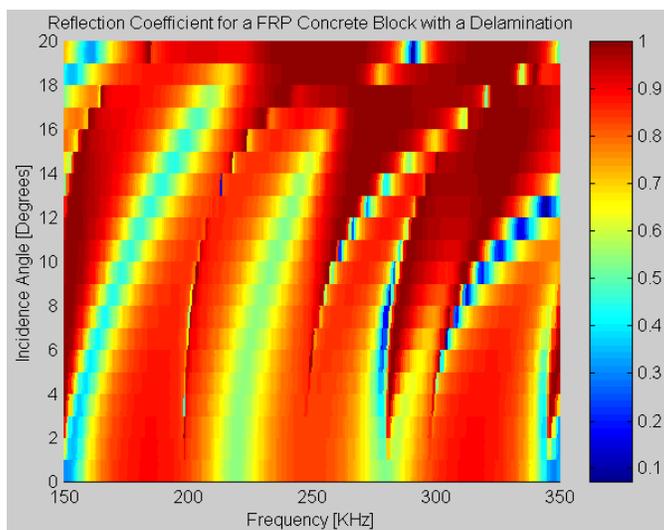
Figure A.3. Reflection coefficient of an FRP/concrete layered structure with delamination between the FRP and the concrete (wave propagation along fiber direction).

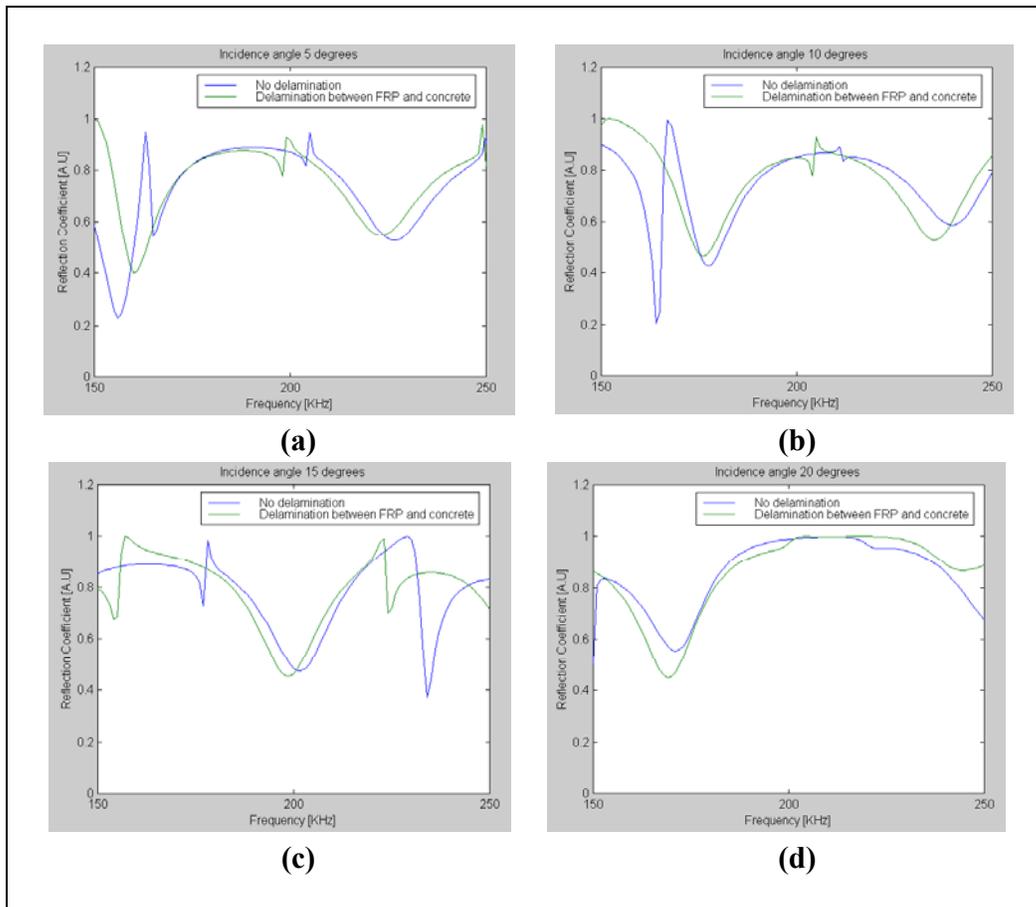
Figure A.4. Comparison between reflection coefficients for an FRP/concrete layered structure with and without a delamination as a function of frequency for a fixed incidence angle. (a) Incidence angle 5 degrees, (b) Incidence angle 10 degrees, (c) Incidence angle 15 degrees, and (d) Incidence angle 20 degrees. Wave propagation is along fiber direction.

Figure A.4(a) presents a comparison of the reflection coefficient with and without a delamination at an incidence angle of 5 degrees. At this angle, a significant difference in the reflection coefficient is observed in a narrow frequency band from 150 to approximately 160 kHz. A similar result is observed in Figure A.4(b) with an incidence angle of 10 degrees. With an incidence angle of 15 degrees, a significant difference is observed for frequencies above 225 kHz. Finally, for an incidence angle of 20 degrees, presented in Figure A.4(d), the difference is so small in this frequency range that it would be very difficult to observe experimentally. Thus, this angle would not be very useful in the detection of a delamination.

The theoretical model predicts that acoustic waves propagating along the fiber direction in the FRP/concrete system will not be sensitive to the presence of a delamination, and therefore will not be effective as a tool for the detection of this type of discontinuity.

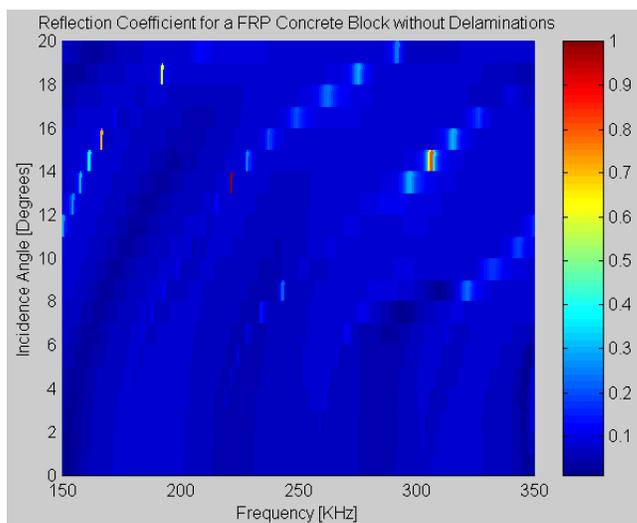
Figure A.5. Reflection coefficient of an FRP/concrete layered structure without delamination between the FRP and the concrete (wave propagation across fiber direction).

The next case studied using the theoretical model was that of acoustic waves propagating in the direction normal to the fibers. Figures A.5 and A.6 show the acoustic wave reflection coefficient for the FRP/concrete layered structure with and without a delamination.

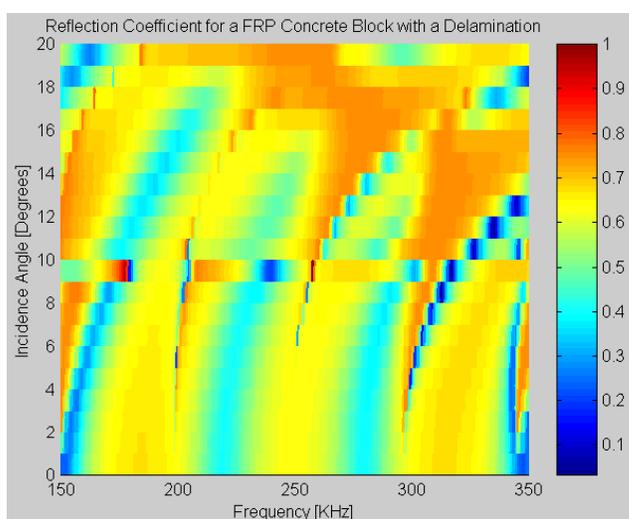
Figure A.6. Reflection coefficient of an FRP/concrete layered structure with a delamination between the FRP and the concrete (wave propagation across fiber direction).

The results in this case are dramatically different from the results obtained when propagation was along the fiber direction. The reflection coefficient is extremely sensitive to the presence of a delamination between the FRP and the concrete. These differences are very clearly shown in Figure A.7, which presents the reflection coefficients at incidence angles of 5, 10, 15, and 20 degrees. The frequency range was limited to 150 – 250 kHz again.
