ERDC/CERL TR-03-10

Investigation of Fiber-Reinforced Polymer for Seismic Rehabilitation of Concrete Structural Frames With Unreinforced Masonry Infill

Ghassan K. Al-Chaar, Justin B. Berman,
and Steven C. Sweeney

May 2003

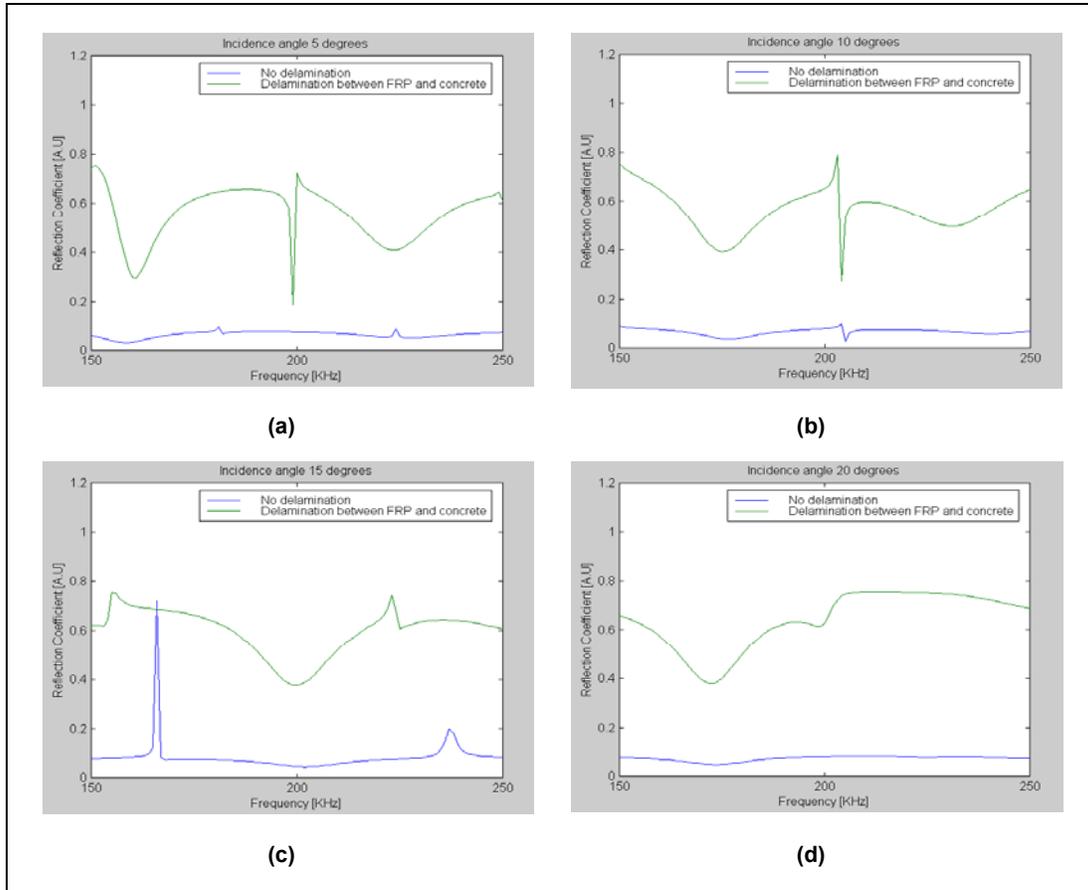
Figure A.7. Comparison between reflection coefficients for an FRP/concrete layered structure with and without a delamination as a function of frequency for a fixed incidence angle. (a) Incidence angle 5 degrees, (b) Incidence angle 10 degrees, (c) Incidence angle 15 degrees, and (d) Incidence angle 20 degrees. Wave propagation is across the fiber direction.

The results in this case are dramatically different from the results obtained when propagation was along the fiber direction. The reflection coefficient is extremely sensitive to the presence of a delamination between the FRP and the concrete. These differences are very clearly shown in Figure A.7, which presents the reflection coefficients at incidence angles of 5, 10, 15, and 20 degrees. The frequency range was limited to 150 – 250 kHz again.

From Figure A.7(a), 5 degrees incidence angle, it is clear that the difference in reflection coefficients is at least 0.5 along the plotted frequency range, except for the dip in the delamination data at approximately 160 kHz, and a very narrow spike at 200 kHz. The same is observed in Figure A.7(b), 10 degrees incidence angle, al-

though in this case the first dip appears to be centered around 175 kHz, and the spike has moved to a frequency slightly higher than 200 kHz.

For an incidence angle of 15 degrees, Figure A.7(c), there is no spike on the delamination reflection coefficient, the dip moved to 200 kHz, and a sharp spike at approximately 170 kHz. Finally for an incidence angle of 20 degrees, Figure A.7(d), the difference is very smooth with a minimum value of 0.4 and a maximum value of 0.7.

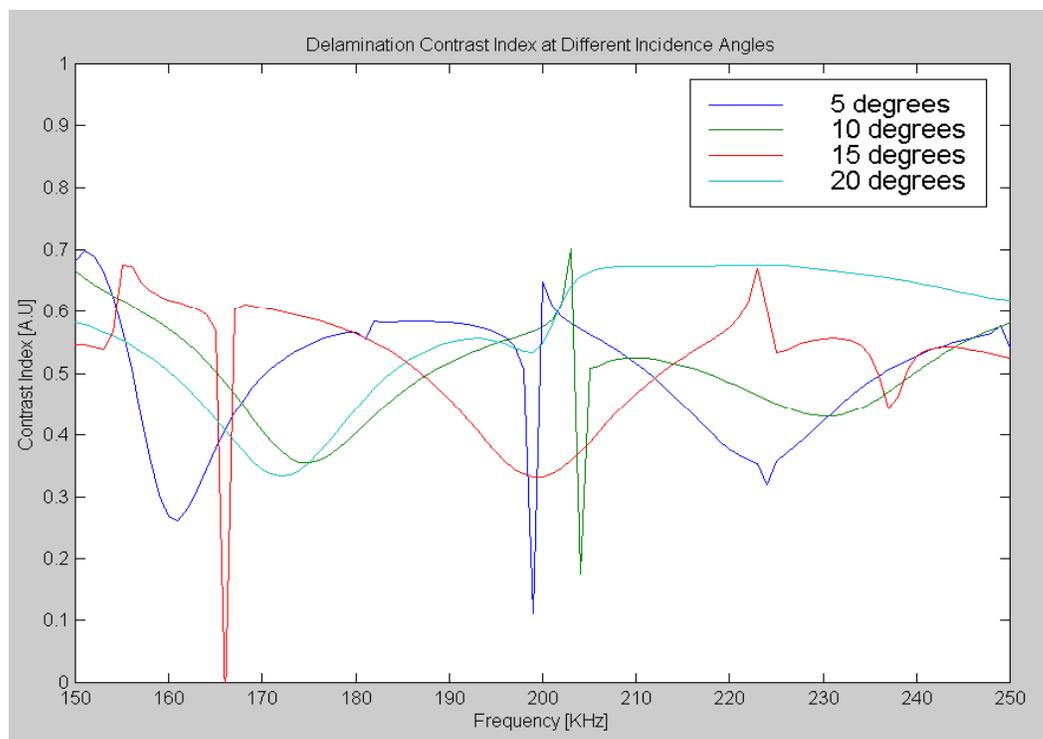
Figure A.8. Delamination contrast index as a function of frequency for different incidence angles. Wave propagation is across the fiber direction.

Figure A.8 presents the contrast index for the delamination between the FRP and the concrete for acoustic waves propagating across the fiber direction. The contrast index presented in this figure suggests that the best incident angles to inspect the FRP/concrete system modeled are 15 and 20 degrees at frequencies between 210 and 250 kHz. In fact, the best angle according to the mathematical model would be 20 degrees. At this angle, the contrast index shows a smooth curve in the presented frequency range with an almost-constant value of 0.65.

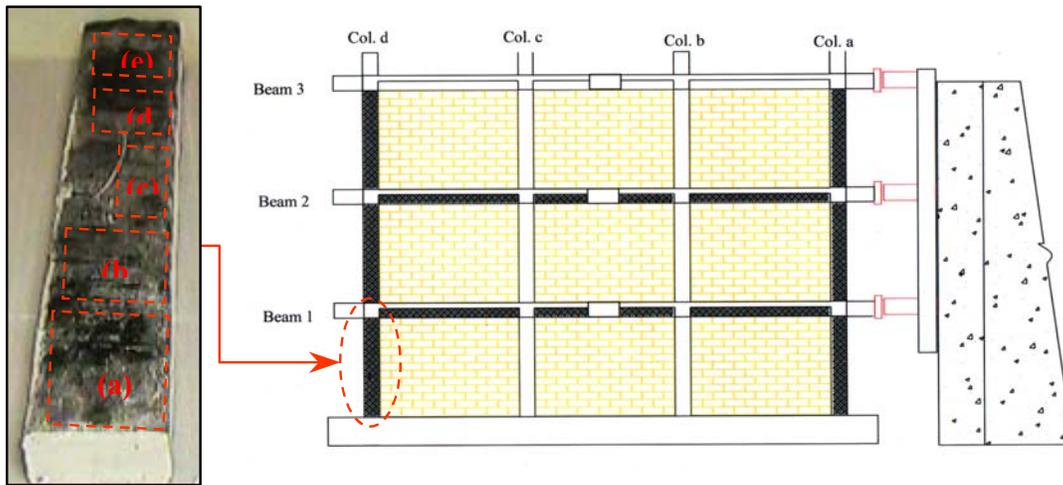
Figure A.9. FRP/concrete section of ERDC/CERL column from Model 2. The areas indicated on the column section were inspected with the guided wave AU system.

As a preliminary test it was important to use the Guided Wave AU system to inspect a section from an FRP-reinforced concrete column described by [Al-Chaar et al. 2002]. Figure A.9 shows a schematic of this structure indicating the position of the column section.

The loading process created cracking in some of the structural components, among them the column section shown in Figure A.9. In order to examine the condition of the bonding between the FRP and the concrete column, C-scan images of five different sections of the column were generated, as also indicated in Figure A.9. Figure A.10 shows a picture of the multi-sensor probe mounted on the scanning bridge while inspecting the FRP retrofitted column.

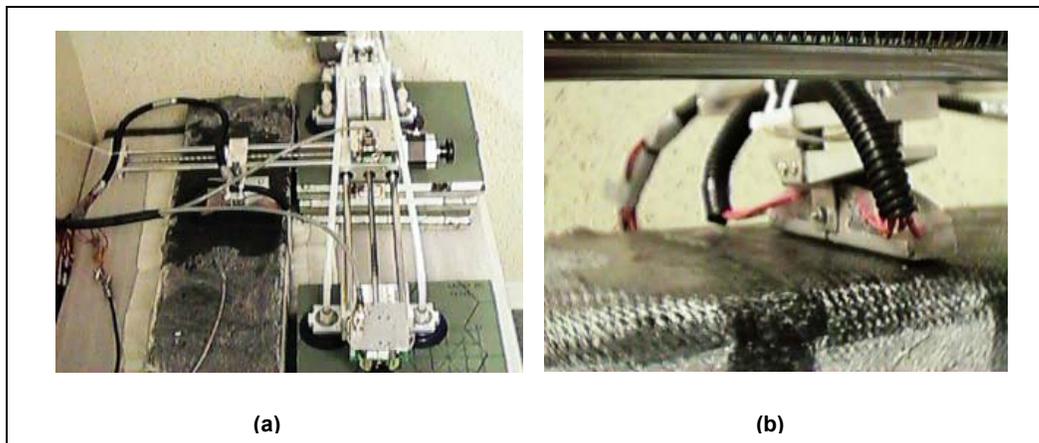
Figure A.10. Guided wave AU inspection of a FRP wrapped concrete column: (a) computer controlled scanning bridge with multi-sensor probe; (b) detail of the multi-sensor probe while scanning a section of the column.

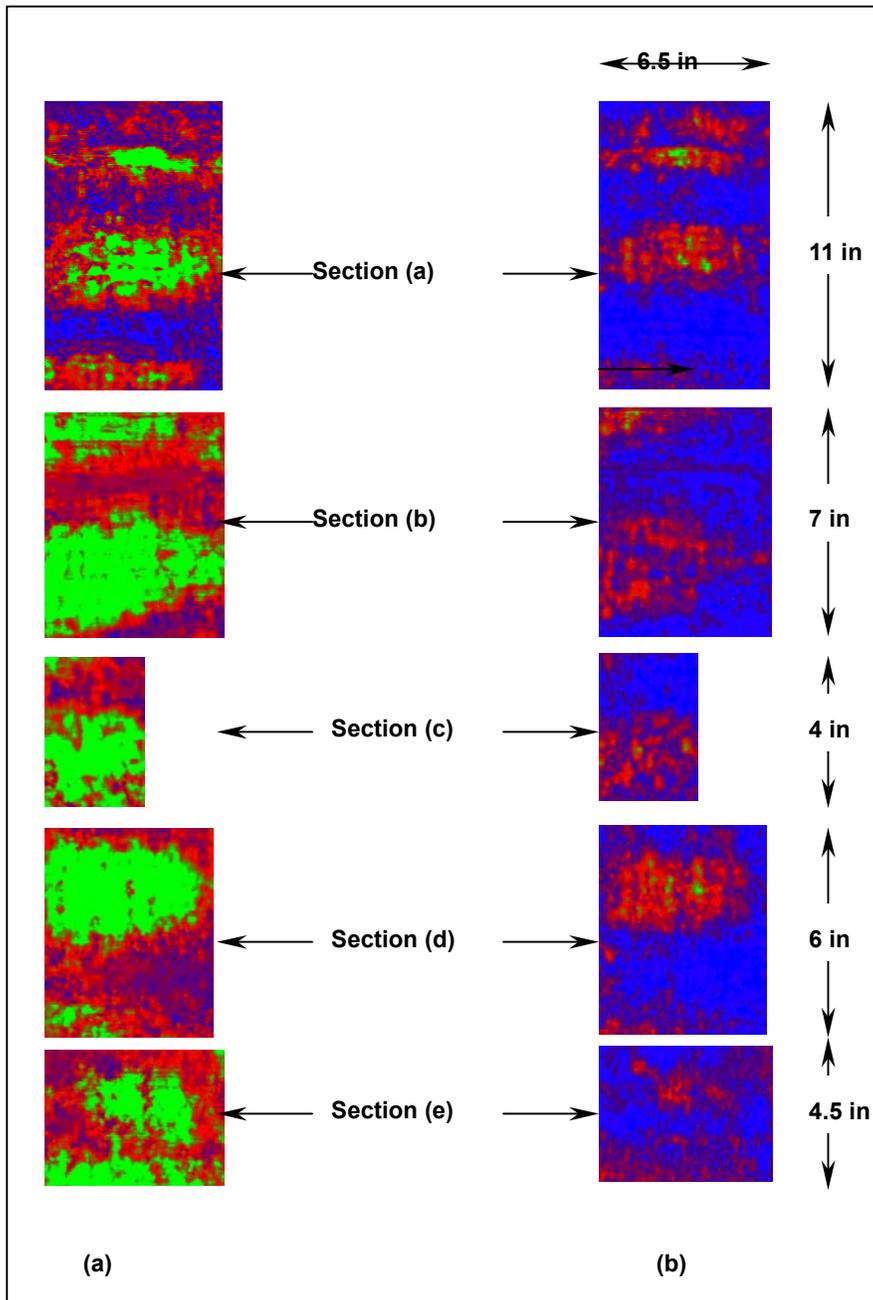
Figure A.11. C-scans of different sections of the ERDC/CERL FRP wrapped concrete column. In all cases the pulsing sensor was oriented at an incidence angle of 15 degrees and the receiving sensors were oriented at (a) 15 degrees or (b) 20 degrees.

The C-scans shown in Figure A.11(a) were generated with the pulsing and receiving sensors oriented at an angle of 15 degrees. The scans in Figure A.11(b) were generated with the pulsing sensor oriented at 15 degrees and with the receiving sensor oriented at 20 degrees. In both cases the sensor was excited with a 10 cycle burst of 4 volts peak to peak amplitude and frequency of 225 kHz. The original plan was to perform the largest possible scans allowed by the scanning bridge, which are scans of 15 in. long. However, the surface of the column section presented areas that were very uneven, in which the scanning probe could not be positioned. Due to the design of the current probe, these areas could be as large as 3 in. making it impossible to overlap the C-scans.

The C-scans in Figure A.11(a) show areas with very high reflected amplitudes, in bright green, which are indicative of delamination between the FRP and the concrete column. The C-scans in Figure A.11(b) confirm the presence of delamination in the concrete column, particularly in sections (a) and (d) where there are areas with high reflected signals detected with the 20 degrees receiver sensor.

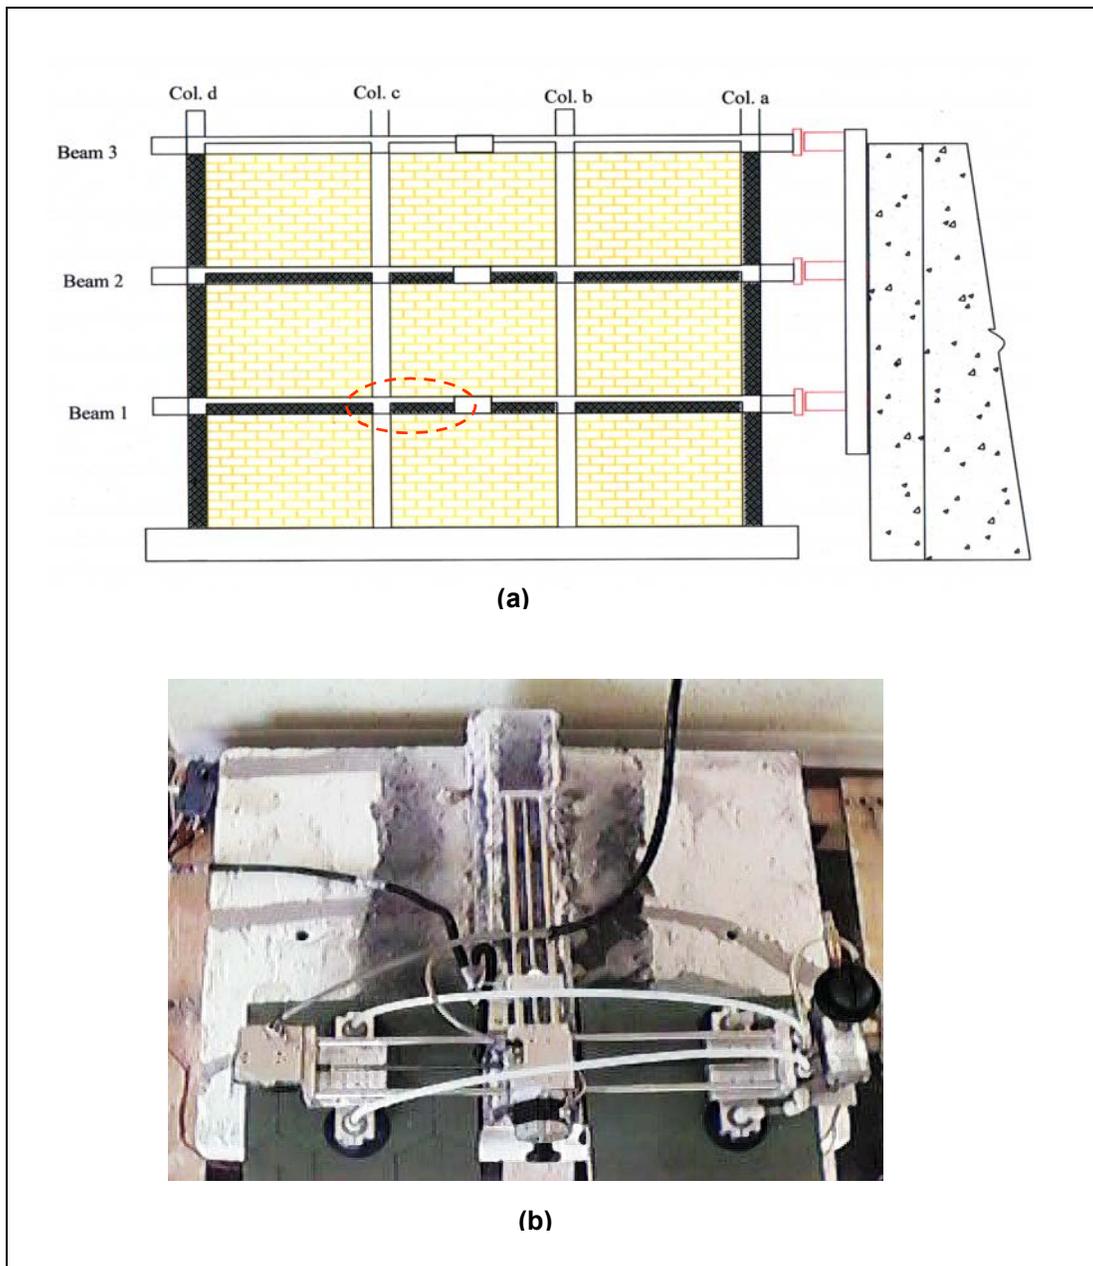
Figure A.12. Location of the deck section inspected (a); guided wave AU inspection of an FRP-reinforced deck (b).

A second FRP-reinforced piece was inspected — in this case, a section of a deck from the multistory structure, whose position is shown in Figure A.12(a). Figure A.12(b) shows a detail of the inspection performed with the scanning bridge. The results of the inspection are shown in Figure A.13.

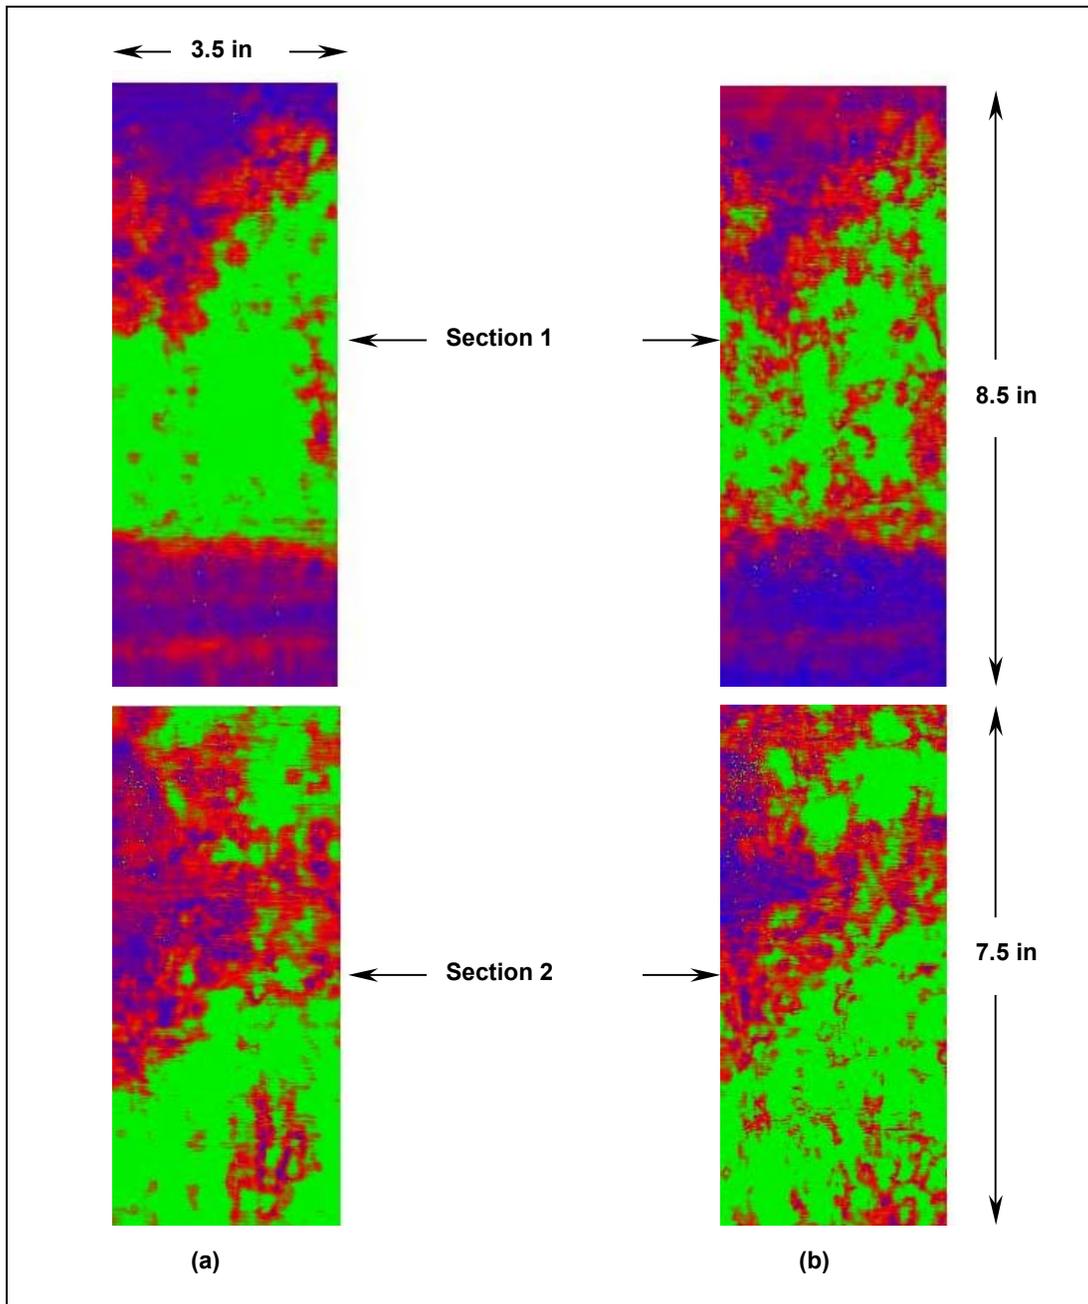
Figure A.13. C-scans of two different sections of the ERDC/CERL FRP reinforced concrete deck (also referred to as the beam section). The pulsing sensor was oriented at an incidence angle of 15 degrees and the receiving sensors were oriented at (a) 15 degrees or (b) 20 degrees.

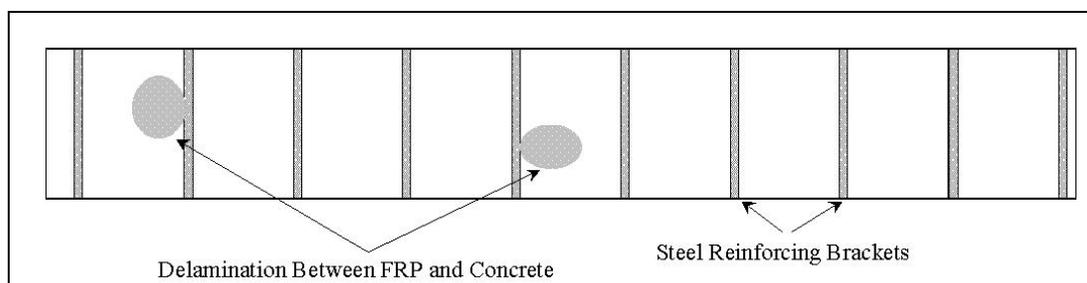
Figure A.14. Dimensions of the FRP-retrofitted column removed from the multistory structure subjected to simulated seismic excitation.

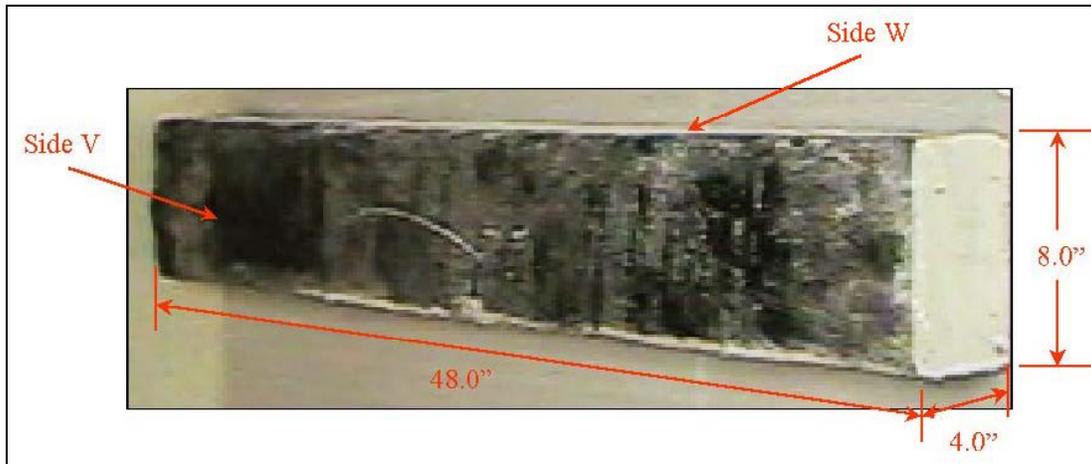
Figure A.15. Location of delamination and steel reinforced stirrups in the -retrofitted column. Side V is shown.

As documented previously in the report, ERDC/CERL provided the column with steel reinforcing stirrups located at approximately 5" intervals along the column. The areas with possible delaminations were approximately 3" in diameter and located the V side of the column. Figure A.15 shows a drawing of side V of the column section with the approximate location of the delaminated areas and the reinforcing stirrups.

Figure A.17(a) shows mostly green tones in the inspected areas, with some areas in red tones and two evident blue spots on sections A and B. The locations of these spots correspond to the position of the delaminations shown in Figure A.15. It is important to note that the scans of section A and B did not cover the delaminated areas completely because of the surface condition of the FRP, as discussed earlier in this section of the report. Also, there was a sudden change in amplitude at the line dividing the section A and section B images, caused by the rougher condition of the surface on section A. In sections C and D, also in Figure A.17(a), three thin strips — mostly in red with a few spots in blue tones — can be distinguished, the most noticeable being the one located on the middle of section D.

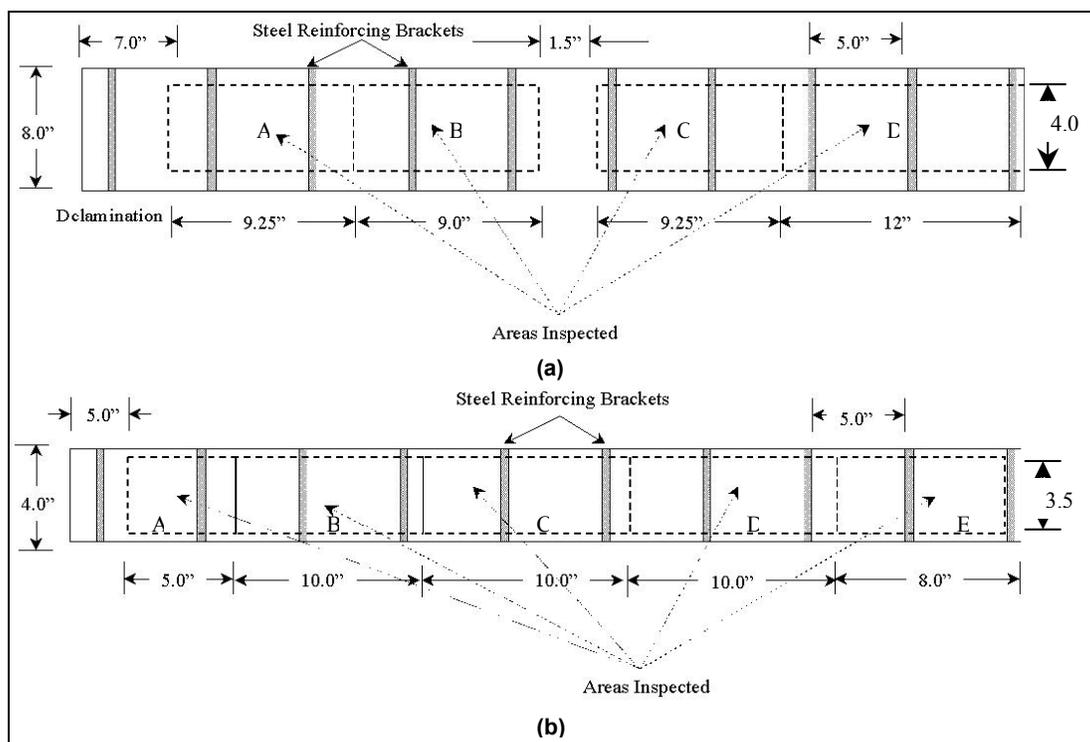
Figure A.16. Dimensions and location of the areas inspected on the FRP-retroffited column section: (a) side V and (b) side W.

Four sections of side V of the column section were scanned. These sections were 9.25 in. (A), 9.0 in. (B), 9.25 in. (C), and 12 in. (D) long and 4 in. wide, as shown in Figure A.16(a). These sections were chosen because the FRP surface roughness and ripples were smaller than 0.0625". Ripples higher than 0.0625 in. made good coupling between the sensor probe and the FRP very difficult. Also, five sections were scanned on side W as shown in Figure A.16(b). The dimensions of these sections were 5.0 in. (A), 10.0 in. (B), 10.0 in. (C), 10.0 in. (D), and 8.0 in. (E) long and 3.5 in. wide.

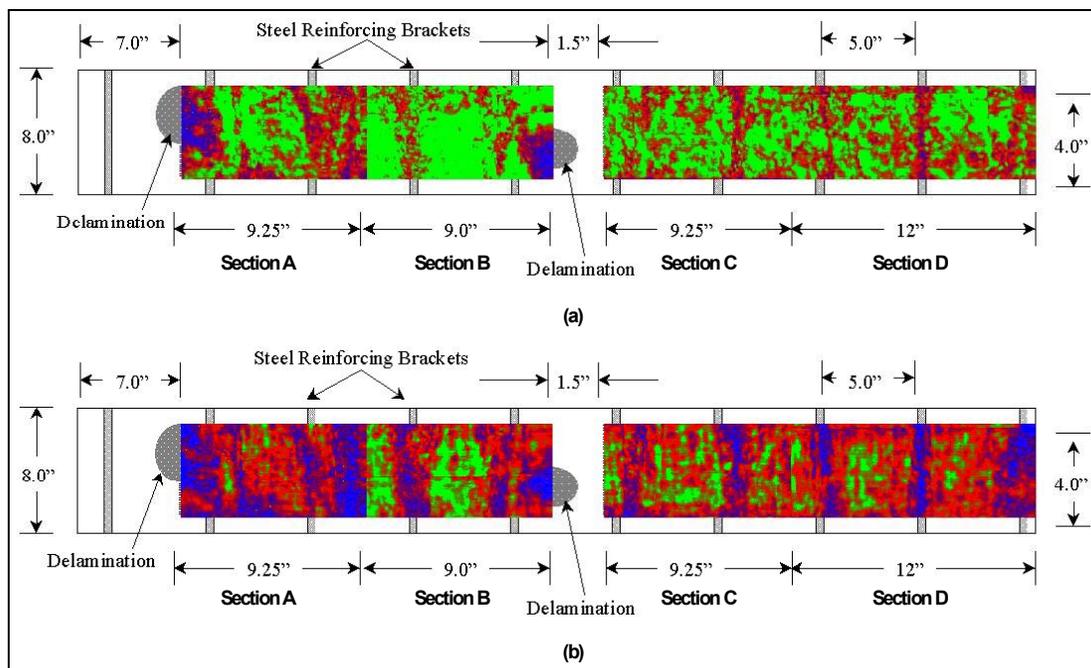
Figure A.17. C-scan images of the areas inspected on side V of the FRP-retrofitted column section. The scans were generated by pulsing with a sensor oriented at 10 degrees and receiving with (a) receiver oriented at 10 degrees and (b) receiver oriented at 15 degrees.

Figures A.17(a) and A.17(b) show the C-scan images of side V obtained when using the pulser oriented at 10 degrees and receiving the signal with sensors oriented at 10 and 15 degrees, respectively.

The C-scans in Figure A.17 (a) and (b) show high-amplitude reflected AU signals in green tones, medium-amplitude signals in red tones, and low-amplitude signals in blue tones.

When a delamination is present, the AU pulses are forced to propagate along the FRP, which causes a severe loss of energy due to the FRP structure, thus the low amplitude detected at the receiver end.

The three medium-amplitude stripes aligned with the reinforcing stirrup position are caused by dispersion of the AU signals at the concrete/stirrup interface. The C-scan images of Figure A.17(b) show more clearly the three stripes, now in blue tones, already observed in Figure A.17(a). In addition, a fourth stripe is now observed on the left-hand side of section C, which corresponds to the position of another reinforcing stirrup. In this case, the stripe is not aligned with the direction of the stirrup, which may be an indication of the real orientation of the reinforcing stirrup. The same is observed for another stripe now visible on the right-hand side of section D, where there is another reinforcing stirrup. The same is observed for another stripe now visible on the right-hand side of section D, where there is another reinforcing stirrup.

The C-scan images of sections A and B in Figure A.17(b) show also three stripes, corresponding to the locations of steel stirrups although the alignment is off. The first one is located on the right-hand side of section B to the left of the delamination, and the second on the left-hand side of the section. The third one is on section A, to the left of a wide blue area between the two stirrup positions. This wide blue area, also visible in red tones in Figure A.17(a), is the result of a coupling loss between the sensor and the FRP caused by the extremely uneven surface of the FRP in that particular location.

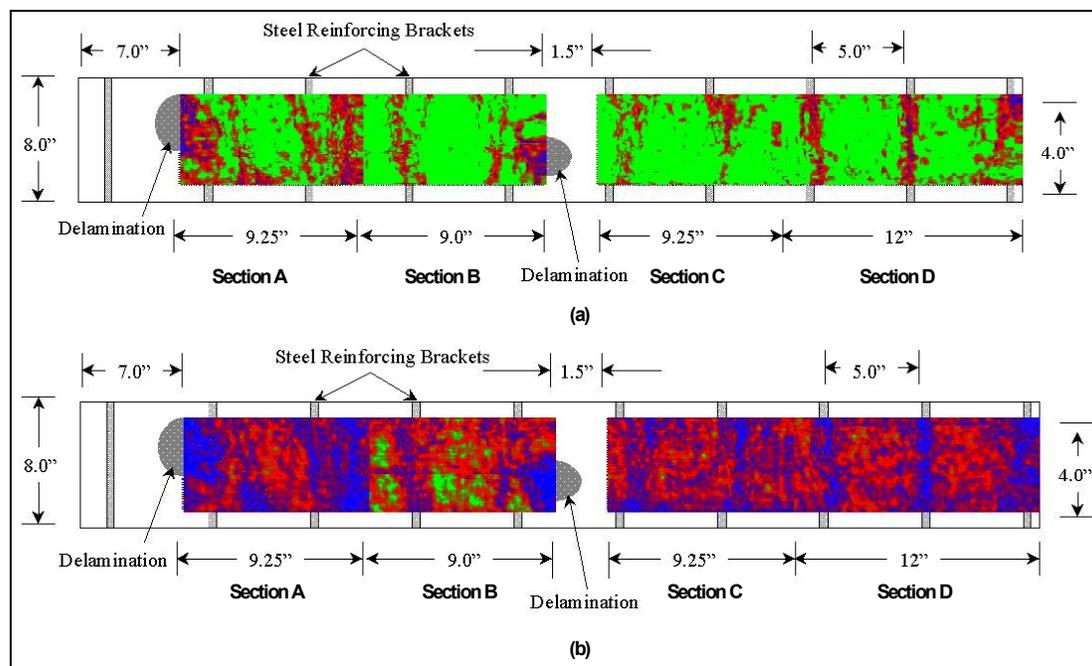
Figure A.18. C-scan images of the areas inspected on side V of the FRP-retrofitted column section. The scans were generated by pulsing with a sensor oriented at 15 degrees and receiving with (a) receiver oriented at 10 degrees and (b) receiver oriented at 15 degrees.

Figures A.18(a) and A.18(b) show the C-scan images generated using a pulsing sensor oriented at 15 degrees and sensors at 10 and 15 degrees as receiver, respectively.

The C-scan images generated with the signal received at 10 degrees, Figure A.18(a), show the same stripes as in Figure A.17(a). In this case, the contrast between the stripes in red tones and the background in bright green is much better than in the case of the pulser oriented at 10 degrees. However, the delaminated areas do not appear as well defined as in the previous case. This is an indication that the configuration with the pulser at 10 degrees provides a better definition of delaminated areas.

Figure A.18(b) shows the C-scan images generated with the signal received at 15 degrees. The contrast is similar to Figure A.18(a) although the background is in red tones and the stripes and delaminations appear in blue, an indication of a general reduction in the amplitude of the reflected signals. It is important to note that the delaminations are better defined in Figure A.18(b) than in Figure A.18(a). The area between sections A and B, where coupling was lost, is also present in Figures A.18(a) and A.18(b).

A total of ten cuts were made, eight of them in places where the C-scans of Figure A.18(b) show indications of the presence of reinforcing stirrups, and the remaining two in the middle of the locations where Figure A.18(b) showed evidence of delamination. As a result of this process, the column was cut into 11 pieces.

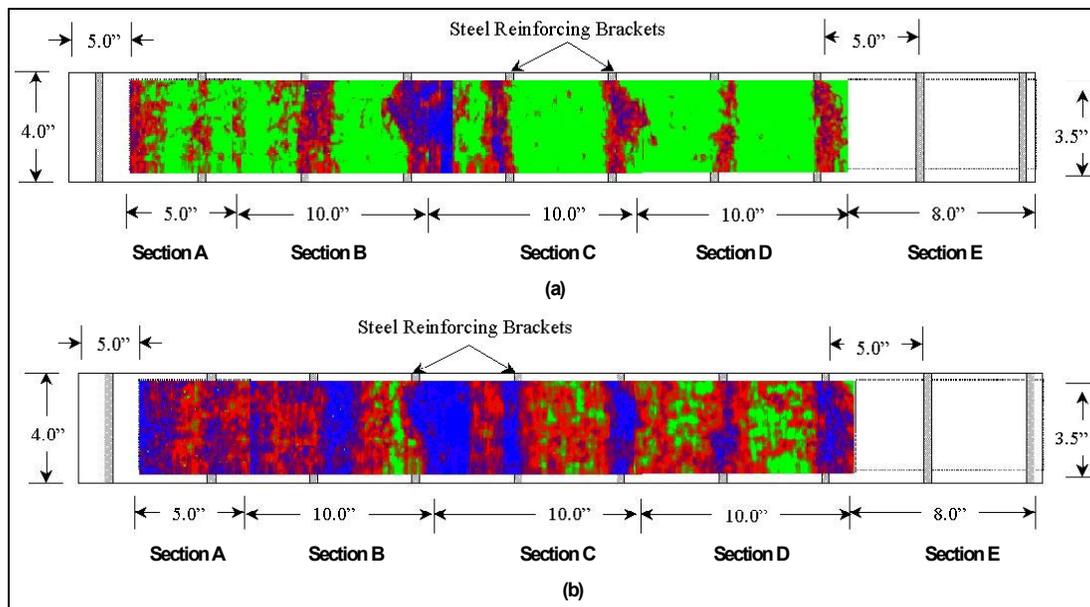
Figure A.19. C-scan images of the areas inspected on side W of the FRP-retrofitted column section. The scans were generated by pulsing with a sensor oriented at 10 degrees and receiving with (a) receiver oriented at 10 degrees and (b) receiver oriented at 15 degrees.

Figure A.19 shows the C-scan images of the sections inspected on side W of the FRP-retrofitted column section. These scans were generated by pulsing with a sen-

The positions of the reinforcing stirrups are clearly seen in Figure A.19(a), as stripes in red tones over a bright green background in sections B, C, and D. Section A also shows a red stripe over the position of a stirrup, although not as well defined as the stripes in the other sections. The stripes in sections C and D show particularly good contrast, followed by the stripes in section B, with the stripe on section A showing the worst contrast. The left-hand side of the section C image shows a very well defined blue stripe, which seems to be caused by a delamination between the concrete and the FRP. The data for section E were damaged and a C-scan image for this section could not be generated.

Figure A.19(b) shows the C-scan images generated with the receiver sensor oriented at 15 degrees. The contrast is similar to that observed in Figure A.19(a) and the features shown by the images are basically the same. The only difference is the overall amplitude of the reflected signals, which is lower for this case. This reflects in the red background with a few green spots, while the reinforcing stirrups are shown in blue tones.

The left-hand side of section A shows a reduction in the reflected signal amplitude, blue and red tones, perhaps caused by roughness on the FRP surface. This is also observed in the images in Figures A.19(a) and A.19(b).

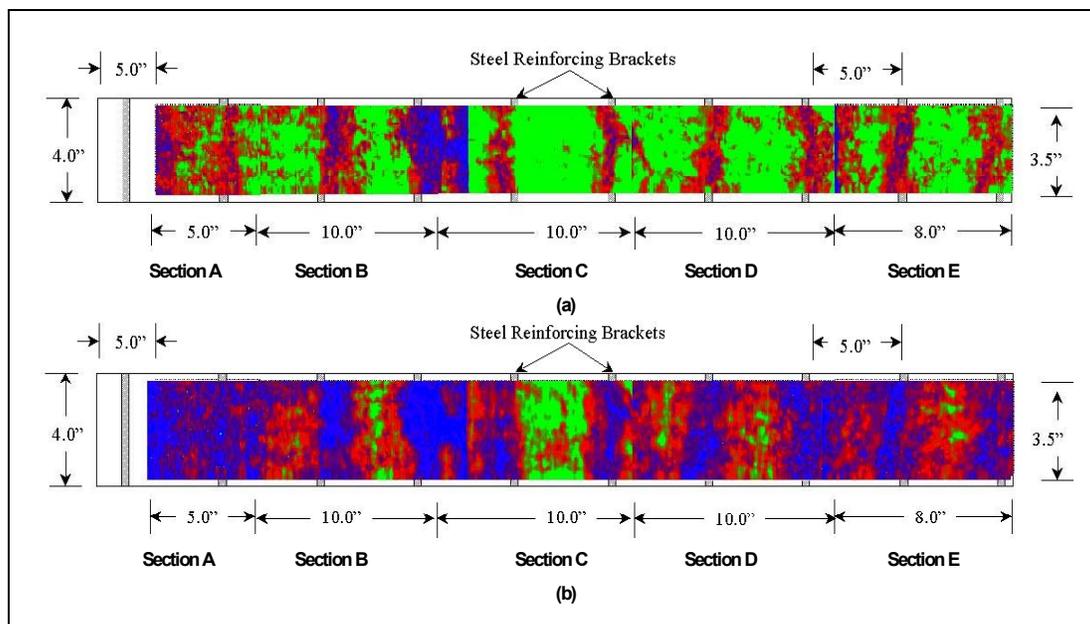
Figure A.20. C-scan images of the areas inspected on side W of the FRP-retrofitted column section. The scans were generated by pulsing with a sensor oriented at 15 degrees and receiving with (a) receiver oriented at 10 degrees and (b) receiver oriented at 15 degrees.

The last set of C-scans is shown in Figures A.20(a) and A.20(b) and it corresponds to images generated with the pulsing sensor oriented at 15 degrees and the receivers oriented at 10 and 15 degrees, respectively. These C-scan images show similar

characteristics as those in Figures A.19(a) and A.19(b). In Figure A.20(a), the receiver is at 10 degrees, the reinforcing stirrups appear as very well defined red stripes over a bright green background in all the sections. As in Figure A.19(a) there is one area, located between sections B and C, that shows very low signal amplitudes, blue tones, which seems to be caused by a delamination. It is important to note that the presence of this possible delamination was not detected in the preliminary NDE inspection (section A-4.1) since this side of the column was not scanned.

The C-scan images of Figure A.20(b) show an overall reduction in reflected signal amplitude with respect to Figure A.20(a) but the reinforcing stirrups are visible as blue stripes over a generally red background. The only exception is the central area of section C that shows a green background which is caused by a very smooth FRP surface that allows excellent coupling with the sensor probe.

The area on the left-hand side of section C, which seems to be caused by a delamination, is visible as in Figure A.20(a) and it overlaps with the blue stripe caused by the reinforcing stirrup located on the right-hand side of section B.

Figures A.22(a) and A.22(c) show pictures of the cross-section of pieces 1 and 5, both containing delaminations on side V of the column. The close-up pictures clearly show the delaminations between the FRP wrap and the concrete column. Figure A.22(b) shows the cross-section of piece 4, with the delamination detected on side W, visible as a clear blue area on Figure A.20(b), pulser and receiver oriented at 15 degrees.

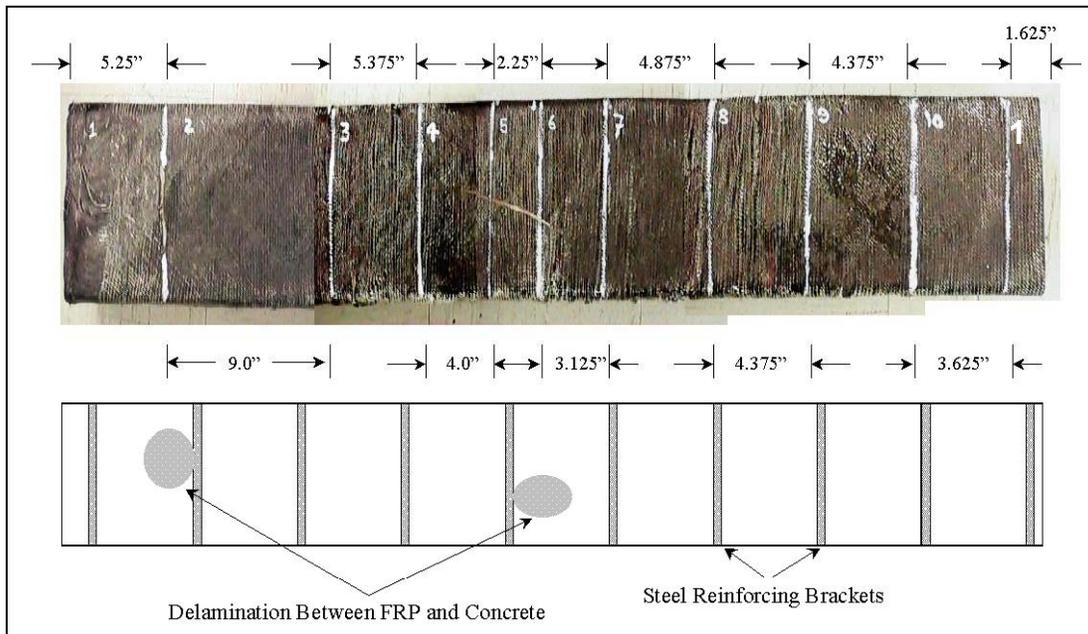
Figure A.21. Location of the cuts performed on the column section. The position of the cuts was determined according to the delaminations and stirrup positions on side V.

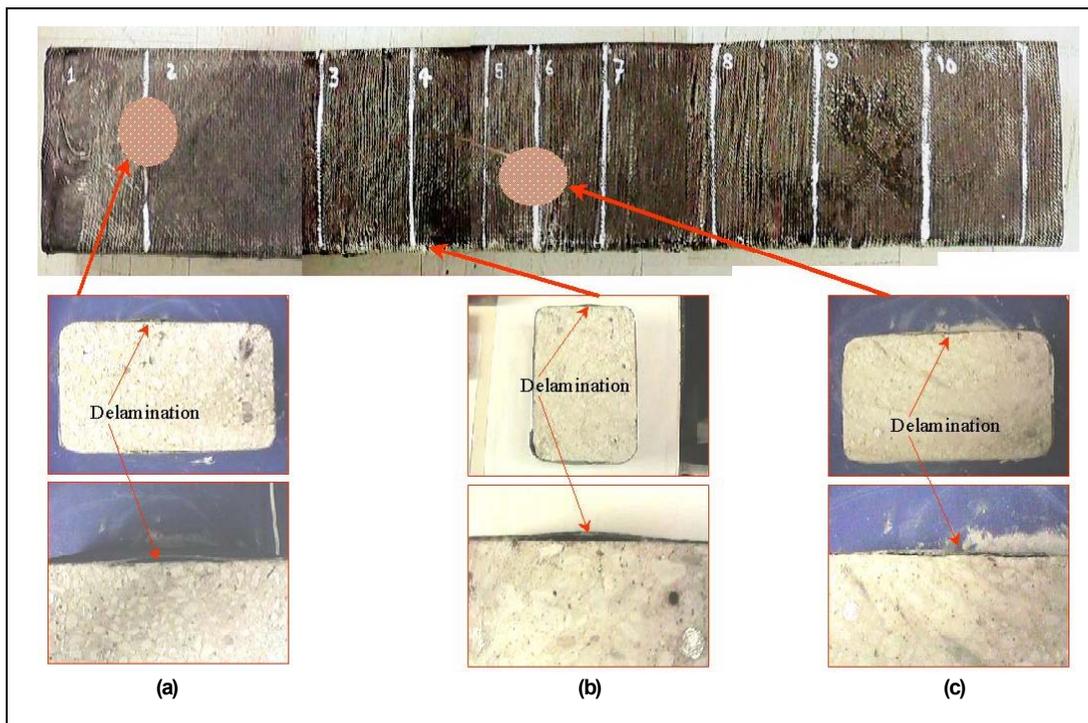
Figure A.22. Cuts on the column section shown the delaminations detected in the column section using the AU C-scan images of side V and W: (a) First delamination on side V, (b) delamination detected on side W, and (c) second delamination on side V.

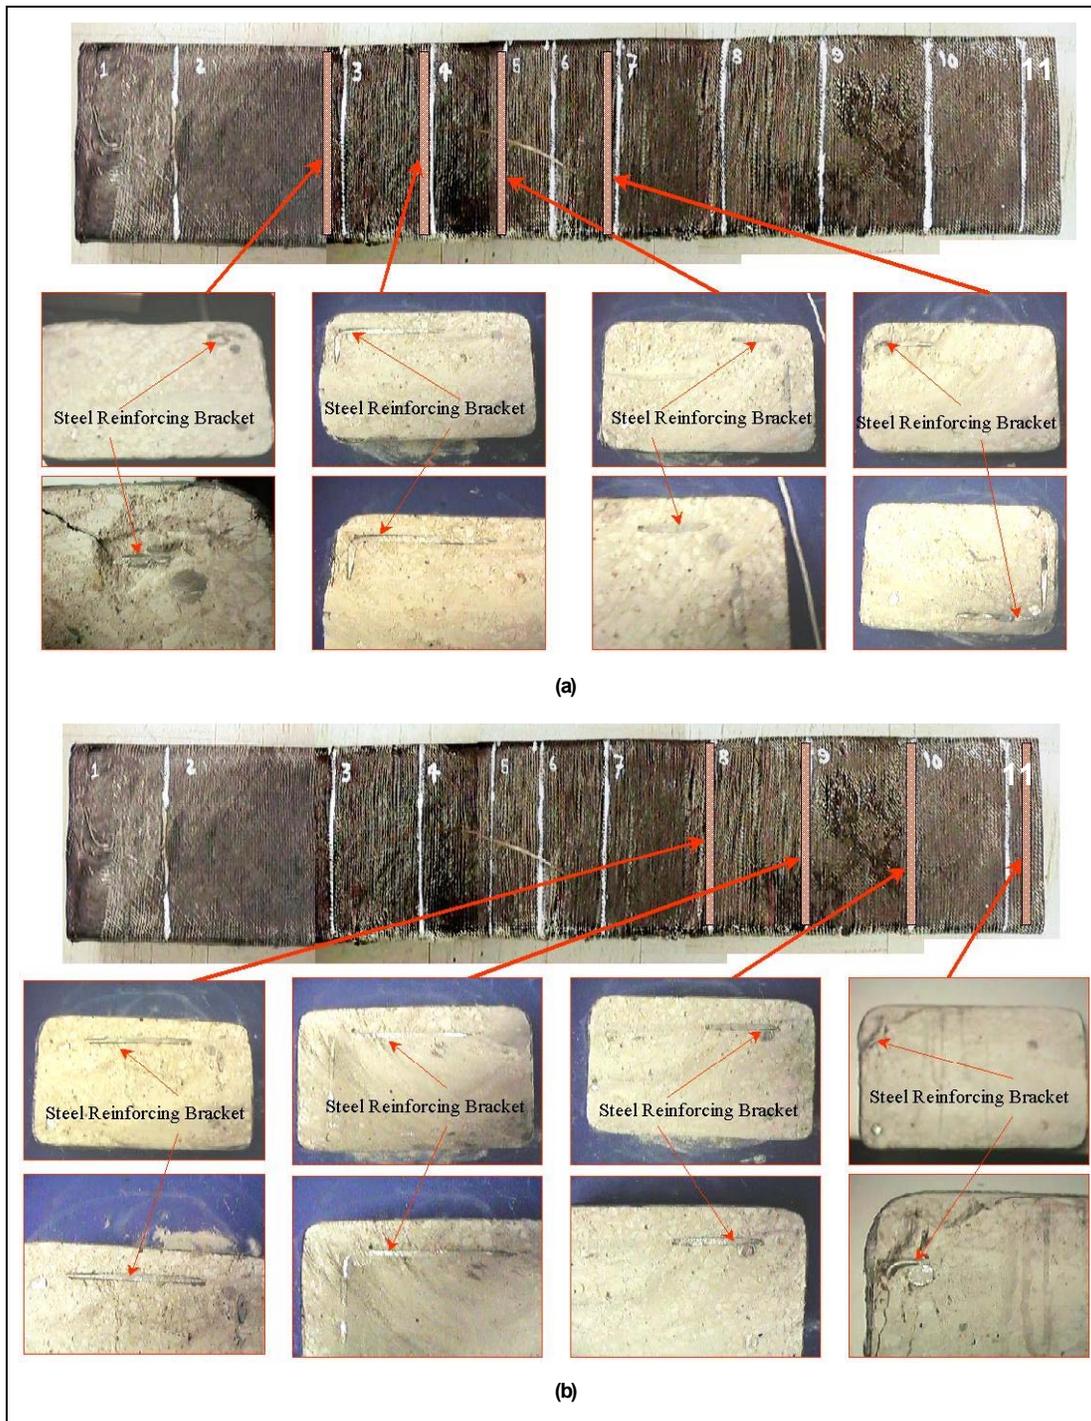
Figure A.23. Cuts on the column section showing the steel reinforcing stirrups detected using the AU C-scan images of side V.

Figure A.23 presents cross section and close-up pictures of the 8 pieces of the cut column that contained steel reinforcing stirrups. These pieces were numbered 2, 3, 4, 6, 8, 9, 10, and 11. In every one of the pictures, the steel stirrups are revealed.

Pieces 3, 4, 6, 8, 9, and 10 revealed the stirrups right on the position of the cuts, without any need for removing extra material. This indicates that the location of the stirrups, extracted from the C-scan images of side V were accurate within 0.125 in., which is the thickness of the cutting blade used. For pieces 2 and 11, it was necessary to remove about 0.250 in. of material to uncover the reinforcing stirrups.
