ERDC/CERL TR-03-32

Technology Demonstration of Wet Abrasive Blasting for Removal of Lead- and Asbestos- Containing Paint

Final Report

ABSTRACT: A group of 1940s-era concrete block buildings at Fort Carson, CO, must be demolished, but they are coated with lead-based paint containing asbestos filler that must both be disposed of as hazardous waste. In order to decrease waste disposal costs, an improved method was needed to remove both coatings while rendering the lead-containing debris non-leachable). This technology demonstration showed that wet blasting using an engineered abrasive can safely and effectively remove lead- and asbestos-containing paint from exterior concrete masonry unit walls, producing an asbestos-free substrate ready for conventional demolition or renovation. The combination of water injection into the blasting process and a ventilated containment structure produced zero visible emissions and complied with applicable asbestos and lead air quality standards. Use of the chemical stabilizing product Blastox® in the dry blast media eliminated the toxic lead characteristic from the paint removal waste. The estimated unit area cost (UAC) of the demonstrated technolog

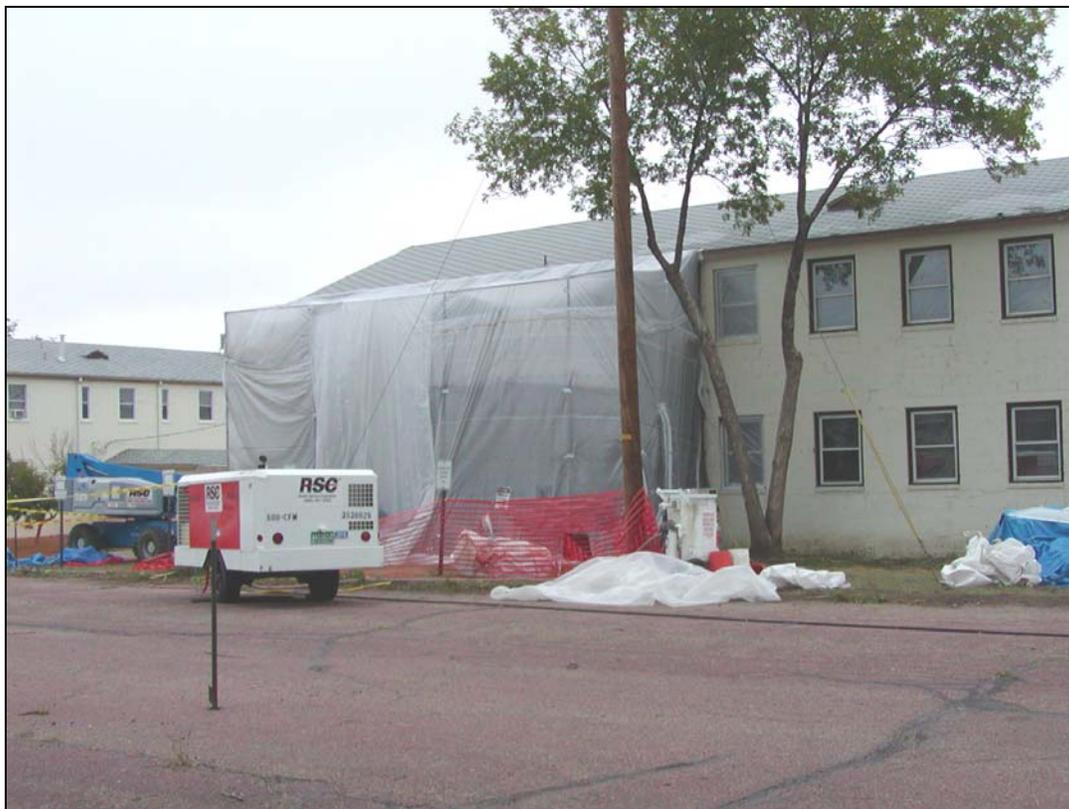
Figure 1. Overview of paint removal operation.

Mobilization consisted of staging and erecting all project equipment, including the containment structure, critical barriers, decontamination area, air ventilation and filtration systems, blasting equipment, man-lift, waste storage area, and demarcation of the regulated area (Figure 1).

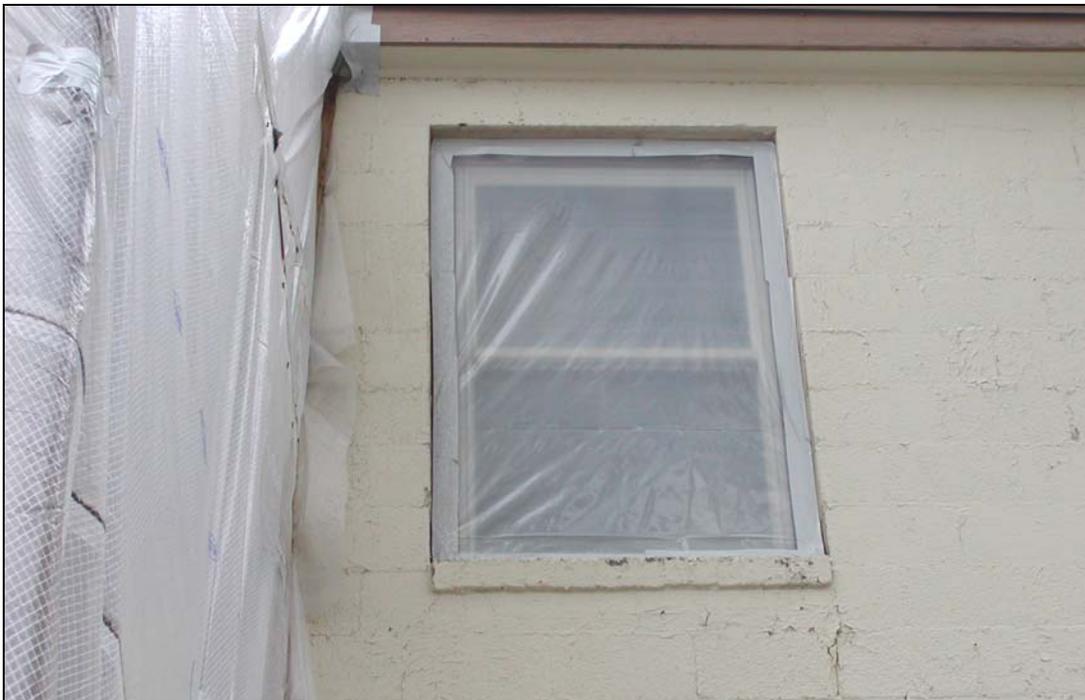
Figure 2. Critical barrier of 6-mil polyethylene sheeting placed over window.

Critical barriers of 6 mil polyethylene (PE) sheeting were placed over all building openings including windows, doors, ventilation ducts, and other openings (Figure 2). A containment structure consisting of 6 mil reinforced PE sheeting affixed to a vertical pipe tube-frame structure (cover photograph) was erected. The tube-frame was attached to the CMU wall using screw fasteners. The containment floor was constructed of 1 in. plywood overlaid with two layers of 6 mil PE sheeting. The average containment structure measured 10 ft x 22 ft x 45 – 60 ft (depth, vertical height, horizontal length). The average coated surface area contained by the structure was 1000 sq ft. The decontamination area was a purpose-built plywood box enclosure connected to one end of the containment structure. Ventilation and high-efficiency particulate air (HEPA) air filtration was connected with two flexible 12 in. diameter tubes to the opposite end of the containment (Figure 3). Two ventilation fans rated at 2000 standard cubic feet per minute (scfm) each supplied a maximum ventilation capacity of 4000 scfm. Input air was forced-air using a 1900 scfm rated fan. The containment cross-sectional area was approximately 220 sq ft. The maximum calculated horizontal air velocity inside the containment was 18 feet per minute (fpm). The maximum tube transport velocity was 640 fpm. Air movement was confirmed using smoke tubes each time the containment was erected. Negative air pressure was confirmed using a manometer during operation (Figure 4). The containment and ventilation system utilized was approximately equivalent to SSPC-Guide 6, Class 1W (A1, B3, C1, D1, E2, F2, G1, H2, I1, J1) except that instrument verification of negative air pressure was required (H1) and minimum air velocity was not specified (I2).

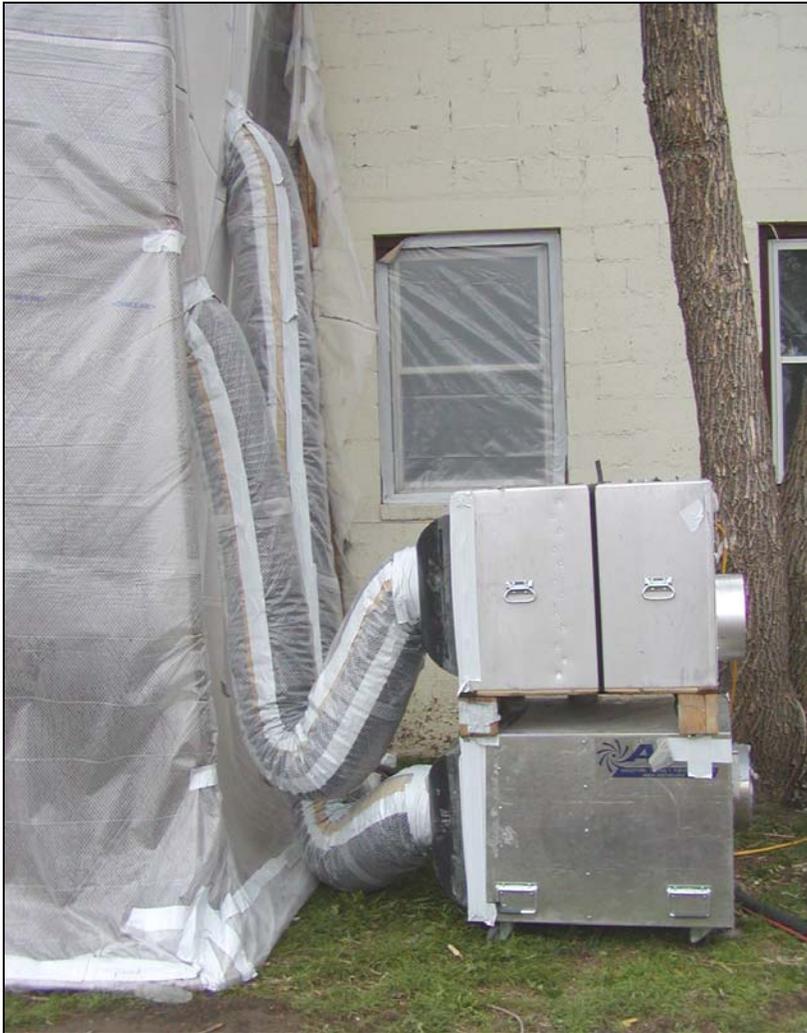
Figure 3. Ventilation units and ducts attached to end of containment.

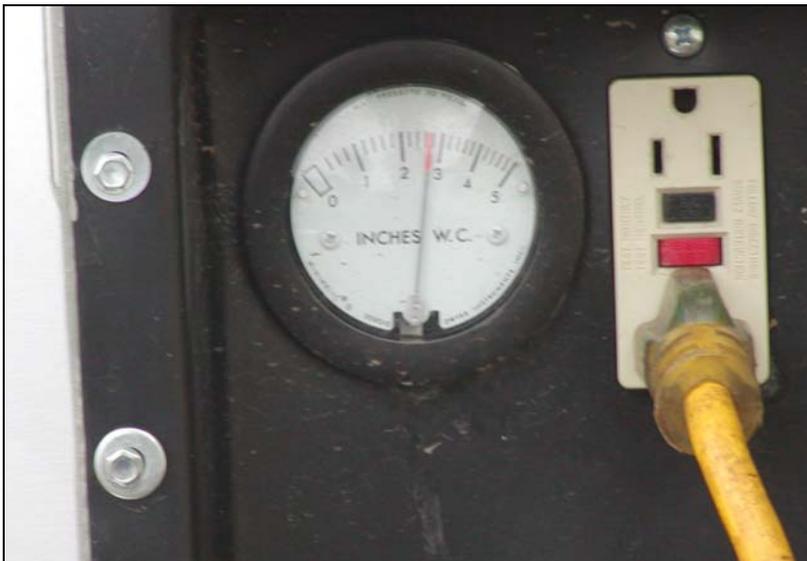
Figure 4. Negative pressure inside of containment as indicated by manometer.

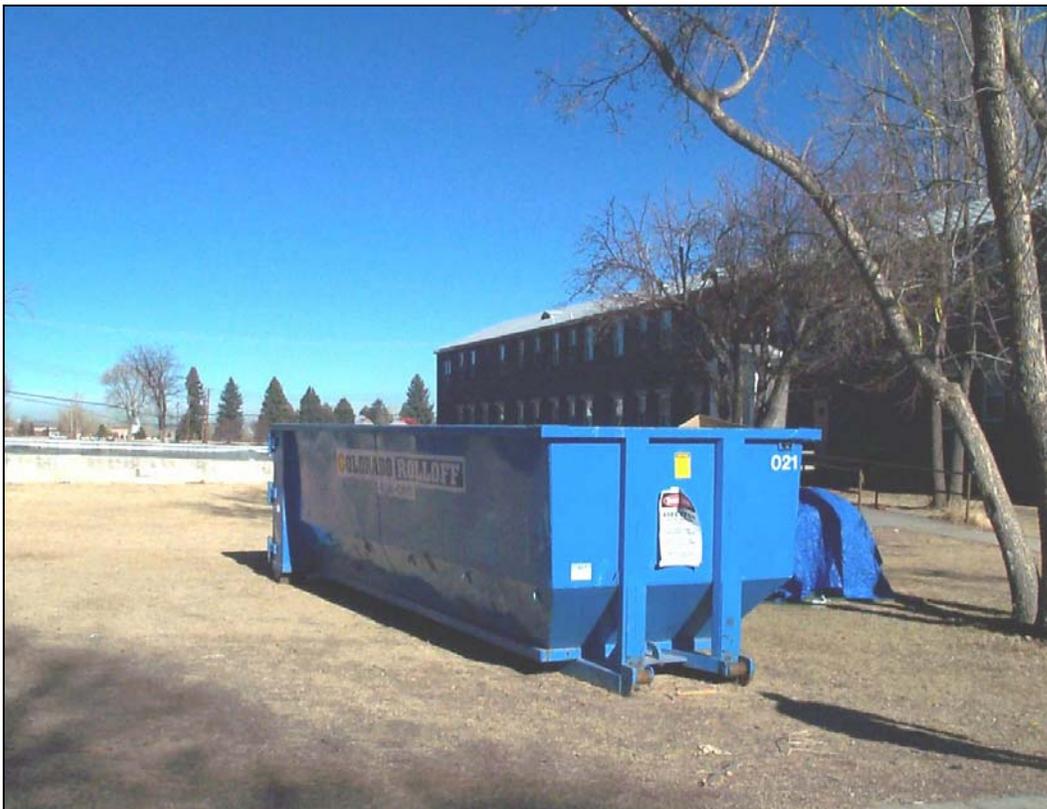
Figure 5. Forty cubic yard roll-off waste container.

A 60 ft boom-type man lift was positioned outside the containment with the boom inserted through the containment wall. The regulated area was demarcated using signs and tape, and the waste storage area was sited close to the containment structure (Figure 5).

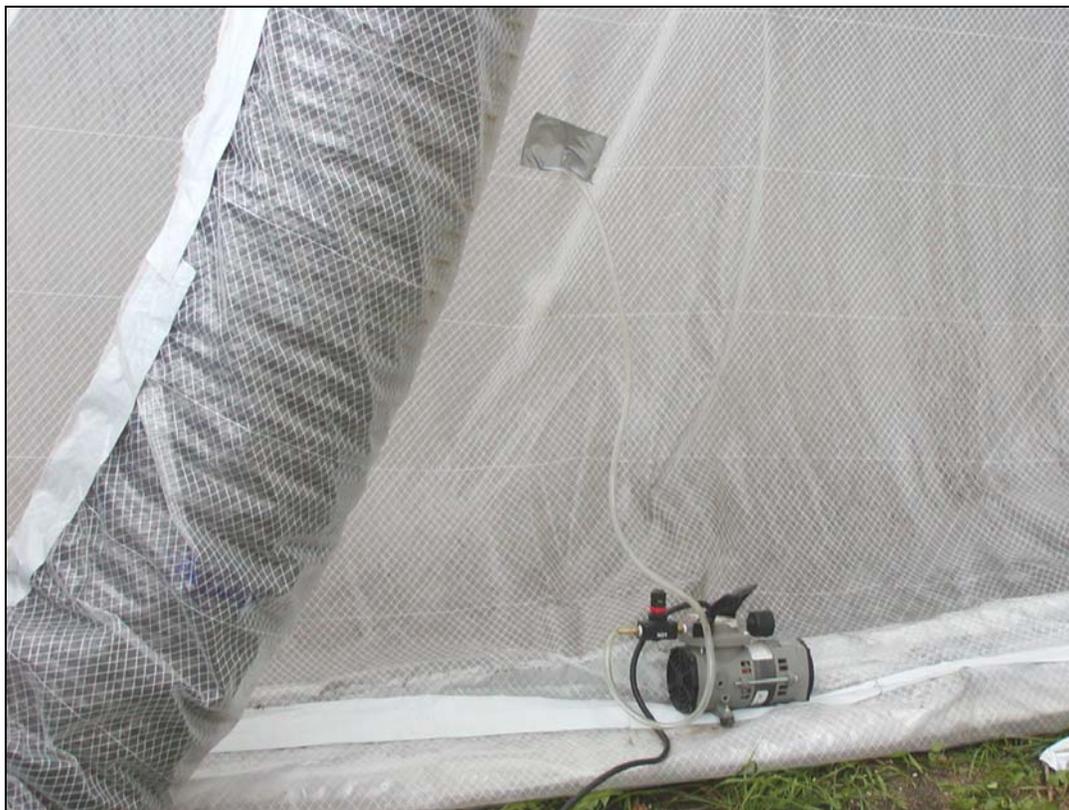
Figure 6. Low-volume air pump for PAM sampling.

Personal air monitoring (PAM) was conducted to assess worker lead and asbestos exposures for the blaster and blast pot tender (Figure 6). Periodic air monitoring for ambient lead and asbestos concentrations was also performed to assess containment and ventilation efficacy.

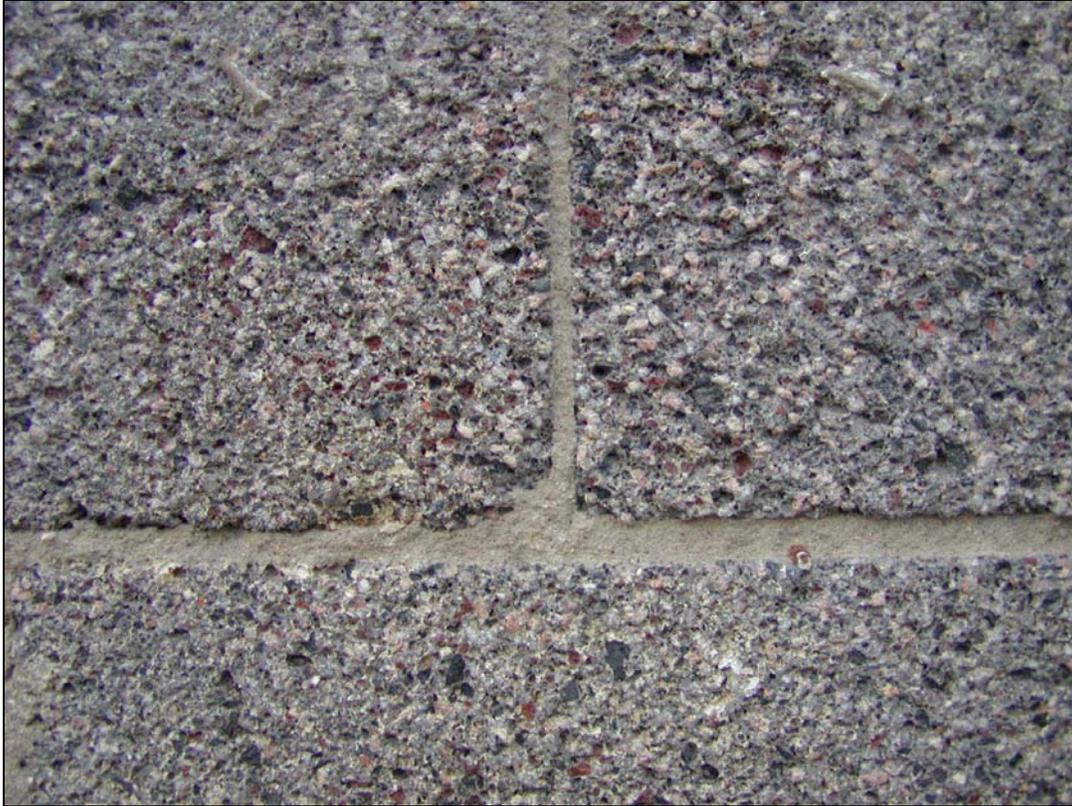
Figure 7. Rough substrate free of ACM.

After cleanup and lockdown, an independent certified industrial hygienist performed visual and instrumental inspections. Surfaces were considered asbestos-free when no areas of residual coating greater than the size a quarter dollar were present (Figure 7). Secondary remediation (i.e., touchup paint removal) was accomplished using a vacuum-assisted needle gun. Instrumental methods were used to determine that the air within the containment met the air clearance criteria specified in UFGS 13280A, para 3.9.7.

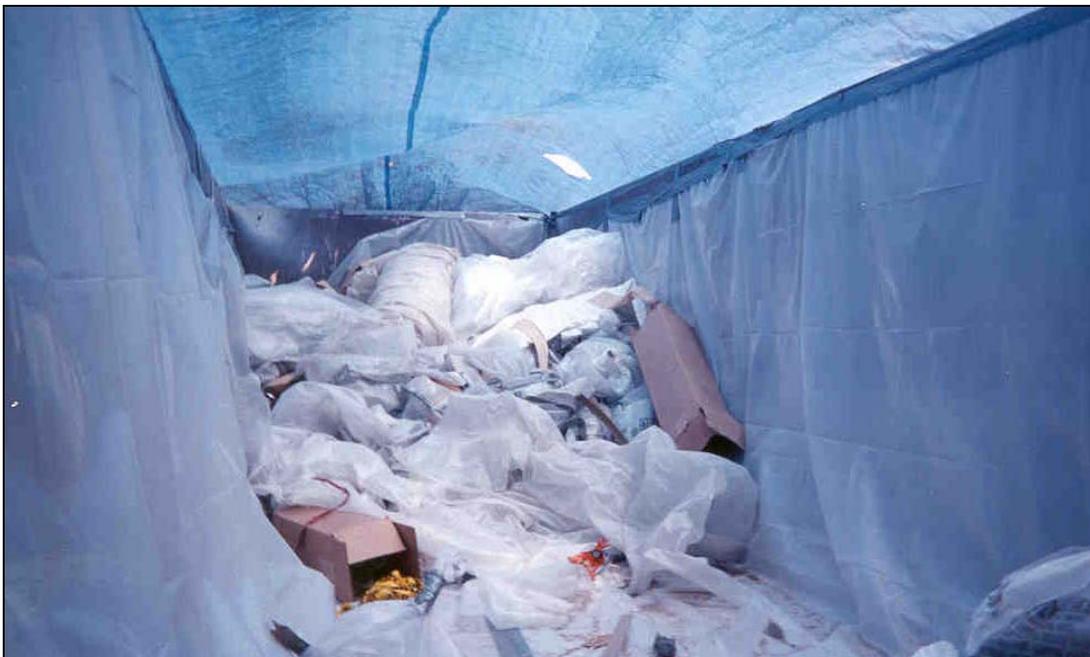
Figure 8. Low-density waste in roll-off container.

Containment was disassembled, and the bulk and low-density debris were placed in the specified disposal containers and packaged and stored as required (Figure 8).

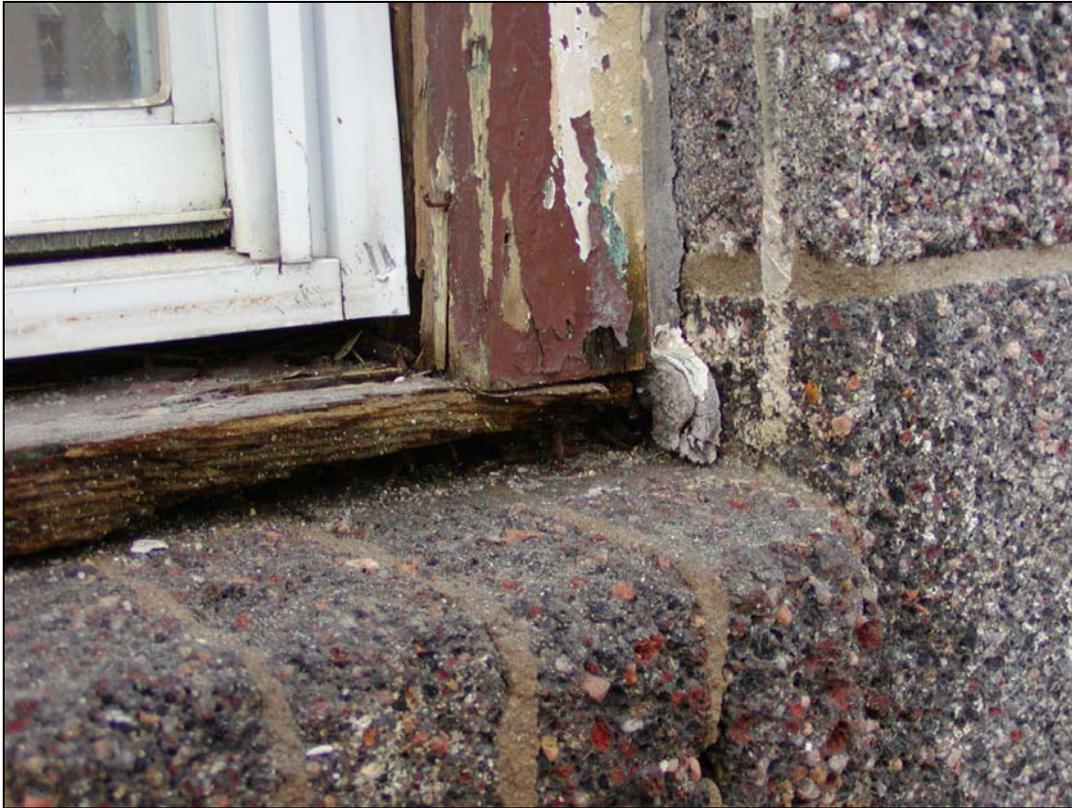
Figure 9. Incidental damage to wood window frame caused by wet abrasive blasting.

In addition to the disposal cost benefit discussed above, wet abrasive blasting has a relatively high production rate. Also, the addition of water to the process suppresses dust formation, which reduces worker and environmental exposures to hazardous lead and asbestos. The process has several limitations. Wet abrasive blasting is quite aggressive and will rapidly degrade cementitious surfaces if blast pressures and dwell times are not closely monitored. On concrete masonry unit (CMU) walls, grout is more susceptible to damage than the block face, so preferential erosion of the grout lines will occur. For renovation projects this may mean that the block will require re-grouting. Adjacent surfaces such as wood window frames

may also be inadvertently damaged (Figure 9). Wet abrasive blasting also creates a sludge that can be difficult to clean up (Figure 10).

The paint removal process produces a very rough substrate. It damages the mortar and in some cases adjacent wood substrates. Although this incidental damage is not an issue for buildings slated for demolition, it is an important consideration for buildings which are to be renovated. Concrete resurfacing is probably not required for renovation, but mortar repair will be required.

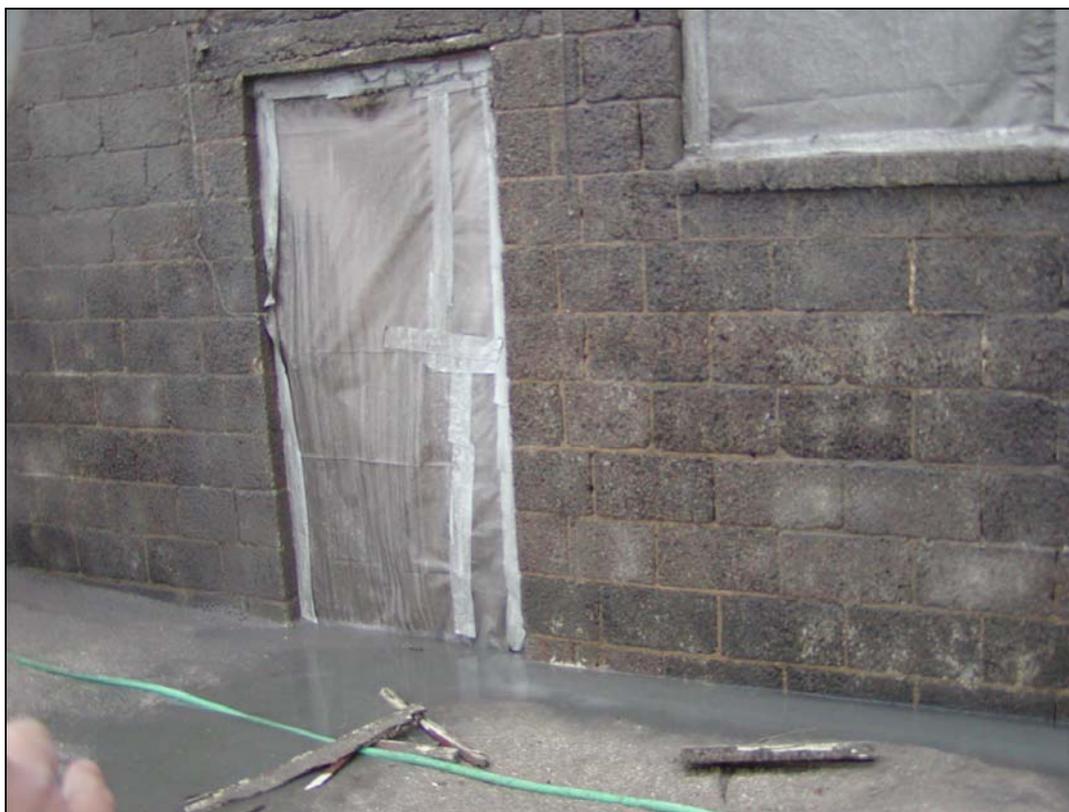
Figure 10. Water and sludge on containment structure floor.

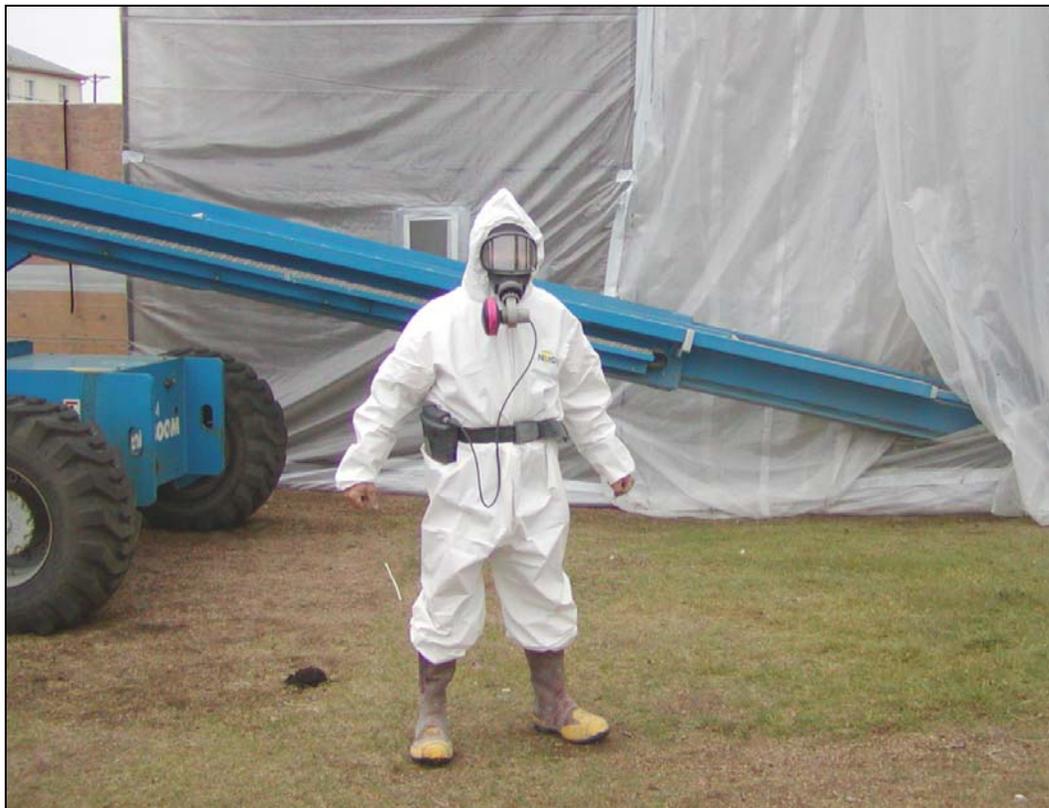
Figure 11. Personal protective equipment worn by abrasive blaster.

Worker safety is a primary consideration in the abatement of any hazardous material, including LBP and ACM. Figure 11 shows the whole-body protective gear used by the workers. These protective suits conform to the requirements of UFGS 13280A, para 1.15.2. Worker exposure to respirable lead and asbestos were evaluated periodically. Clearance testing for asbestos in air was performed each time the containment structure was ready for dismantling. Environmental exposure was assessed by monitoring visible emissions as well as by collecting area samples using high-velocity air sampling methods. The specific performance objectives for this
