ERDC/CERL TR-02-22

Predictive Service Life Tests for Roofing Membranes

Phase II Investigation of Accelerated Aging Tests for Tracking Degradation of Roofing Membrane Materials

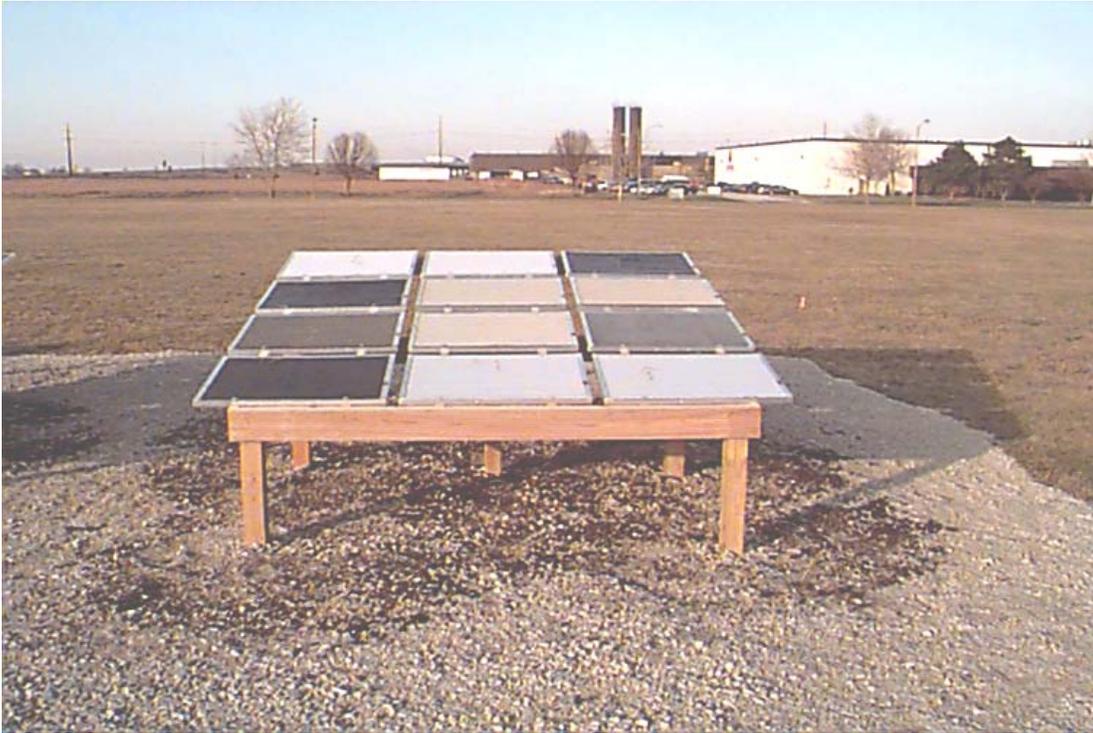
Figure 1. Outdoor exposure table with 12 samples at Champaign, IL weathering site.

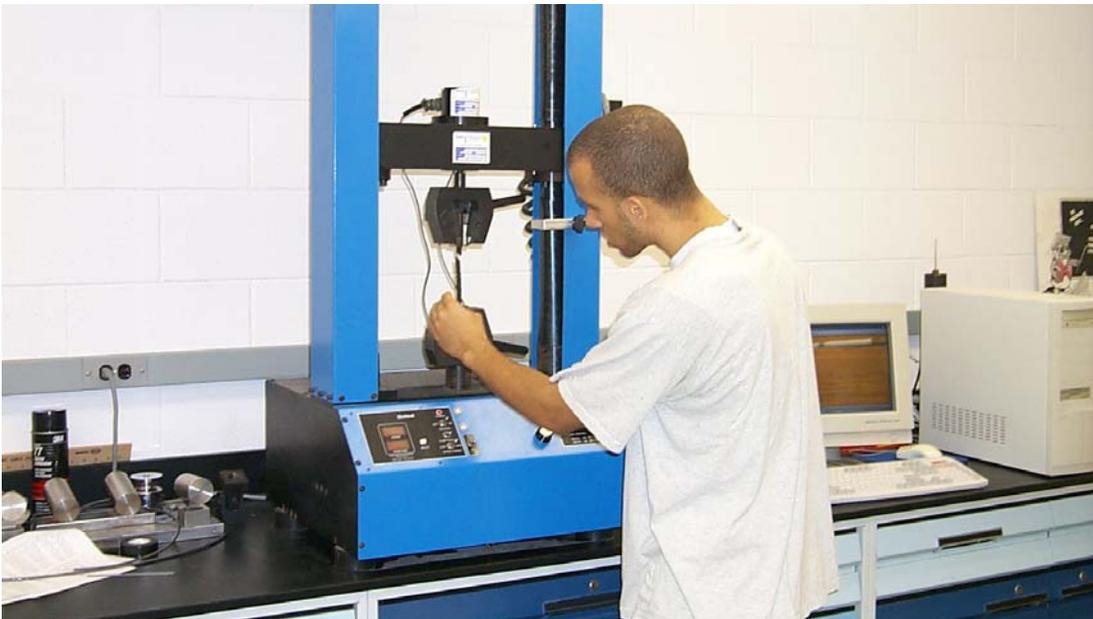
Figure 2. Tensile testing of membrane samples.

Pull tests were conducted on samples using a tensile testing machine as shown in Figure 2. All of these tests used an initial jaw-separation gap of 100 mm and a jaw-separation rate of 0.85 mm/sec. These samples generated three types of load-strain curves. A relatively straight line was generated by each EPDM rubber sample (Figure 3). The TPO samples each generated a sharp peak when the reinforcement ruptured followed by a long tail until the sample ruptured (Figure 4). All of the other samples ruptured at the peak load (Figure 5).

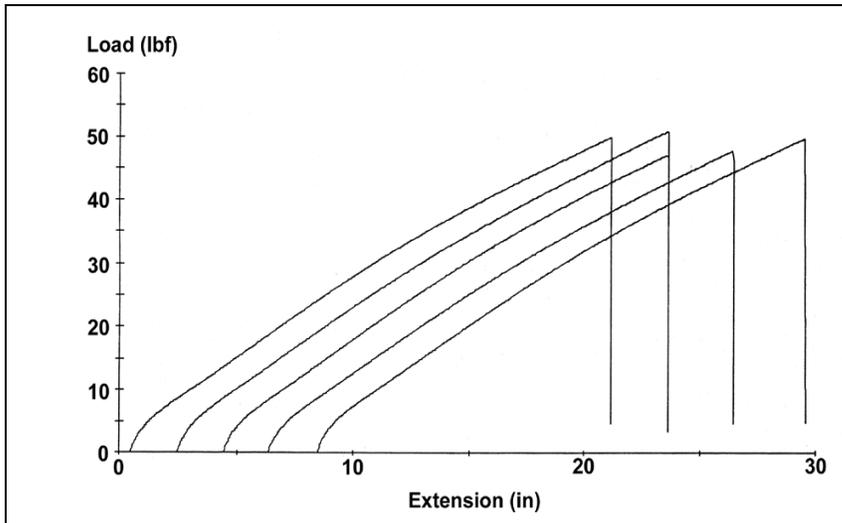
Figure 3. EPDM load-strain curve.

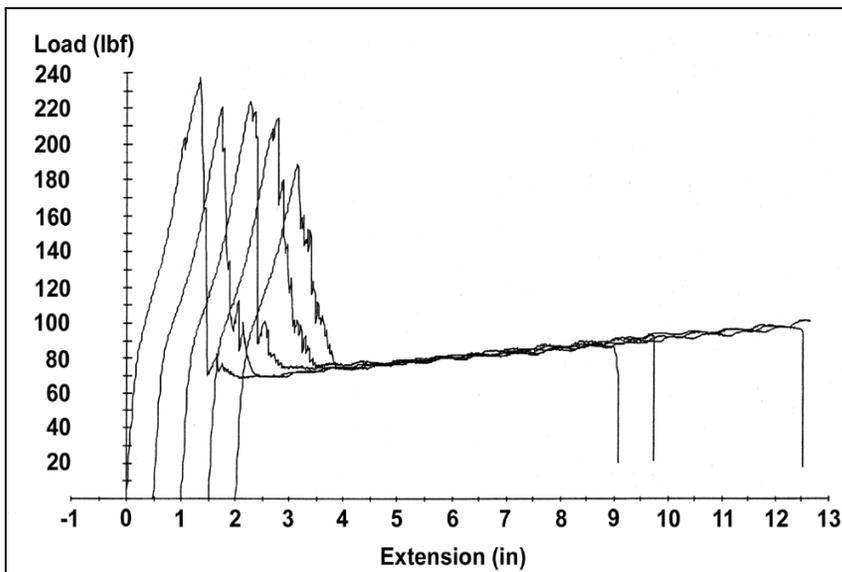
Figure 4. TPO load-strain curve.

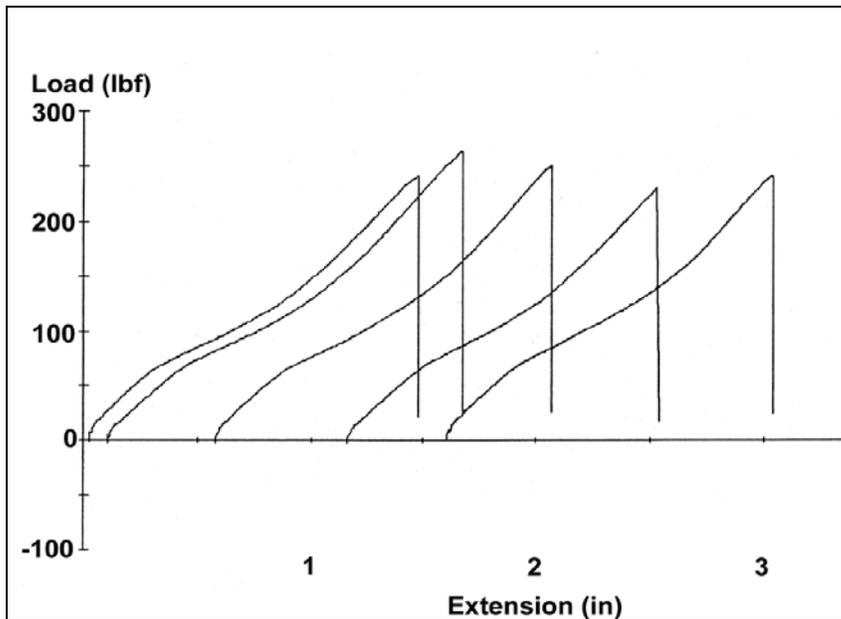
Figure 5. PVC load-strain curve.

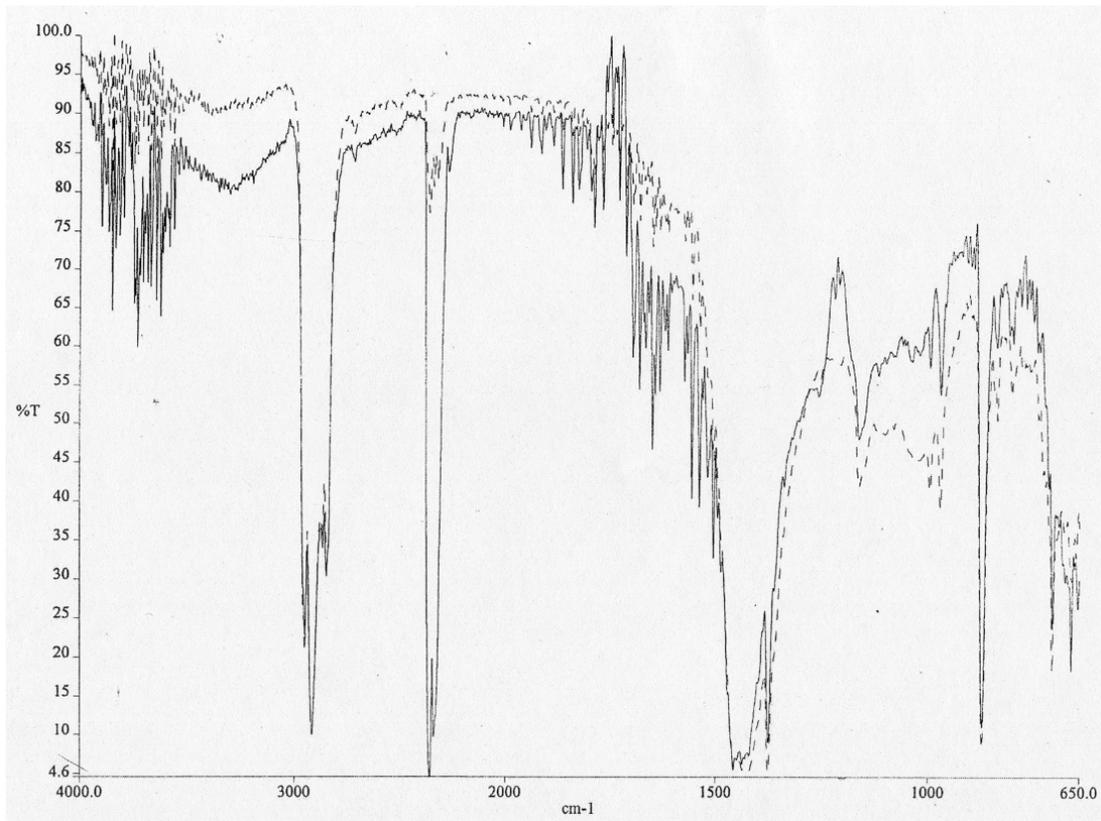
Sample A (TPO), bottom surface.

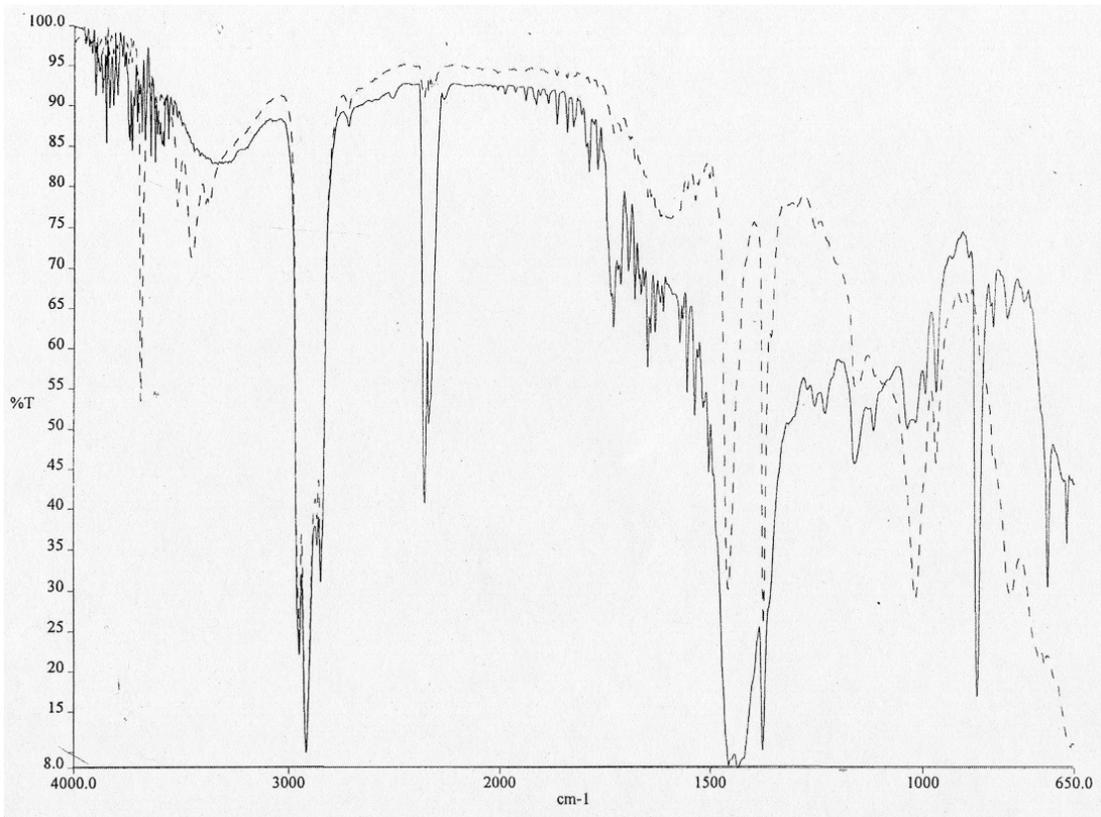
Sample A (TPO), top surface.

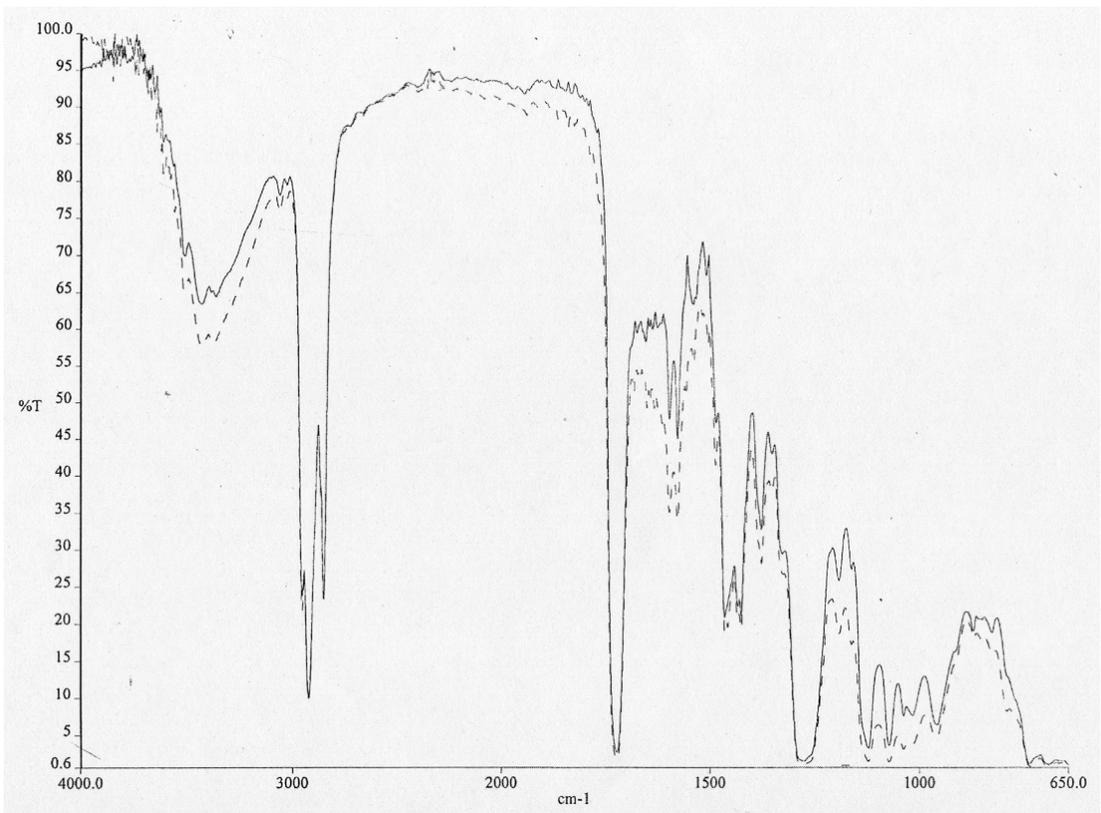
Sample B (PVC alloy), top surface.

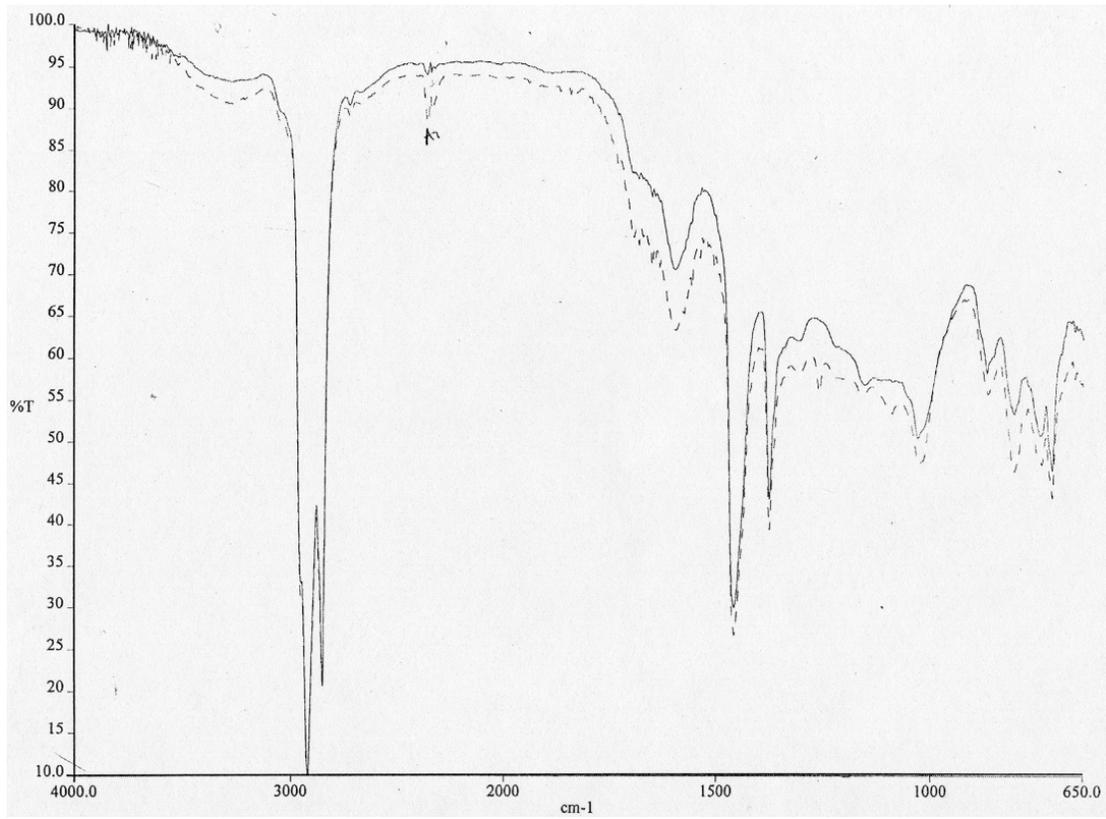
Sample C (BUR), top surface.

Samples C (BUR) and D (BUR). No significant changes were observed. There may be a slight increase in the -C=O (carbonyl groups).

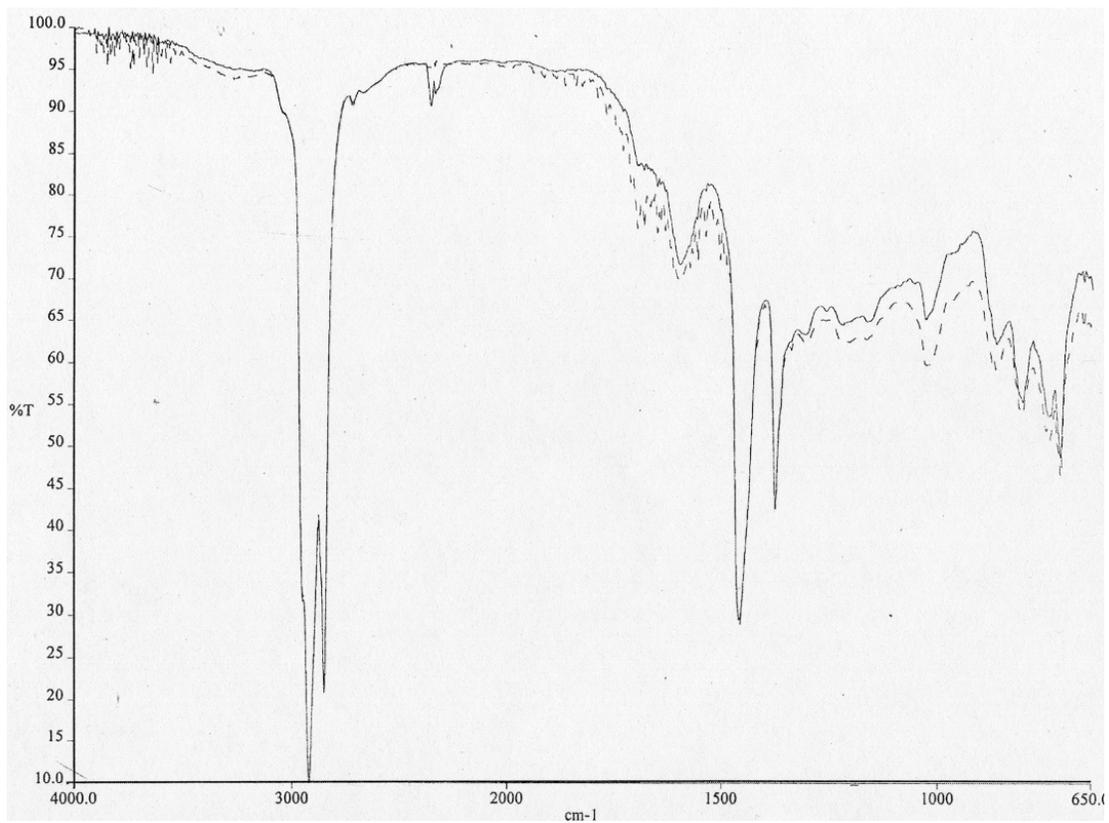
Sample D (BUR), top surface.

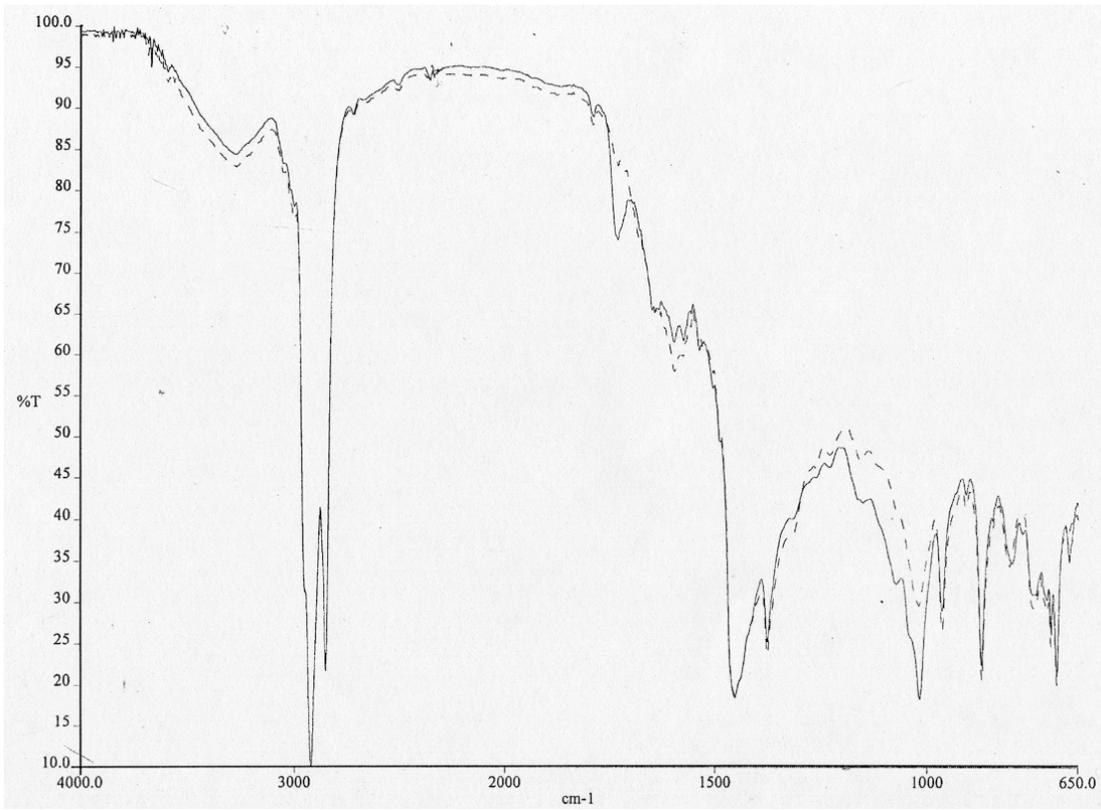
Sample E (SBS MB), granular surfacing removed.

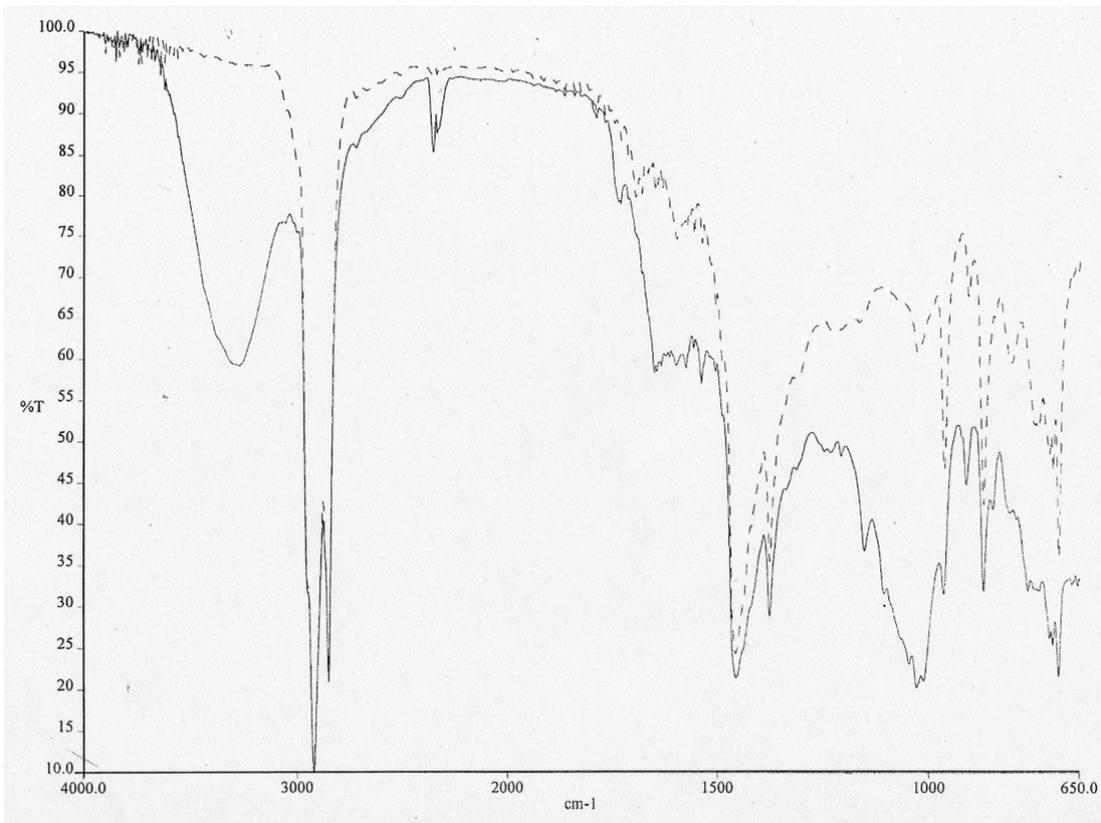
Sample F (SBS MB), granular surfacing removed.

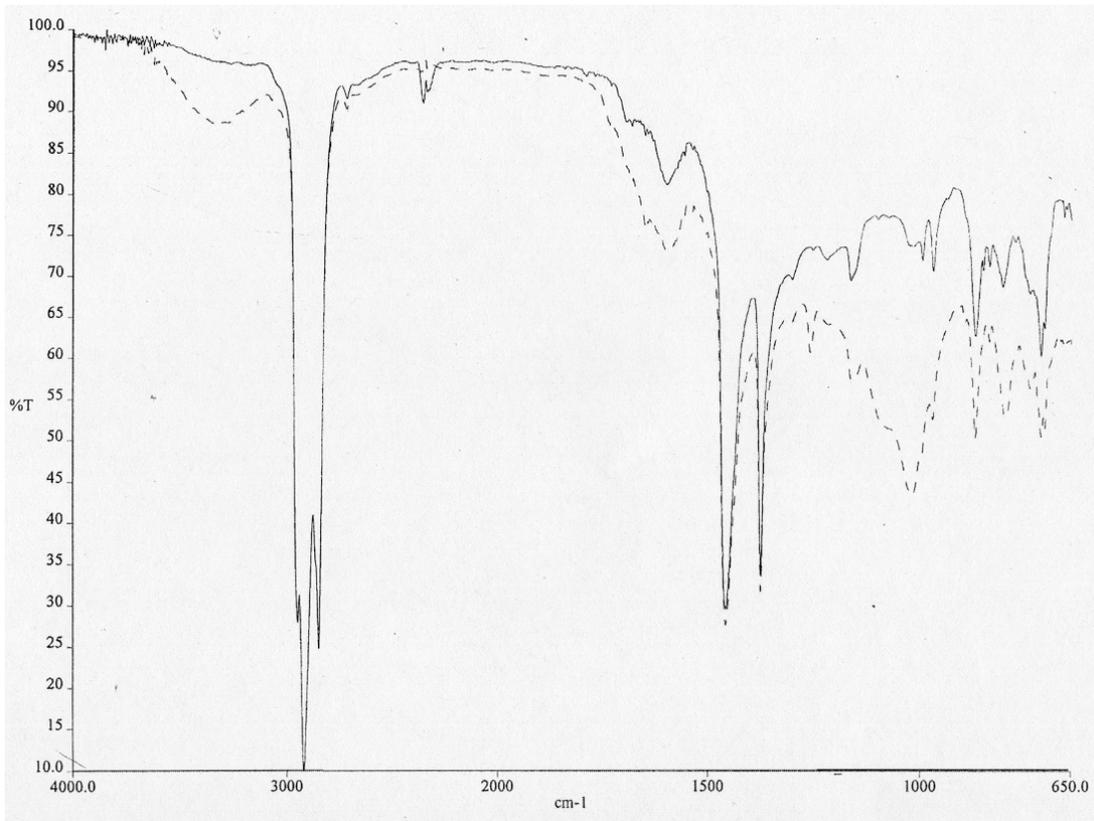
Sample G (APP MB), granular surfacing removed.

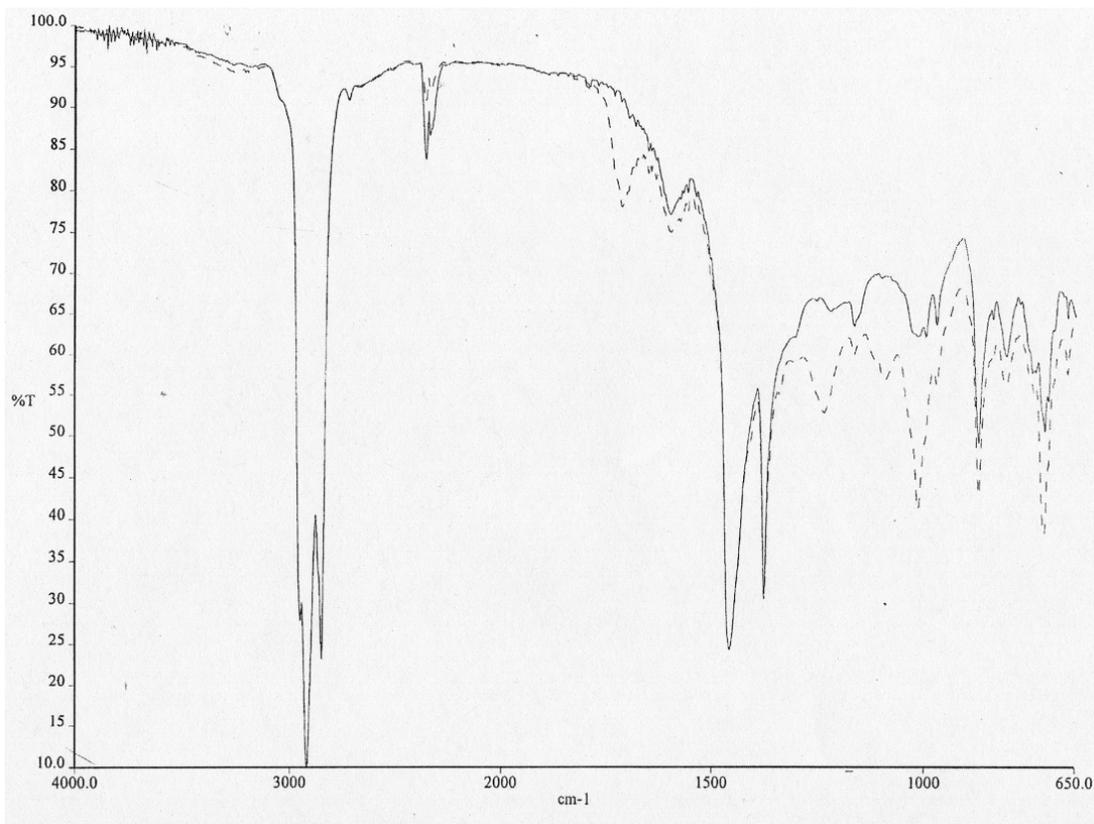
Sample H (APP MB), granular surfacing removed.

Sample H (APP MB). An increase was observed in -C=O groups and in unidentified groups near 1000, 1100, and 1300 cm^{-1} .

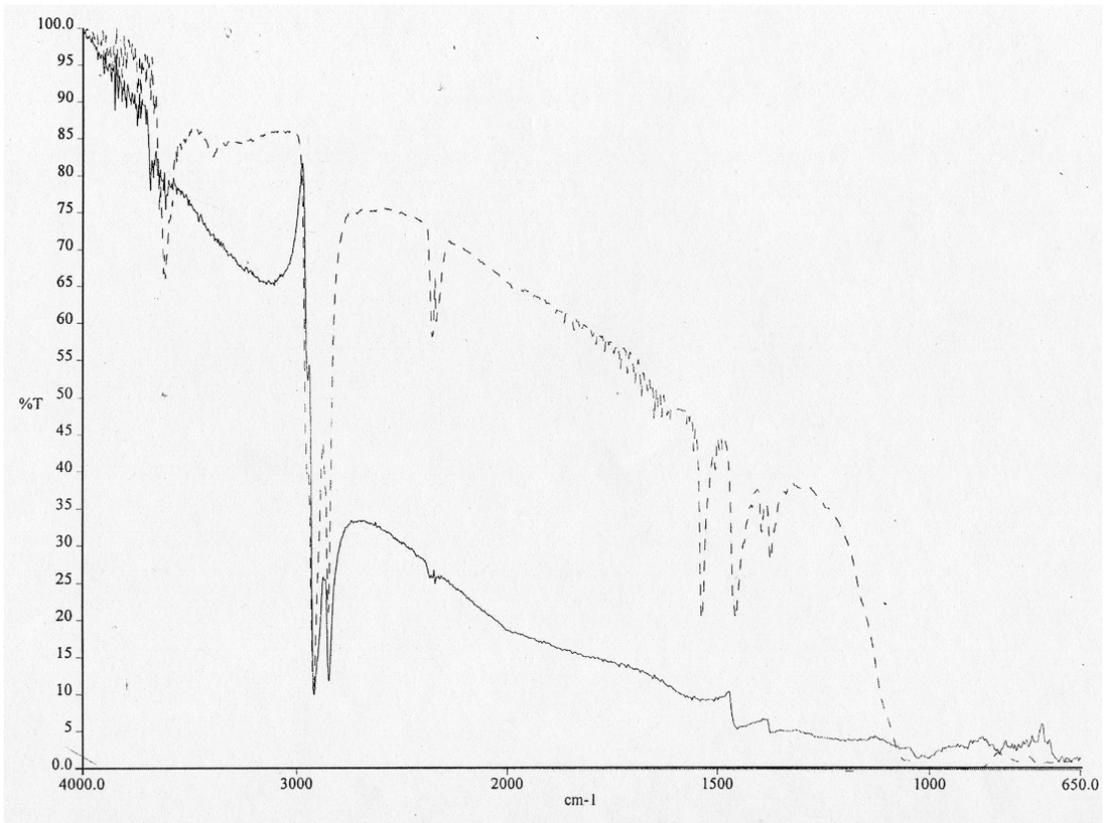
Sample J (EPDM).

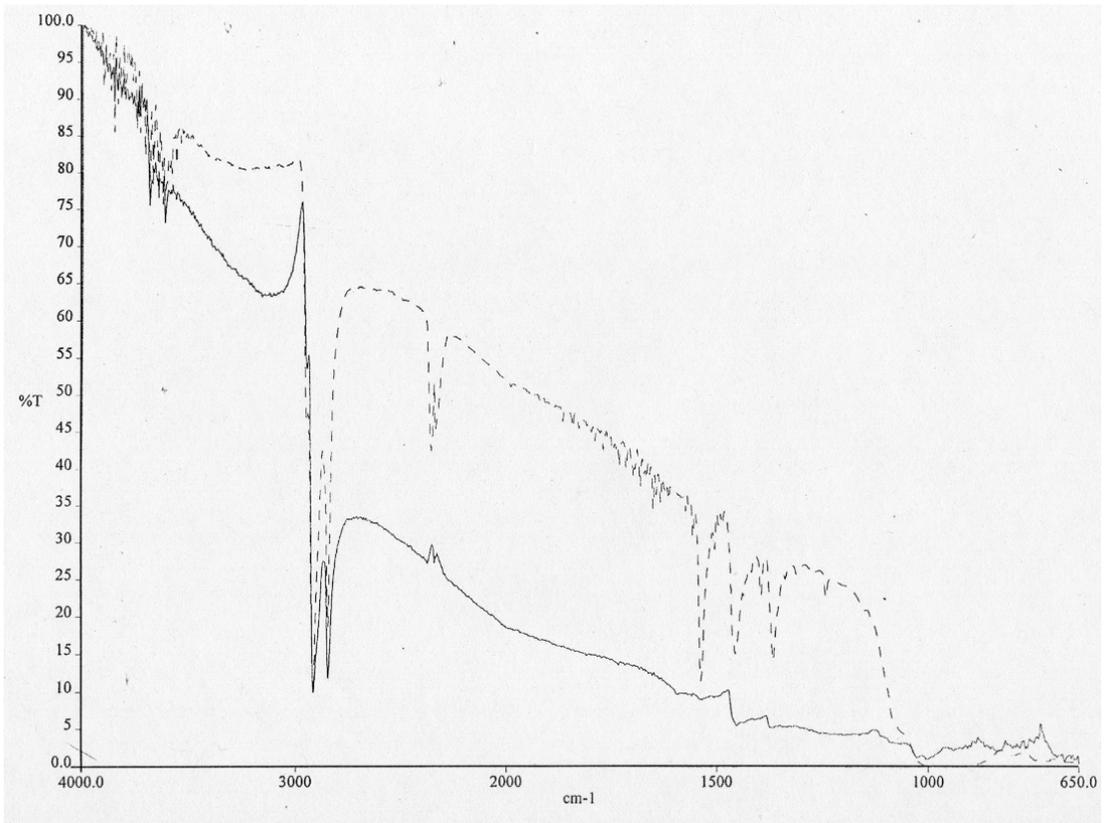
Sample K (EPDM).

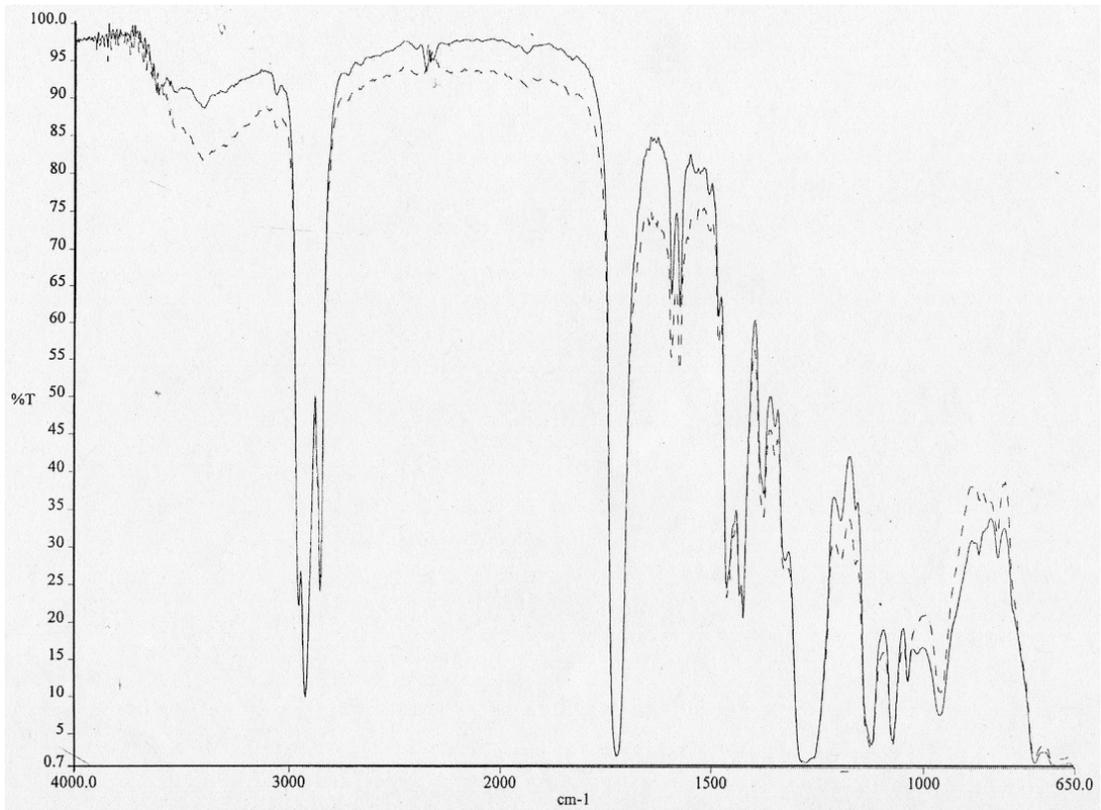
Sample L (PVC), top surface.

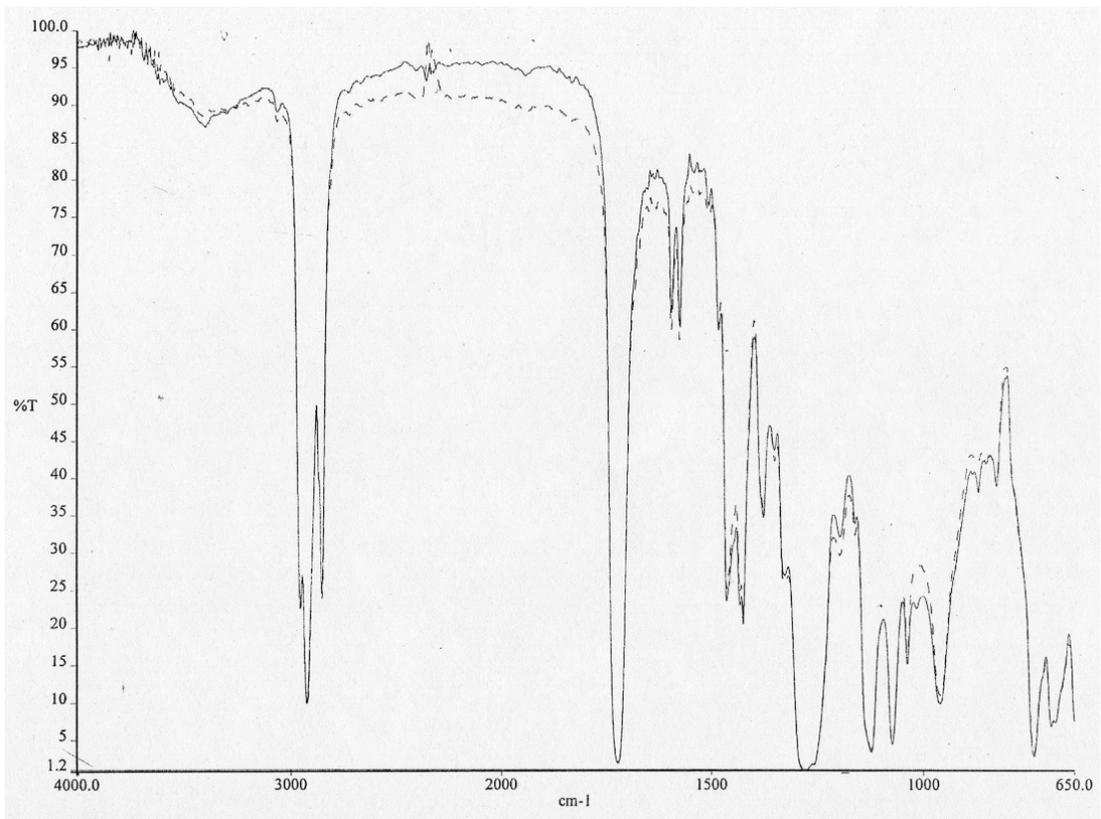
Sample L (PVC), bottom surface.

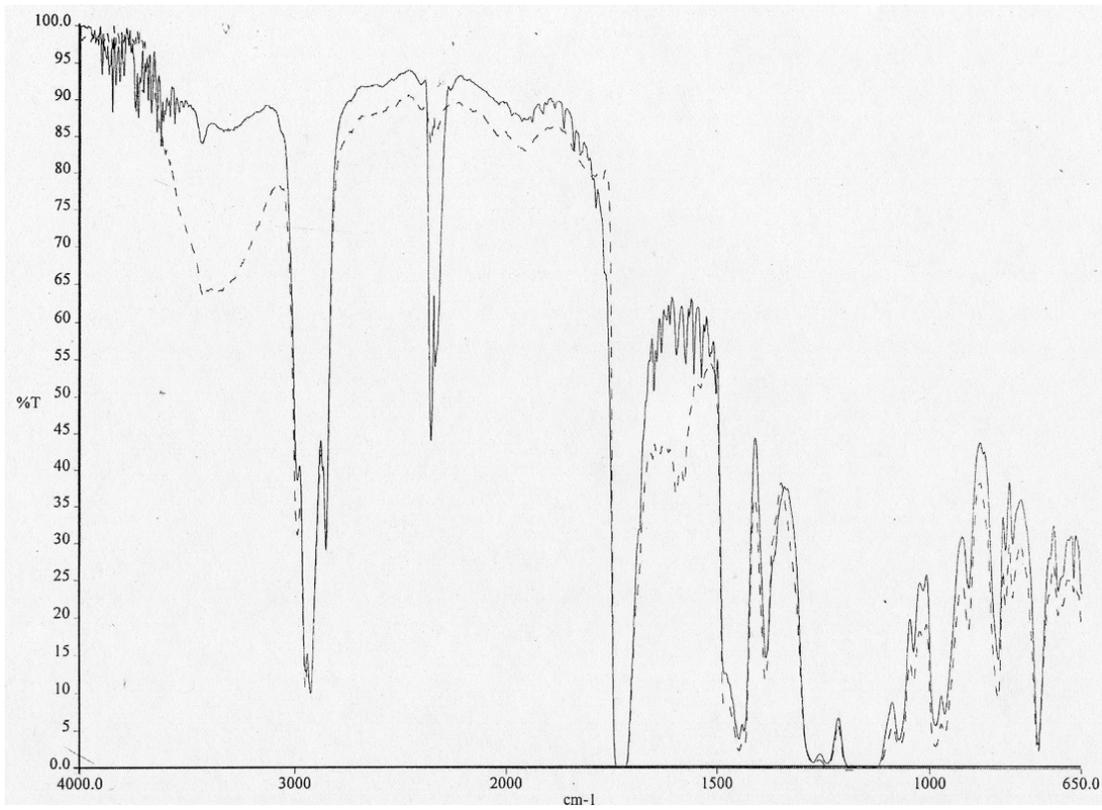
Sample M (PVC), top surface.

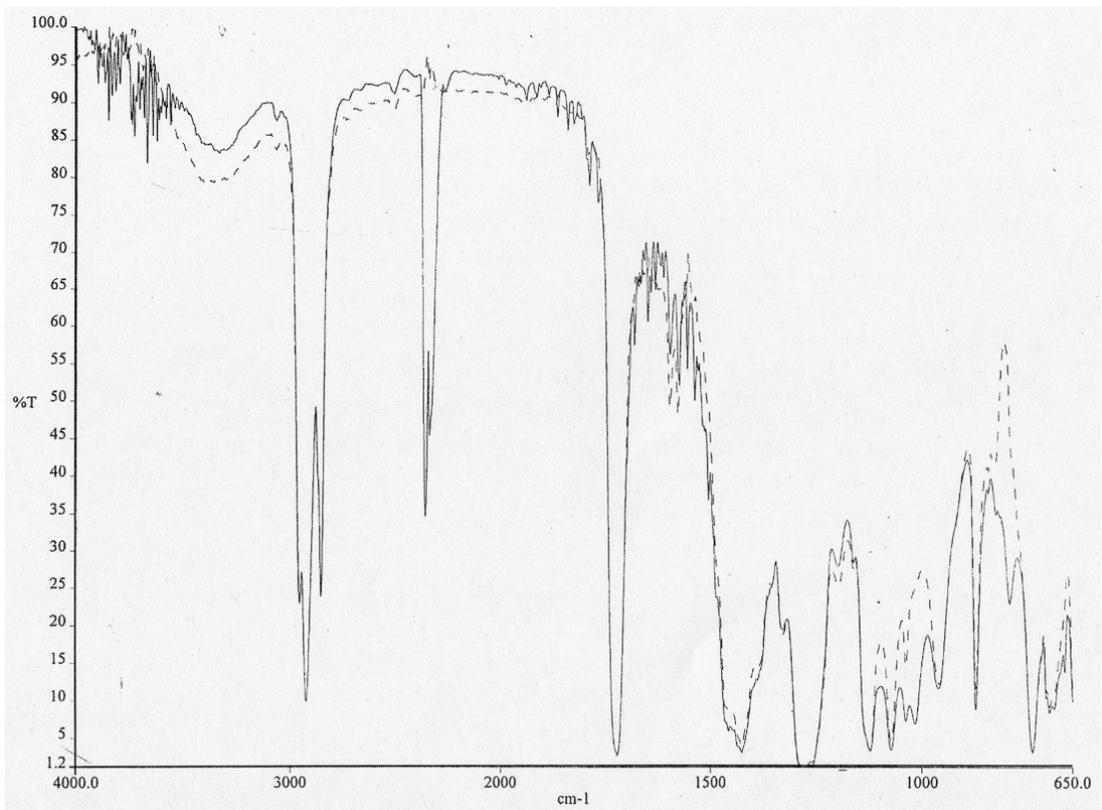
Sample M (PVC), bottom surface.
