ERDC TR-02-7

Biaxial Loading and Failure Behavior of Brick Triplets with Fiber-Reinforced Polymer Composite Upgrades

J.B. Berman, G.K. Al-Chaar, and P.K. Dutta

December 2002

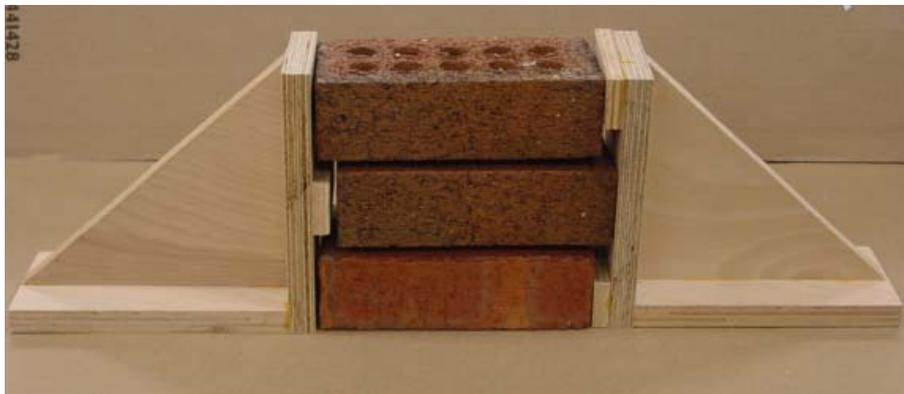
Figure 1. Construction of triplet samples.

All triplets were constructed and prepared under controlled laboratory conditions. Standard red clay bricks were used along with a type N mortar and constructed as shown in Figure 1. The mortar was allowed to cure 30 days before application of FRP and/or testing of the triplets. Prior to FRP application all samples were thoroughly cleaned with a wire brush using at least 60 strokes on both sides of the triplet.

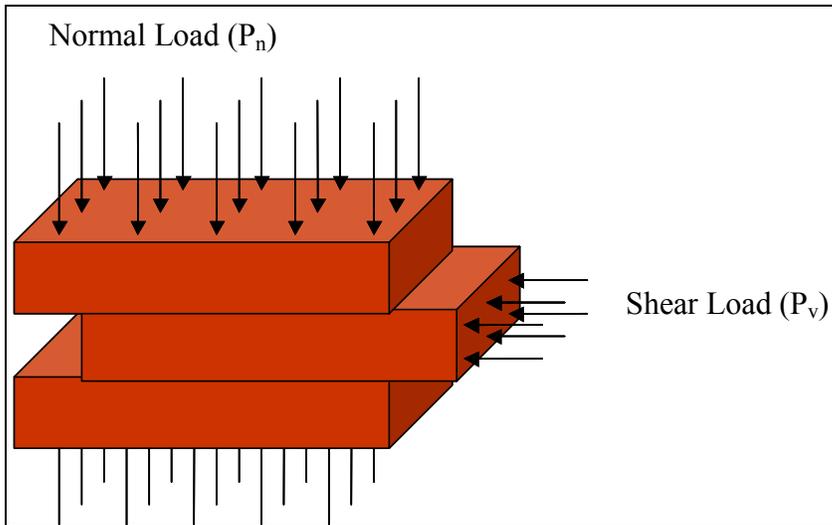
Figure 2. Triplet test under normal and shear loads.

All samples were tested biaxially such that the normal load was controlled to reflect percentage of its normal load capacity while the shear load is applied to failure (Figure 2). The test setup is shown in Figure 3.

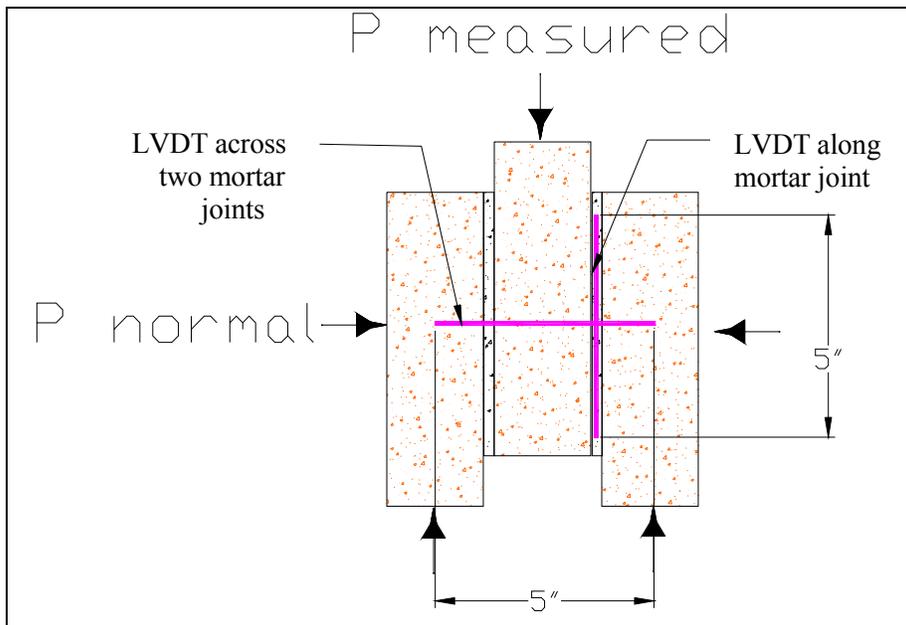
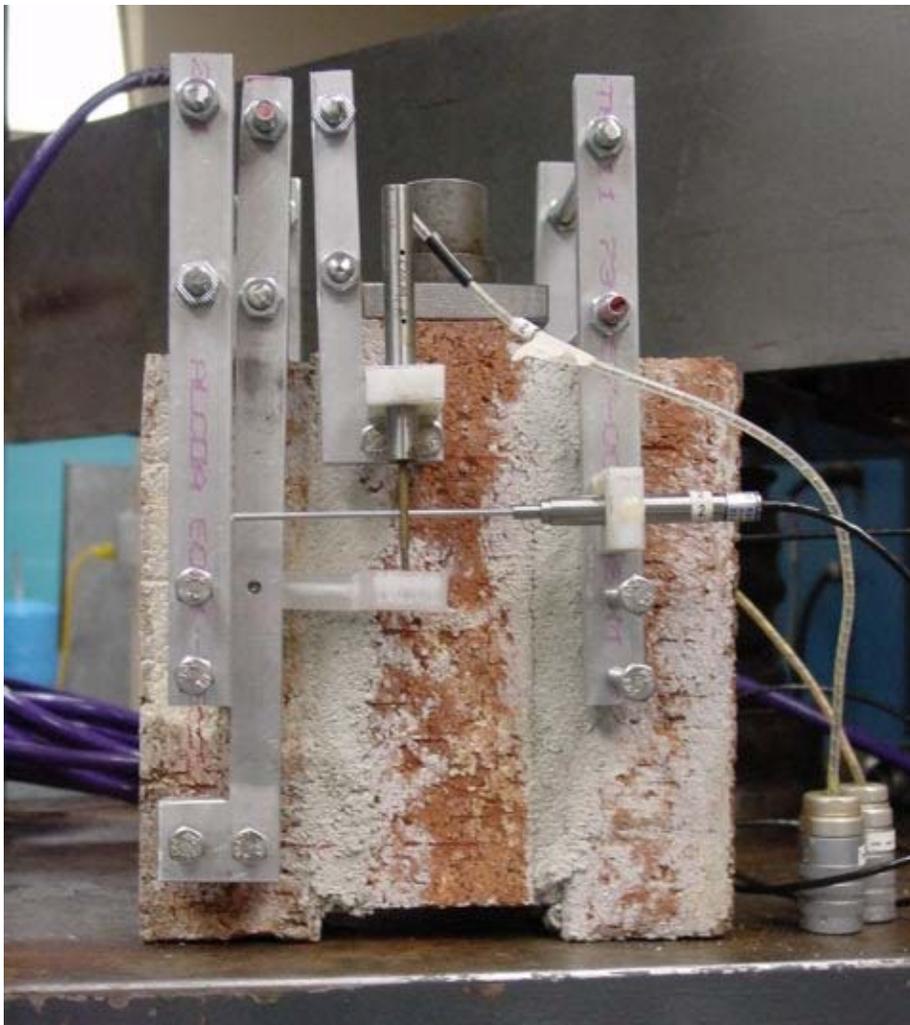
Figure 4. Schematic (top) and photo (bottom) of triplet test with LVDT.

This chapter documents background research (i.e., a survey of relevant literature), specimen preparation, test setups, and results of all 100 triplet sample tests. Figures 1 – 4* illustrate the design of the brick triplet specimens and the experimental setup. The loads at yield and ultimate failure, and their corresponding displacements, are summarized in Tables 1 – 4. The observed modes of failure for each sample are summarized in Tables 5 – 7 and Figures 5 – 8. The effect of different normal loads and the two different FRP application schemes are explained in detail. The results are analyzed in terms of capacity and displacement.

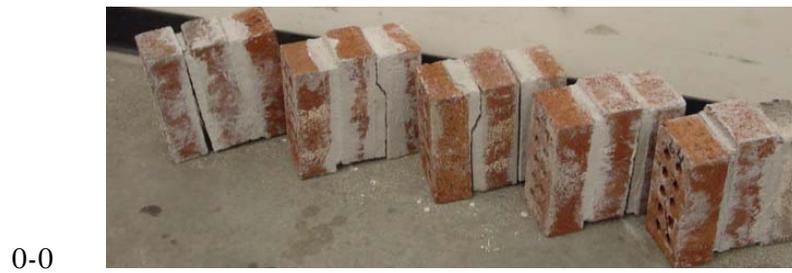
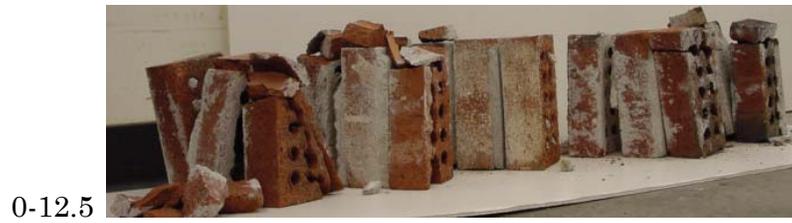
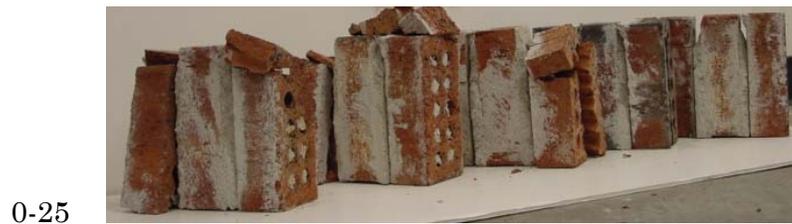
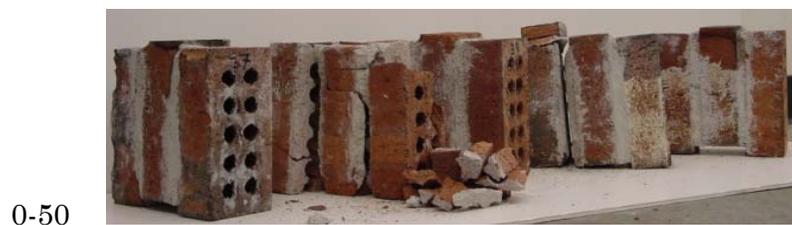
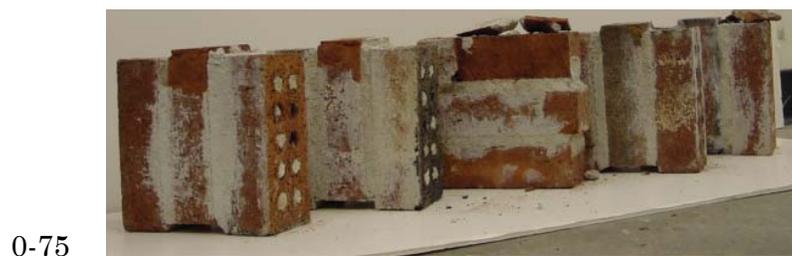
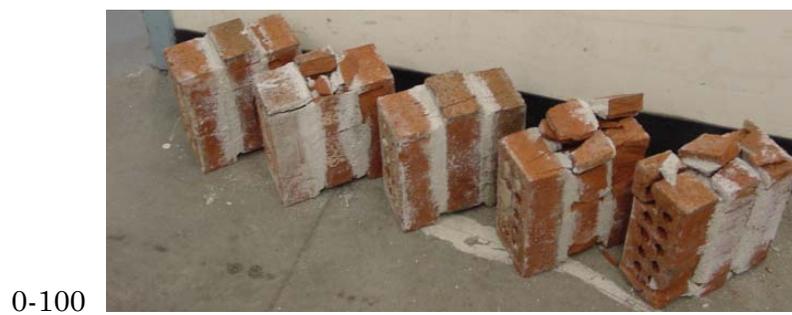
Figure 5. Modes of failure for Series 0.

0-0	AI	A shear crack was visible along one mortar joint in the xz-plane
0-12.5	All	<p data-bbox="362 1115 492 1213">3</p> <p data-bbox="492 1115 1451 1213">Exhibited shear cracks in both mortar joints.</p>
0-25	All	Shear cracks formed in both mortar joints. Tension cracks passed through the holes in the brick in the xy-plane. A single tension crack also appeared in the yz-plane of one exterior brick unit.
0-25	All	Shear cracks formed in each mortar joint in the xz-plane. Tension cracks appeared in the exterior brick units.
	4	Mode of failure was atypical. The specimen appeared to be loaded eccentrically causing a shear failure through the center brick and one exterior brick.
	5	Tension cracks materialized through the brick holes in the xy-plane.
0-50	1	Cracks initiated in the two mortar joints in the xz-plane. A small amount of corner spalling occurred at the loading end of the center brick.

2	A tension crack was visible in the xy-plane of one exterior brick and the center brick. Tension cracks formed in the exterior bricks in yz-plane.
	3	Tension cracks appeared in the xy-plane of the two exterior brick and the center brick. Tension crack also formed in the interior brick unit in the yz-plane.
	4	Tension cracks were visible in the xy-plane of the two exterior bricks. Shear cracks materialized along one mortar joint in the xz-plane.
	5	Partial spalling occurred at the loading end of the center brick unit. A tension crack formed in the xy-plane of one exterior brick unit.
0-75	All	Partial spalling was observed at the loading end of the center brick. The confining pressure on the sample was high causing local failure at the loaded end. Several tension cracks also appeared in the yz-plane of one exterior brick unit.
0-100	All	Several tension cracks formed in the yz-plane along with spalling of the overhangs. (Note: Overhangs are not considered part of the prism area)

The failure modes of the various triplet series were captured in Figures 5 – 8 and discussed in detail in Tables 4 – 7. The resulting normal load versus shear load failure envelopes, along with their associated standard deviations, are provided for Series 0, I, and II in Figures 48, 49, and 50, respectively. One item to observe is that near the lower normal load levels, sometimes two points are plotted for a given normal load. This represents deviations in bilinear yield and ultimate failure loads. The reasoning for this difference is discussed below.

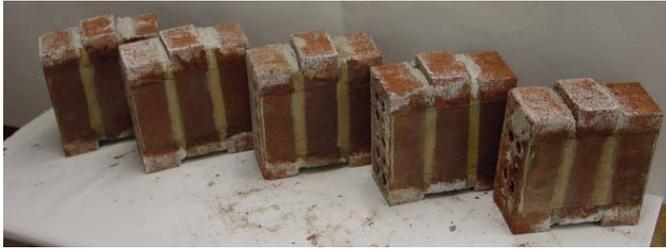
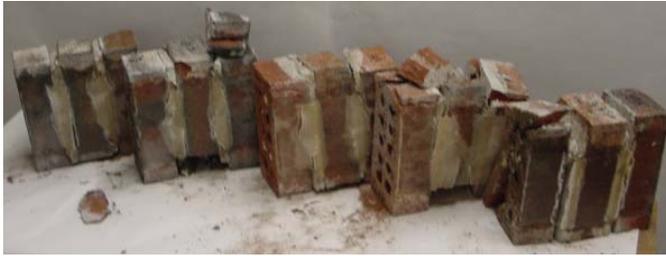
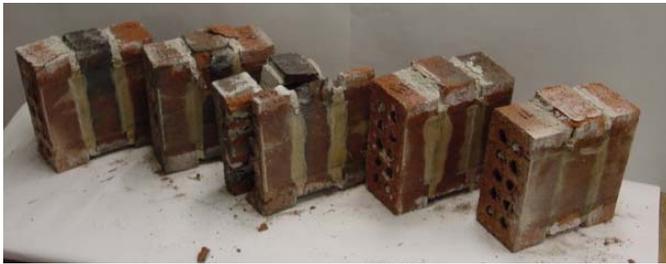
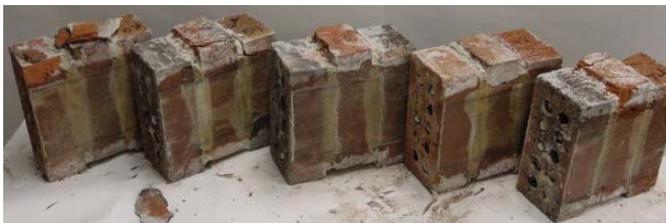
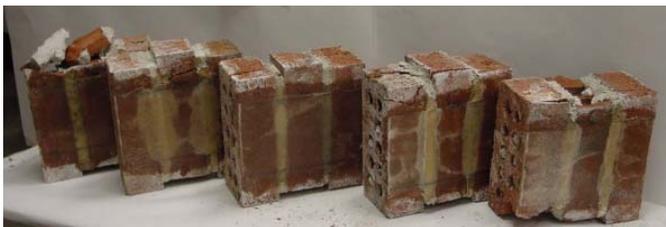
Figure 6. Modes of failure for Series I.

Group	Sample	Modes of Failure
I-0	1, 3, 4, 5 2 3	Full debond between mortar joints and FRP was observed. Debond occurred between the mortar and the FRP along one mortar joint. A tension crack in the yz-plane was resisted by the FRP.
I-12.5	All 2 3 4 5	Specimens hardly intact after testing. All FRP was torn along the mortar joints. Severe tension cracks materialized in the center brick along the xy-plane. One exterior brick exhibited a shallow crack in xz-plane. Severe tension cracks formed in the center brick in the xy-plane. Tension cracks developed in both exterior bricks in the xy- and the yz-planes. One exterior brick contained two orthogonal cracks in the xy- and xz-planes.
I-25	All 1 2 3 4 5	Full debond between mortar joints and FRP was observed in all samples. One exterior brick contained a tension crack in the xy-plane and separation. The center brick and one exterior brick exhibited a tension crack in the xy-plane and separation. Spalling occurred at the edge of the loading end of the center brick. The area of debond between the FRP and the masonry was the largest for all samples. This indicated the center brick tended to move in the out-of-plane direction. One exterior brick exhibited cracks in the yz- and xy-planes through the top holes. The exterior bricks were cracked. One brick split in yz-plane while the other split as a result of diagonal (about 45 degrees) cracking.

I-50	All 1 2 3 5	Full debond between mortar joints and FRP occurred. A split in the center brick was observed in the xy-plane. A small amount of spalling was evident at one corner of the loading end of the center brick. Many cracks formed in the xy-plane of exterior bricks. Specimen was severely fractured as a result of tension cracks developing in the three bricks along the xy-plane. The edge of the center brick at the loaded end was chipped. Many tension cracks initiated in the exterior bricks along the yz-plane.
I-75	All 1 2 3 4 5	Full debond between mortar joints and FRP was observed in all samples. One corner of one exterior brick was chipped. A fracture formed in the center brick on the unprotected side. A tension crack materialized on the other exterior brick in the yz-plane. The extent of debond between the FRP and the mortar joints was the largest in the set. The center brick tended to move out-of-plane away from the FRP. Both exterior bricks developed one tension crack in the xy-plane. One exterior brick exhibited two tension cracks in the xy-plane. All bricks developed large tension cracks in the xy-plane.

I-100	1 2, 4, 5 3	Local debond was evident along one mortar joint due to premature failure in the loading end of the center brick accompanied by a tension crack in one exterior brick in the yz-plane. Full debond occurred between mortar joints and FRP. Debond initiated between the mortar and the FRP along one mortar joint. A longitudinal crack also formed in the adjacent exterior brick in the xy-plane.

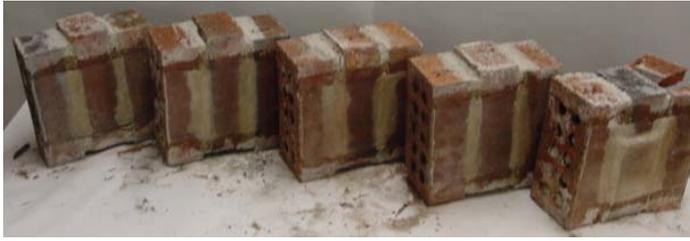
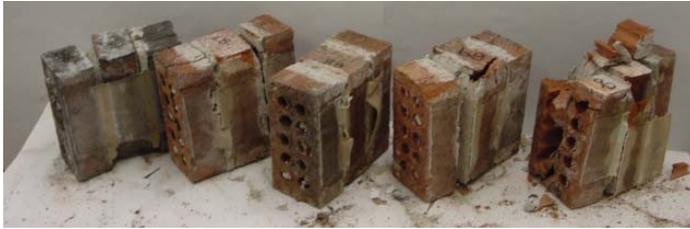
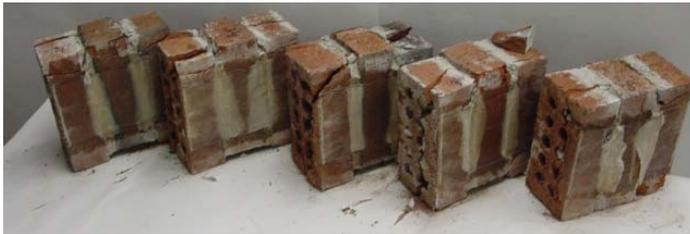
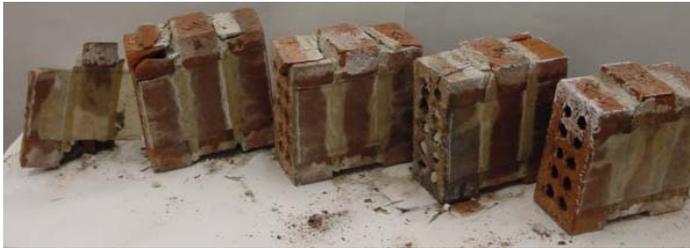
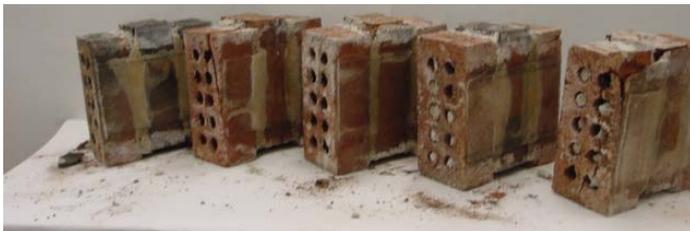
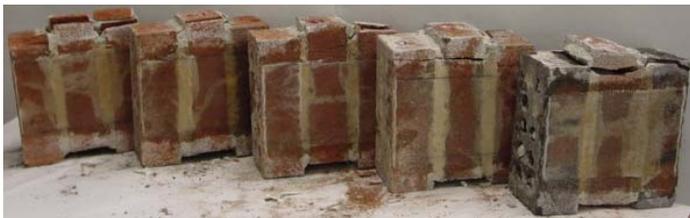
Figure 7. Modes of failure for Series II.

Group	Sample	Modes of Failure
II-0	All	Full debond between mortar joints and FRP occurred in all samples except Sample 5.
	5	The center brick totally debonded and one exterior brick contained a crack in the xy-plane.
II-12.5	1	Debond of the FRP on both sides along with spalling along the bottom of the center brick was observed.
	2, 3, 4	FRP was torn along both mortar joints.
	5	Debond between the FRP and one exterior brick occurred. Fracture of the loaded end of the central brick was observed. Orthogonal cracks developed along both xy- and yz-planes.
II-25	All	Full debond between mortar joints and FRP was observed. One or two cracks in the exterior brick formed along the yz-plane through the holes. Further cracking in the exterior bricks along the yz-direction was evident.
II-50	All	All exterior brick contained severe cracks in the xy-plane through the holes.
	1	Burst into several pieces upon failure.

II-75	All	The loading end of the center brick was chipped. Longitudinal cracks appeared in the exterior bricks along the xy-plane through the holes.
II-100	1, 2	Full debond between mortar joints and FRP was evident. Severe cracking and spalling occurred in the center brick. Tension cracks formed in the exterior bricks in xy- and xz-planes.
	3, 4, 5	Cracks developed in the xz-plane in all bricks outside the FRP surface.

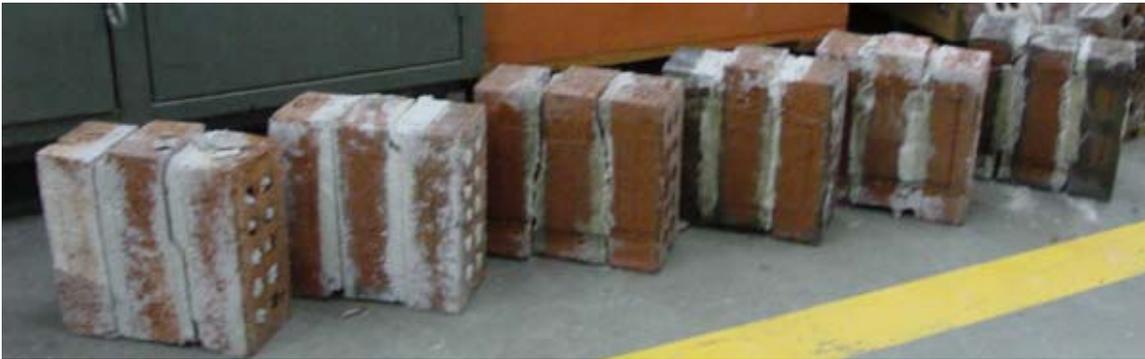
Figure 8. Modes of failure for Series 0, I, and II for samples with LVDTs.

Group	Sample	Modes of Failure
0-LVDT	All	Shear cracks initiated in each mortar joint.
I-LVDT	All	A shear crack was evident in each mortar joint along with tears in the FRP.
II-LVDT	All	Shear cracks appeared in each mortar joint as well as tears in the FRP on both sides. A crack in one exterior brick formed in the xy-plane.

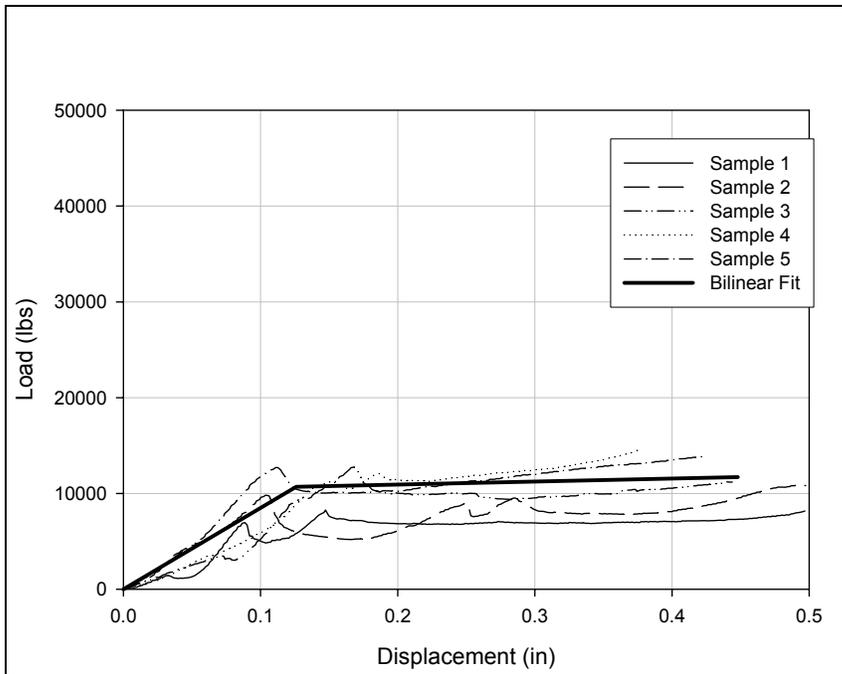
Figure 11. Load-displacement curves of 0-12.5 group.

Load-displacement curves are shown in Figures 9 – 14. The raw data for the five samples graphed for each load level are plotted along with a linear (or bilinear) fit. The fitted curves were developed by plotting the origin of the axis against the value where the average peak loads and displacements occurred (determined from Table 1). In some cases, as in Figure 9, initial data have been removed to adjust for the initial upward concavity of the curve due to initial load settling. With this information it is observed that in Figures 9 and 10, brittle failure is indicated by both curves under 100% normal load and under 0% shear load. Bilinear curves are observed in Figure 11 and 12 under 12.5% and 25% normal load levels, respectively. At higher normal load levels the failure transfers from bilinear (25% normal load) to slightly bilinear (50% normal load, shown in Figure 13) to completely linear again (75% normal load, shown in Figure 14).

One commonality found in all three triplet series is that the presence of a normal load below 12.5% produces a general increase in shear capacity followed by shear failure of the brick/mortar interface. This increase in shear load is due to internal friction and is coincident with the Mohr-Coulomb phenomenon. This can be frictional force between the masonry and the mortar (in Series 0) or between the masonry, mortar, and FRP (in Series I and II). This phenomenon has been docu-

mented in load-displacement Figures 11, 17, and 23, as is noted by the second low-slope portion of the bilinear response. To a lesser extent, Figures 12, 18, and 24 illustrate similar behavior for the series under 25% normal loading, but the greater slope indicates that there are other mechanisms at play.

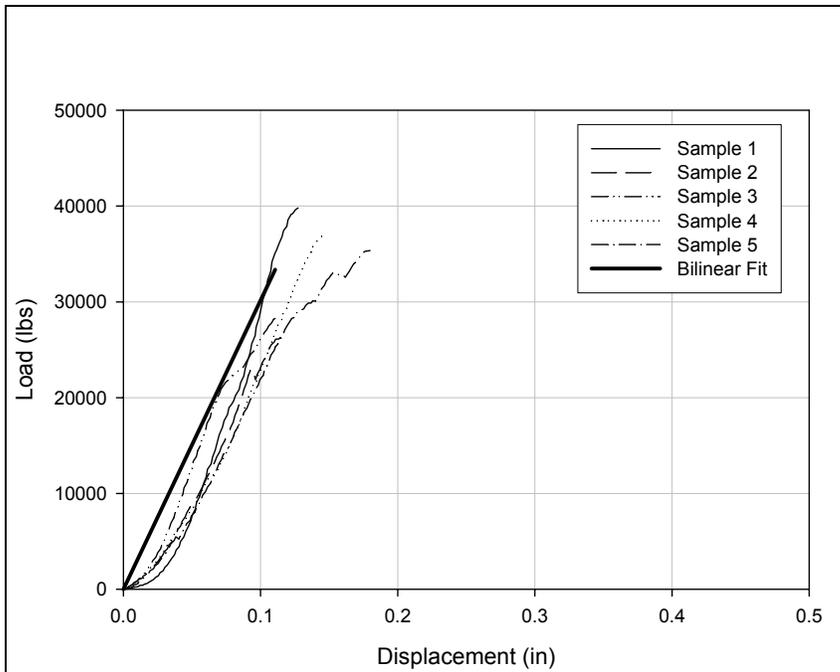
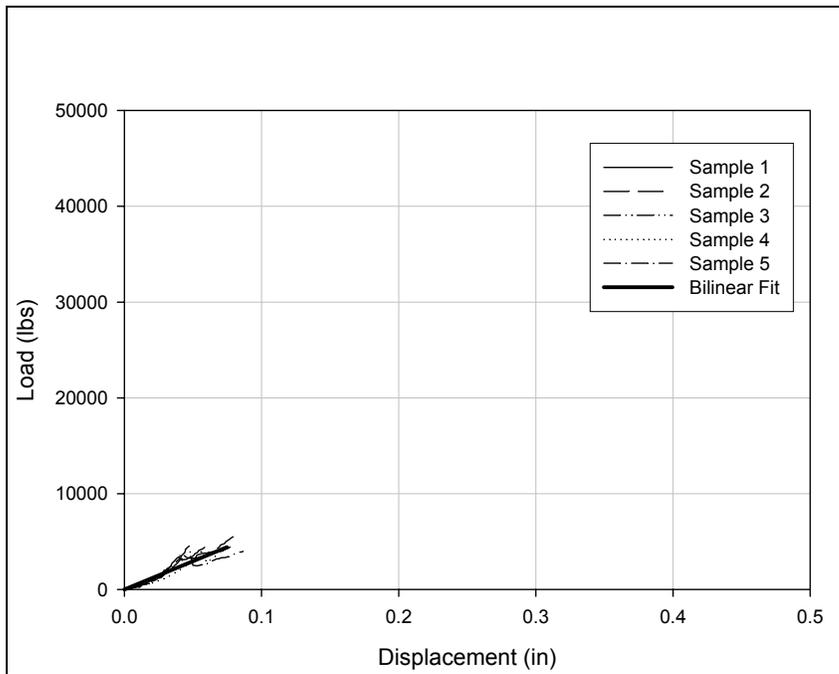
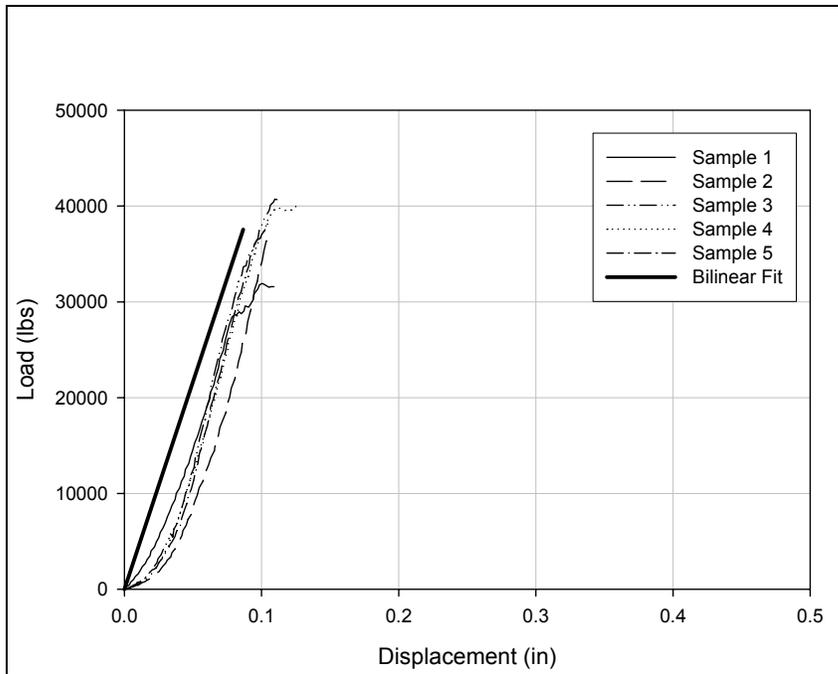
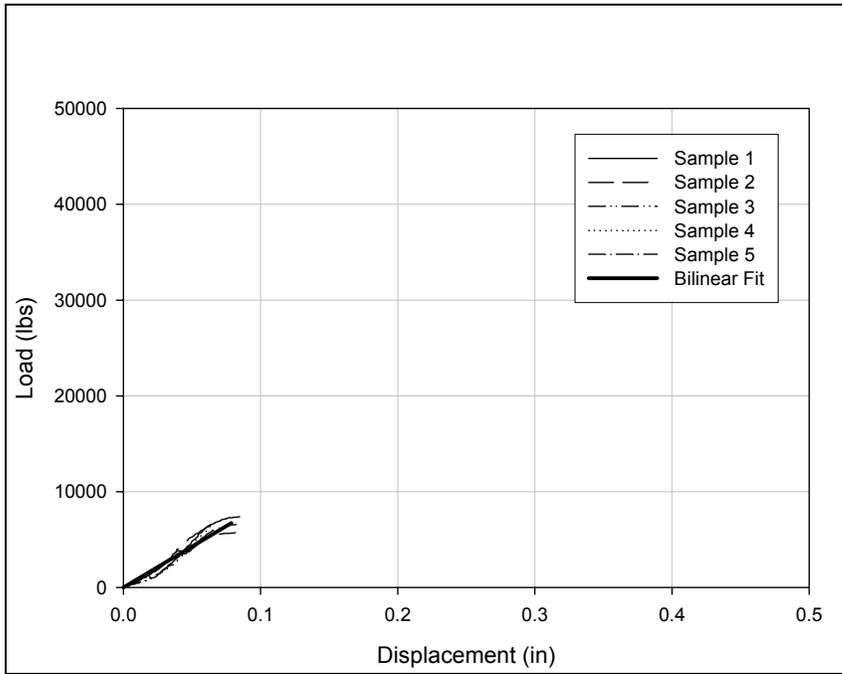
Load-displacement curves are shown in Figures 15 – 20, for Series I, and in Figures 21 – 26 for Series II. In Figures 15, 16, 21, and 22, brittle failure is observed in both curves under 100% normal load and under 0% shear load. As seen in the Series 0 triplets, bilinear curves are observed under 12.5% and 25% normal load levels for

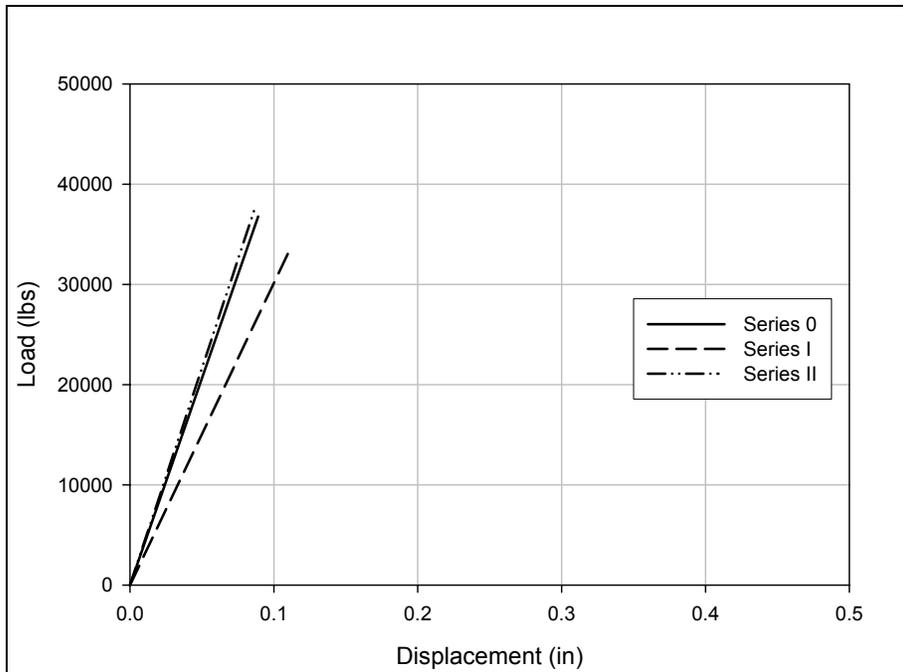
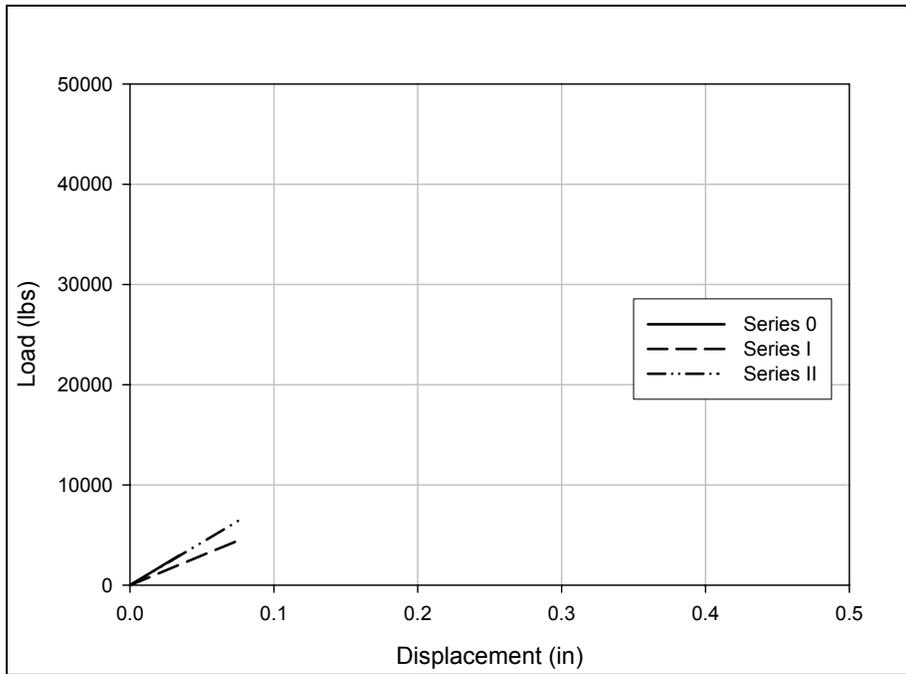
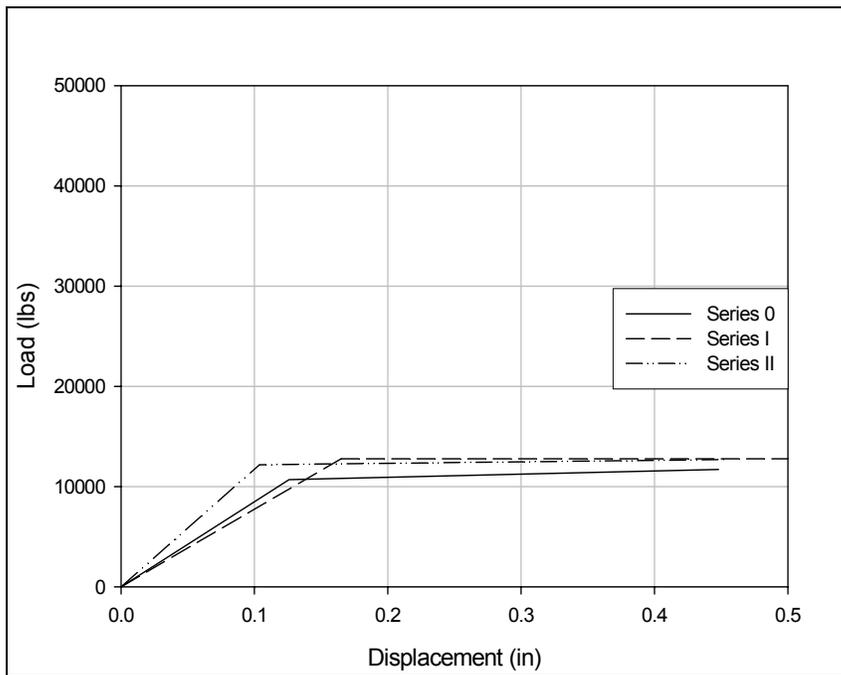
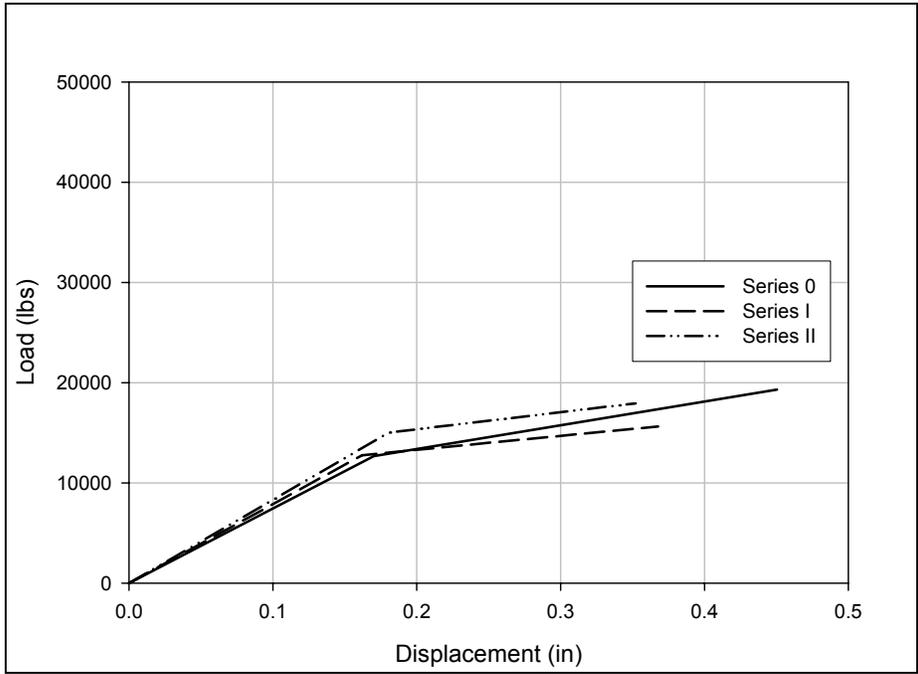
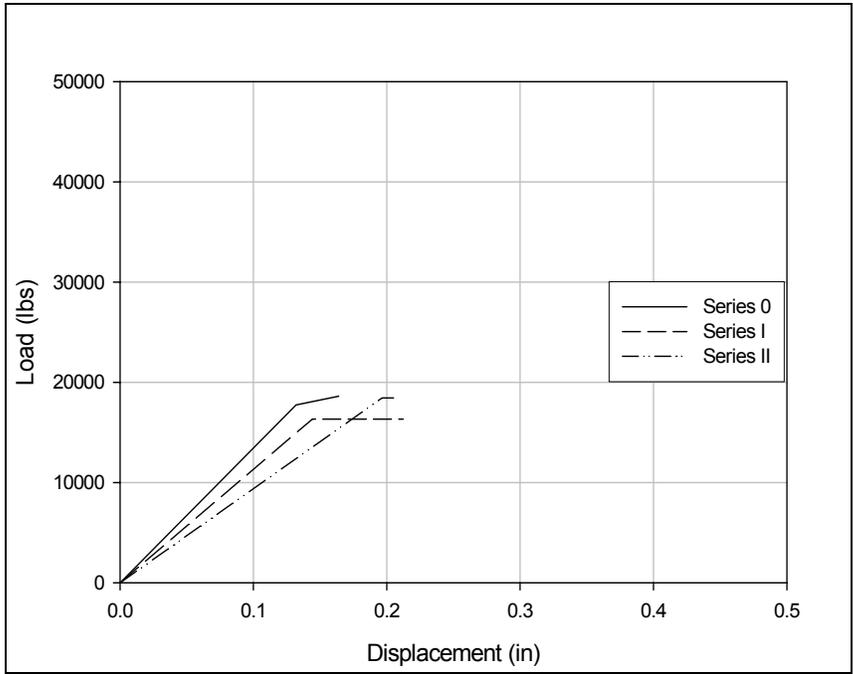
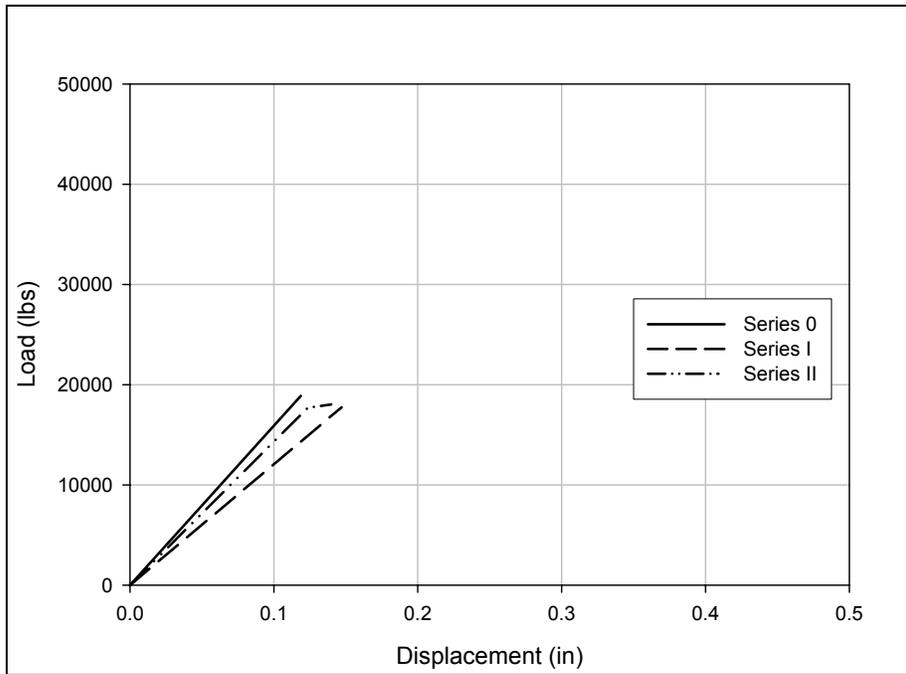
and a_0 , b_0 , b_1 and δ_{ult} are the four bilinear curve-fitting parameters. The parameters for Figure 39 – 44 are summarized in Table 13. Figure 45 – 47 present the average load-displacement curves, ranging from 0% through 100% normal load for each given series. Again, the fitting parameters for these equations can be found in Table 13.

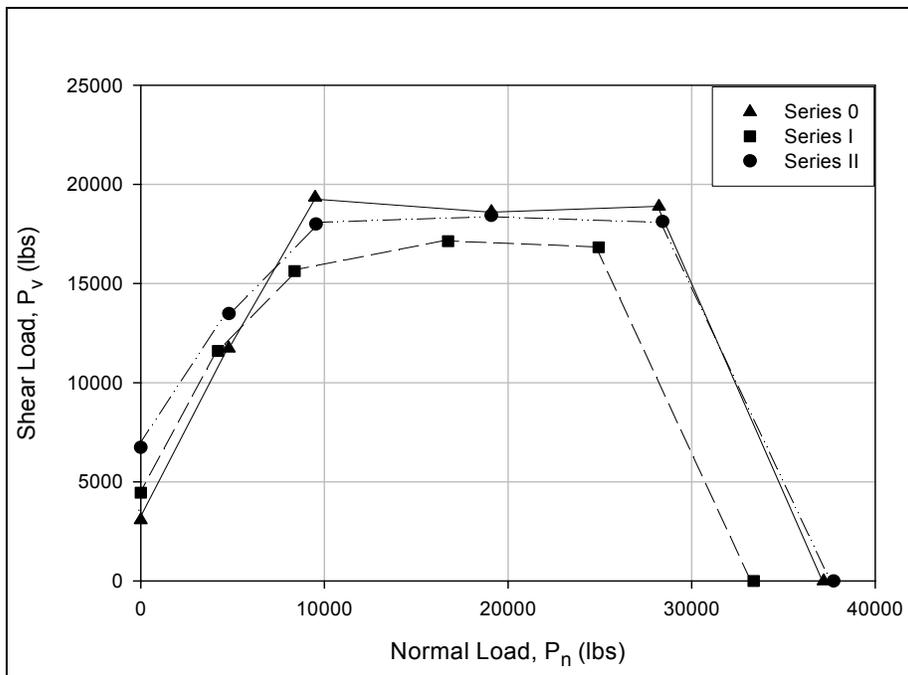
Figure 51. Absolute normal load vs shear load at ultimate for Series 0, I, and II.

A summary of the normal load versus shear load failure envelopes for all Series 0, I, and II triplets is superimposed and provided in Figure 51. It is observed in Figure 51 that the FRP resulted in higher shear value at a low normal load of (12.5%) and lower shear value at higher normal loads (greater than 25%). One explanation for this phenomenon is that the presence of FRP results redirects the loads at high normal stress levels to the weakest load path, hence resulting in earlier failure. Figure 52 shows the data presented in Figure 51 presented as normalized failure envelopes. The figure illustrates how the failure envelopes separate further when normalized versus absolute values are presented.

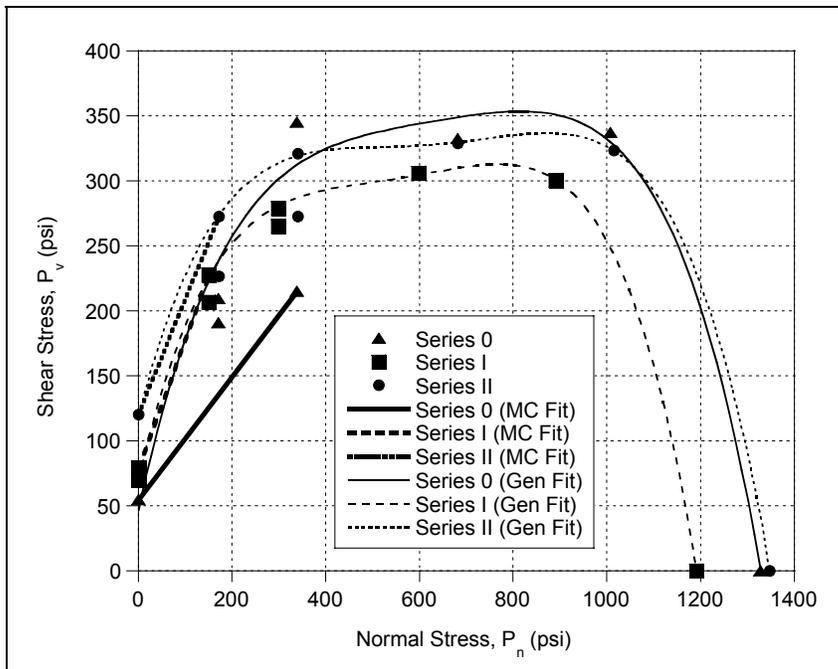
Figure 53. Normal stress vs shear stress with Mohr-Coulomb and Generalized Failure Criteria.

Figure 53 presents the normal load versus shear load failure envelopes along with the Mohr-Coulomb and Generalized Failure Criteria models.

To develop the ultimate failure criterion for the full quadrant behavior in the triplet, a broader generalized model is needed. The simple linear relationship, as presented in the Mohr-Coulomb model (equations 3 and 4), is insufficient to describe

the full envelope of behavior for two reasons. First, it only adequately describes the failure mode up to yield and not from yield to ultimate, which is indicative of the bilinear behavior. Second, transverse cracking within the brick from 25% normal load and beyond renders the equation invalid. However, for the generalized failure model, the data for each of the three series can be expressed as a quartic equation and still correlate with data at greater than $r = 0.99$:
