ERDC/CERL TR-00-18

Performance Testing of Fiber-Reinforced Polymer Composite Overlays for Seismic Rehabilitation of Unreinforced Masonry Walls

June 2000

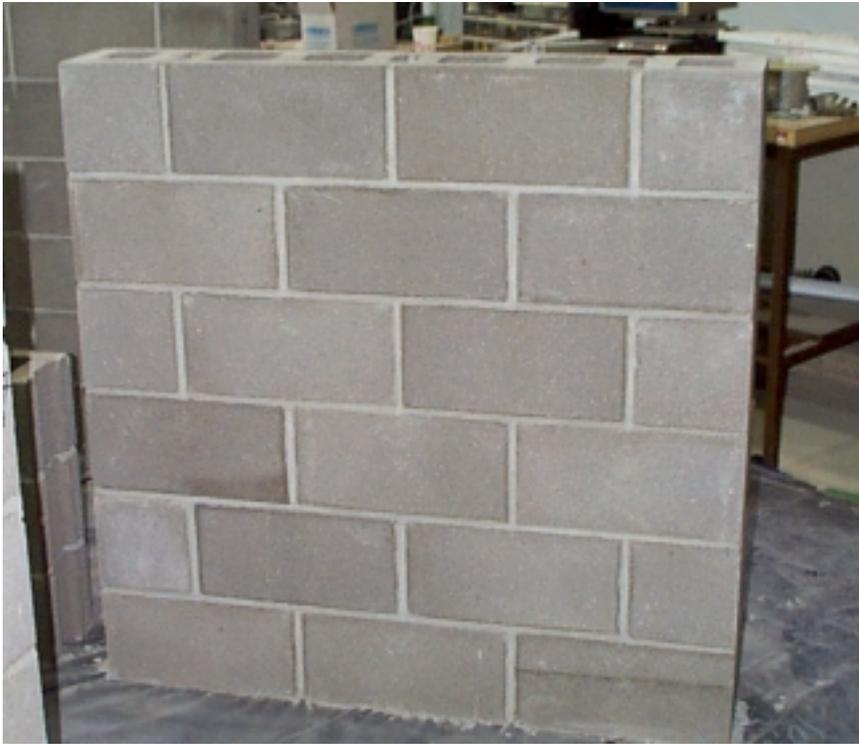
Figure 1. CMU wall panel (4 x 4 ft).

Twenty 4 x 4 ft concrete masonry unit (CMU) wall panels (Figure 1*) and twenty 4 x 4 ft double-wythe brick wall panels (Figure 2) were constructed, as well as prisms and triplet test specimens that are described later in this chapter. Four different FRP composite systems were used: glass epoxy, carbon epoxy, glass vinyl ester, and adhesively bonded glass-epoxy grid. Each FRP system was applied to one face of four CMU wall panels and four brick wall panels. Four unaltered CMU panels and four brick panels were used as controls. The reinforcing fiber orientation used for all of these wall panels was 0/90 degrees to the mortar joints.

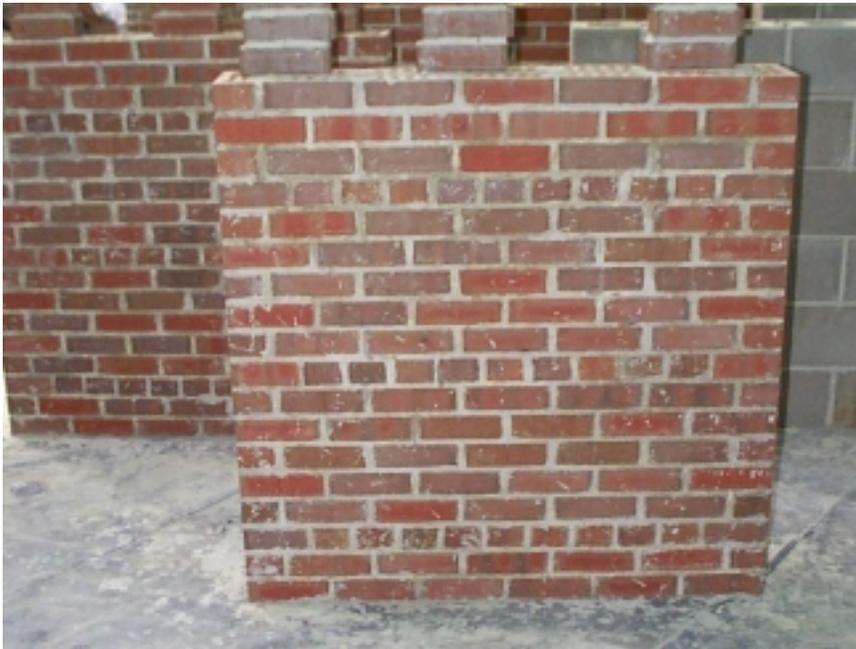
Figure 2. Brick wall panel (4 x 4 ft).

The brick test specimens were constructed using standard 10-hole red clay bricks. The CMU specimens were constructed using standard 8 x 8 x 16 in. blocks.

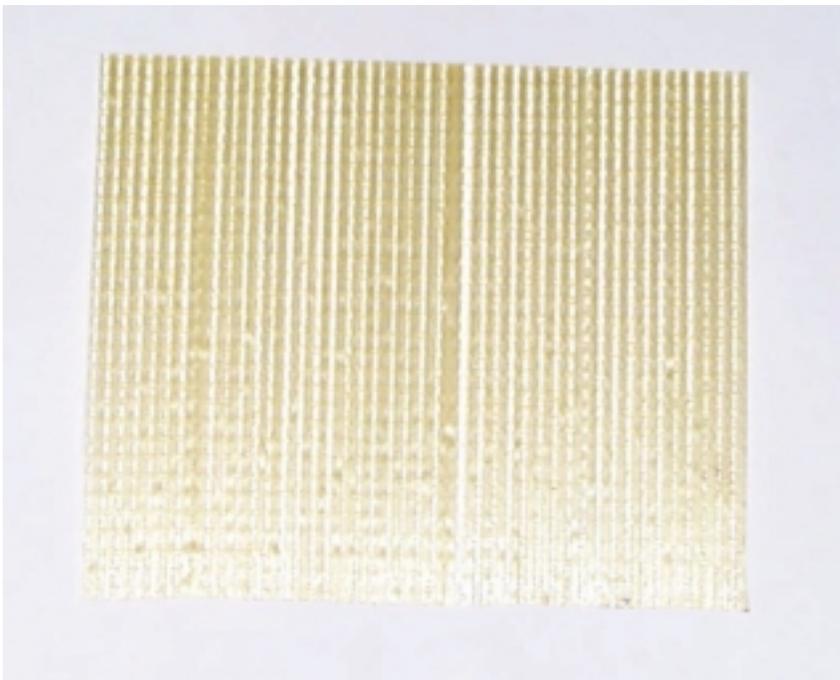
Figure 3. Glass-epoxy grid.

The *glass-epoxy grid* system consisted of a prefabricated and cured grid made of E-glass and a biphenyl-A epoxy resin. The grid was 12.45 oz/sq yd with five tows (strands) per inch in the warp direction and four in the fill (Figure 3). The grid was fastened to the wall using a filled epoxy adhesive system. The adhesive was trowelled onto the wall surface and the grid was pressed into the adhesive using metal rollers. Two layers of grid were used. The first layer was pressed into the adhesive with the warp in a vertical direction. After it was pressed into the adhesive, more adhesive was trowelled onto the wall and a second layer of fabric was pressed into it with the fill in the horizontal direction. The surface of the adhesive was then trowelled to provide a smooth finish.

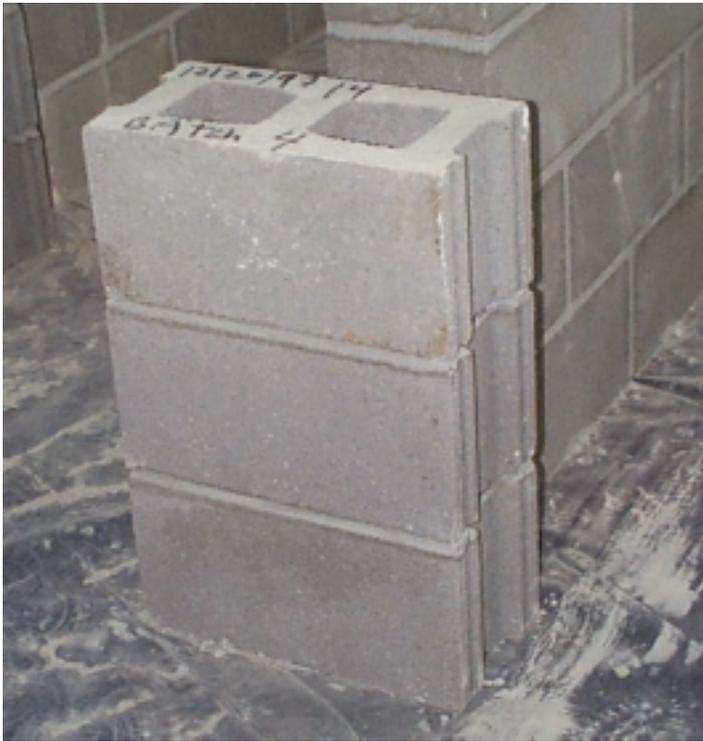
Figure 4. CMU prism.

Thirty masonry prisms were constructed; half were a 3-CMU-block stack (Figure 4) and the other half were a 5-brick-high stack (Figure 5). Each FRP system was applied to one face of three of each type of prism. The reinforcing fiber orientation used for all of these wall panels was 0/90 degrees to the mortar joints. Three CMU and three brick prisms were used as controls.

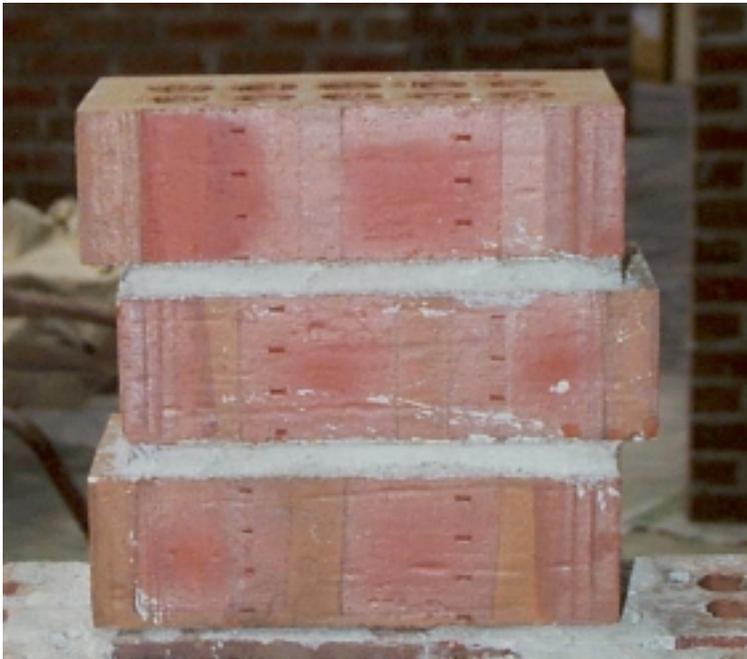
Figure 6. Brick triplet.

Fifty-one brick triplets were also constructed, consisting of three bricks stacked so that the center brick was offset approximately ½ in. (Figure 6). Six triplets were used as controls with no FRP applied to them. Strips of the glass-epoxy system, one fabric-layer thick and oriented at 0/90 degrees to the mortar joints,

The triplet tests were a non-standard test designed to evaluate the shear strength of a masonry specimen across the mortar joint. This test consisted of applying a compressive load at a rate of 2 kips/min on the center offset brick, which created shear in the mortar joints on either side. Testing was conducted using a United Testing Machine (United Calibration Corp., Garden Grove, CA) with a 10 kip capacity. When the capacity of the United machine was reached, the final tests were conducted on the million-pound test machine.

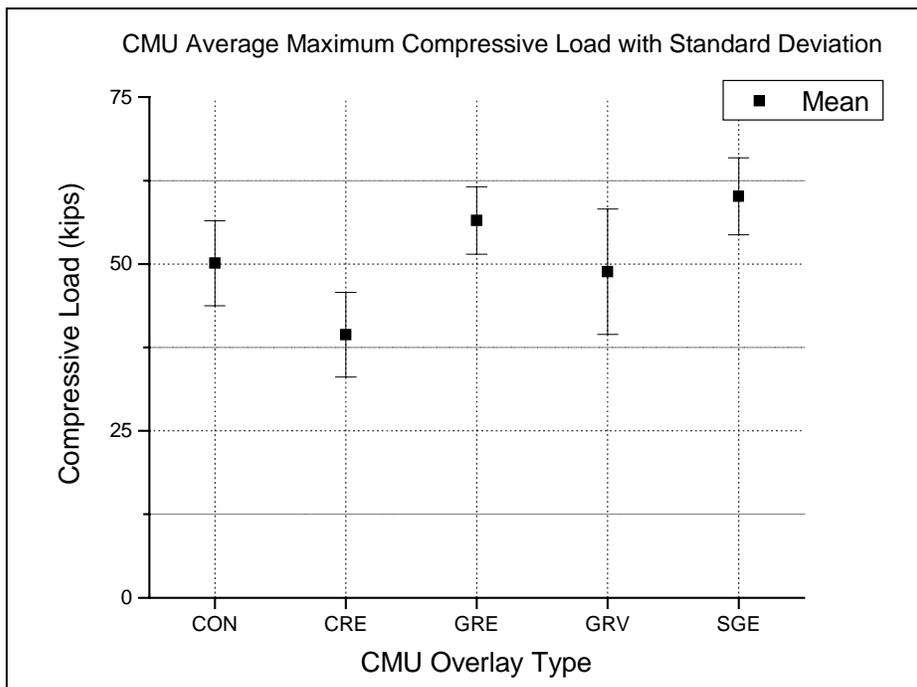
The diagonal tension tests did not demonstrate any statistically significant increase in strength attributable to the composite overlays, but significant changes in the failure behavior were observed. Figures 7 and 8 show the average failure loads versus the overlay type for CMU and brick, respectively. Some increase in the area under the load-deflection curve was seen in some of the walls. Figure 9 shows the load/deflection curves for the CMU control specimens and Figure 10 shows those for the brick control specimens. These curves show typical brittle behavior with little ductility. Figures 11 – 14 show load/deflection curves for the different overlays on CMU walls, and Figures 15 – 18 show load/deflection curves for the brick wall panels. These show an increase in the area under the load/deflection curve relative to the controls, indicating that the wall was able to sustain loads at a higher displacement with the composite overlays than were the control specimens. This ability to sustain load beyond peak load is significant in that it represents *pseudo ductility* in the system. Ductility is the ability of a material to deform plastically before fracturing. A pseudo ductile materials system behaves as if it were ductile even though individual components of the system may fail in a brittle manner. In these tests, the masonry typically failed but the FRP was able to sustain a load beyond that failure point. Appendix A shows the data for all wall section tests.

Figure 7. Average diagonal tension test failure loads vs the overlay type of CMU.

The results of the diagonal shear testing of the 4 x 4 ft wall sections were mixed. No significant change in ultimate strength was observed as a result of the composite overlays. Some change in behavior, however, can be seen in the post peak load behavior of the specimens. In the control specimens, the failure was sudden and resulted in total collapse of the specimen. In some test specimens, however, the composite overlay apparently helped to prevent a total masonry collapse. The composite appears to have helped hold some fractured wall chunks together, thereby preventing masonry units and wall segments from falling away. This benefit is significant from a life-safety standpoint in that it reduces the hazards associated with masonry failure. It is also significant in that the failed wall maintains some residual load carrying capacity.

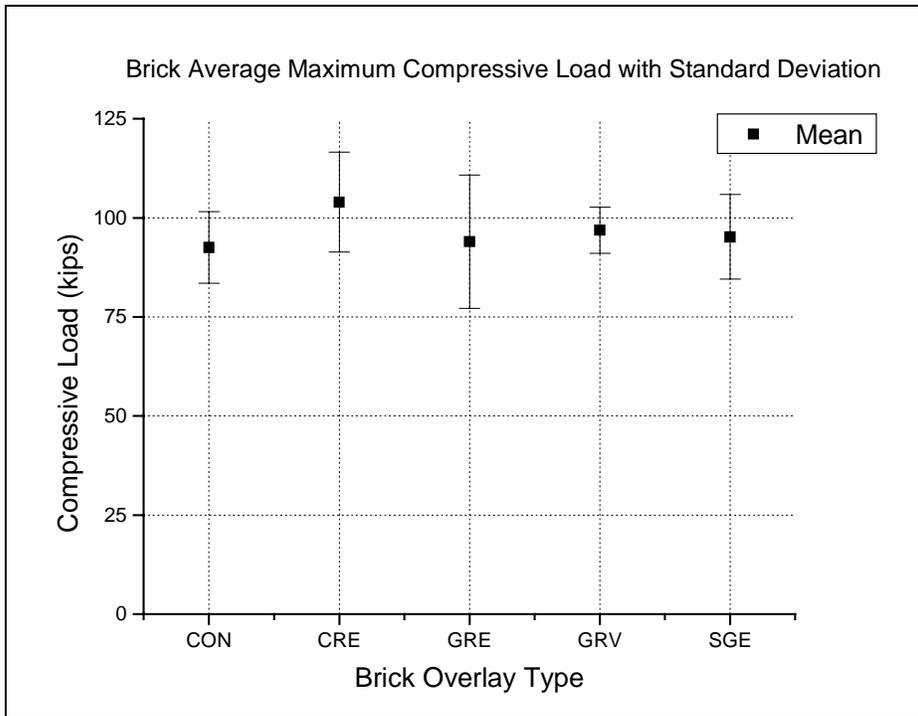
Figure 8. Average diagonal tension test failure loads vs the overlay type for brick.

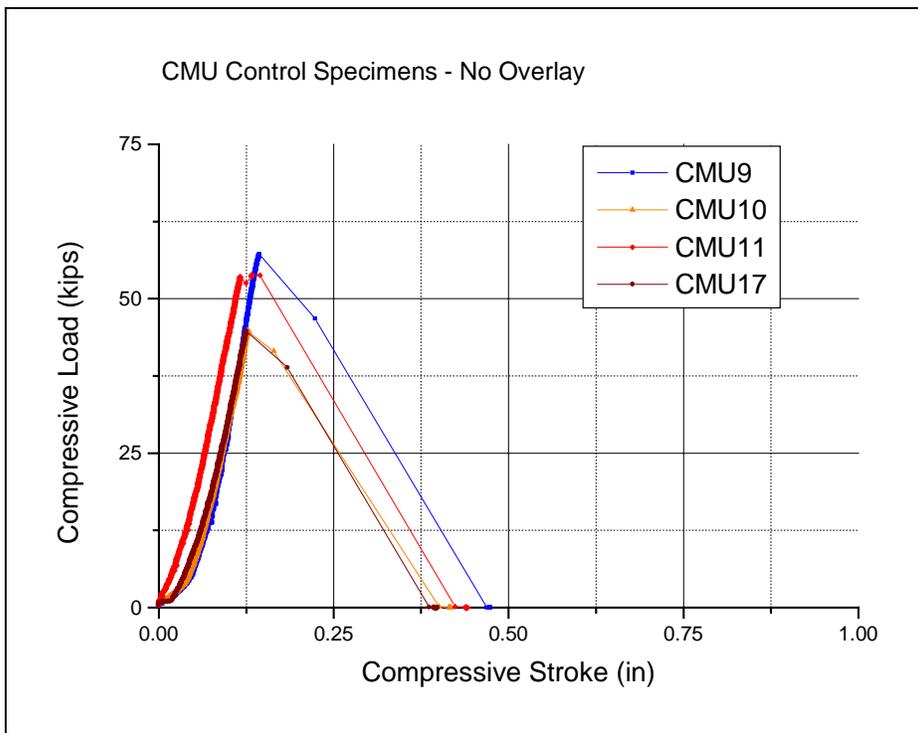
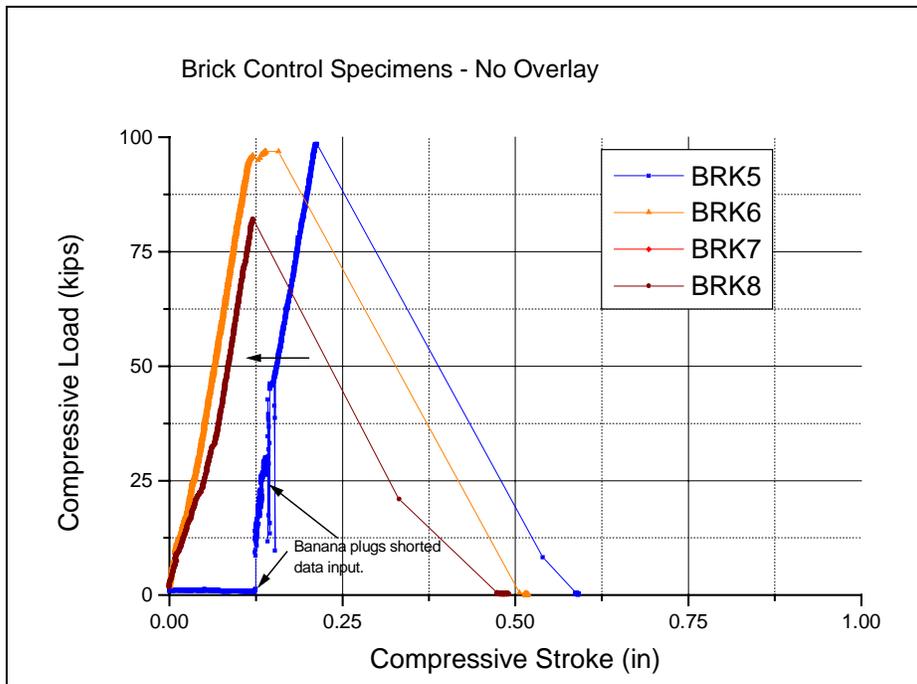
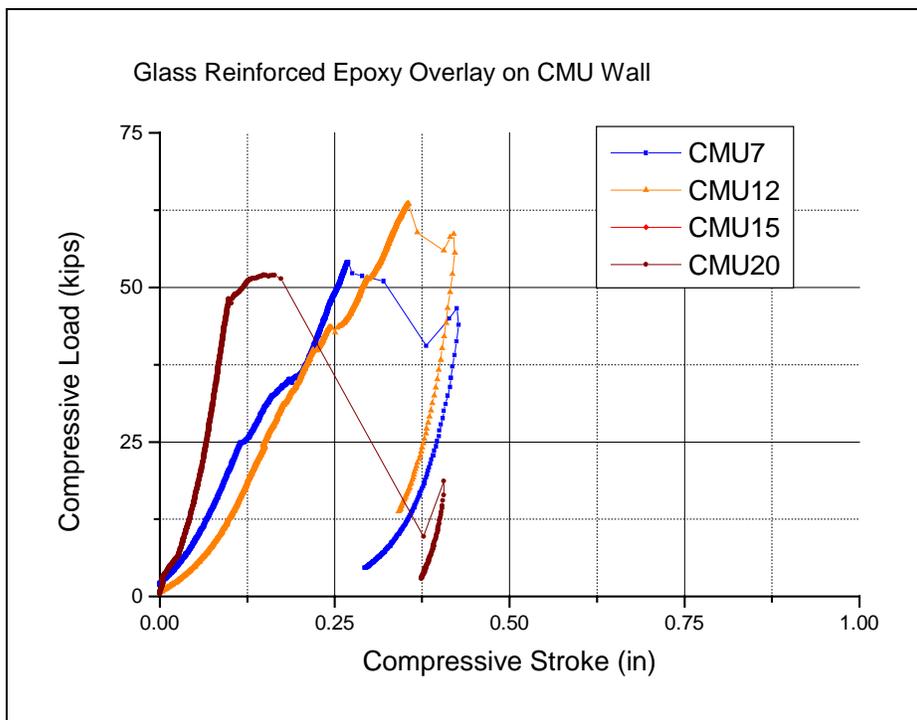
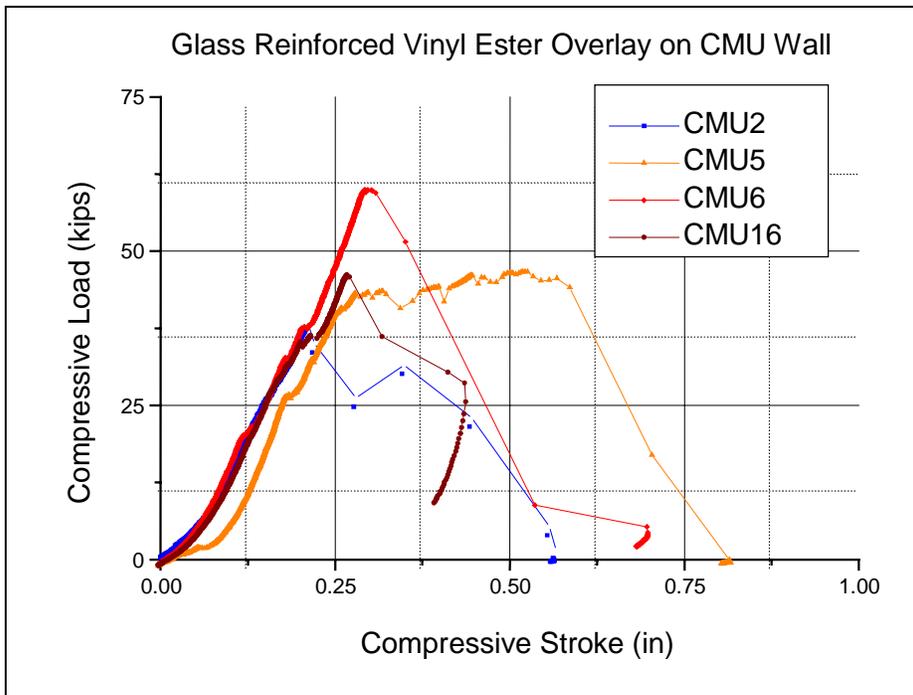
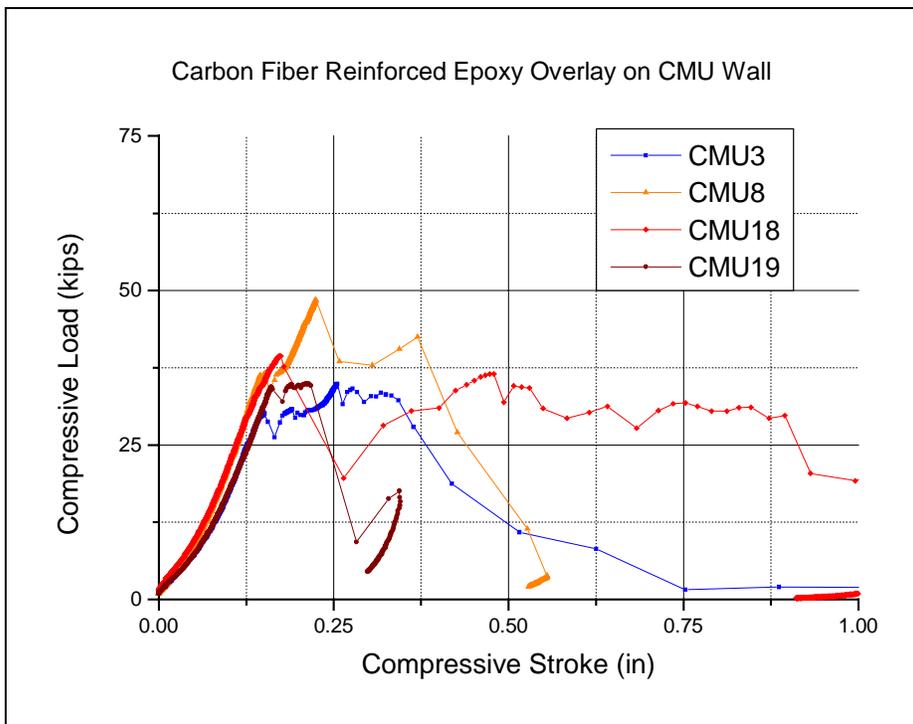
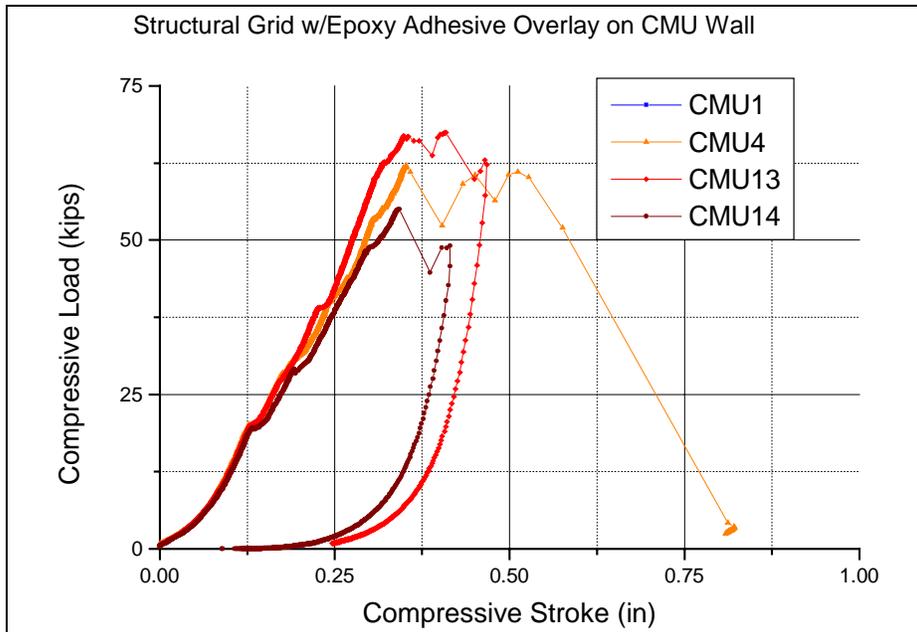
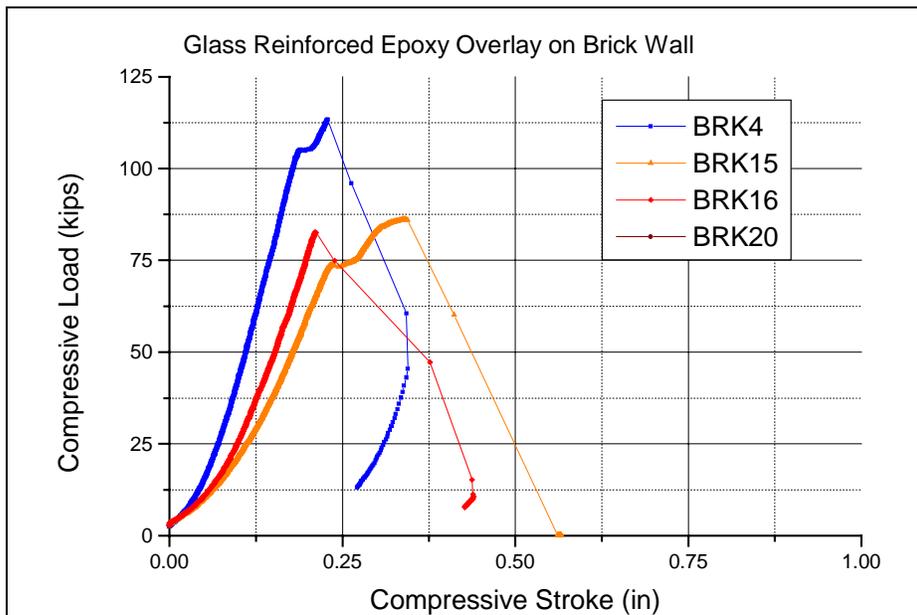
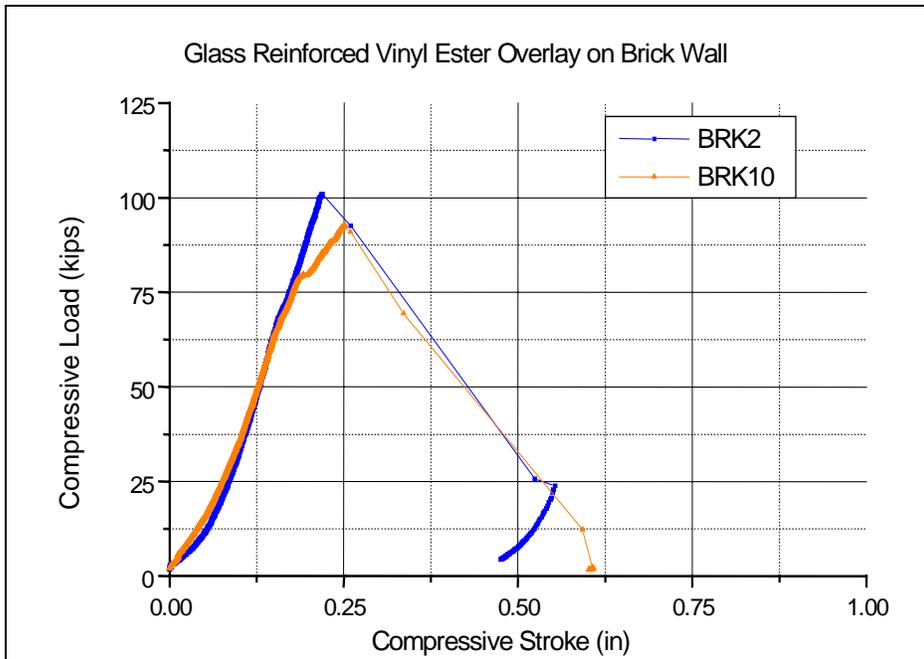
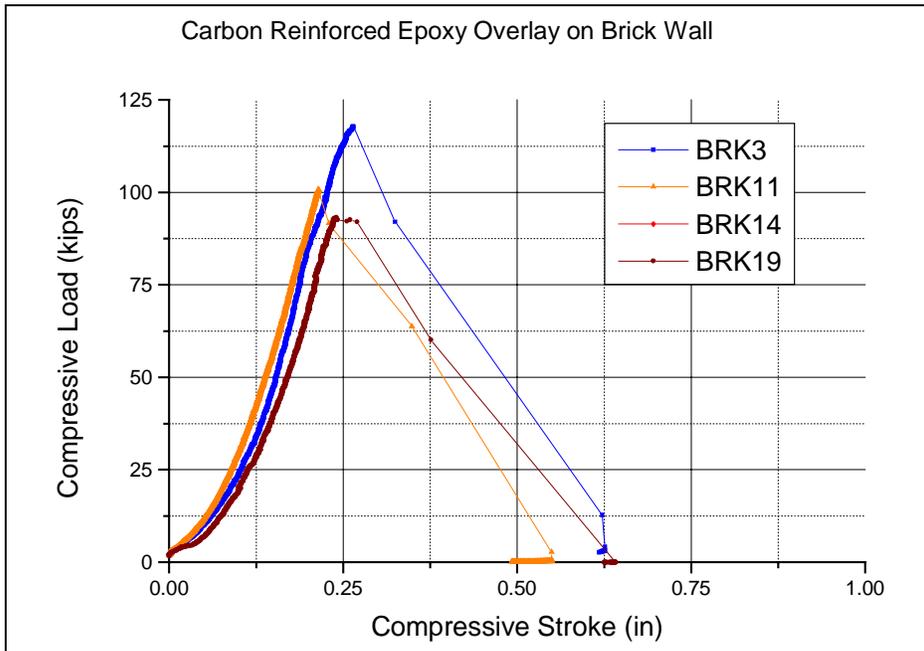
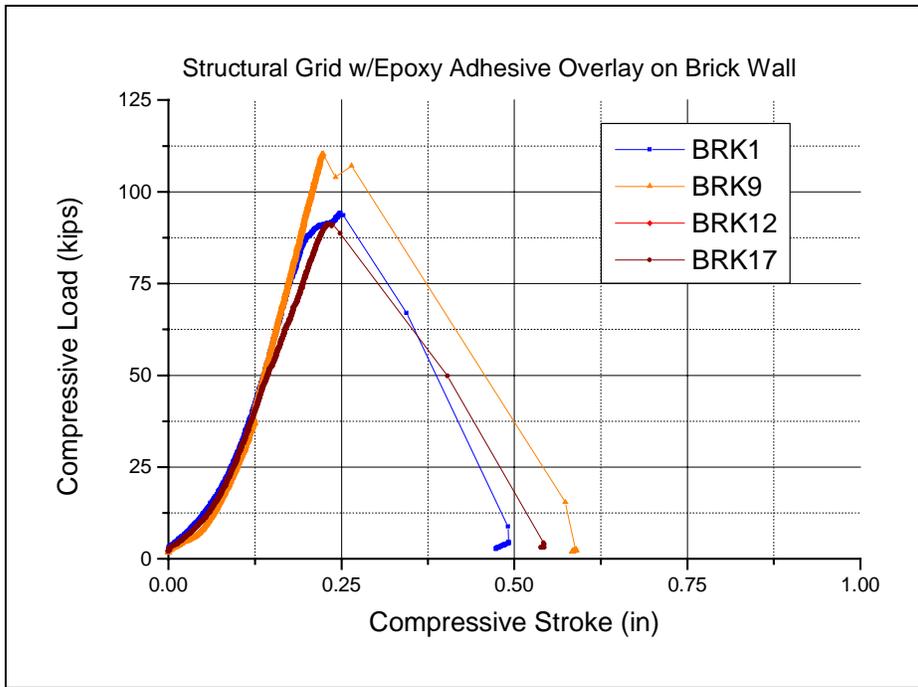
Figure 9. Diagonal tension test load/deflection curves for the CMU control specimens.

Figure 10. Diagonal tension test load/deflection curves for the brick control specimens.

Figure 11. Diagonal tension test load/deflection curves for the glass-epoxy FRP system on CMU walls.

Figure 12. Diagonal tension test load/deflection curves for the glass-vinyl ester FRP system on CMU walls.

Figure 13. Diagonal tension test load/deflection curves for the carbon-epoxy FRP system on CMU walls.

Figure 14. Diagonal tension test load/deflection curves for the glass-epoxy grid FRP system on CMU walls.

Figure 15. Diagonal tension test load/deflection curves for the glass-epoxy FRP system on brick walls.

Figure 16. Diagonal tension test load/deflection curves for the glass-vinyl ester FRP system on brick walls.

Figure 17. Diagonal tension test load/deflection curves for the carbon epoxy FRP system on brick walls.

Figure 18. Diagonal tension test load/deflection curves for the glass epoxy grid FRP system on brick walls.

The control specimen failures were all sudden and brittle — either bed joint sliding or stair step fracture along mortar joints. Walls upgraded with FRP generally showed a different failure mechanism: cracking would initiate at one loading shoe and progress across the specimen to the other shoe. Generally, crack growth would progress slowly to a point, then suddenly progress to completion. Appendix B contains drawings of the wall crack patterns documented in these tests. The FRP overlay materials adhered very well to the masonry and held the wall pieces together after failure. This failure behavior is also significant in that the FRP overlay prevents masonry units and wall sections from becoming disassociated from the structure and falling. Because this type of falling hazard often causes injury or death when URM structures fail, it can reasonably be inferred that composite overlays may help to reduce casualties even when a masonry structure fails during an earthquake.

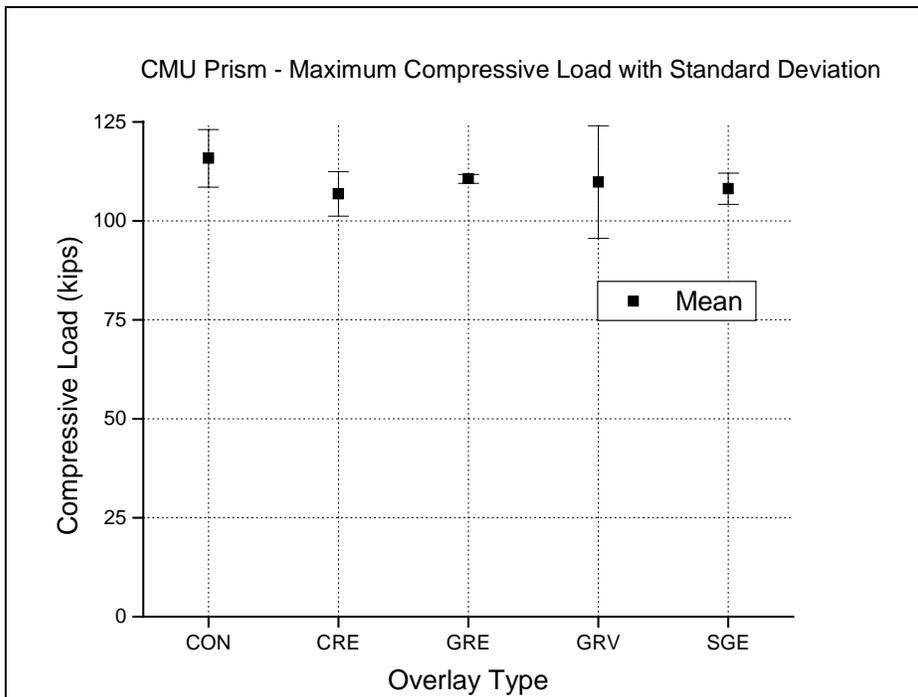
No strengthening was observed in the CMU prism tests as a result of the composite overlays (Figure 19), primarily due to the failure mechanism of the masonry units themselves. Failure always initiated by fracture of the cross webs, allowing the two faces of the CMUs to separate. This is the typical failure mode for block masonry prisms. Average f_m values for the control, glass-epoxy, glass-vinyl ester, carbon-epoxy, and glass grid-epoxy systems were 2362, 2257, 2241, 2178, and 2201 psi, respectively.

Figure 19. Average failure loads vs FRP configuration for CMU prisms.

As predicted, the CMU prisms showed no increase in strength, but there was a 20 – 45 percent strength increase for the brick masonry prisms compared to the control specimens. Two possible explanations are offered. First, masonry prism strength is significantly affected by the strength of the mortar. Approximately 3 months passed between testing of the control specimens and the overlay specimens. The controls were tested 31 days after construction. The glass-epoxy, glass-vinyl ester, and carbon-epoxy prisms all were tested 120 days after construction, and the glass grid-epoxy prisms were tested 162 days after construction. While it is possible that this time lapse may account for some disparity in the strength results, a strength increase of 25 percent or more beyond the 28 day standard cure time would be extreme. Furthermore, the composite specimen with the lowest average strength was tested after the longest cure time, and this also suggests other factors were affecting prism strength.

The failure mode of a brick prism is different than for a CMU block prism. An ungrouted (hollow) block prism tends to split longitudinally, fracturing through the cross webs. A solid brick prism tends to split transversely, through the face of the brick. It is evident from the test data that the composite overlay had a significant effect on the prism strength.

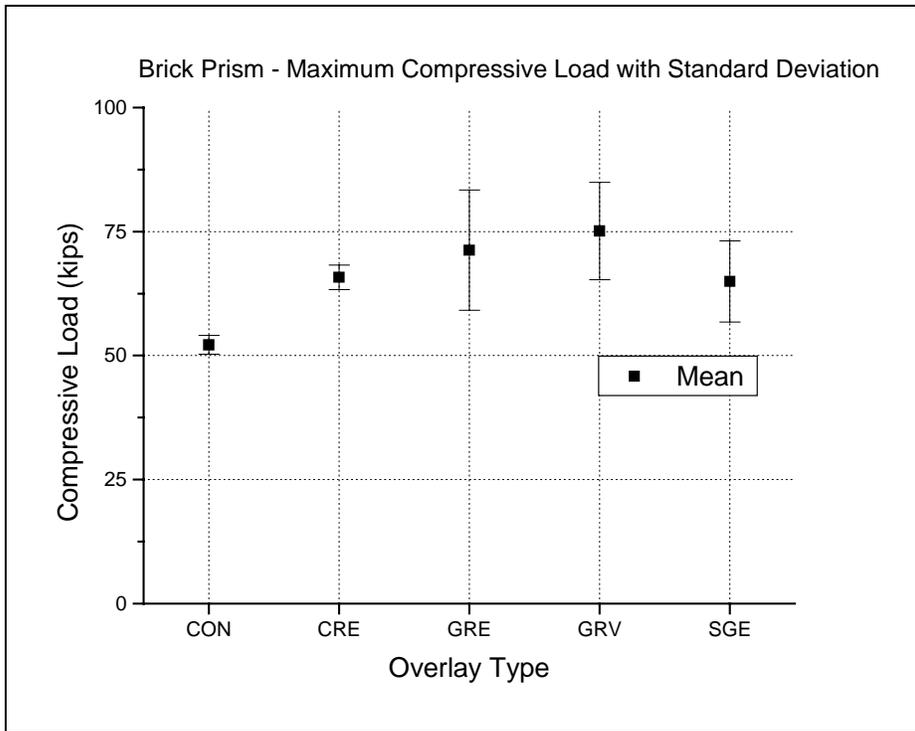
Some strengthening was observed in the brick prism specimens, however (Figure 20). The typical failure mode in a brick prism is splitting along the short dimension of the specimen, along the face where the composite was applied. In this case, the composite was applied to the critical section of the specimen, so it was more likely to have a positive effect on strength. Average f_m values for the control, glass-epoxy, glass-vinyl ester, carbon-epoxy, and glass grid-epoxy systems were 2164, 2976, 3130, 2738, and 2700 psi, respectively. The glass-vinyl ester system provided the highest increase in strength at 45 percent, while the glass grid-epoxy system provided the lowest with a 25 percent increase in strength. Appendix D shows the prism test data for all tests.

Figure 20. Average failure loads vs FRP configuration for brick prisms.

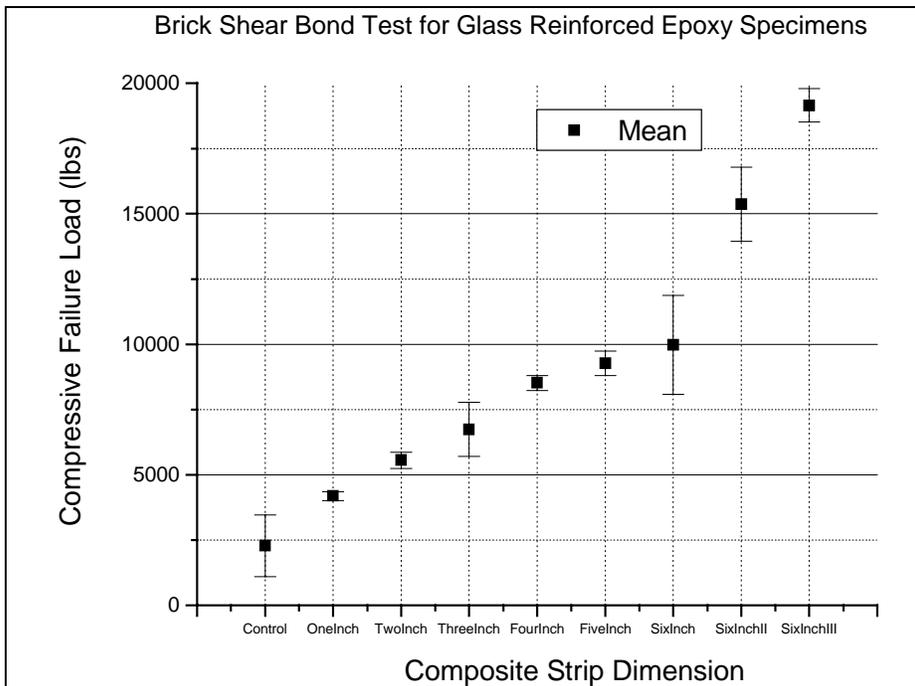
The brick triplet tests evaluate shear bond strength across the mortar joints and the ability of FRP composites to strengthen that shear bond. As the width of the FRP composite on the specimen increased, so did the triplet strength. The average failure load of the control specimens was 2.28 kips. One 6 in. wide glass-epoxy specimen exceeded the 10 kip capacity of the test machine, as did a 4 in. wide carbon-epoxy specimen. The strength increase was fairly linear in proportion to the increase in FRP width. Figure 21 shows the glass-epoxy triplet test results and Figure 22 shows the results for the carbon-epoxy system. Appendix E shows the data for all triplet tests.

Figure 21. Average failure loads vs FRP configuration for glass epoxy triplets.

The triplet tests showed that FRP composite overlays can strengthen the brick/mortar joint, and that strengthening increases at an approximately linear rate as a function of the FRP overlay width. The testing equipment available for these investigations did not permit a study of joint strengthening as a function of FRP overlay thickness.

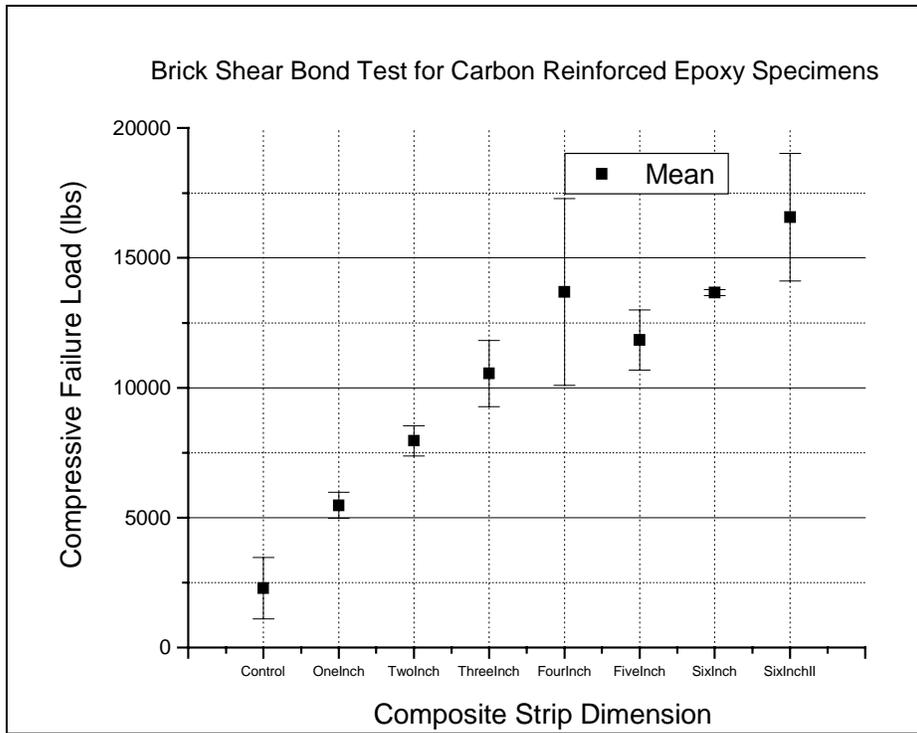
Figure 22. Average failure loads vs FRP configuration for carbon epoxy triplets.
