USA-CERL TECHNICAL REPORT M-87/13, VOL. II

Roofing Maintenance Management System

# Membrane and Flashing Condition Indexes for Built-Up Roofs

## Volume II: Inspection and Distress Manual

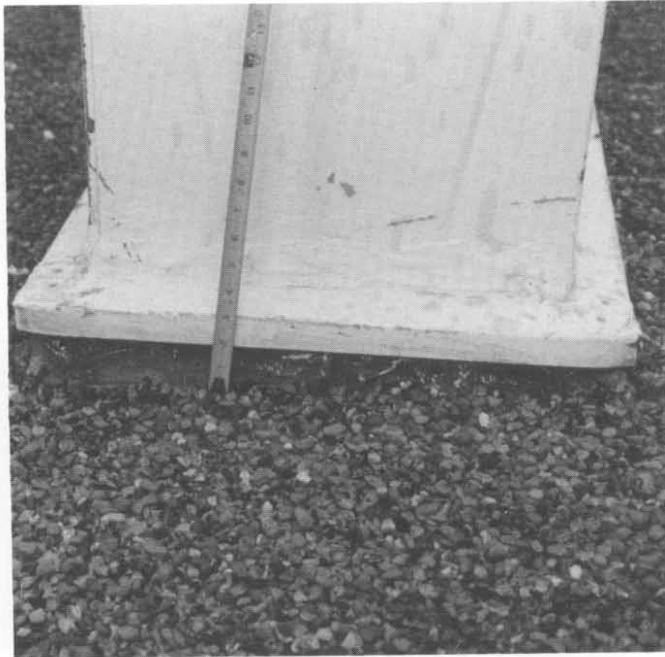
Figure 5. Check height of base flashing above deck.

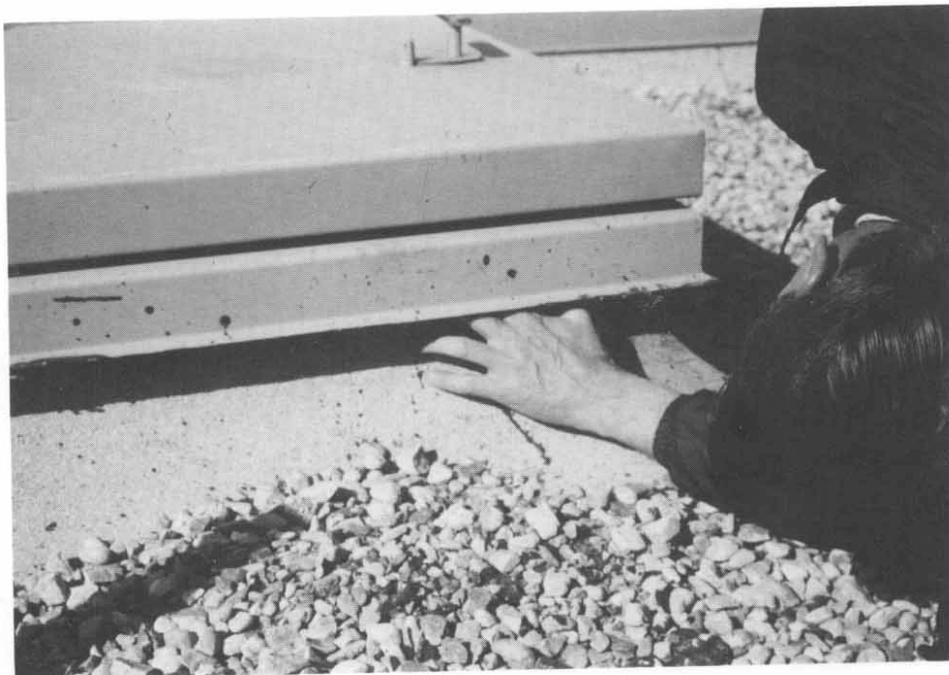
Figure 6. Check base flashing height by running fingers behind counterflashing.

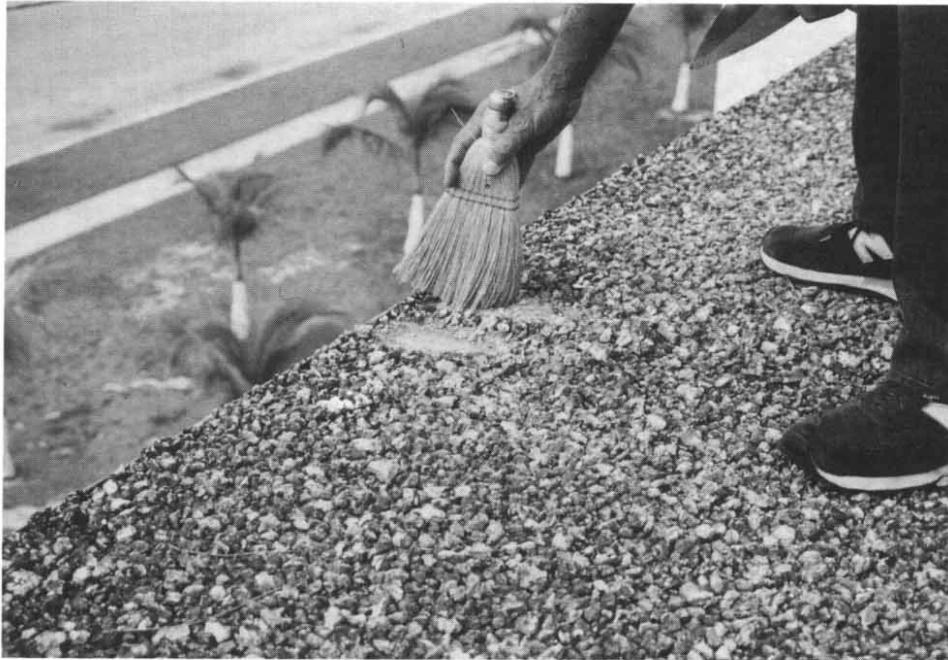
Figure 7. Sweep gravel back from embedded edge metal to expose joints.

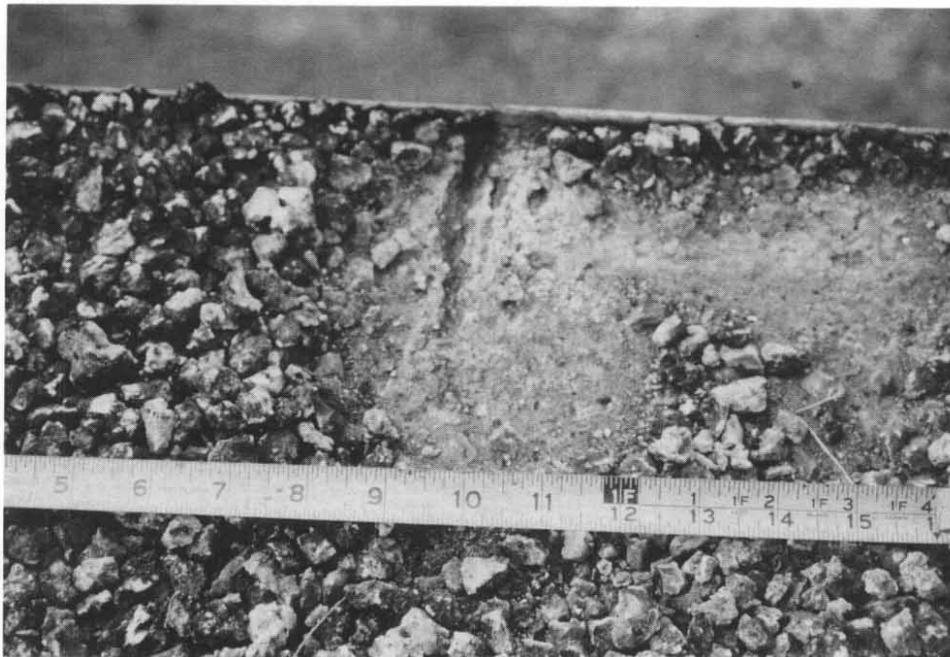
Figure 8. Tear in stripping felts exposed by sweeping gravel away at joints.

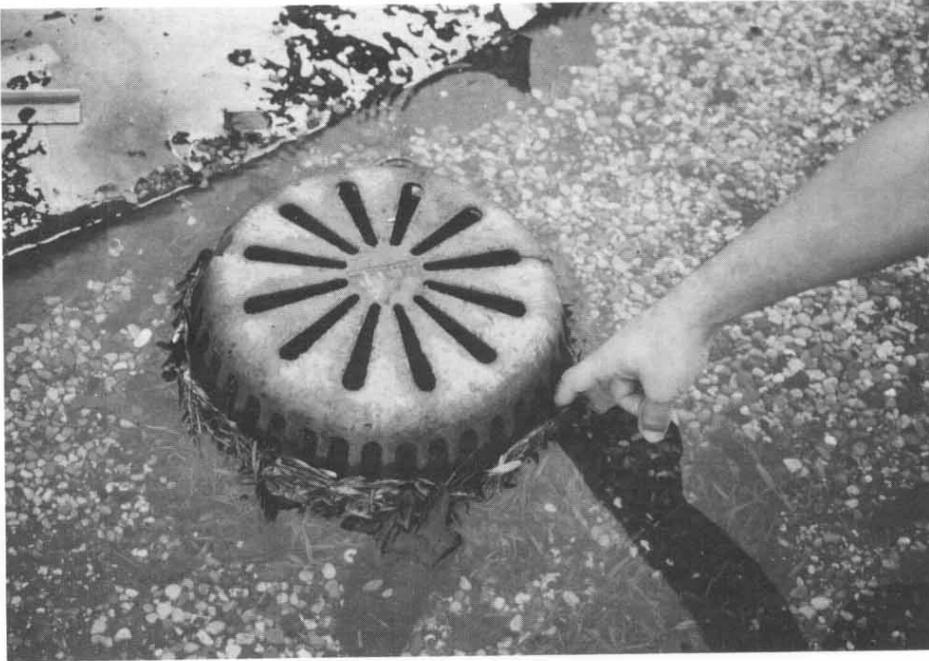
Figure 9. Roof drain clogged by debris.

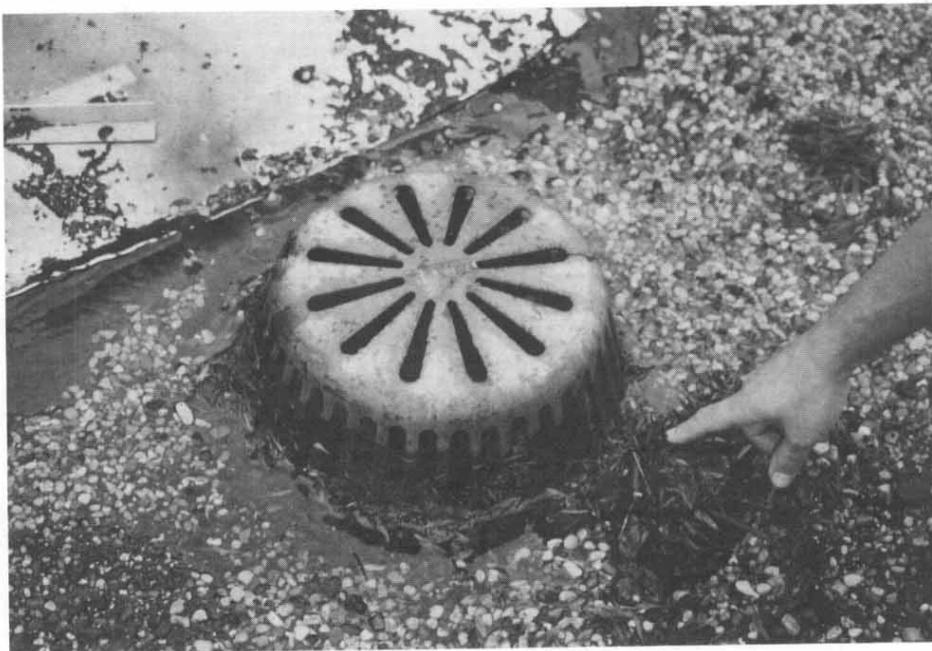
Figure 10. Removing debris frees the drain.

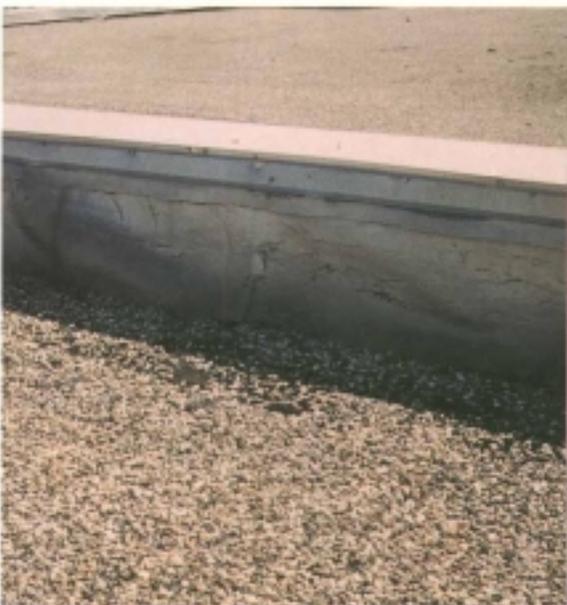
**BF7** Base Flashing  
<Medium Severity>  
Flashing material has sagged

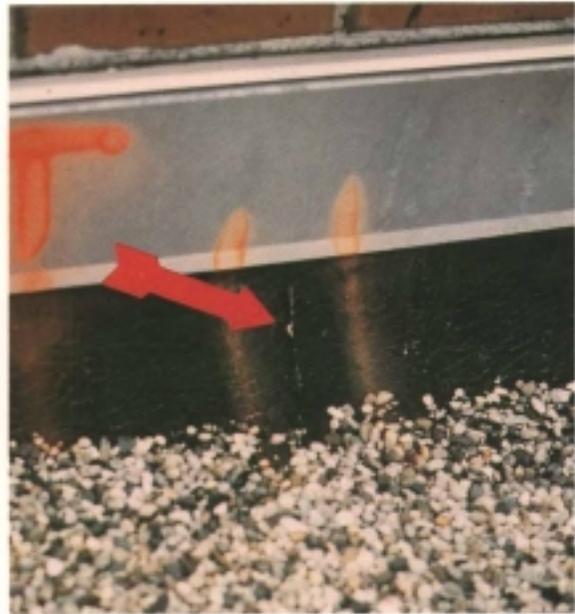
BF10 Base Flashing  
<High Severity>  
There is an open seam in the flashing

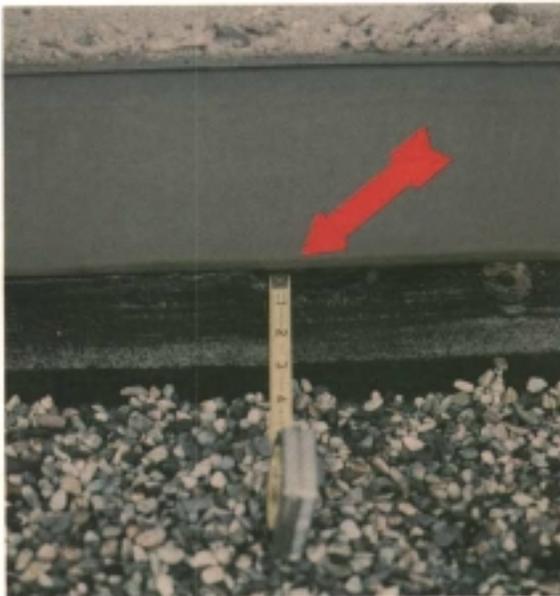
BF11 Base Flashing  
<High Severity>  
Flashing has sagged; top is open

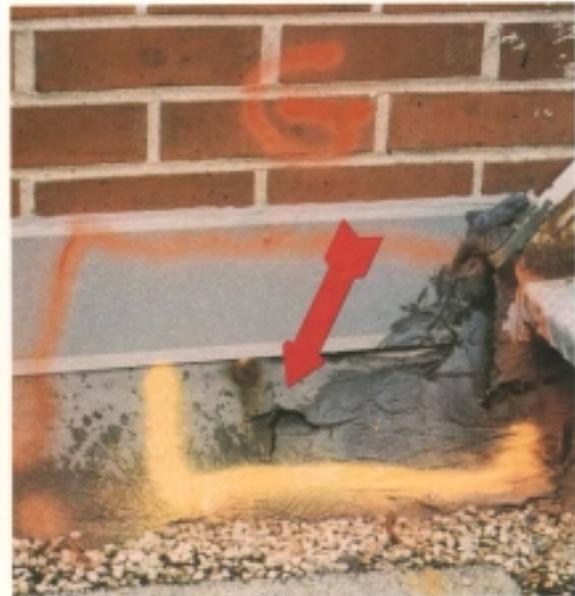
BF12 Base Flashing  
<High Severity>  
There is a hole through the flashing material

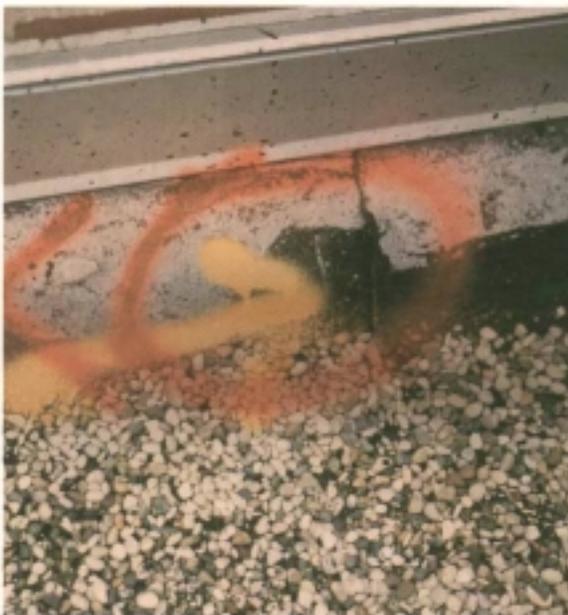
BF13 Base Flashing  
<High Severity>  
There is an open seam in the flashing

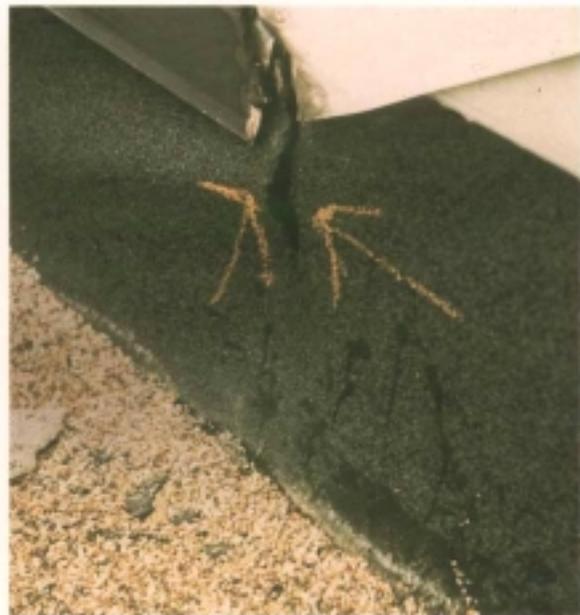
BF14 Base Flashing  
<High Severity>  
There is a hole in the flashing material

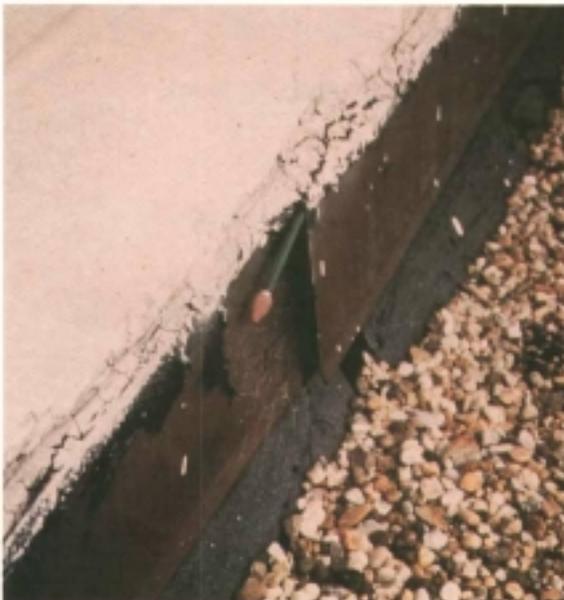
**MC3 Metal Cap Flashing**  
 <Low Severity>  
 The metal is bent but still is able to function

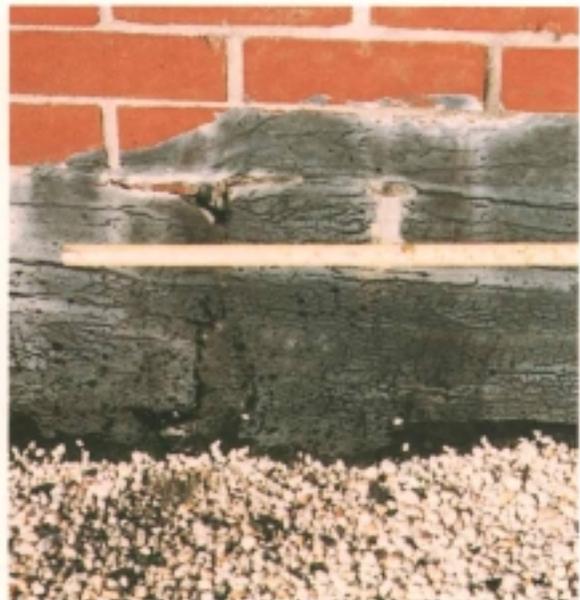
**MC4 Metal Cap Flashing**  
 <Low Severity>  
 The counterflashing has been sealed to the base flashing

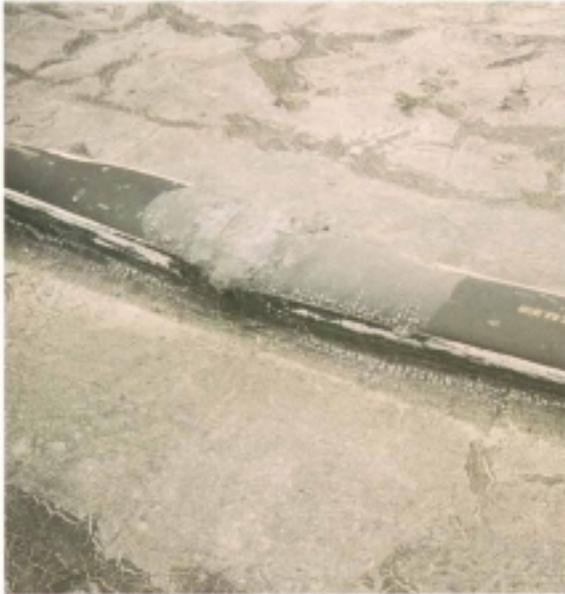
MC5 Metal Cap Flashing  
 <Low Severity>  
 Metal or accessories have been deformed or damaged

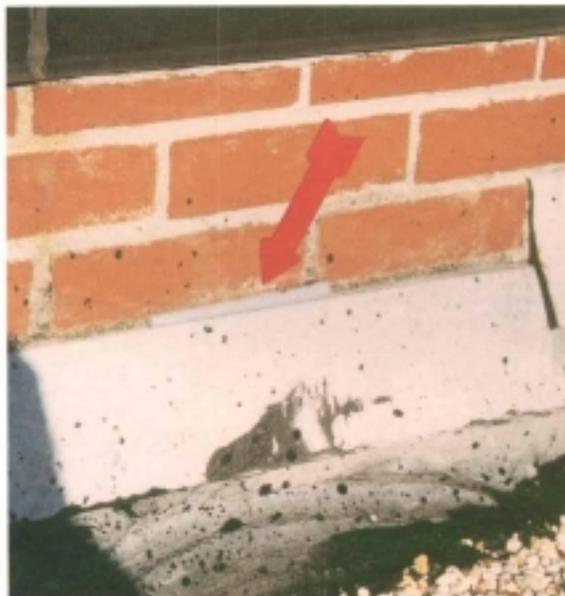
MC7 Metal Cap Flashing  
 <Medium Severity>  
 The metal has been bent so that water can accumulate on the joint in the masonry

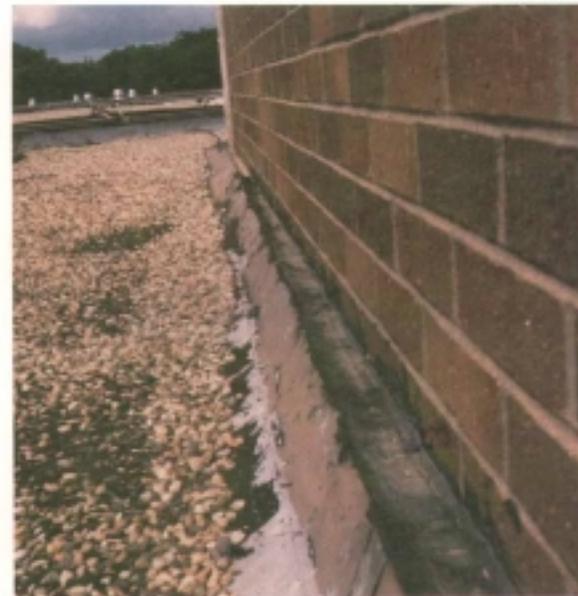
MC8 Metal Cap Flashing  
 <Medium Severity>  
 The top of the counterflashing holds water

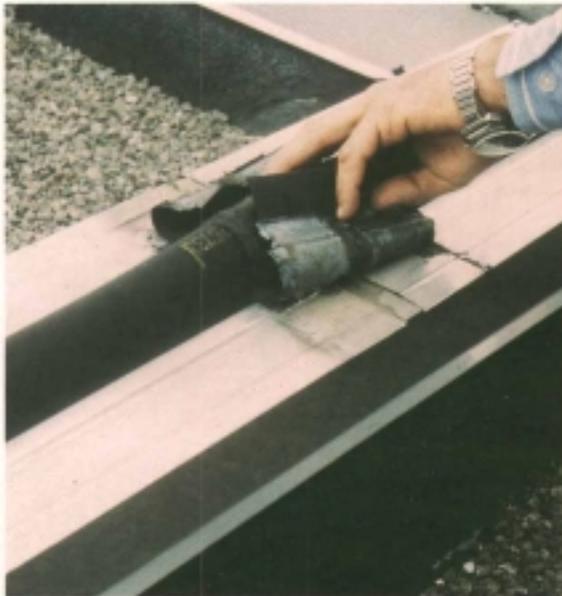
**MC11 Metal Cap Flashing**  
<Medium Severity>  
Neoprene cover at joint has failed

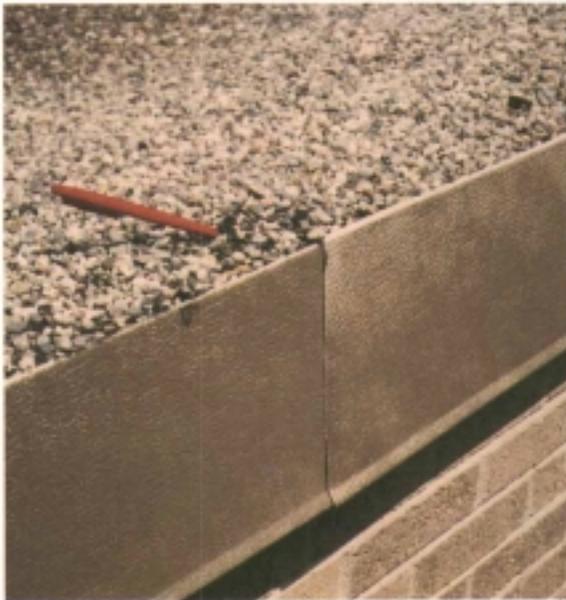
EM3 Embedded Edge Metal  
 <High Severity>  
 The stripping shows the beginning of a tear or break

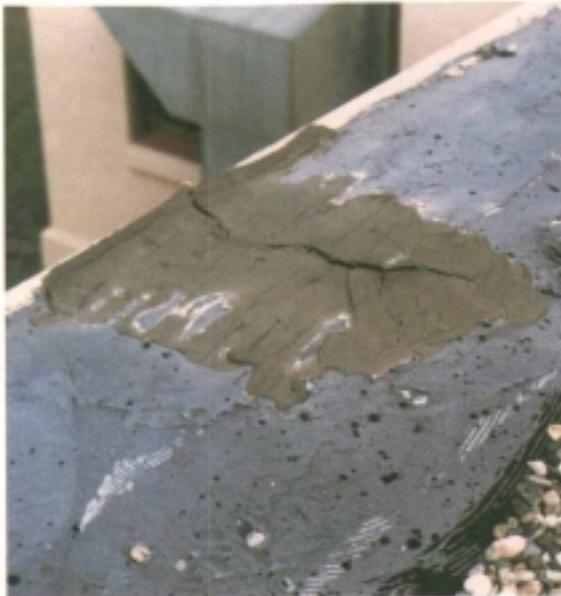
EM7 Embedded Edge Metal  
<High Severity>  
The metal movement has torn the stripping

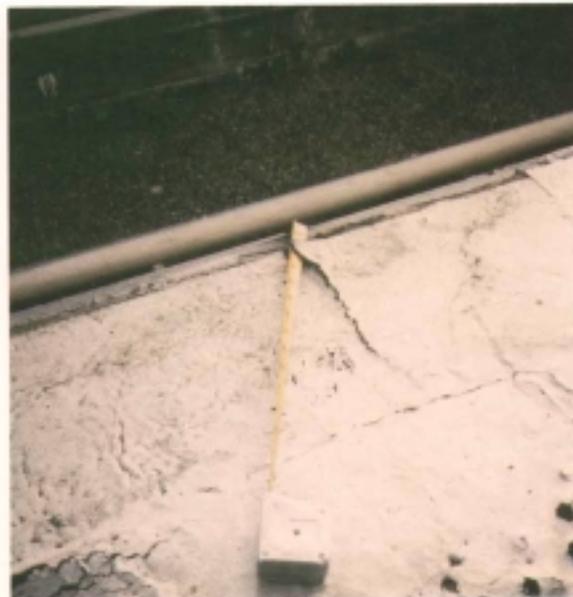
EM8 Embedded Edge Metal  
<High Severity>  
The stripping felts are torn

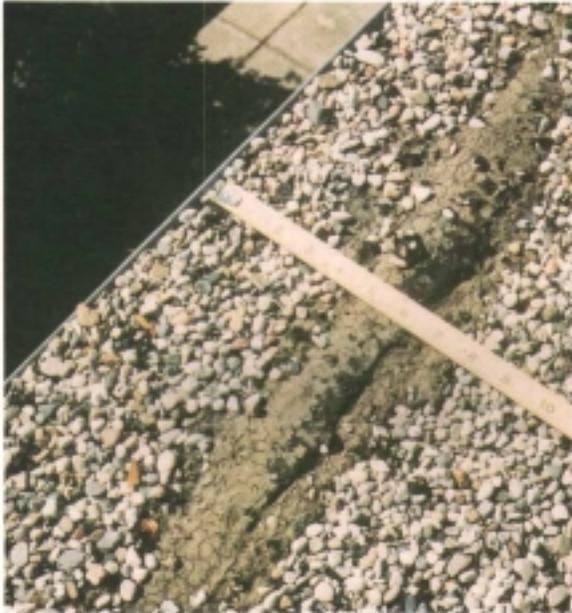
EM9 Embedded Edge Metal  
 <High Severity>  
 The stripping felt is torn along the back edge of the embedded metal

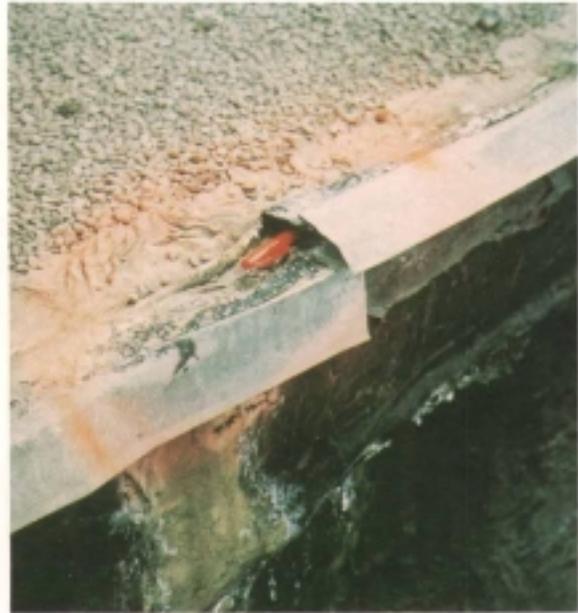
EM10 Embedded Edge Metal  
 <High Severity>  
 The edge metal is bent or deformed; the stripping is torn

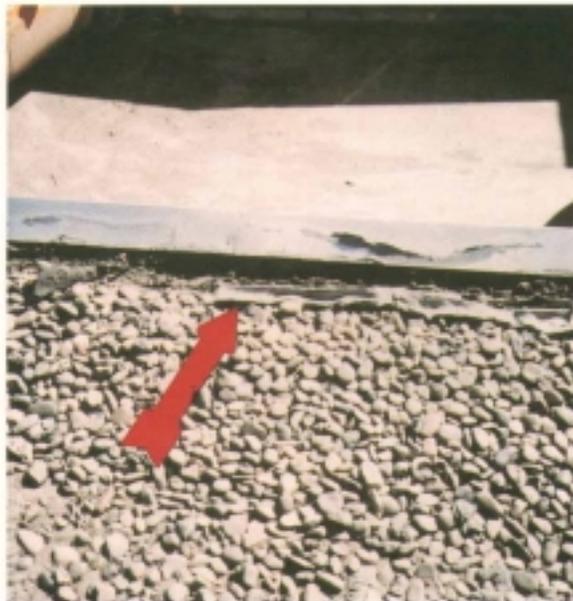
EM11 Embedded Edge Metal  
 <High Severity>  
 The stripping is torn

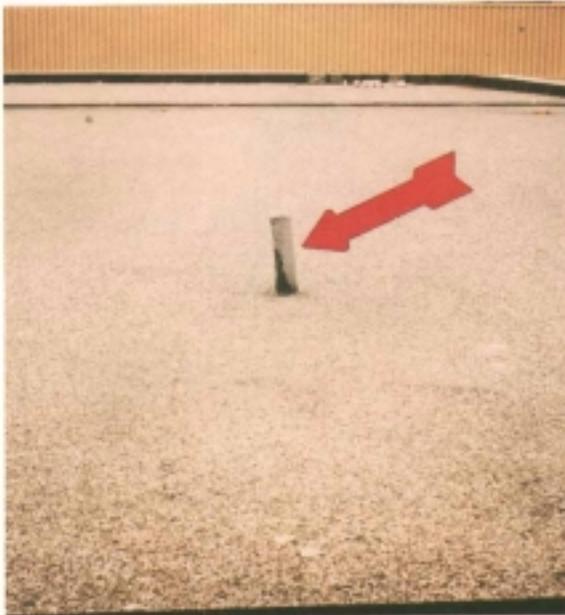
FP1 Flashed Penetration  
 <Low Severity>  
 The vent stack is distorted due to movement of the membrane

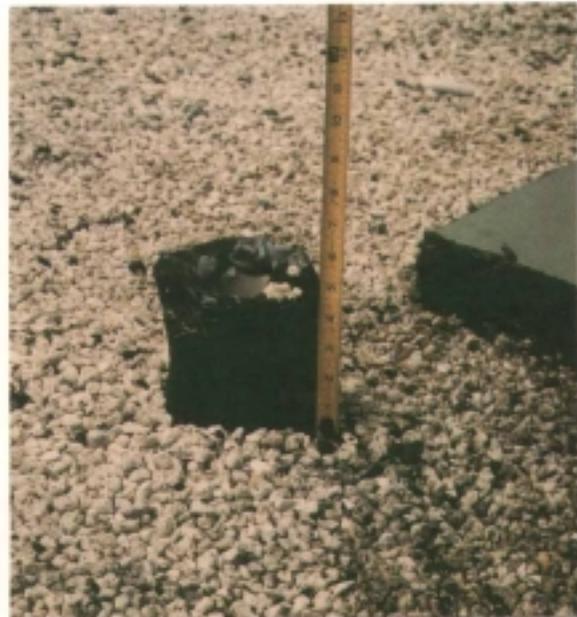
FP2 Flashed Penetration  
 <Low Severity>  
 The top of the flashing is less than 6 in. above the finished roof

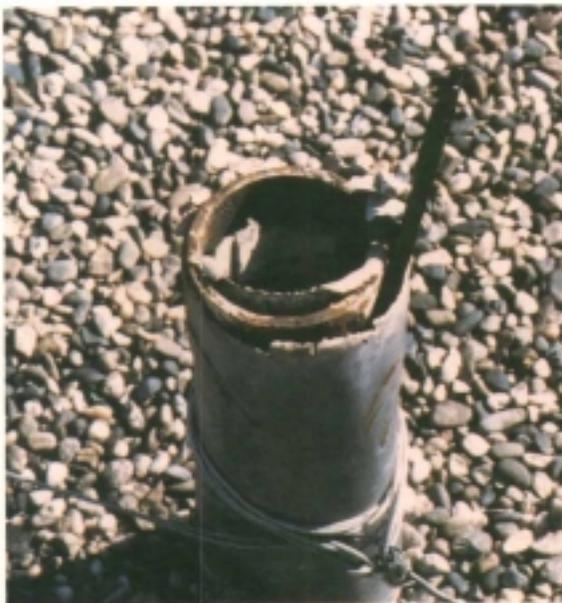
FP3 Flashed Penetration  
 <Low Severity>  
 The top of flashing sleeve is not sealed

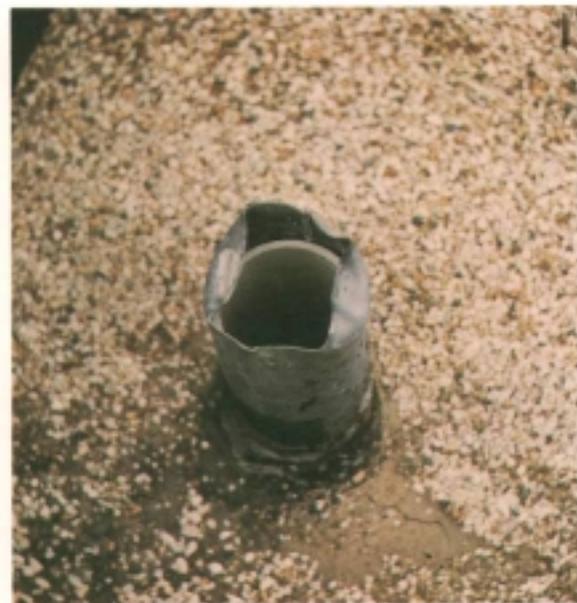
FP4 Flashed Penetration  
 <Medium Severity>  
 The lead had not been rolled down into the vent

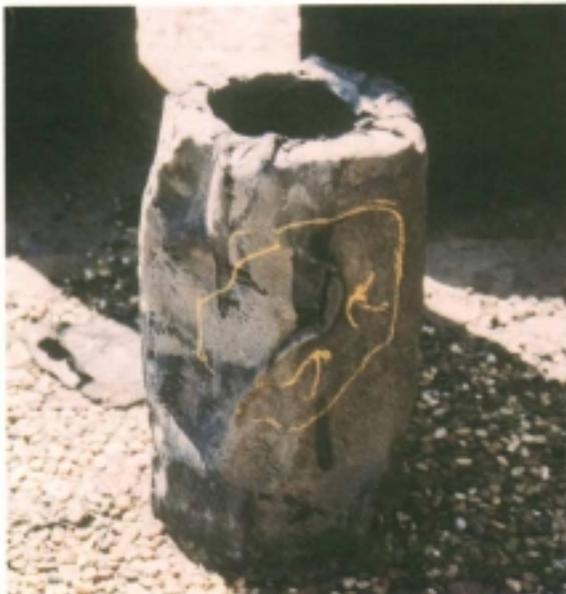
**FP7** Flashed Penetration  
<Medium Severity>  
The flashing sleeve is cracked or broken

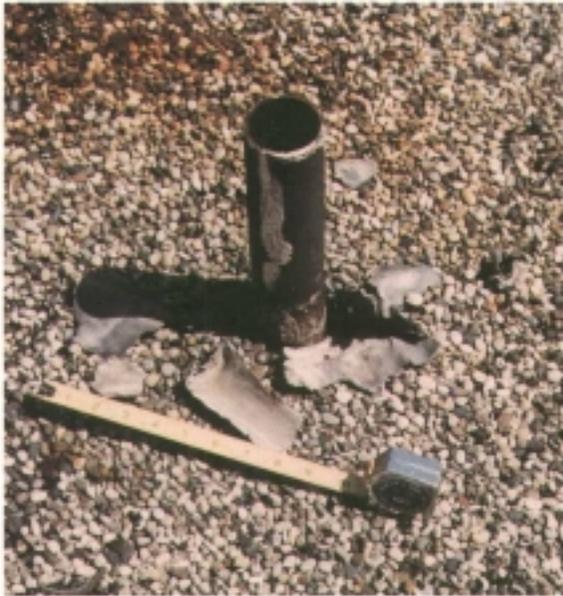
FP9 Flashed Penetration  
<High Severity>  
The lead flashing is broken

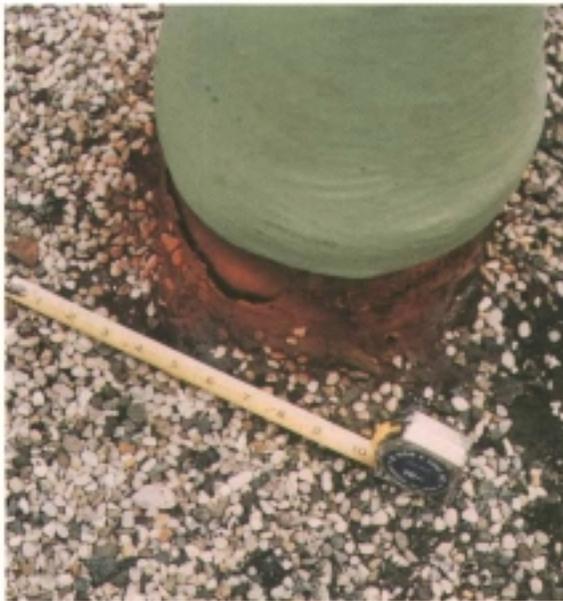
FP11 Flashed Penetration  
<High Severity>  
The metal has corroded and holes are evident

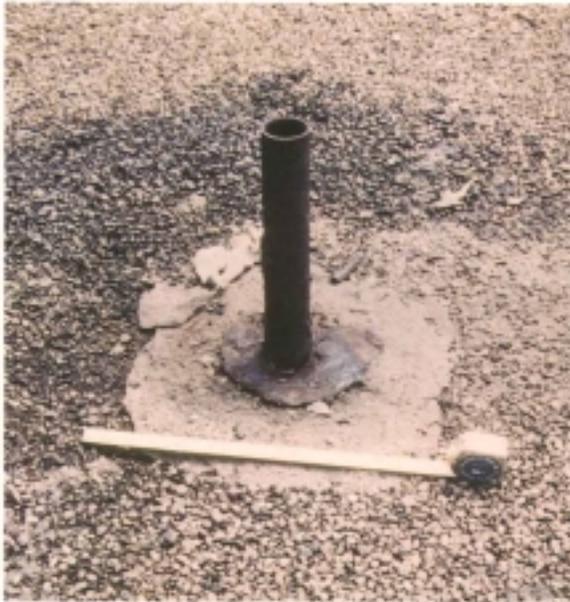
FP13 Flashed Penetration  
<High Severity>  
Unflashed pipe penetration sealed  
with roofing cement

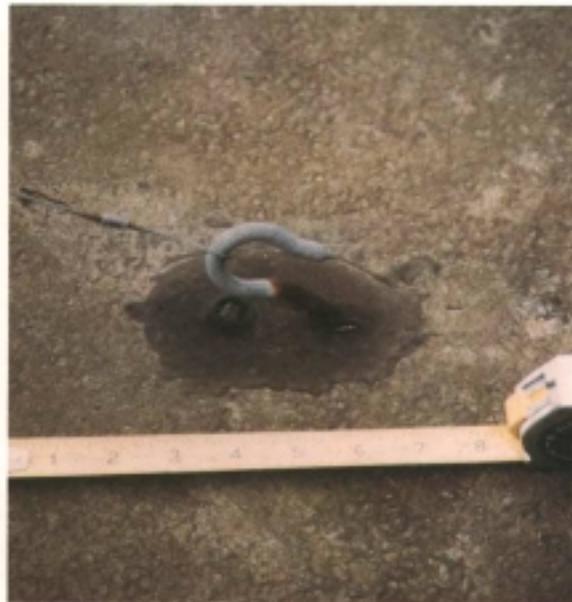
FP14 Flashed Penetration  
<High Severity>  
Guy wire anchor has not been  
flashed

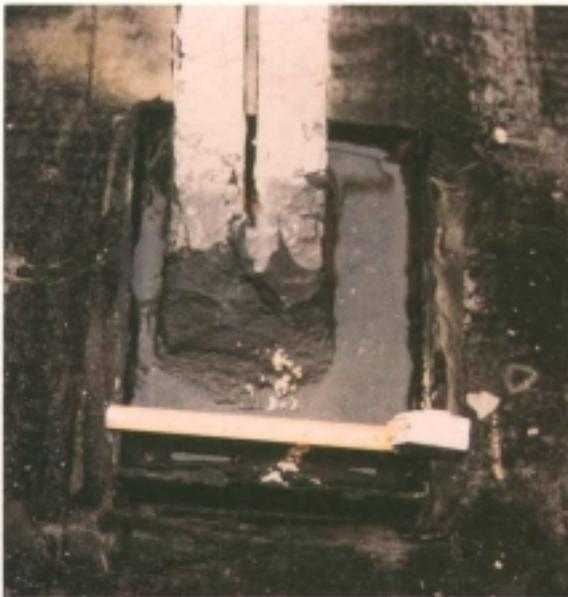
PP3 Pitch Pans  
<High Severity>  
Water standing in pitch pan; fill material not complete

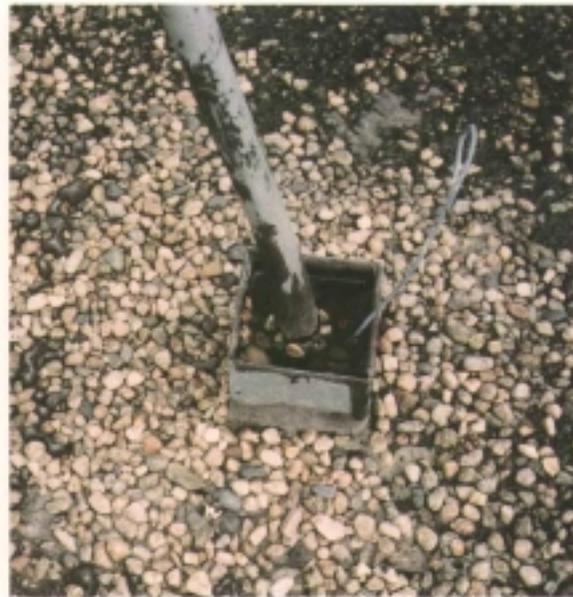
PP4 Pitch Pans  
<High Severity>  
Fill material is low; water standing in pan

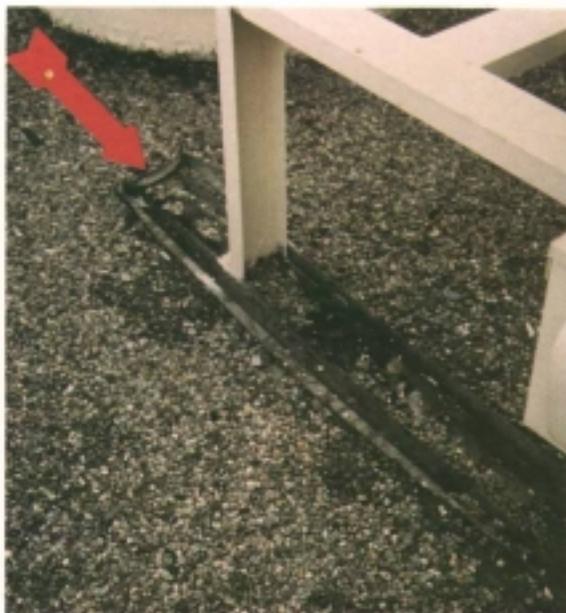
PP5 Pitch Pans  
 <High Severity>  
 Sides of pan are distorted; fill material is low

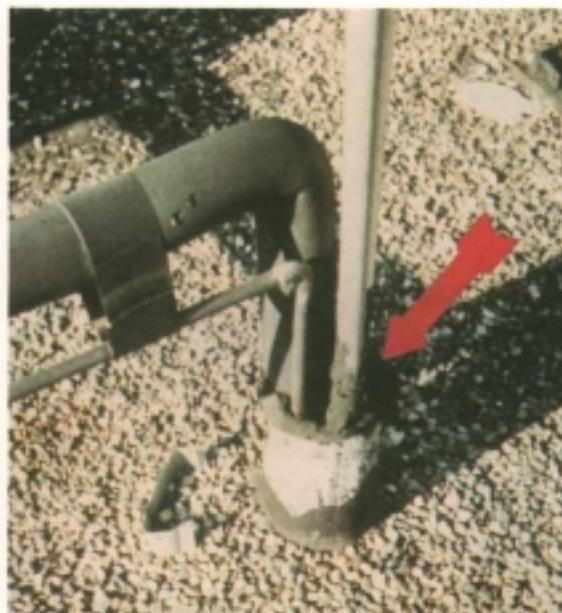
PP6 Pitch Pans  
 <High Severity>  
 Pipe sleeve used as pitch pan has not been filled

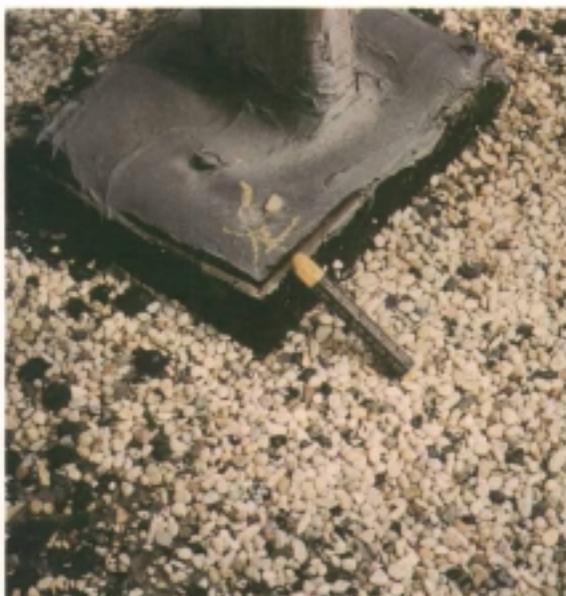
PP7 Pitch Pans  
 <High Severity>  
 Fill material has pulled away from the sides of the pan

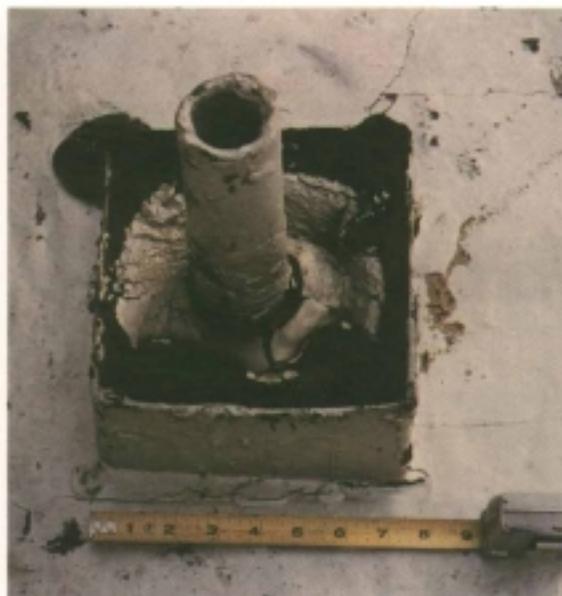
PP8 Pitch Pans  
 <High Severity>  
 Material has pulled away; water can penetrate pan

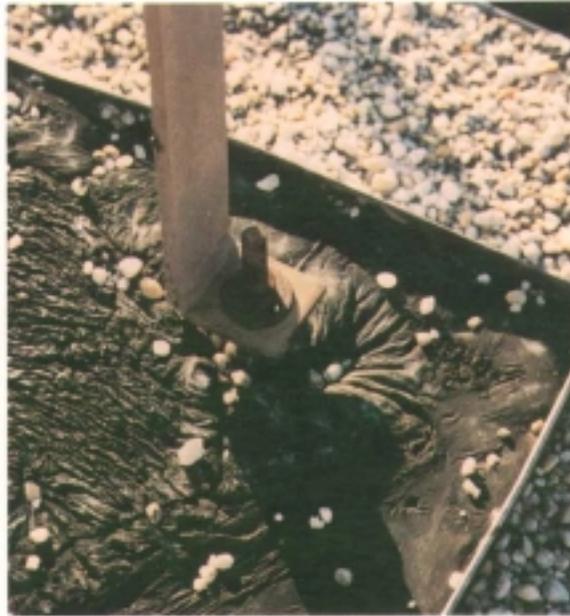
PP9 Pitch Pans  
<High Severity>  
Pan not full

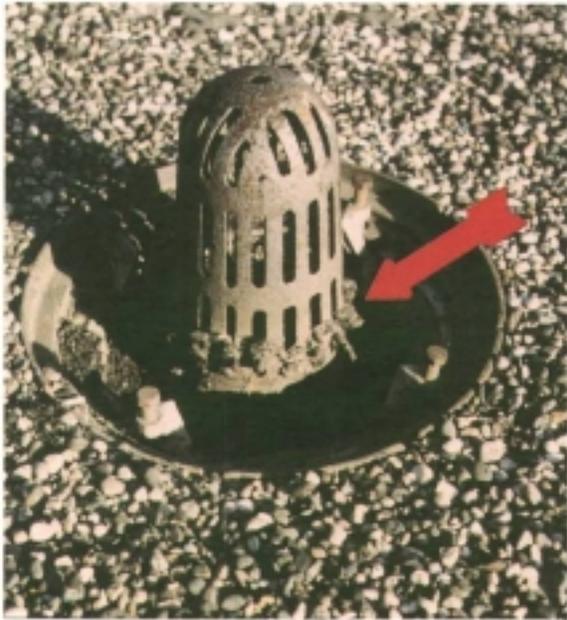
DR1 Drains and Scuppers  
 <Low Severity>  
 Bituminous material has flowed into the drain

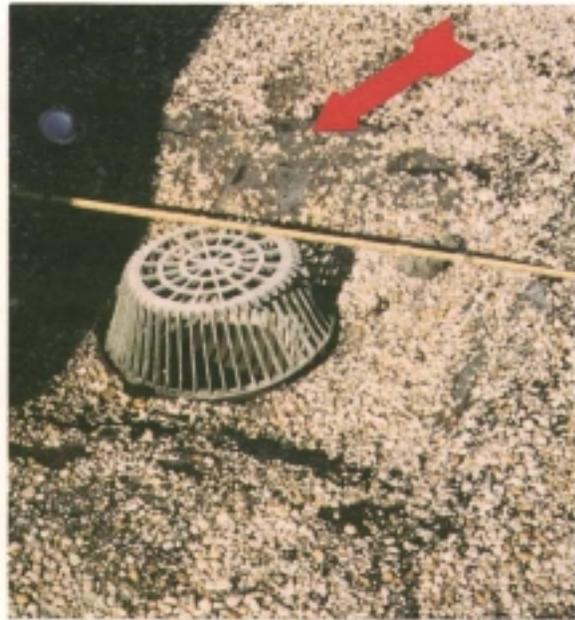
DR2 Drains and Scuppers  
 <Medium Severity>  
 The felts around the drain are exposed

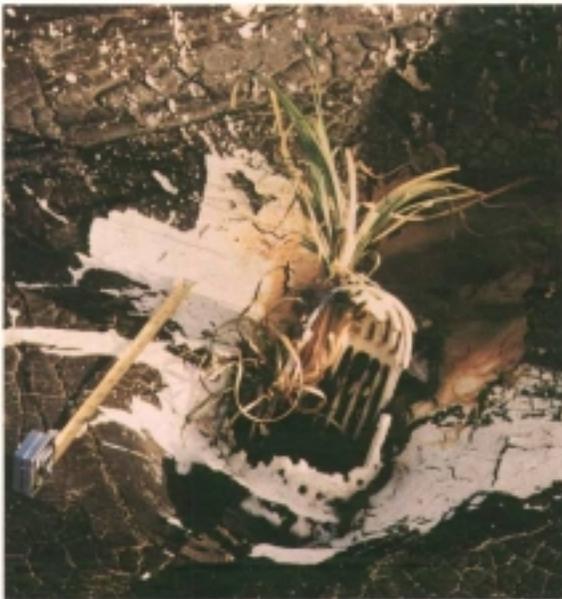
DR7 Drains and Scuppers  
<High Severity>  
The drain is clogged, the clamping ring is missing, and the strainer is broken

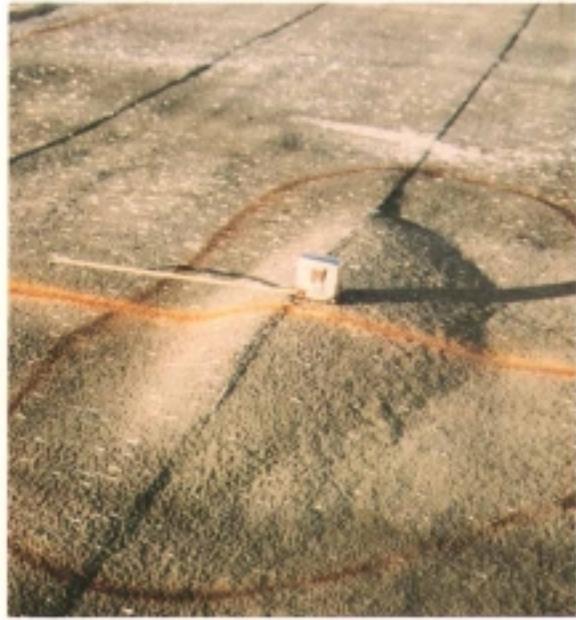
BL2 Blisters  
<Low Severity>  
Large blister but still low severity  
level

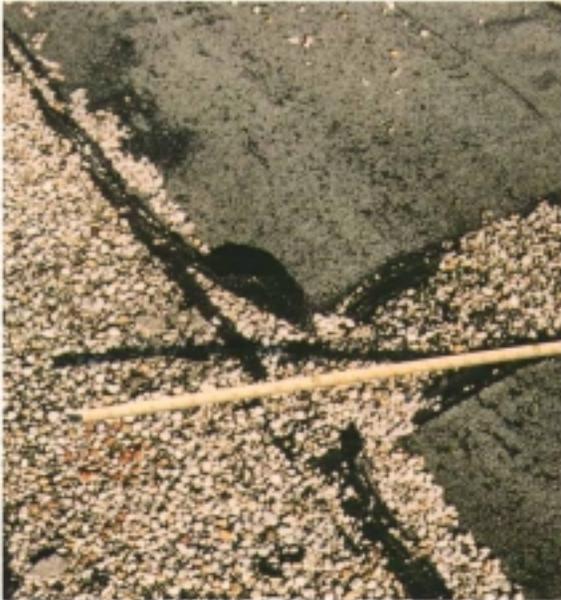
BL3 Blisters  
<Low Severity>  
Blisters in walk-pad application

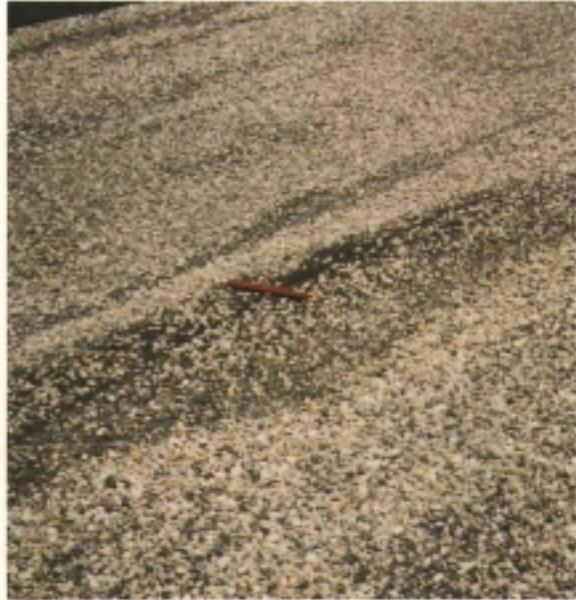
BL4 Blisters  
<Low Severity>  
Blisters in gravel surfaced  
membrane

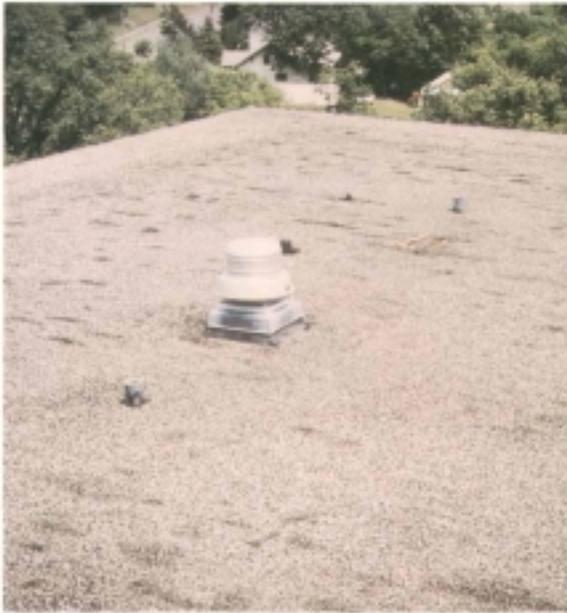
BL5 Blisters  
<Low Severity>  
General blistering over all of roof surface

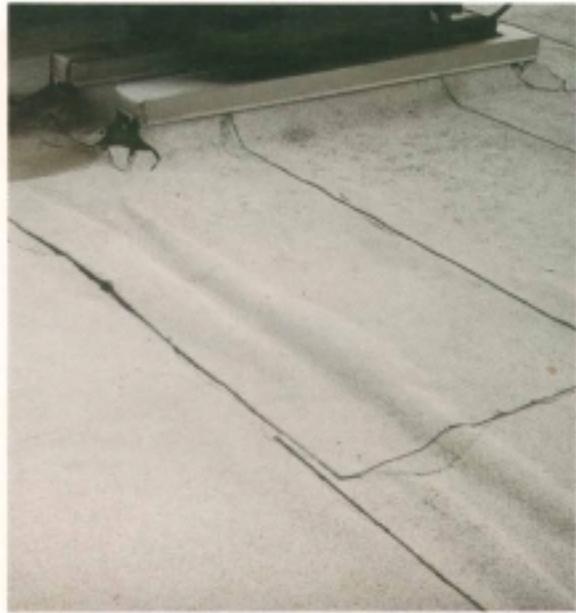
BL6 Blisters  
<Low Severity>  
Blisters in cap sheet

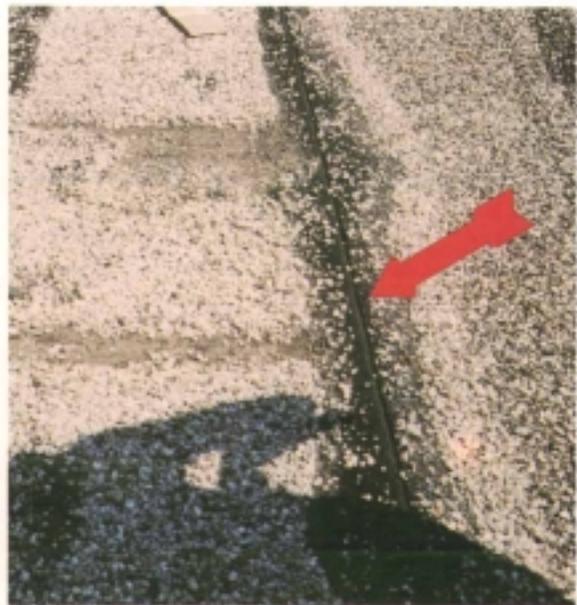
RG4 Ridges  
 <Medium Severity>  
 Bare felt showing; some slippage of felt at lap is evident

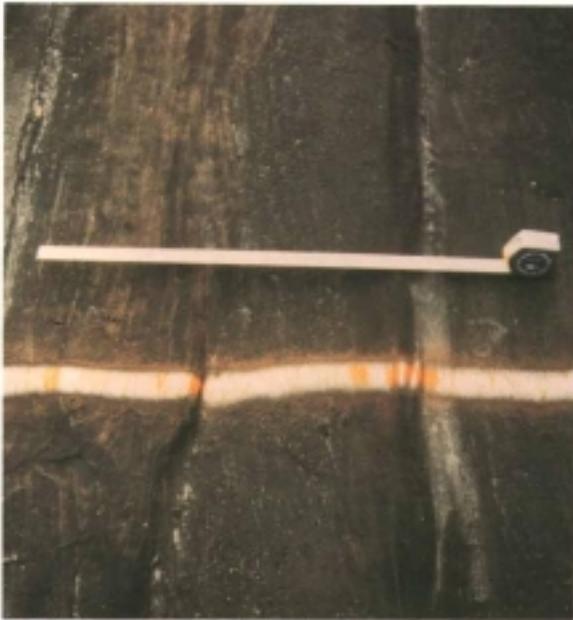
RG5 Ridges  
 <Medium Severity>  
 Smooth surface membrane

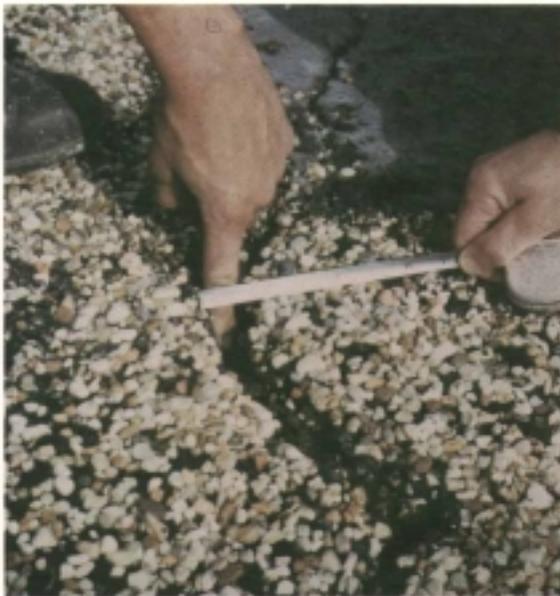
SP3 Splits  
 <High Severity>  
 Large split in gravel surface roof

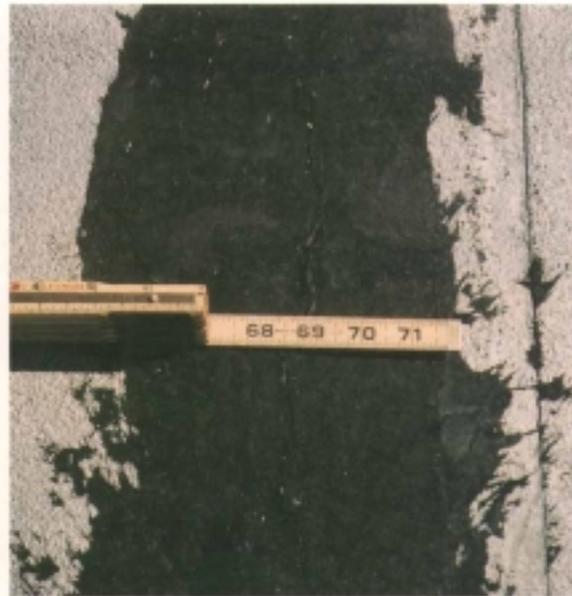
SP4 Splits  
 <High Severity>  
 Split in mineral cap sheet

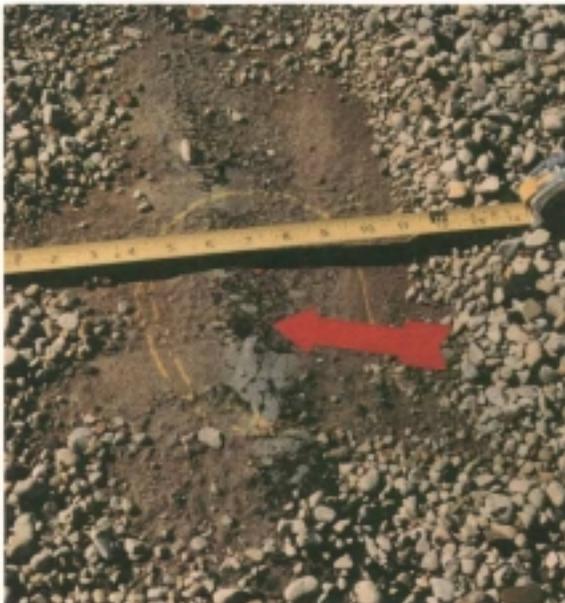
HL1 Holes  
<High Severity>  
Membrane below gravel surface has been penetrated by a sharp object

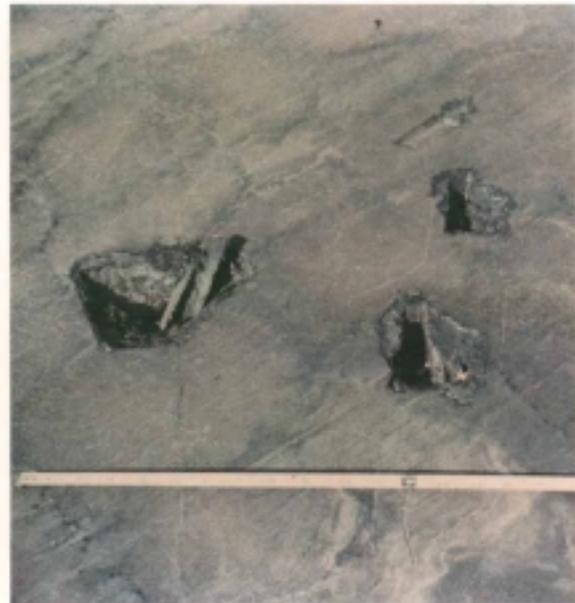
HL2 Holes  
<High Severity>  
Holes in smooth surfaced roof

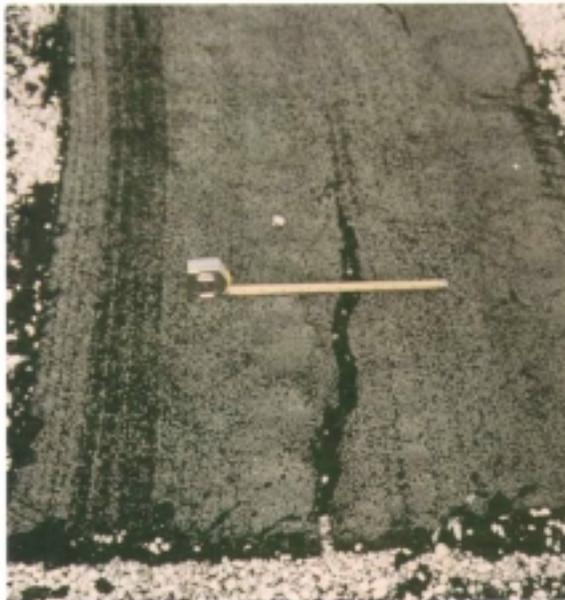
SR3 Surface Deterioration  
 <Low Severity>  
 Walkways are cracked or blistered

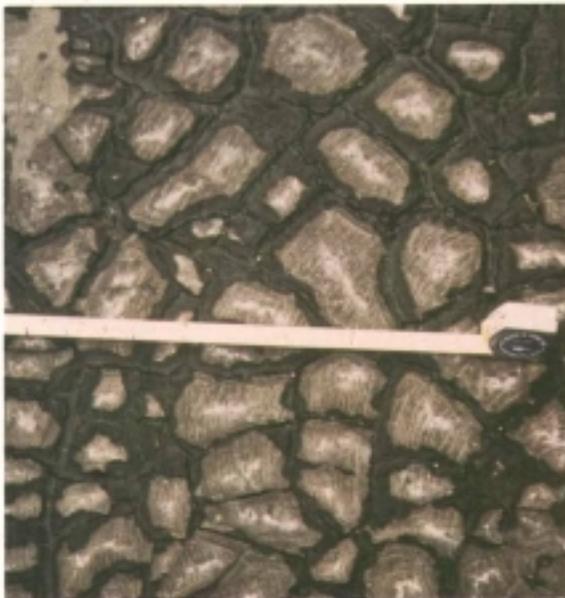
SR7 Surface Deterioration  
<Medium Severity>  
Alligator cracking of the surface  
extends down to the felt

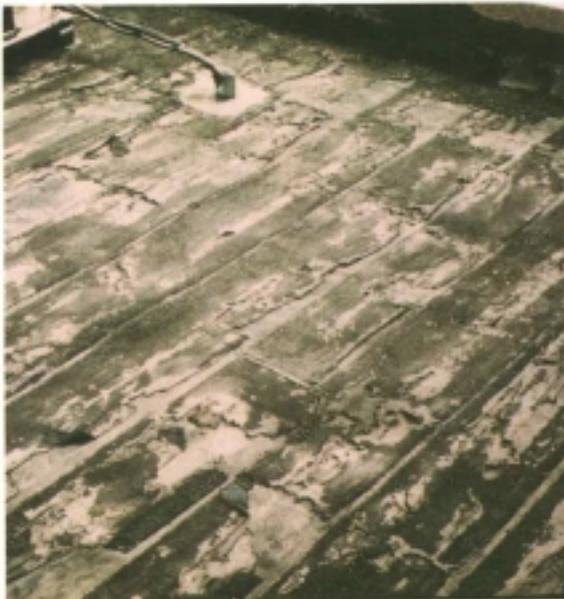
SR11 Surface Deterioration  
 <High Severity>  
 Smooth surface membrane is deteriorated

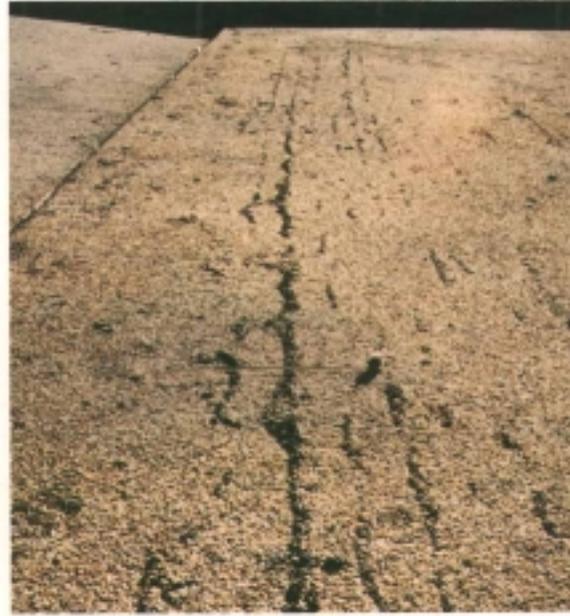
SL2 Slippage  
<High Severity>  
Slippage is greater than 2 in.

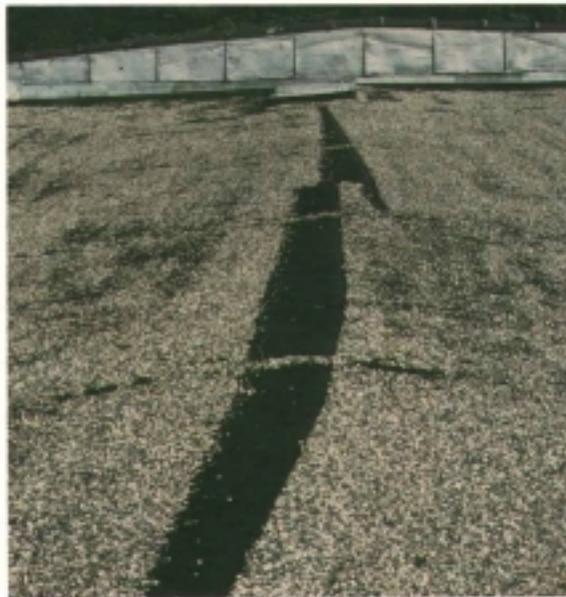
SL3 Slippage  
<High Severity>  
Slippage is evident in surface and  
is greater than 2 in.
